Bryant

319 Westover Road

Historical Brief

REUSE ASSESSMENT

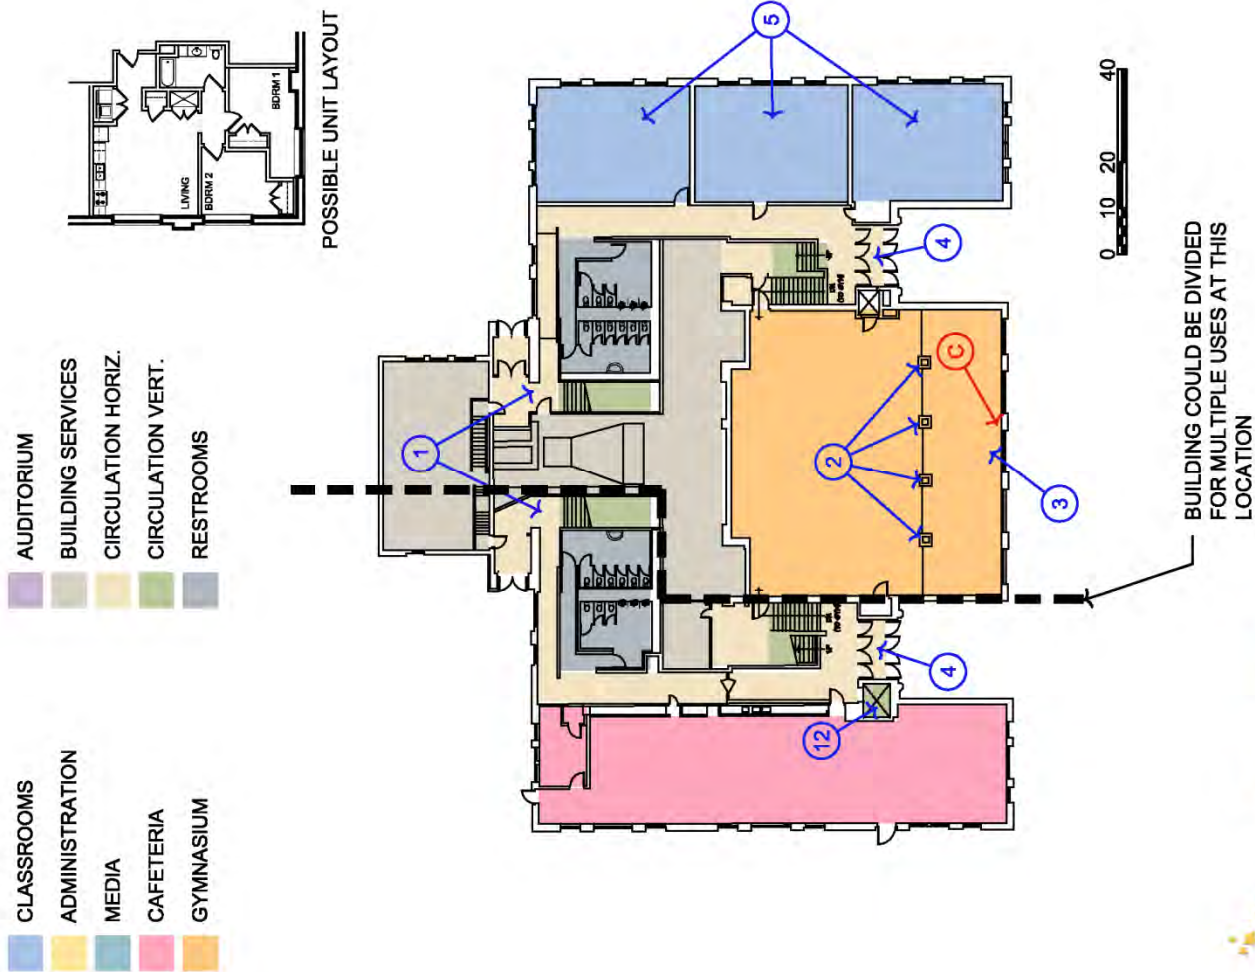
First Floor

1. No connection to opposite side of building at this location
2. Column line in gymnasium
3. Collapsible bleachers
4. Historic vestibules
5. Classrooms are partially below grade
6. Library - housed in original auditorium, raised stage, no fixed seating, and modern finishes
7. Raised stage with no procenium or trim
8. Cloak room
9. Glazed wall
10. Typical classroom includes:
 - a. Coat closet with overhead doors
 - b. Framed chalkboards on perimeter walls
11. Wide corridors and stairs provide ample circulation
12. Single elevator may be small to serve multiple uses

- A. Mold on ceiling
- B. Cracked plaster likely due to settlement
- C. Peeling paint
- D. Damaged plaster
- E. Deteriorated exterior concrete header

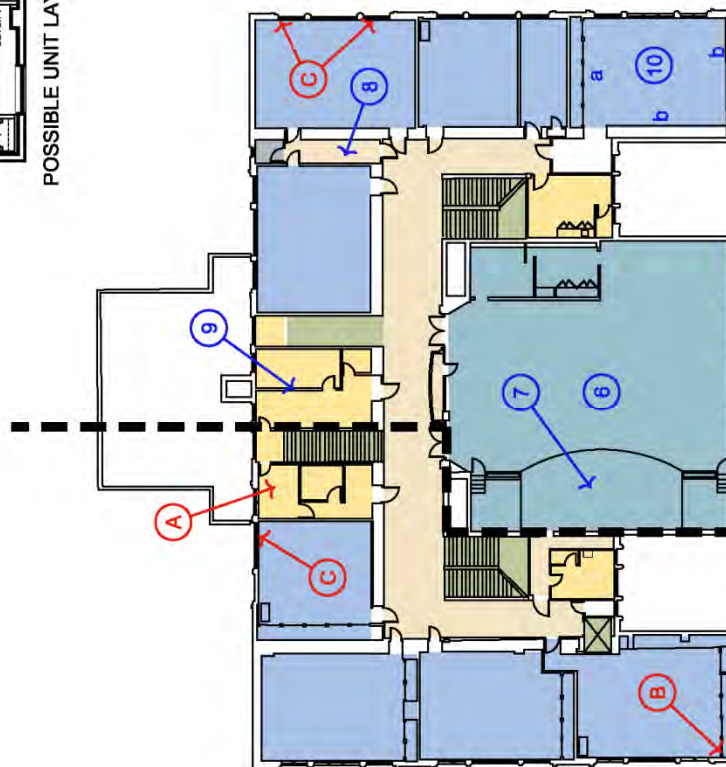
Second Floor

1. No connection to opposite side of building at this location
2. Column line in gymnasium
3. Collapsible bleachers
4. Historic vestibules
5. Classrooms are partially below grade
6. Library - housed in original auditorium, raised stage, no fixed seating, and modern finishes
7. Raised stage with no proscenium or trim
8. Cloak room
9. Glazed wall
10. Typical classroom includes:
 - a. Coat closet with overhead doors
 - b. Framed chalkboards on perimeter walls
11. Wide corridors and stairs provide ample circulation
12. Single elevator may be small to serve multiple uses

- A. Mold on ceiling
- B. Cracked plaster likely due to settlement
- C. Peeling paint
- D. Damaged plaster
- E. Deteriorated exterior concrete header

BUILDING COULD BE DIVIDED FOR MULTIPLE USES AT THIS LOCATION

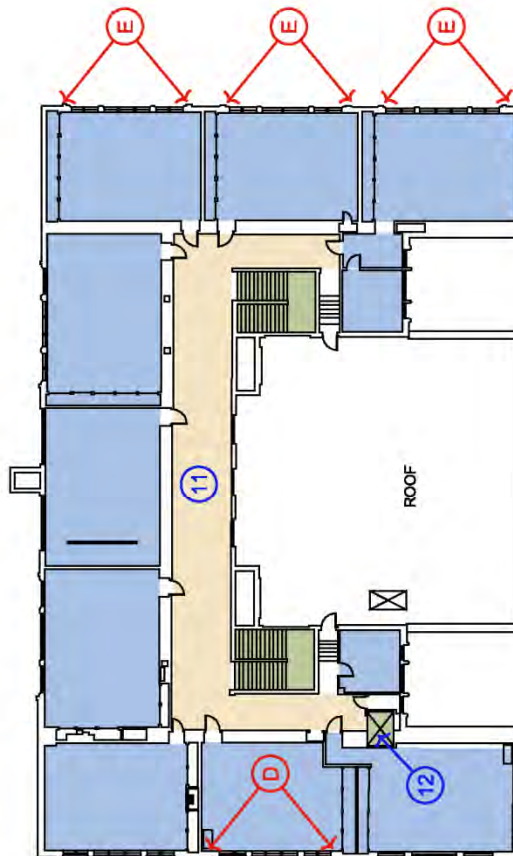
Third Floor

1. No connection to opposite side of building at this location
 2. Column line in gymnasium
 3. Collapsible bleachers
 4. Historic vestibules
 5. Classrooms are partially below grade
 6. Library - housed in original auditorium, raised stage, no fixed seating, and modern finishes
 7. Raised stage with no procenium or trim
 8. Cloak room
 9. Glazed wall
 10. Typical classroom includes:
 - a. Coat closet with overhead doors
 - b. Framed chalkboards on perimeter walls
 11. Wide corridors and stairs provide ample circulation
 12. Single elevator may be small to serve multiple uses
- CONDITION NOTES**
- A. Mold on ceiling
 - B. Cracked plaster likely due to settlement
 - C. Peeling paint
 - D. Damaged plaster
 - E. Deteriorated exterior concrete header

THIS LEVEL COULD NOT BE DIVIDED FOR MULTIPLE USES UNLESS MORE EXITS ARE PROVIDED

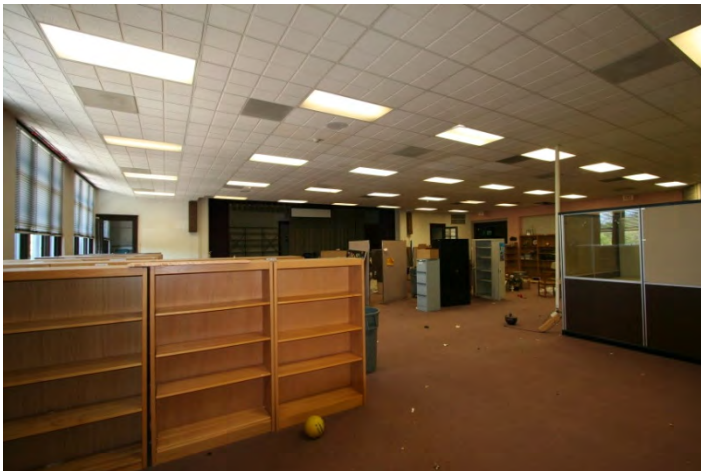
Media library (old auditorium)

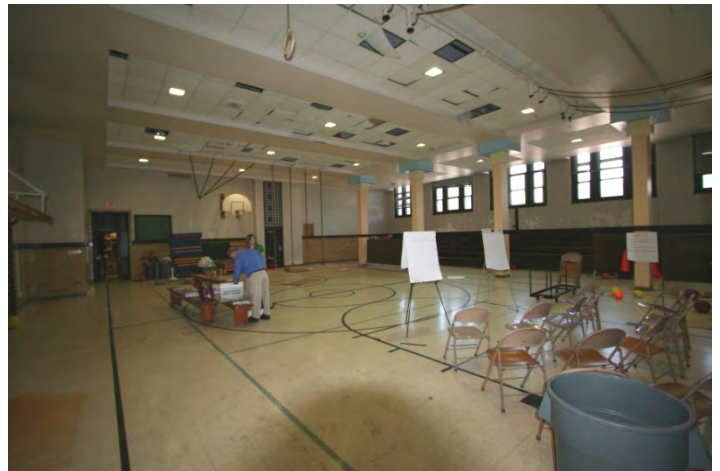
Gymnasium
