REUSE STRATEGY AND ACTION PLAN

DOUGLASS SCHOOL SITE

2640 Belleview, Kansas City, Missouri 64108

KANSAS CITY, MISSOURI SCHOOL DISTRICT

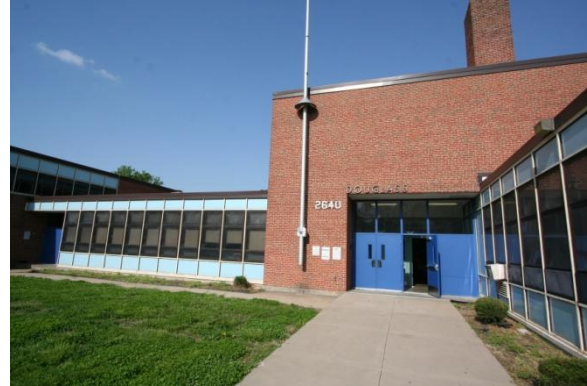
Rosin Preservation and SWD conducted a site visit to the building on April 30, 2011. The site visit examined the school site and the exterior and interior of the building. The team visited the ground floor, first floor and second floor. The roof was not accessible for review, and mechanical and electrical systems were not reviewed. No invasive or destructive review techniques were employed.

The building is structurally sound. The exterior envelop is in good condition with remaining usable life of the envelop components. Building envelop requires only minor repairs. Interior finishes are in fair condition with typical wear from use. The mechanical and electrical systems appear to be sufficient and in good condition for immediate building use. The exterior site requires repairs of damaged areas, including parking and playground areas and stone retaining walls.

- Foundation: Concrete, generally in good condition.
- Floor Framing: Concrete, generally in good condition.
- Roof Framing: Undetermined, believed to be concrete.
