**Re: Consumer Protection Investigation of Crumbling Concrete Home Foundations**

# **INVESTIGATING THE DETERIORATION OF BASEMENT WALLS MADE OF CONCRETE IN CT**

Kay Wille<sup>1</sup> and Rui Zhong<sup>2</sup>

August, 31st 2016

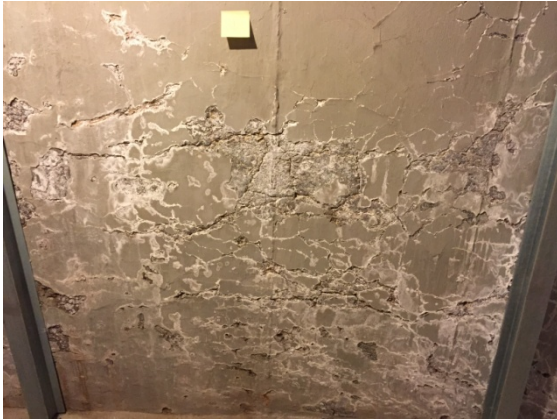
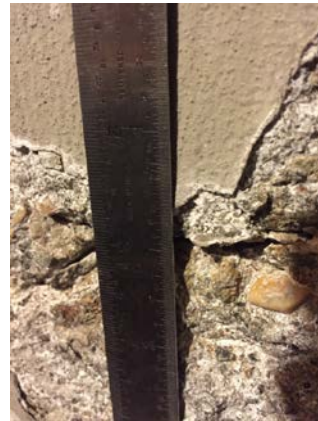
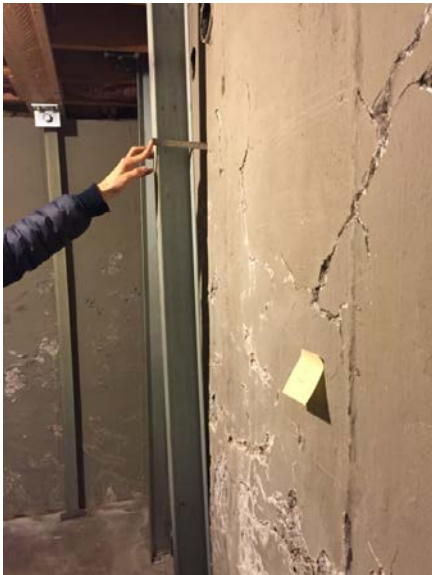
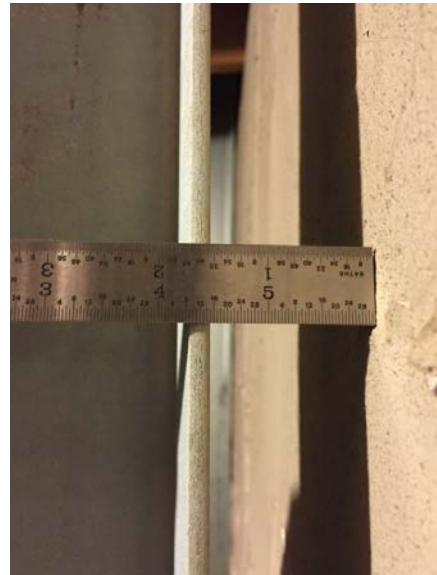
**Fig. 3.2 Typical symptoms of deteriorated foundation**

- map cracking with wide opening and/or significant deformation of the wall
- whitish formation of minerals at the vicinity of cracking surface
- reddish - brown discoloring

a) map cracking

b) Abundant whitish powder

c) reddish – brown discoloring

d) crack opening (>4mm)

e) significant deformation of the concrete foundation wall

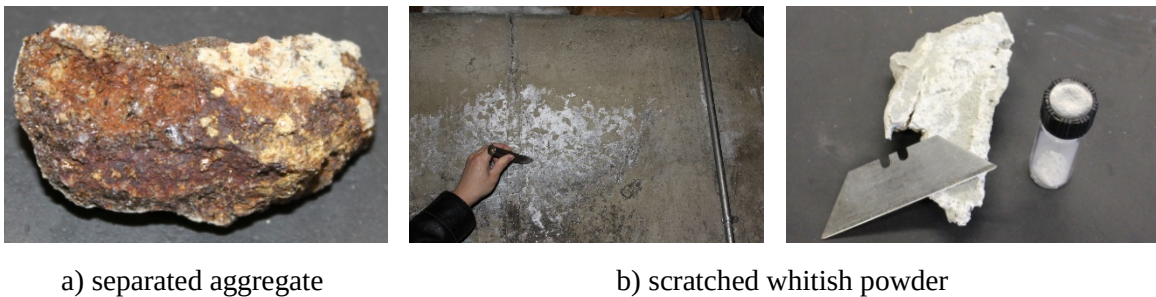
Brown aggregate, which is a sign of iron sulfide oxidation, were selected for this investigation. Aggregates were separated from cement matrix (**Fig. 6.1a**). Similar procedures described in section 5.1.1 were followed. The whitish formation was scratched off the surface of the deteriorated concrete foundation for XRD testing (**Fig. 6.1b**). All specimens were step-scanned as random powder from  $11^\circ$  to  $80^\circ$  at  $0.02^\circ$   $2\theta$  steps integrated at  $1\text{s step}^{-1}$ .

Fig. 6.1 Sample preparation for XRD testing

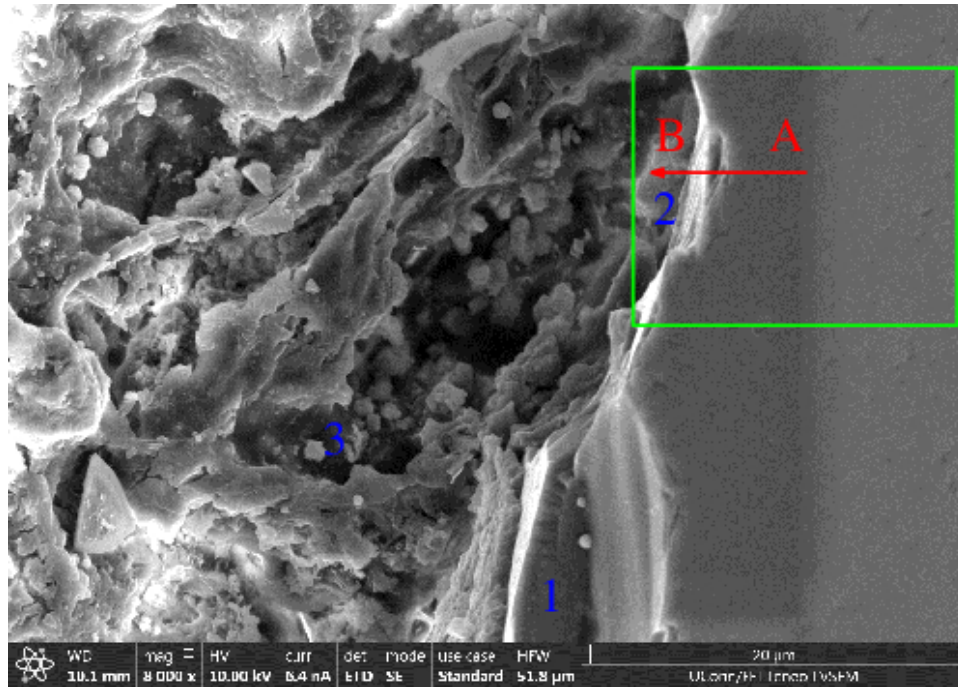
Sulfate is required for the delayed formation of expansive and thus detrimental secondary minerals. A potential source is the release of sulfate upon oxidation of pyrrhotite contained in aggregate. Previous examination on aggregate has proven the existence of pyrrhotite. In this section, a micro structural assessment of the aggregate was conducted to confirm the oxidization of aggregate. **Fig. 7.2** shows the microstructure of an interfacial transition zone (ITZ) between aggregate and cement paste. Point, linear and mapping EDXS elementary analysis were conducted.

**Fig. 7.2 Micro structure of the investigated ITZ**

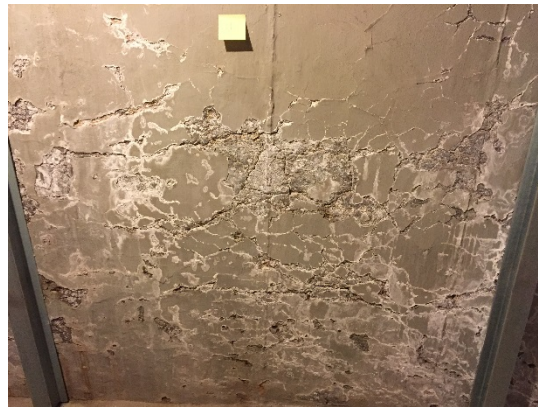
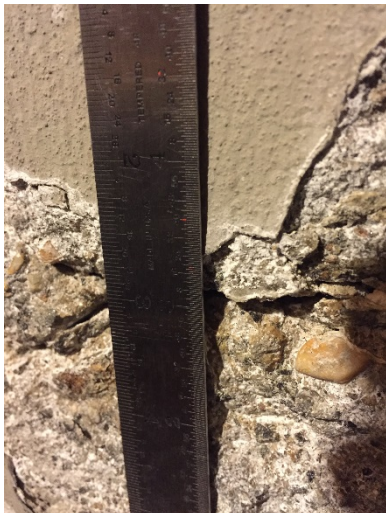
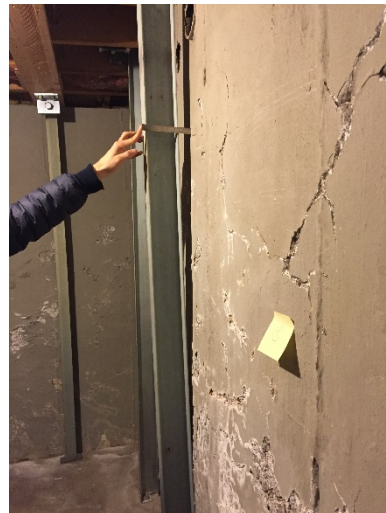
**Fig. A- 1 House 1**

(a) whitish powder

(b) brown trace

(c) map cracking

(d) wide crack opening

(e) large deformation

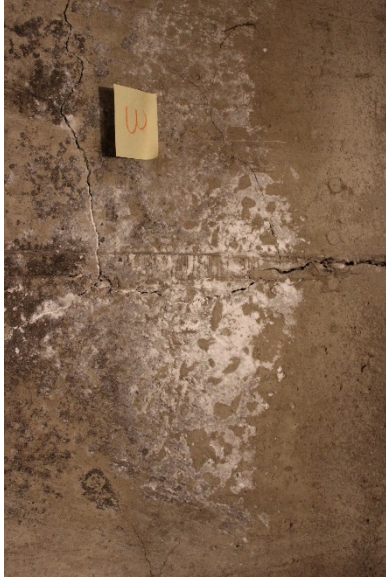
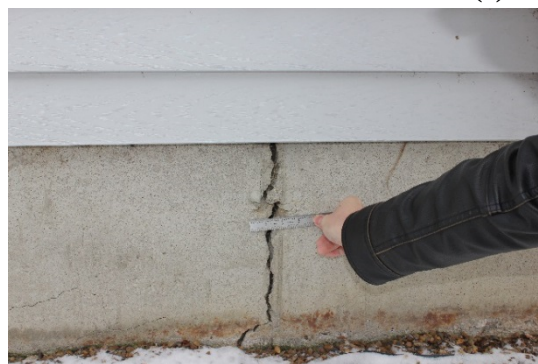
**Fig. A- 3 House 3**

(a) whitish powder

(b) brown trace

(c) map cracking

(d) wide crack opening

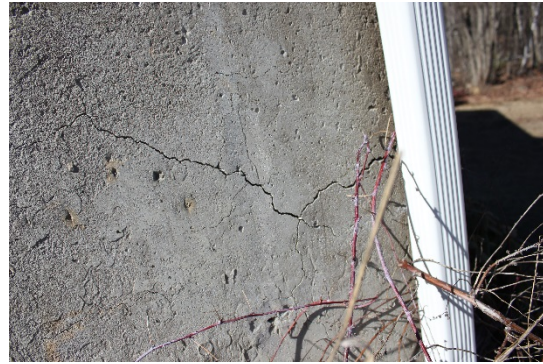
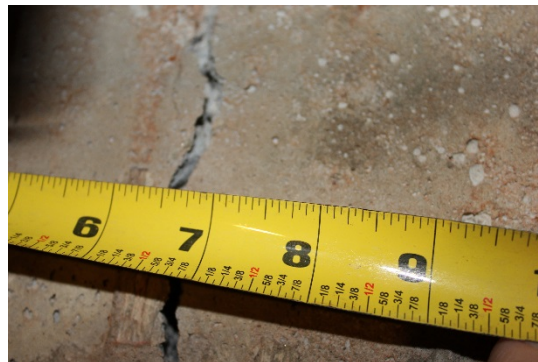
**Fig. A- 4 House 4**

(a) whitish powder

(b) brown trace

(c) map cracking

(d) wide crack opening

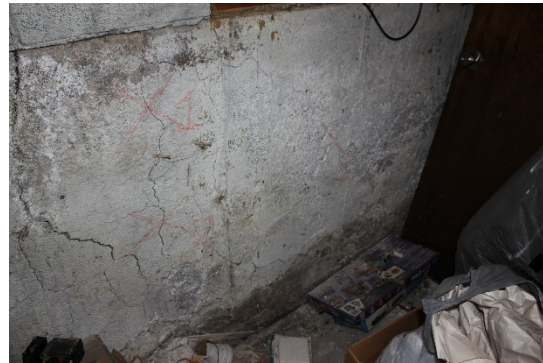
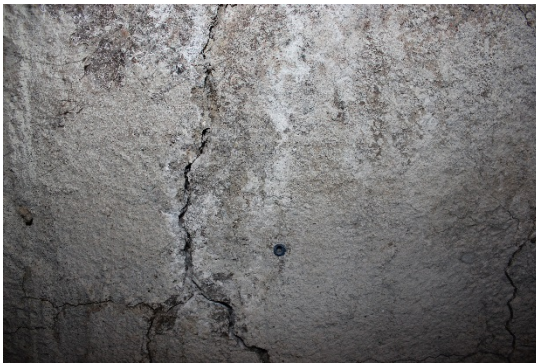
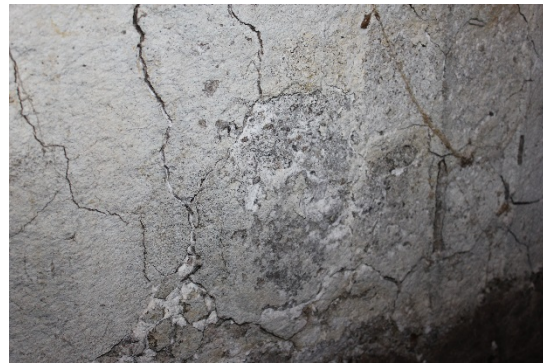
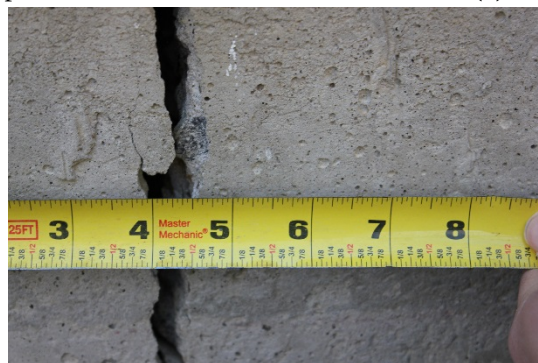
**Fig. A- 5 House 5**

(a) whitish powder

(c) map cracking

(d) wide crack opening

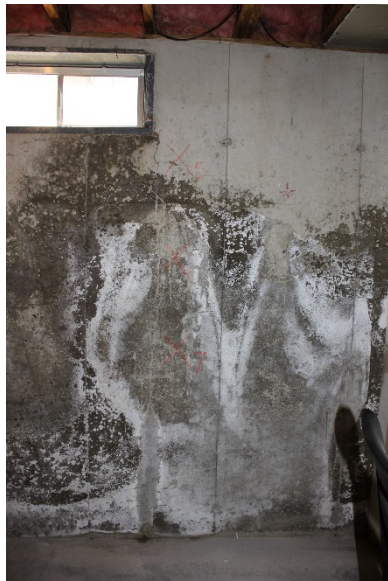
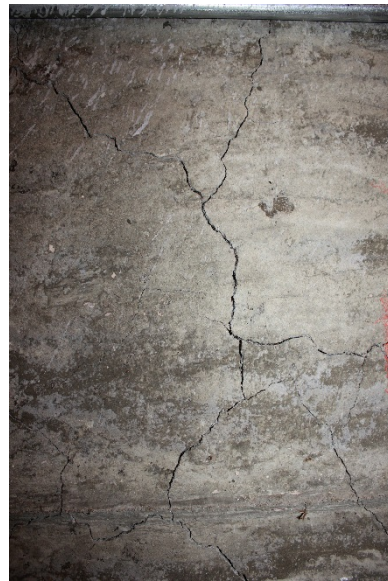
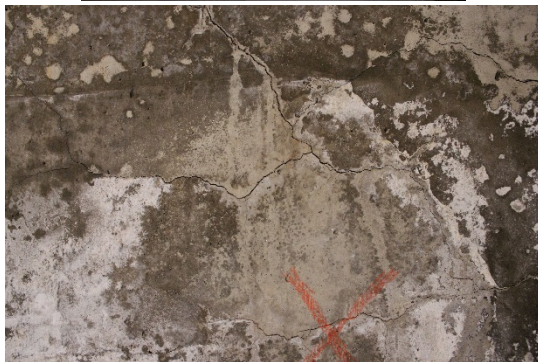
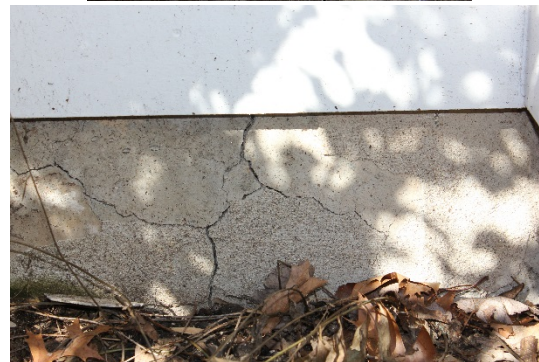
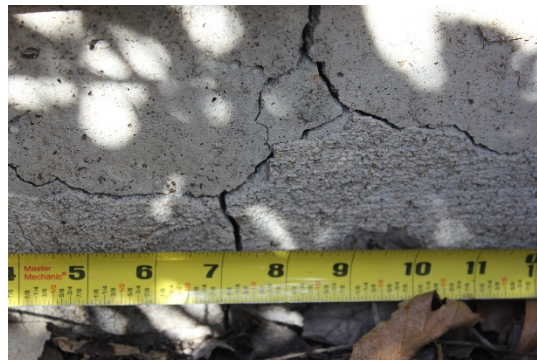
**Fig. A- 6 House 6**

(a) whitish powder

(b) map cracking

(c) wide crack opening

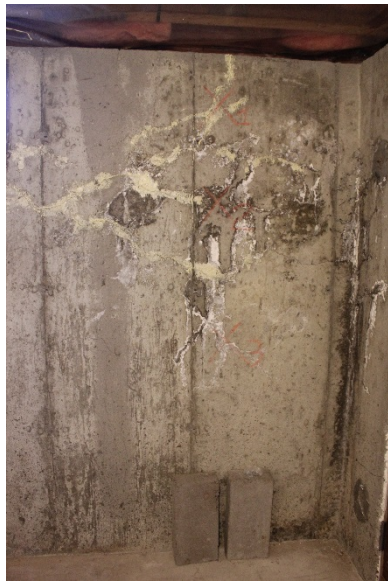
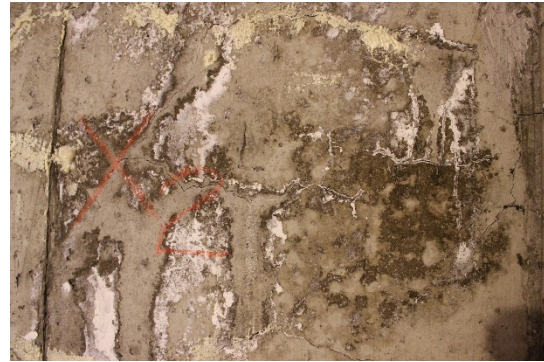
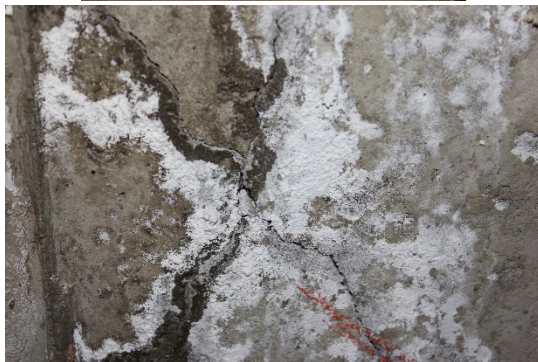
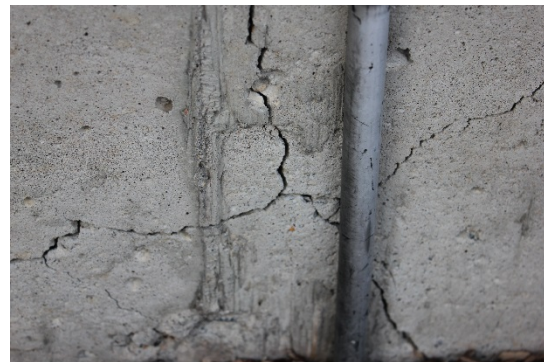
**Fig. A- 7 House 7**

(a) whitish powder

(b) map cracking
