# ROCHESTER COMMUNITY SCHOOLS

## **2021 FACILITY ANALYSIS AND RECOMMENDATION TO THE BOARD OF EDUCATION**

April 12, 2021

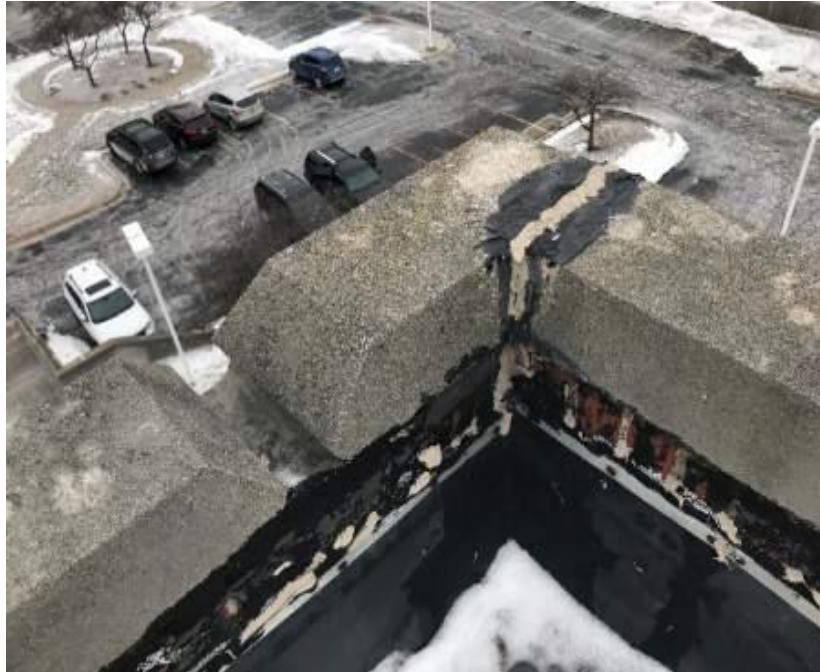
Typical issue for the top of the wall where there is stone coping. Roof membrane should go up the wall and under the stone coping.

1. **Roof replacement** – including reworking parapet to roofing material intersections; removing and replacing top stone/precast caps; sealing the roof and parapets from the elements; removing and replacing steel lintels over windows

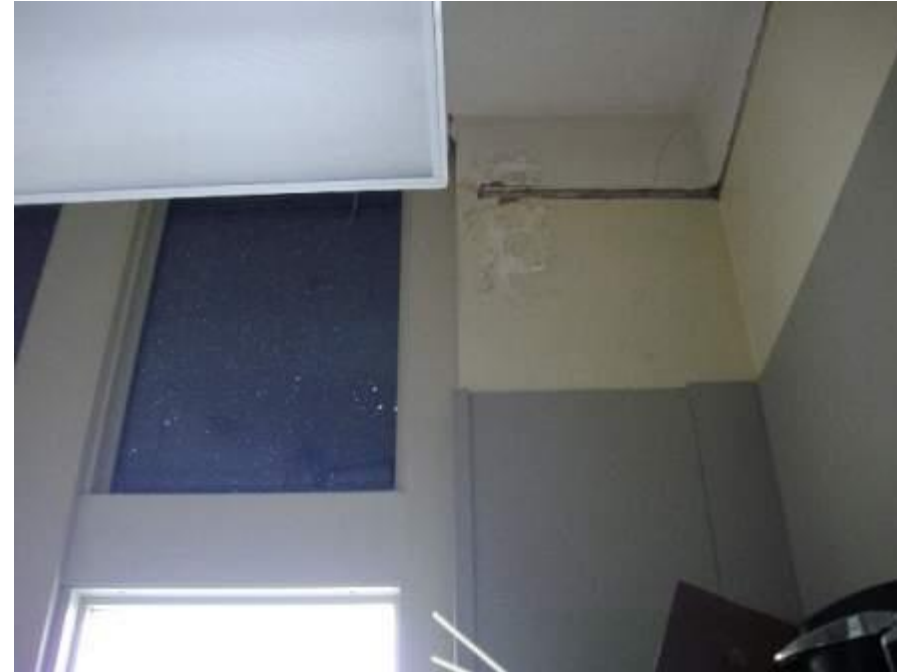
Typical window head on the third level. Water damage to window head and wall.

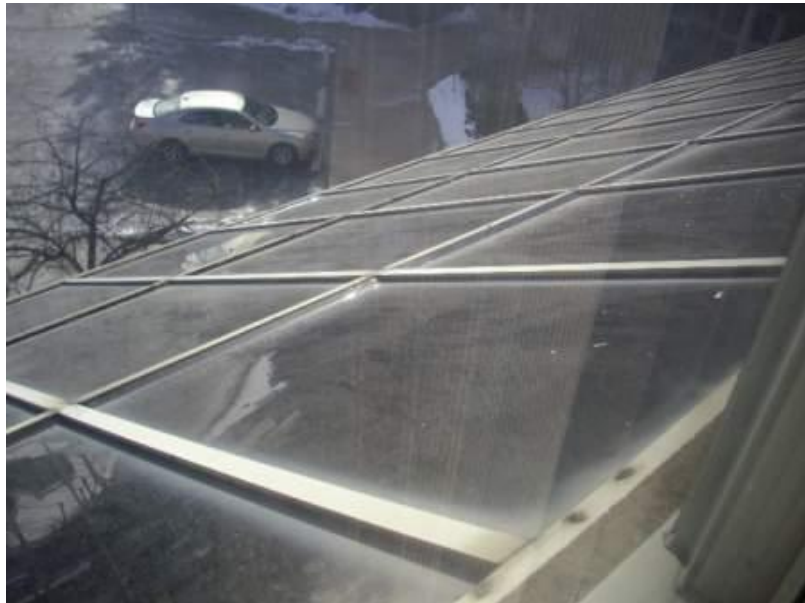
Typical condition of main corridor sloped skylight. Design does not allow for free flow of moisture.

2. **Replace 1989 lobby addition** – damage to structure over time above the lobby and corridor windows is so severe remediation is impossible; entire structure must be demolished and rebuilt

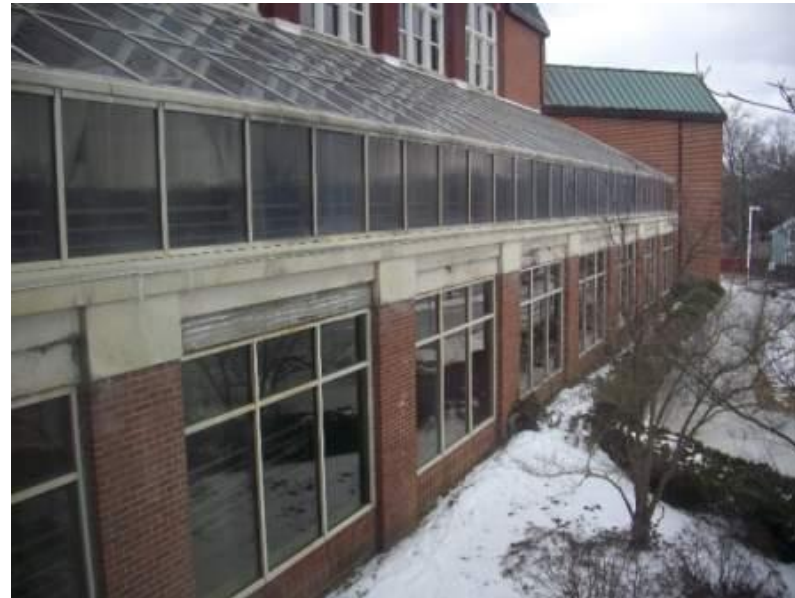
Hallway atrium in disrepair. Full re-build required in any renovation.

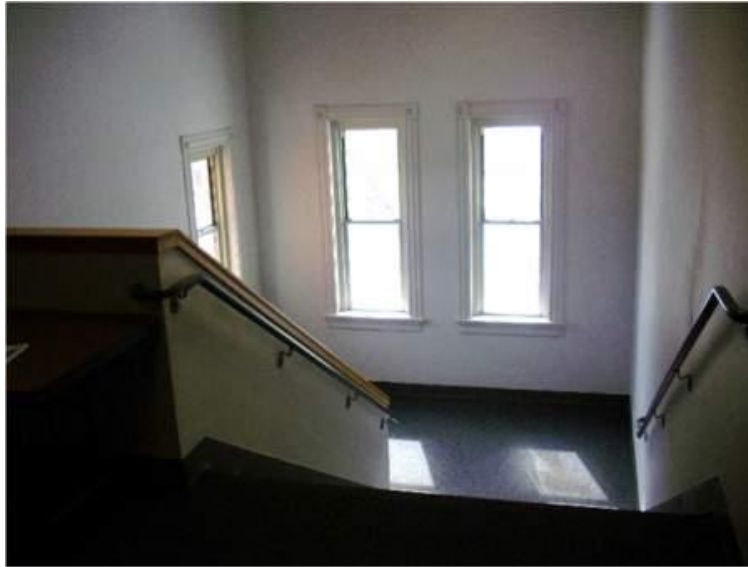
Stair to be enclosed and combustible material replaced. Under renovation, code dictates stairs to be enclosed.

4. **Stairways and elevators** – none of the stairways within the facility meet current codes; guardrails and handrails would have to be rebuilt in two of the stairways; two stairways would have to be enclosed with fire-rated doors installed; fire rated doors would have to be replaced in two stairways; and the combustible material would have to be removed in one stairway. New fire-rated doors and frames would have to be installed at the freight elevator on all floors.

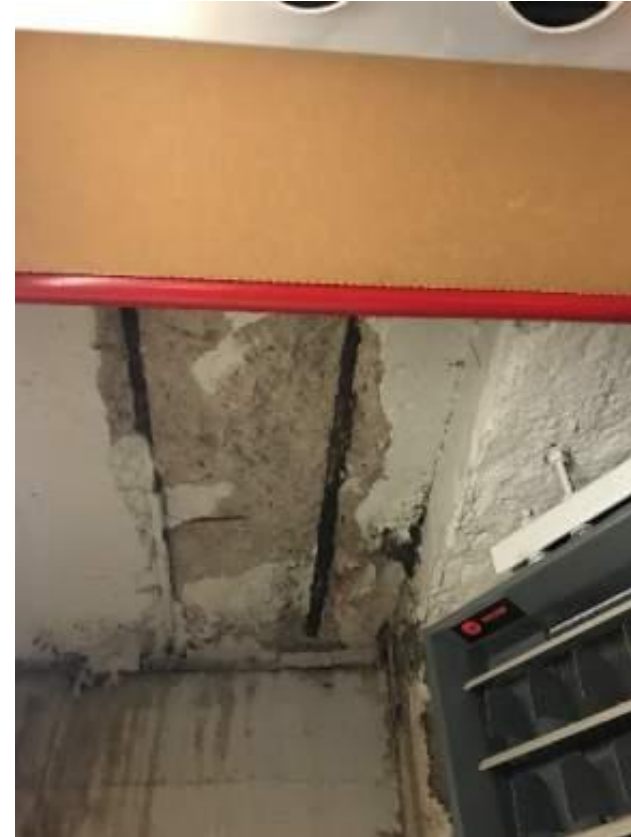
Room under exterior walkway. Damage has been caused by the infiltration of water and room should be demolished.

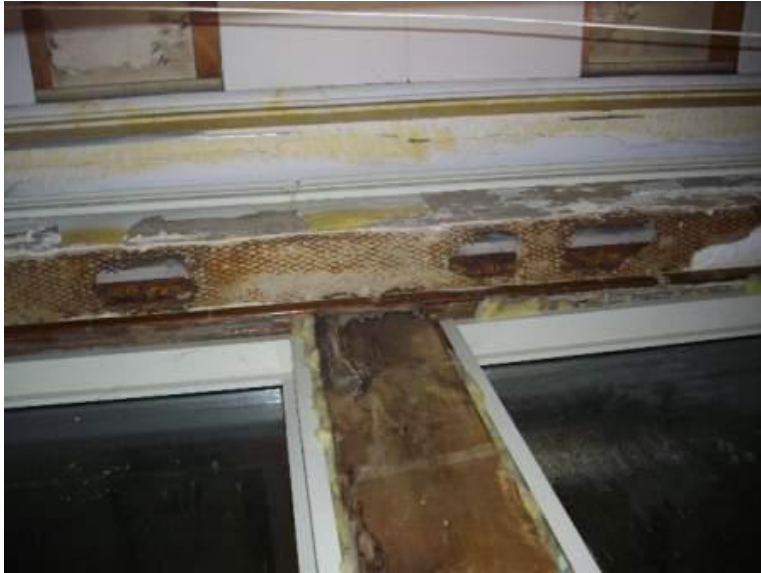
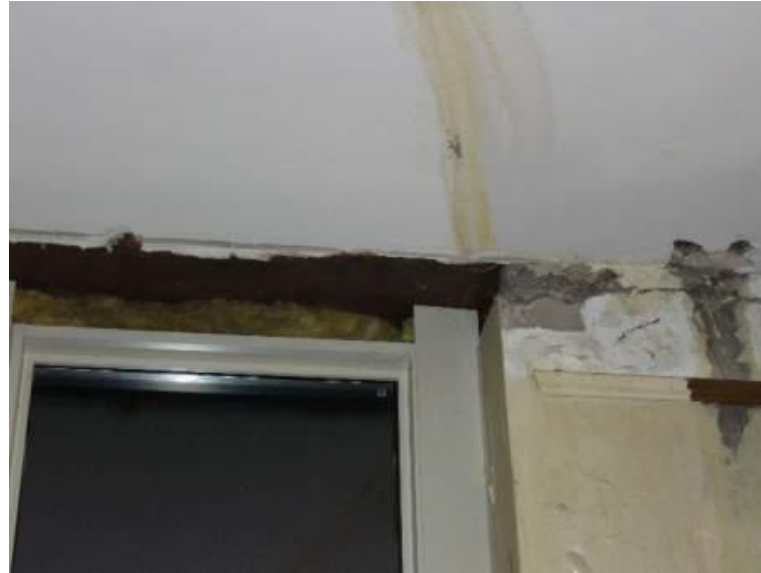
Typical level 3 window head above ceiling.

**Also:** windows (majority have failing sealant and have been damaged over time from leaking parapets and lack of weep holes; doors (some do not meet barrier-free clear space); ramp (does not meet barrier-free code; stairs are deteriorating); exterior stair to board room (does not meet code standards and would require new drainage and replacement of concrete around stairway)
