April 12, 2021

RE: **WETLANDS ASSESSMENT: *Summary of Findings***
 The Village at Naek Road

291 & 293 Talcottville Road, 27, 32,37,38, & 46 Naek Road, Vernon, CT

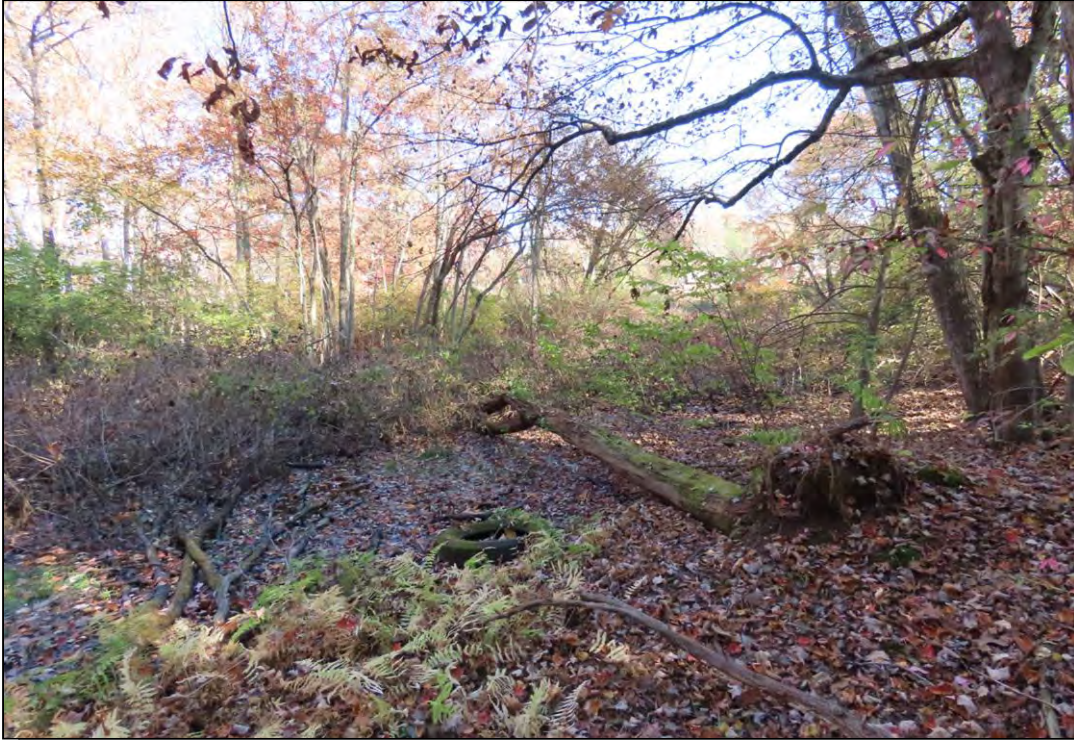
Photo 1: Facing easterly. Wetland B1, the northern wetland with vernal pool habitat, when water level is very low. Buttonbush shrub swamp in background at left.

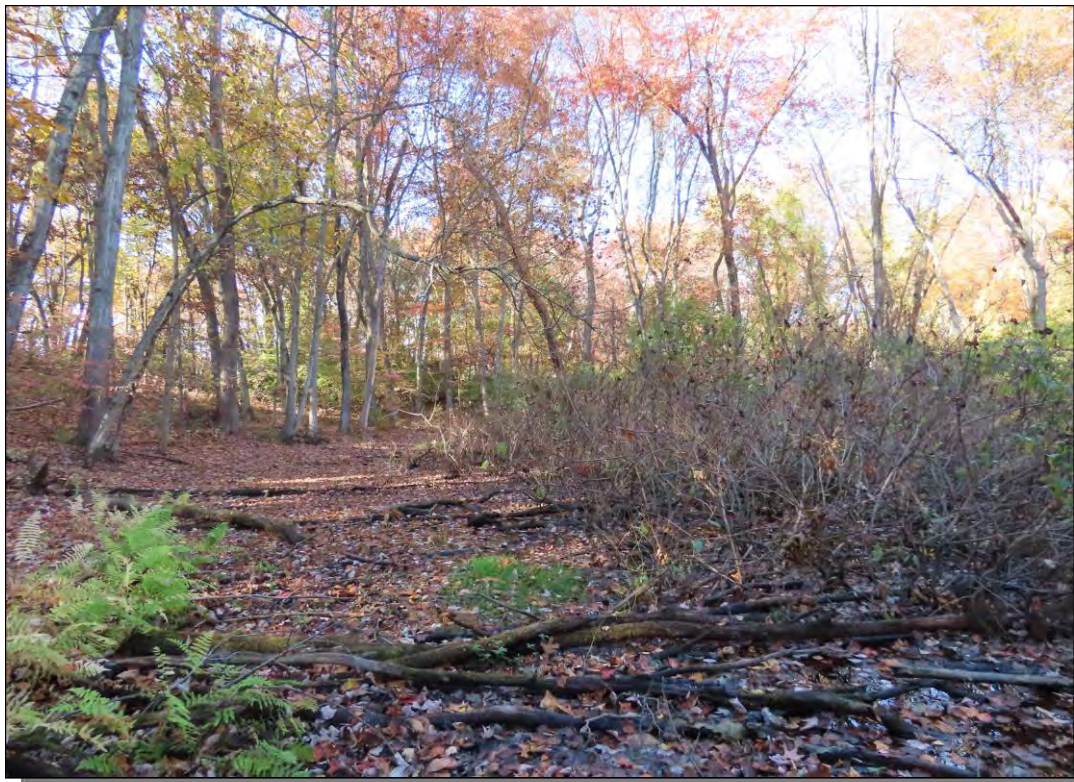
Photo 2. Westerly view. Wetland C; buttonbush shrub swamp at right. 100-feet of the upland mixed hardwood forest at left rear is to be preserved.

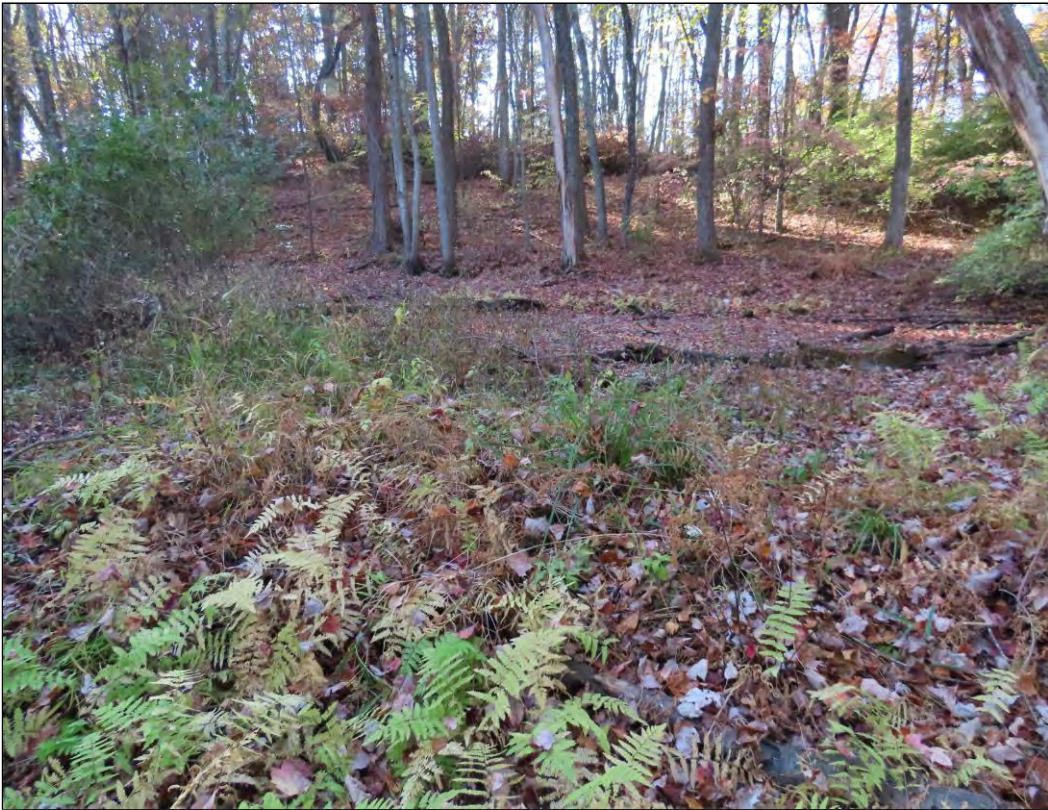
Photo 3: Southwesterly view of wet meadow fringe of eastern vernal pool, Wetland B, and of the adjacent upland with maturing, post-agricultural mixed hardwood forest.

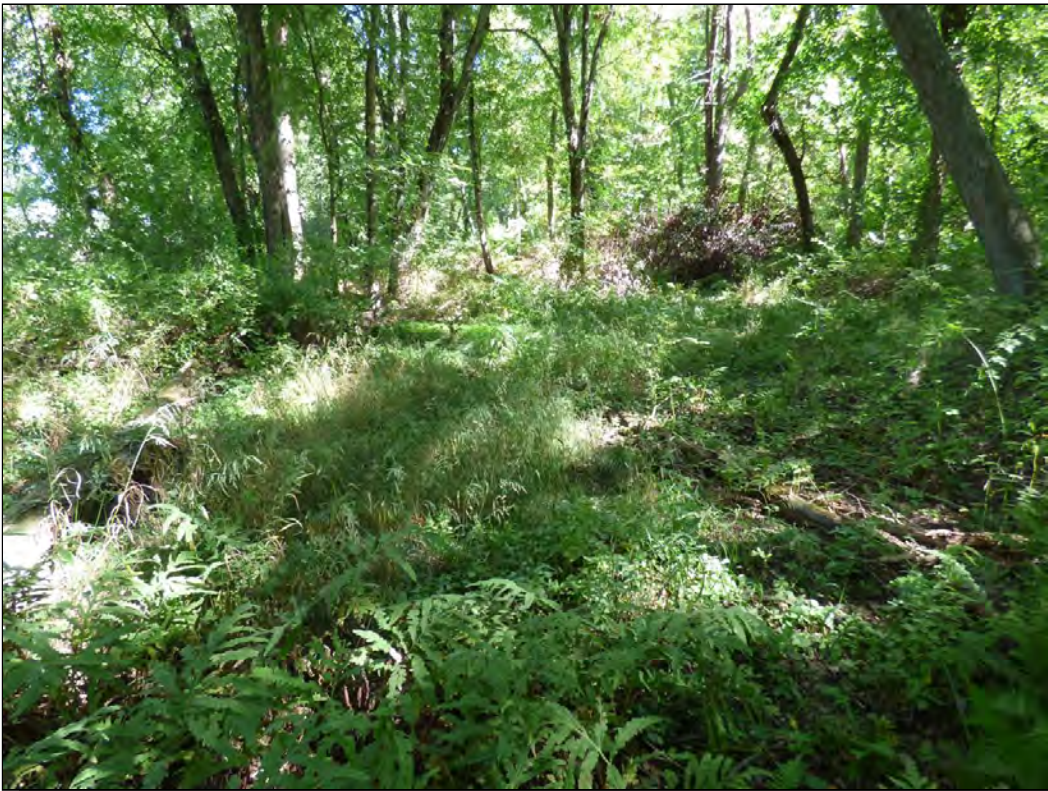
Photo 4. Northeastern floodplain terrace (Wetland B) with a mosaic of red maple clumps and wet meadow, including sensitive fern and blue joint grass.

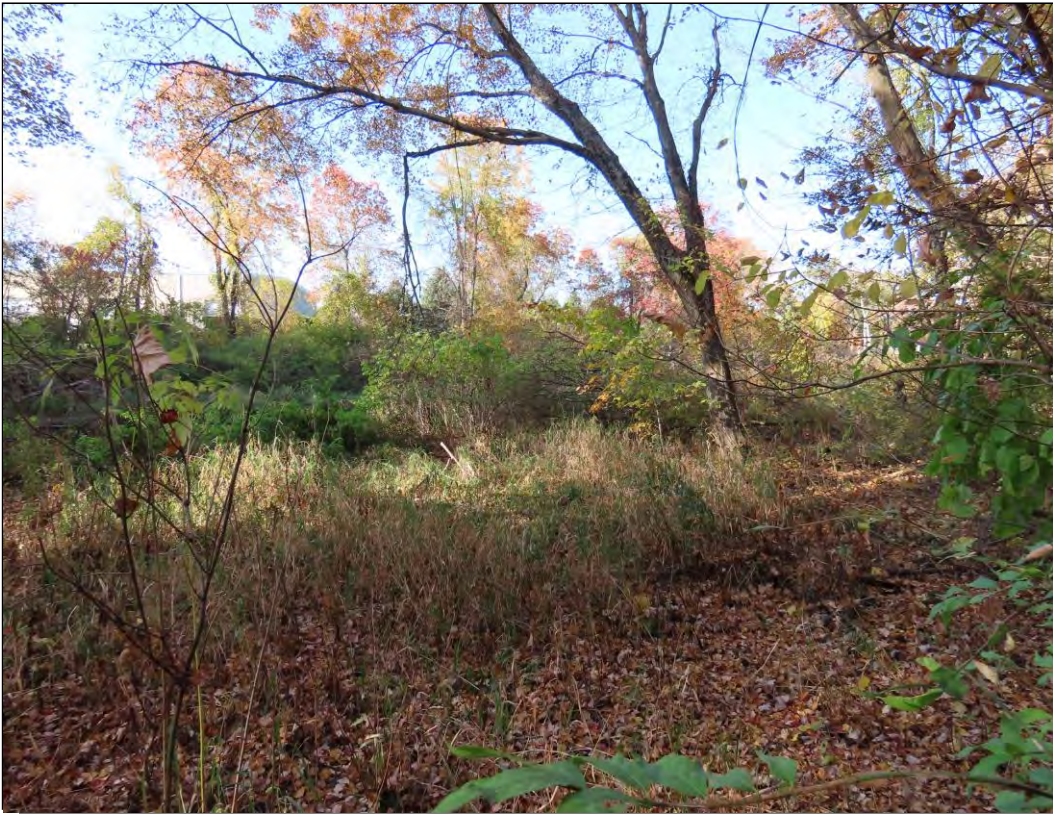
Photo 5: Mid-October view of wet meadow on the river terrace, with shrubs and trees in background, closer to the river. Trail in foreground.

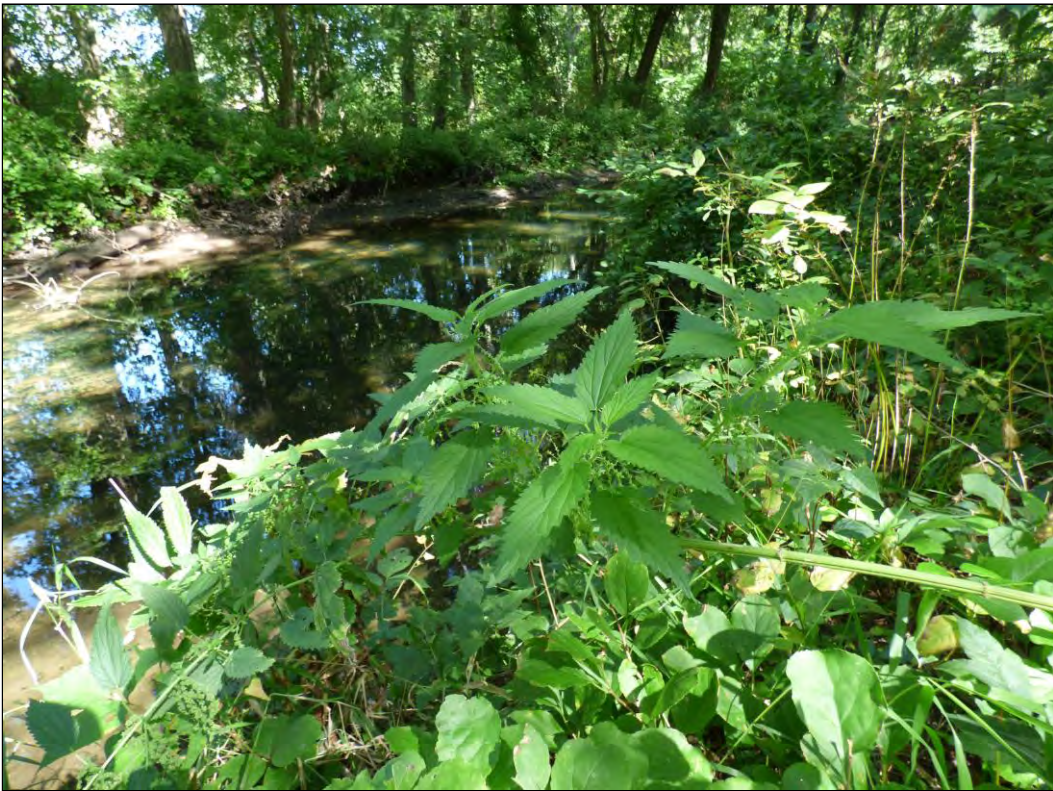
Photo 6. Floodplain herbaceous vegetation includes tall, heavy-seeding annual forbs, that often grow on the riverbank. Stinging nettles are shown here.

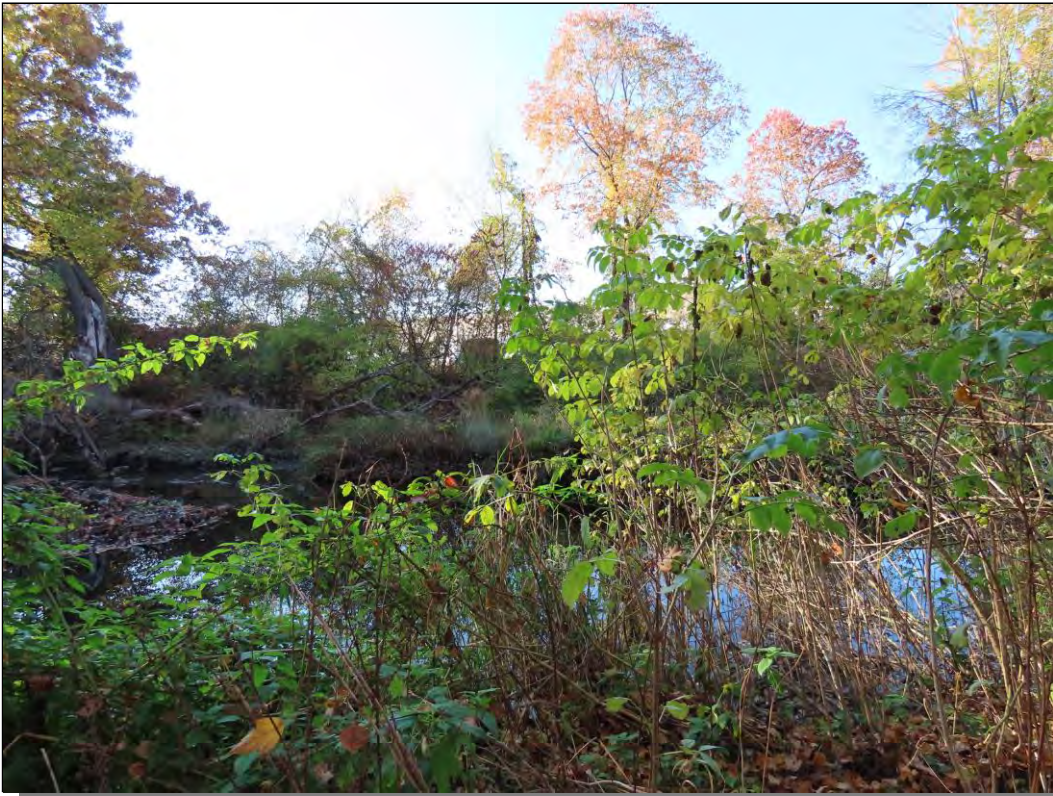
Photo 7: Sambucus canadensis, common elderberry bordering meadow habitat, at the top of the riverbank, eastern section of the Hockanum riparian terrace.

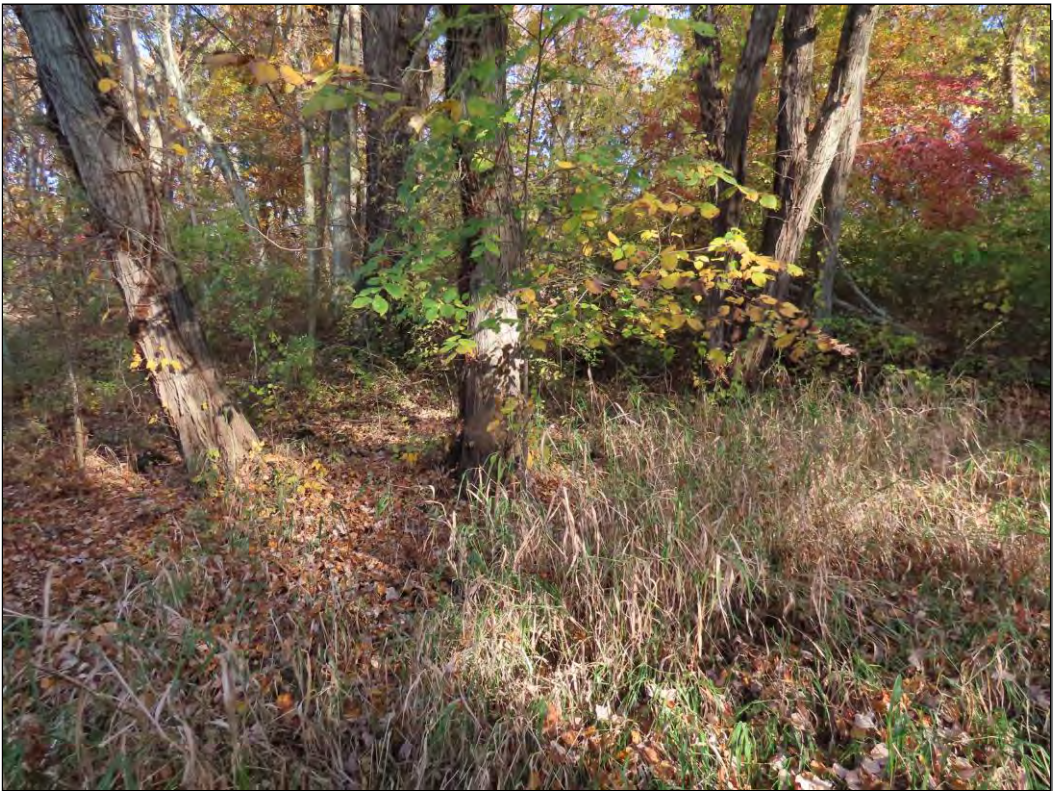
Photo 8. Facing northeasterly. A stand of trees, mostly red maples is on the higher elevation river levee, with wet meadow further back from the river.

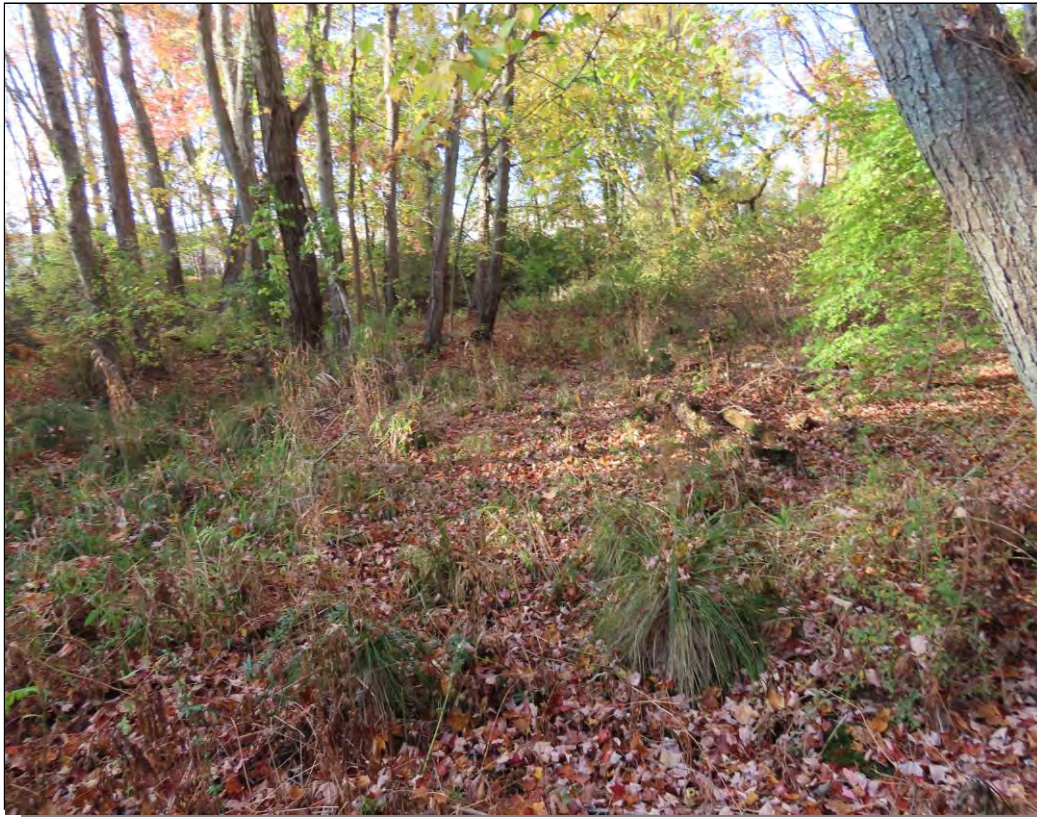
Photo 9. Mid-October view of sedge-dominated meadow in a wetland swale downgradient of the Naek Road cul-de-sac. Tussock sedge in foreground. 10-22-20.

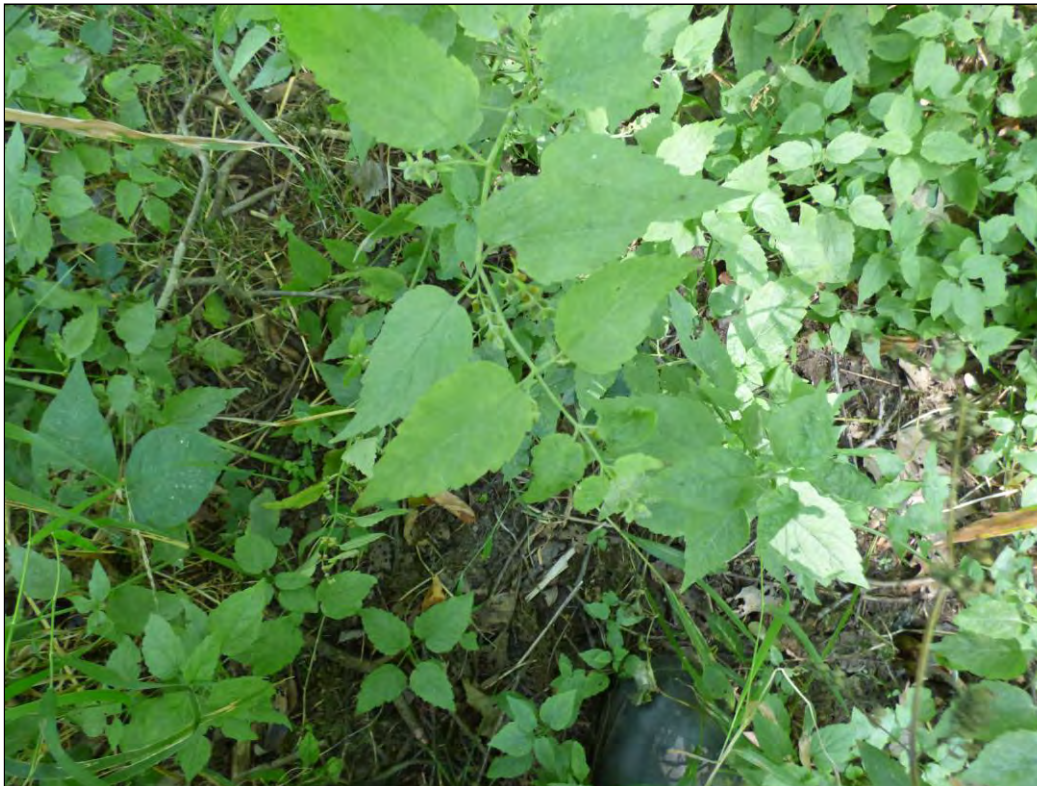
Photo 10. Downgradient of the swale draining from the sandstone ridge (Wetland C), the floodplain wet meadow has different species. *Scutellaria lateriflora* (mad dog skullcap) is common. 9-19-20.

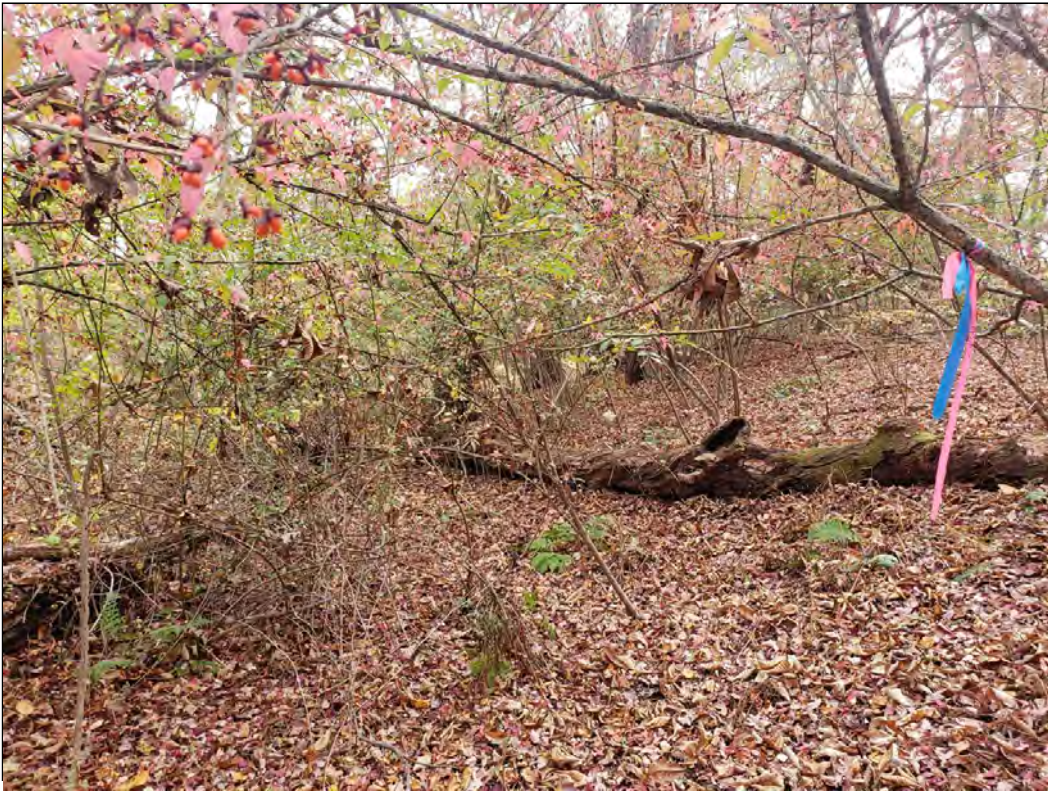
Photo 11. Wetland A, the central swale, has dense, diverse shrub cover. Southeasterly view.

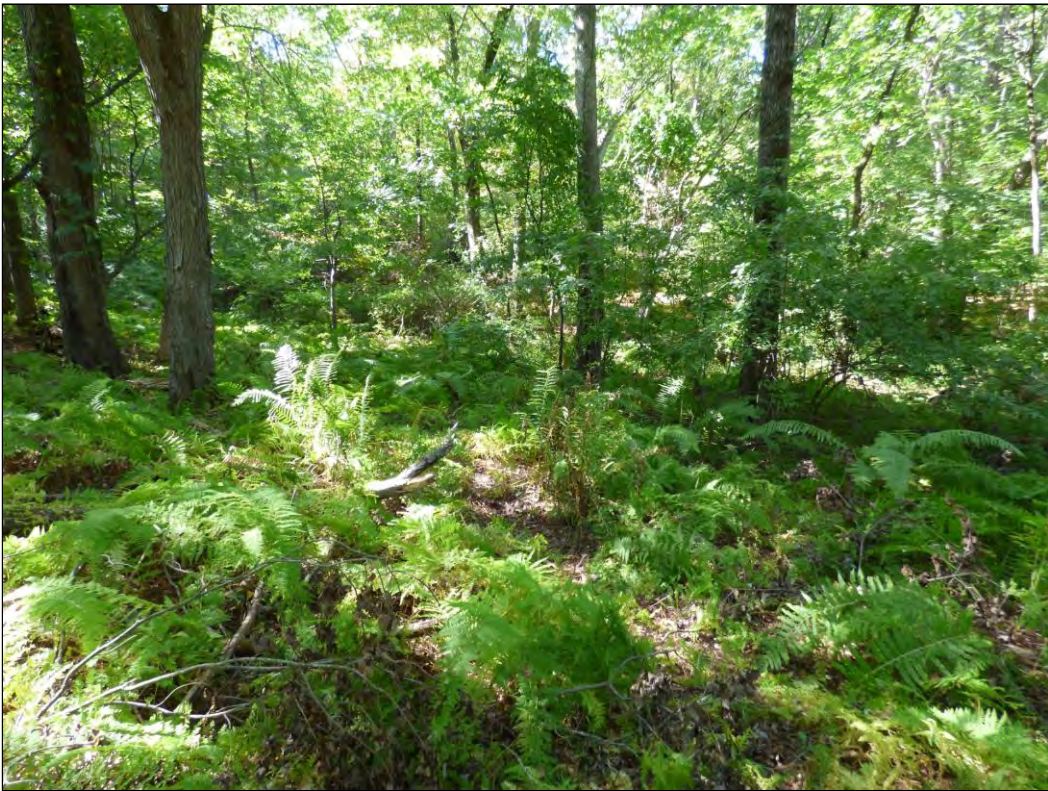
Photo 12. Ferns comprise a high percent of groundcover along the base of the forested slopes, in the southwestern portion of the site, extending onto the wet meadow terrace (Wetland B) in the floodplain.

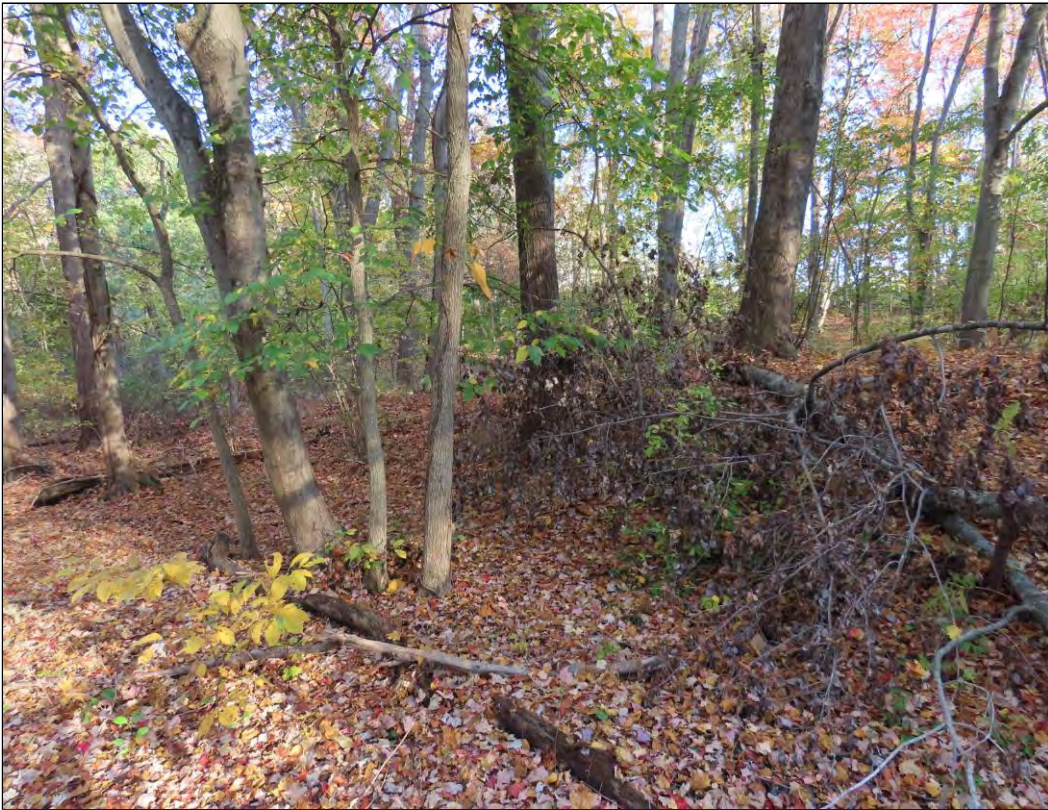
Photo 13. Southeasterly view upslope through mixed hardwood forest on the upland slope below the Naek Road cul-de-sac.

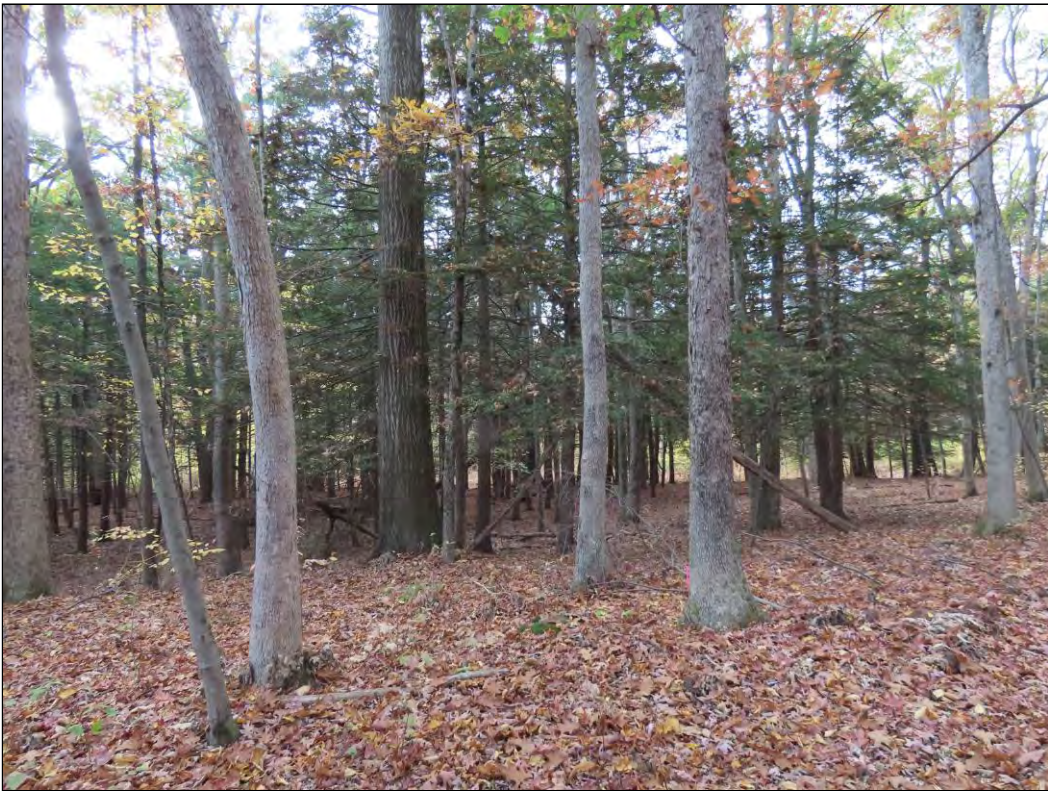
Photo 14. Westerly view downslope from the oak-hop hornbeam forest up top of slope, through the hillside forest of E. hemlock, in the southwestern portion of the site.

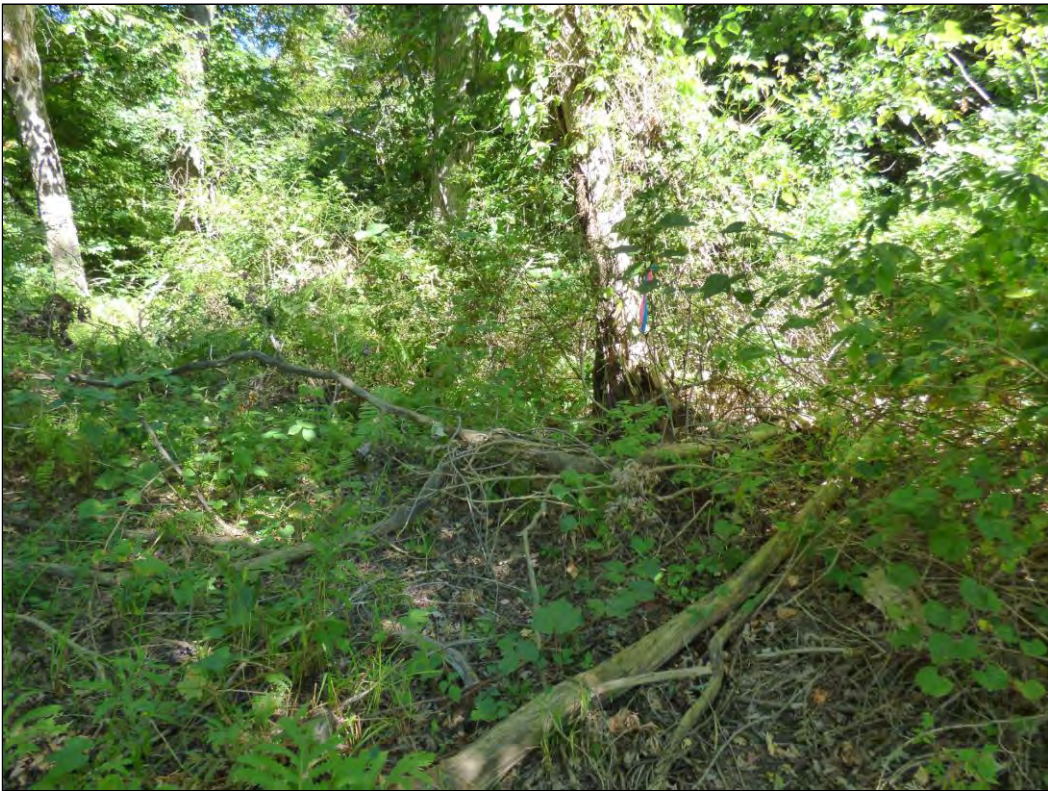
Photo 16. Close-up of bank vegetation showing trees rooted along banktop, about 75% cover of herbs and woody debris on the bank, and dense vine and shrub cover.

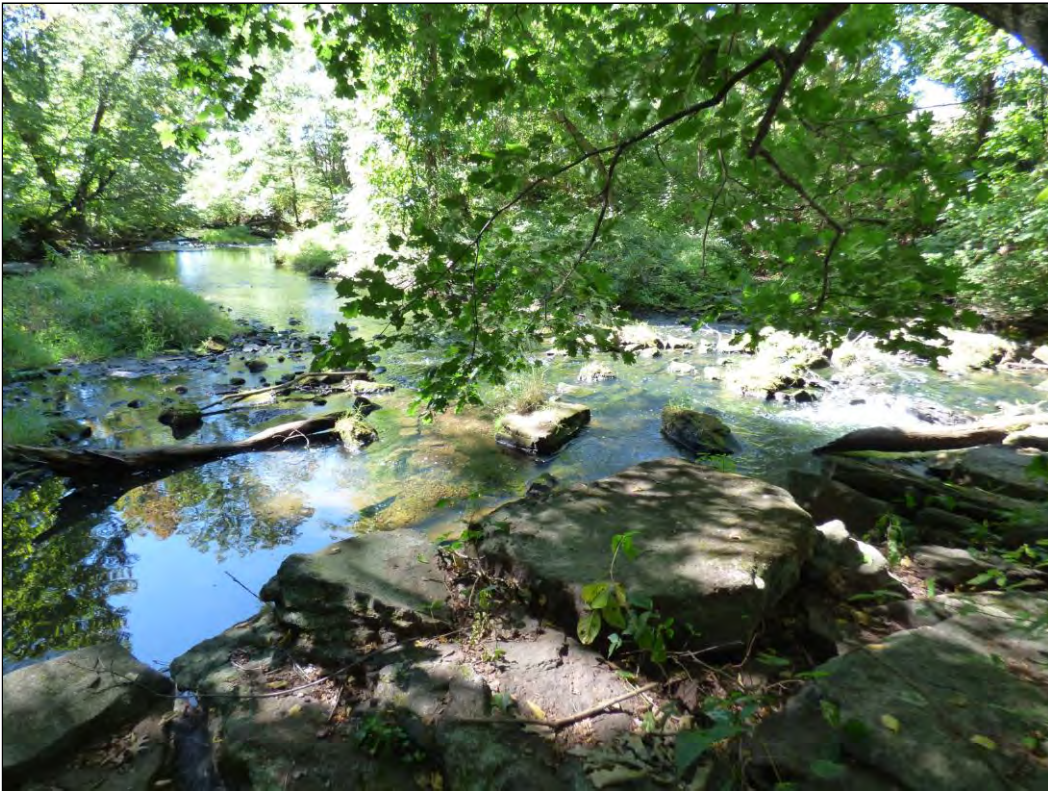
Photo 17. View downriver from the wall at the river's sharp bend to the south, where it crosses the sandstone ridge. Platy boulders in water, riffle in distance. 9-19-20.

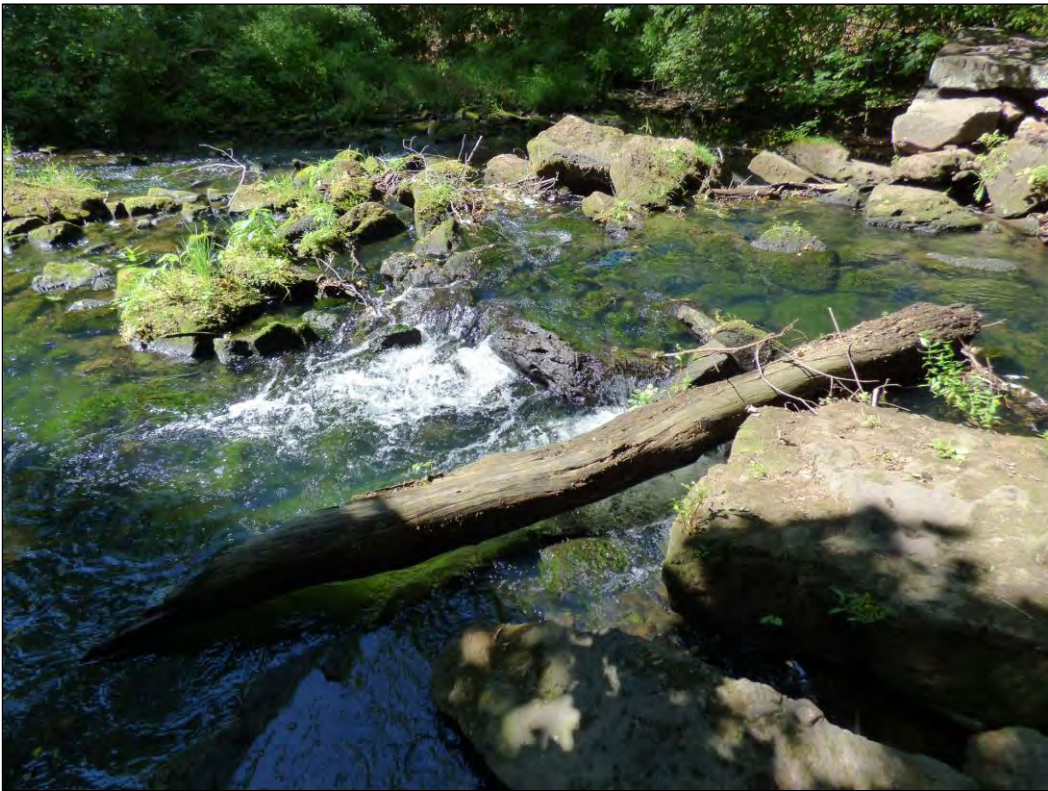
Photo 18. Close-up of riffle at the sharp bed in the river. Well oxygenated water and rocky substrate is cleared of silt by turbulence. This area is potential fish spawning habitat.

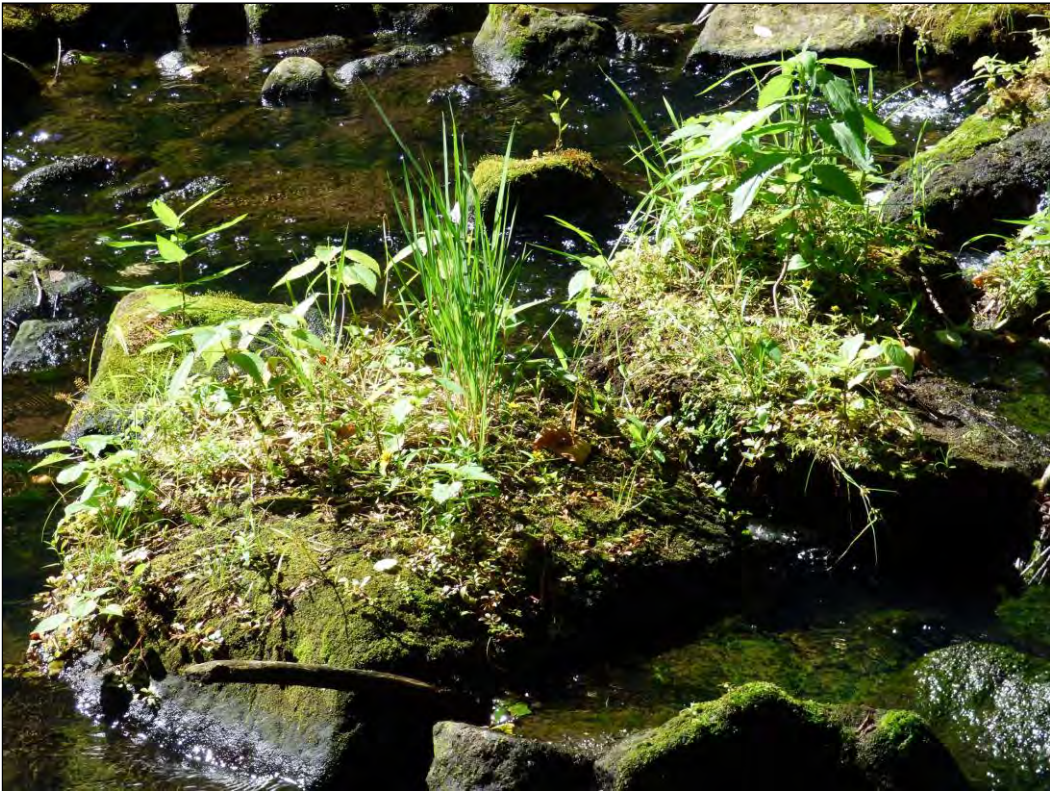
Photo 19. Wetland B, continued. Seedlings germinating on rocks within river channel, at the sharp bend; presence of moss indicates good water quality.

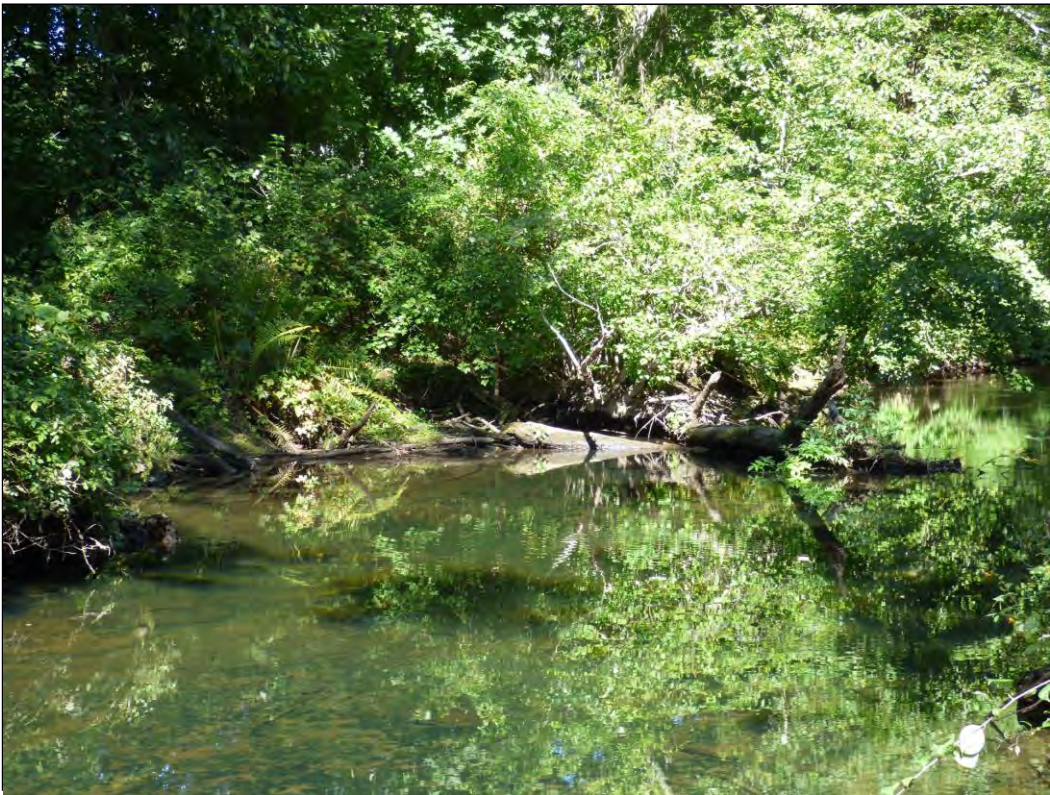
Photo 20. Further downriver, a large, recent treefall nearly blocks the river channel, and creates protected sub-habitats. Note that the substrate is rocky.

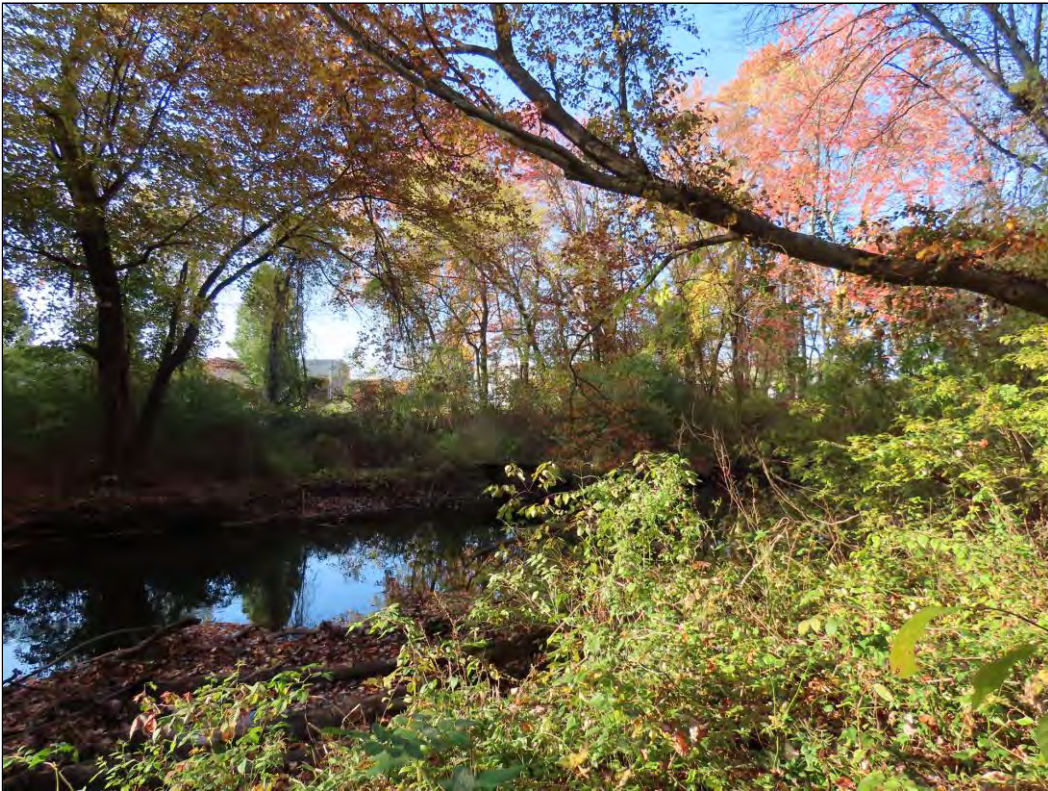
Photo 21. Wetland B, continued. Forested buffer is mostly narrow and sparse on the far side of river, across from this site.
