Subject: Water Testing for Lead
Lake View Elementary School
1802 Tennyson Ln.

As requested by the Madison Metropolitan School District (MMSD), TRC Environmental Corporation (TRC) performed testing for lead in water at Lake View Elementary School.

Appendix A
Location Map

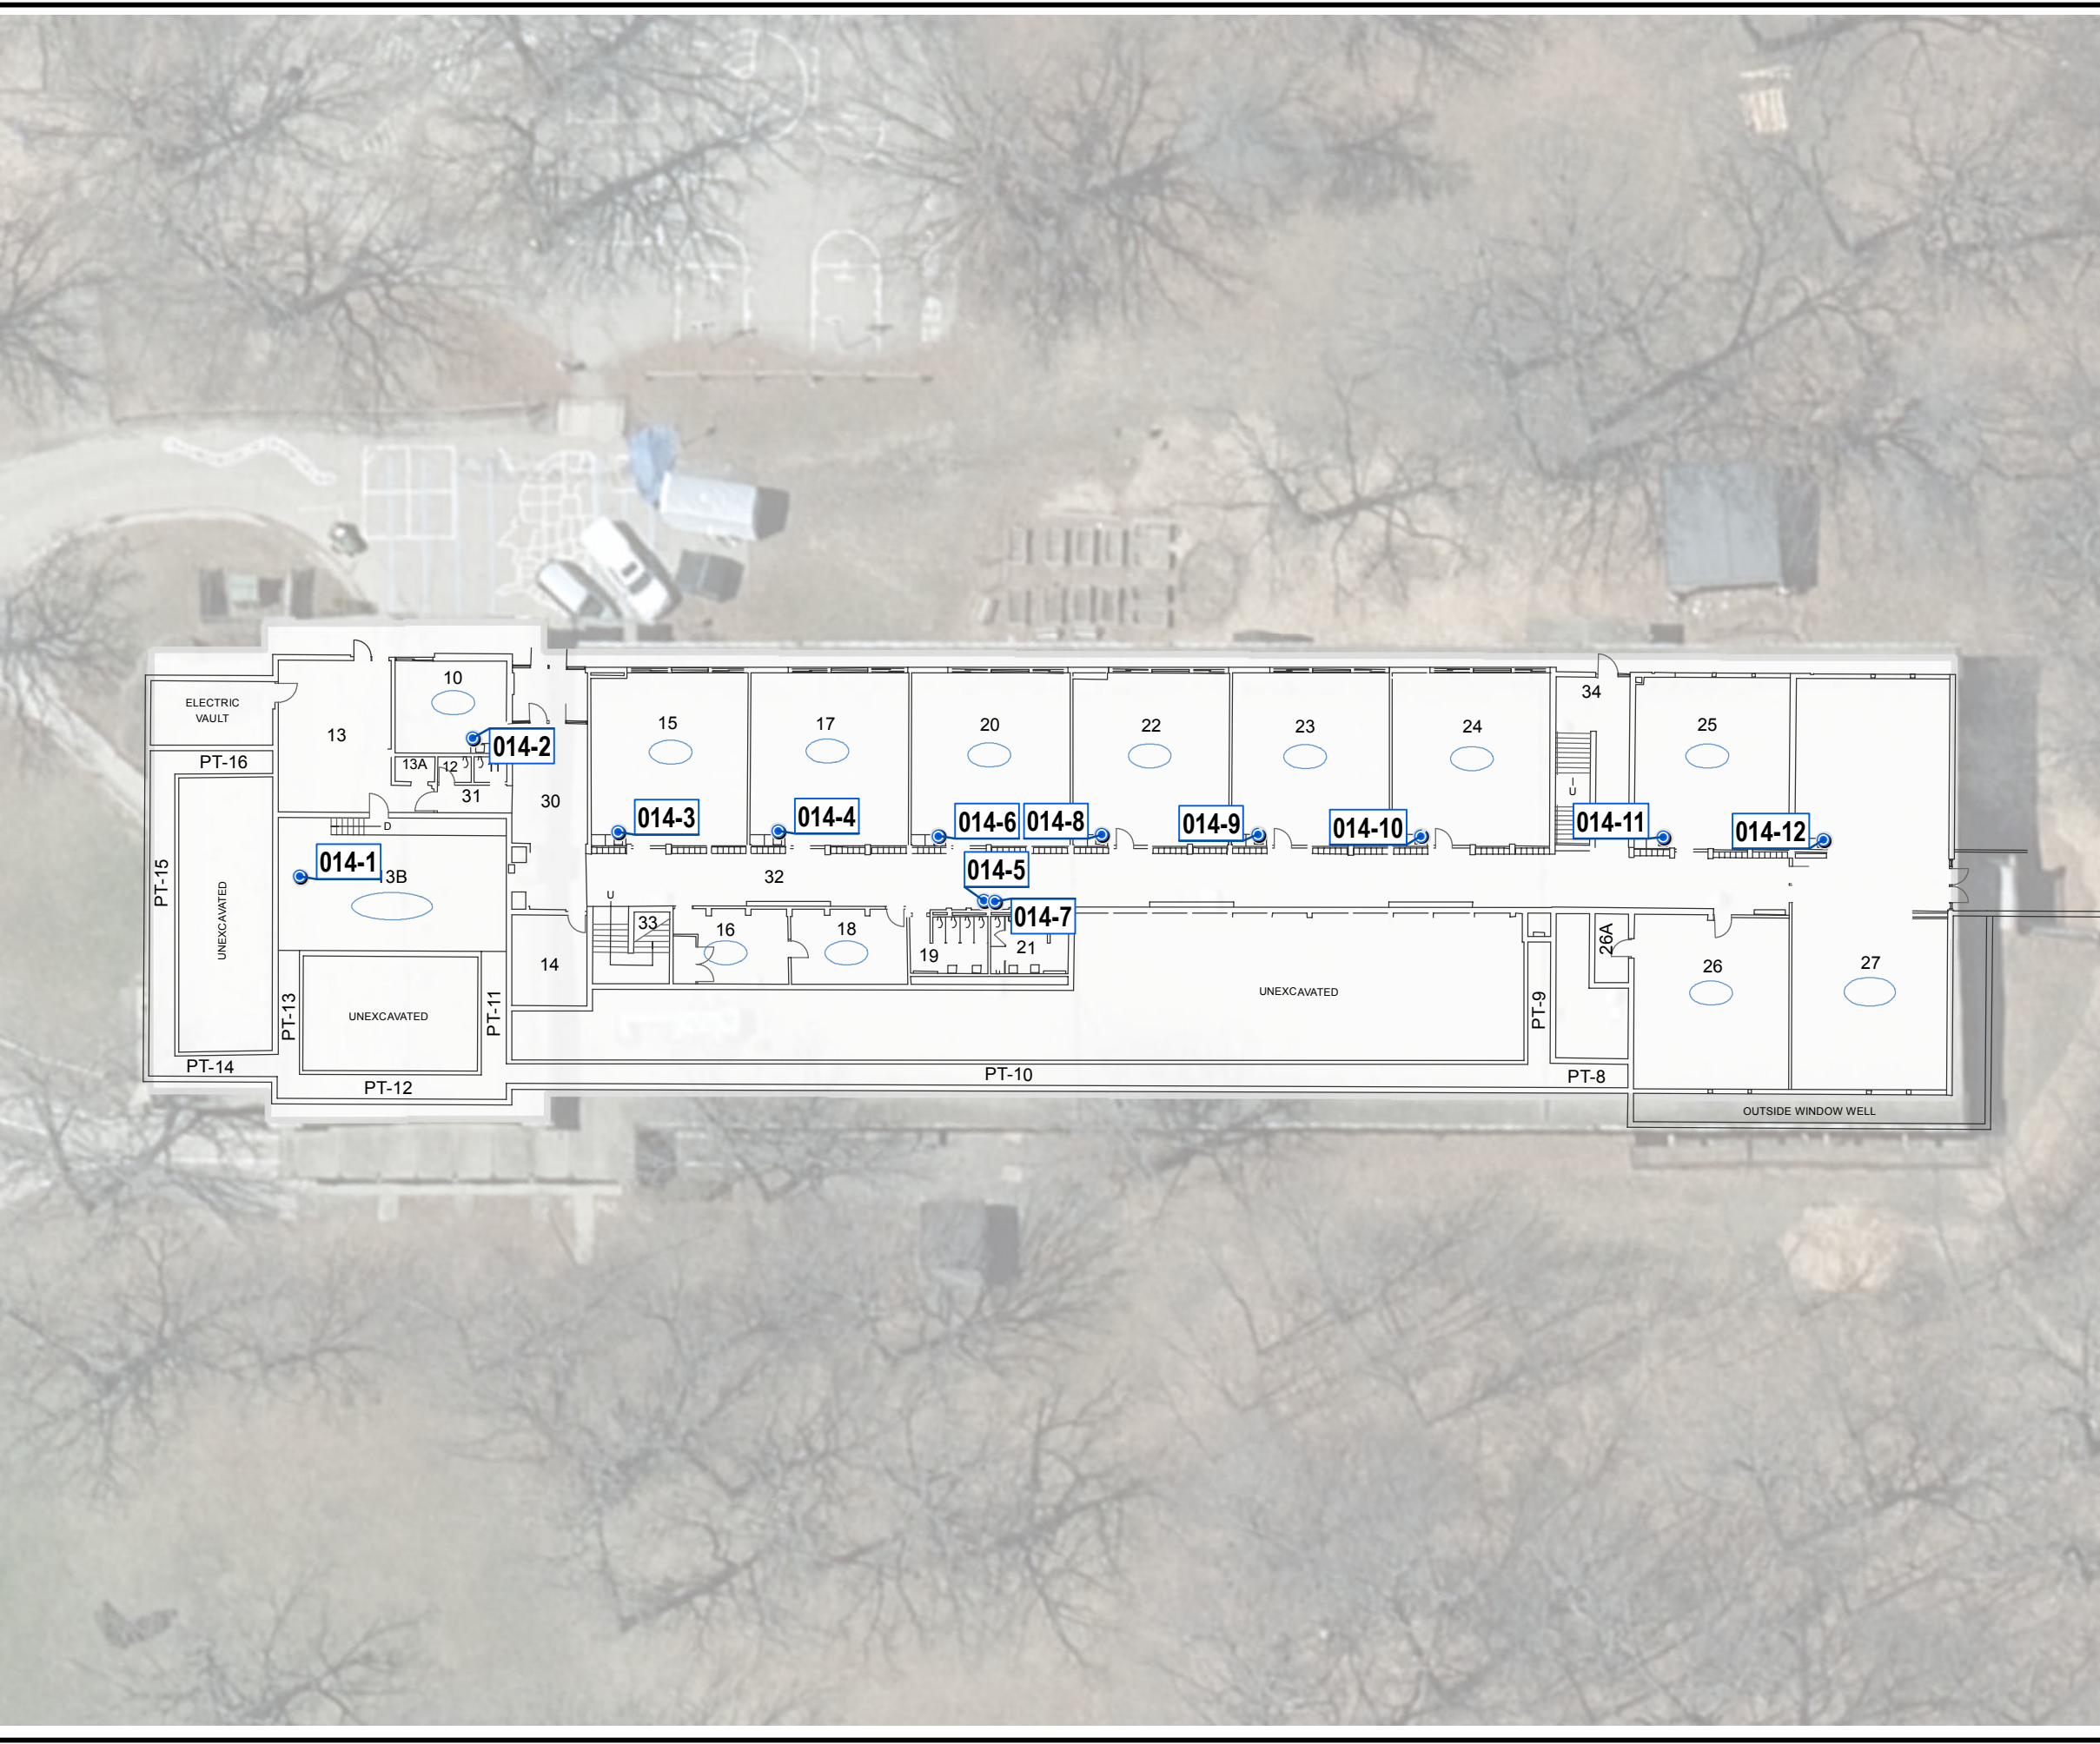
Preliminary sample locations were identified by maps provided by MMSD. Following completion of sampling, TRC prepared a map of each school annotated with the final sample locations and identification numbers for each outlet. See Appendix A: Location Map.
