# SUFFIELD FACILITIES MASTER PLAN

## TRI-BOARD UPDATE MEETING

SUFFIELD, CT

6.14.2021

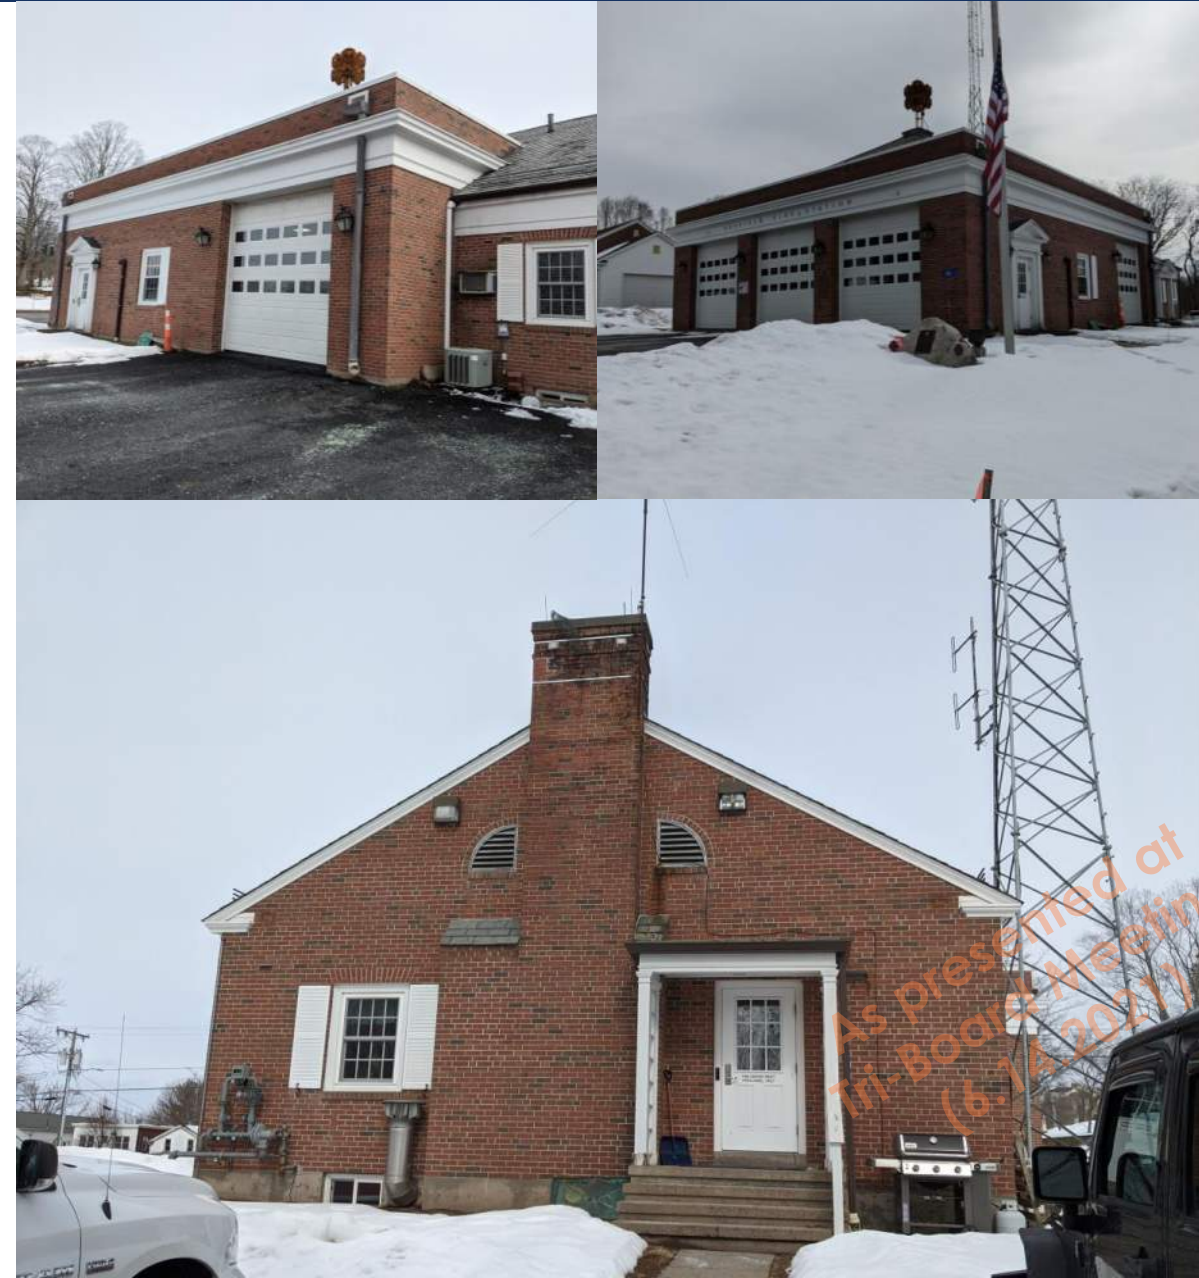
# FD STATION #1 ~ EXISTING CONDITIONS

1. Recent expansion to paved site area
2. Differential settlement and cracking in existing concrete sidewalks
3. Apparatus Bay apron is in good condition

1. Masonry restoration required at chimney
2. Minor rot repair and repainting at wood trim work, railings, and louvers
3. Minor downspout repairs/replacement of downspout clips

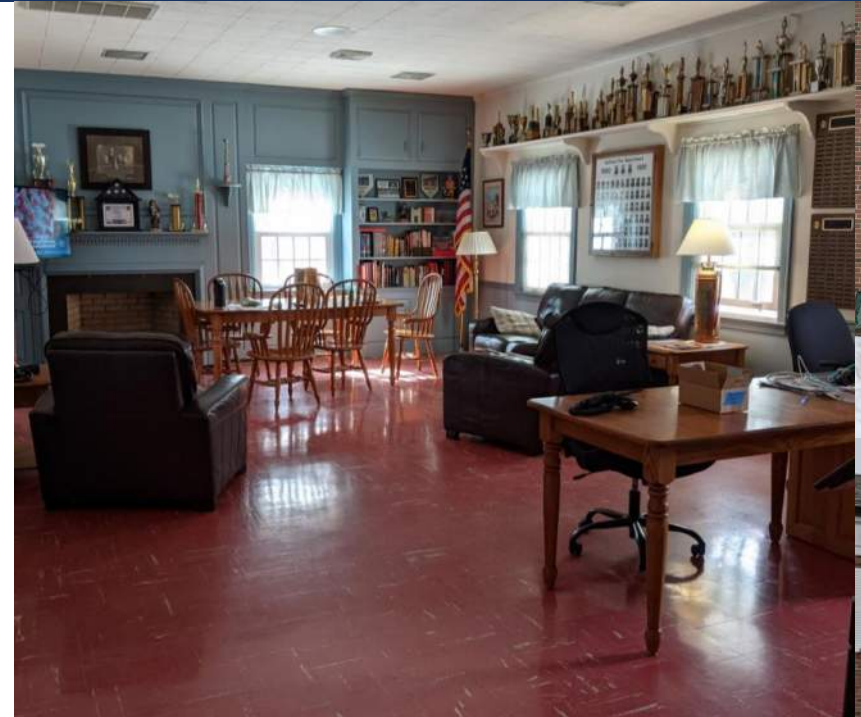
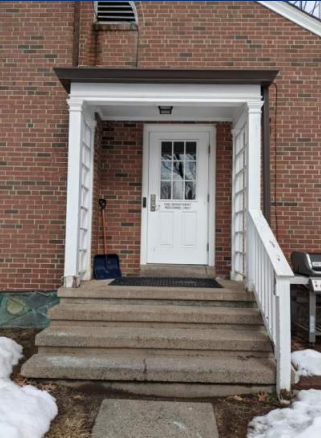
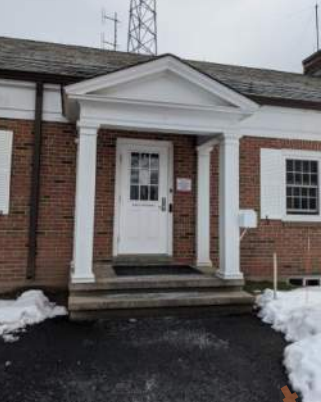
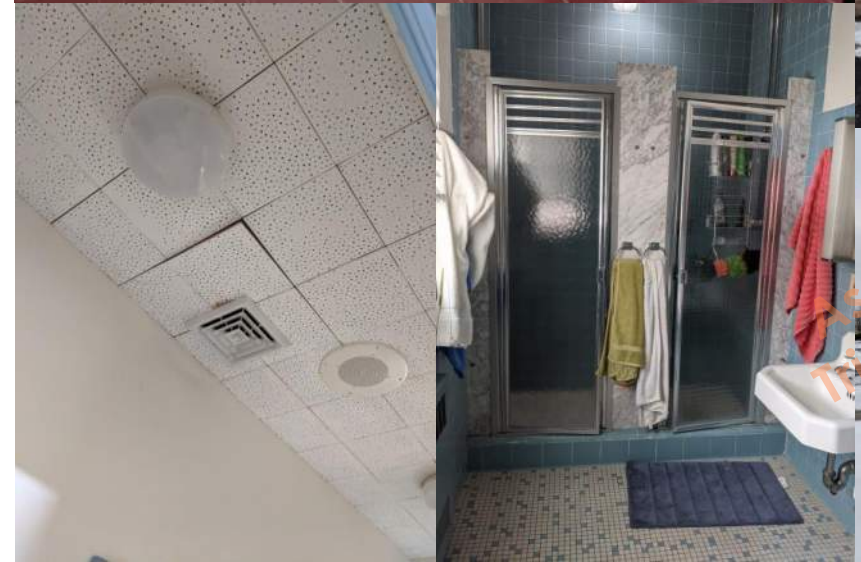
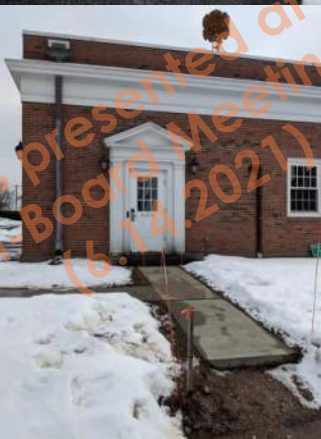
# FD STATION #1 ~ EXISTING CONDITIONS

1. Vinyl asbestos tile present in the building
2. Wood fiber tile ceilings present throughout

1. No accessible entrances
2. Non-accessible plumbing fixtures
3. Step at transition between apparatus bay and other program areas

1. All MEP Systems are old and past their useful life.
2. Needs full replacement of all systems

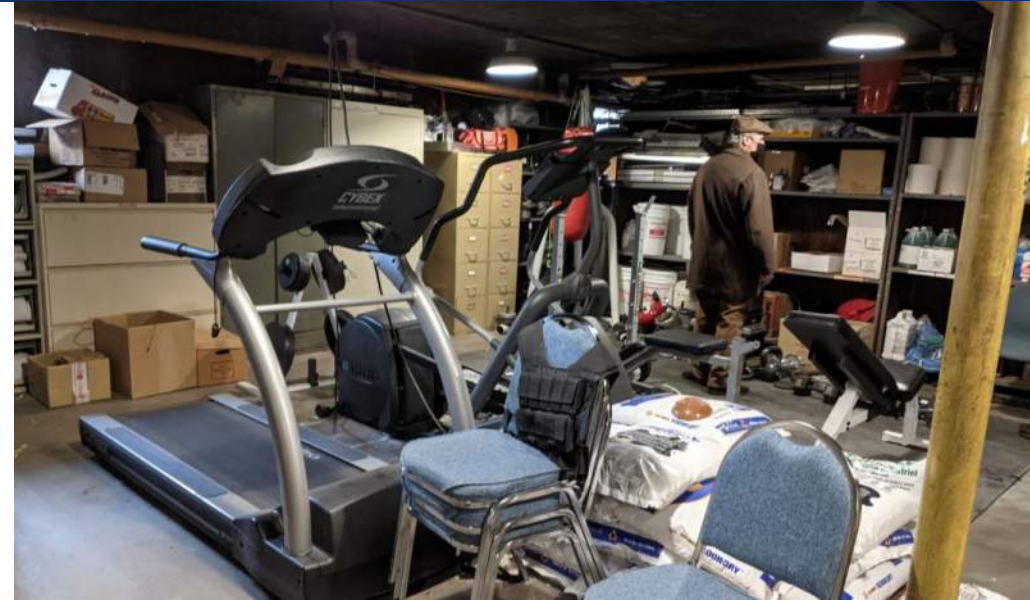
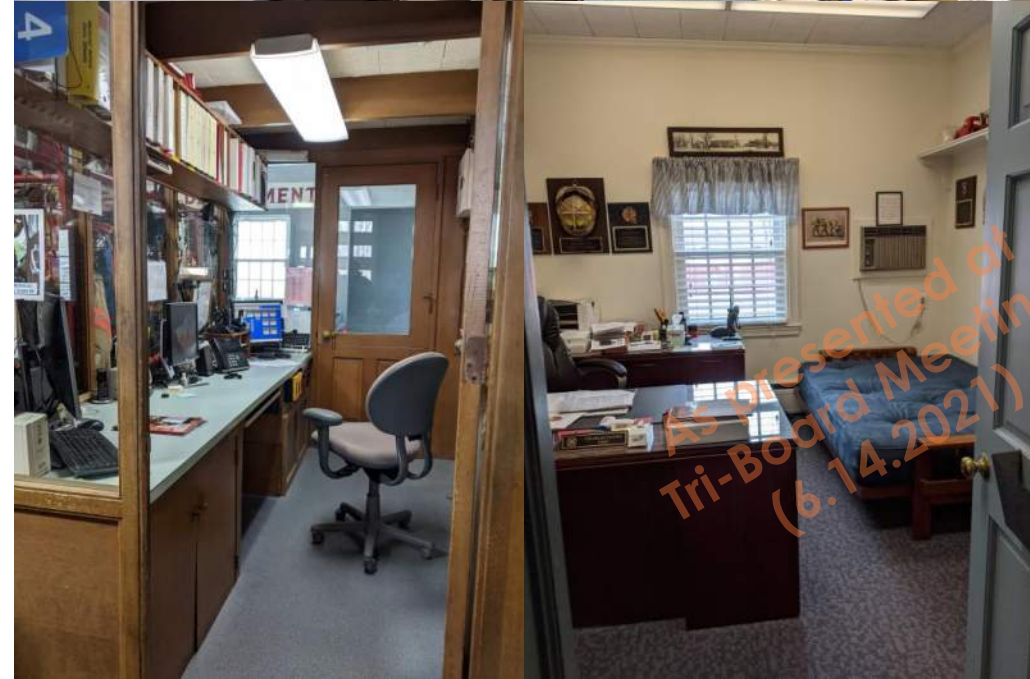
# FD STATION #1 ~ PROGRAMMING

1. No Public Lobby, Entry or restrooms
2. Insufficient Training Room, currently use Substation #2 for Training needs
3. Insufficient Administrative offices
4. Insufficient bunk and living quarters
5. Fitness equipment is currently in basement
6. Insufficient Apparatus Space and lacking physical training elements
7. Insufficient bay storage, decontamination, SCBA per NFPA standards
8. Lack of hot/cold transition zones
9. No segregated turnout gear storage

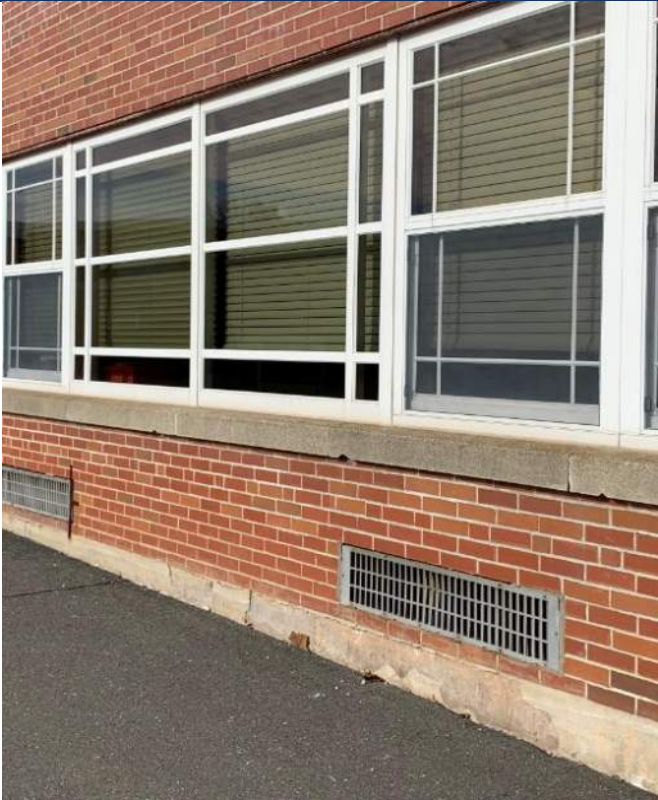
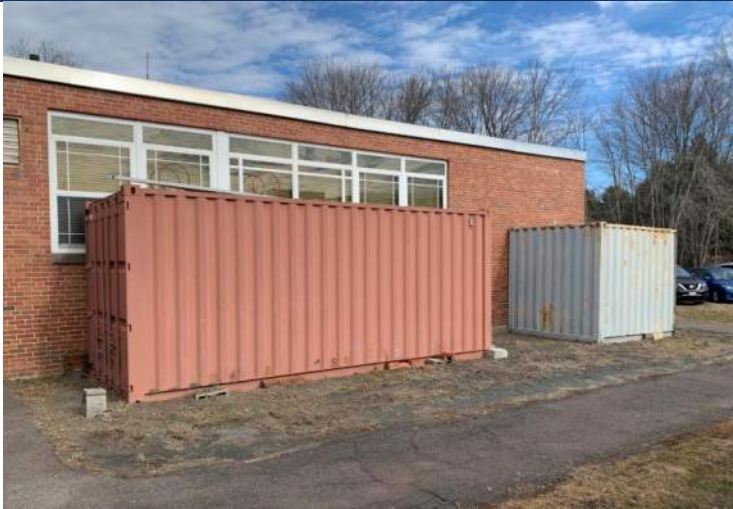
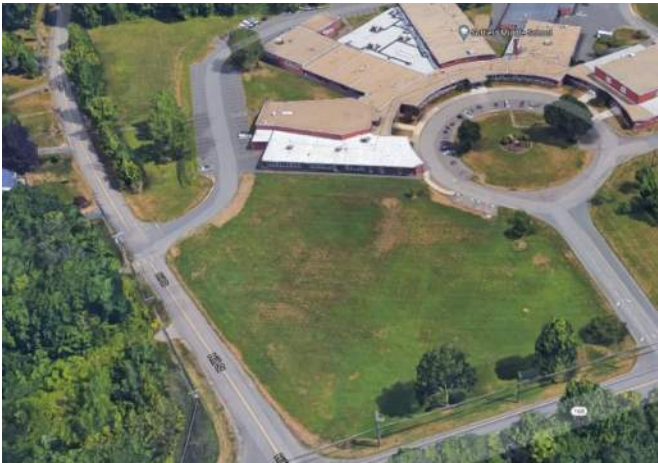
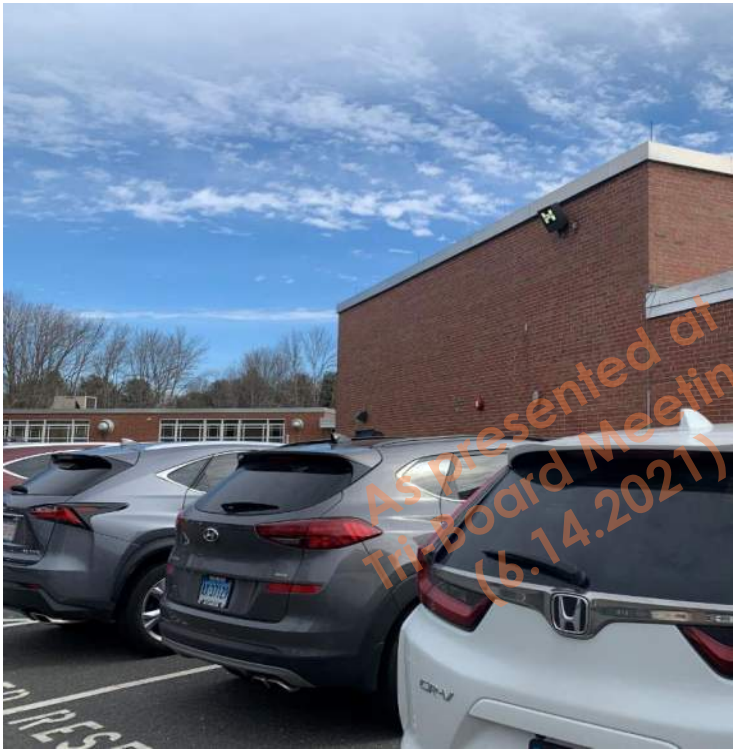
# SUFFIELD MIDDLE SCHOOL ~ EXISTING CONDITIONS

- 1. Site conditions are in fair to poor condition ~ sidewalks, curbs, paving, drainage issues,
- 2. Site traffic flow, parking, security major concerns. Unsecured perimeter access & parking a security concern.
- 3. Fields are remote from building with limited outdoor opportunities for education. Areas of poor drainage on west/southwest side of site.

- 1. Consistent roof leaks, roof replaced in phases by different contractors, various warranties, other envelope concerns ~ pointing of masonry, doors, etc.
- 2. Majority of building contain brick veneer in fair to good condition with areas of isolated spalling at base of wall/ exposed concrete foundation wall. Existing lintels are in fair to poor condition.

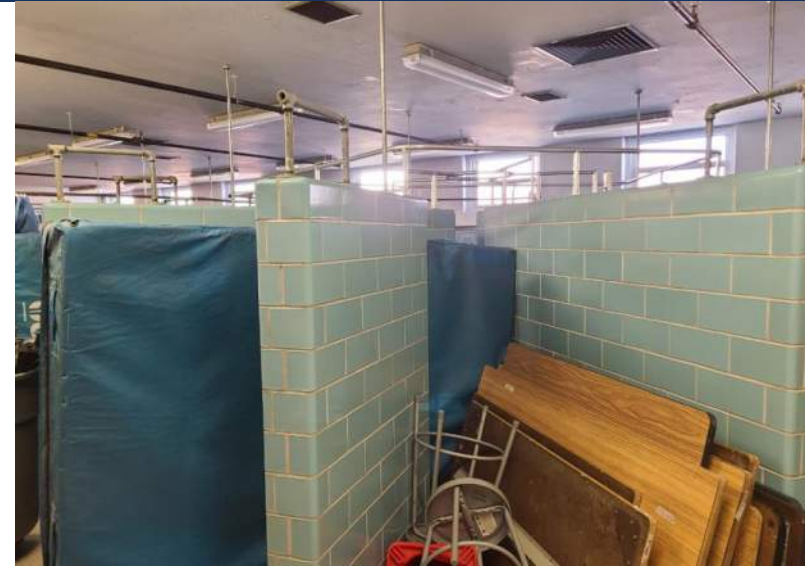
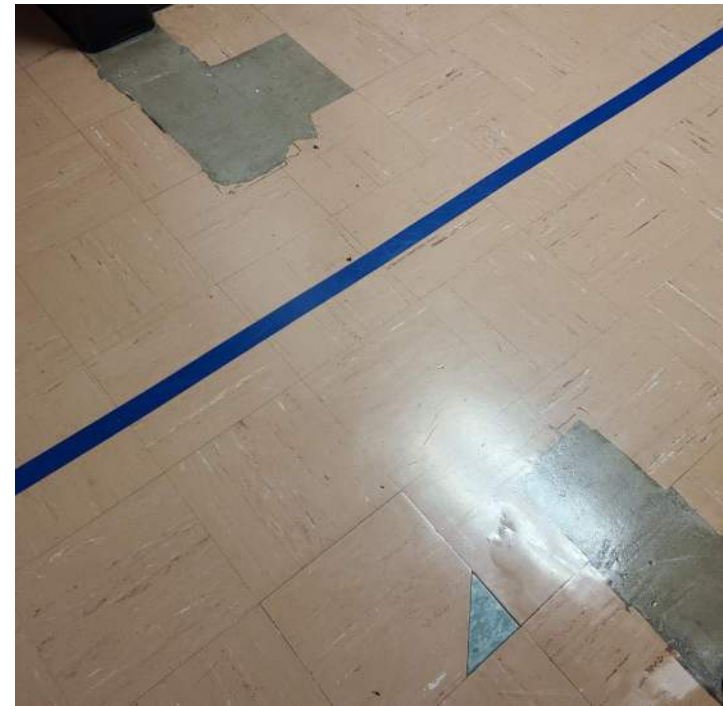
# SUFFIELD MIDDLE SCHOOL ~ EXISTING CONDITIONS

1. Overall, well maintained, original building well built, but many areas poorly constructed.
2. Observed significant inefficiencies due to additions/renovations over time.
3. Noise/Acoustical concerns in 70's additions renovations due to "modular" wall construction.
4. Various additions eliminated natural daylight to educational space creating poor conditions for educating students.
5. Overall condition of finishes are generally in poor condition. However yearly improvements have been made to isolated areas, science labs, finishes in media center, tech education planned.
6. Majority of toilet cores are in poor condition due to age and use. In some instances, are not used/obsolete

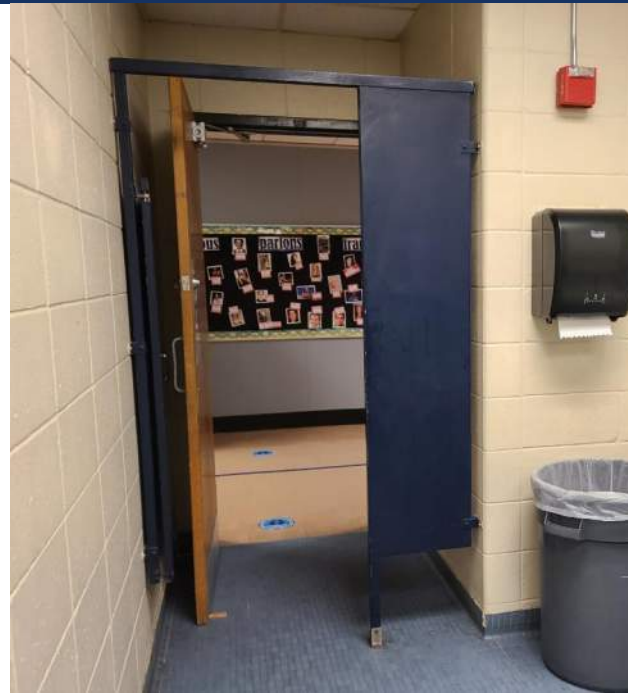
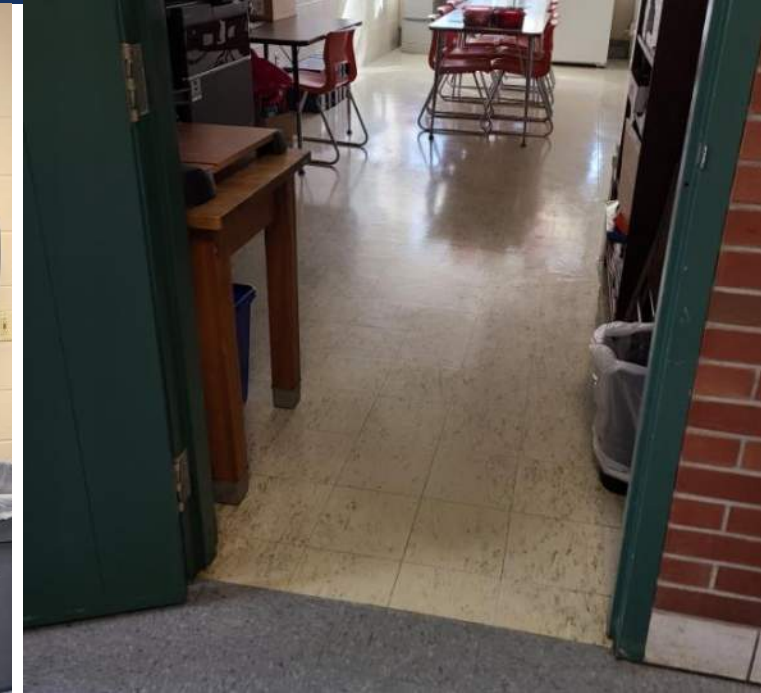
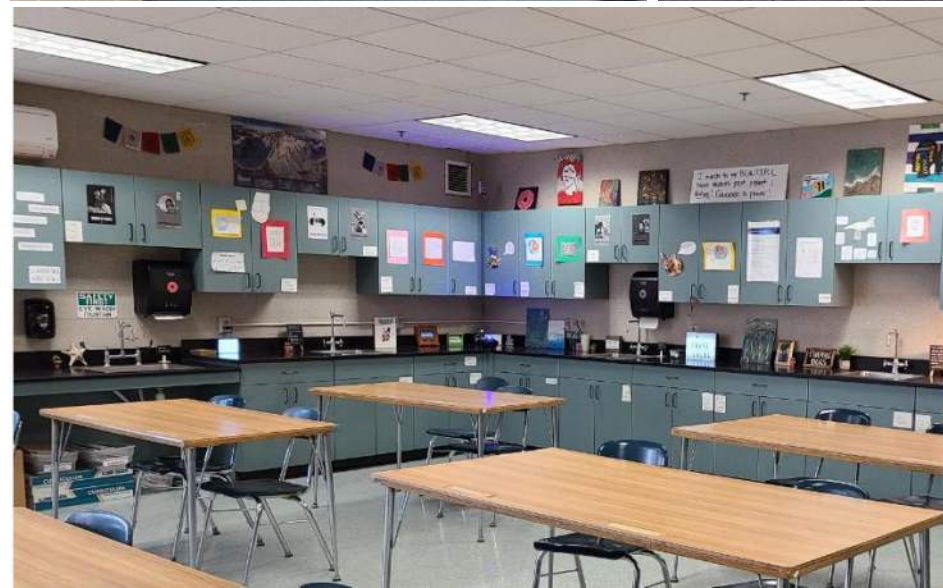
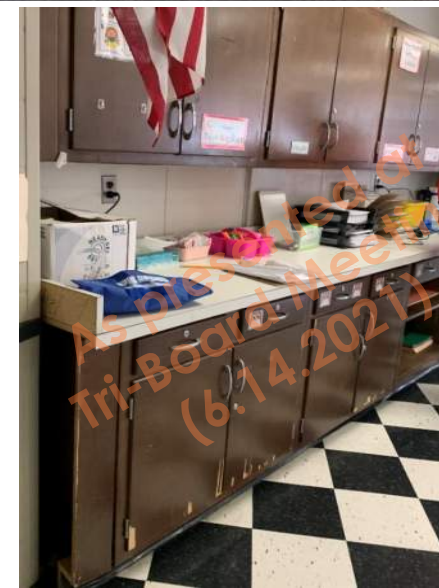
# SUFFIELD MIDDLE SCHOOL ~ EXISTING CONDITIONS

1. While 2002 upgrades addressed some code issues, some accessibility compliance issues remain related to floor & push/pull clearances and reach requirements
2. Egress stairwells appear to meet current codes for both guard and handrail requirements.

1. Structural system of original building steel frame superstructure with brick/block infill. Traditional slab on grade with concrete infill metal desk slab for second floor.
2. No observed structural conditions with building.

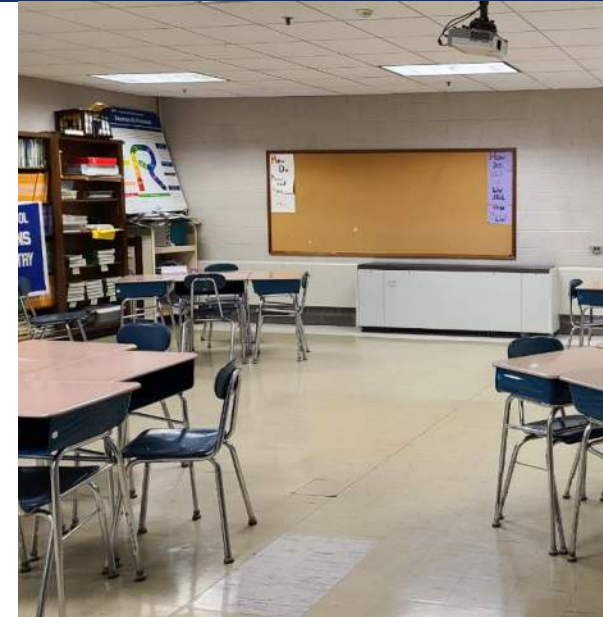
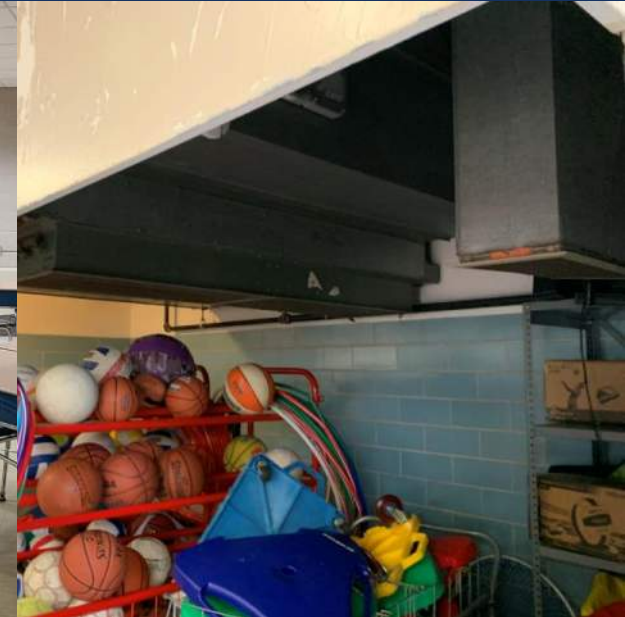
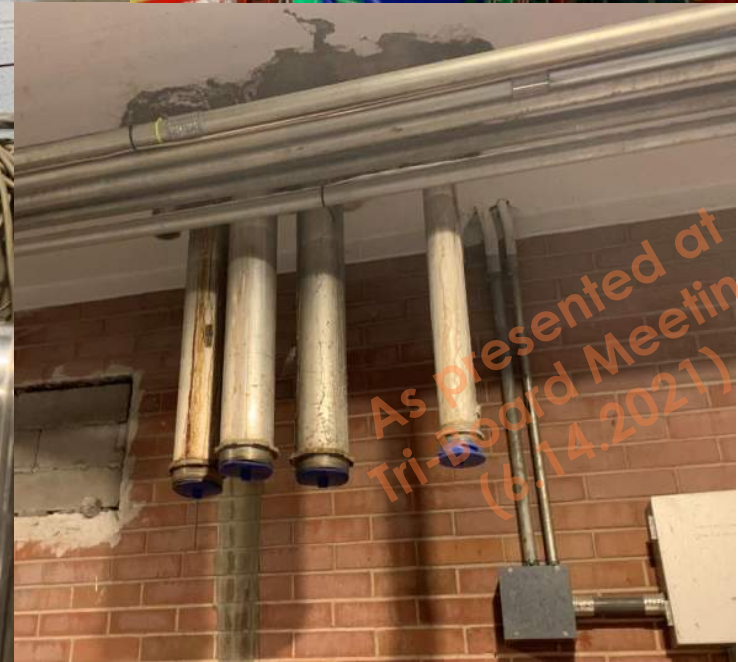
# SUFFIELD MIDDLE SCHOOL ~ EXISTING CONDITIONS

1. Many renovations and varying vintages of systems. Some newer, some original.
2. No central domestic Hot Water Plant. Lots of distributed water heaters. Leads to more maintenance and repairs.
3. Electrical systems has many vintages. While service is newer it back feeds original vintage systems.
4. Most major mechanical systems past or at the end of their useful life.
5. No natural ventilation/windows to many classrooms/educational spaces.
6. Overall MEP systems need a complete overhaul.

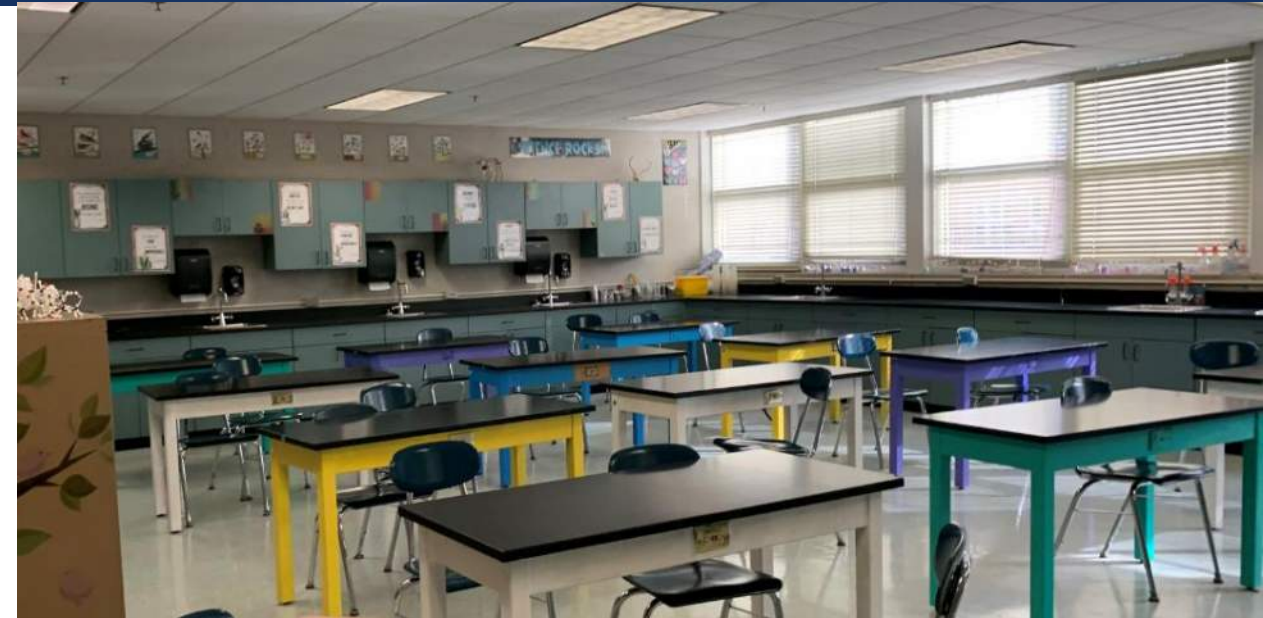
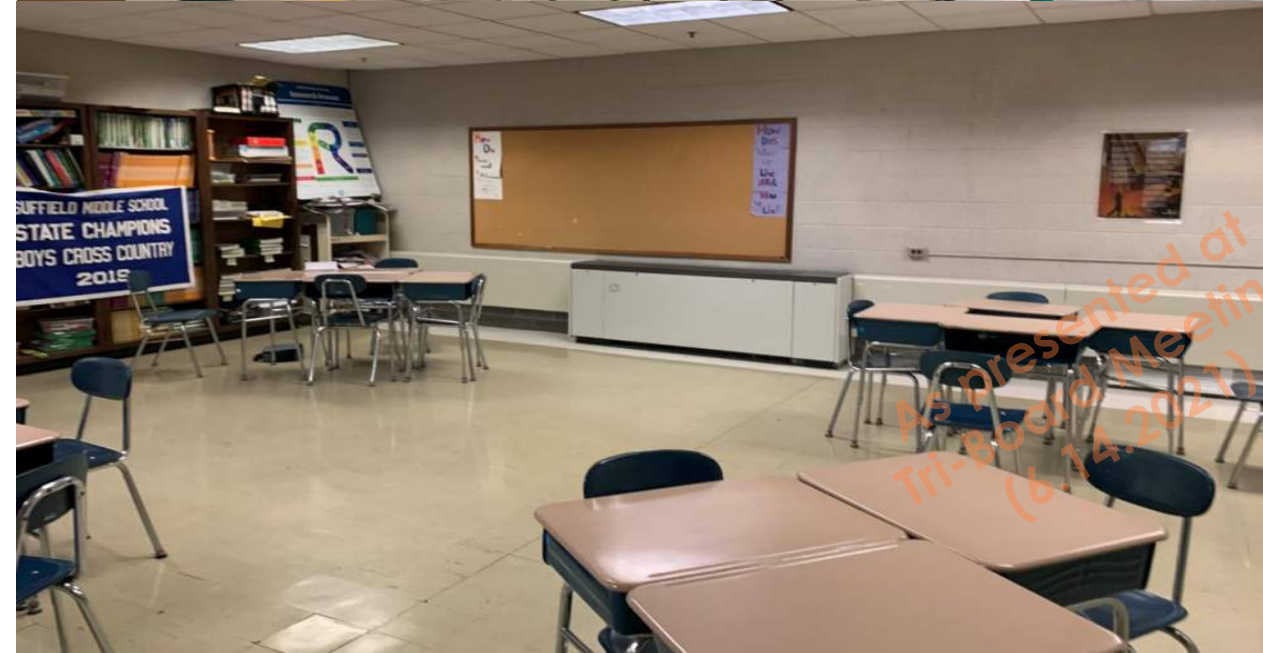
1. Classrooms are decent size throughout school although many of the specialized classrooms are not sized nor do the function correctly (ex. World language)
2. Flow of the overall building a concern, tough to implement team model, share spaces, promote collaboration ~ important for this demographic.
3. Specialized teaching rooms & core facilities biggest concern – band, cafeteria acoustics & queuing, media center, family & consumer science outdated, limited space for tech ed., many poorly located
4. Lack of efficiency in the layout affects quality of education, time in class, and programs offered.
5. Currently circulate through classroom to attend special education classes, would like to centralize and share, save on time & reinvest into student

Grade Level	6-8
Building Area/Site	128,489 sf / 32.4 acres (shared)
Age/Construction	1964, 1965 (Vo-Ag), 1972, 2002

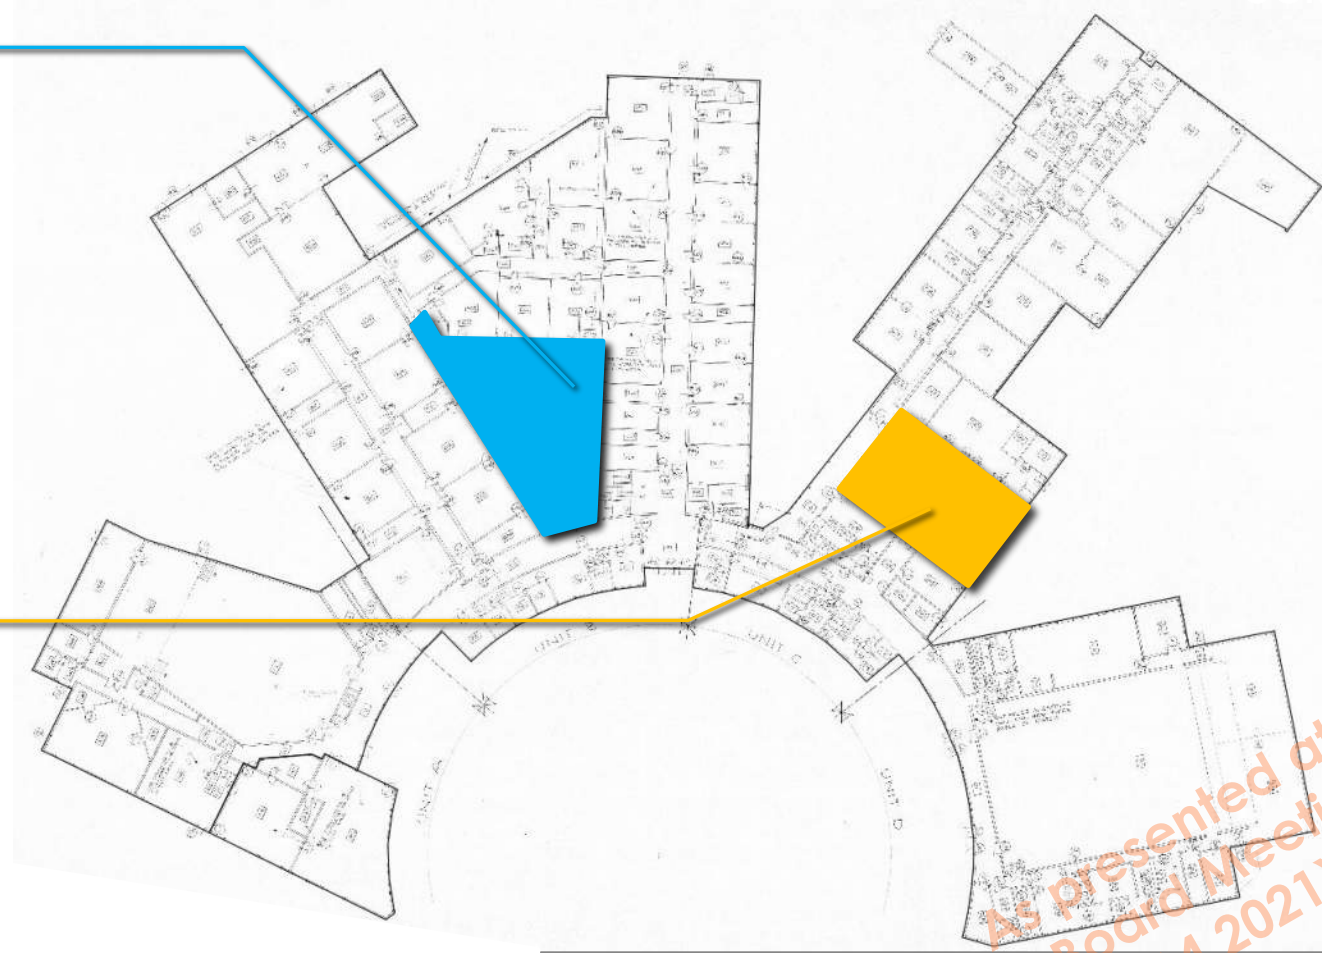
## The importance of Efficiency in a Building

Area ~ 128,489 SF

Grade Level ~ 36,134 SF

Upper Level ~ 4,437 SF

**Blue Area (41,991 sf)**

**Yellow Outline (128,489 sf)**

**32.6%**

Typical Efficiency Factor ~ 25-30%  
**Loss of Education Space  
is 3,340 – 9,765 sf**

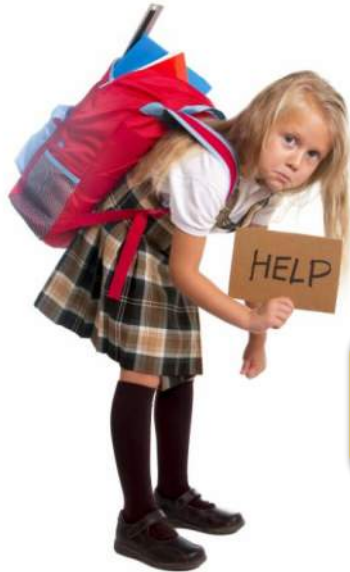
# A. WARD SPAULDING SCHOOL ~ BENCHMARKING

Distance of Classroom to Media Center  
and/or Specialized Education Area...  
**Approximately 630 feet!**

Average speed of a 5-year-  
old ~ 50 ft every 20 -25  
seconds

About a 5 min. walk!  
Or... 10 minutes  
away from the  
classroom with  
each trip.
