SUFFIELD FACILITIES MASTER PLAN

PROGRESS UPDATE MEETING

SUFFIELD, CT 5.6.2021

EXISTING CONDITIONS INVENTORY & ANALYSIS

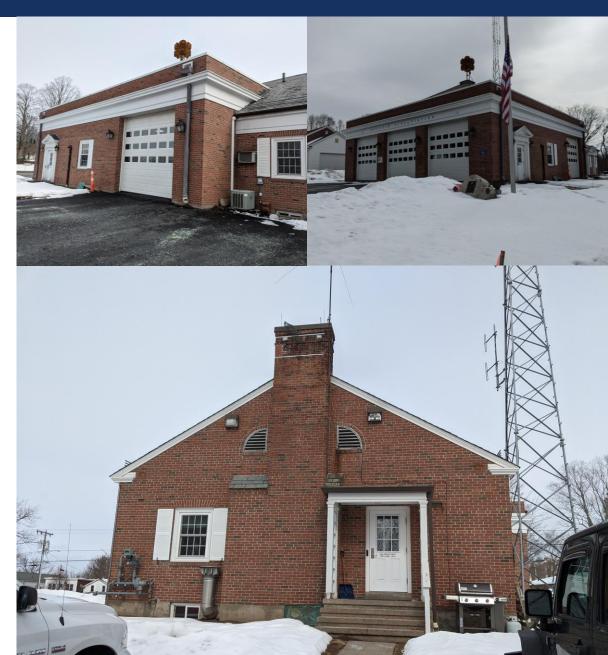
FD STATION #1 INITIAL FINDINGS

- 1. Recent expansion to paved site area
- 2. Differential settlement and cracking in existing concrete sidewalks
- 3. Apparatus Bay apron is in good condition

- 1. Masonry restoration required at chimney
- 2. Minor rot repair and repainting at wood trim work, railings, and louvers
- 3. Minor downspout repairs/replacement of downspout clips

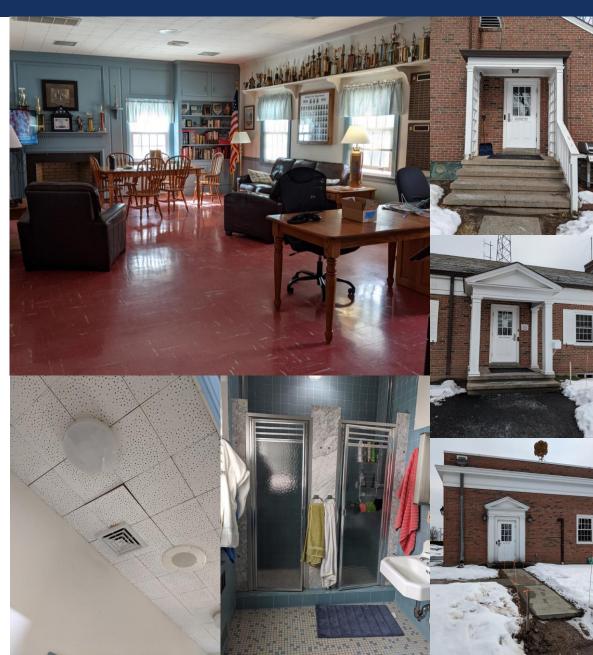
- 1. All MEP Systems are old and past their useful life.
- 2. Needs full replacement of all systems

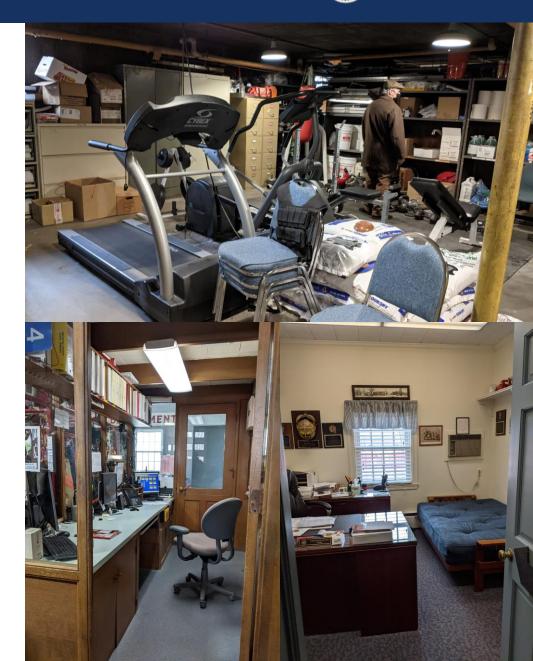
Address	73 Mountain Road
Building Area/Site	4,200 sf / 3.49 acres
Age/Construction	1962(61)

- 1. No Public Lobby, Entry or restrooms
- 2. Insufficient Training Room, currently use Substation #2 for Training needs
- 3. Insufficient Administrative offices
- 4. Insufficient bunk and living quarters
- 5. Fitness equipment is currently in basement
- 6. Insufficient Apparatus Space and lacking physical training elements
- 7. Insufficient bay storage, decontamination, SCBA per NFPA standards
- 8. Lack of hot/cold transition zones
- 9. No segregated turnout gear storage

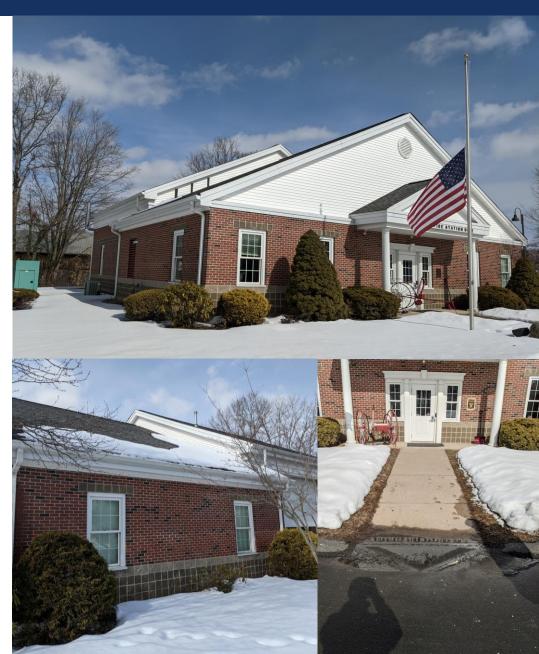
- 1. Newer station, well built, good apparatus space, in relatively good condition
- 2. Some ponding at transition between sidewalk and drive
- 3. Minor rusting at bottom of bollards

- 1. Ice dams present at time of walkthrough, persistent issue for some time. May cause damage elsewhere if not properly addressed.
- 2. Exterior materials are in good condition.

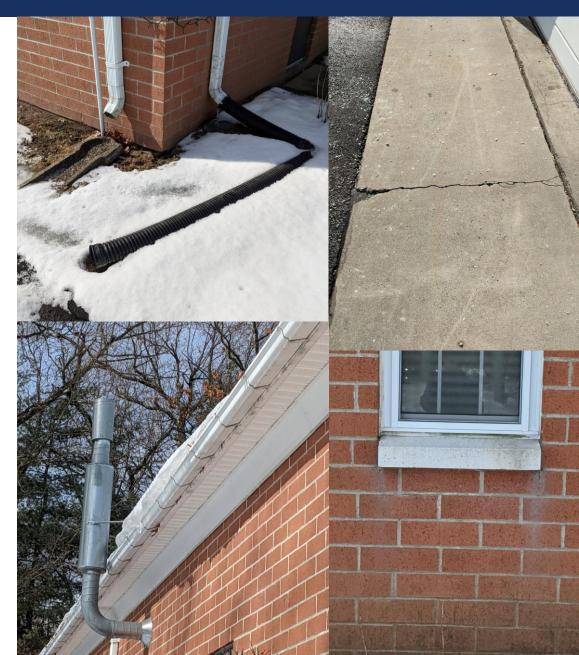
FD STATION #3 INITIAL FINDINGS

- 1. Poor site drainage causing hazardous conditions with ice, grading revisions
- 2. Minor cracking at apparatus bay apron
- 3. Anecdotal reference to storm water infiltrating tight tank

- 1. Older building but in relatively good condition for its age
- 2. Some signs of ice damming present
- 3. Minor staining on brick from water shed
- 4. Recommend preventative maintenance to extend useful life (caulking, sealants, etc.)

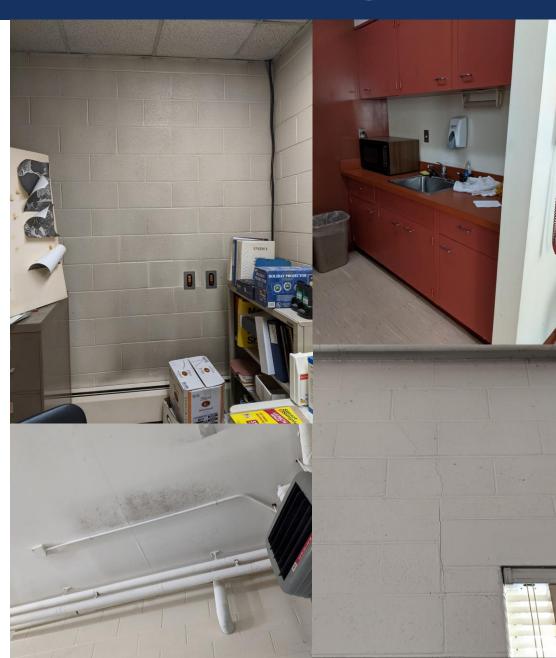
- 1. Suspected mold on apparatus bay ceiling, possible condensation buildup
- 2. Possible accumulation of exhaust from vehicles settling on radiant heater resulting in wall staining, lack of hot/cold transition zone

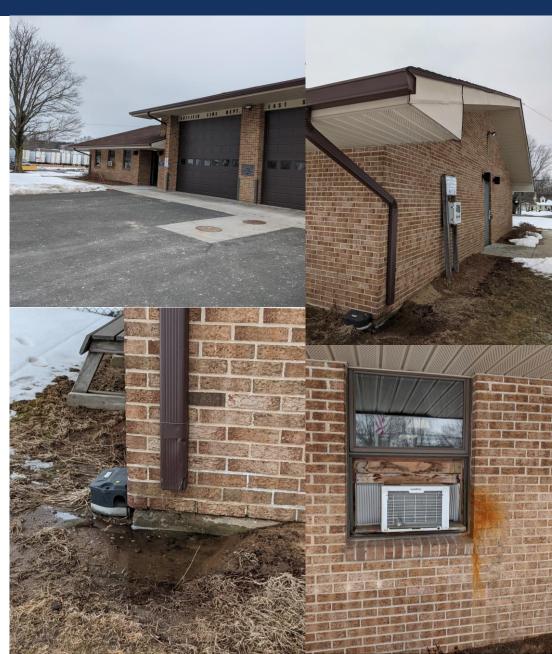
FD STATION #4 INITIAL FINDINGS

- 1. Minor cracking in asphalt
- 2. Lack of tie-in or splash block at downspout causing soil erosion

- 1. In good condition relative to its age.
- 2. Minor cracking at foundation/sidewalk
- 3. Improper fit of window air conditioning unit and staining of adjacent brick wall.

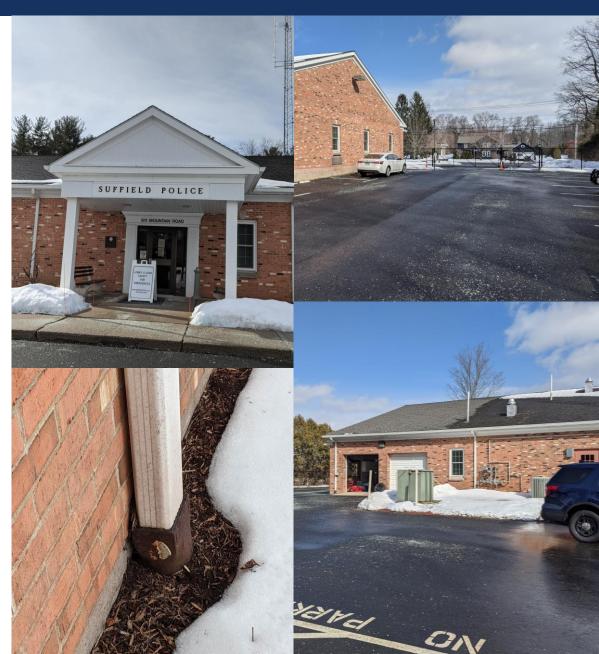
POLICE DEPARTMENT INITIAL FINDINGS

- 1. Minor cracking at sidewalk control joints
- 2. Rust present at downspout boots
- 3. New paving and fence
- 4. Recommend preventative maintenance program to extend useful life.

- 1. In good condition relative to its age well maintained and built.
- 2. Minor snow build up and possible damming at roof valleys
- 3. Exterior materials have been well maintained
- 4. Snow melt on roof uneven due to super heating of garage spaces

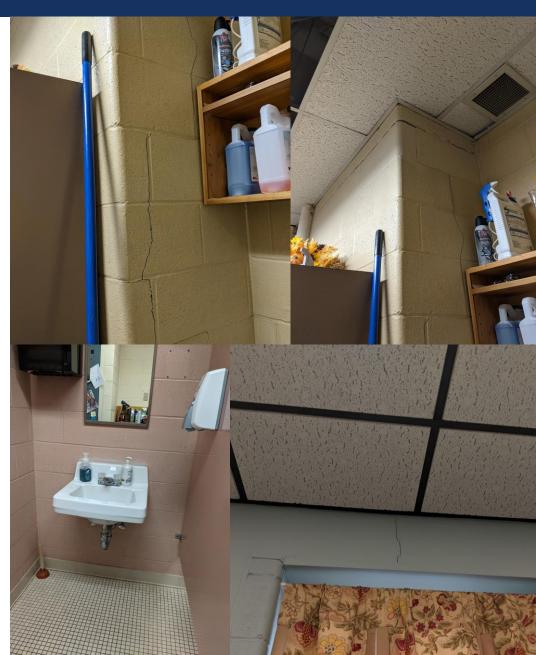
- 1. Drywall cracking present at window lintels
- 2. Discoloration of ceiling tiles due to age.
- 3. Relatively minor cracking at multiple interior CMU walls, non structural issue.

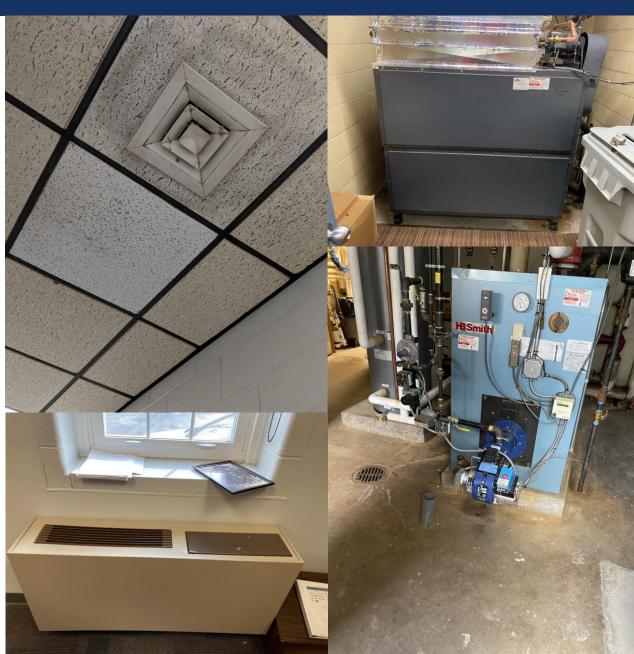
- 1. MEP Systems all old and need to be upgraded.
- 2. Garage spaces overheating, temperature control issue?
- 3. Almost all systems original to building. 33 years old
- 4. No automatic sprinkler system within building.
- 5. Only 1 boiler. No redundancy. If boiler was to go down for repair or maintenance. No heat.
- 6. No exhaust systems in garages. Required by current code.

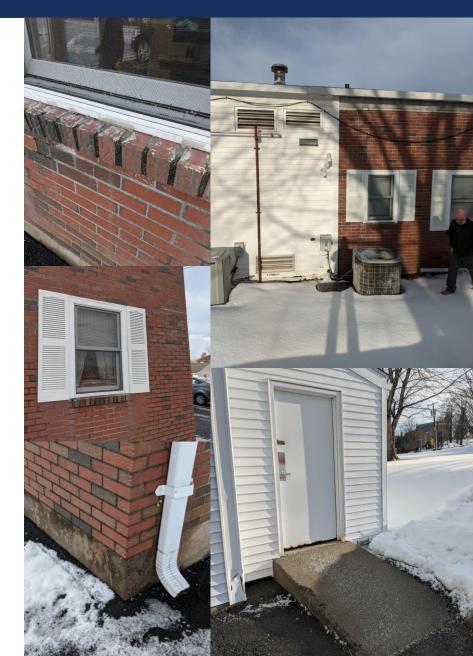
TOWN HALL ANNEX ~ EXISTING CONDITIONS

- 1. Pavement cracking throughout parking lot
- 2. Cracking and deterioration at garage door aprons
- 3. Storm water ponding at exterior wall

- 1. Appears to be pre-engineered structure with conventional wall framing
- 2. General cleaning of exterior masonry and foundation walls needed
- 3. Missing trim at joint between brick and siding
- 4. Corrosion of exterior hollow metal door
- 5. Damage to corner trim, trim between garage doors, and siding near grade
- 6. Re-caulk windows and clean up excess

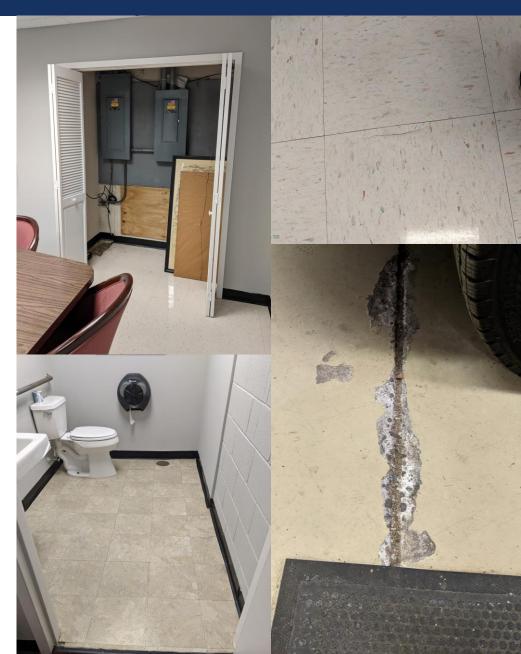
TOWN HALL ANNEX ~ EXISTING CONDITIONS

- 1. Ripped insulation lining throughout garage
- 2. Moisture infiltration at exterior garage doors
- 3. Concrete slab chipping along control joint
- 4. Minor cracking in VCT

1. Toilet facilities missing grab bar

- 1. No automatic sprinkler system within building.
- 2. Mechanical systems is small furnaces. OK Condition.
- 3. Electrical Older. OK Condition.
- 4. Plumbing Older. OK Condition.

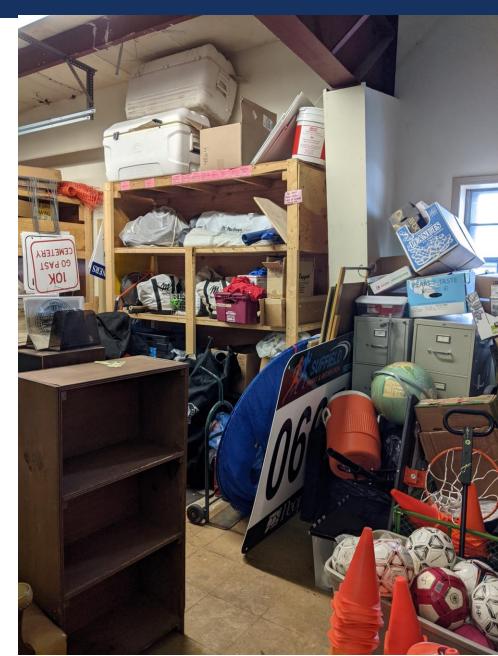
Address	97 Mountain Road
Building Area/Site	2,060 sf / 1.62 acres
Age/Construction	1976 (45)

- 1. Need to identify possible future uses and/or discarded
- 2. Potential for centralized storage location to serve town needs
- 3. Could be removed to make room for higher priorities to possibly create "campus"

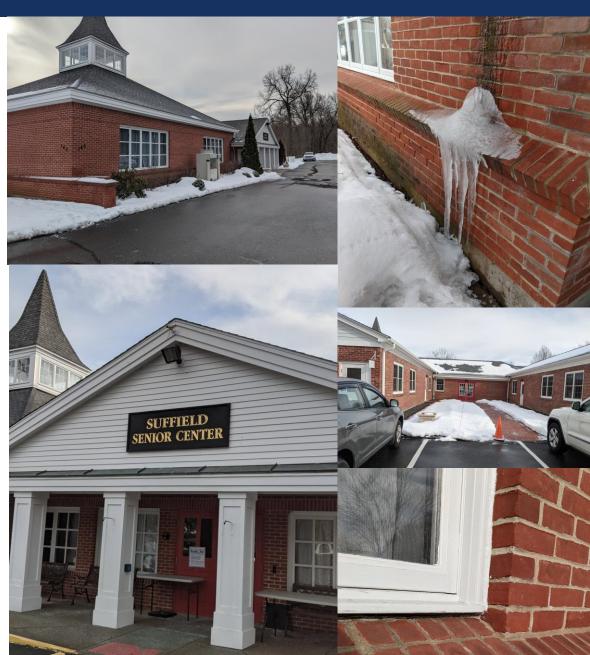
- 1. Cracking in pavement throughout
- 2. Uneven brick patio in courtyard

- 1. Recent renovations (2009) in good condition.
- 2. Lack of gutters at large hip roof and main entrance
- 3. Brick staining at windows
- 4. Exterior wood windows may need replacement within 5-10 years
- 5. General brick cleaning needed
- 6. Lack of gutter causing ice building up at exterior wall

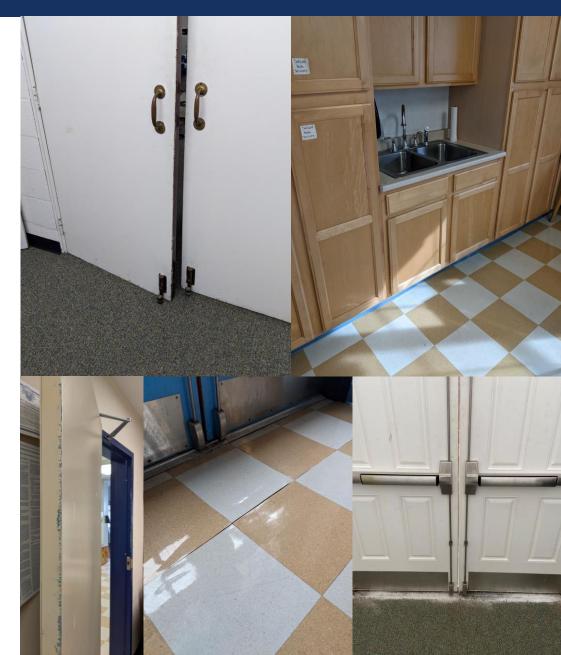
- 1. Hollow metal doors rubbing on frames, causing paint damage
- 2. Movement of VCT flooring near exterior door threshold causing separation
- 3. Lack of weatherstripping at chapel exterior door causing air infiltration

- 1. Youth Services and Parks & Rec do not have accessible entrances from exterior
- 2. Non-accessible sink at Youth Services
- 3. Damaged VCT at Youth Services

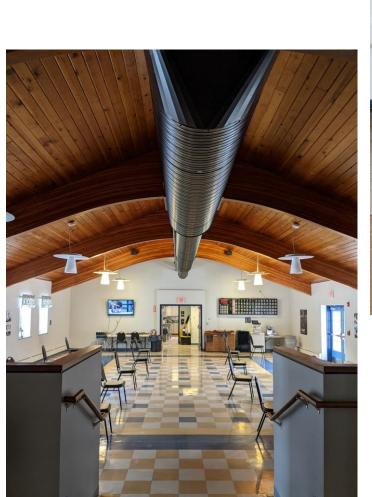
- 1. No Automatic Sprinkler System.
- 2. Renovated recently.
- 3. Most MEP in good condition.
- Will start to need more maintenance in the next 5 – 10 years.
- 5. Perimeter radiant heating units leaking, causing damage to flooring

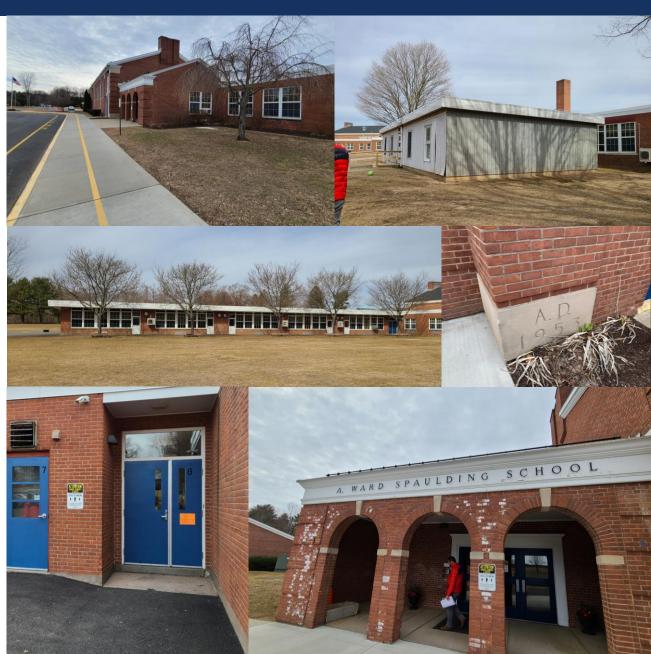
A. WARD SPAULDING SCHOOL ~ EXISTING CONDITIONS

- 1. Insufficient parking for events, parking immediately adjacent to building a safety concern.
- 2. Parent/Bus repayed 2020, remaining parking in fair condition. Remaining parking in need of replacement. Curb and sidewalks are in fair to poor condition overall with some portions recently replaced.
- 3. Poor definition of school boundary, remote/unprotected playground and playscapes

- 1. Masonry in need of repointing/repair, efflorescence on portions of building
- 2. Remaining original exterior door, frames, soffits and trim in poor condition
- 3. Modular addition in poor condition

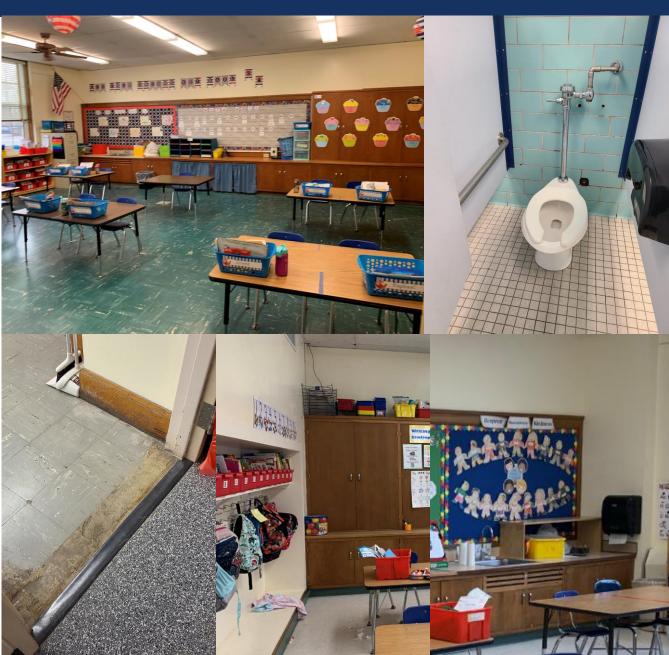
A. WARD SPAULDING SCHOOL ~ EXISTING CONDITIONS

- 1. Original masonry bearing, steel roof joist, truss & wood plank gym/Aud. In fair to good condition.
- 2. Addition(s) steel frame superstructure masonry infill.

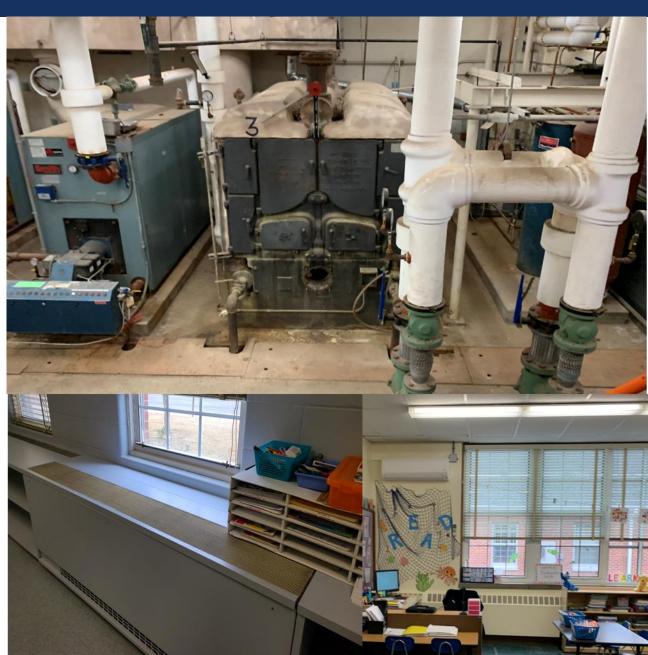
A. WARD SPAULDING SCHOOL ~ EXISTING CONDITIONS

- 1. No automatic sprinkler system within building.
- 2. Unit Vents are needing lots of repairs. Will all need to be replaced.
- 3. Unit Vents are not ventilation properly and need to be repaired.
- 4. Controls do not work. Town said will be replaced during the Summer of '21.
- 5. Electrical Lighting and Power Distribution are at the end or past their useful life.
- 6. Boiler plant needs to be replaced. At the end of its useful life.

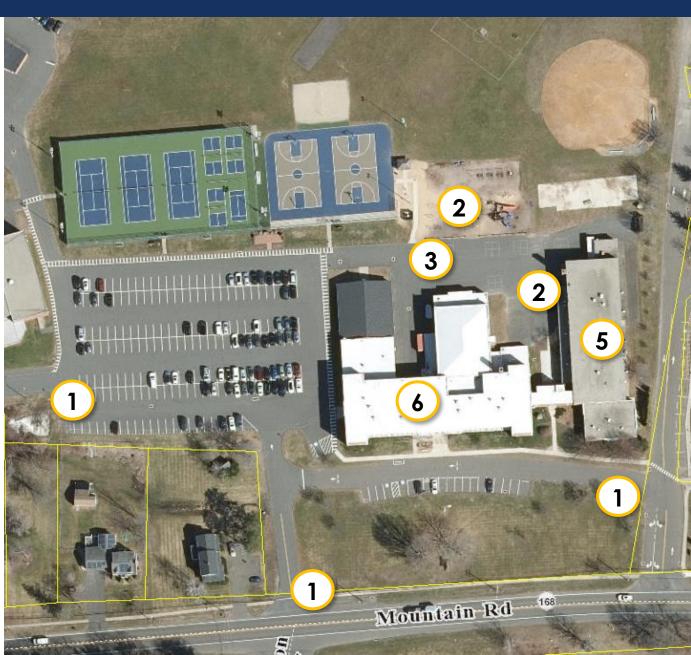
Grade Level	3-5
Building Area/Site	72,263 sf / 32.4 acres (shared)
Age/Construction	1939 (82), 1956 (65), 1987 (34), 1994 (27)

- 1. Roof replaced in sections, 1956 portion to be replaced to match. Masonry repointed and chimney repairs.
- 2. Many non or poorly functioning windows and exterior doors, persistent concerns/repairs (2001) and flashing/water infiltration issues.

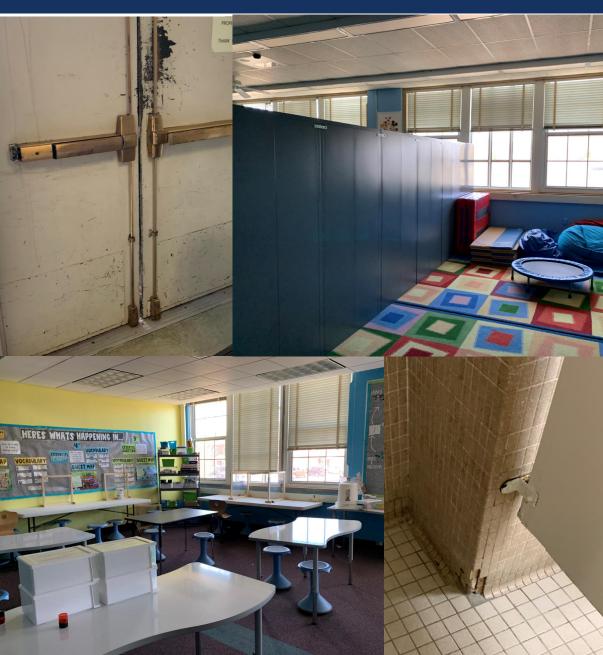
Grade Level	3-5
Building Area/Site	72,263 sf / 32.4 acres (shared)
Age/Construction	1939 (82), 1956 (65), 1987 (34), 1994 (27)

- 1. Overall, well built, durable original construction and well maintained. Many important investments & preventative maintenance (roofs, A/C, isolated room renovations)
- 2. Many components (finishes, millwork, lockers) of original construction are past useful life and/or non accessible (ADA @ toilet rooms, ramp, doorways)
- 3. Inconsistent construction of various room modifications over the years. Ventilation concerns in portions of buildings related to construction of additions and encapsulation
- 4. Gym condition poor, bleachers to be removed currently a safety concern.
- 5. Lockers original poor condition throughout
- 6. Inadequate separation of specials areas.

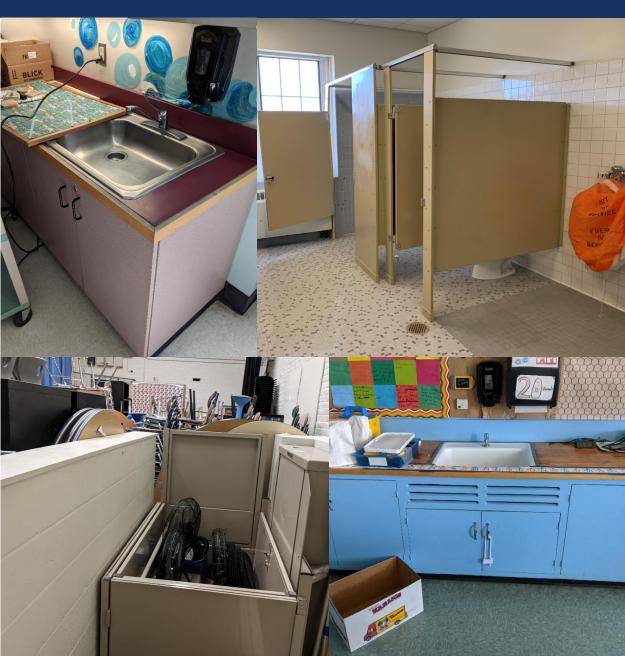
Grade Level	3-5
Building Area/Site	72,263 sf / 32.4 acres (shared)
Age/Construction	1939 (82), 1956 (65), 1987 (34), 1994 (27)

- 1. Original building and 1956 addition wall bearing, steel joist, wood plank flooring (original) concrete deck (1956).
- 2. Floor to floor noise transfer and acoustical concerns in original portion of the building.

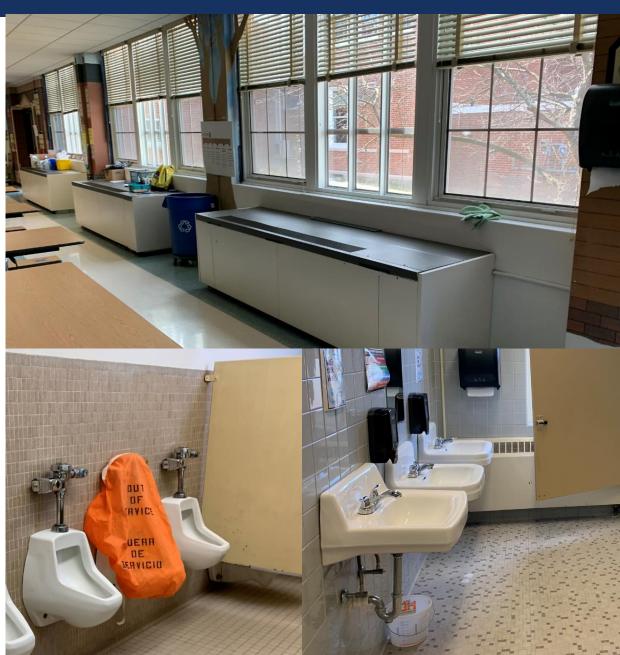
- 1. Fresh air relies on window ventilation, limited to no mechanical ventilation
- 2. No automatic sprinkler system within building
- 3. No Building Management System in the school
- 4. Plumbing fixtures are old and are failing, many are non-compliant with code
- 5. Unit ventilation in majority of spaces do not meet current codes, difficult to control/maintain/repair, staffing/student comfort concerns
- 6. Issues with technology including paging and clocks. Need to be replaced.
- 7. Electrical power distribution and lighting are at the end or past their useful life.

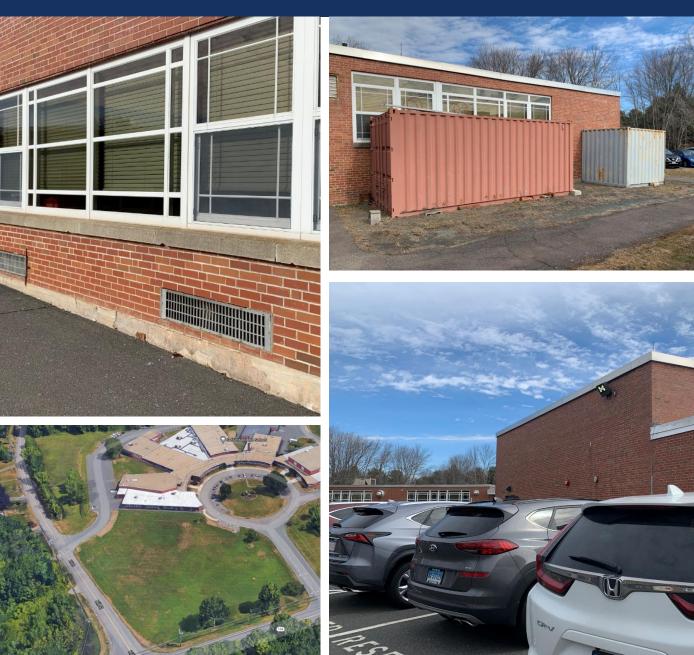
Grade Level	6-8
Building Area/Site	128,489 sf / 32.4 acres (shared)
Age/Construction	1964, 1965 (Vo-Ag), 1972, 2002

- 1. Consistent roof leaks, roof replaced in phases by different contractors, various warranties, other envelope concerns ~ pointing of masonry, doors, etc.
- 2. Majority of building contain brick veneer in fair to good condition with areas of isolated spalling at base of wall/ exposed concrete foundation wall. Existing lintels are in fair to poor condition.

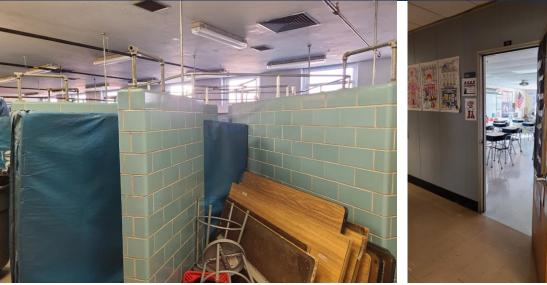
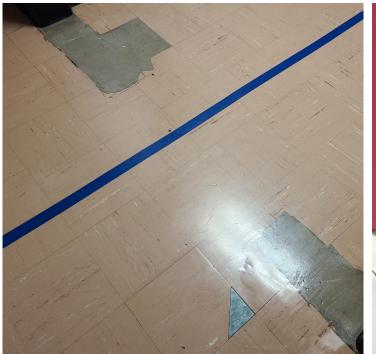
Grade Level	6-8
Building Area/Site	128,489 sf / 32.4 acres (shared)
Age/Construction	1964, 1965 (Vo-Ag), 1972, 2002

- 1. Overall, well maintained, original building well built, but many areas poorly constructed.
- 2. Observed significant inefficiencies due to additions/renovations over time.
- 3. Noise/Acoustical concerns in 70's additions renovations due to "modular" wall construction.
- 4. Various additions eliminated natural daylight to educational space creating poor conditions for educating students.
- 5. Overall condition of finishes are generally in poor condition. However yearly improvements have been made to isolated areas, science labs, finishes in media center, tech education planned.
- 6. Majority of toilet cores are in poor condition due to age and use. In some instances, are not used/obsolete

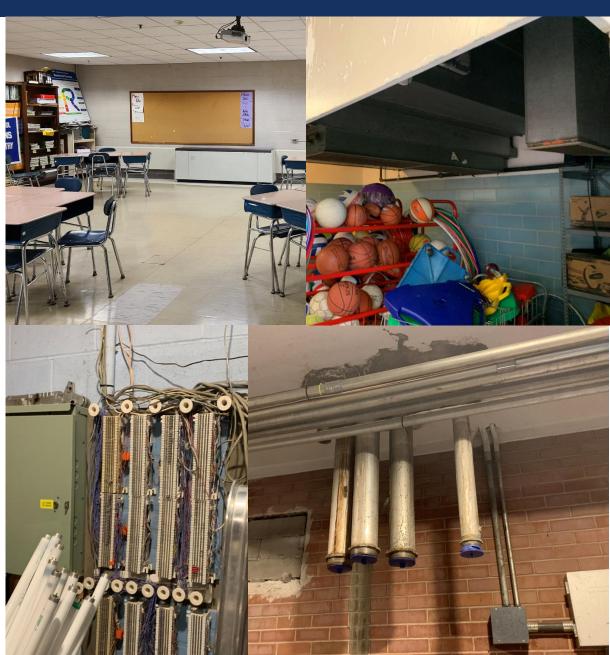
Grade Level	6-8
Building Area/Site	128,489 sf / 32.4 acres (shared)
Age/Construction	1964, 1965 (Vo-Ag), 1972, 2002

- 1. Many renovations and varying vintages of systems. Some newer, some original.
- 2. No central domestic Hot Water Plant. Lots of distributed water heaters. Leads to more maintenance and repairs.
- 3. Electrical systems has many vintages. While service is newer it back feeds original vintage systems.
- 4. Most major mechanical systems past or at the end of their useful life.
- 5. No natural ventilation/windows to many classrooms/educational spaces.
- 6. Overall MEP systems need a complete overhaul.

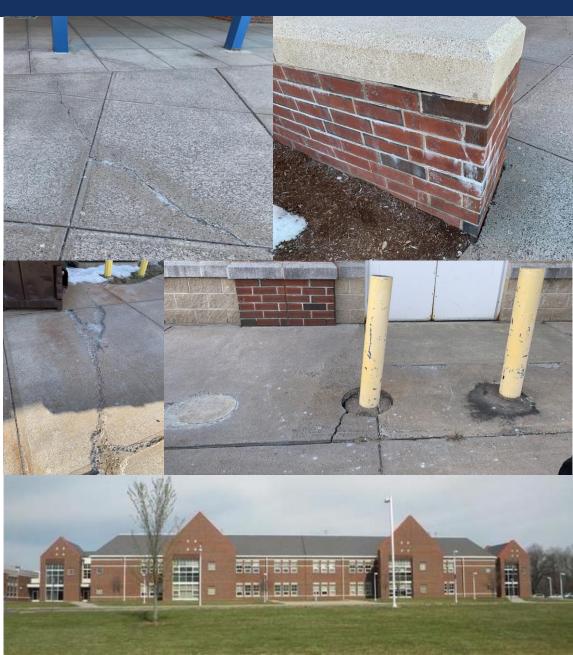
Grade Level	9-12
Building Area/Site	204,016 sf / 60.48 acres
Age/Construction	2002 (19)

- 1. Generally good to fair condition. Durable and well maintained. Recommend prev. maint. (caulking/sealants)
- 2. Under-utilized Courtyard Space. Gaps in perimeter roof flashing exposing building to loss of energy and wildlife
- 3. Original roof designed with 15-year warranty, 4 years out of warranty.

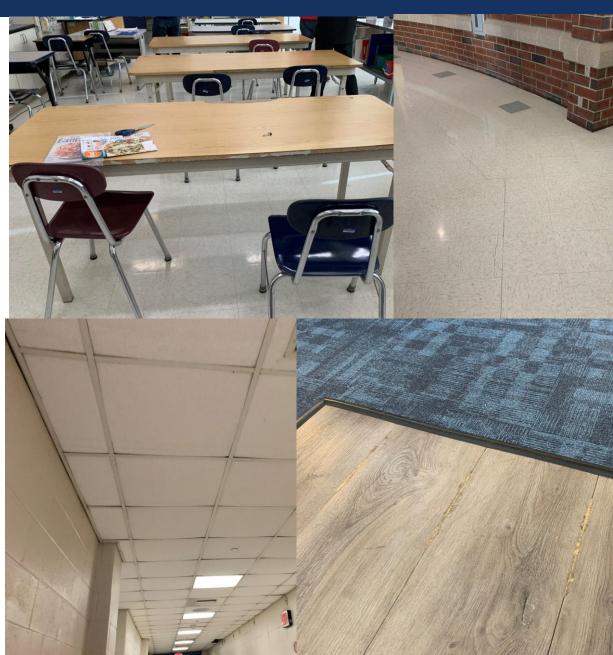
Grade Level	9-12
Building Area/Site	204,016 sf / 60.48 acres
Age/Construction	2002 (19)

- 1. Overall, well maintained, some areas of questionable quality of original construction, overall building has worn faster than anticipated (accelerated wear and tear on finishes)
- 2. Visual indications of various slab cracking throughout building with possible water/vapor infiltration. Persistent issue causing finishes/glue to bubble due to moisture.
- 3. Curious curling ceiling tiles leads team to be concerned about the HVAC balancing of the school.
- 4. Obsolete program functions have been transformed into new uses on a yearly/on-going basis
- 5. Original doors, hardware, finishes are beginning to show signs of age and deterioration.
- 6. Fairly significant deterioration of furniture in areas, in some cases it is mismatched.

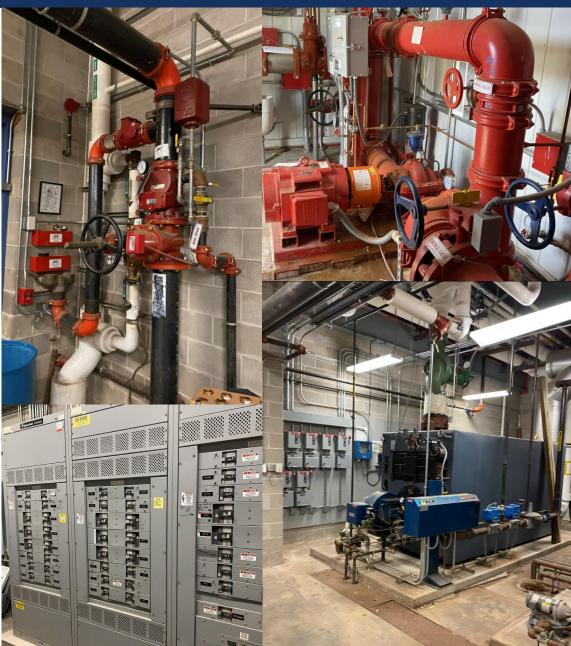
Grade Level	9-12
Building Area/Site	204,016 sf / 60.48 acres
Age/Construction	2002 (19)

- 1. Major Air Handling units 20 years old but failing at a high rate.
- 2. Electrical distribution is challenging and is difficult to troubleshoot. Additionally nothing is labeled.
- 3. Plumbing Flush Valves for Water Closets and Urinals and Faucets were installed as sensor faucets. Faucets failing at a high rate. Need to be replaced throughout.
- 4. Controls throughout are an issue. Town is currently fixing this.
- 5. Overall ALL MEP systems are starting to get to the age where they will need some major maintenance. If maintenance is delayed then the repair costs will be greater.
- 6. Concern related to water treatment & affects on systems

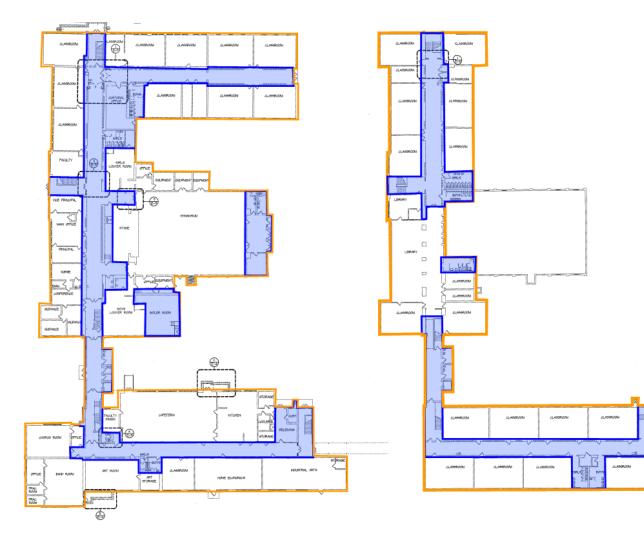
McAlister Intermediate School Area Analysis

Orange Outline Total Gross Floor Area ~ 72,263 GSF
