Fawcett Elementary School
Tacoma Public Schools

Conditional Use Permit (CUP) Narrative

August 16, 2021
AHBL Project No. 2200932.10

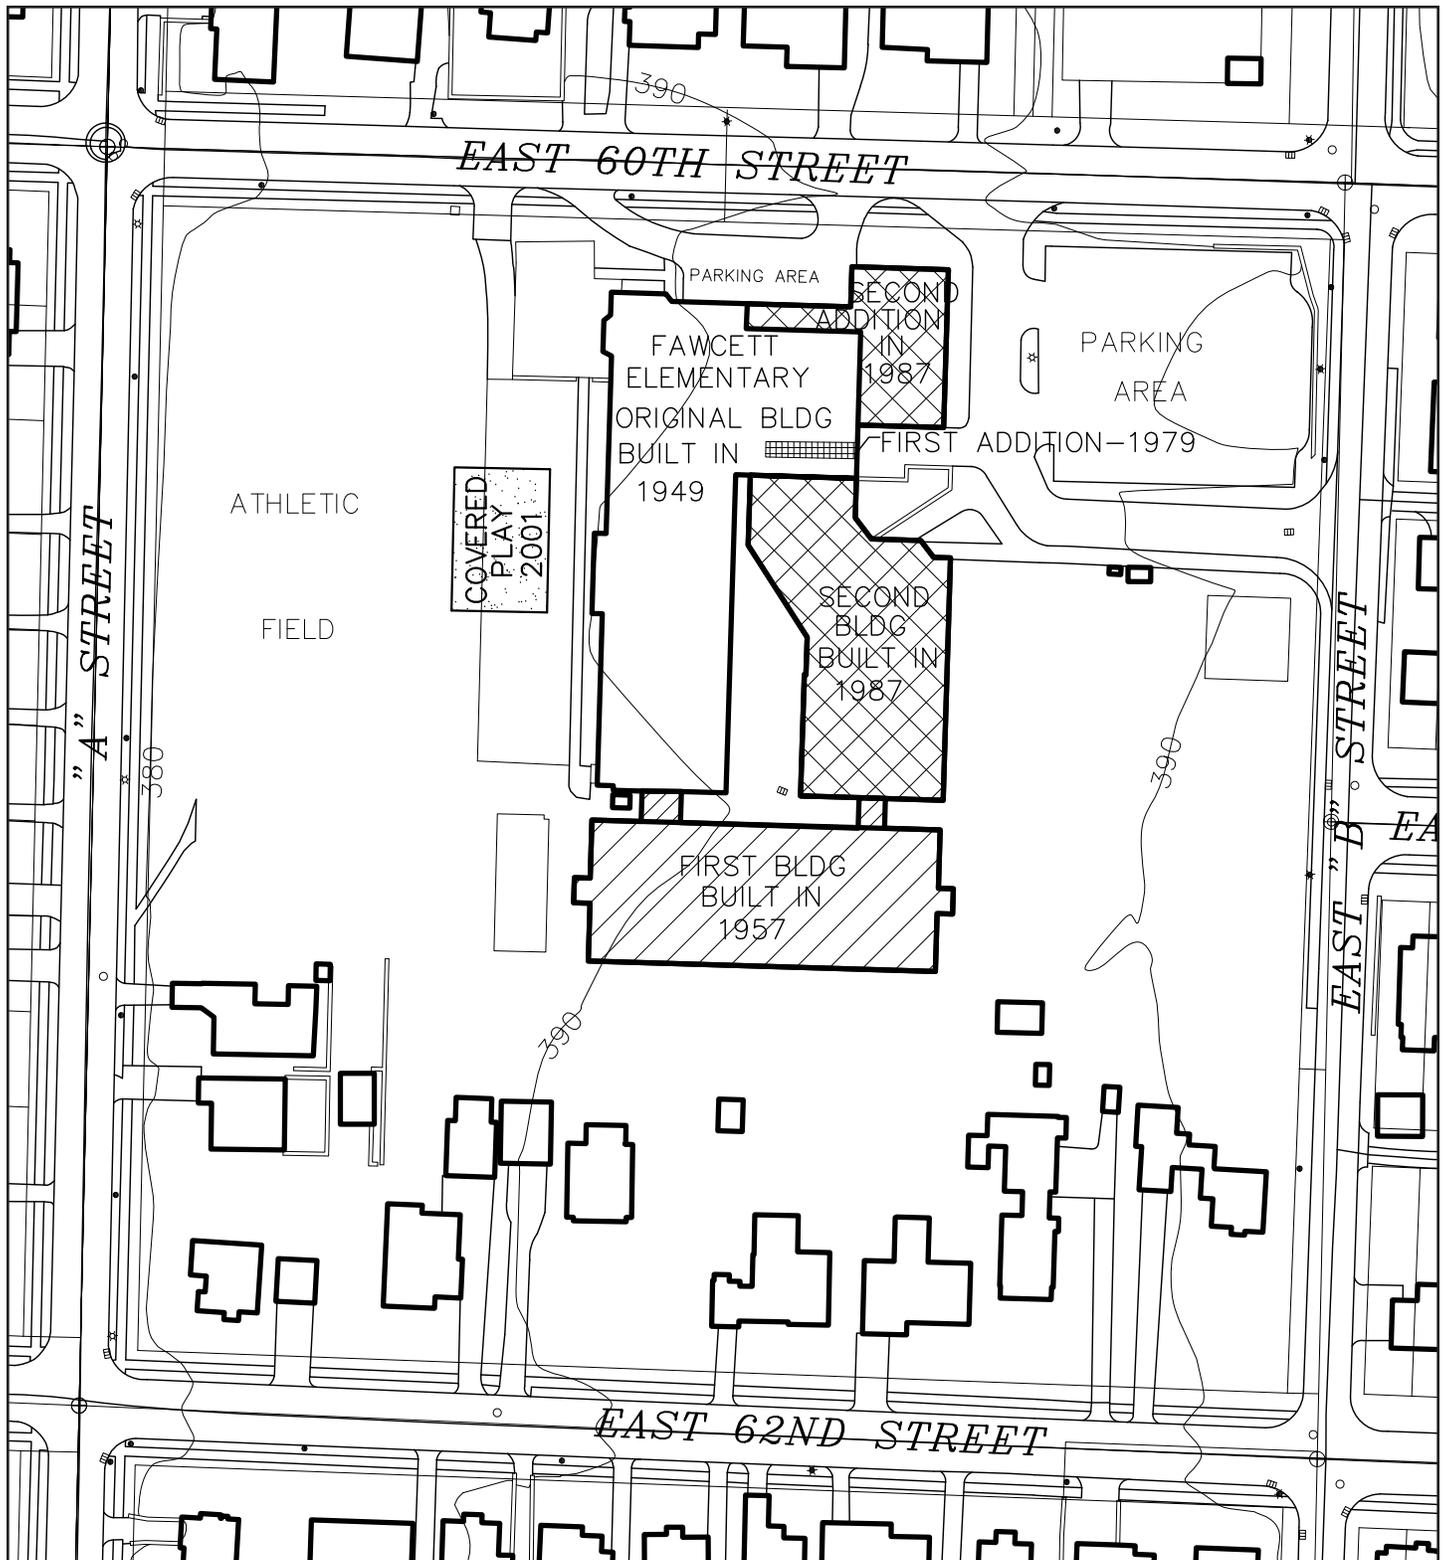
Site plan showing dates of construction for the original building [sic, 1950] and subsequent additions. Fenceline along south edge of parcel not shown. Surrounding buildings are primarily residences. Source: BLRB Architects.

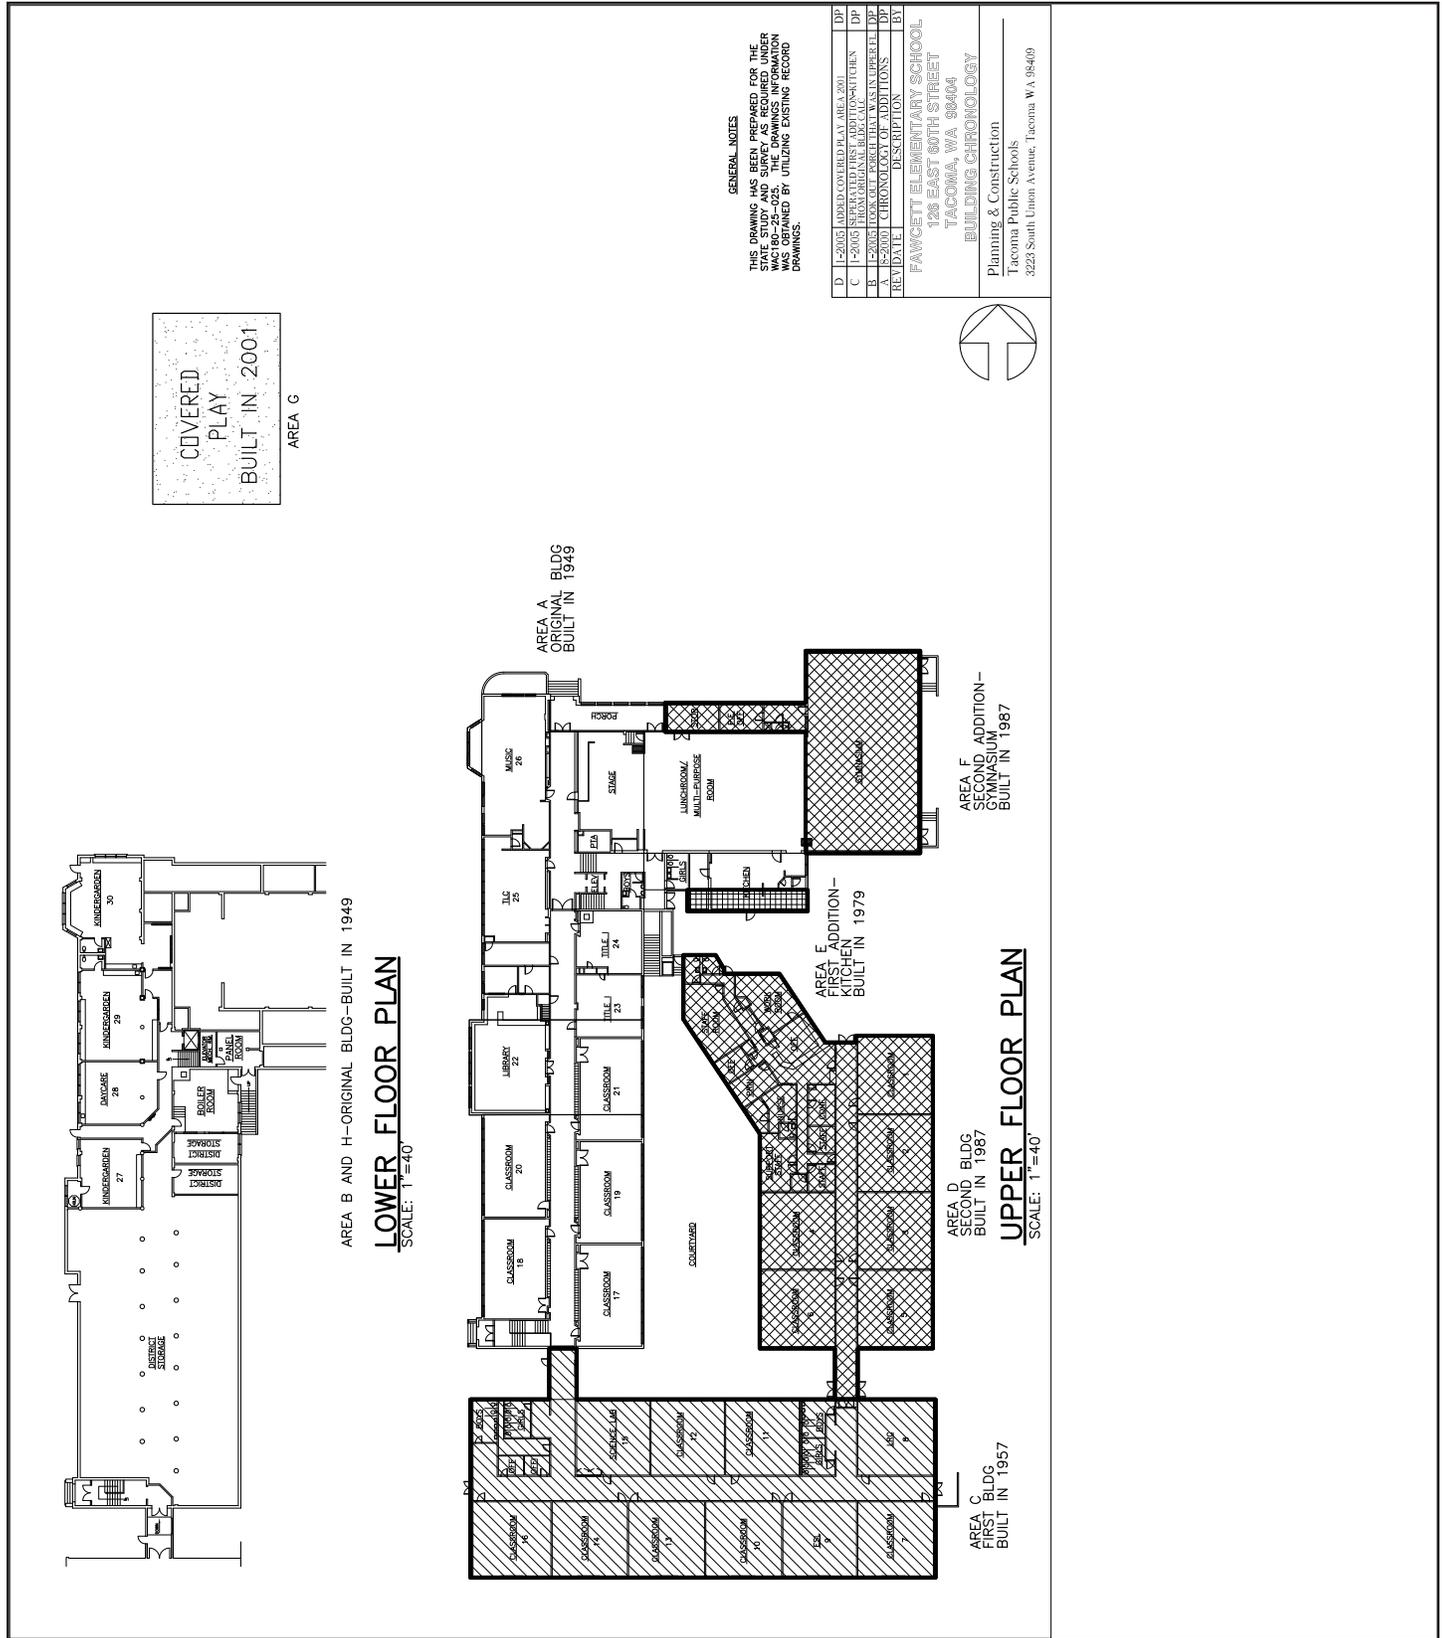
Floor plan, as-built and current to 2021. Source: Tacoma School District via BLRB Architects.

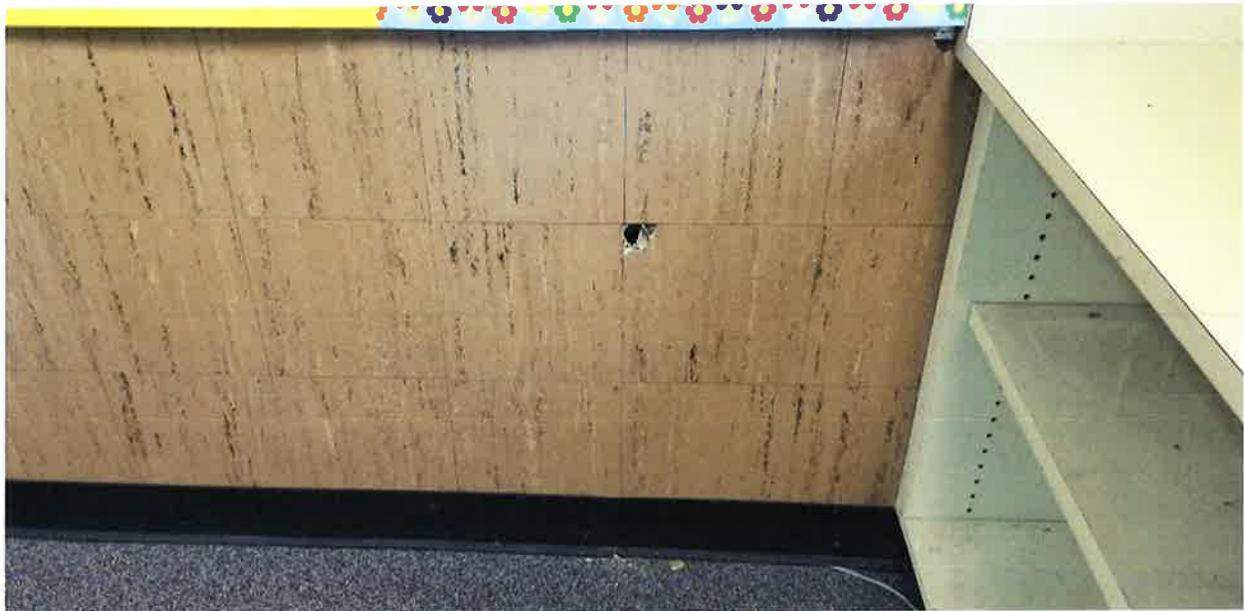
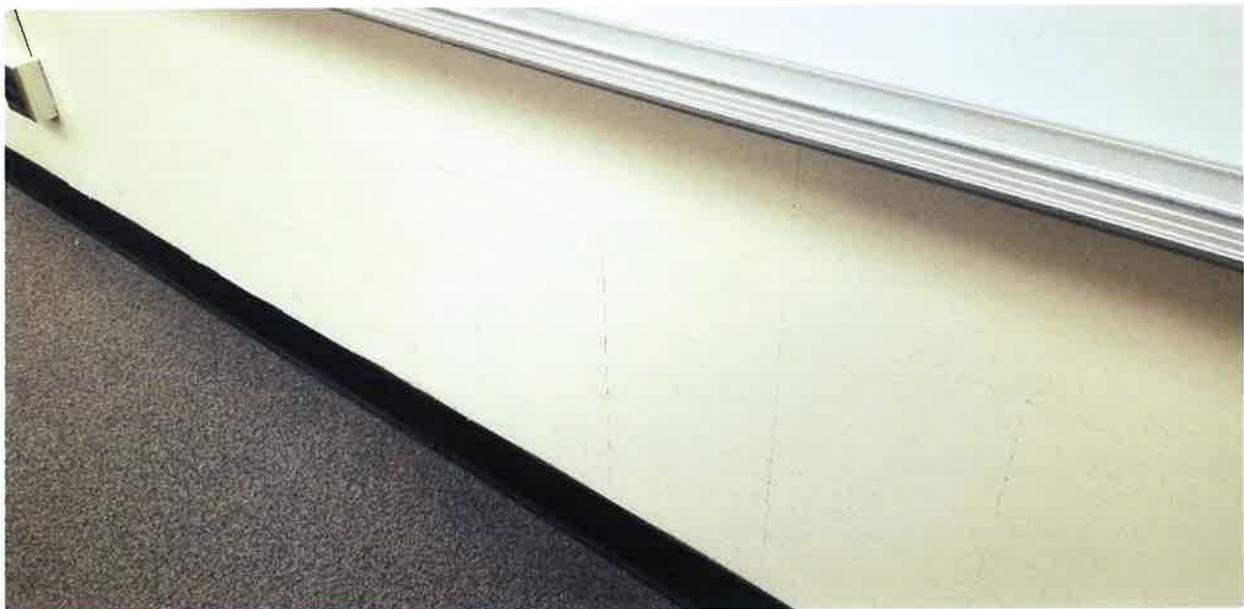
Vinyl Flooring - Floor Tile 4 (FT 4)
Samples No. 13 and 14

This non-friable vinyl tile can be found on the walls in a majority of the classrooms 7, 8, 9, 10, 11, 12, 13, 14, 15, and 16 (walls are painted) and on the floor in room ESL 9. On the wall, material is adhered to a wallboard or plaster substrate and in room ESL 9, it is adhered to a concrete substrate in front of the sink. The vinyl tile contained 3% Chrysotile while no asbestos was found in the mastic. Although sample number 13 was found non-detect, it was homogenized with sample number 16 which was found asbestos containing. Estimated quantity is 2,500 square feet.

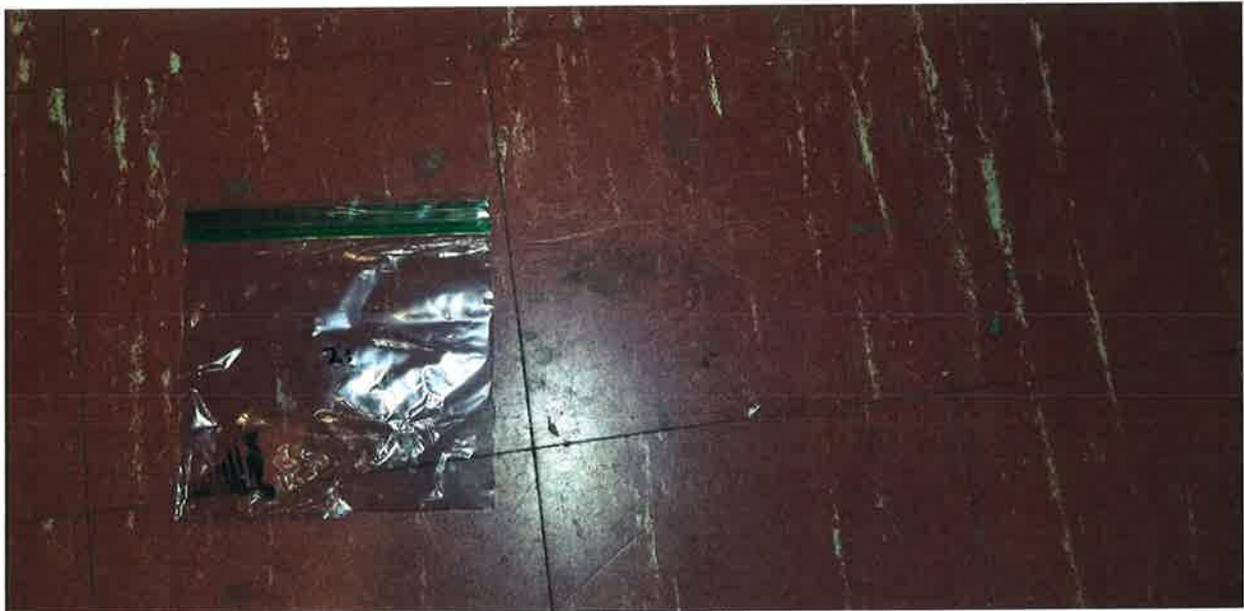
Sample No. 21

This non-friable vinyl tile can be found in the southwest end of the building in a supply room of the hallway between the girl's and boy's bathroom with an estimated quantity of 120 square feet. Vinyl tile contained 2% Chrysotile fibers and is adhered to a wood substrate. The mastic associated with the tile did not contain asbestos.

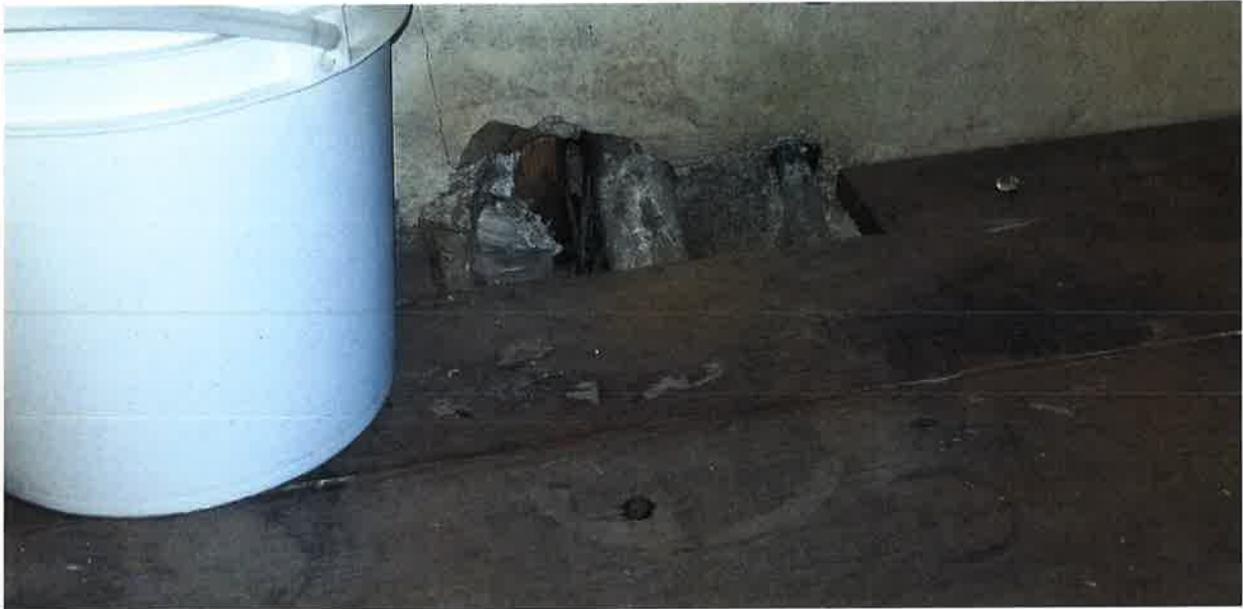
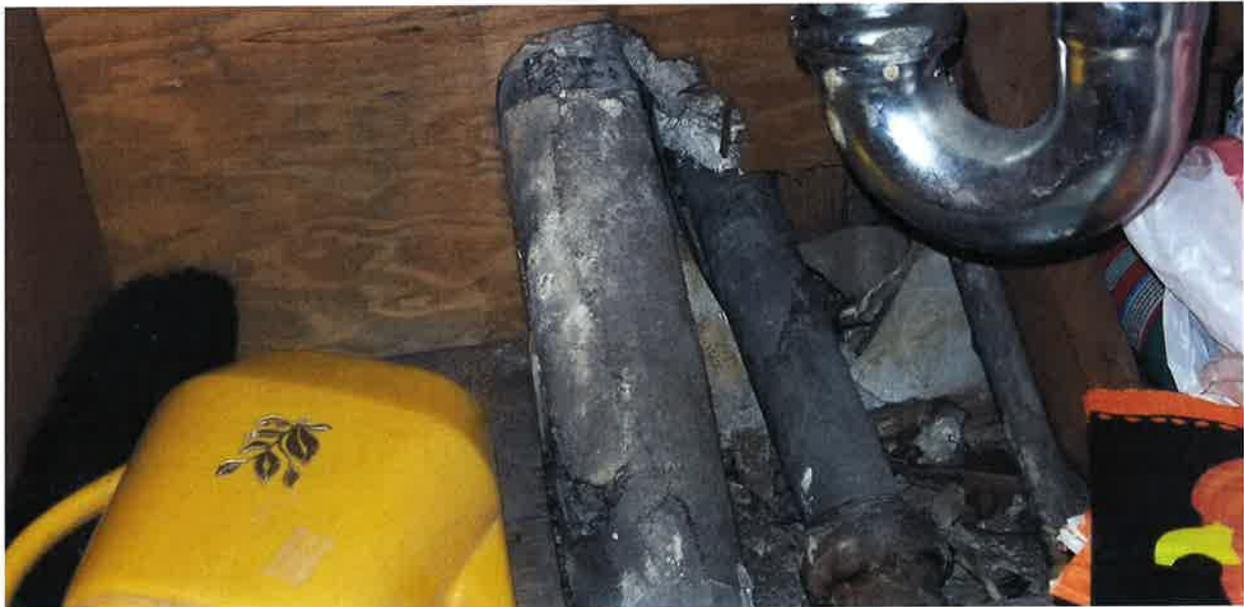
Pipe Insulation – TSI 1
Sample No. 59 and 60

This friable pipe insulation (air-o-cell) is found in association with classroom sinks and other locations throughout the building. Material may be exposed or may be underneath a wood door found under the sink. The material is in poor condition with debris found underneath the piping. Material contained 40% Chrysotile fibers. Material from the base may extend up to 3 feet behind the wall and cabinetry. It is assumed that the material may also extend approximately up to 1 foot below the base as a penetration. Estimated quantity for this material is 120 linear feet visible. We also estimate 250 linear feet may be concealed. NOTE: Materials stored in the cabinets may be contaminated with this insulation.

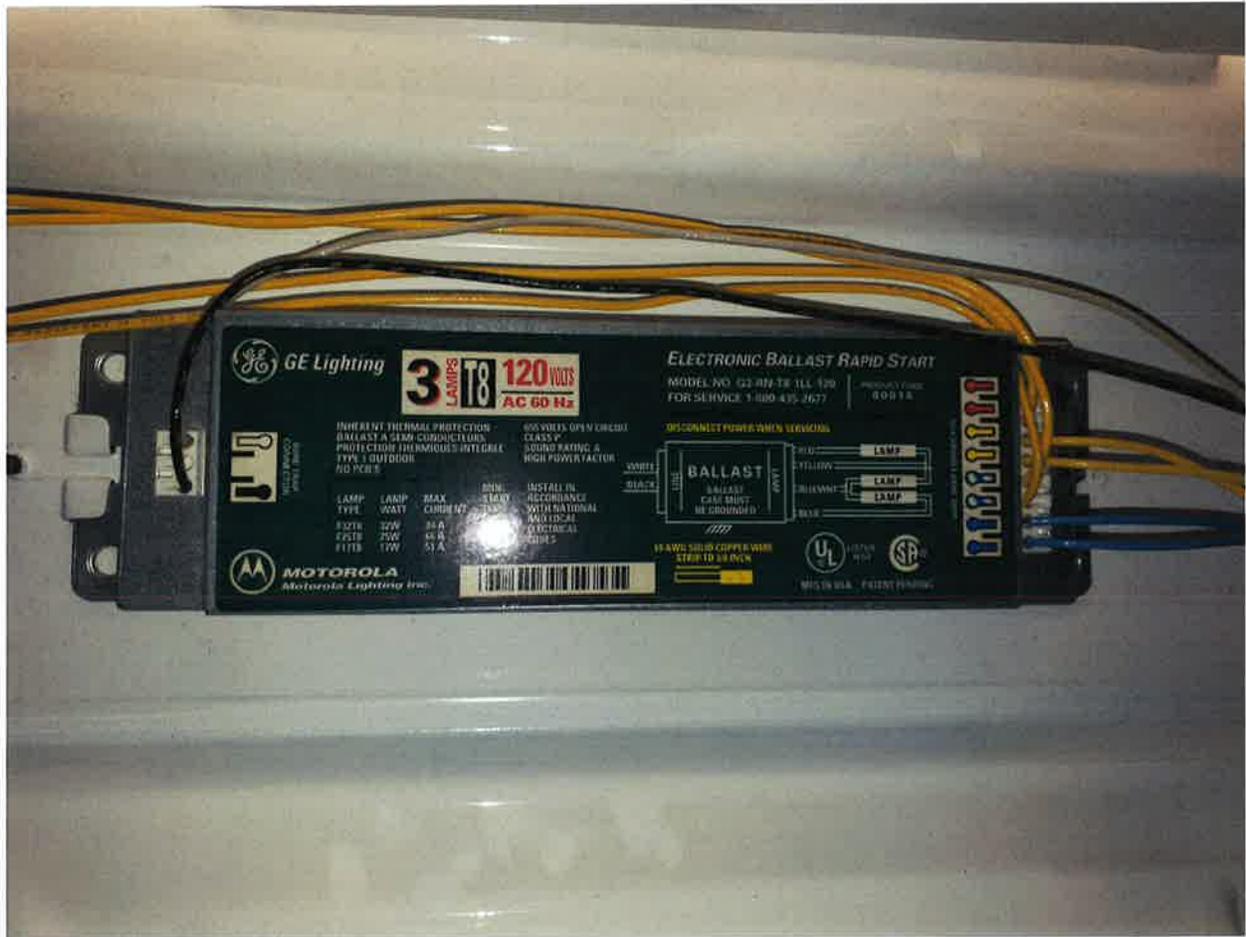
Fluorescent light ballasts were randomly examined throughout the buildings. The ballasts of these fixtures we identified were either electronic or ballasts were marked as “No PCB”

Ballast marked as “Electronic”

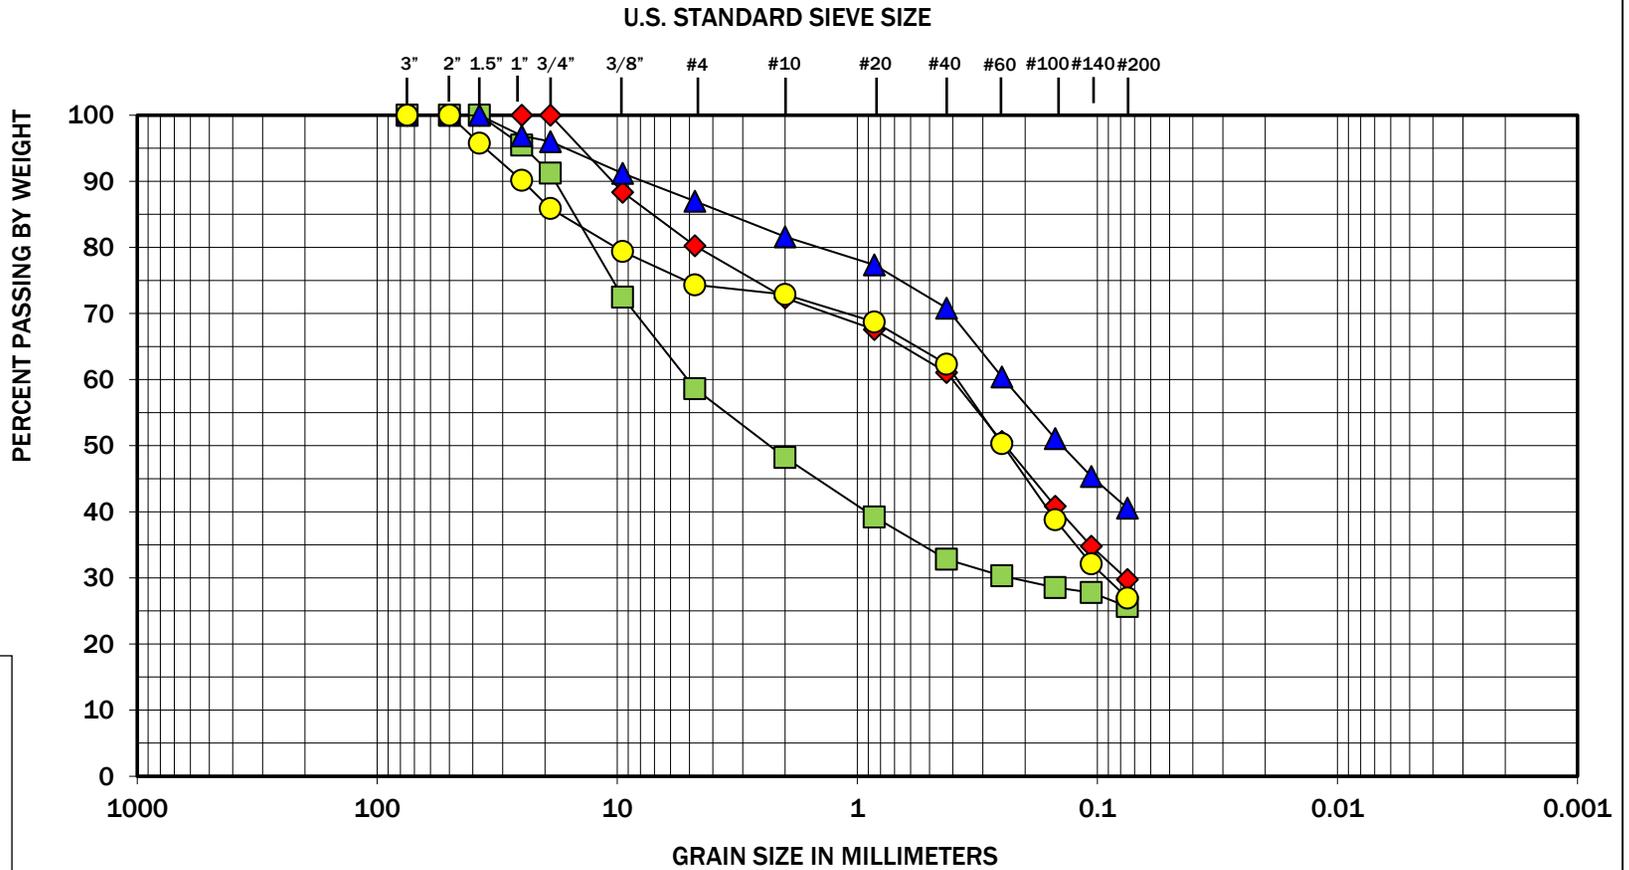
Symbol	Test Pit Number	Depth (feet)	Moisture (%)	Soil Description
◆	TP-2	2.5	12	Silty sand with gravel (SM)
■	TP-3	0.75	6	Silty sand with gravel (GM)
▲	TP-4	3	12	Silty sand (SM)
●	TP-5	5.5	10	Silty sand with gravel (SM)

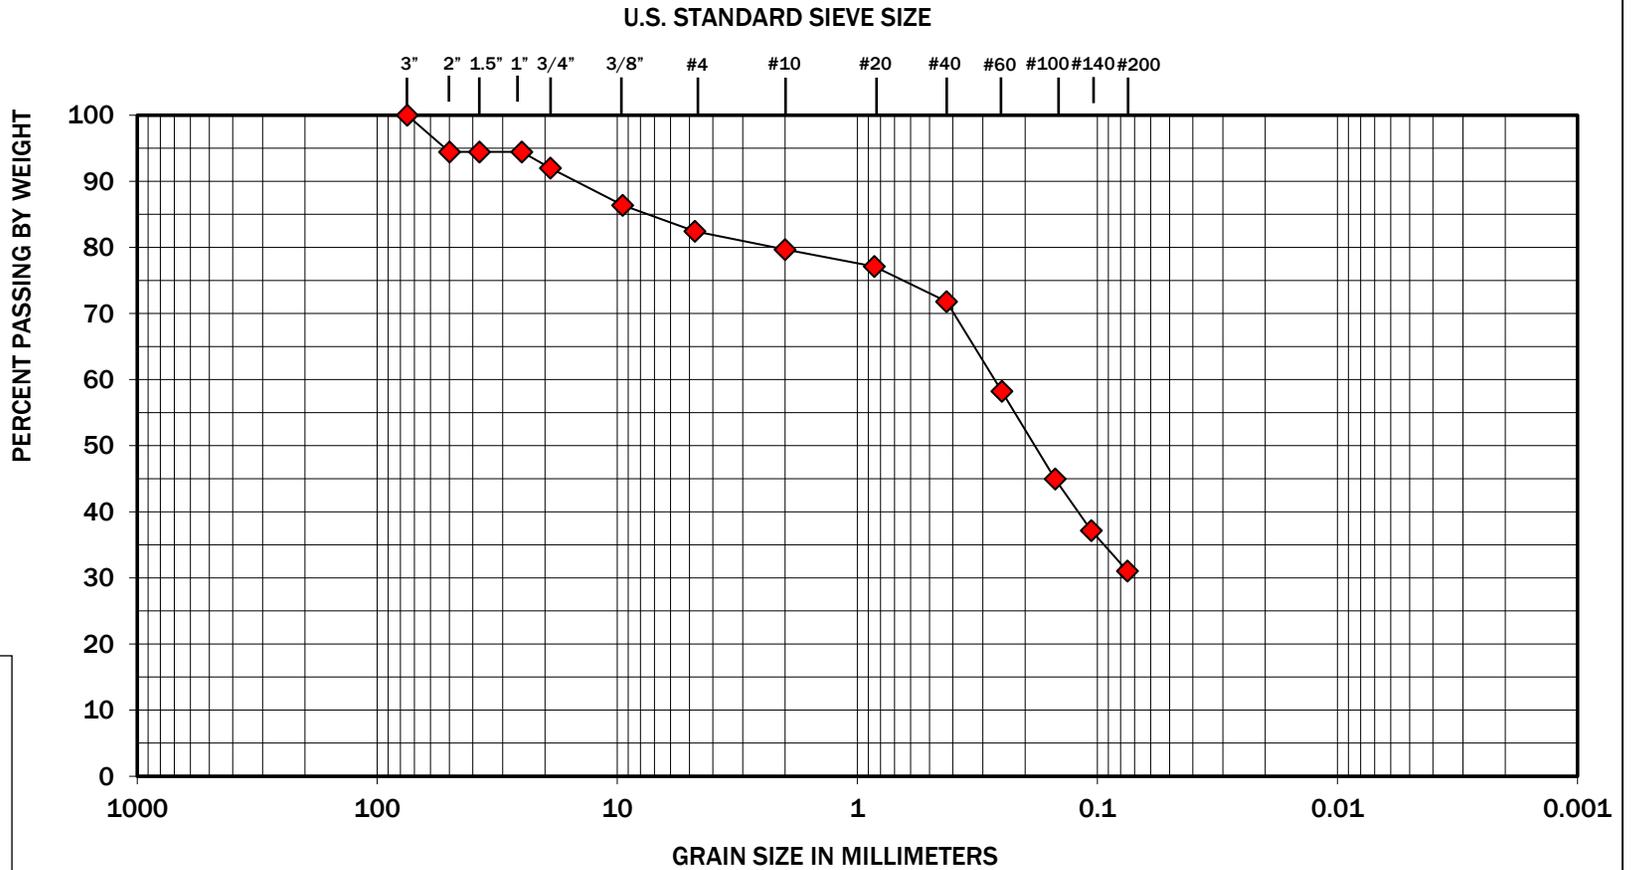
Sieve Analysis Results

Symbol	Test Pit Number	Depth (feet)	Moisture (%)	Soil Description
◆	TP-6	4	12	Silty sand with gravel (SM)

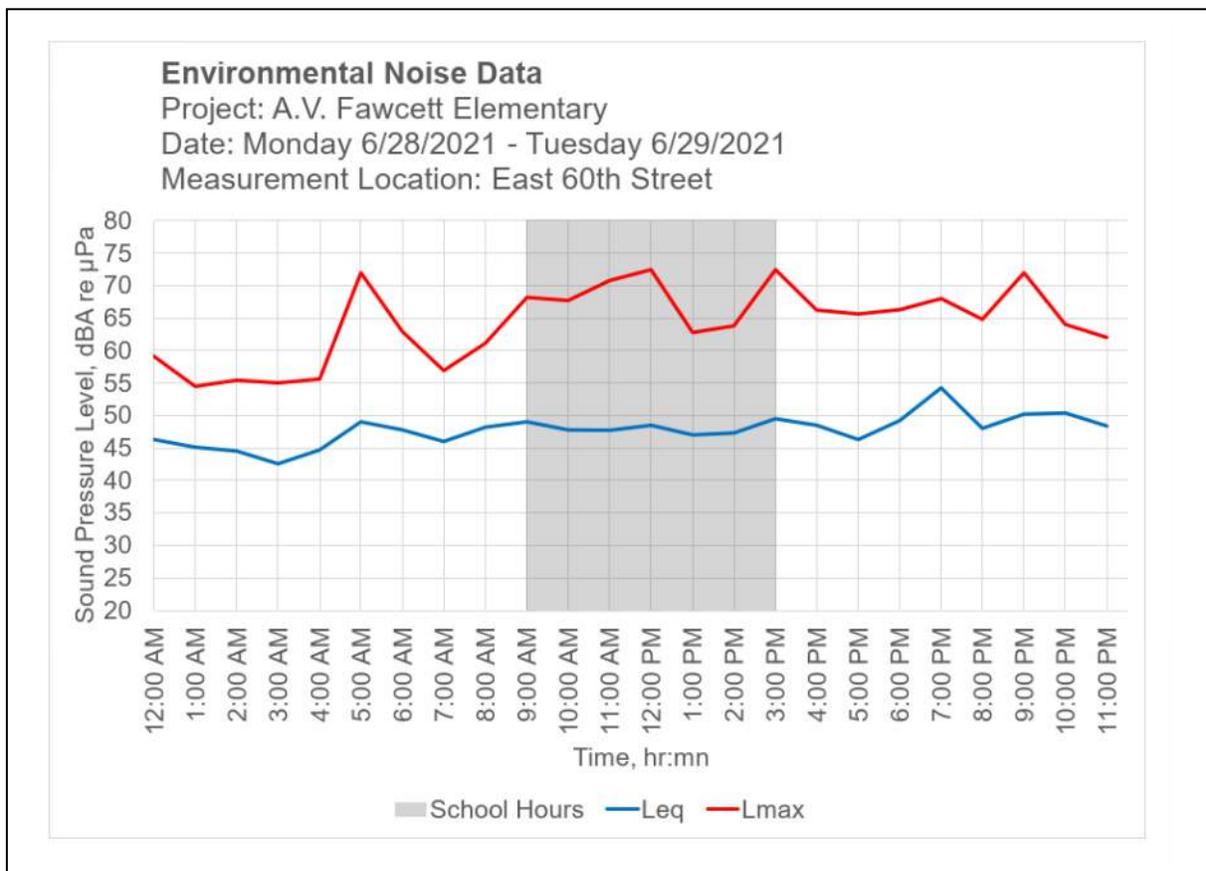
The long-term measurements were presented as hourly Leq and as hourly Lmax values, reported as A-weighted decibels (dB(A)). The average hourly measurements are presented in the following graph.

Values in the graph were measured at the street location and had hourly Leq values during school hours ranged from 46.0 to 49.5 dB(A) between 7:00 a.m. and 5:00 p.m. Lmax values did not exceed 75 dB(A). Based on these noise levels, no mitigation in the building envelope design to achieve full compliance with the requirements of Washington Administrative Code. Standard building construction practices should be utilized. The planned additions to the school will not be impacted by environmental noise.

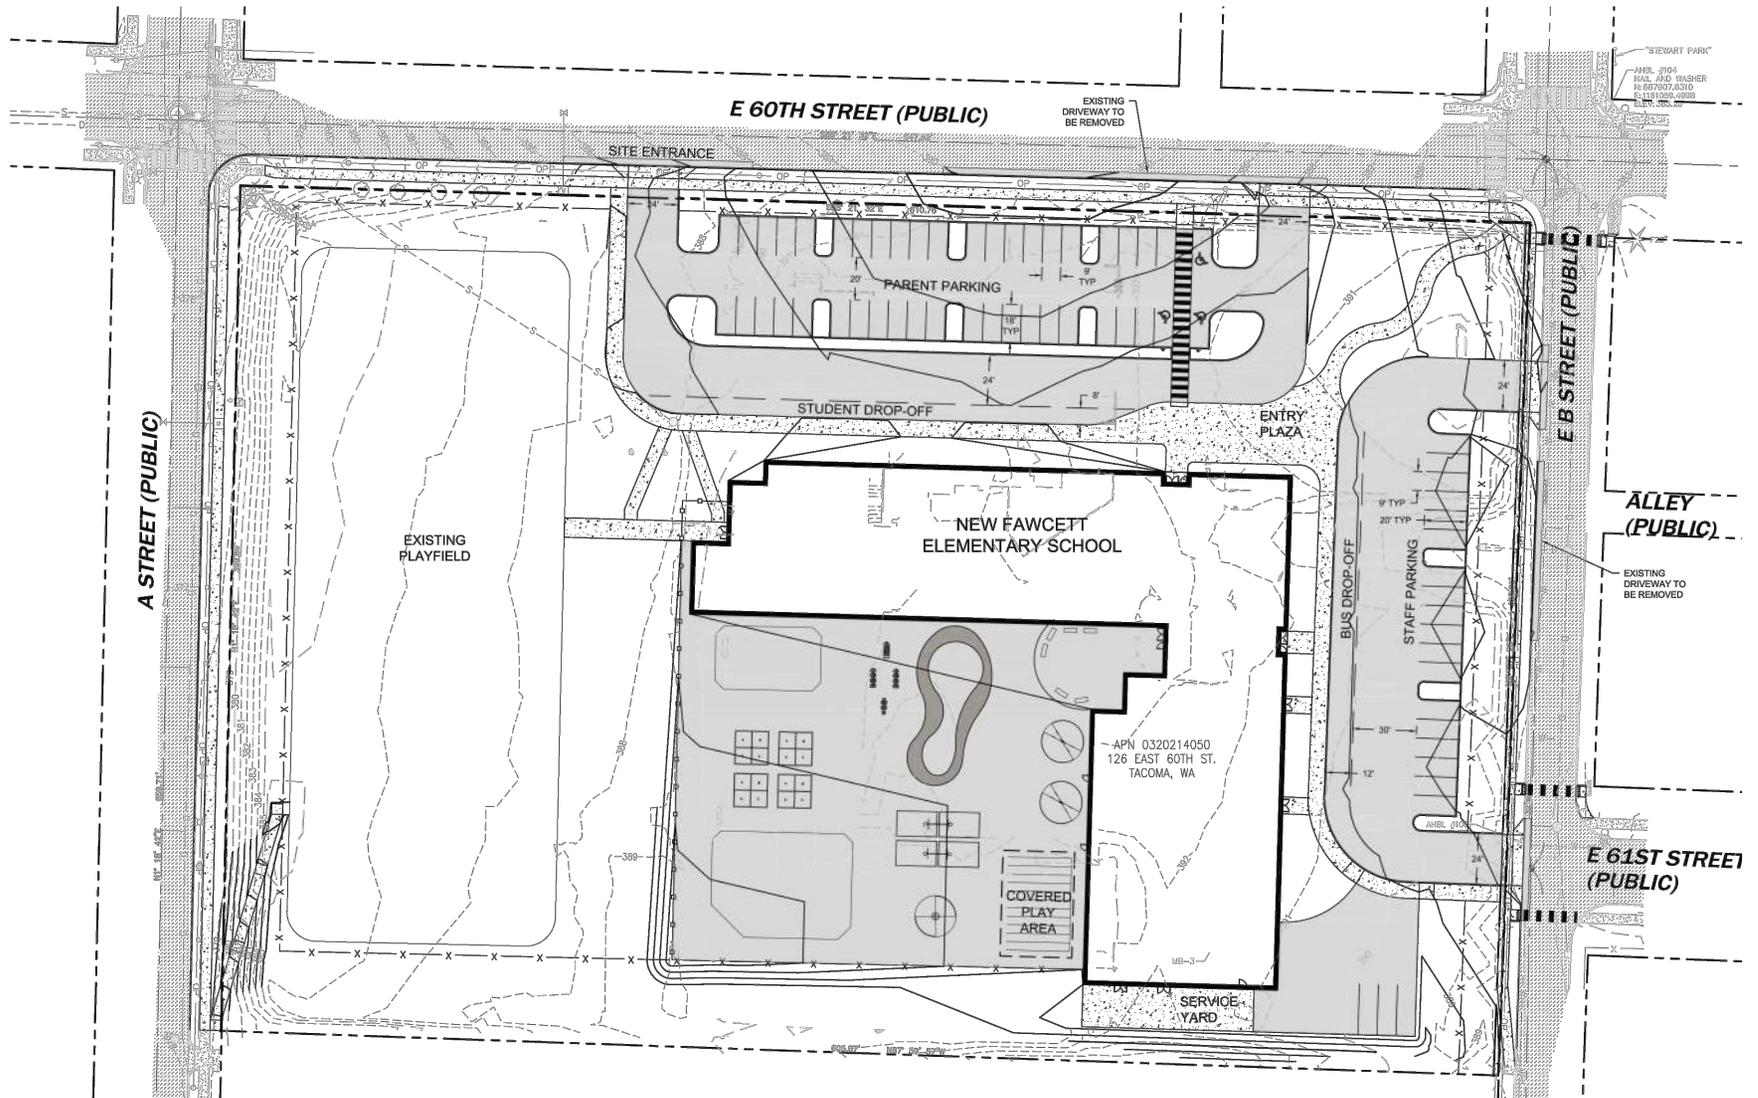
FAWCETT ELEMENTARY
SITE PLAN
FIGURE 2

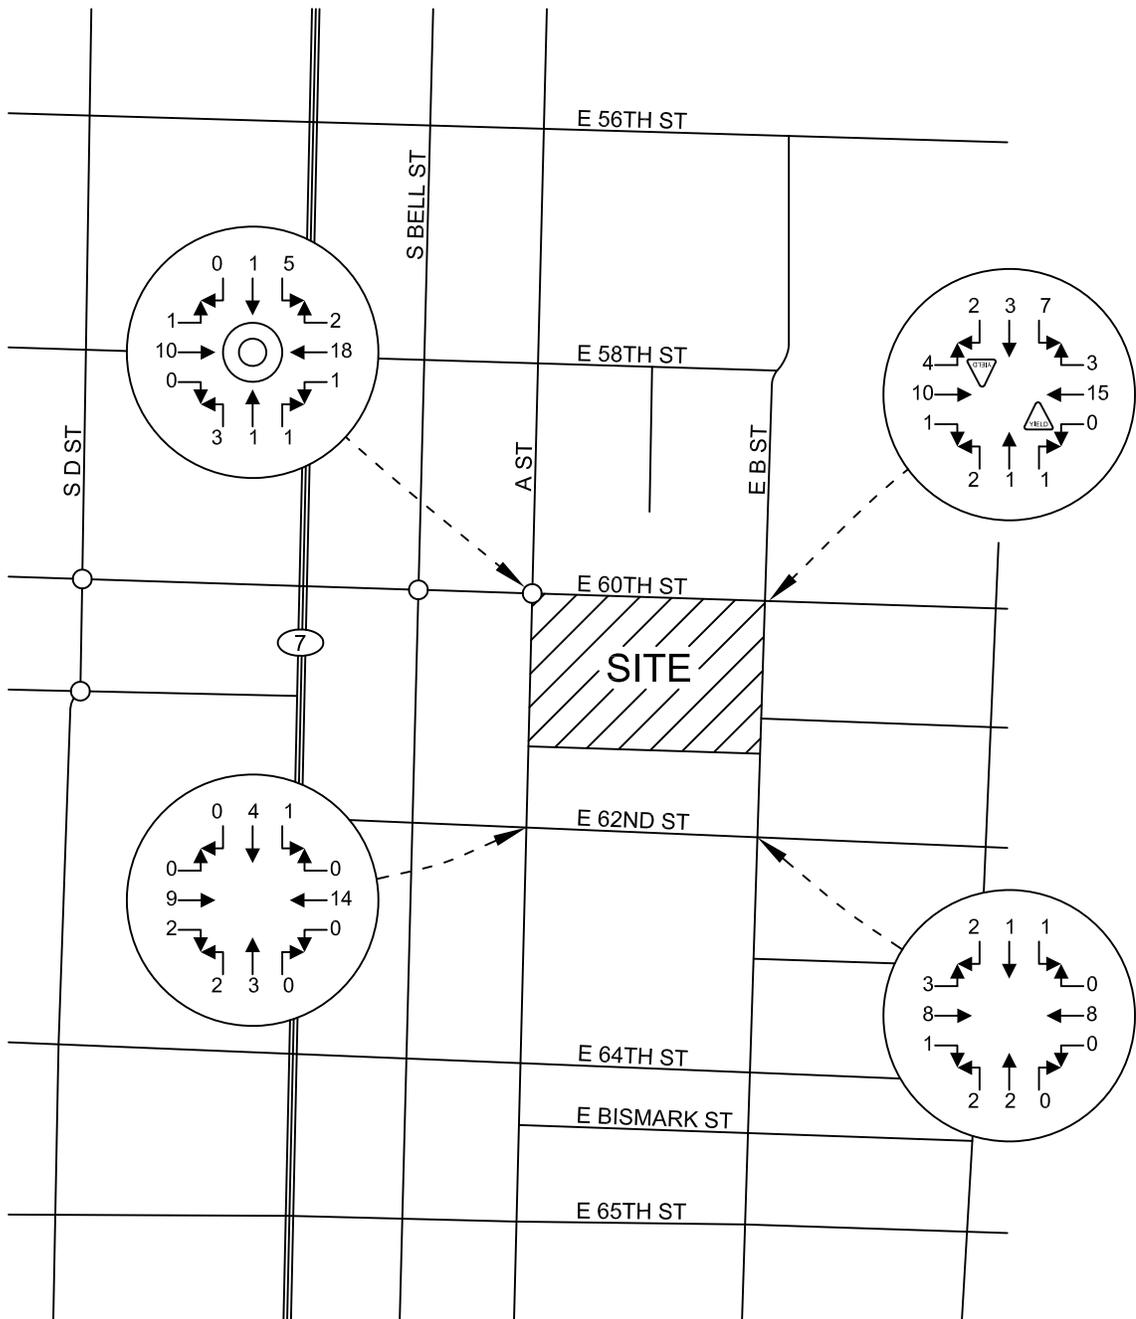
FAWCETT ELEMENTARY
EXISTING SCHOOL AM PEAK HOUR VOLUMES
FIGURE 3

The one hour reflecting highest overall roadway volumes (peak hour) was then derived from these counts. Existing School AM and School PM peak hour volumes at the study intersections are illustrated in Figures 3 and 4, respectively. Full-count sheets have been included in the appendix.

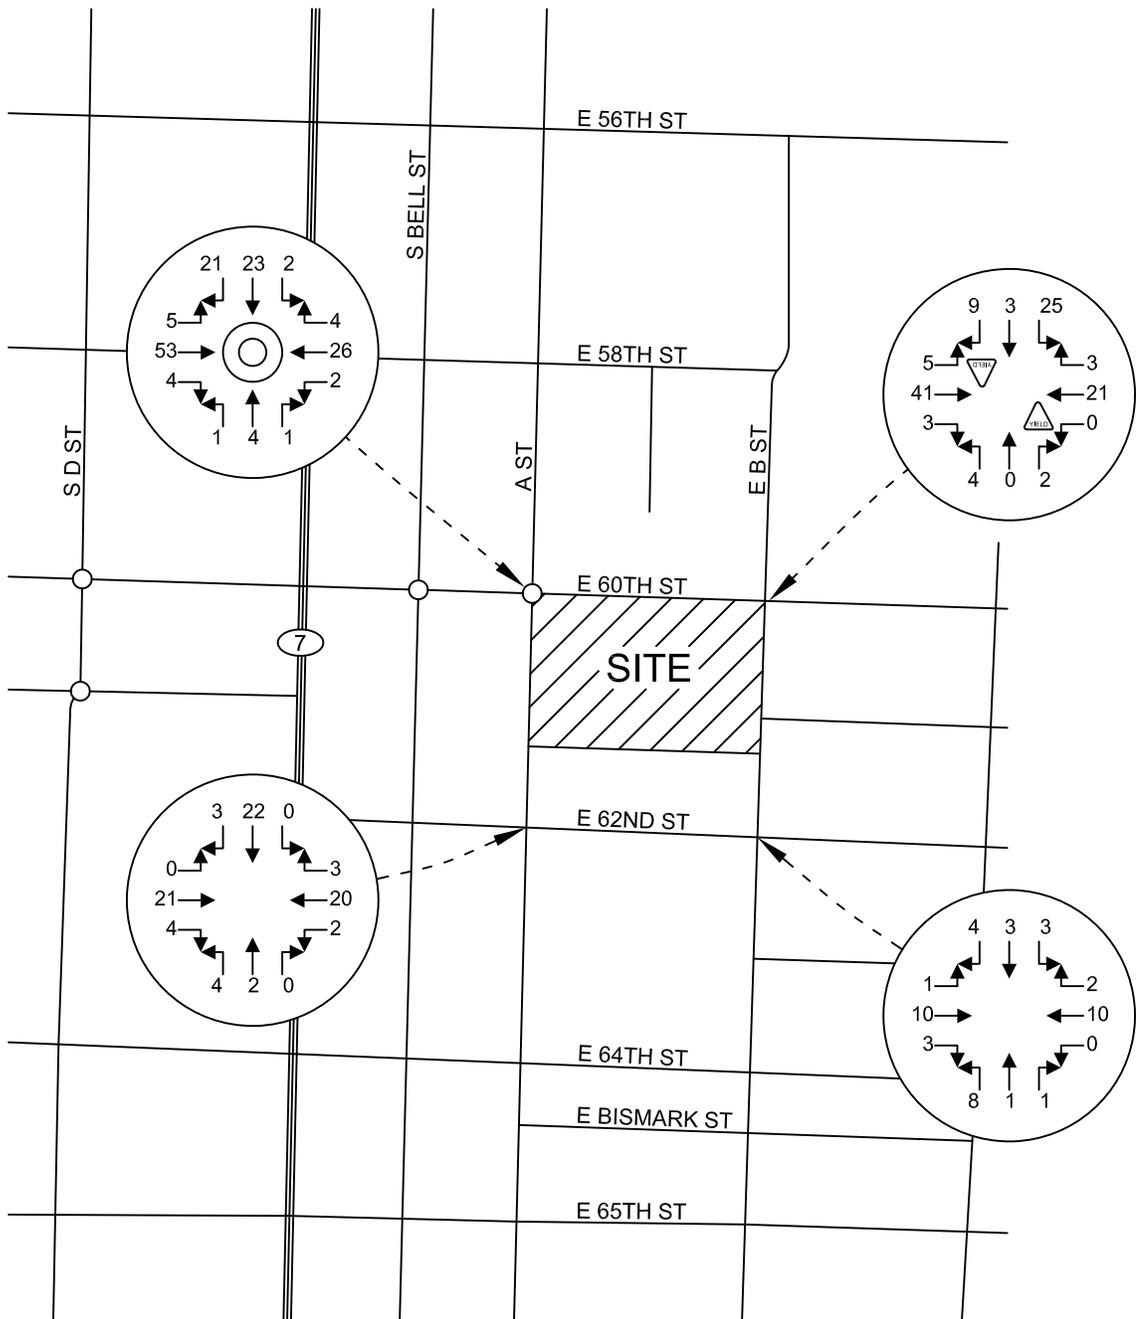
FAWCETT ELEMENTARY
EXISTING SCHOOL PM PEAK HOUR VOLUMES
FIGURE 4

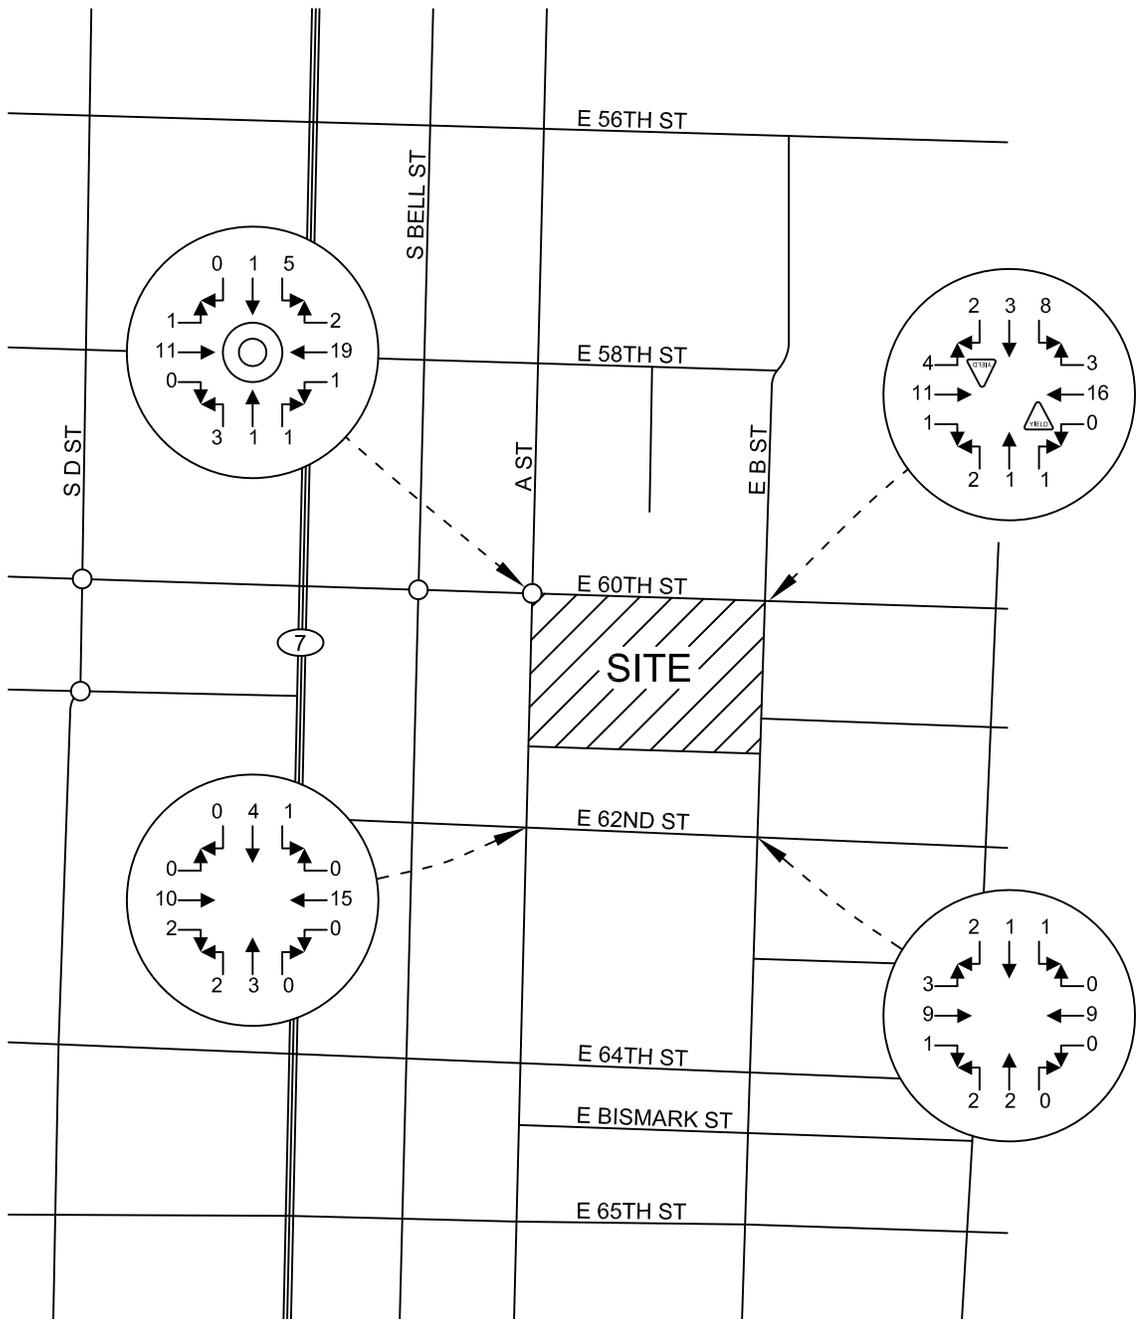
FAWCETT ELEMENTARY
FORECAST 2027 SCHOOL AM PEAK HOUR BACKGROUND VOLUMES
FIGURE 7

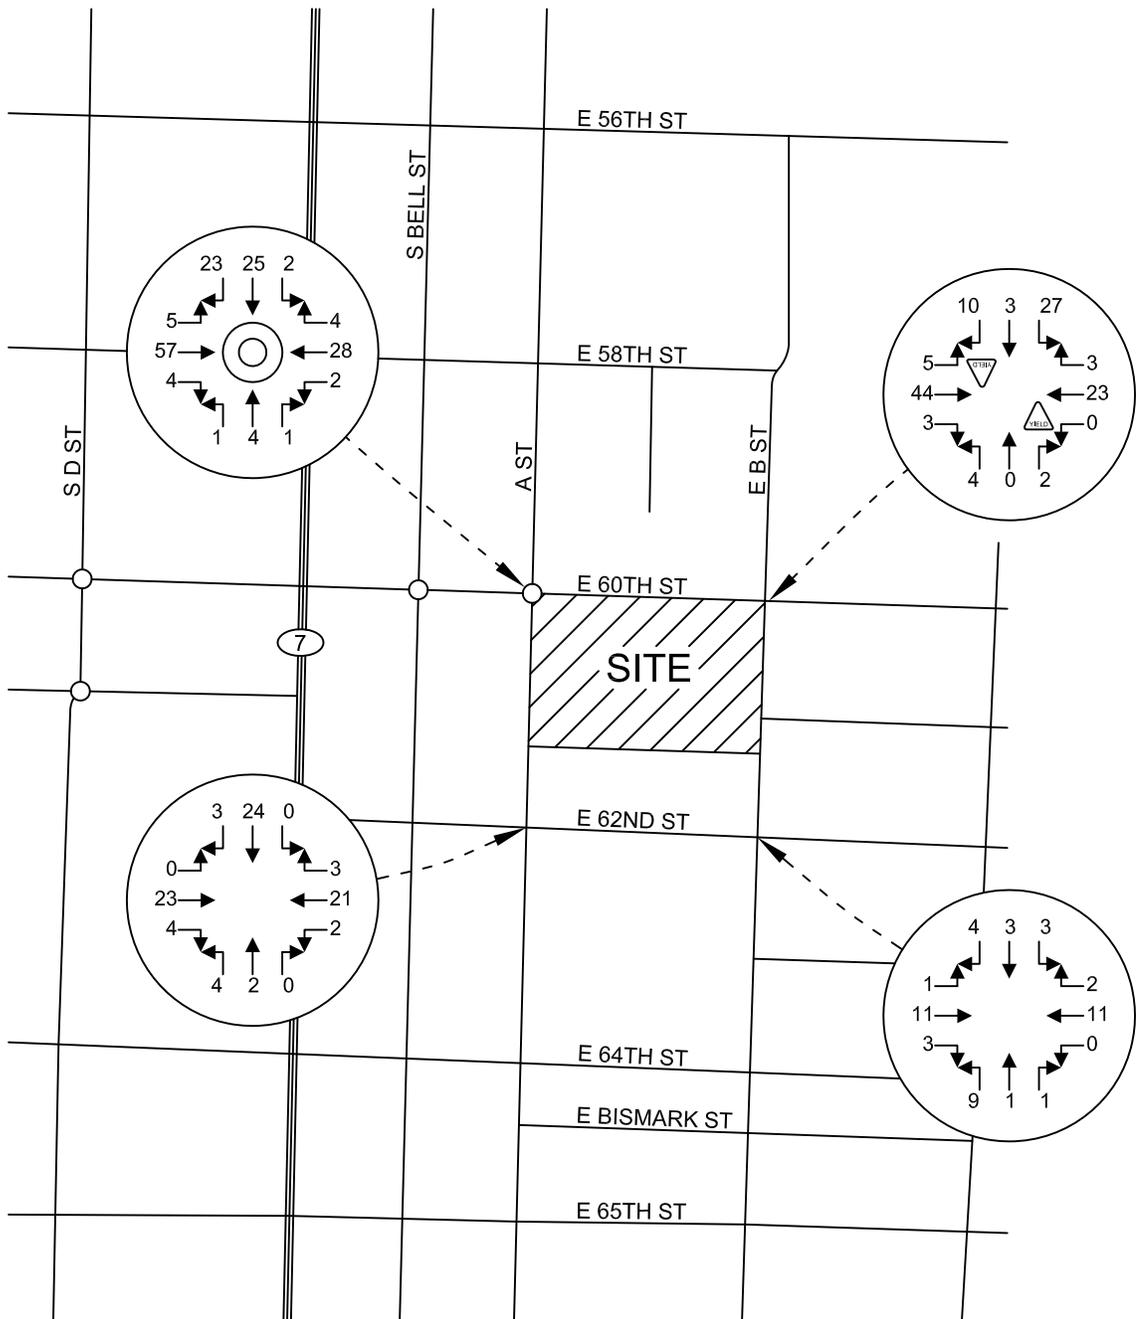
FAWCETT ELEMENTARY
FORECAST 2027 SCHOOL PM PEAK HOUR BACKGROUND VOLUMES
FIGURE 8
