Fawcett Elementary School
Tacoma Public Schools

Conditional Use Permit (CUP) Narrative

August 16, 2021
AHBL Project No. 2200932.10

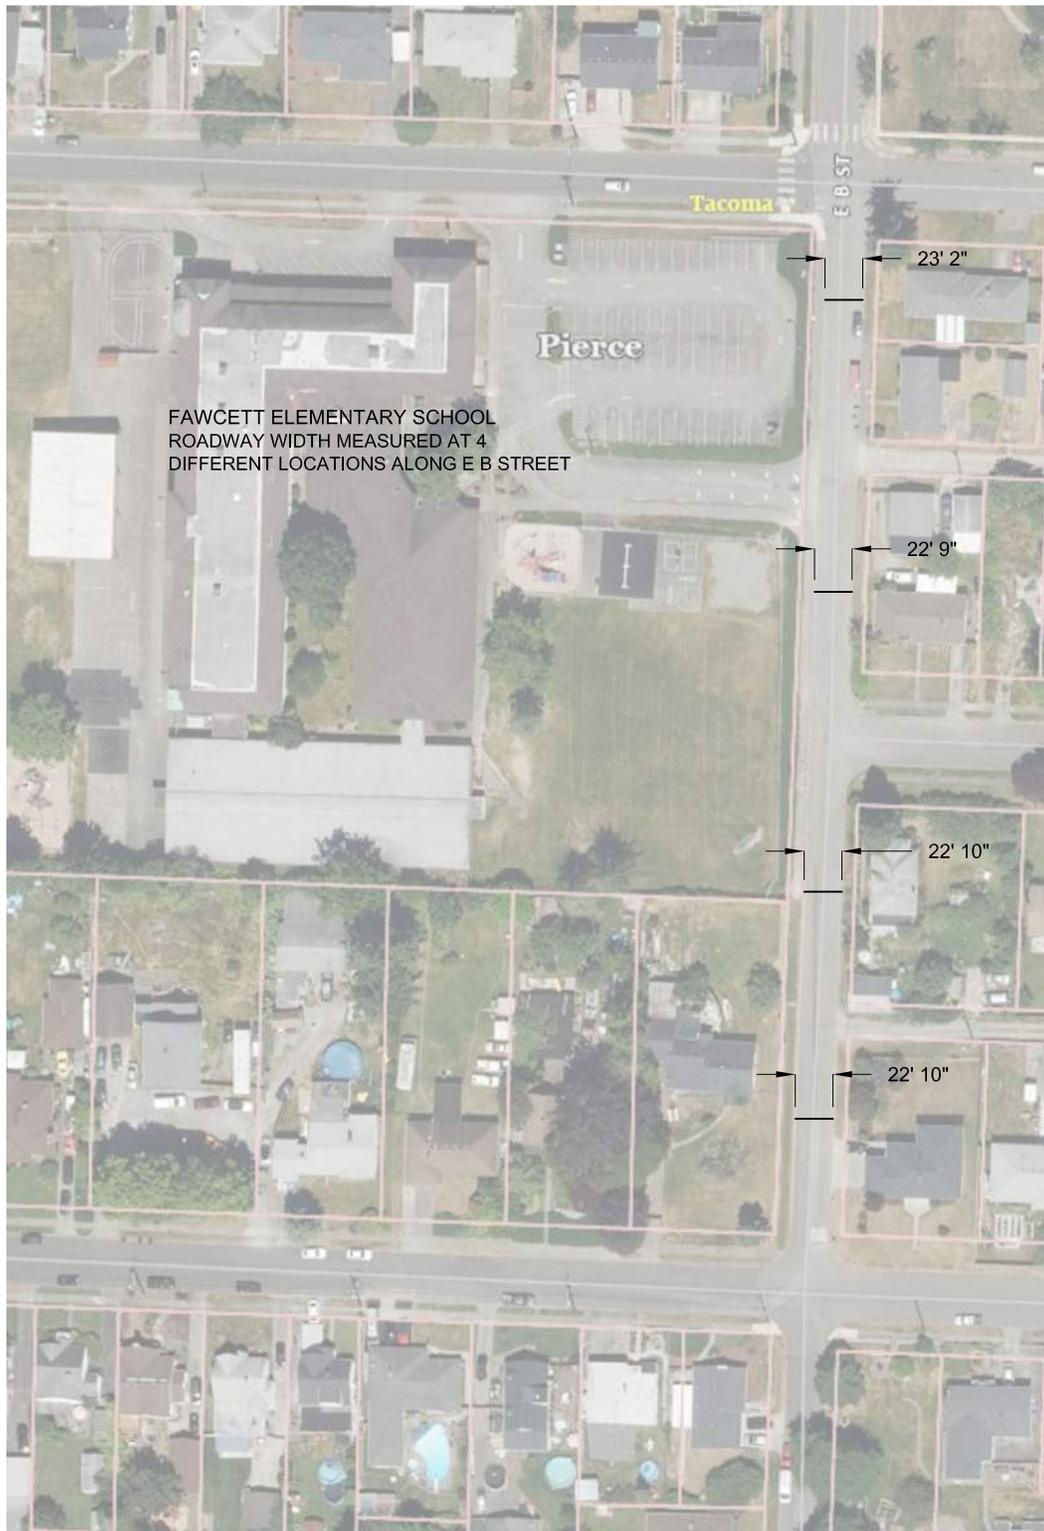
FAWCETT ELEMENTARY SCHOOL
ROADWAY WIDTH MEASUREMENTS
FIGURE A
