# SUFFIELD FACILITIES MASTER PLAN

BOE WORKSHOP

SUFFIELD, CT 9.20.2021

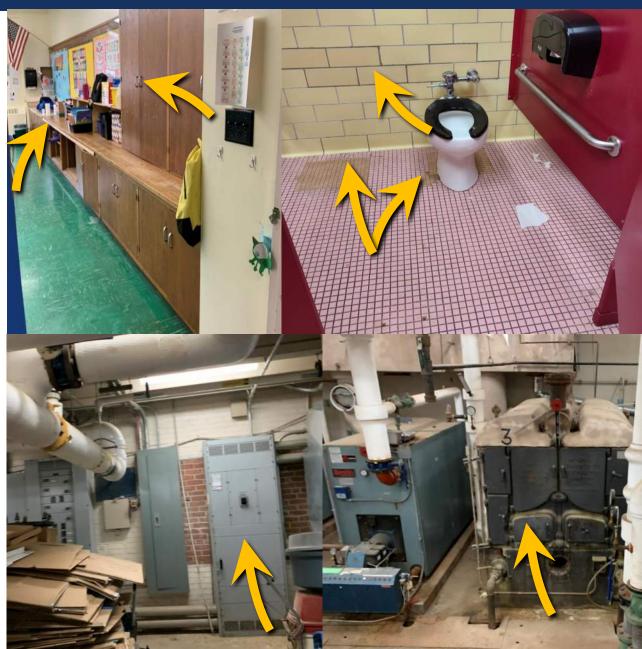
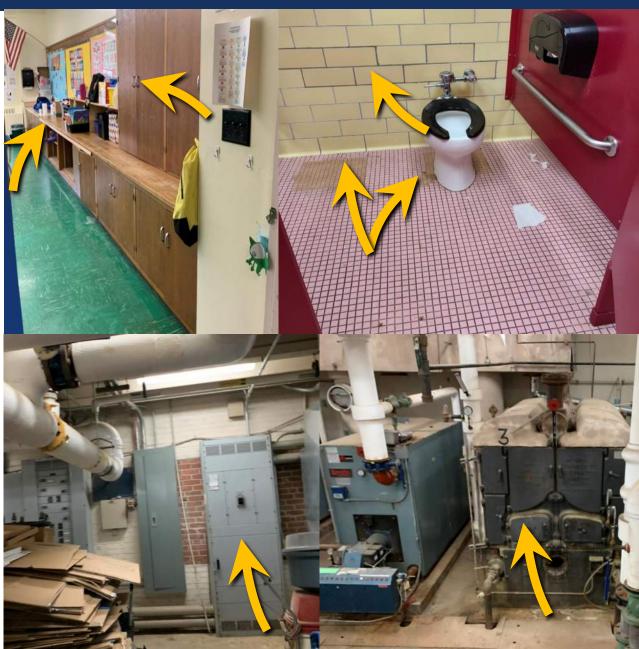
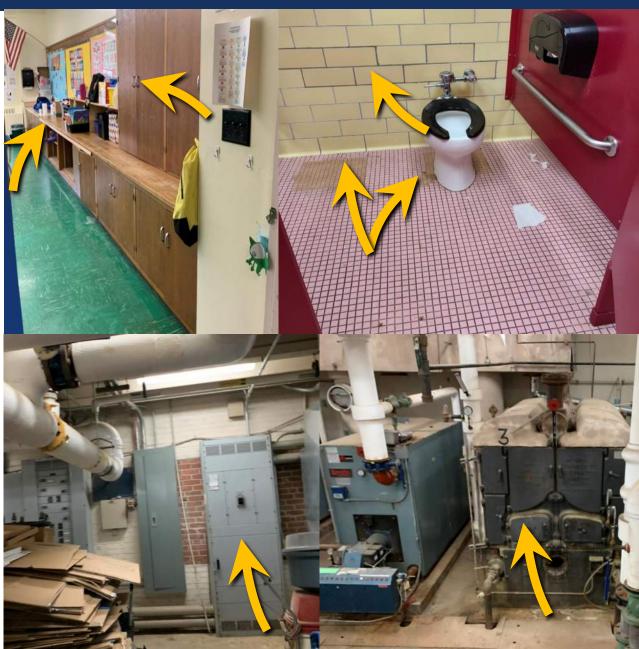
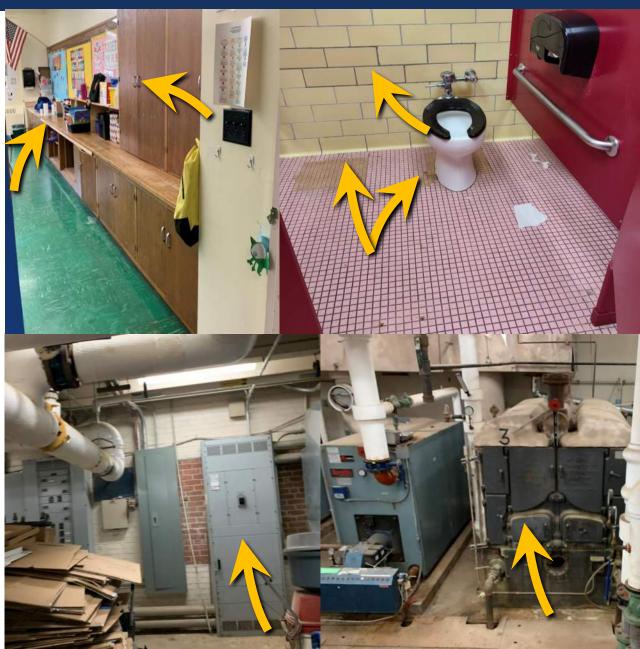
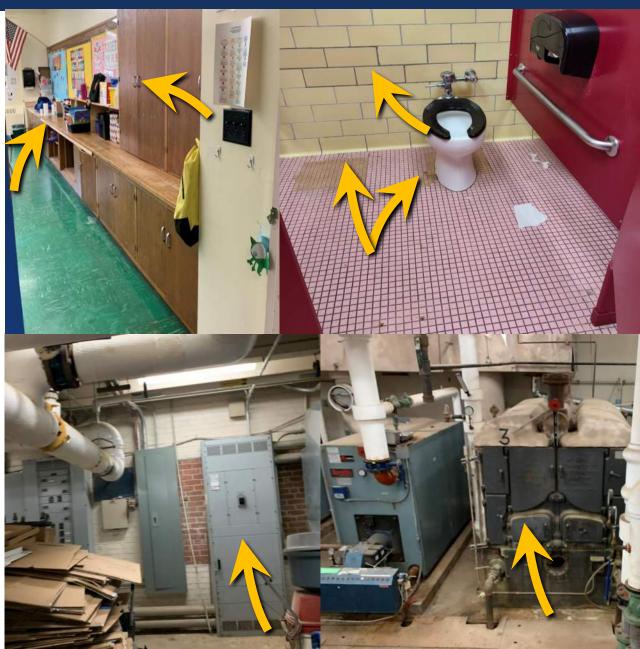
**Site** ~ Insufficient parking for events, parking immediately adjacent to building a safety concern, over 50% of paved areas and sidewalk in need of replacement, poor definition of school boundary, remote/unprotected playground and playscapes

Architectural Exterior ~ Masonry in need of repointing/repair, efflorescence on portions of building, windows approach 20 years, modular addition in poor condition

Architectural Interior ~ Overall well built, some replacement of finishes, ACM removal program, majority of finishes past useful life (millwork, floors, doors, ceilings)

**Code/Accessibility/Life Safety ~** Several accessibility compliance issues, floor clearances/reach at entranceways, sinks, and millwork, lift at stage.

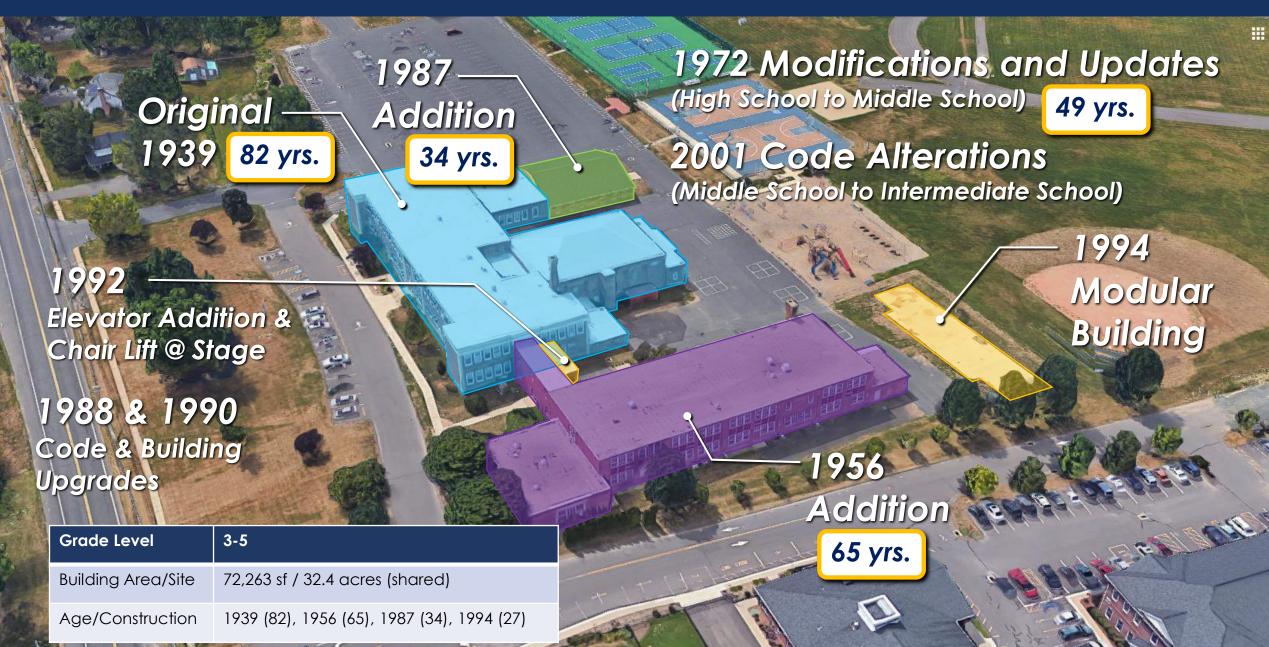
Mountain Rd

**Site** ~ Site traffic, parking and perimeter security major concerns for site (pedestrian and vehicular safety), play areas exposed, no definition of school boundary, pavement & site lighting are in poor condition

Architectural Exterior ~ Several improvements over time, many poorly functioning windows, persistent water infiltration/leaks at windows, doors, roofs

Architectural Interior ~ Overall well built, some replacement of finishes, majority of finishes past useful life (millwork, floors, doors, ceilings), gym, lockers, toilets all poor. Significant noise transfer in original wood plank floors/struct.

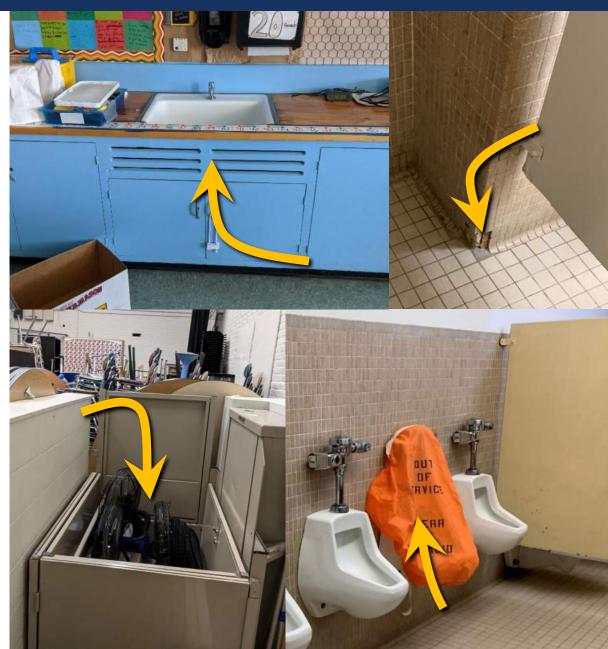
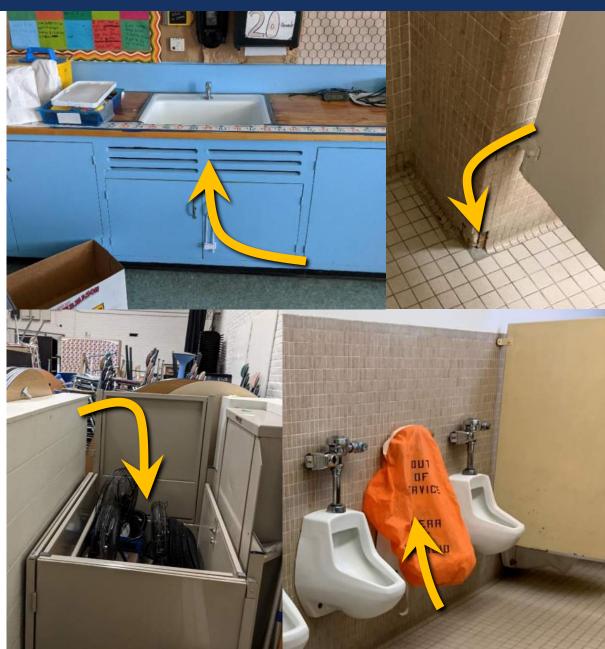
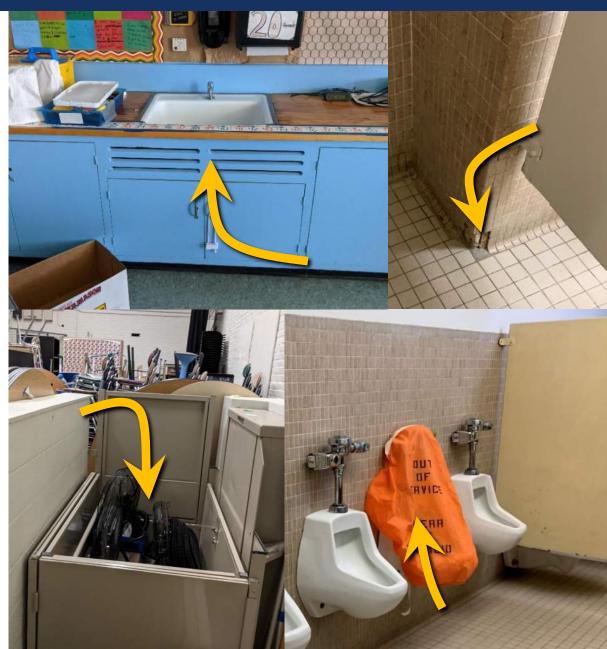
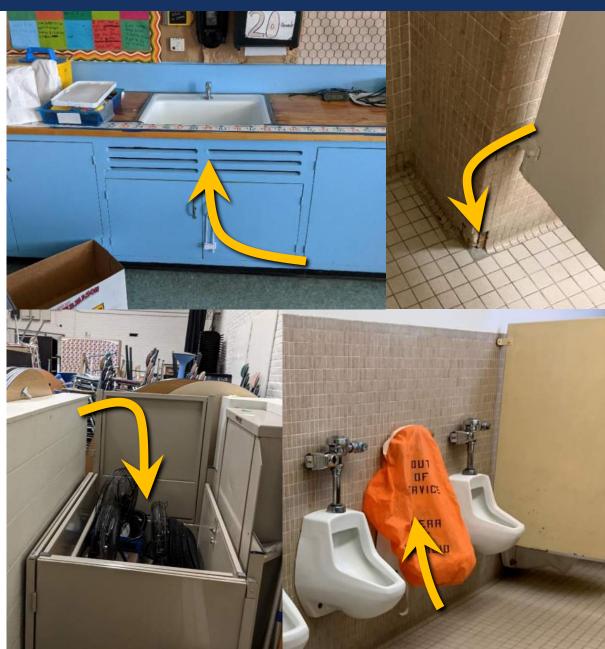
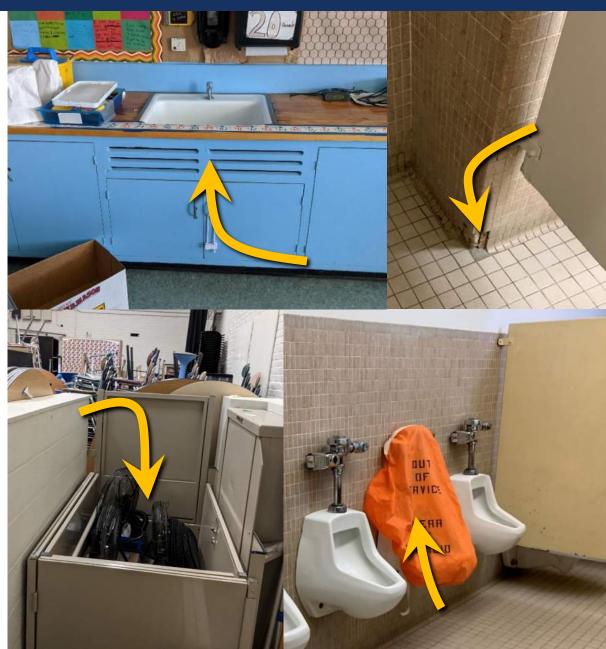
**Code/Accessibility/Life Safety** ~ Many toilet areas non accessible, Several compliance issues at floor clearances/reach at entranceways, sinks, and millwork, lift at stage.

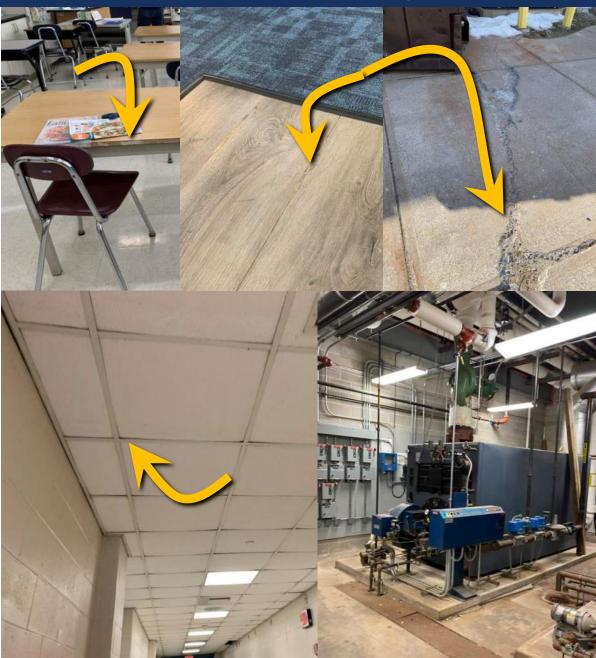
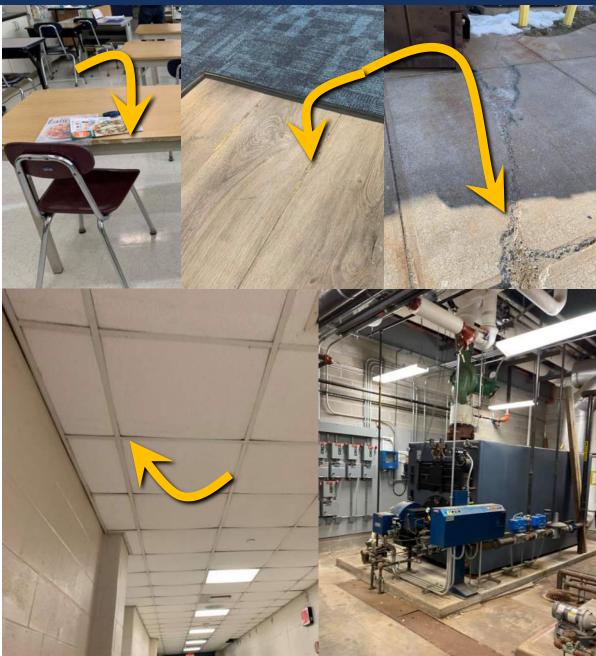
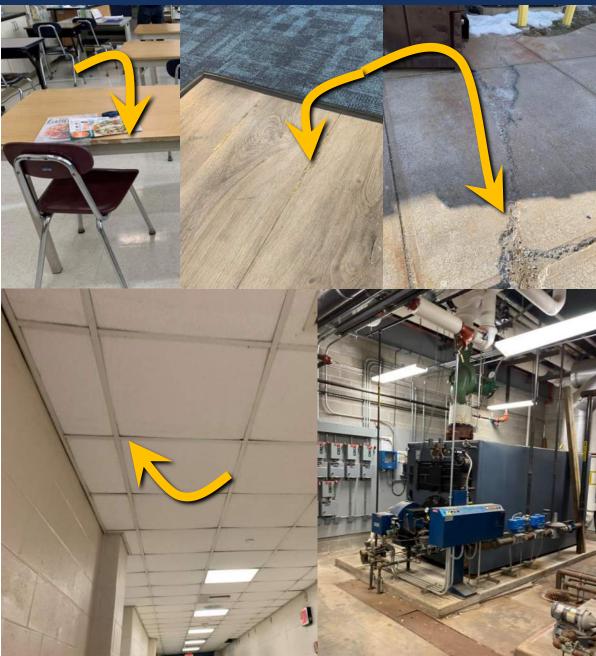
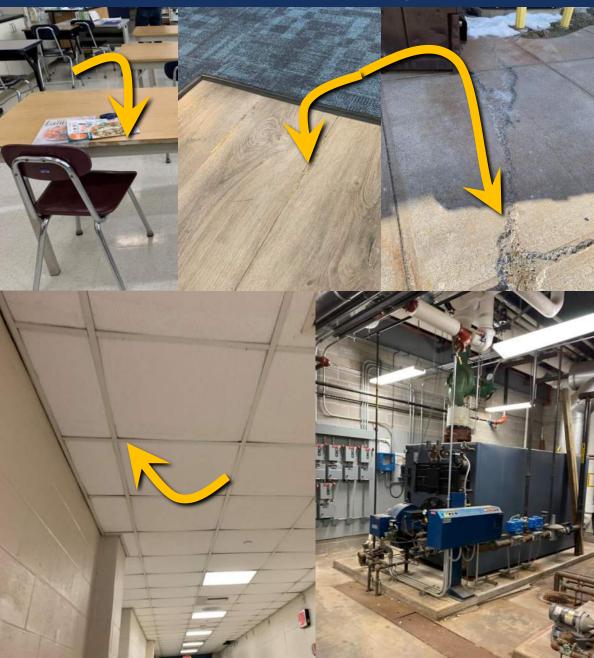
**Site** ~ Site circulation concerns – separation of bus, parent, and student. Pavement, sidewalks in fair condition overall, areas deteriorating, cracking, spalling. (Differential settlement at bollards ~ a representative indication of poor soils and/or moisture migration) Site walls show efflorescence/water infiltration

Architectural Exterior ~ Generally good to fair condition. Durable and well maintained. Recommend prev. maintenance (caulking/sealants), gaps in perimeter roof flashing lead to loss of energy and wildlife, 15 year roof design, 4 years out of warranty.

Architectural Interior ~ Overall, well maintained, some areas of questionable quality of original construction. Building has worn faster than anticipated. Slab cracking with possible water/vapor infiltration, persistent issue, finishes/glue to bubble, curious curling ceiling tiles HVAC balancing issue. Fairly significant deterioration of furniture in areas, in some cases it is mismatched.
