# PHILLIPS BROOK WATERSHED

## MANAGEMENT PLAN

# A STUDY OF BANK EROSION RATES IN PHILLIPS BROOK: HEADWATER TO TIDAL REACHES

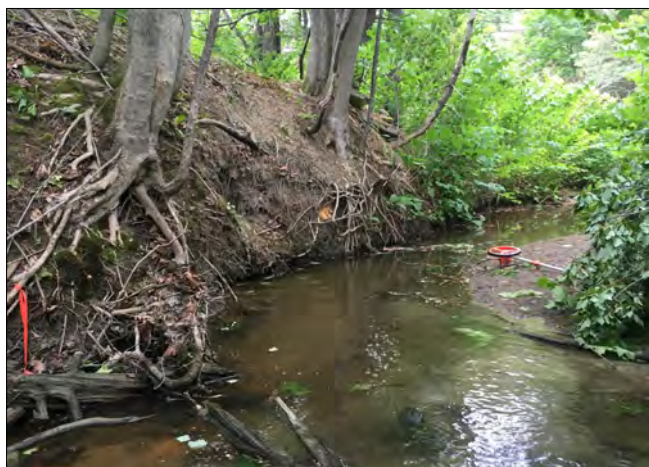
**Figure 12.** Altered flow patterns have caused severe bank erosion in Phillips Brook.

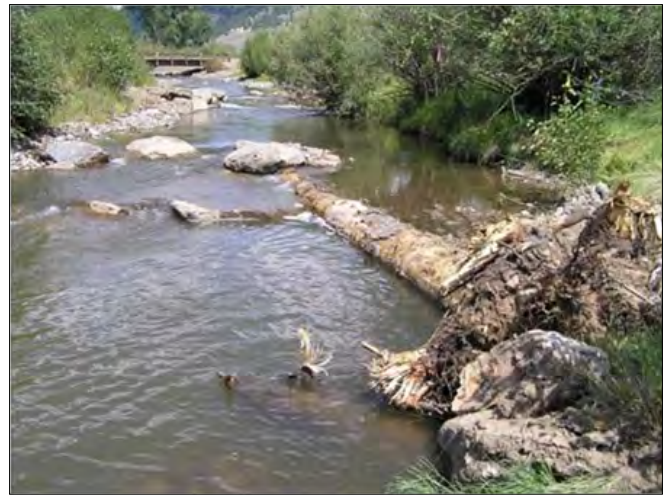
Log J-hook structures are log, root wad, and boulder structures constructed on the outside of stream bends where strong helical flows, high boundary stress, and high velocity gradients create high stress in the near-bank region. Log J-hook structures reduce accelerated streambank erosion on the outside of meander bends by reducing near-bank slope, velocity, velocity gradient, stream power, and shear stress. They also redirect flows away from the outside bend and provide opportunities for overhead cover for fish.

**Figure 13:** J-Hook log vane

*Log J-Hook Structures* Log J-hook structures are log, root wad, and boulder constructed structures constructed on the outside of stream bends at the head of pools where strong helical flows, high boundary stress, and high velocity gradients create high stress in the near-bank region. Log J-hook structures are designed to reduce accelerated streambank erosion on the outside of meander bends by reducing near-bank slope, velocity, velocity gradient, stream power, and shear stress. They also redirect flows away from the outside bend, and provide opportunities for overhead cover for native and resident fish species.

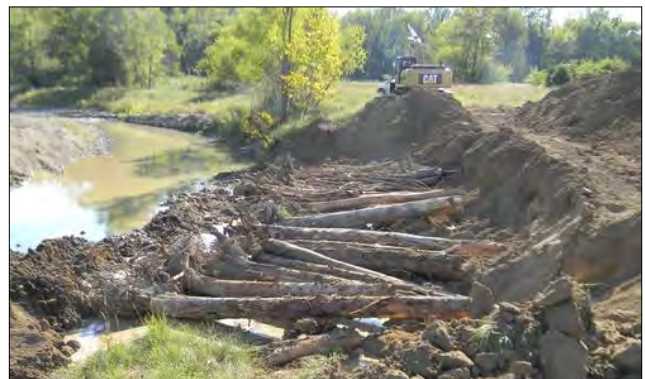
Wood toe structures (Figures 14 & 15) are relatively inexpensive, easy to construct structures which utilize a combination of woody debris, live cuttings, fill, and sod mats (materials readily available on most stream restoration projects). Wood toe structures serve to protect vulnerable and unstable banks while also providing a roughness element to help ensure pool habitat remains viable. Wood toe structures are a cover feature for numerous aquatic species.

**Figures 14 & 15:** Wood toe structures

***Wood Toe Structures*** Wood toe structures are relatively inexpensive, easy to construct structures which utilize a combination of woody debris, live cuttings, fill, and sod mats (materials readily available on most stream restoration projects). Wood toe serves to protect vulnerable and unstable banks while also providing a roughness element to help ensure pool habitat remains viable. Wood toe structures are a cover feature for numerous aquatic species and also serve as a long-term in-stream carbon source. Wood toe structures can be modified to provide additional overhead cover for native and resident fish species, simulating the presence of under-cut bank habitat on stable streams. Wood toe structures can also be incorporated into bankfull benches. Wood toe structures have been built for over 15 years and have proven to be effective.

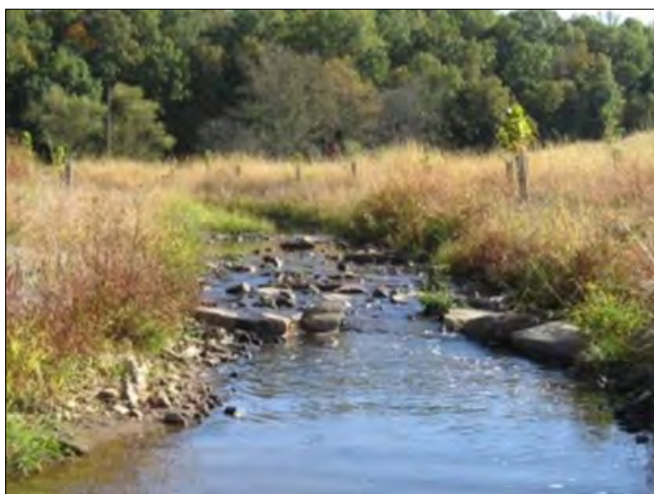
Constructed riffle features create a range of velocities and depths, providing habitat for a host of aquatic species. Riffle structures can be modified to include pocket pools, woody debris, and the occasional boulder cluster to further provide habitat diversity while meeting the project needs.

**Figure 16:** Constructed riffle

*Constructed Riffles* Boulder/cobble constructed riffles serve as vertical grade control while allowing sediment transport and fish passage. Boulder/cobble constructed riffles are constructed of large anchor boulders as well as a moveable bed in the low-flow region of the cross-section. Typically, materials are harvested from existing reaches that are armored with natural substrate.

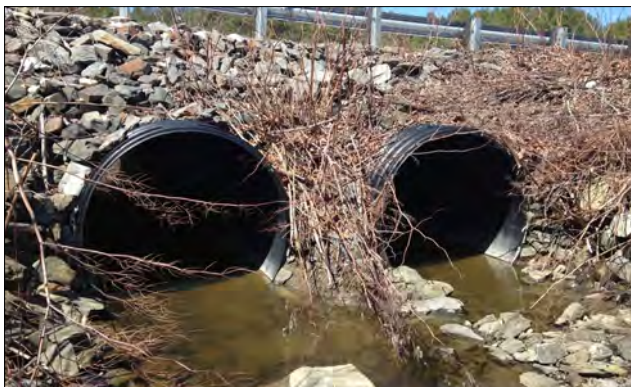
In order to protect and restore the physical and biological integrity of the stream, future road construction projects and replacement of existing culverts should strive to utilize stream crossing standards that allow for aquatic organism passage.

**Figure 19:** Payne Road culverts, 2015

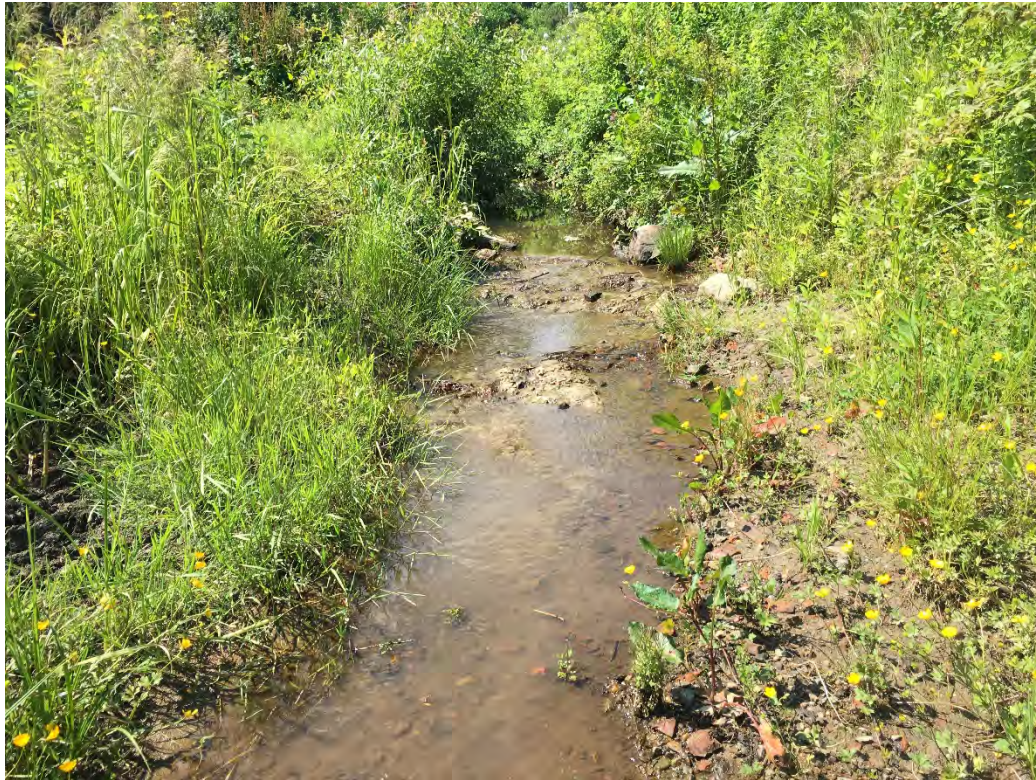
Photo 1: Phillips Bk with bank conditions with a BEHI rating of Very Low

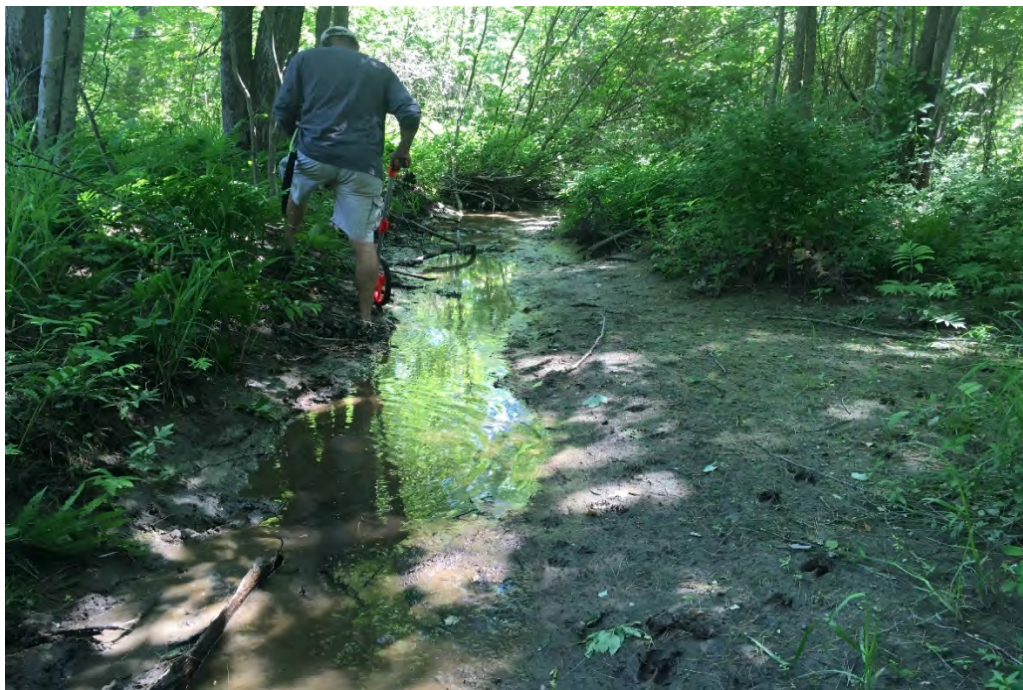
Photo 2: Phillips Bk with bank conditions with a BEHI rating of Low

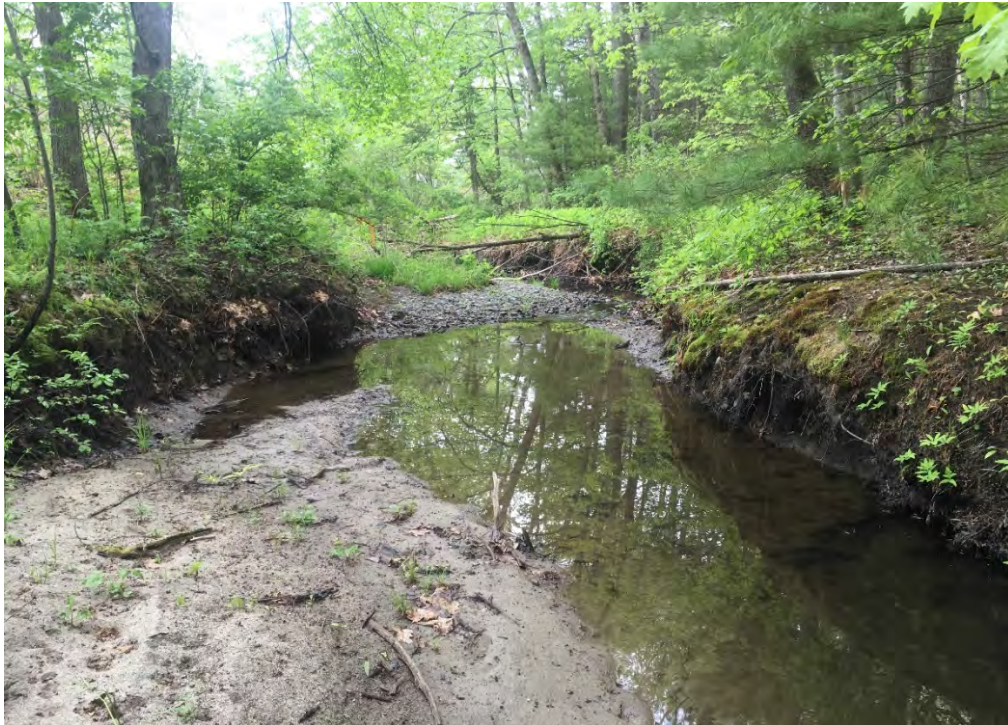
Photo 3: Phillips Bk with bank conditions with a BEHI rating of Moderate/High

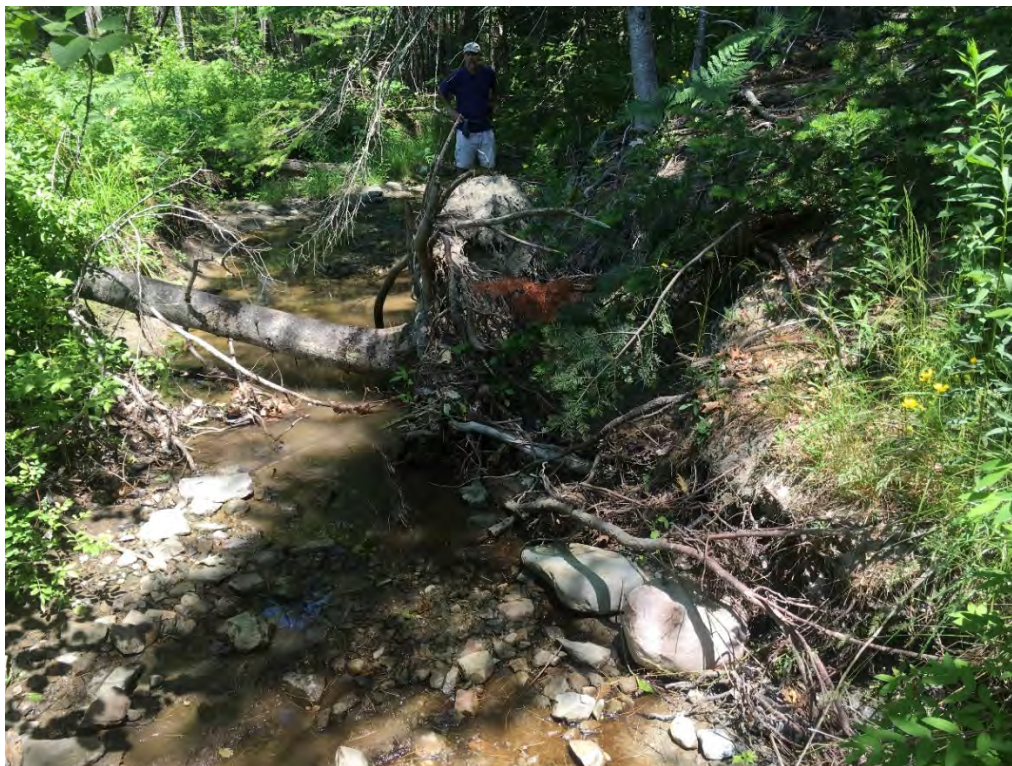
Photo 4: Phillips Bk with bank conditions with a BEHI rating of High/Extreme

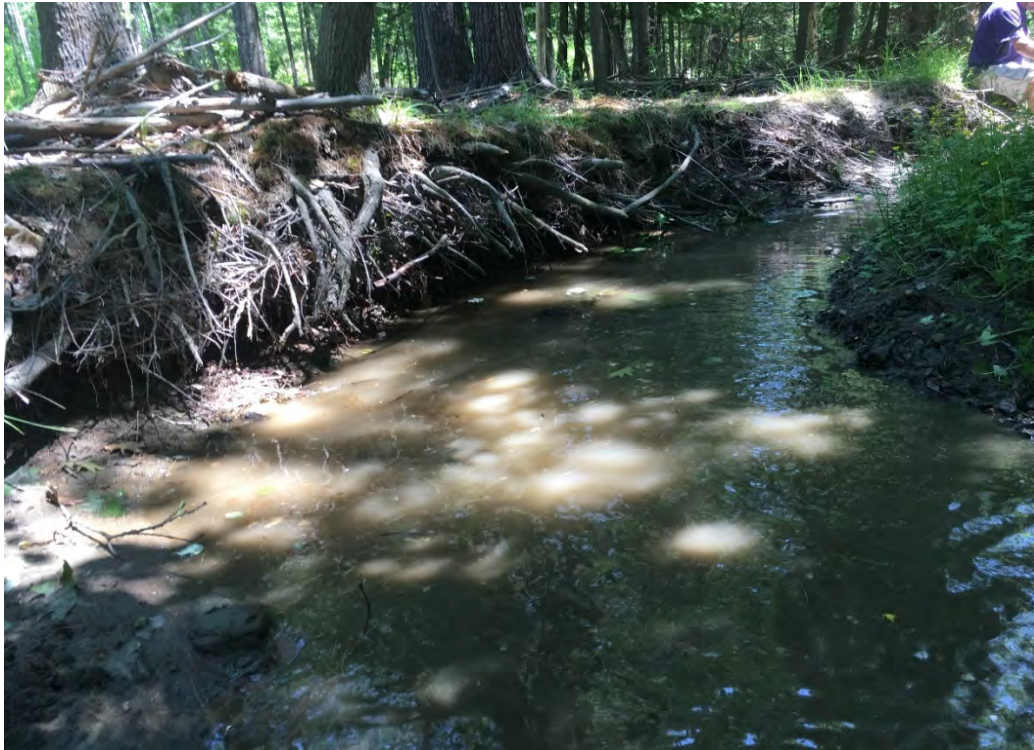
Photo 5: Phillips Bk with bank conditions with a BEHI rating of very high

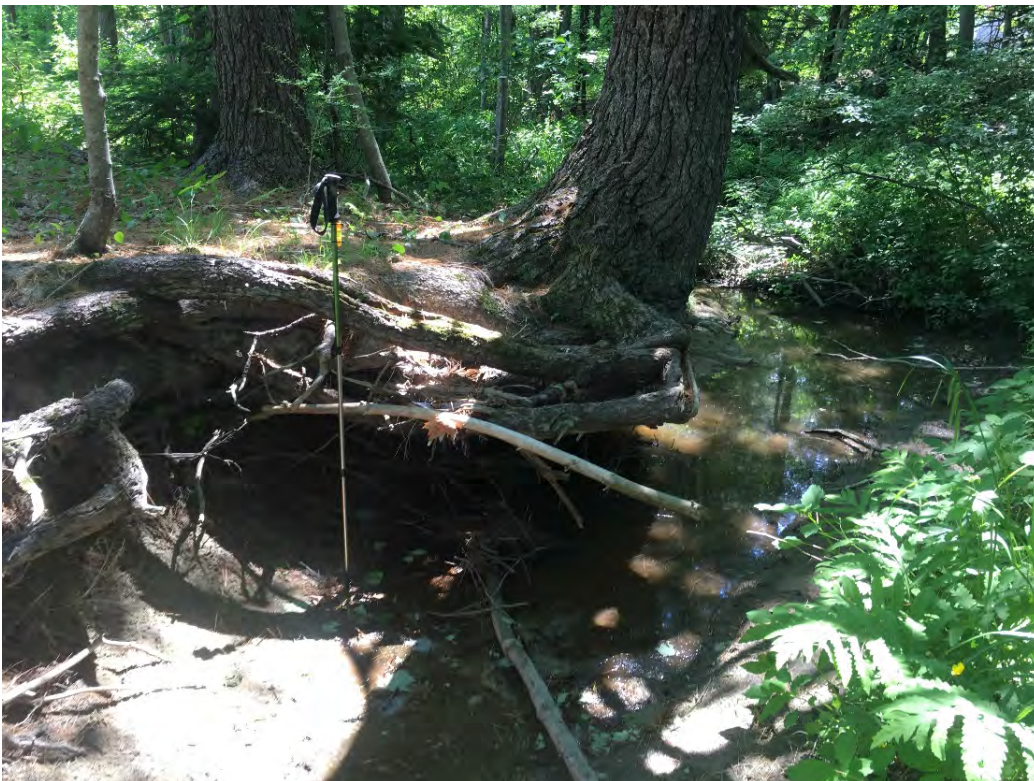
Photo 6: Phillips Bk with bank conditions with a BEHI rating of extreme
