# SAWYER ROAD CULVERT TIDAL CROSSING ASSESSMENT

CAPE ELIZABETH &  
SCARBOROUGH, MAINE

PRELIMINARY  
DESIGN REPORT

ACADIA CIVIL WORKS  
ENGINEERING DESIGN & CONSULTATION

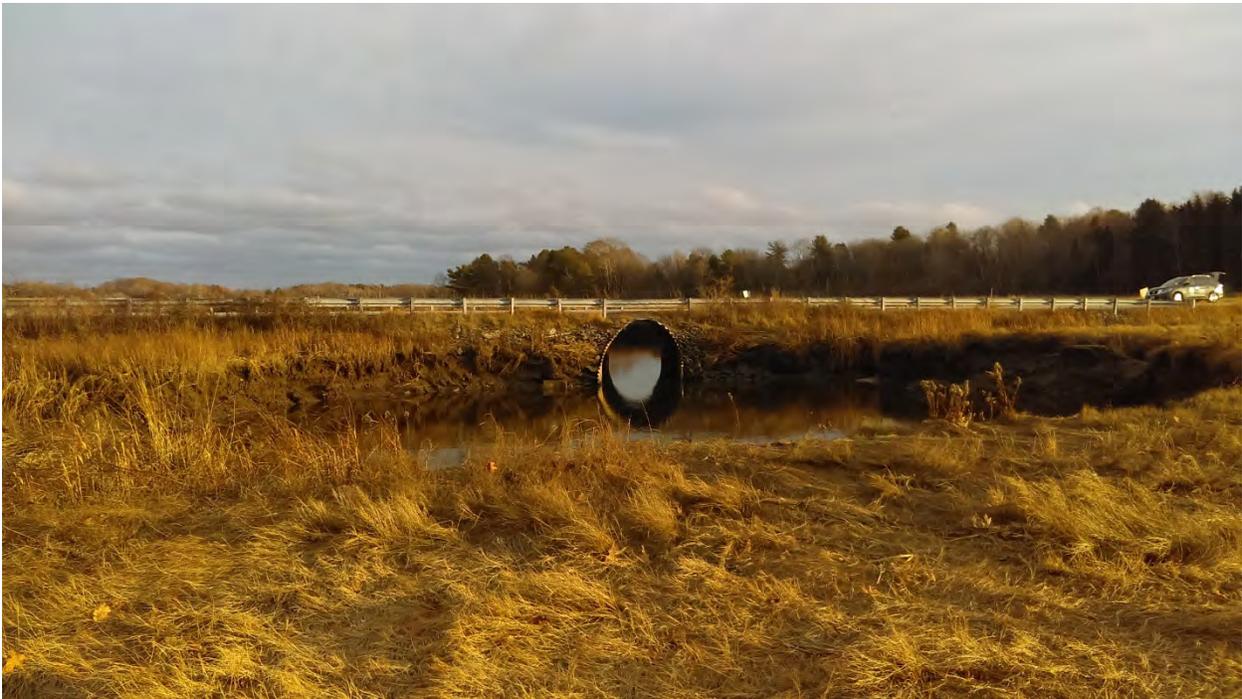
Existing Aluminum Culvert Crossing at Sawyer Road  
(Photo Credit: Wells National Estuarine Research Reserve)

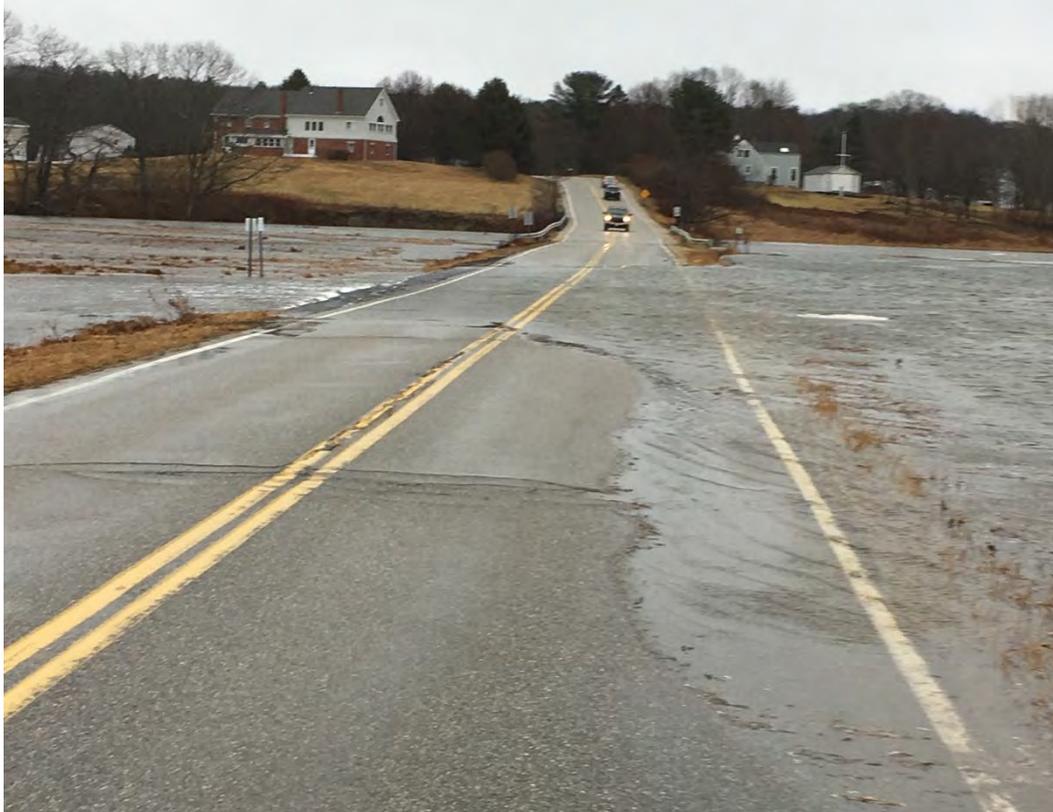
Sawyer Road Crossing Overtopping During High Tide on 3/2/2018  
(Photo Credit Town of Cape Elizabeth)

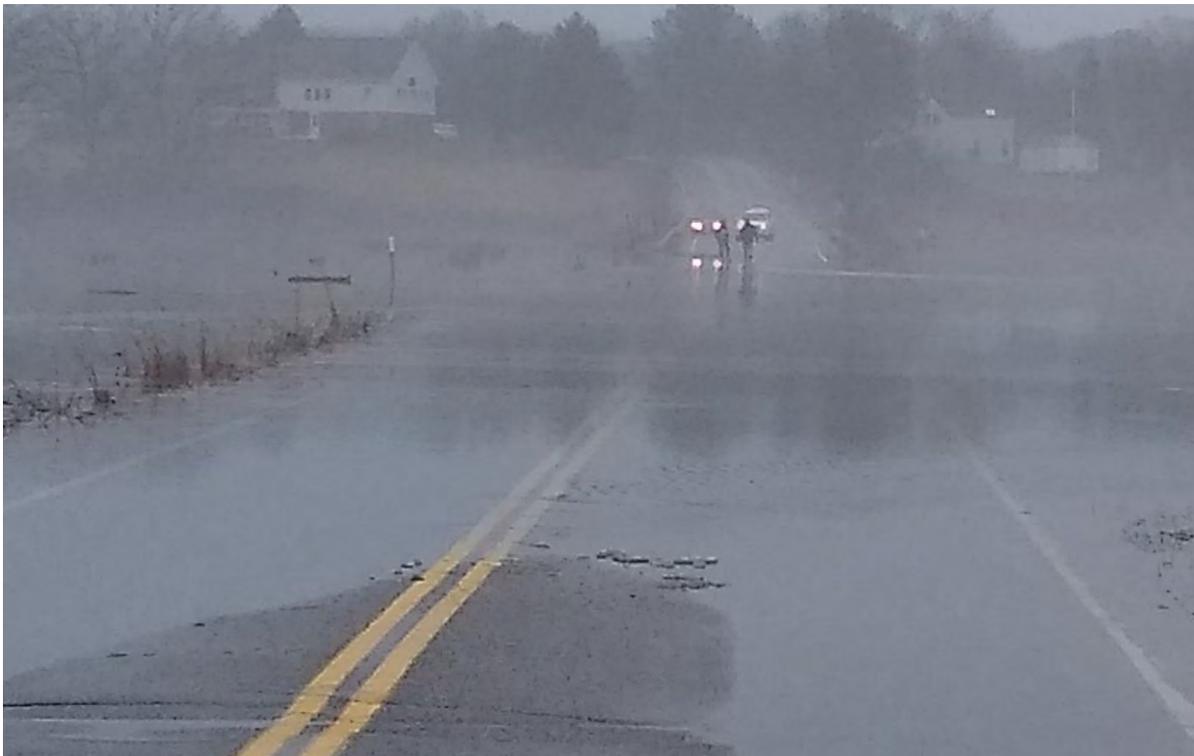
Sawyer Road Crossing Overtopping During High Tide on 12/14/2019  
(Photo Credit: Casco Bay Estuary Partnership)

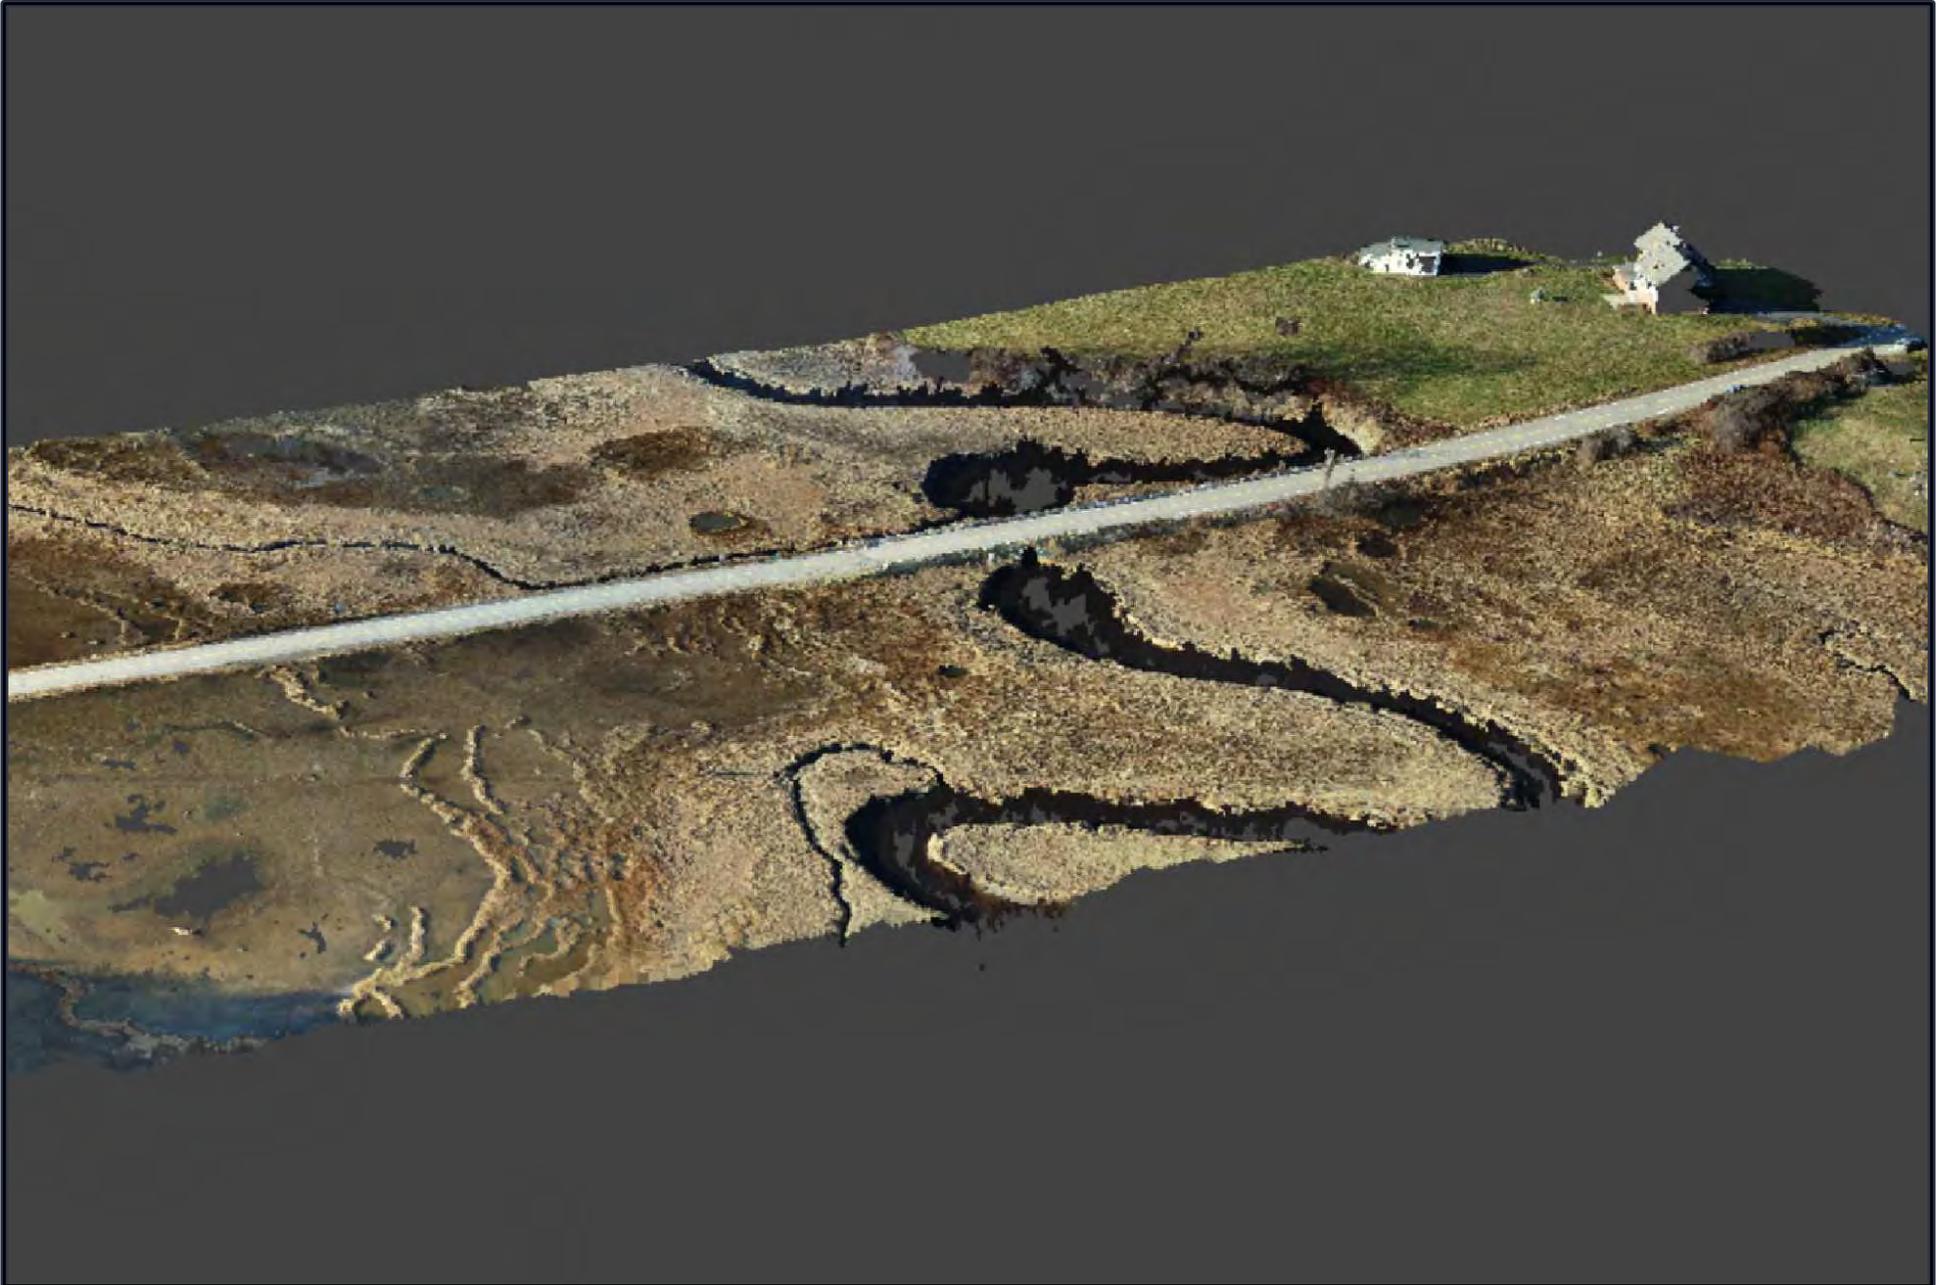
FIGURE 6

SAWYER ROAD - TOPOGRAPHIC PERSPECTIVE  
SAWYER ROAD CROSSING ASSESSMENT

In addition to the photography, the Wright-Pierce surveyors utilized photogrammetric techniques to develop a topographic surface and an existing conditions topographic plan of the Sawyer Road crossing. A perspective view of the topographic relief of the Sawyer road site, as well as a clip of the CAD survey plan are provided as Figures 6 and 7, respectively.

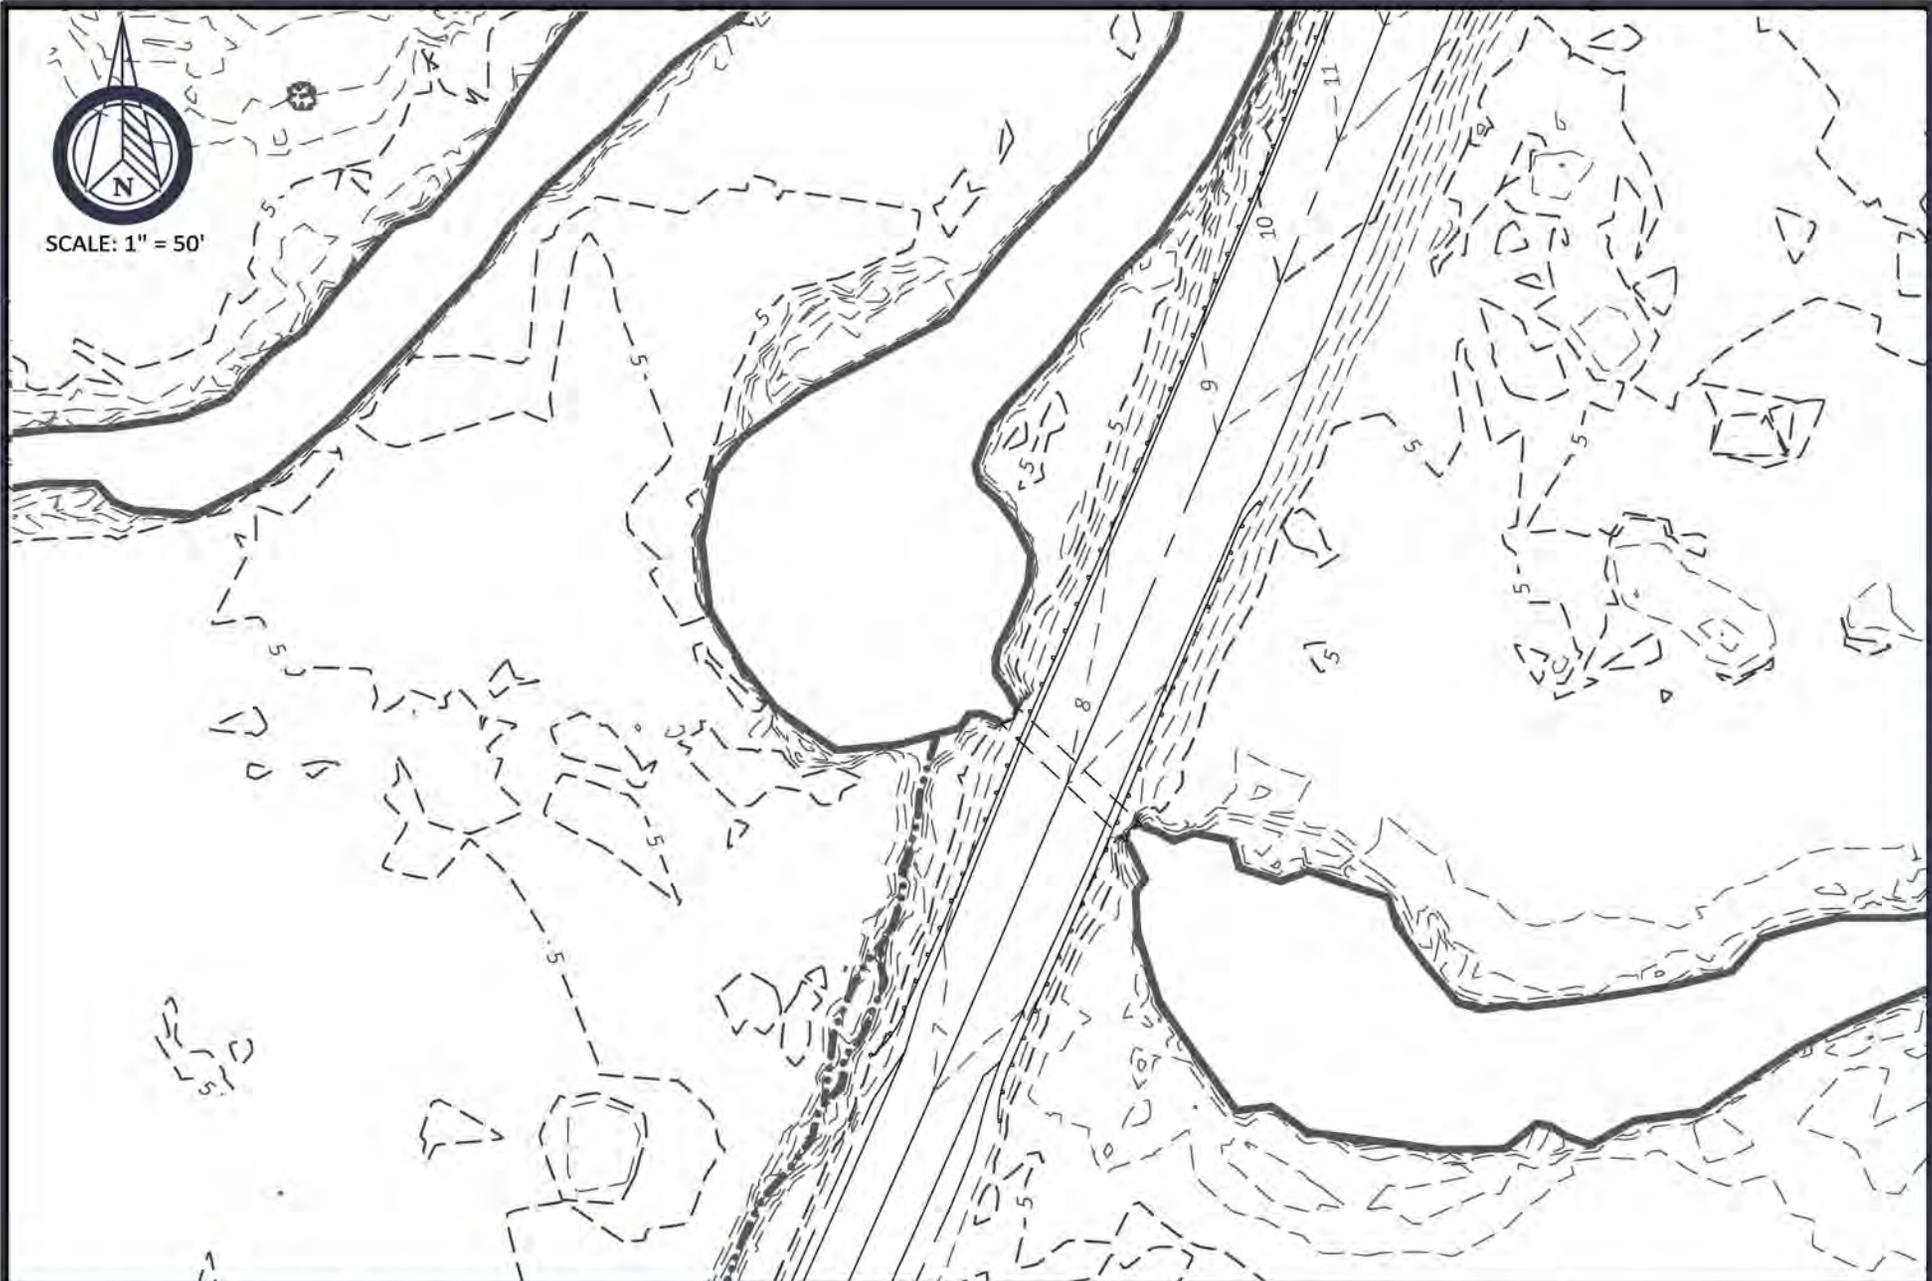
SAWYER ROAD - EXISTING CONDITIONS PLAN  
SAWYER ROAD CROSSING ASSESSMENT

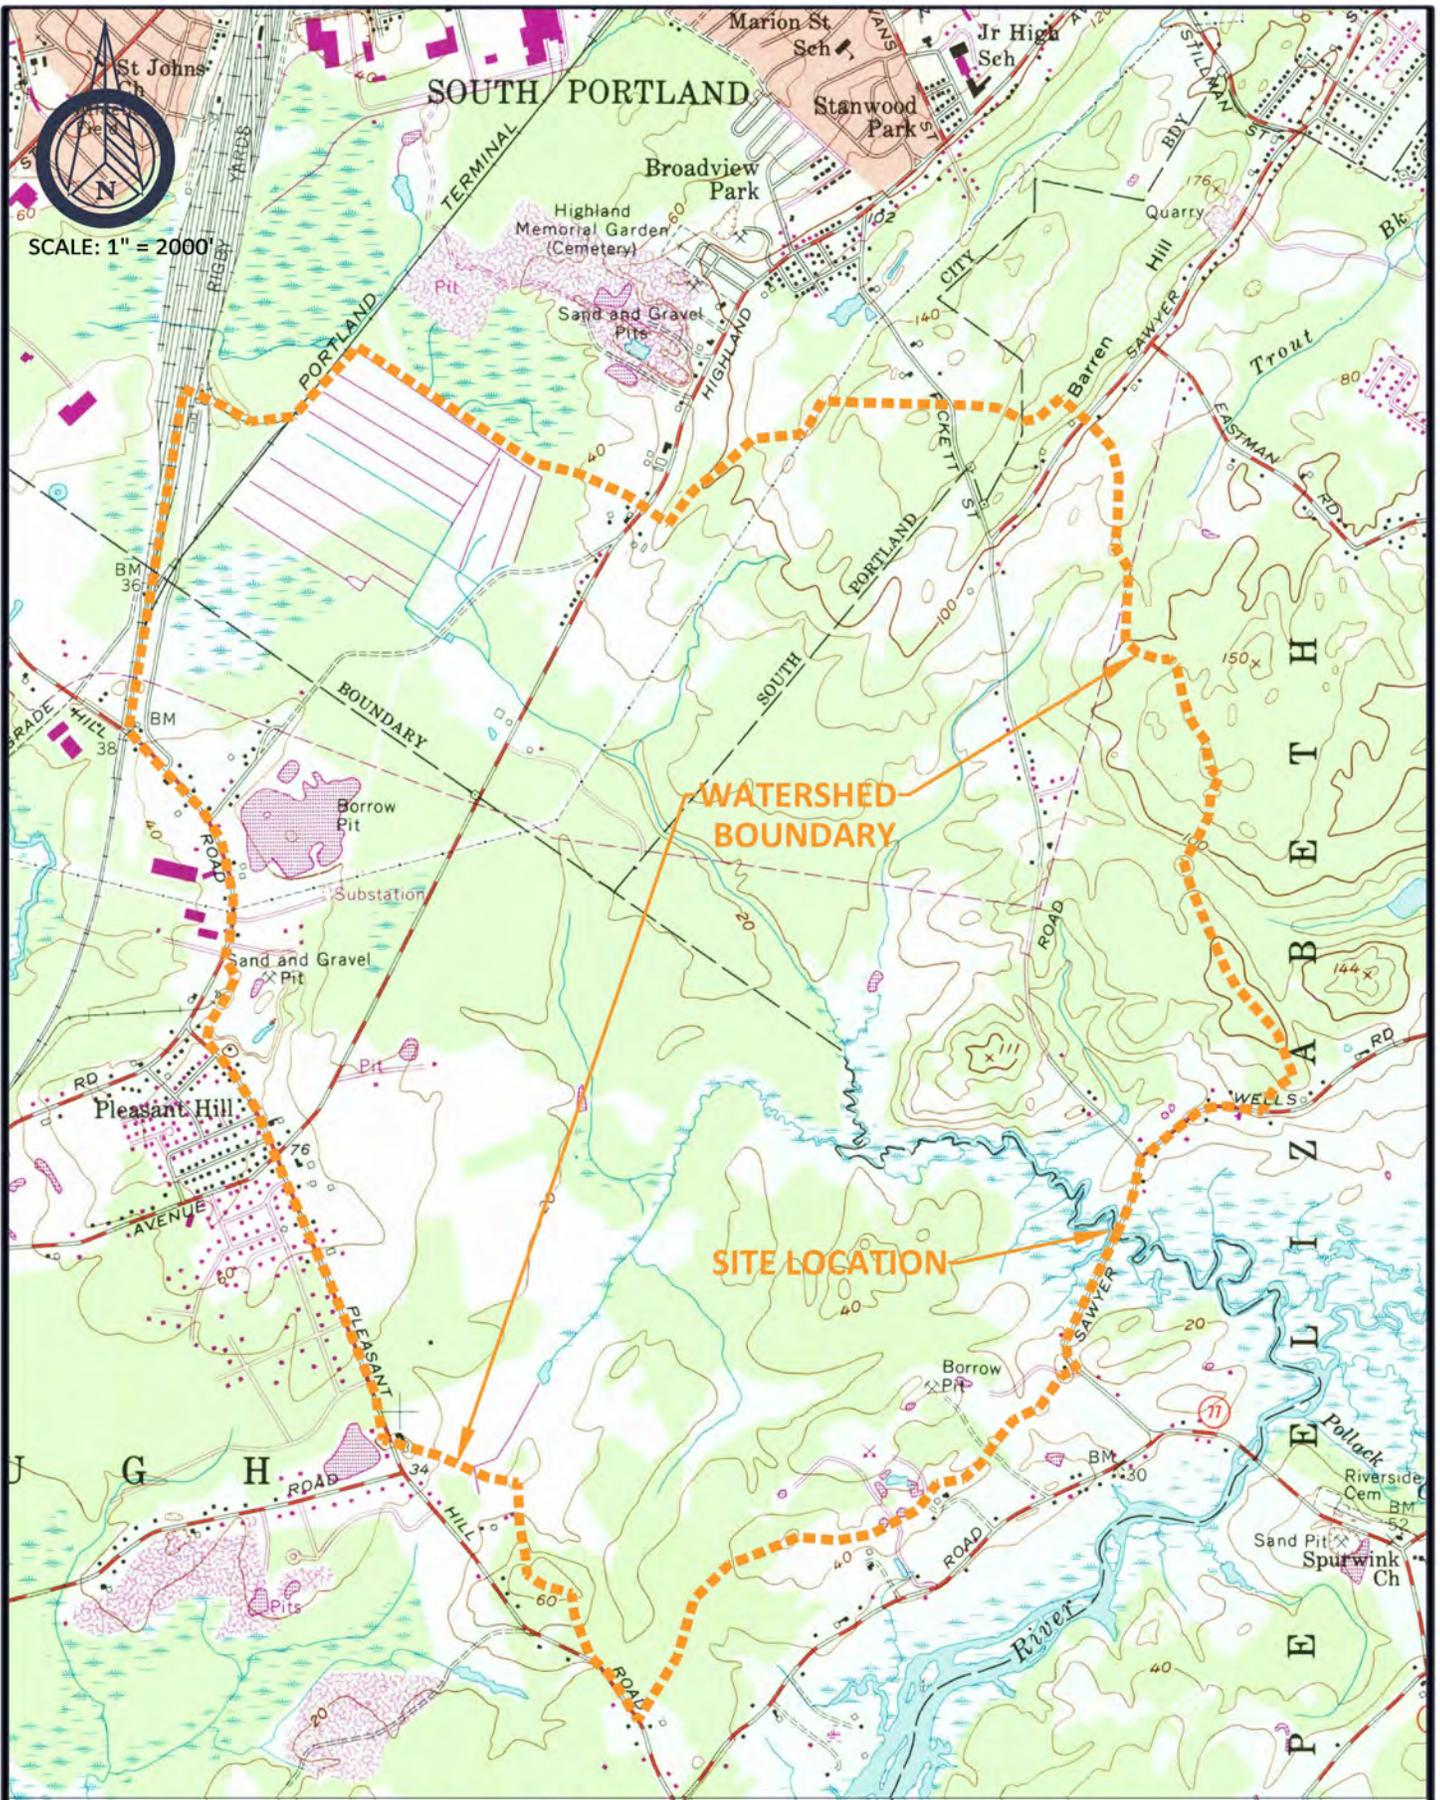
FIGURE 8

WATERSHED MAP  
SAWYER ROAD CROSSING ASSESSMENT  
C.ELIZ. & SCAR., ME | NOVEMBER 2019

The Sawyer Road crossing has a tributary watershed of approximately 4.5 square miles. Of this area, approximately 0.35 square miles (7.8%) is mapped as a sand and gravel aquifer, and 1.0 square miles (23.0%) is wetland area as identified by the National Wetlands Inventory mapping. This 4.5 square mile water shed includes the areas of Spurwink Marsh upstream of Sawyer Road, as well as abutting development around the perimeter of the marsh and tributary stream channels. Figure 8, included on the following page, depicts the tributary watershed area to the project location overlain on the associated 7.5-minute USGS quadrangle.

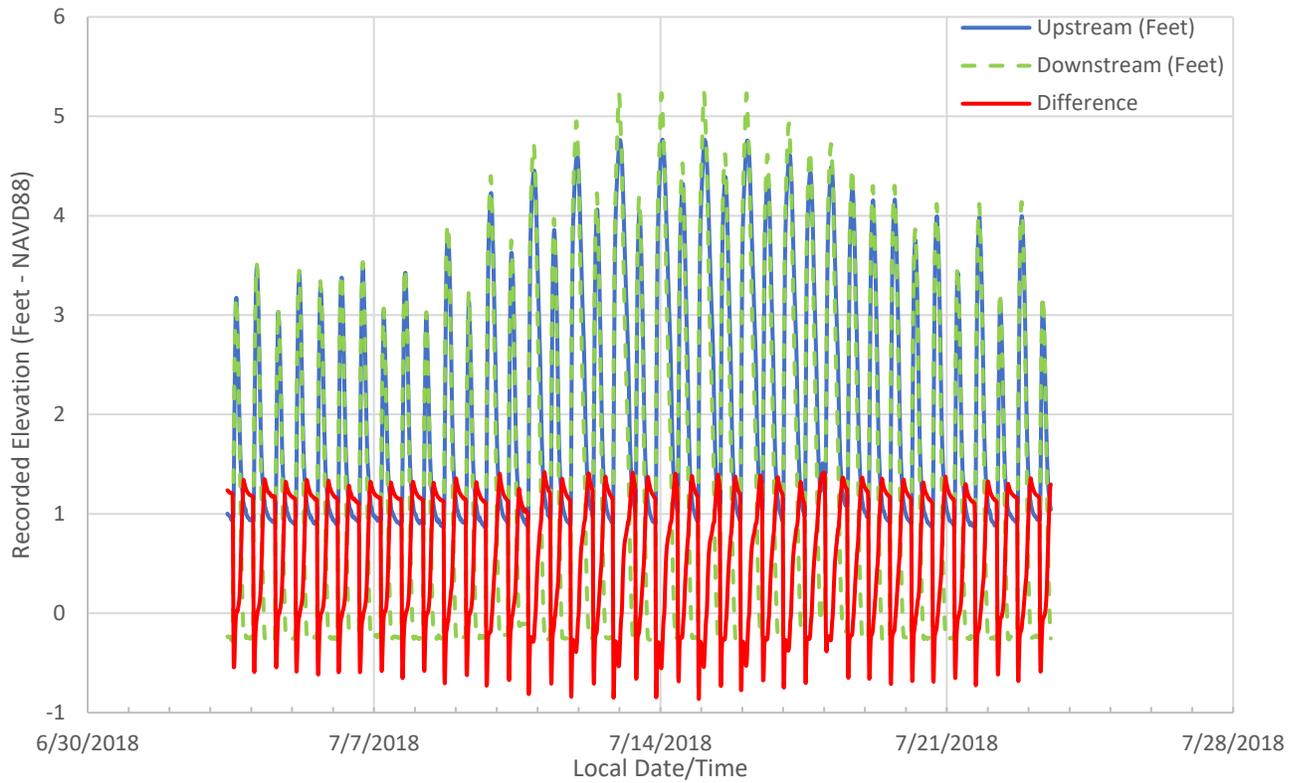
**Figure 9 - Recorded Water Surface Elevations at Spurwink Road**

As shown in Figures 9, 10, and 11, there is substantial tidal activity at each crossing location. Each figure contains data for both the upstream gauge and the downstream gauge. Additionally, a third dataset is plotted in red, which indicates the difference between the upstream and downstream values as the associated time of recording. A difference of zero (0) feet indicates that the upstream and downstream tidal observations are identical.

At Spurwink Road (Figure 9), there is substantial difference between upstream and downstream tidal elevations. This is most pronounced at the lower end of the tide cycle when upstream elevations are “hung” by the culvert crossing and the upstream area is impounded at higher elevations. However, the higher end of the tide cycle is also affected, as the downstream water surface reaches higher elevations than the upstream areas.

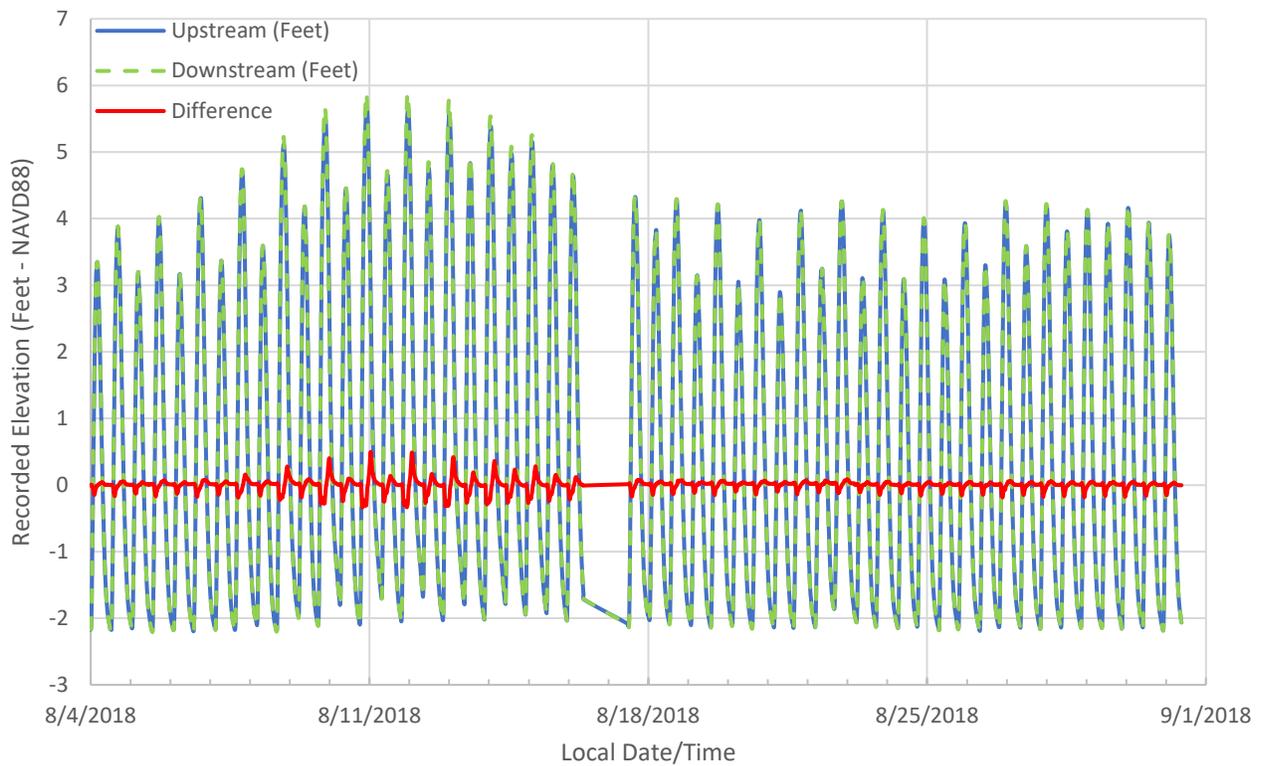
**Figure 10 - Recorded Water Surface Elevations at Route 77 Bridge**

The Route 77 Bridge (Figure 10), does not vary much at all from downstream to upstream, which is reflected by the red “difference” line slightly oscillating around a value of zero (0). This indicates that the Route 77 bridge is somewhat effective at conveying the tide across the highway with minimal effect. However, it should be noted that the most significant difference to tidal elevations is during

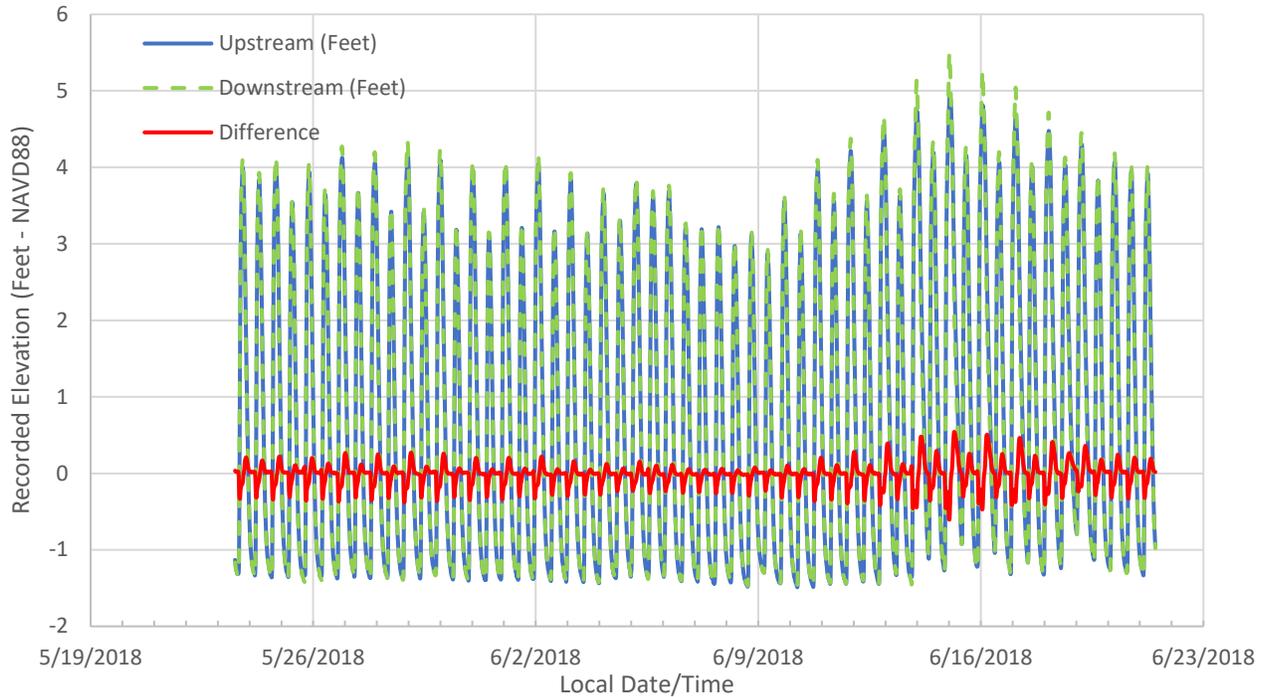
**Figure 11 - Recorded Water Surface Elevations at Sawyer Road**

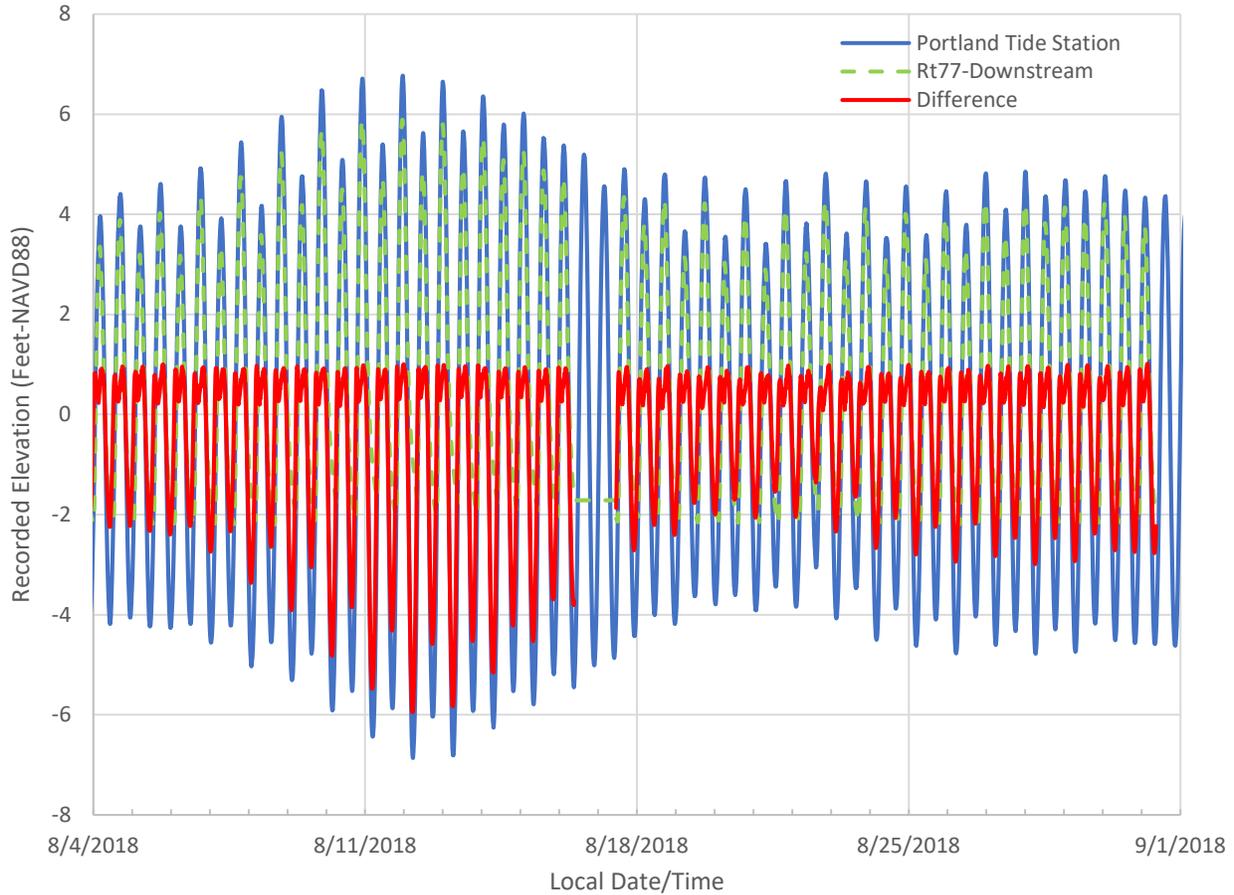
**Figure 12- Comparison of Portland Tide Gauge to the Recorded data Downstream of Route 77 (Overview)**

Note: The Portland Tide Gauge experiences peak high elevations approximately 24 minutes prior to the Route 77 Bridge. The Portland Tide Station Data shown on this figure has been translated in time to align the high tide elevations in each dataset.

As shown in Figure 12, there is rather substantial difference in the comparison, particularly at low tides. The difference at low tides is due to the fact that the Spurwink River thalweg channel elevations are located higher than the low tide. So, during low tides at the Portland Tide Gauge, the water surface elevation in the Spurwink River at Route 77 is not driven by the tide, but rather by typical subcritical flows driven by watershed related discharge. These are two different processes that will not have a good correlation.

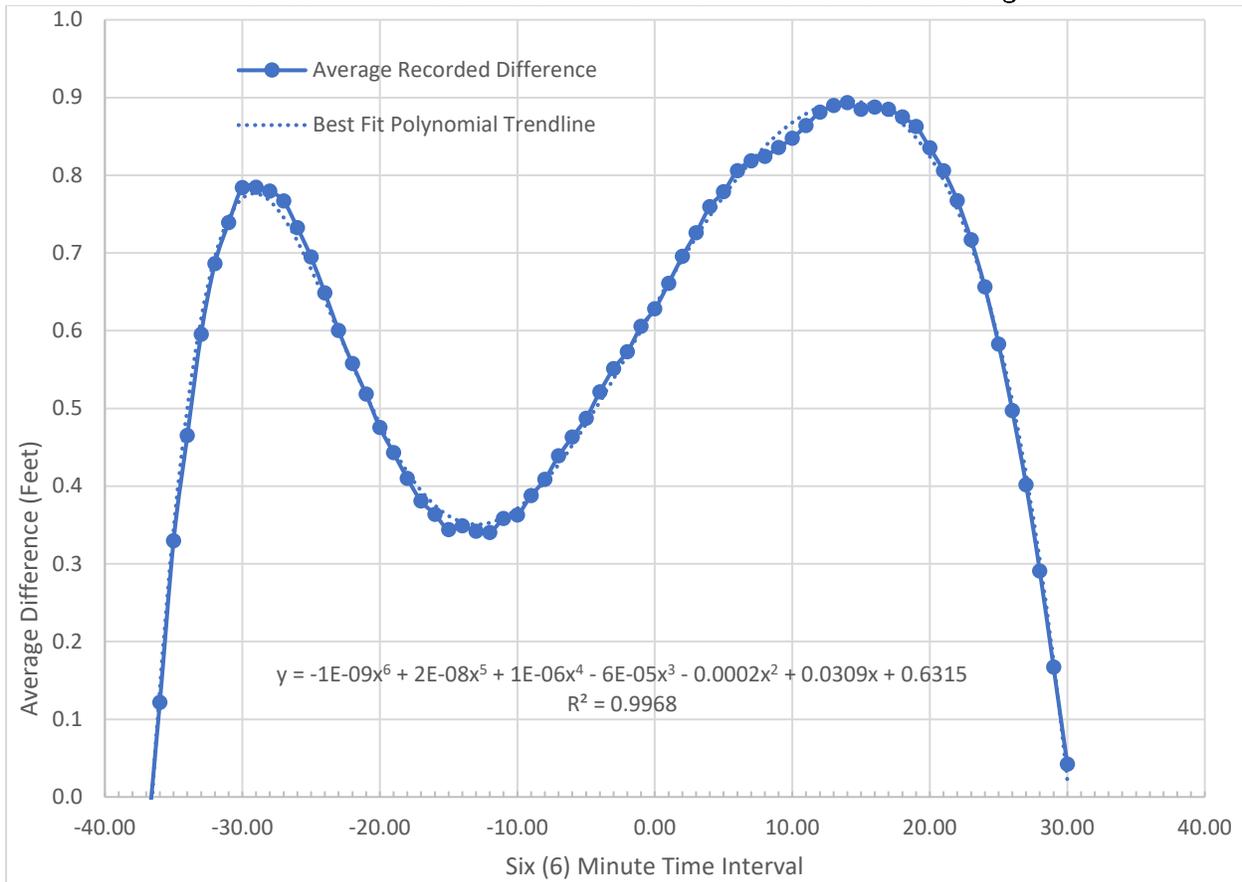
**Figure 13 - Average High Tide Difference  
Between Localized Route 77 Data and the Portland Tide Gauge**

Note: The Portland Tide Gauge collects elevation data once every six minutes. Time interval zero (0) is the peak (high) tide elevation interval. Negative intervals are the six (6) minute intervals prior to high tide and positive interval values reflect the intervals after high tide occurs at the Portland Tide Gauge.

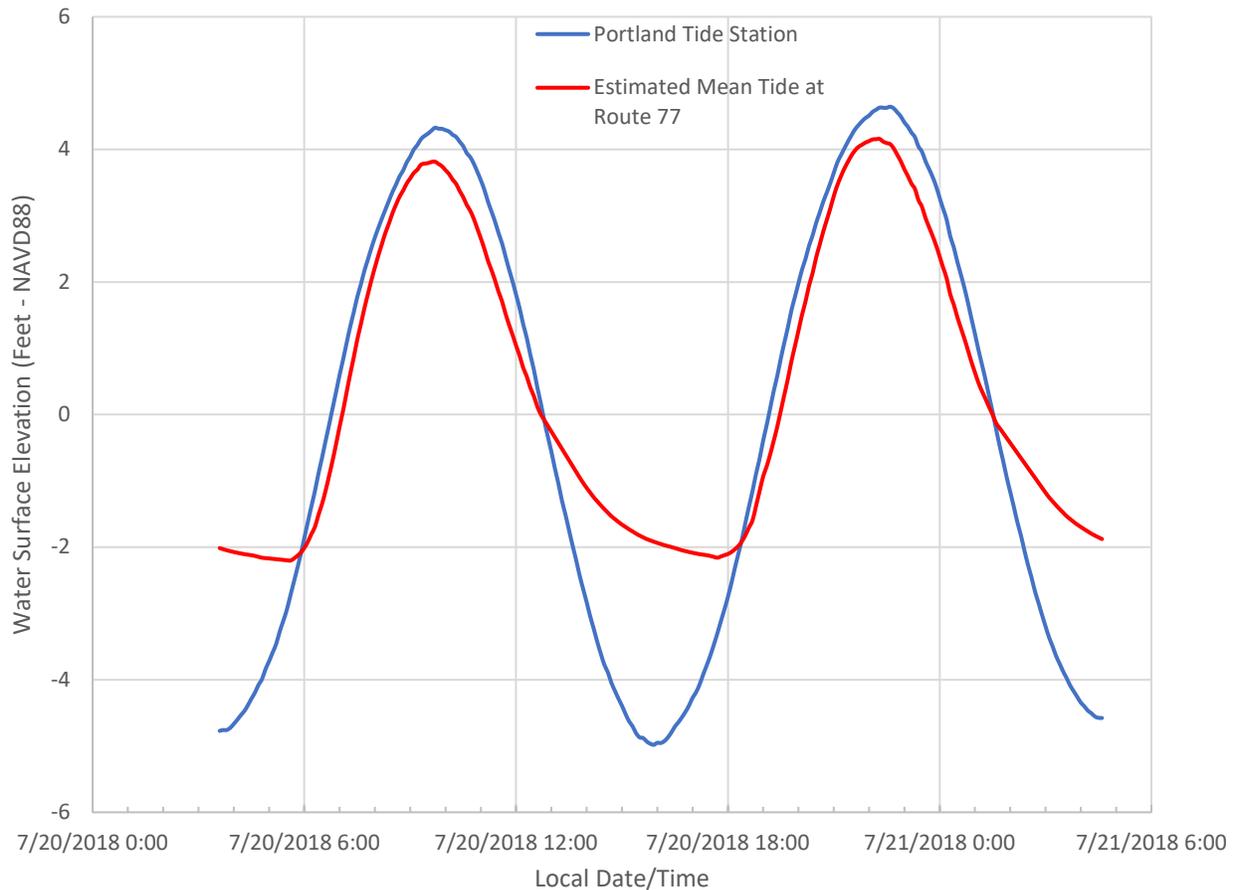
**Figure 14 - Estimated Mean Tide Conditions at Route 77 Bridge**

77 Bridge. Figure 14 depicts the estimated mean tidal conditions downstream of Route 77 and is overlain on the Portland Tide Station data for July 20, 2018.

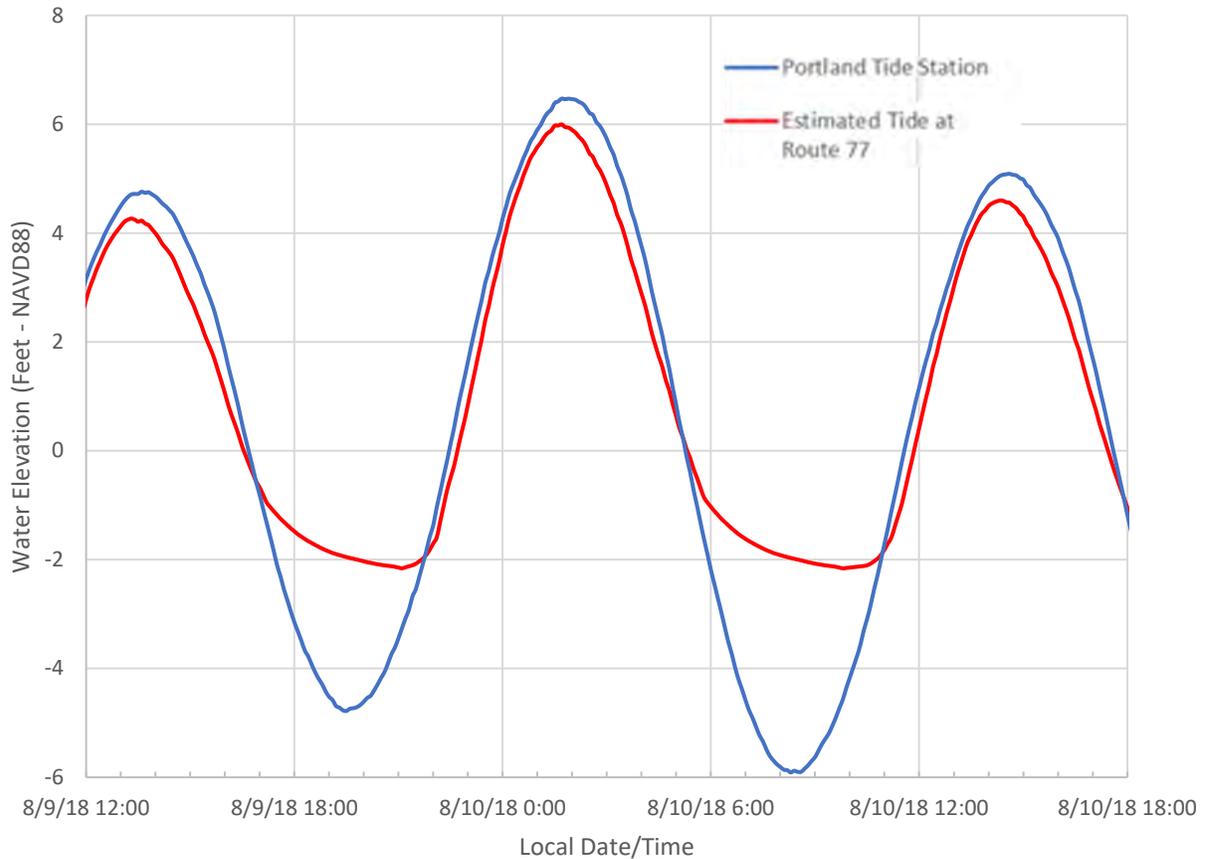
Figure 15 - Estimated HAT Condition at Route 77 Bridge

The Maine Department of Environmental Protection (MeDEP) also publishes Highest Annual Tide (HAT) information across the coast of Maine. The HAT data published by the MeDEP in 2018 indicates that the HAT in Portland is 6.5 feet (NAVD88). After a review of the 2018 NOAA Portland Tide Gauge data, it was determined that the tide that occurred on August 10, 2018 was very similar to the HAT published by MeDEP. Using the August 10<sup>th</sup> data as a proxy for the HAT condition, the curve shown in Figure 13 was applied to the Portland Tide Data to develop the approximated HAT condition downstream of the Route 77 Bridge. Figure 15 depicts the estimated HAT condition downstream of Route 77 and is overlain on the Portland Tide Station data for August 10, 2018.

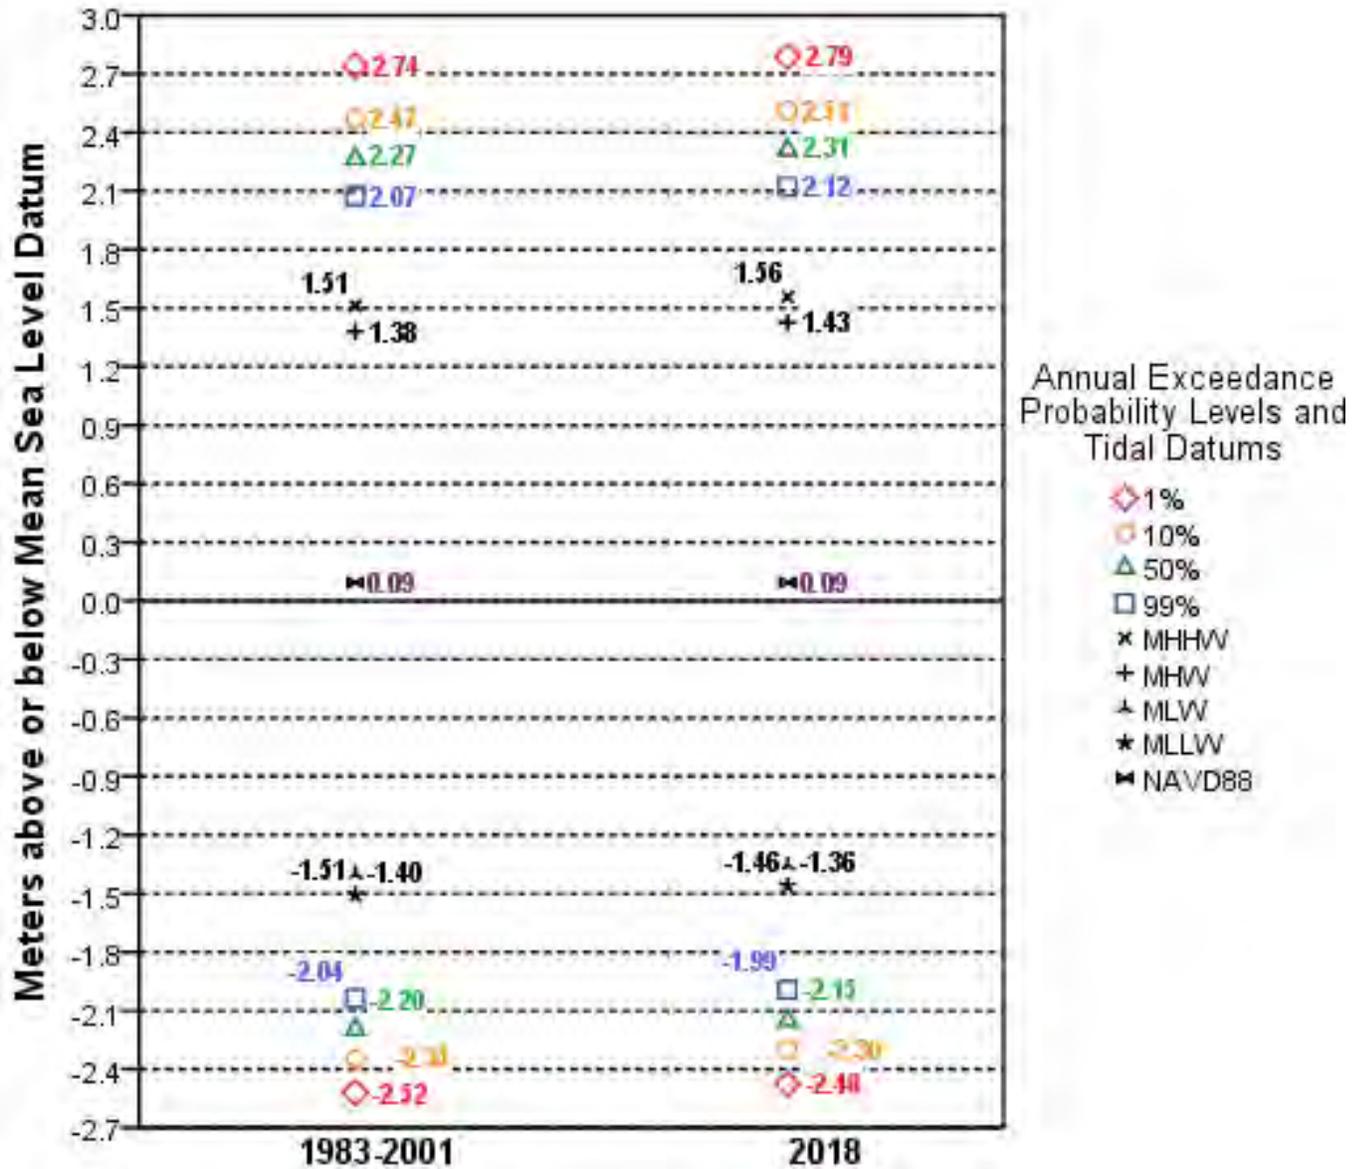
Figure 16 - NOAA Portland Tide Station (8418150)

During large storms or other extreme conditions, tides will reach higher elevations than the HAT. NOAA has published the following data (See Figure 16) related to annual exceedance probability levels at the Portland Tide Gauge (ID# 8418150).

As shown in Figure 16, the 100-year tide elevation (1% annual exceedance) is estimated to be at an elevation of 2.79 meters above mean sea level (elevation 8.8 feet - NAVD88). The 10% exceedance (10-year) tide elevation is estimated to be at elevation 7.9 feet - NAVD 88 (2.51 meters above mean sea level). Similar to the estimated tides calculated in Section 3.2.3, a proxy was identified in 2018 for the 10% exceedance tidal event (March 2, 2018). Using the March 2nd data as a proxy for the 10% exceedance condition, the curve shown in Figure 13 was applied to the Portland Tide Data to develop the approximated 10% exceedance condition downstream of the Route 77 Bridge. Figure

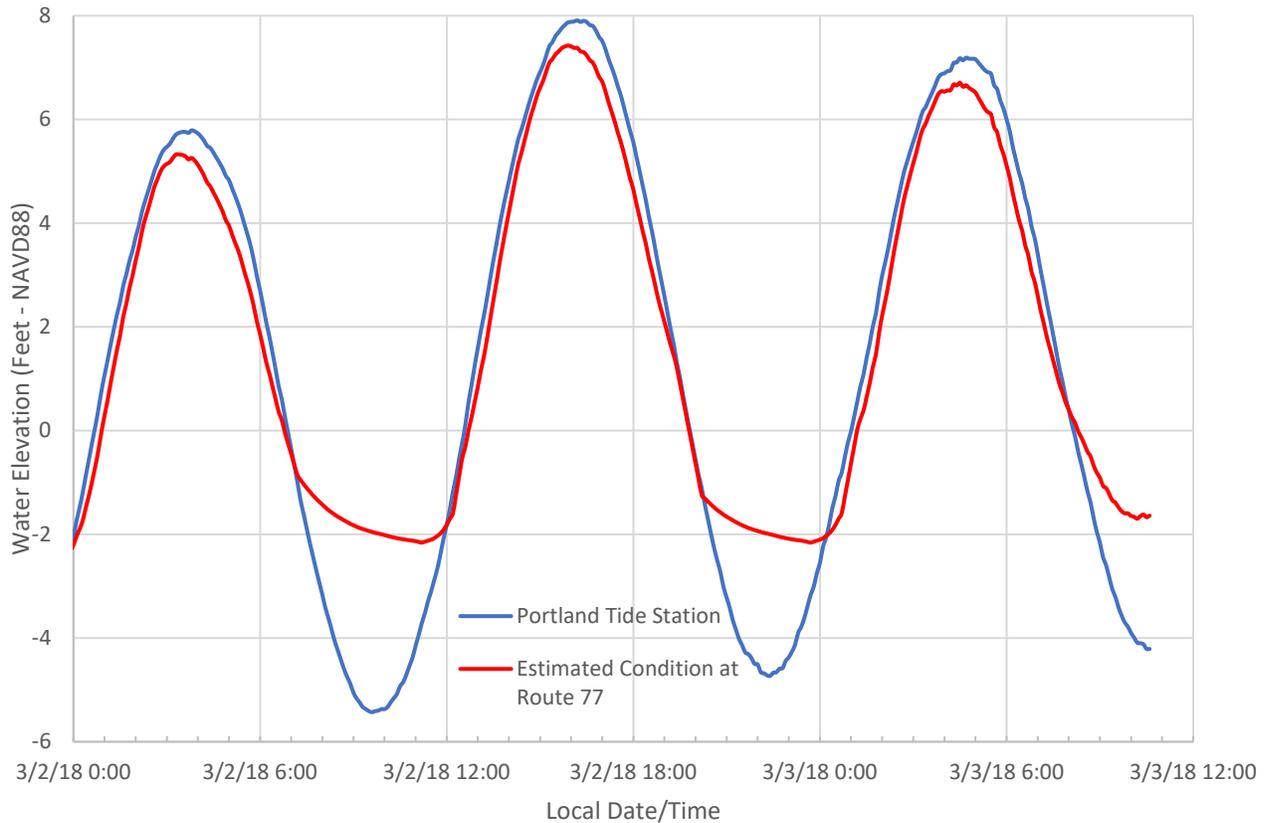
**Figure 17 - Estimated 10% Exceedance (10-year) Event at Route 77 Bridge**

17 depicts the estimated 10% exceedance condition downstream of Route 77 and is overlain on the Portland Tide Station data for March 2, 2018.

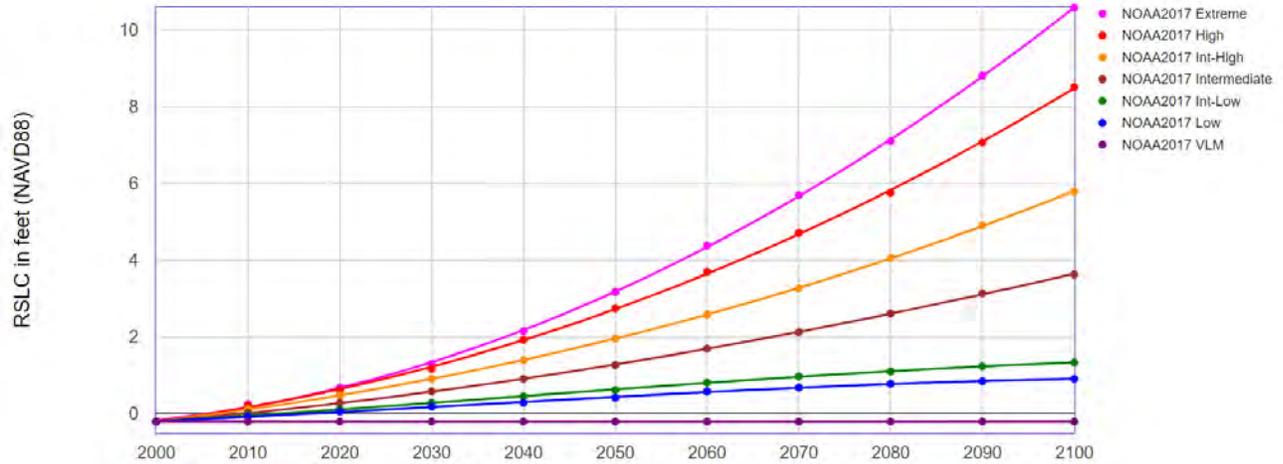
**Figure 18 - NOAA et al. 2017 Relative Sea Level Change Scenarios for Portland, ME**

As identified in Figure 18, there are a range of potential sea level rise scenarios. These range from more than 10 feet of relative sea level change to minimal change over the course of the current century.

As shown in Figure 18, there is approximately 3.34 feet of relative sea level change that will occur over the next 80 years (2020 to 2100) in the NOAA2017 Intermediate curve scenario. That change increases to 5.32 feet of change when considering the NOAA2017 Int-High scenario. This calculated change was applied to the estimated HAT condition at the Route 77 bridge. The existing and anticipated future HAT conditions downstream from the Route 77 Bridge are depicted on Figure 19.
