# SAWYER ROAD CULVERT TIDAL CROSSING ASSESSMENT

CAPE ELIZABETH &  
SCARBOROUGH, MAINE

PRELIMINARY  
DESIGN REPORT

ACADIA CIVIL WORKS  
ENGINEERING DESIGN & CONSULTATION

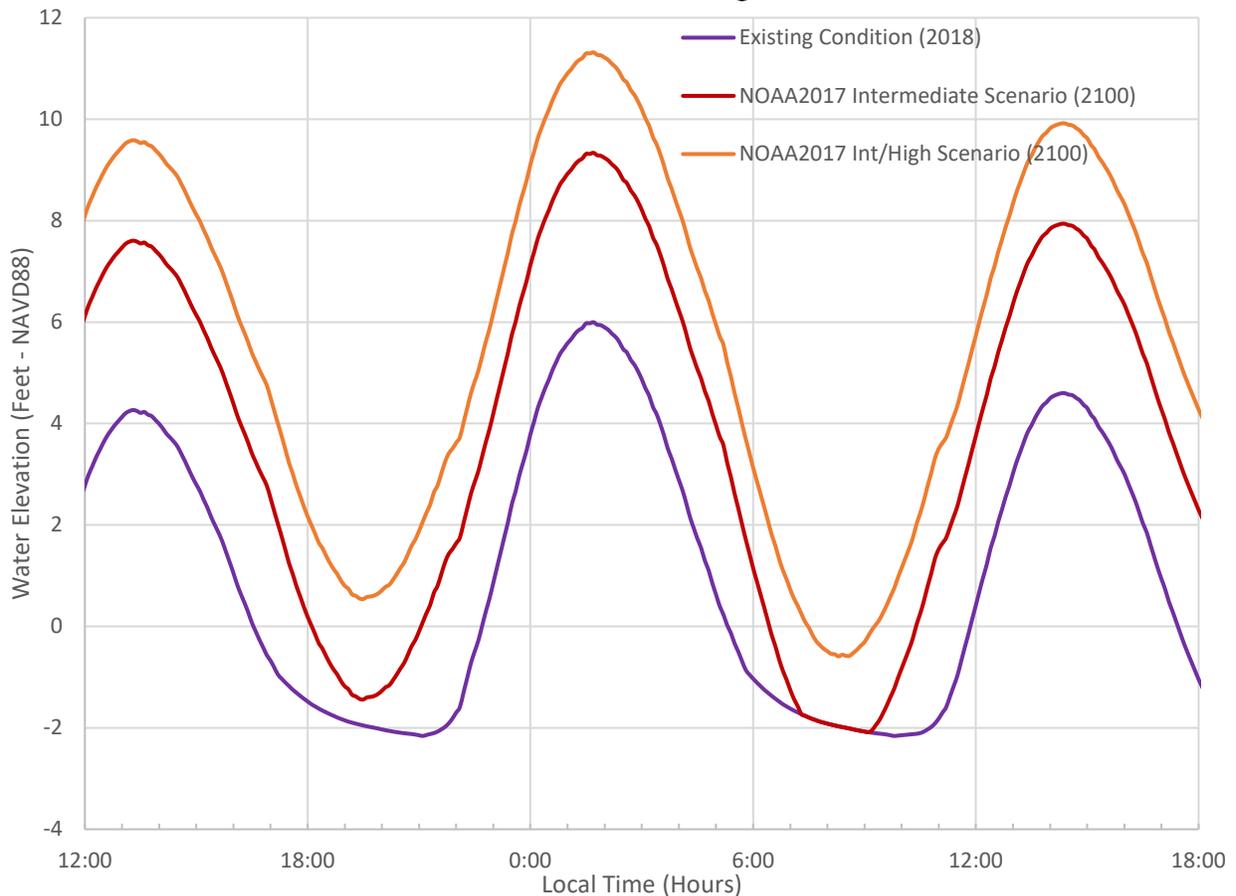
**Figure 19 - Estimated Current and Potential Future HAT Conditions at the Route 77 Bridge**

As shown in Figure 18, there is approximately 3.34 feet of relative sea level change that will occur over the next 80 years (2020 to 2100) in the NOAA2017 Intermediate curve scenario. That change increases to 5.32 feet of change when considering the NOAA2017 Int-High scenario. This calculated change was applied to the estimated HAT condition at the Route 77 bridge. The existing and anticipated future HAT conditions downstream from the Route 77 Bridge are depicted on Figure 19.

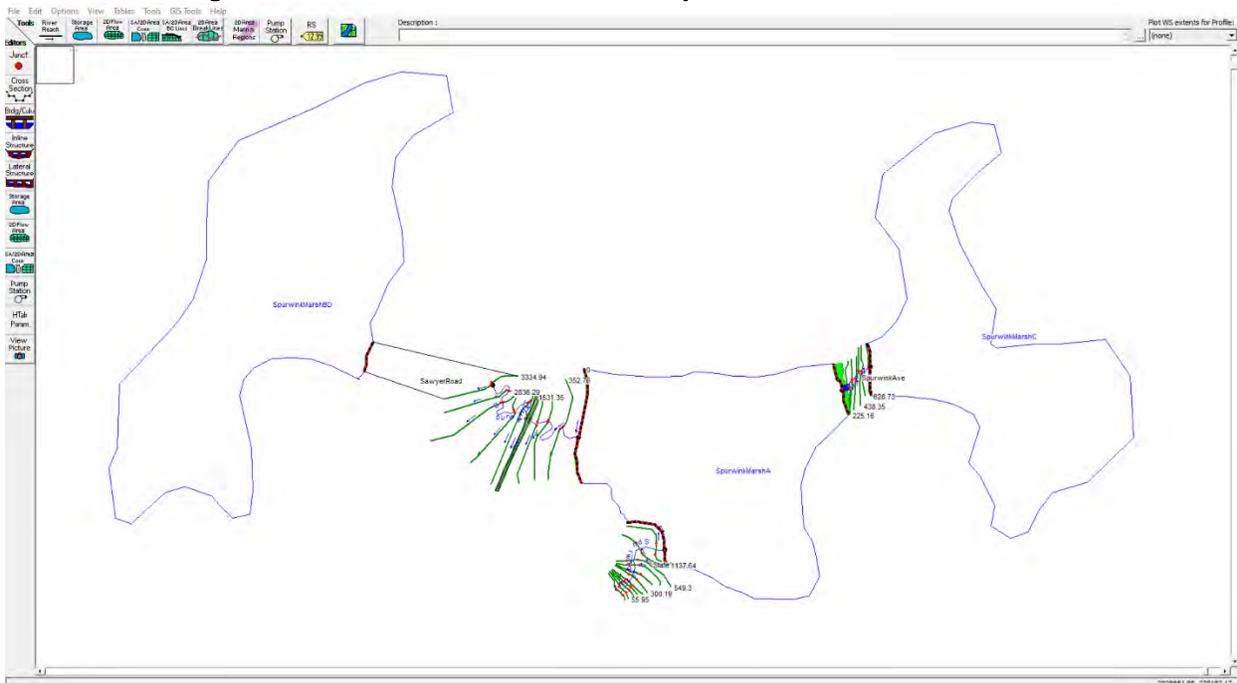
Figure 20 - HEC-RAS Model Geometry Overview (one-dimensional)

The initial HEC-RAS modeling was developed utilizing a variety of data sources. The most significant of which, is the 2006 LiDAR dataset (Section 2.3). This LiDAR data formed the foundation of the model geometry construction, which was supplemented by field crew survey efforts (Section 2.4) and record drawings (2.5). The model was constructed as a network of reaches and storage volumes. Each of the three major crossings (Route 77 Bridge, Spurwink Road, and Sawyer Road) were modeled as a reach with cross sections extend several hundred feet up and downstream from the crossing structure. Connecting each of these reaches is a large storage volume, representing the central section of the Spurwink Marsh. Additional storage nodes were developed upstream of Sawyer Road and Spurwink Road to model these upper marsh extents. A depiction of the model geometry is shown below in Figure 20.

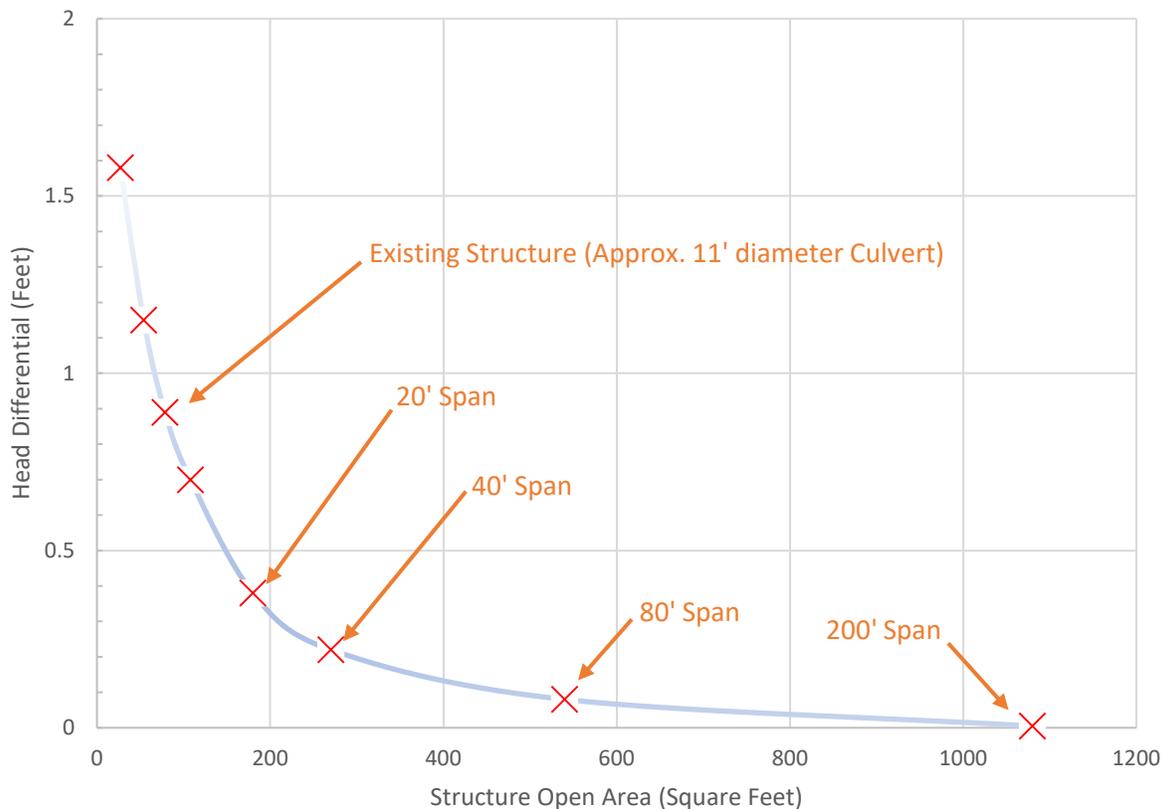
**Figure 21 - Existing (2018) HAT Sizing Curve at Sawyer Road**

The sizing curves shown in Figures 21, 22, and 23 also include an approximate “span size” label at key data points. This “span size” should be considered approximate as there are a number of details associated with the final structural design, which will affect the actual span size (such as abutment configuration, location in the channel versus overbank, etc.). However, the span size should provide context and reference to the approximate magnitude of structures under consideration. As an additional point of reference, Table 4.1 is provided below, which shows the peak head differential in relation to the approximate span size for each of the tide conditions shown in Figures 21 thru 23.

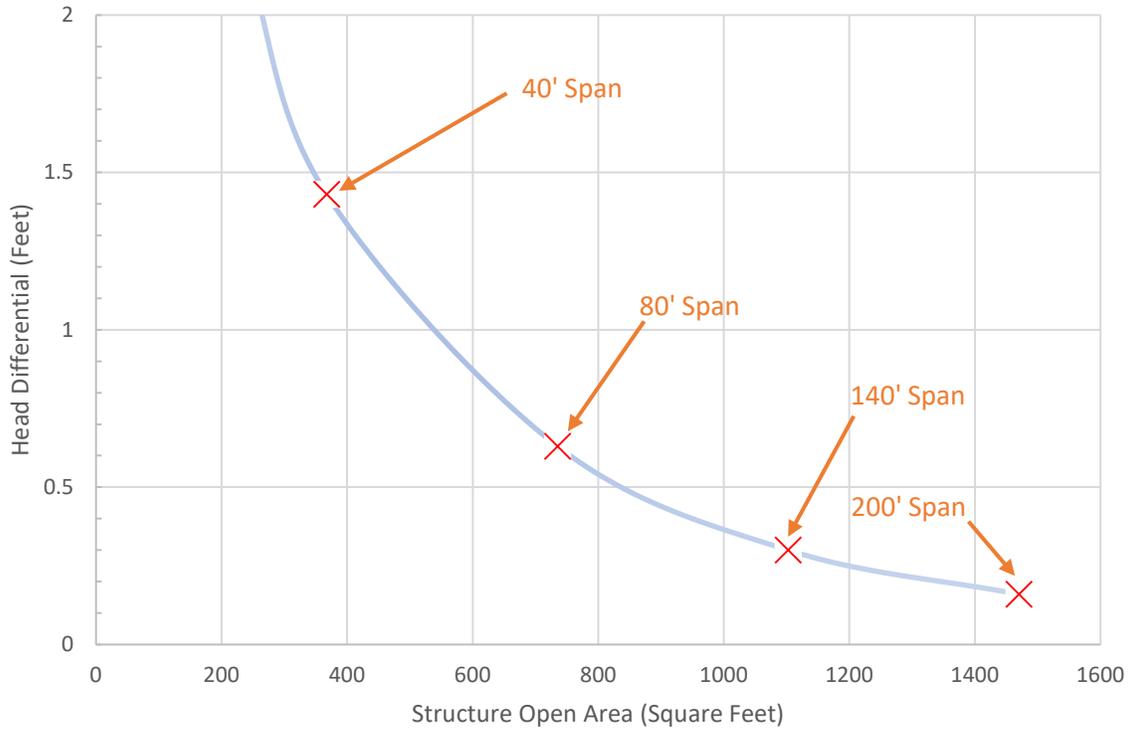
**Figure 22 - Future (2100 - NOAA17 Intermediate) HAT Sizing Curve at Sawyer Road**

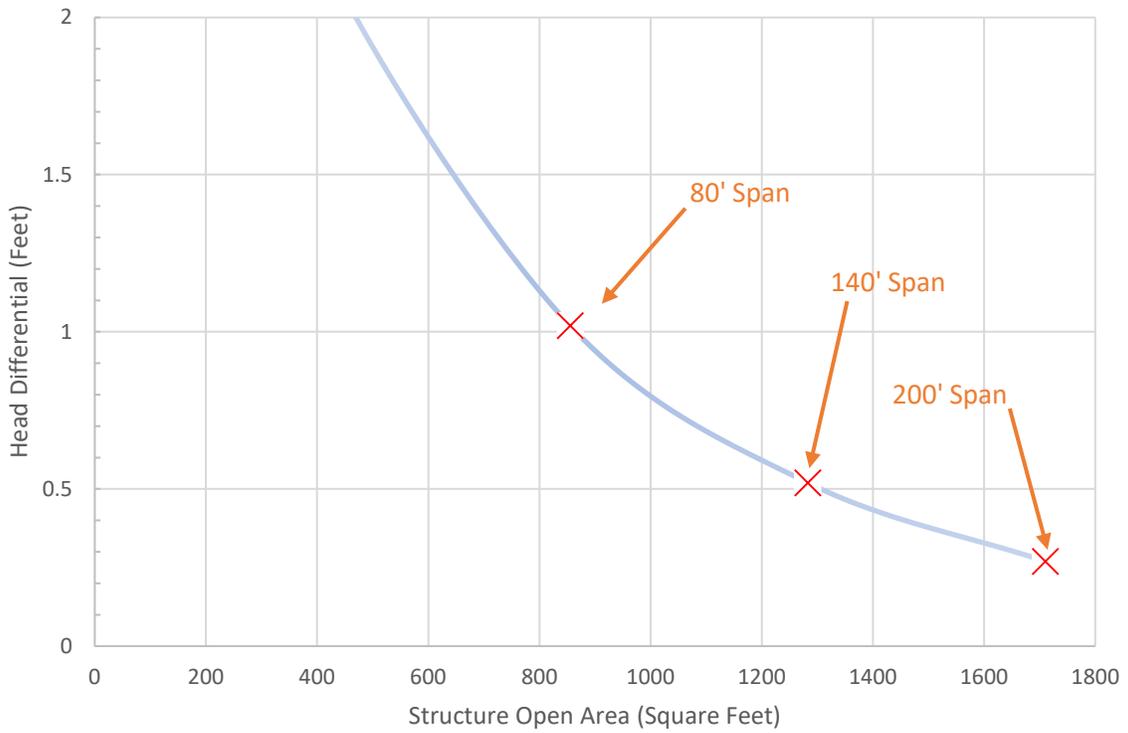
Figure 23 - Future (2100 - NOAA17 Int-High) HAT Sizing Curve at Sawyer Road

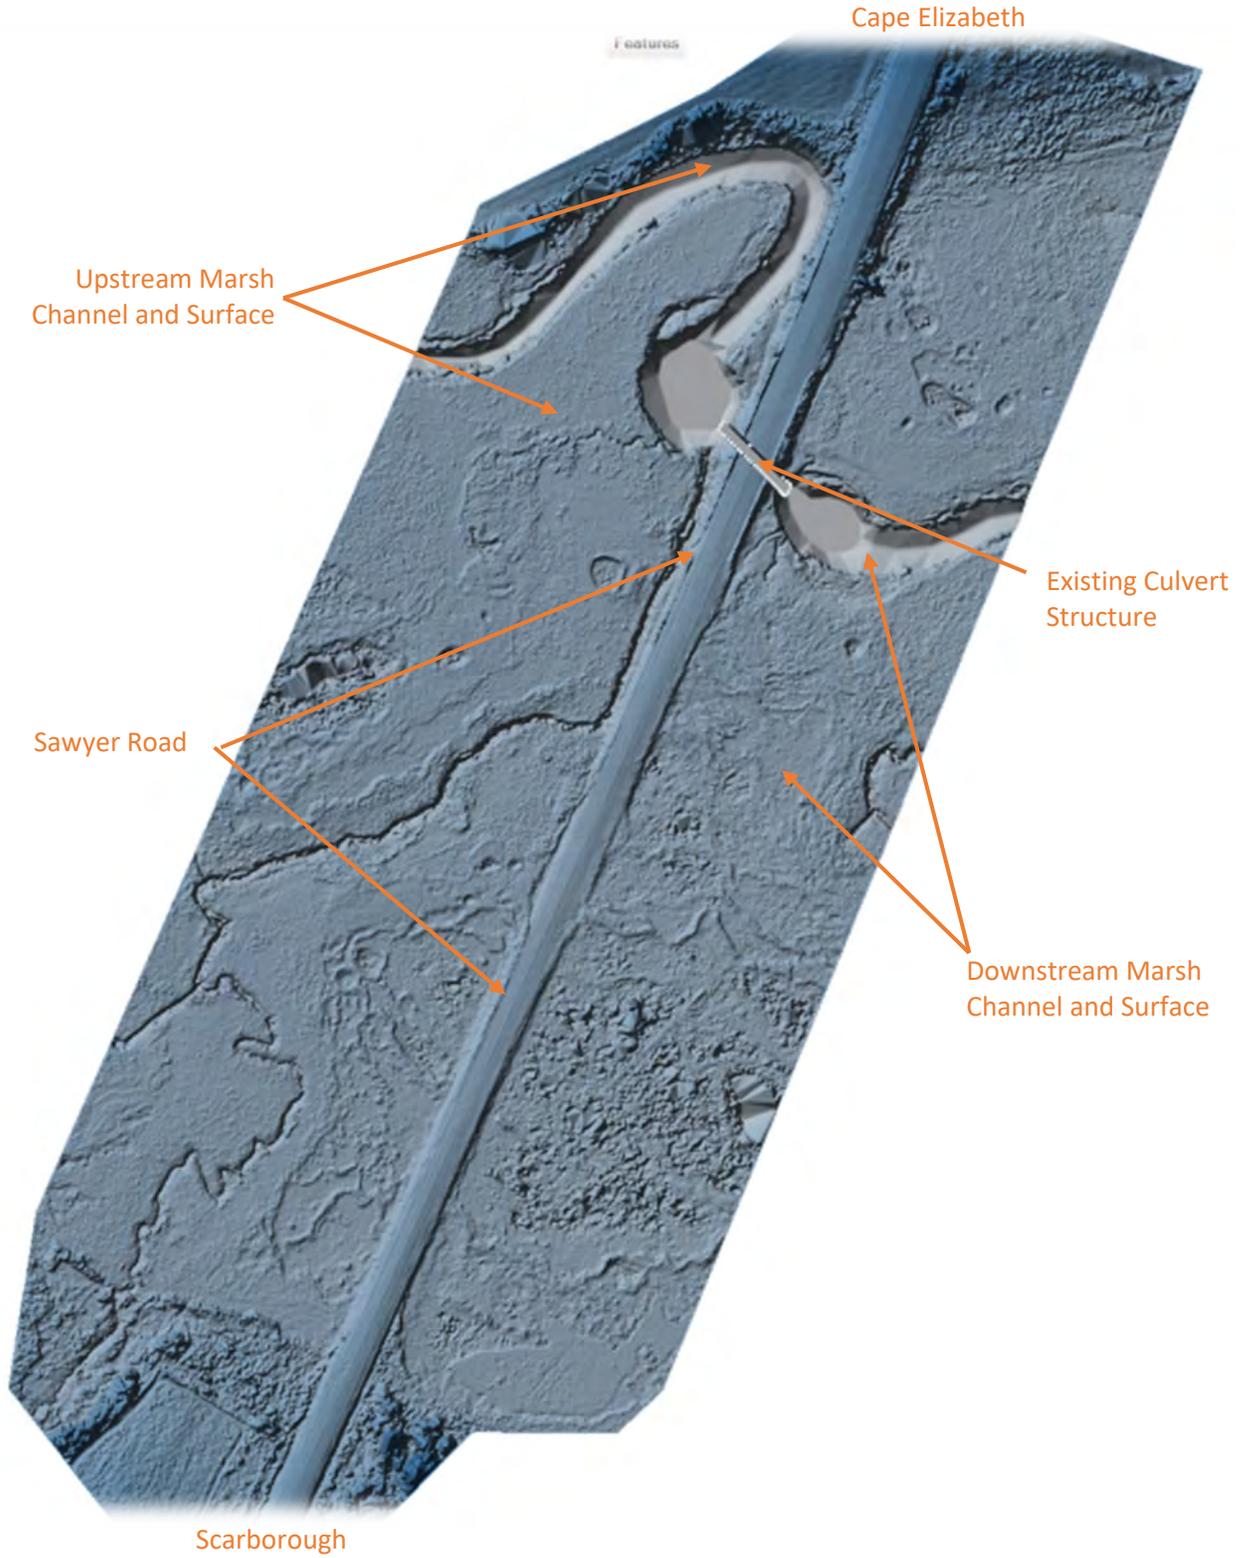
Figure 24 - Existing Conditions 2-Dimensional Terrain Model

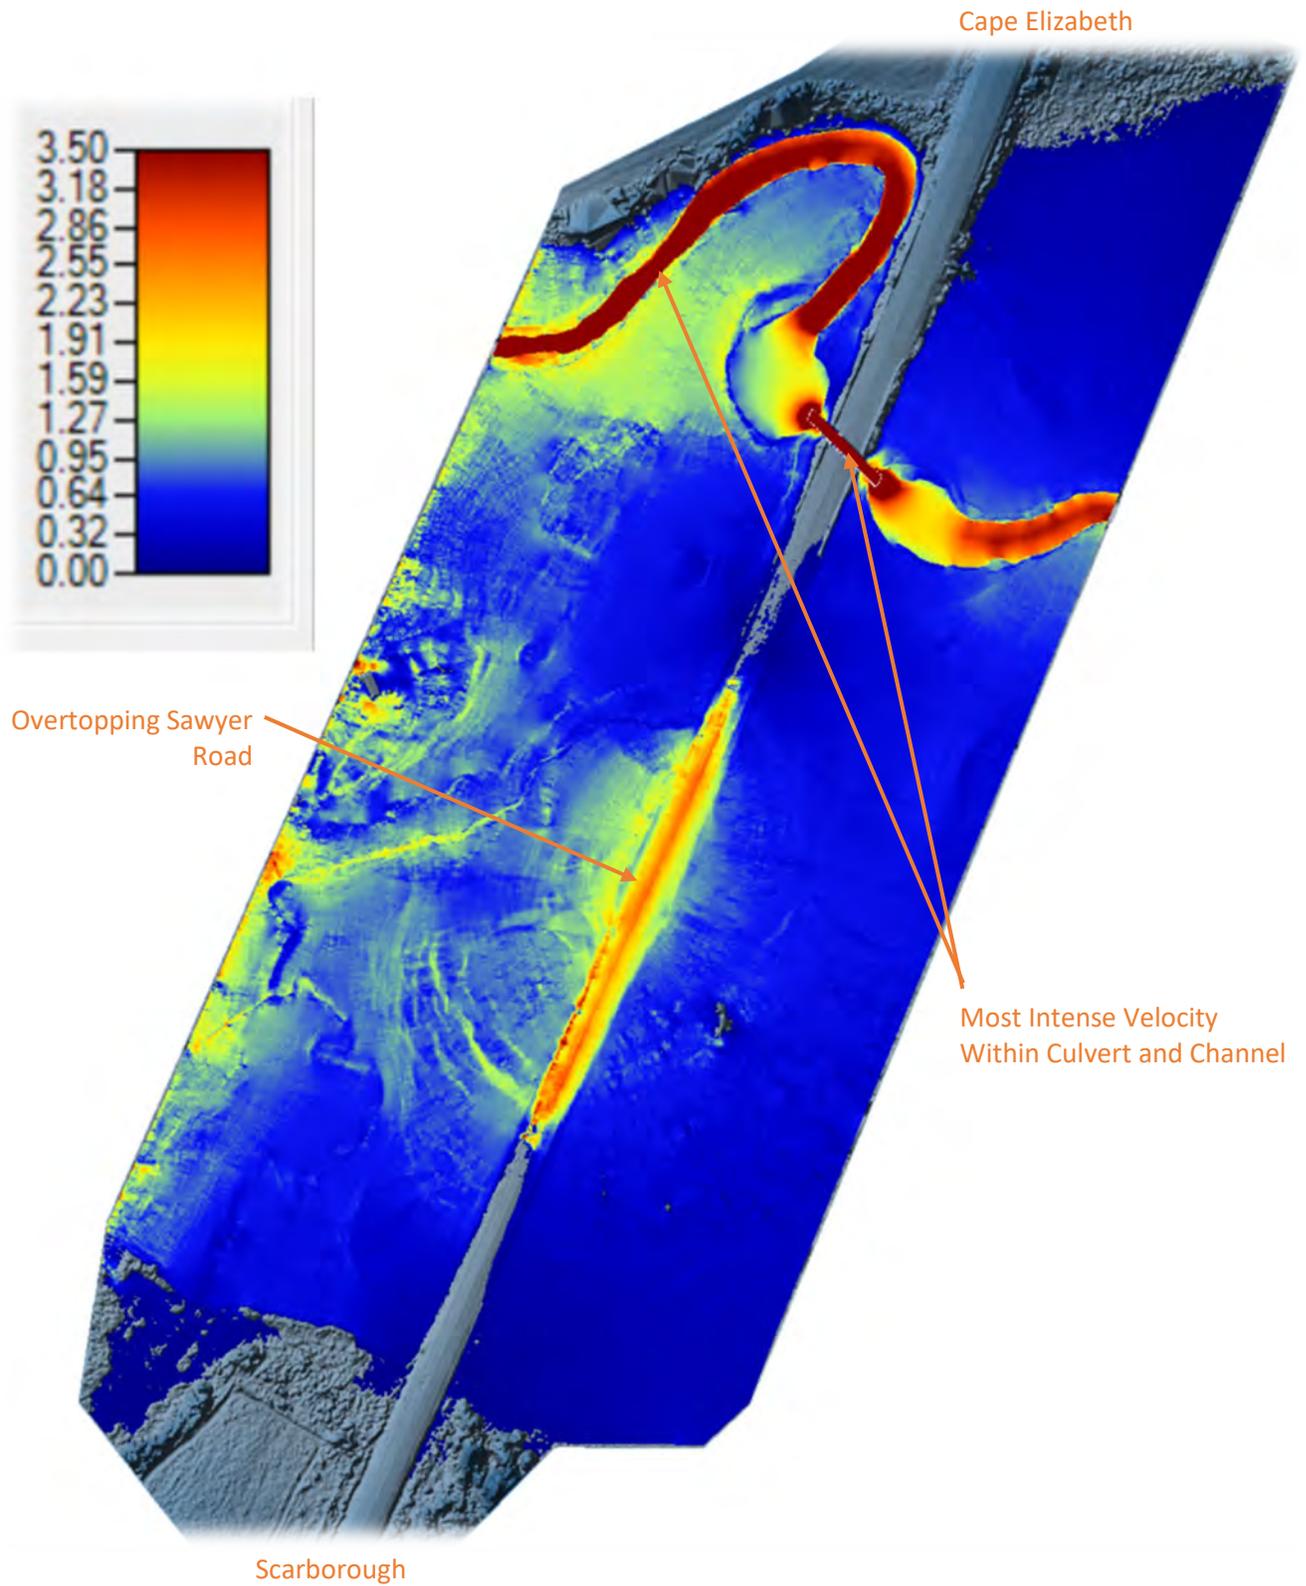
Figure 25 - Existing Conditions Peak Velocity Heat Map

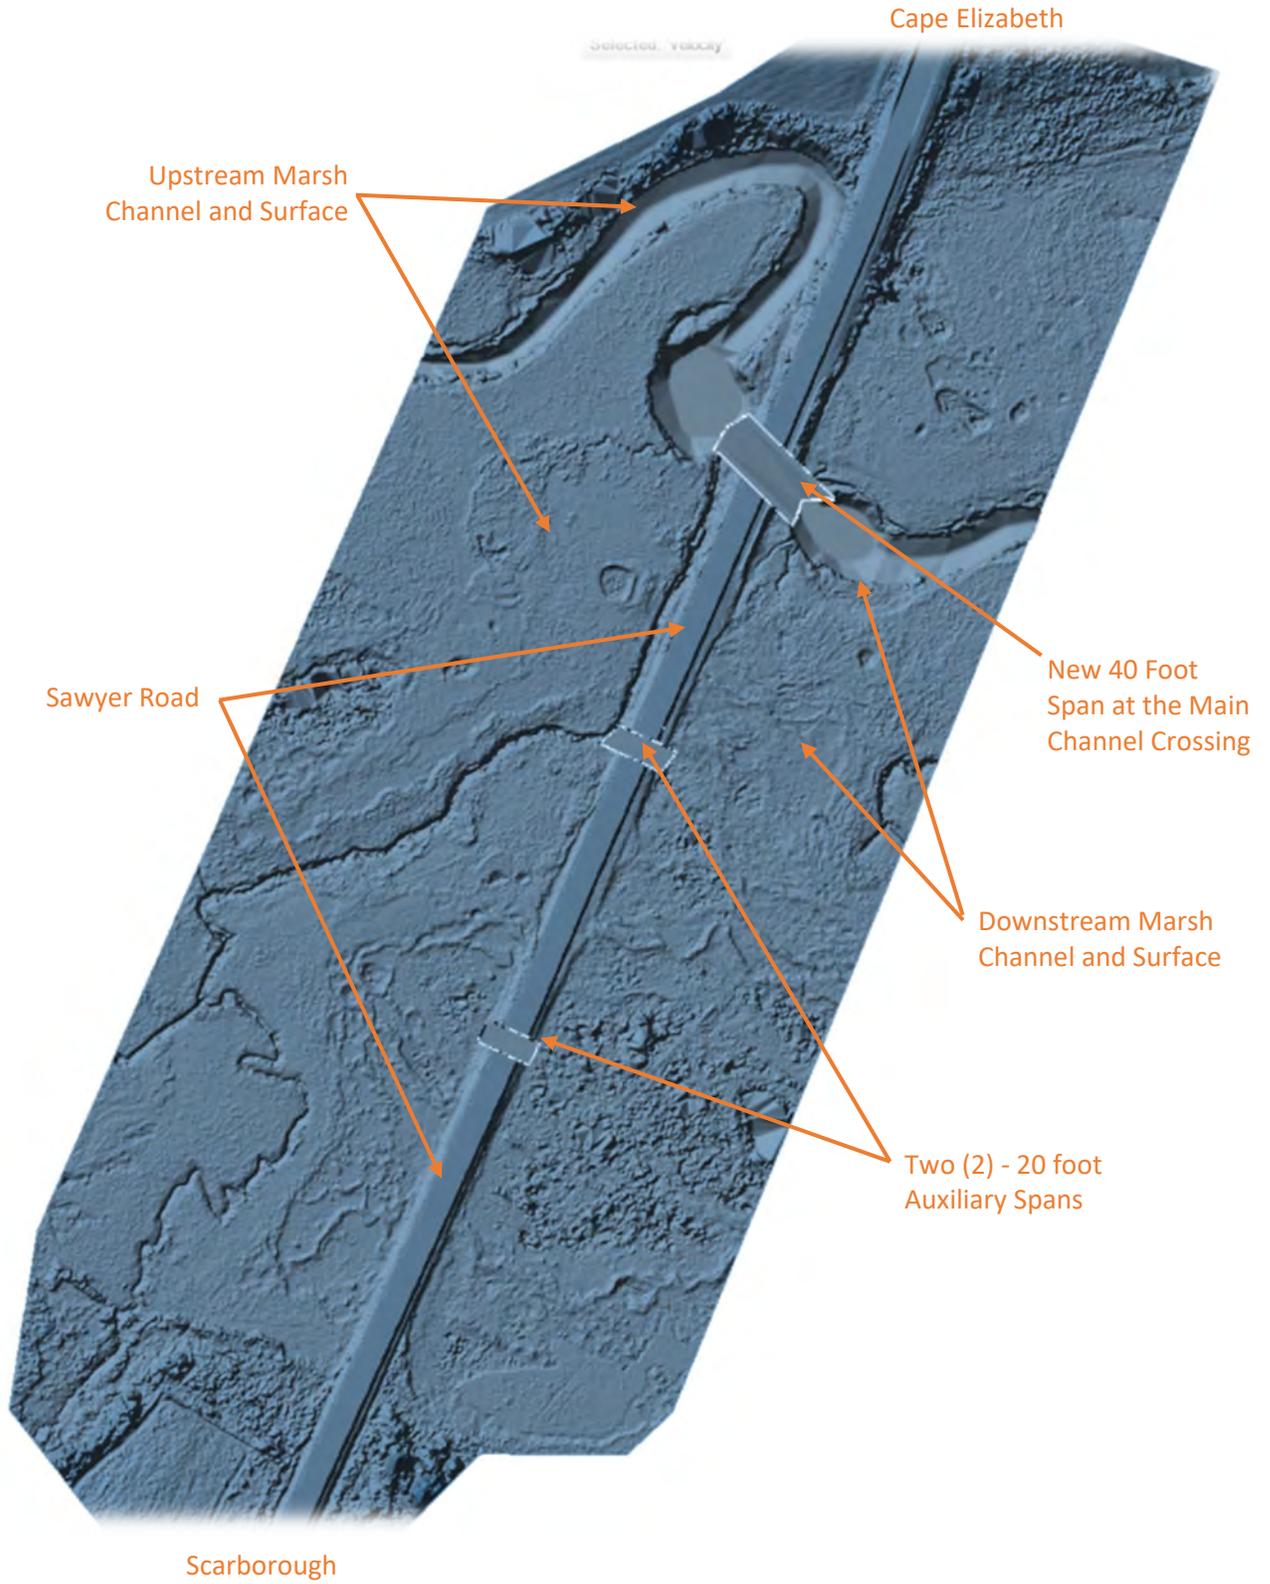
Figure 26 - Concept A - Two-Dimensional Terrain Model

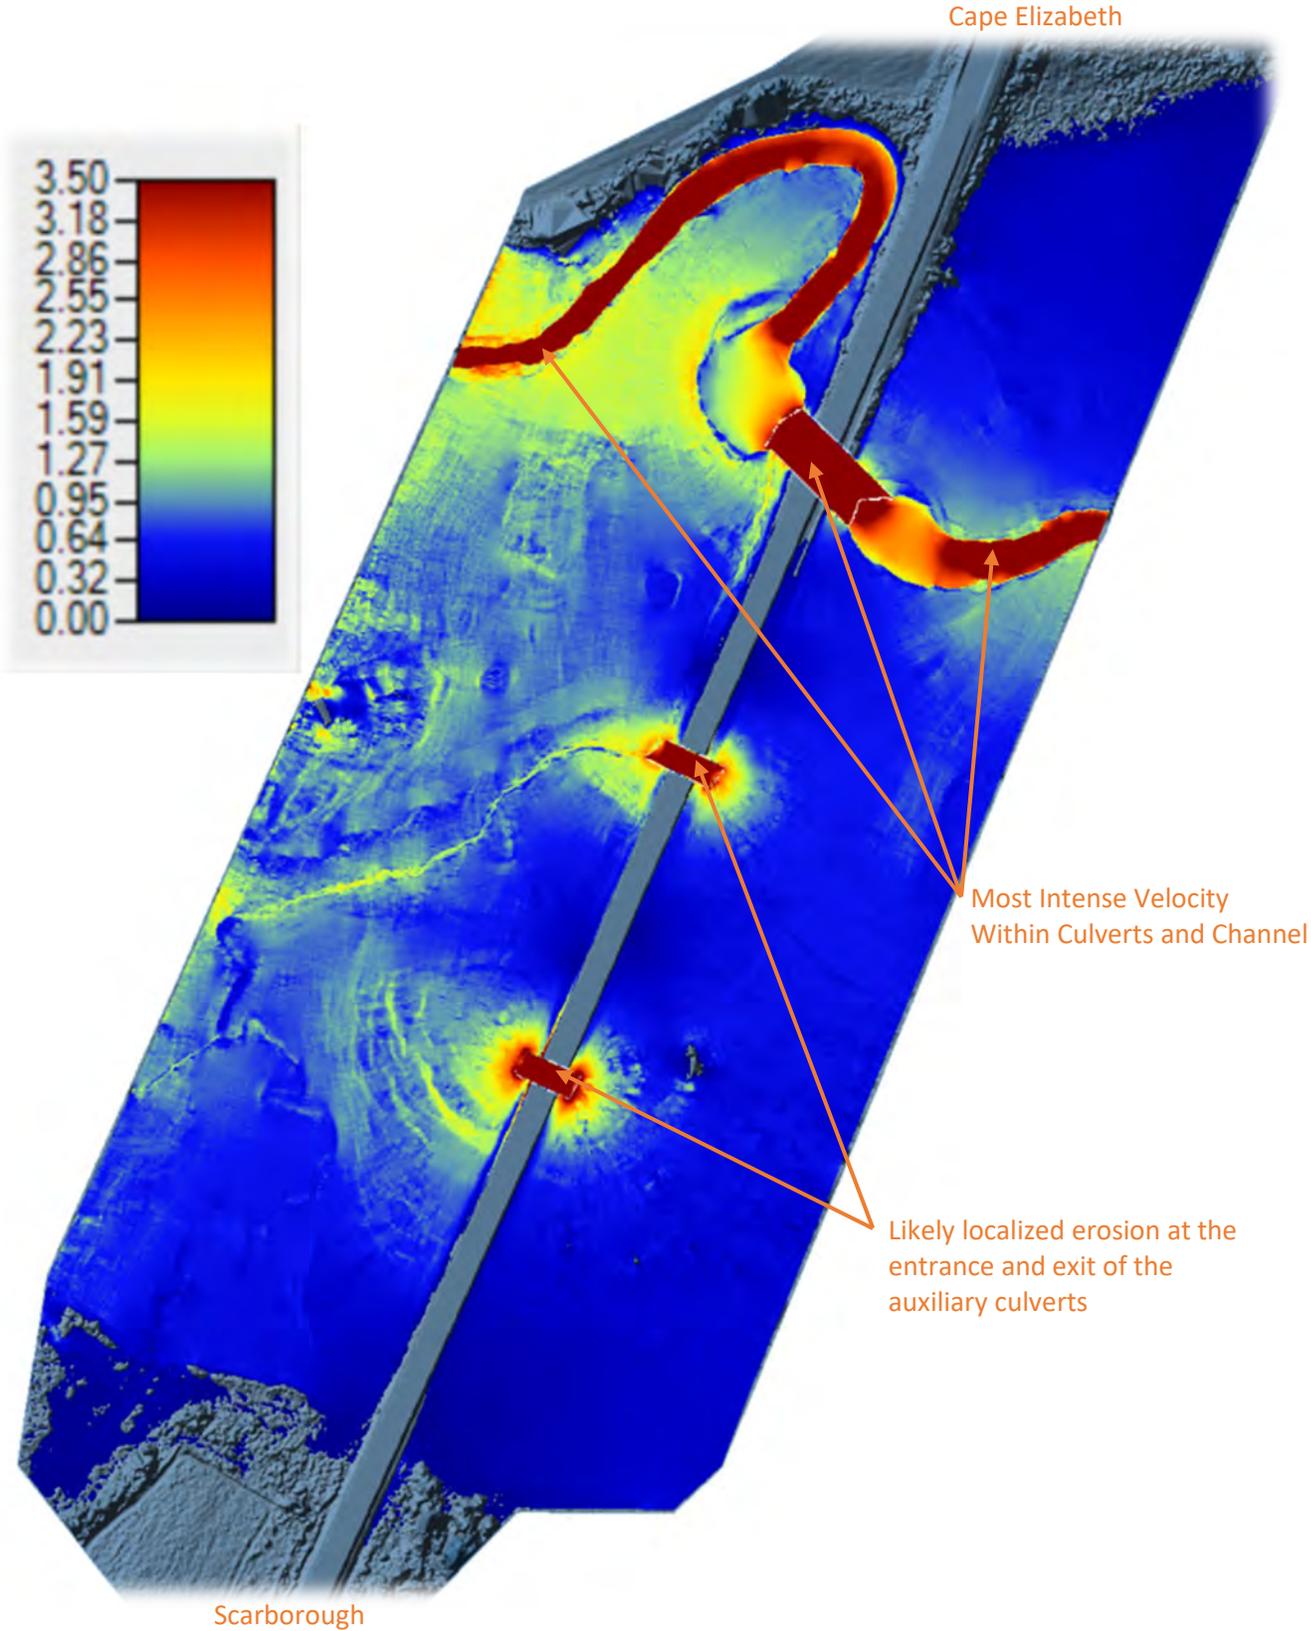
Figure 27 - Concept A - Peak Velocity Heat Map

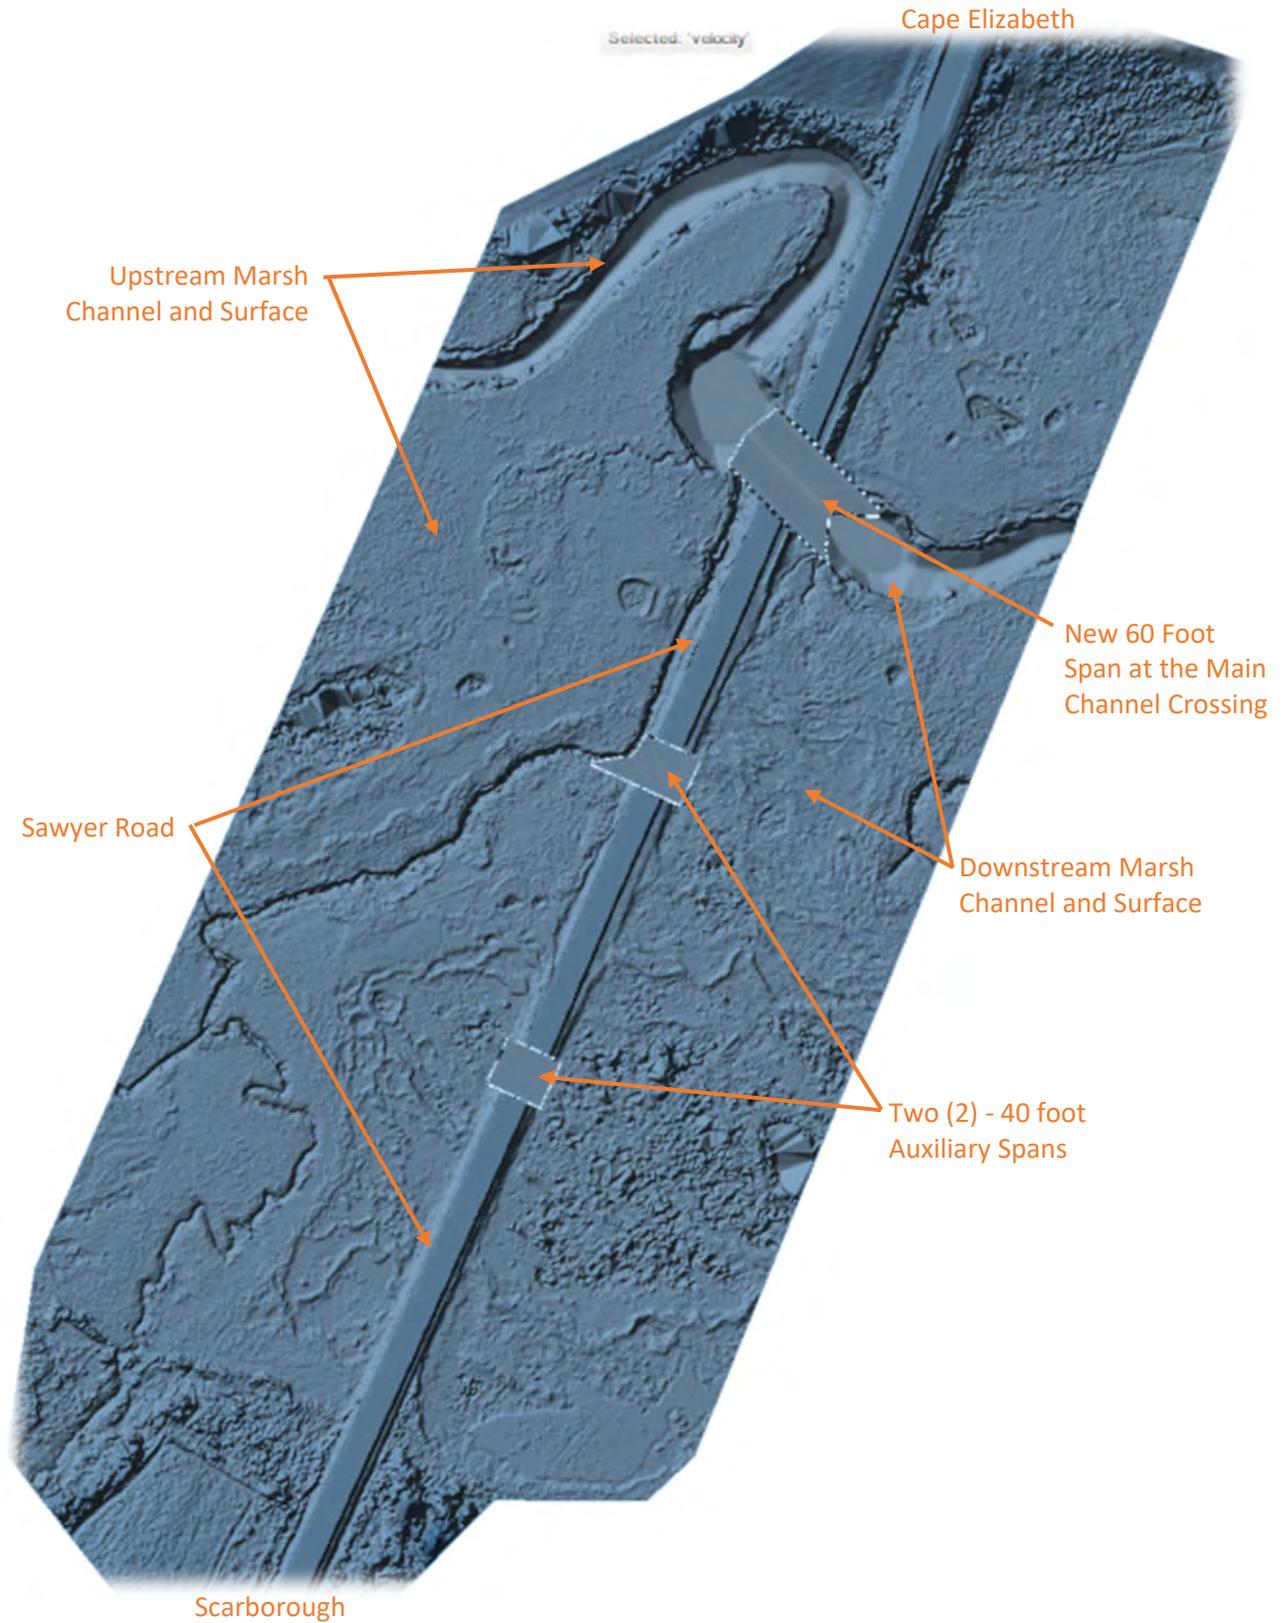
Figure 28 - Concept B - Two-Dimensional Terrain Model

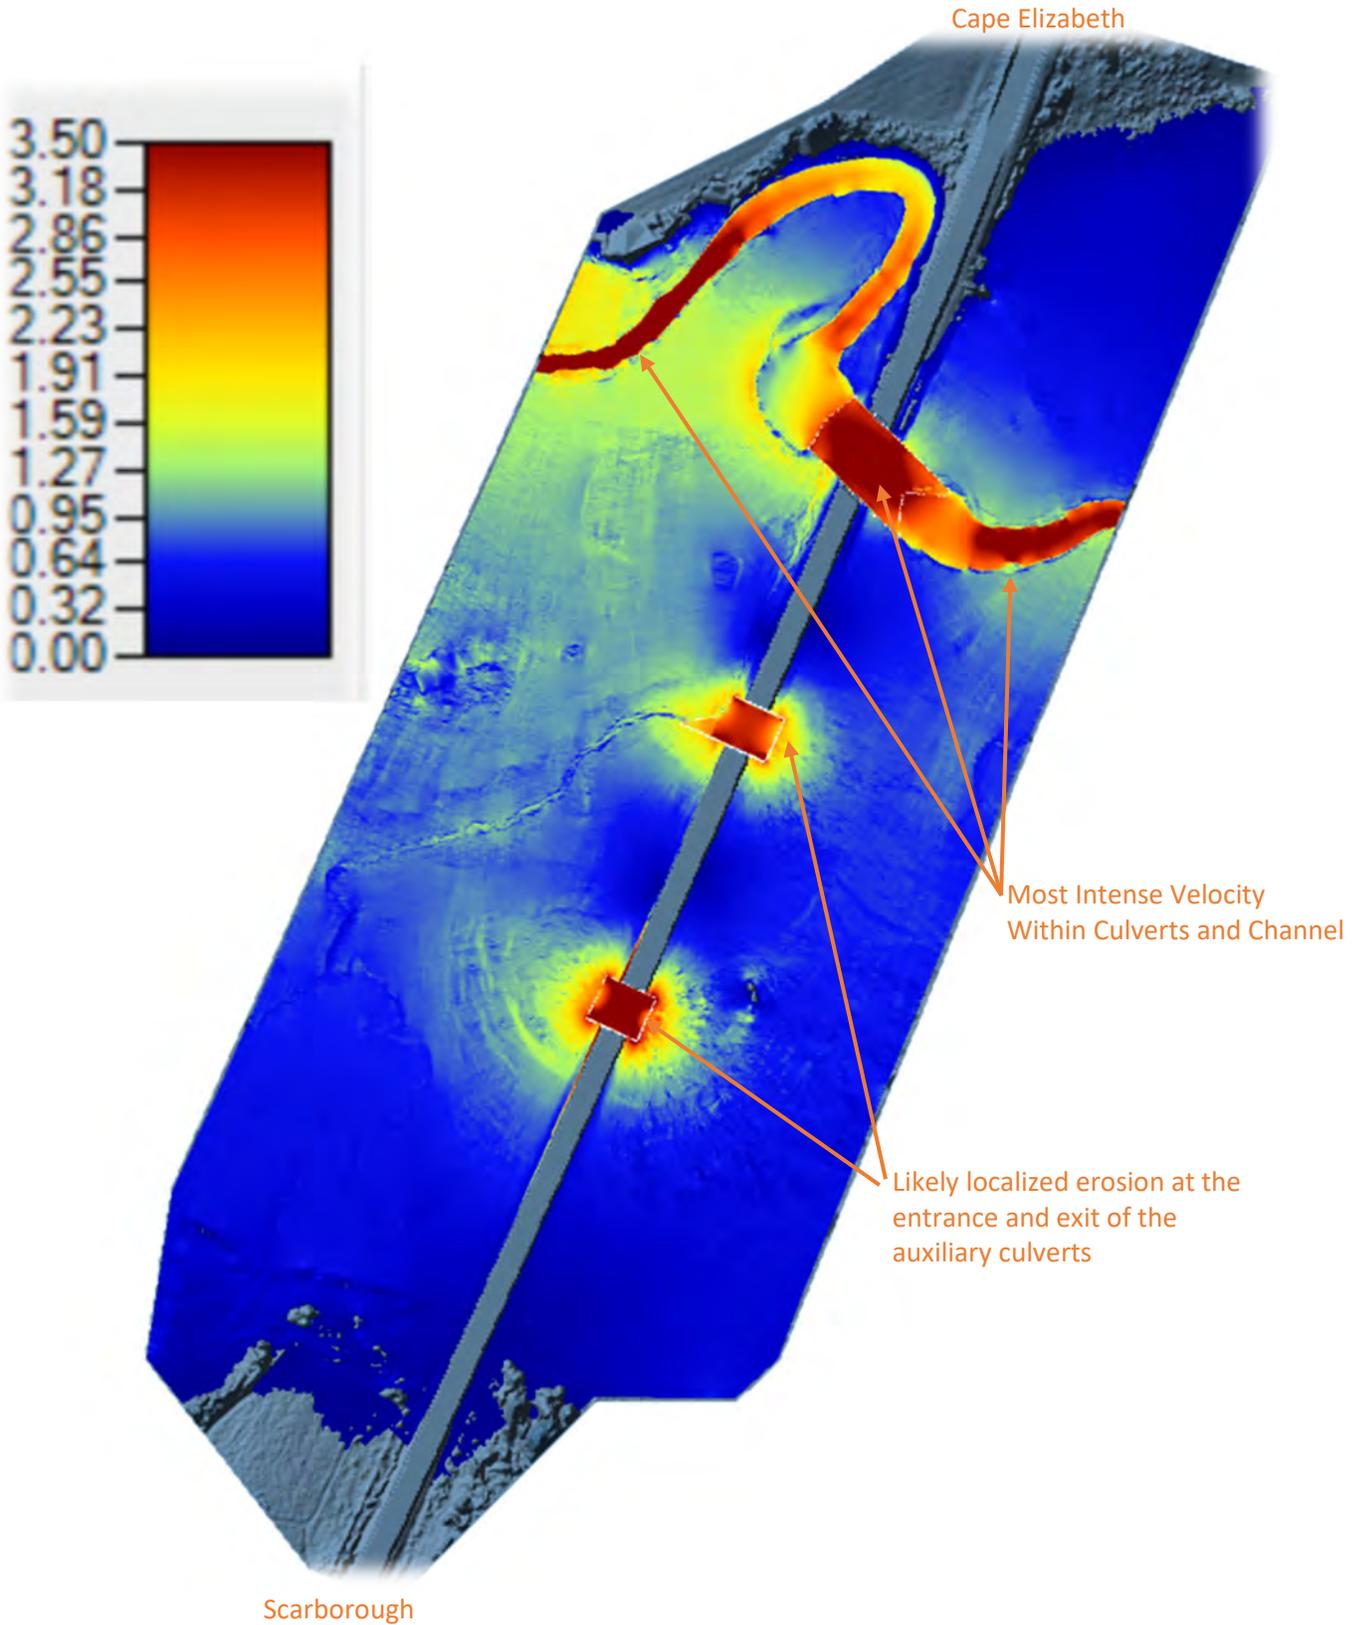
Figure 29 - Concept B - Peak Velocity Heat Map

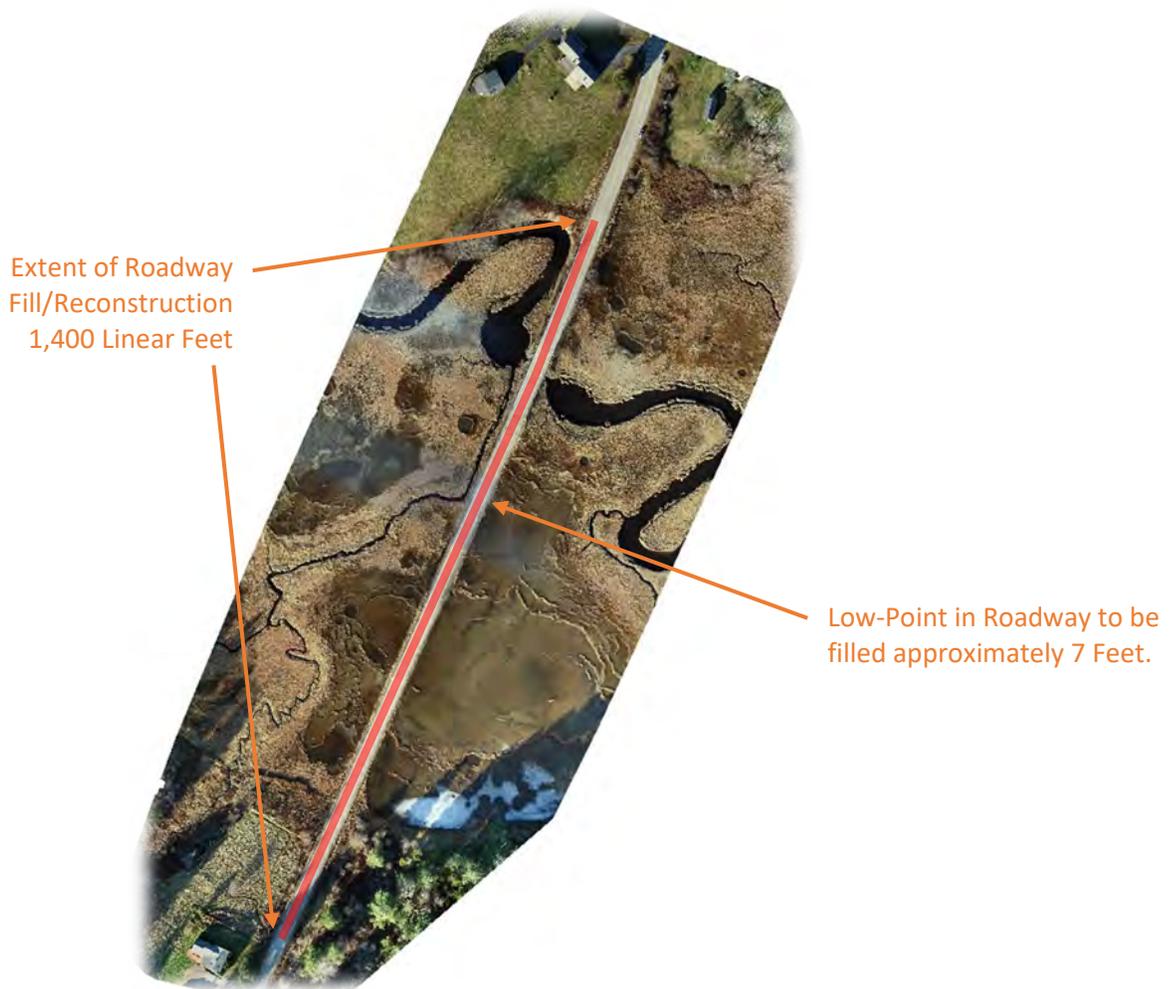
**Figure 30 - Extent of Roadway Reconstruction to Prevent Overtopping by the 50-year Tide (including the NOAA17 Intermediate Sea Level Rise)**

The paved width of the roadway is approximately 22 feet. A gravel shoulder of approximately 3 to 4 feet is also located on each side of the pavement. To maintain this width, while also raising the roadway (as described above), there will be a rather steep embankment (approximately 2 horizontal to 1 vertical) located on either side of the roadway. At its peak, this embankment may be as much as 9 feet tall. The total width of the roadway embankment measured to the toe of embankment on each side of the roadway may be as much as 65 feet. Based upon the MDOT record plans for Sawyer Road dated 1963, the road Right-of-way width is approximately 50 feet. This indicates that the embankment fill may extend beyond the limits of the Right-of-way.

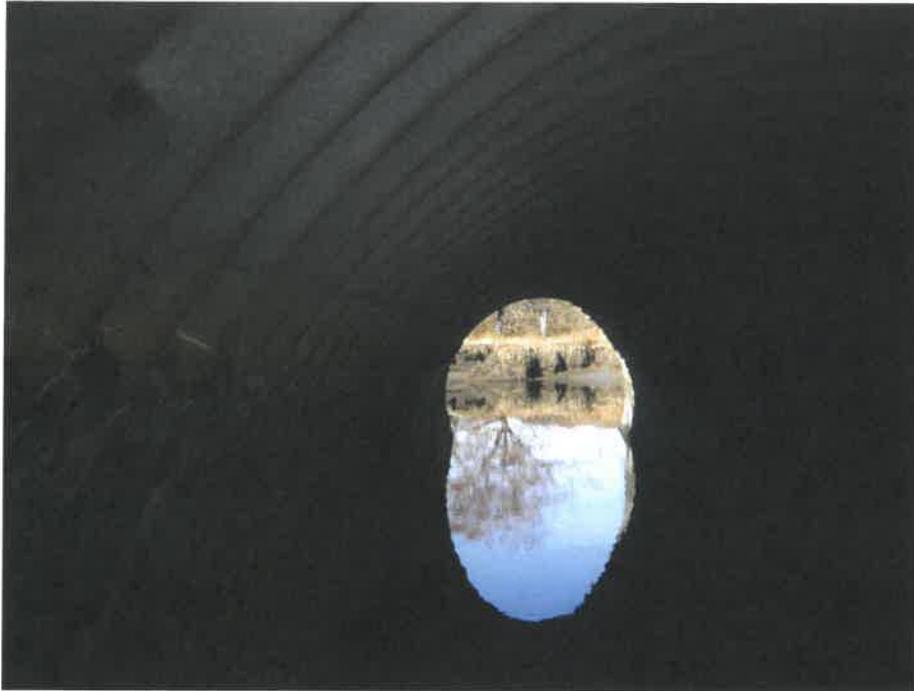
PHOTO 3

Description General view of barrel showing some corrosion along bolt line

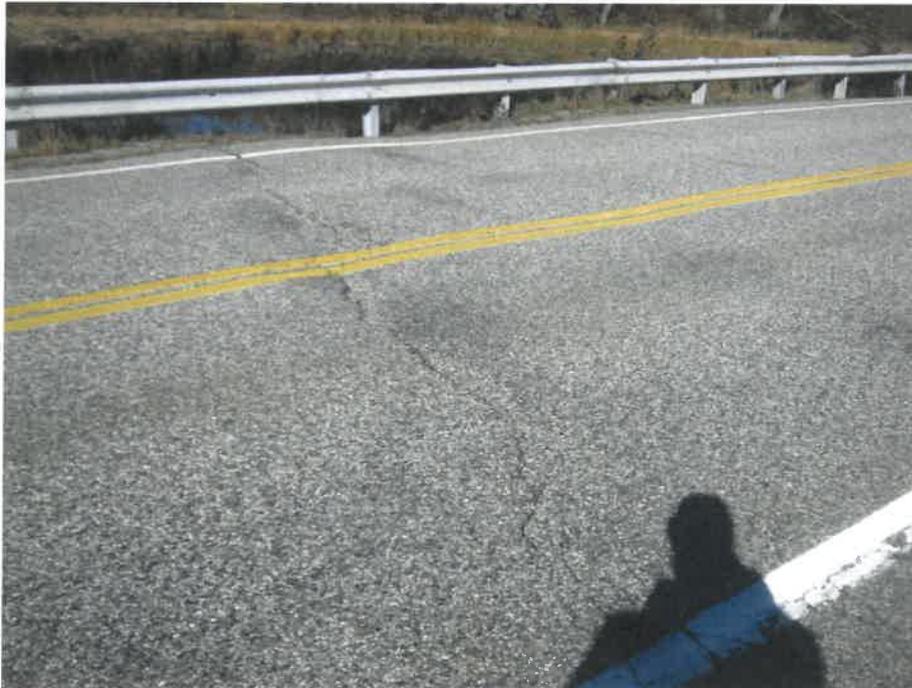
PHOTO 4

Description View showing crack in pavement above pipe

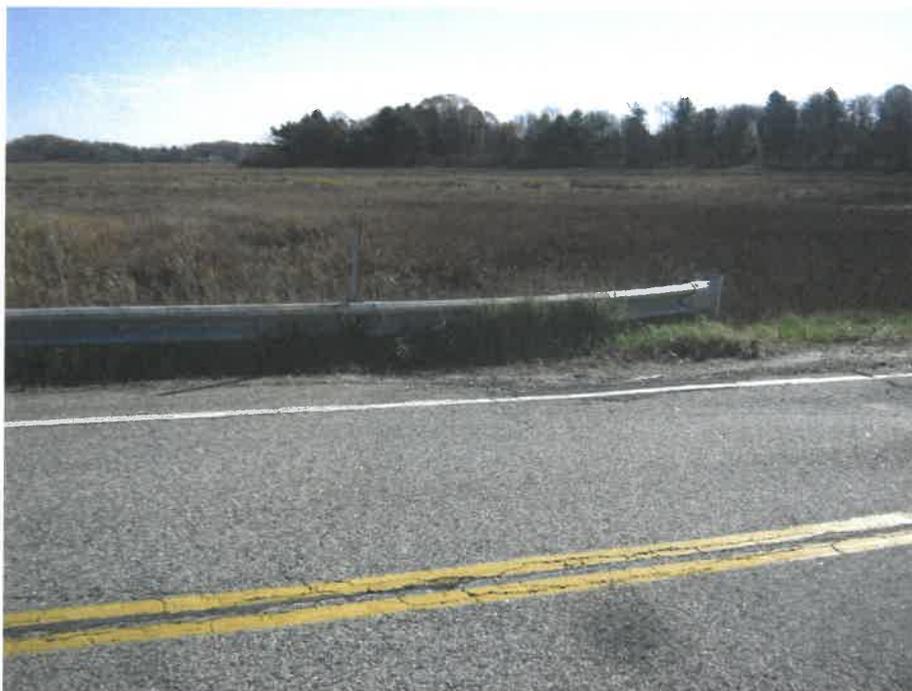
PHOTO 6

Description View showing low approach rail
