HISTORIC STRUCTURE REPORT

OVERVIEW GUIDE to Historic Structure Report

CROW ISLAND SCHOOL

WINNETKA,
ILLINOIS

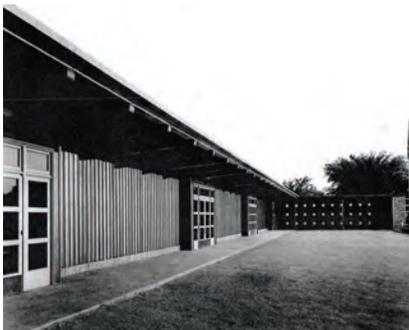
View of the east and south façades of the northwest wing and the play terrace, 1940 (Hedrich Blessing)

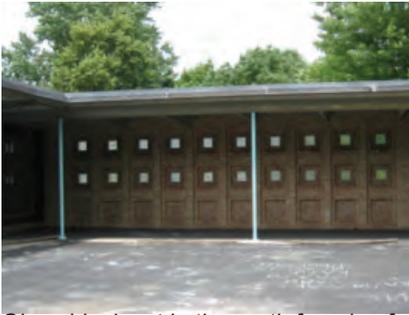
Glass block set in the north façade of play terrace, northwest wing (BHC)

The redwood boards are weathered and discolored due to water splashing up from the pavement.

A brick screen wall extends east of the main structure to create the north end of the raised play area. There are two rows of ten small square openings that have glass block inset into them. Beneath them is a third row of square openings that have been infilled with brick. Originally all three rows had glass block. The overhanging roof and pre-cast concrete rafters are in poor condition and have spalls and visible cracks.

- Glass block set in brick screens. Inspect joint sealant and provide necessary repairs. Replace any broken or damaged block units (p. 4-32).
- Signage - maintain bronze lettering and check anchoring (p. 4-34).
- Conduct repairs to flagpole structure, including rust removal and repainting (pp. 3-152, 4-35).

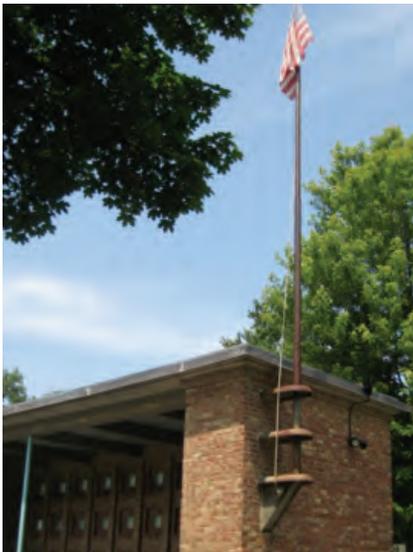
East Façade with Flagpole, Northwest Wing

Flagpole at east façade of northwest wing (BHC)

This façade consists of a simple flat brick end wall. On the south end there are three cantilevered semicircular supports and a substantial metal base bracket that encloses and supports a metal flagpole that extends approximately 24-feet high. The metal supports and the pole have lost their protective paint coating and rust has stained the concrete steps below. The brick wall is in good condition, but shows signs of repaired brick and mortar joints that may have cracked due to stress from the weight of the flagpole structure attached to the brick wall. Another consideration is that there could be rusted metal reinforcing components within the wall that will continue to cause oxide jacking and cracking at the wall. See "Flagpole" in the *Artwork* section (p. 3-152) and *Exterior Material Repair Recommendations* (p. 4-35) for a detailed description of the flagpole and work recommendations.

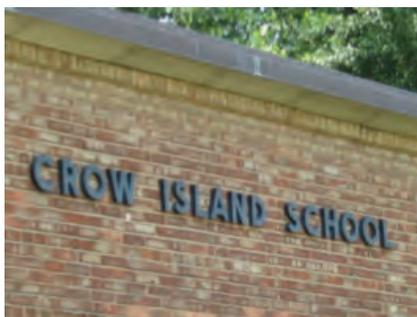
Contributing 1980 bronze signage on the north façade of the northwest wing (BHC)

This façade faces Willow Road and includes the school signage "CROW ISLAND SCHOOL" in block letters. The bronze lettering was a commemorative gift in 1980, from alumni, for the 40th anniversary.¹ The signage is not historic, but is considered a contributing feature on the façade. To the west of the signage is the backside of the brick screen wall mentioned at the south façade where there are two rows of ten small square openings that have glass block inset into them. Beneath them is a third row of square openings that have been infilled with brick. Originally all three rows had glass block.

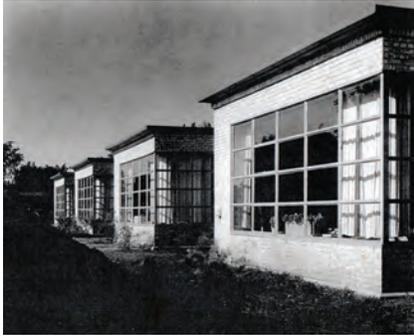
West Façade, Northwest Wing

Northwest wing classroom units with corner steel windows and inset courtyards, 1940 (Hedrich Blessing)

The four classrooms of the west façade (rooms 111-114) are identical classroom units that create a repeating design rhythm. Each classroom unit has an outside west-facing wall and three inner courtyard walls. The west end walls each contain a large multi-lite opening with 20 rectangular windows that occupy most of the wall and butt up against the southwest corner of the classroom. The inner courtyard’s south-facing façade contains a large multi-lite opening containing 16 rectangular windows that butt up against the same southwest corner. The appearance is one of two glass walls that meet at the corner. At the east end of this bank of windows is an entrance door topped by a transom window. This door accesses the classroom. Each courtyard’s west façade has a wide, horizontal opening with two rows of three steel sash (6-lites), with the six windows located above the workroom counters. A second window opening consists of a tall, narrow window where the restroom is located. A narrow brick screen shields this opening. The north-facing façades each have a flat brick wall. There is a singular rectangular louvered vent at the east end and whimsical colored terra cotta sculptures inset within a brick frame located in varied positions at the west end of the wall. (See the “ceramic sculptures” in the *Artwork* section (p. 3-148) for more information on the terra cotta wall sculptures). Brick failure was observed at the base of the doors. Each bathroom screen has had repeated rebuilding--often not matching the original design. Damaged brick was observed at corners.

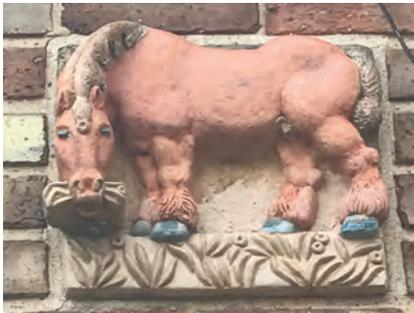
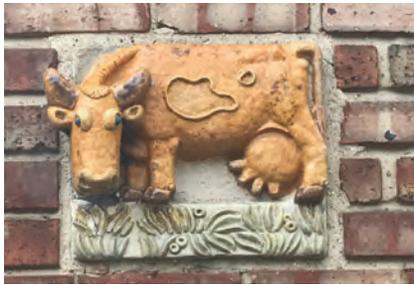
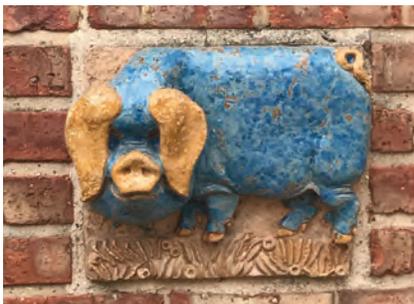
Terra cotta sculptures, designed by Lily Swann Saarinen at classroom 111 courtyard (Winnetka Public Schools Archives)

Highest priority façade repairs :

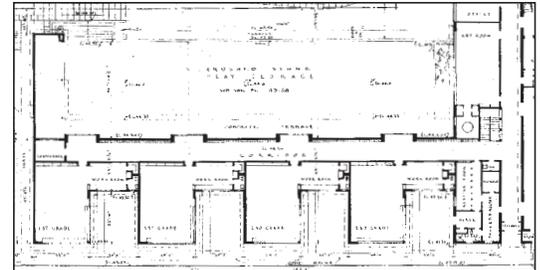
Northwest Wing Classrooms, Floorplan, 1939

As will be seen from the floor plan, each classroom is L shaped, the main part of the room being 22x32, and the work room off it 12x15. This work room can be separated from the main room by sliding doors. In the work room is a work bench overlooking the little yard. The bench is equipped with gas and electric outlets for cooking and science, and is also used for woodworking. Under it are storage cabinets for the things children are making. At the south end of the work room is a sink and drinking fountain. Beside this is a door into the individual toilet for the particular classroom.

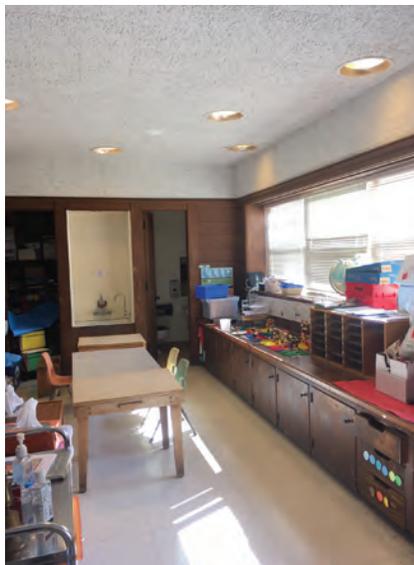
View of northwest wing classroom, 2017 (Winnetka Public Schools Archives)

Each classroom has its own characteristic color- red, yellow, green, or blue-as indicated by the color of the door through which one enters it from the corridor. This same color lines the cupboards and bookshelves, is on the steel mullions of the windows, and is picked up in the curtains. The general tone of each room, however, is that of light, natural-finished wood. This is true of the mottled asphalt-tile floors, of the tables and chairs, of the ground work of the curtains, and of the wood work generally. The wood paneling of the north wall, however, is a slightly deeper tone.

On the north wall is a blackboard with electric lights recessed into the ceiling above it and focused on it. Over the blackboard is a map rail on which charts and maps can be hung. The north wall, as indicated before, is paneled in soft pine, into which the children’s work may be thumb tacked without harm. The wood is in a warm natural finish with a light coat of wax.

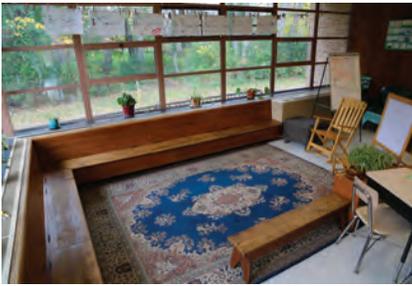
Former kindergarten classroom, 2016
(Winnetka Public Schools Archives)

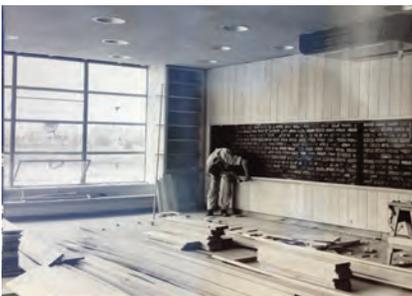
Classroom construction of pine plank walls and blackboard, ca. 1939
(Winnetka Public Schools Archives)

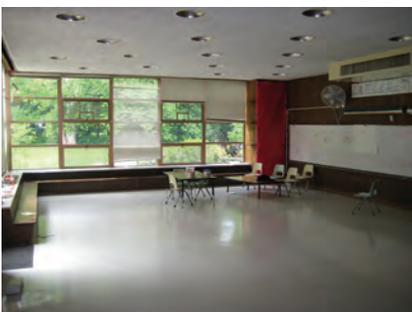
View of classroom, 2017 (BHC)

The wall between the classroom and corridor -the east wall in this primary wing- consists entirely of cupboards of various kinds-file drawers for the filing of the teacher’s records, deep shelves for large drawing paper, other shelves for various other types of school supplies, a coat closet for the teacher, and so on.

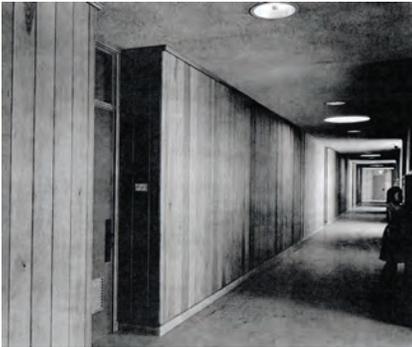
Vertical pinewood paneling lines the west wall of corridor 133, 1940 (Hedrich Blessing)

The corridor remains unchanged in original layout. Material changes include the replacement of the ceiling and skylights, floors, lighting, and lockers. Stair B also is unaltered.

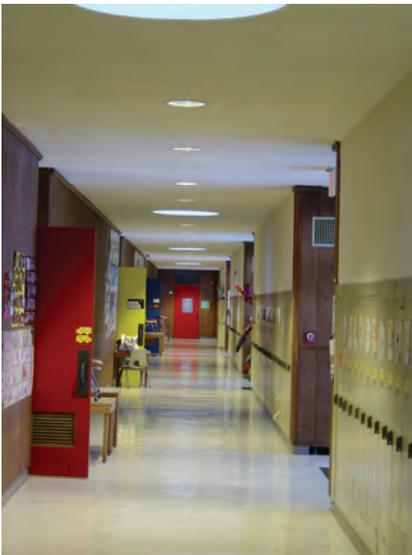
Extending north from the west end of the main corridor (corridor 147), the northwest classroom wing is composed of a single loaded corridor (corridor 133) with four classrooms (rooms 111-114) at the west wall. At the north end of the corridor is a small room (room 134) used as a psychology office. The east wall has exterior doors that open onto the exterior play terrace. Each set of exterior doors is set directly across from the classroom doors. Lockers are inset into the walls and are located throughout the corridor.

Northwest wing corridor, 133 (BHC)

The treatment approach *Preserve* is recommended for this area, except room 134. This treatment places a high premium on the retention of the space and all historic fabric through conservation, maintenance, and repair. It reflects a space's continuum over time, through successive uses and occupancies. Attention should be on preserving materials, features, spaces, and spatial relationships that together give the space its historic character.

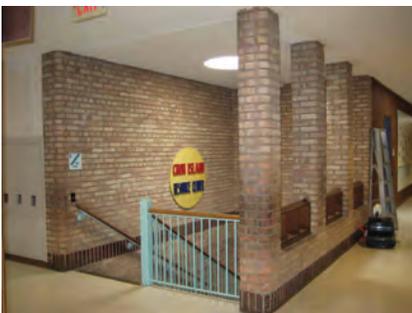
Stair B at the main level (BHC).

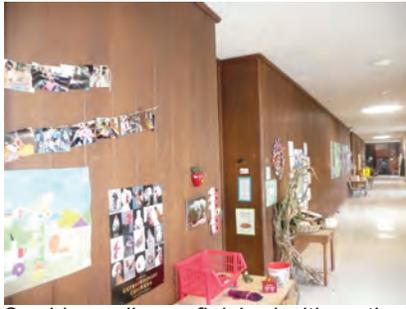
Corridor walls are finished with vertical pine planks with v-grooves (BHC)

Classroom walls have vertical pinewood paneling. Corridors are finished with brick walls, vertical pinewood paneling located at each classroom entrance, acoustical ceilings and resilient tile floors. Four skylights provide natural light in the corridor. Banks of lockers are located in the corridor between the classroom entrances.

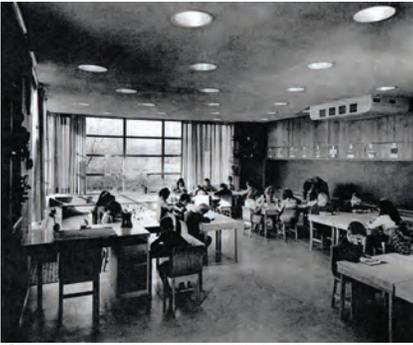
Classroom, 1940 (Hedrich Blessing)

The northwest classroom wing retains its original layout. Changes include new recessed lighting, replacement of ceiling and floor finishes, and installation of new lockers in the corridor. Many blackboards have been replaced with white boards, but the original wood trim and chalk rails remain. Cabinetry and shelving have been altered to varied degrees. Limited doors have been replaced. Original hardware is missing or has been replaced on cabinets and doors.
