**EVALUATION OF SELECTED TREES
AT THE**

ALDERWOOD MIDDLE SCHOOL SITE

**17500 Larch Way
Lynnwood, WA 98037**

September 19, 2014

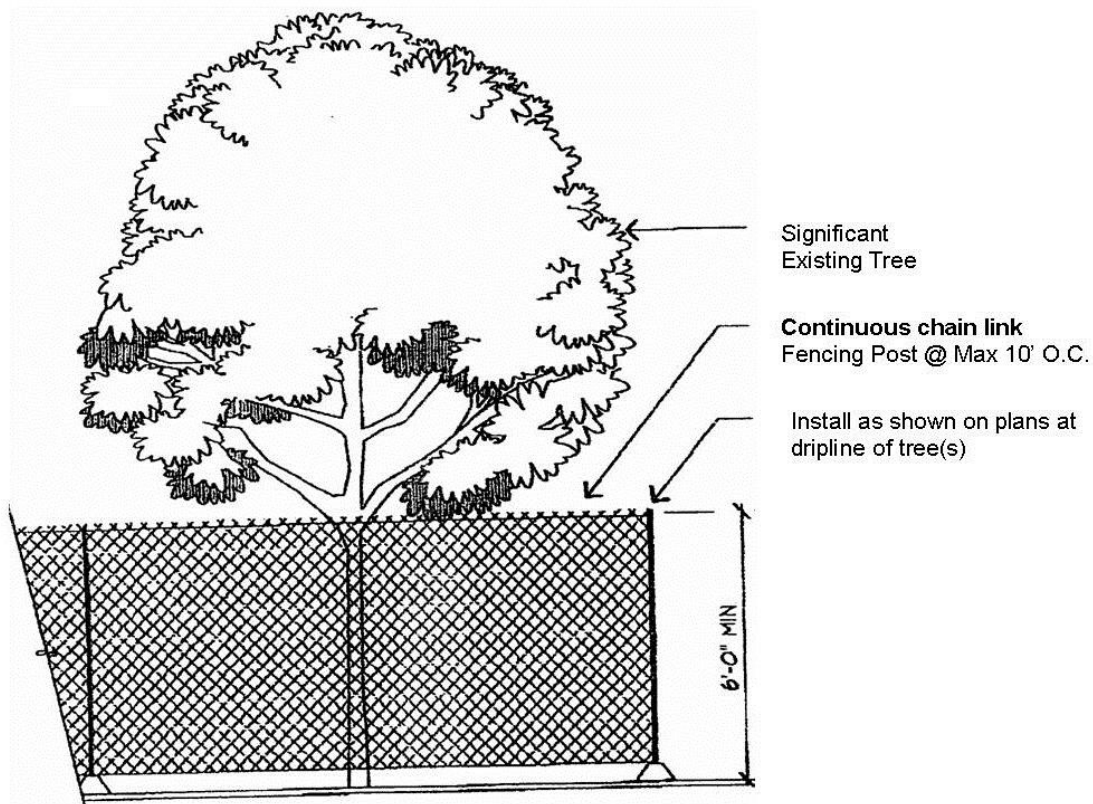
Six-foot high temporary chain link fence shall be placed as shown on plans. Fence shall completely encircle tree(s). Install fence posts using pier blocks only. Avoid driving posts or stakes into major roots.

Make a clean straight cut to remove damaged portion of root for all roots over 1" in diameter damaged during construction. **All** exposed roots shall be temporarily covered with damp burlap and covered with soils the same day, if possible, to prevent drying. If not possible, burlap must be kept moist at all times.

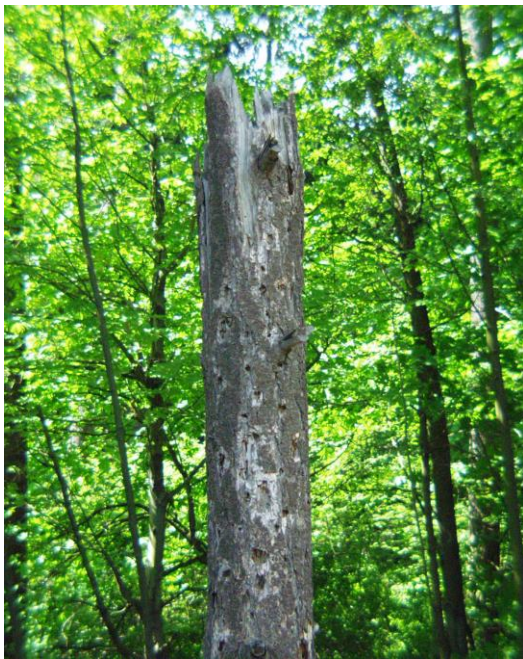
There are occasions where hazardous trees need not be completely removed. Shortening is the preferred methods in these types of areas rather than complete removal. Standing dead trees, also known as “*vertical structure*” in forest ecology terms, provide important wildlife habitat. Recent studies at the University of Washington have shown that the third most significant reason for the decline of songbirds in the Puget Sound region is the lack of standing dead trees. (The primary reason for the decline of desirable wildlife is loss of habitat. The second reason is predation by dogs, cats, Grey Squirrels, and Opossums.)

These studies reveal that as many as 54% of desirable urban wildlife utilize standing dead trees or nurse logs on the ground in one or more important life cycle. For instance, Black Capped Chickadees must excavate a new cavity every spring in order to successfully mate and produce a brood of off spring.

The opportunity exists here to remove the dangerous portions of these trees and leave the snags for wildlife. You can also place trunk sections carefully on the ground as nurse logs. The logs, if in contact with the ground, soak up moisture and release it slowly throughout the summer. This supports plants and animals in the immediate area. Brush piles strategically place for birds and mammals to use as safe areas also have important wildlife benefits. These two measures have the added

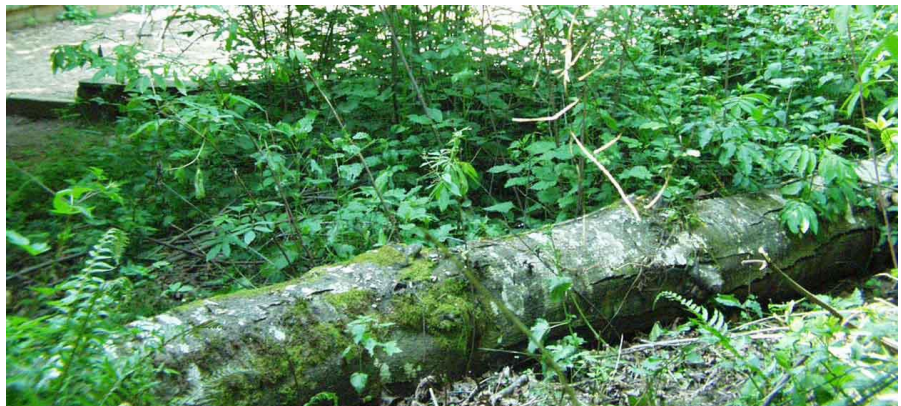
The tree service selected can spend a few extra minutes on the top of each snag to make the cut look like it was snapped off in the wind—jagged and irregular. This enhances the aesthetic appeal of the tree.
