# Spring-Ford Area School District

## Investment Grade Audit Report

**Submitted by:**  
Johnson Controls, Inc.

**August 2022**

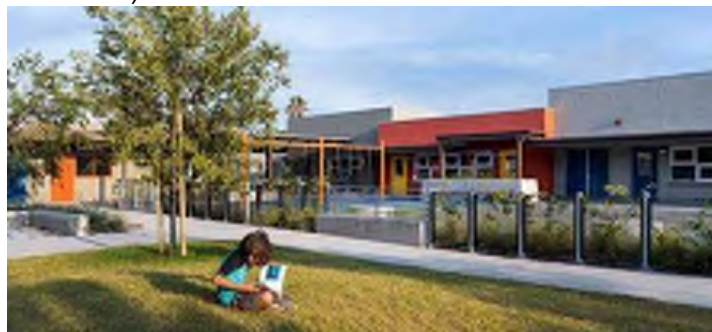
Elementary School with window upgrades. Similar materials to be used for Limerick ES upgrades

This measure will replace all windows at Limerick ES. Windows at this building are over 30 years old and showing their age. This project will provide new windows that match the school district’s standard specification. New windows will be more energy efficient and should provide a level of aesthetic renewal to classroom spaces. There are also advantages to completing this project in concert with proposed HVAC upgrades (i.e. construction can be completed in one summer vs. multiple summers).

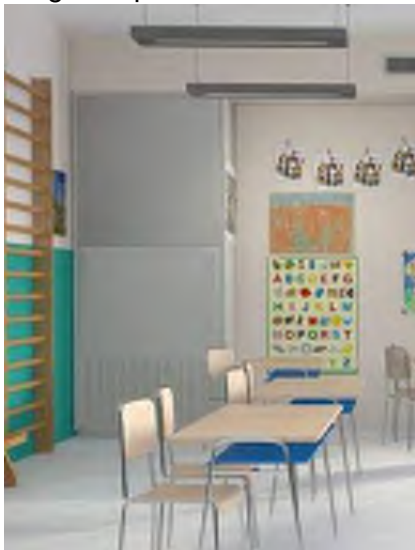
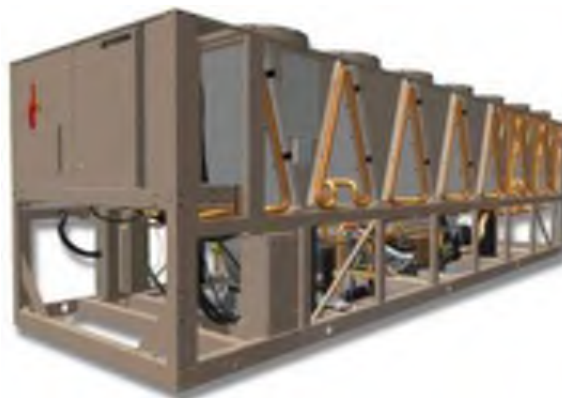
The following is depiction of new classroom unit ventilator and downsized chiller to be installed.

Existing classroom unit ventilators will be replaced with ducted vertical unit ventilators capable of heating and cooling; they also include fresh air ventilation with built-in energy recovery wheels capable (via energy recovery ventilation) of reclaiming nearly 70% of the energy from exhausted air. The new system is a vast improvement over the old ventilation system, which did not recover energy from outgoing air. The existing ventilation method not only created hot and cold spots within the space, but it also significantly increased the load on the chiller and boiler systems. The upgraded system provides even distribution of conditioned air across the classroom and works to eliminate any humidity issues in the classroom. Along with the unit ventilator upgrades, AHUs serving major spaces will be refurbished to improve their longevity and continued service.

By taking on a comprehensive HVAC upgrade for the classrooms, the building heating and cooling requirements will also change. To meet the new reduced cooling demand the existing 190-ton chiller will be right-sized to meet the new cooling demand of the building (new chiller is currently sized to be 160 tons; design to be finalized). This drives additional energy saving potential and critical infrastructure renewal.

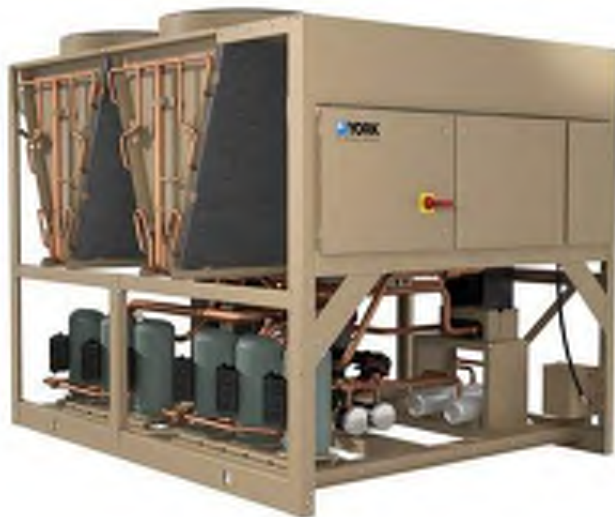
A chiller and boilers similar to the images below will be installed as part of the scope at Royersford ES.

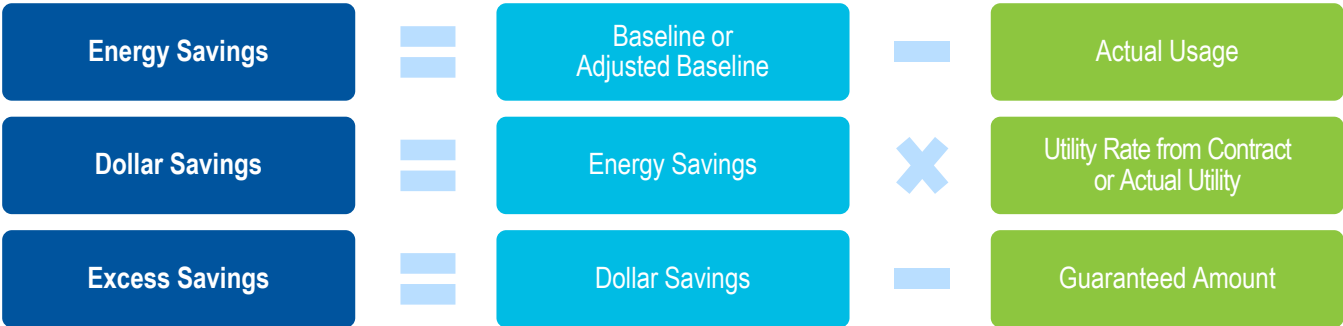
This figure shows how we calculate energy savings, dollar savings, and excess savings.

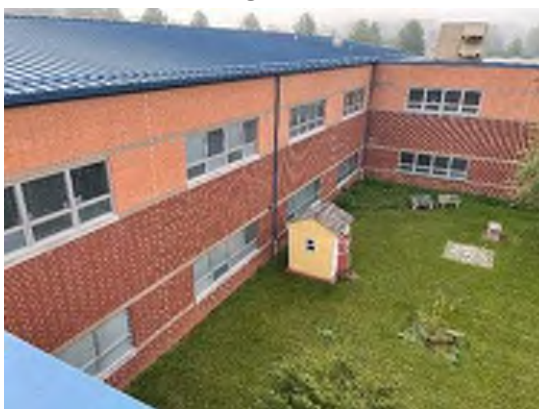
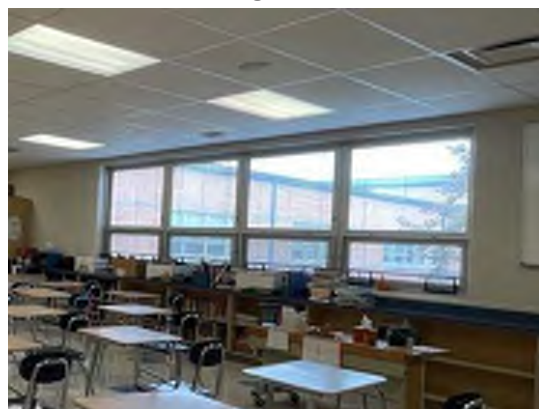
The windows that are installed are double-pane, mostly hopper style in aluminum frames. Windows in the building are in good condition and are shown in Figures 1 and 2.

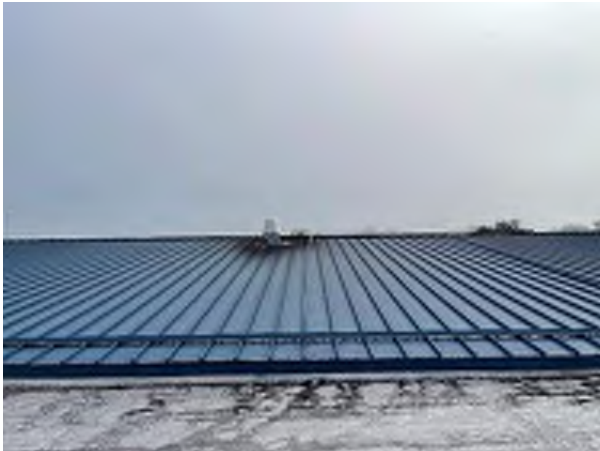
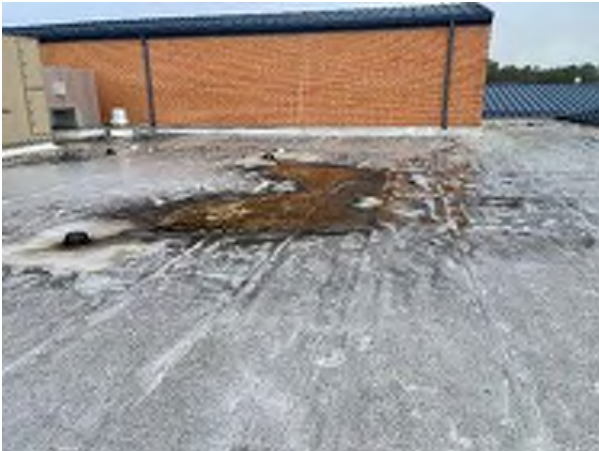
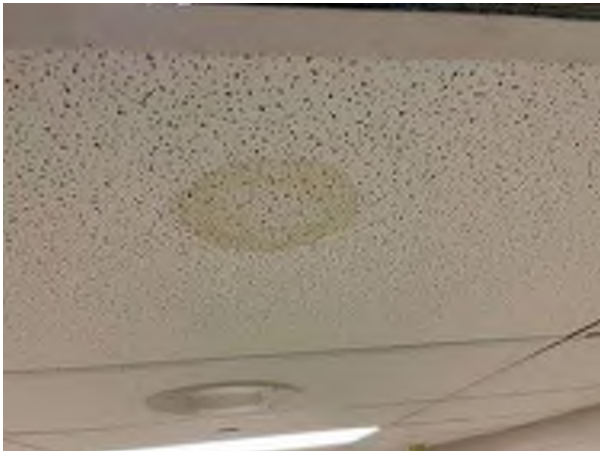
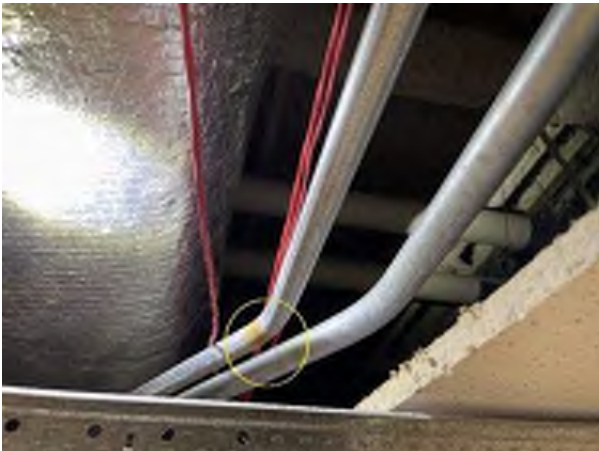
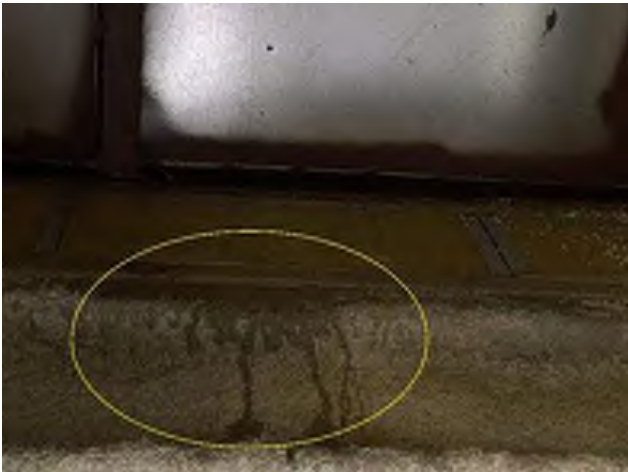
The roof installed is mostly pitched metal with small sections of flat roof for mechanical equipment. From visual inspections, the pitched metal roof appears to be in good condition and

the flat sections in fair condition with water pooling observed at the time of the audit. One instance of a roof leak was also found during the audit and are shown in Figures 3 through 7.

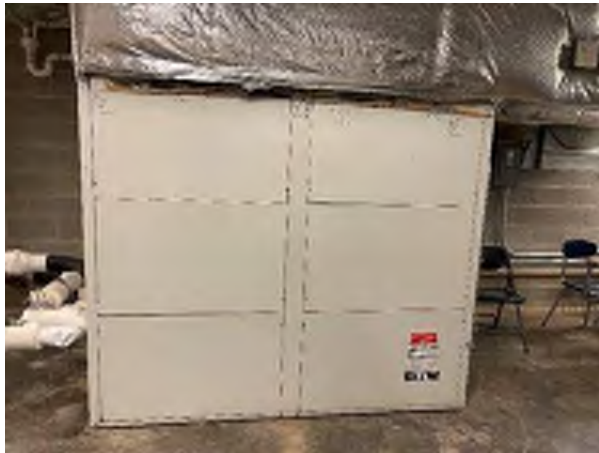
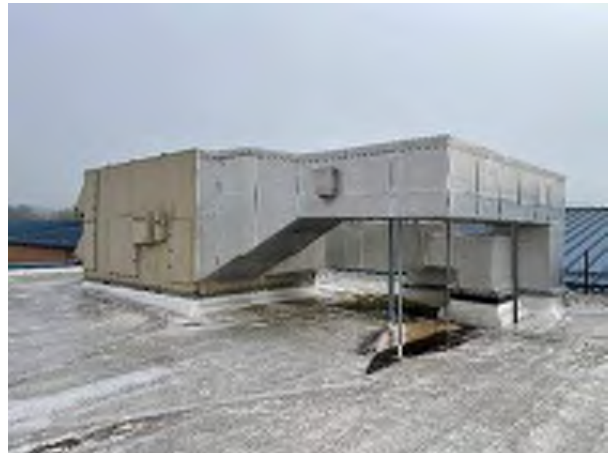
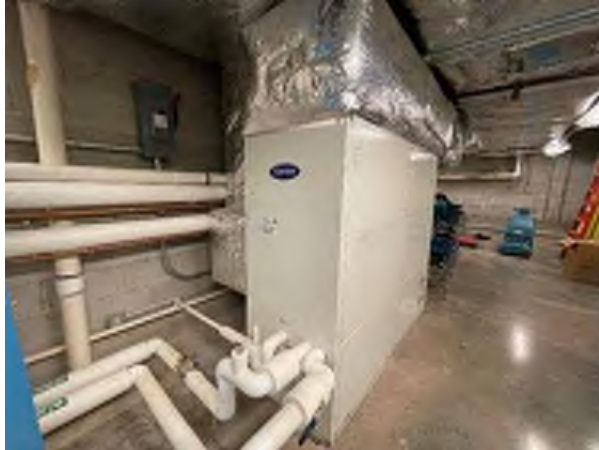
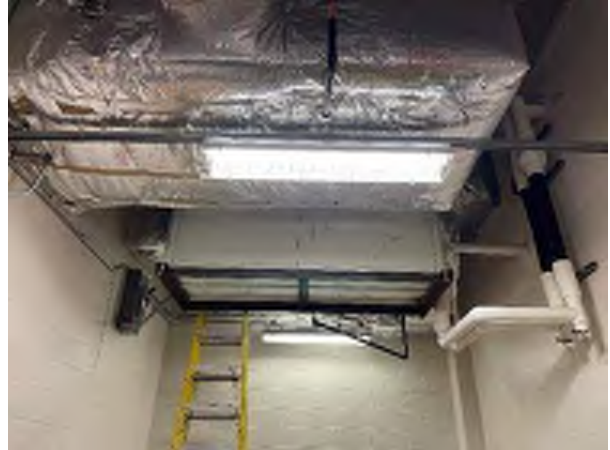
The building's ventilation is primarily through mechanical ventilation. The building is served by heat pumps, heat recovery units, and unit heaters. The units that serve large spaces and can vary the amount of air flow to these spaces for energy efficient operation. These systems work in conjunction with relief vents and exhaust fans in the building to ensure proper air circulation. Figures 8 through 11 show the different type of installed HVAC systems.

Many of the heat pumps in the building are located in the ceiling and are identified by markings on the ceiling tile grids. Larger heat pumps are located in mechanical rooms and is shown in the above pictures.

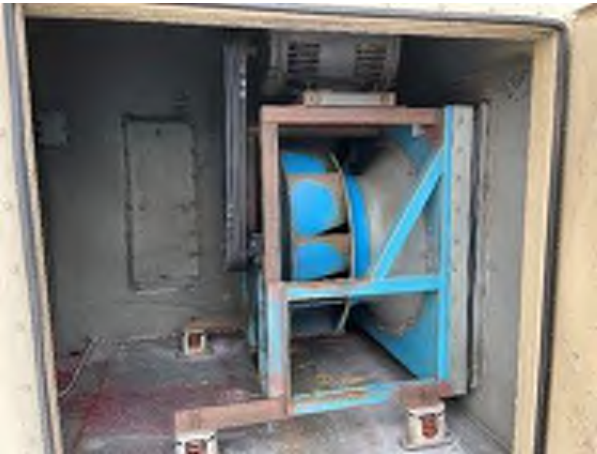
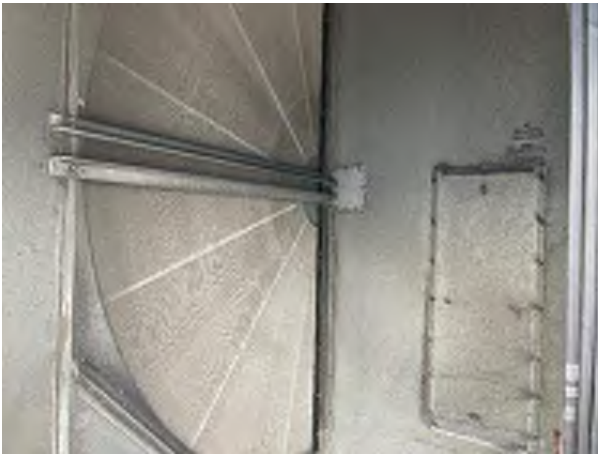
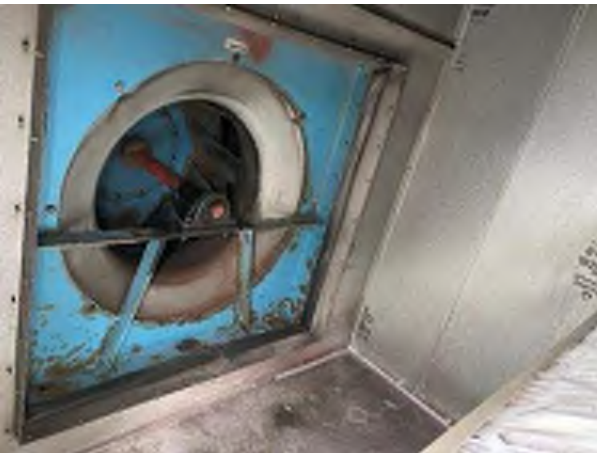
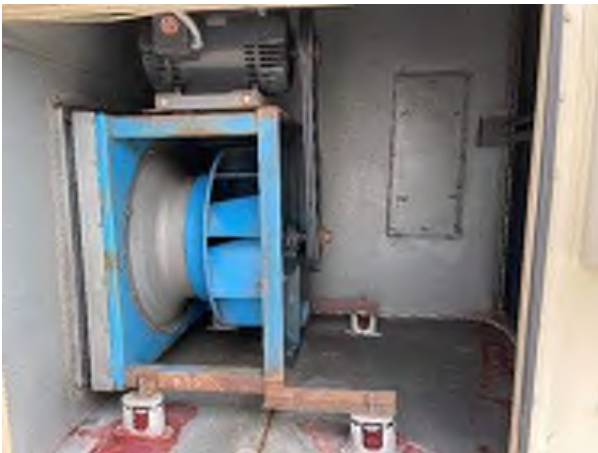
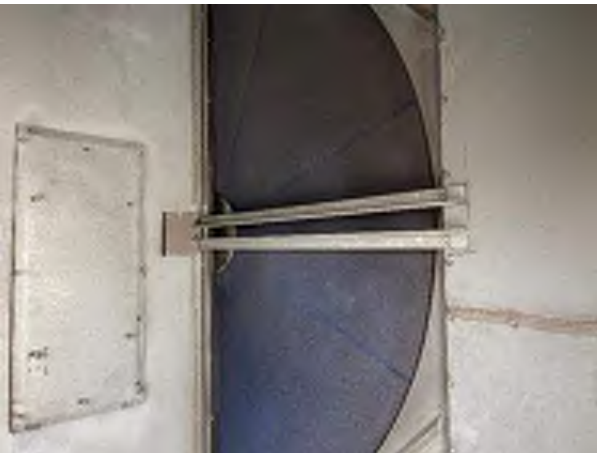
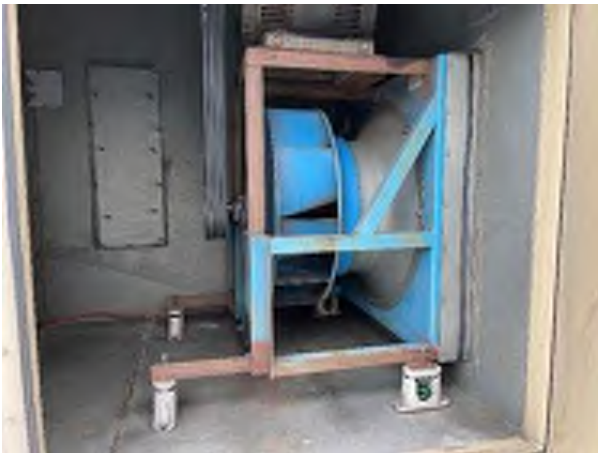
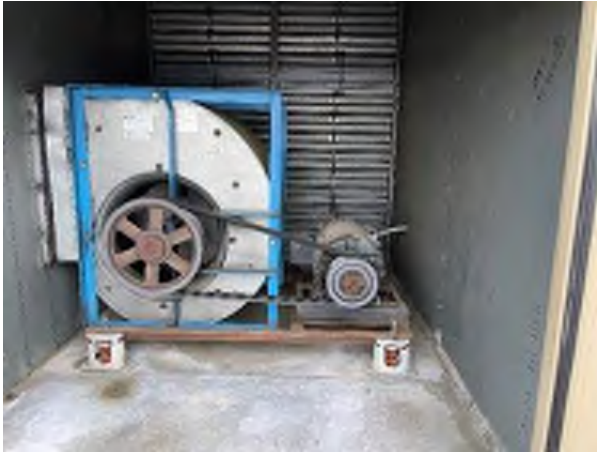
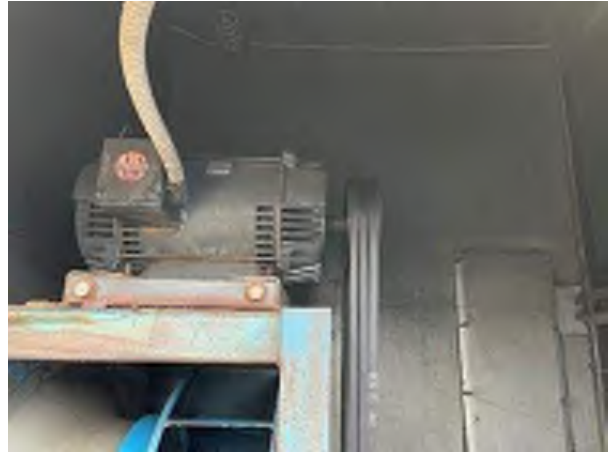
Many of the equipment are in good condition given their age. A sample of the heat recovery units were opened and inspected. These units will benefit from deep retro-commissioning. Opportunities to restore system performance and increase equipment including verifying motor shaft alignments and cleaning heat wheels inside the unit. Audit observations are shown in Figures 12 through 19.

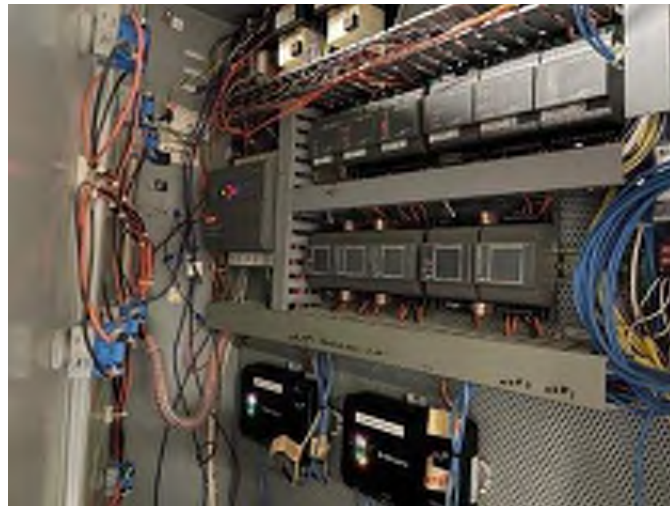
Figure 20

The HVAC equipment installed is controlled by a DDC JCI Metasys system located in the main mechanical room shown in Figure 20.

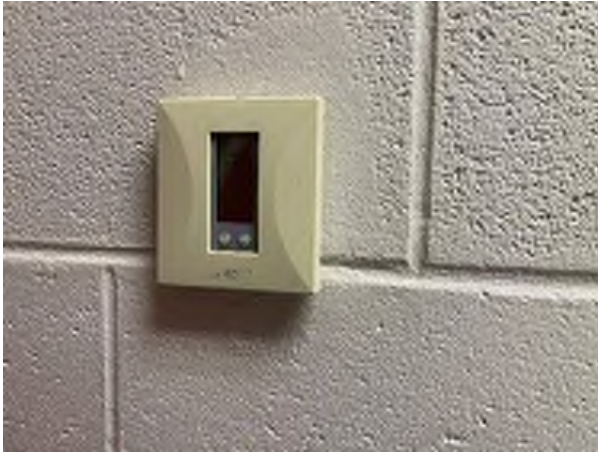
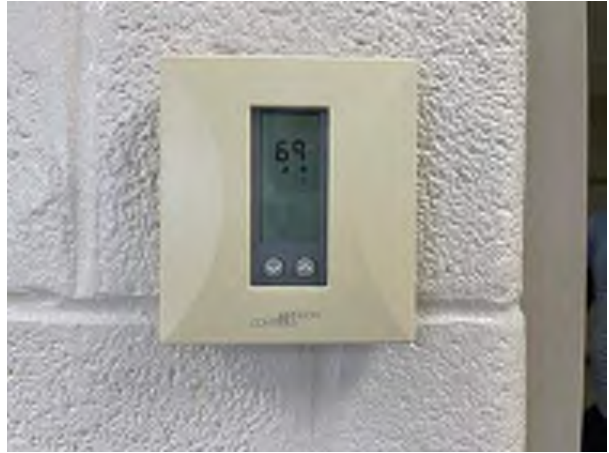
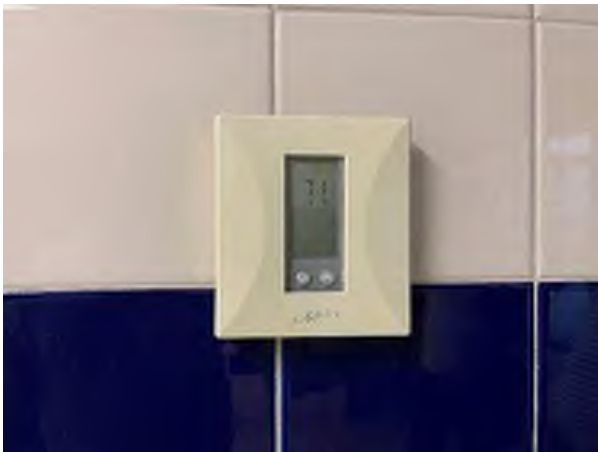
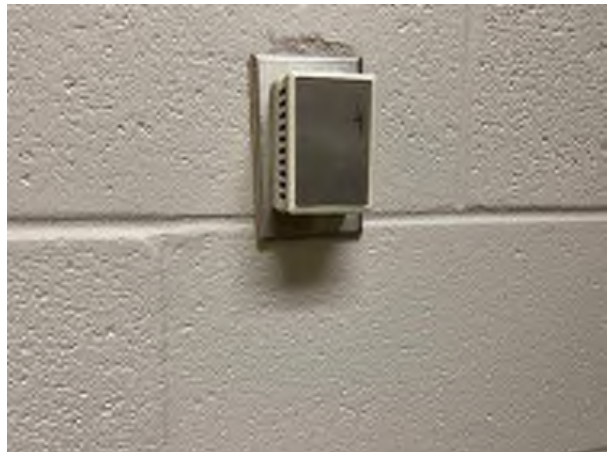
Figures 21 through 24 show a sample of thermostats that are installed in the building. The thermostats are mostly of similar vintage. It is recommended the existing thermostats should be considered for upgrade to standardize to smart thermostats. New smart thermostats also have additional built-in features that allow for deeper space setbacks and efficient space comfort management.

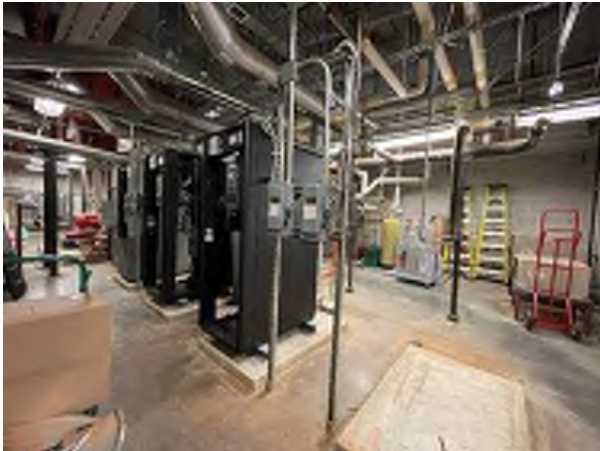
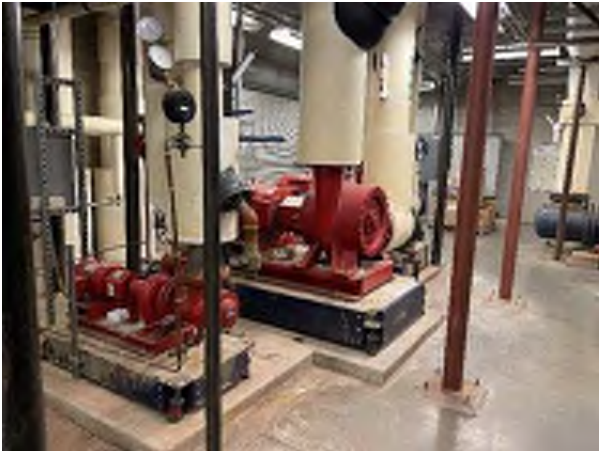
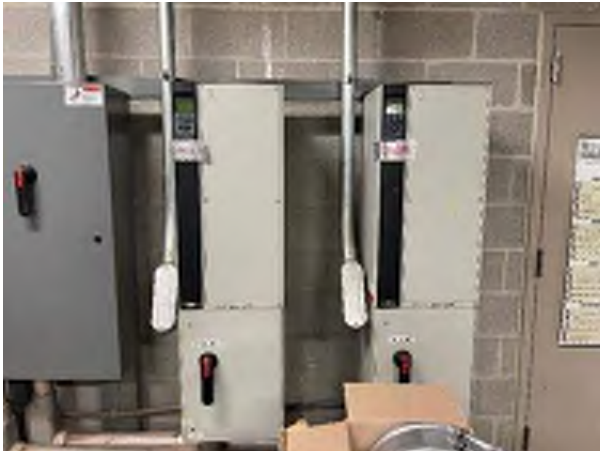
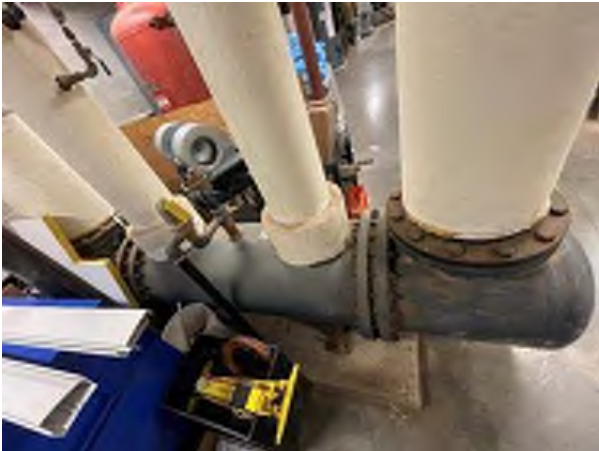
The building is served by a geothermal system with a boiler plant for supplemental heating. During the time of the audit, the boiler plant was in the process of being replaced. The overall system is generally in good condition and is shown in Figures 25 through 28. The existing circulation pumps are high efficiency and the volume of water circulating in the loop is varied through the use of variable frequency drives (VFDs). Air conditioning is provided to most spaces of the building by the ceiling installed water source heat pump systems.

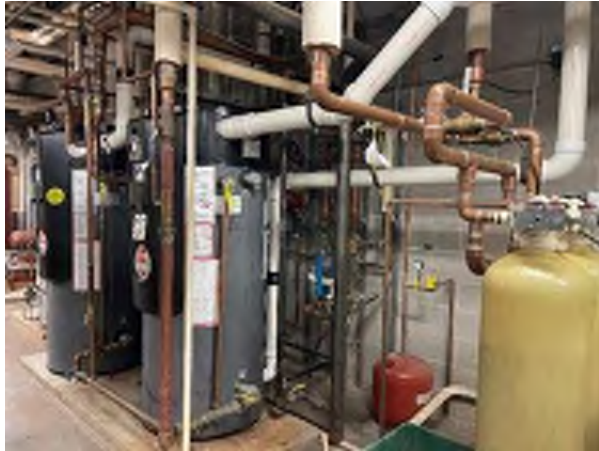
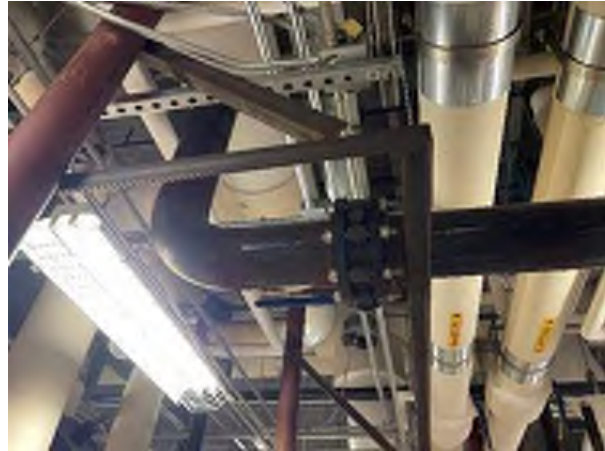
Pipe, valve, and impeller insulation opportunities were identified during the audit and shown in Figures 29 and 30. Insulation opportunities were also identified on exterior duct work on which existing insulation had deteriorated, shown in Figure 31.

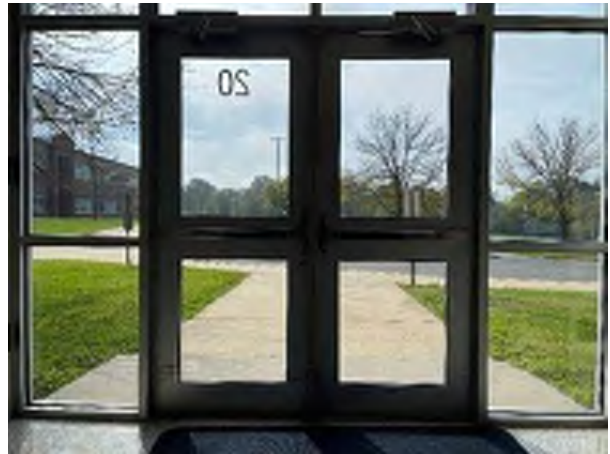
Figure 33

There is generally a tight envelope in the building with minimal air gaps observed. Some opportunities were identified during the audit and are shown in Figures 32 and 33. The useful life of weather-strips will vary with usage of the doors they are installed on. The existing door weather-strips were most likely installed when the building was built in 2004. They should be considered for replacement to reduce the air gap between door and frame and thereby reduce energy loss.

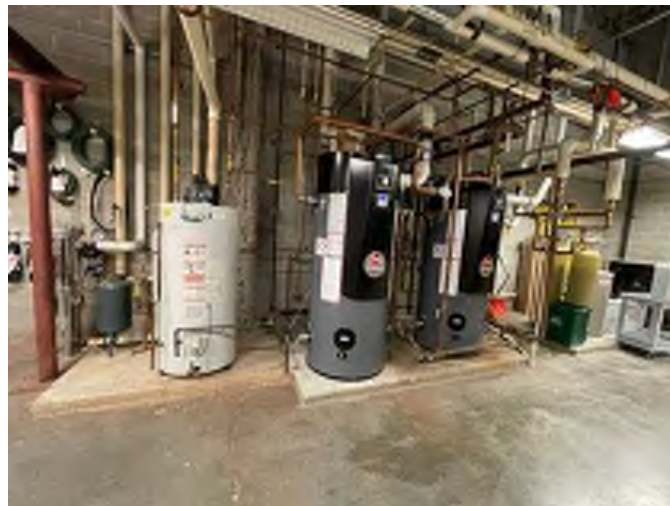
Figure 34

Domestic hot water is supplied to the kitchen and restrooms by three domestic hot water boilers; one AO Smith boiler rated at 80,000 Btu/hr and two Rheem boilers rated at 500,000 Btu/hr each. All three boilers are located in the main mechanical room and shown in Figure 34.

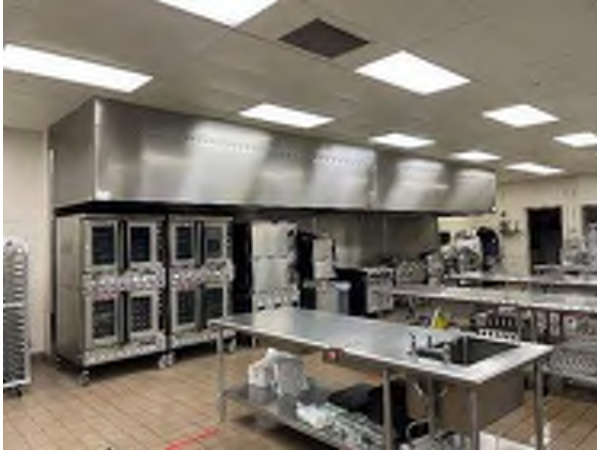
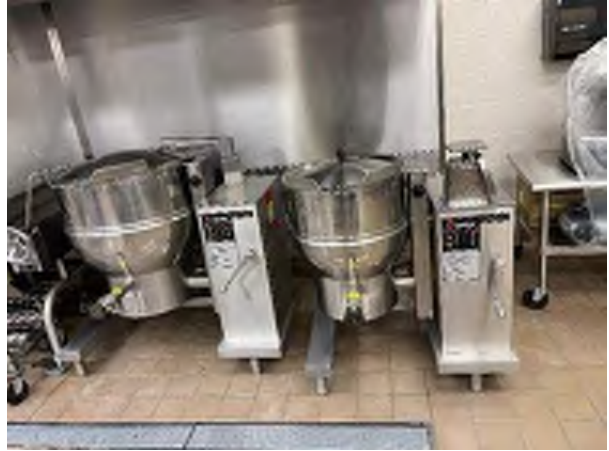
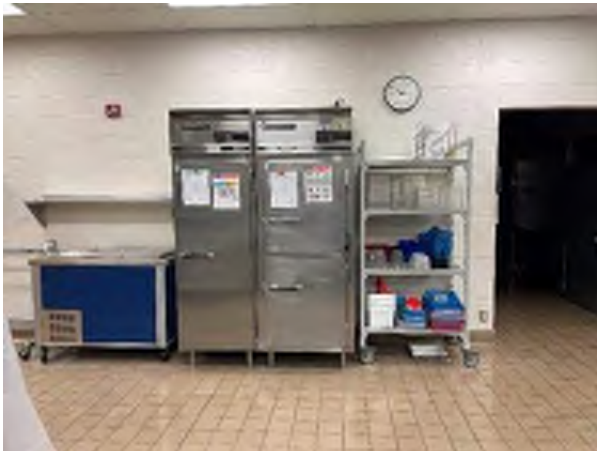
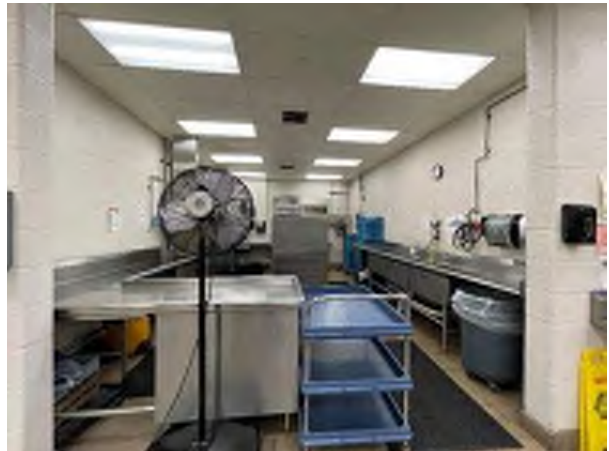
The building has a full functioning kitchen including a stove, pot/prep sinks and large refrigeration units. The kitchen exhaust hood is used each day when the school is in session, typically 7am to 2pm.

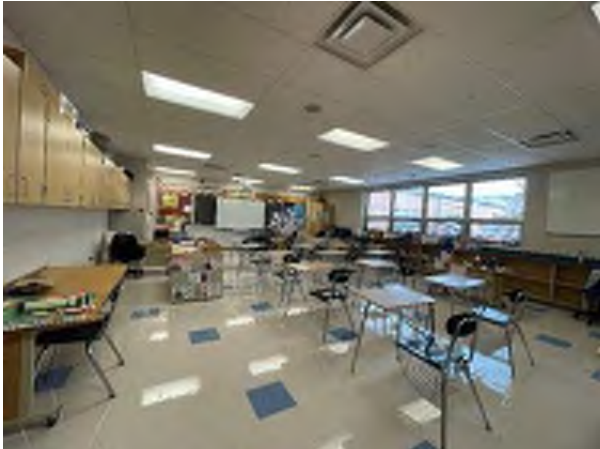
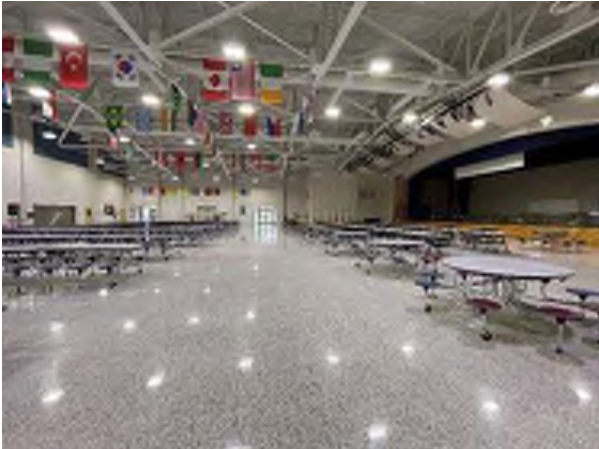
A sizeable quantity of fixtures in the building are T-8 fixtures with electronic ballasts. Some spaces such as the cafeteria have been converted to LED. The T-8 fixtures are generally in good condition; nevertheless, upgrades to LED systems should be considered to reduce overall electric energy consumption in the building.

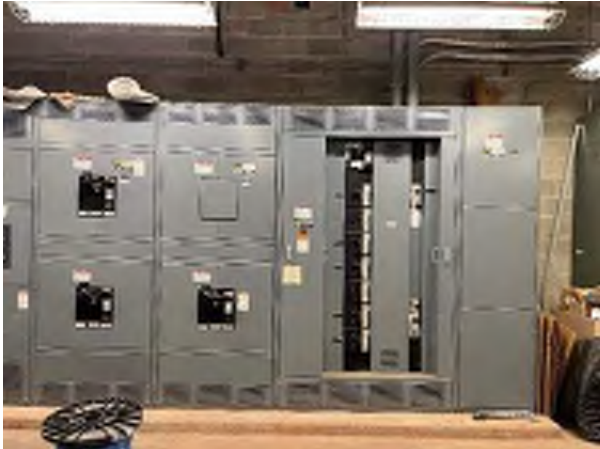
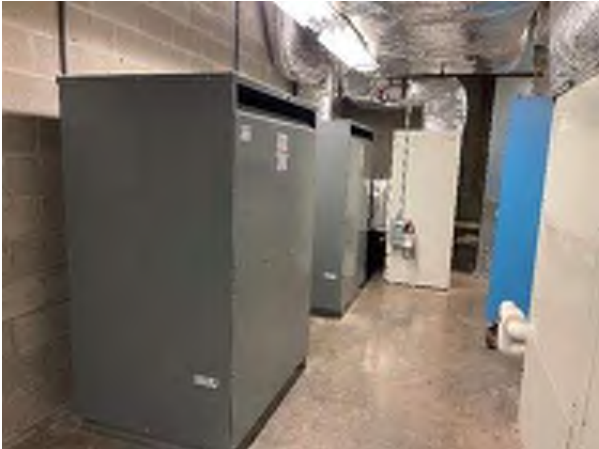
On the electric side, the building is provided with secondary, three-phase service by PECO and have a total capacity of 4,000 amps. There are nine step-down transformers located in an electrical closet in the building. The building also has natural gas service for the supplemental boiler and kitchen use.

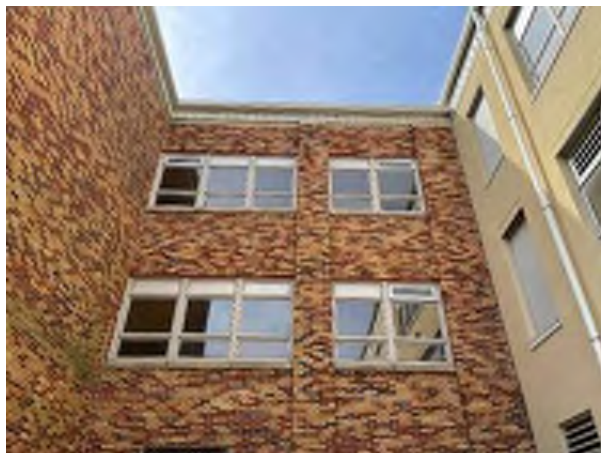
**Figure 1**

The windows installed are double-pane, mostly hopper style in aluminum frames with wood finish frames on the interior. Top sections of the windows systems are fixed and inoperable. Windows in the building are in fair to good condition and are shown in Figures 1 and 2.

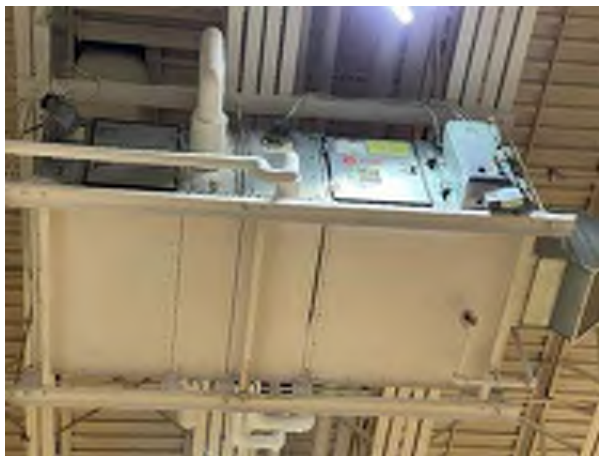
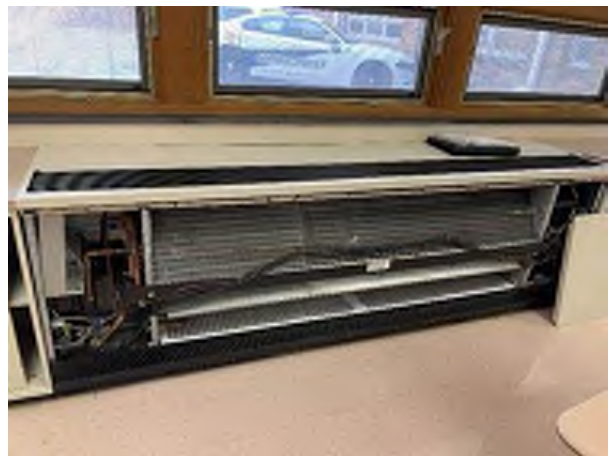
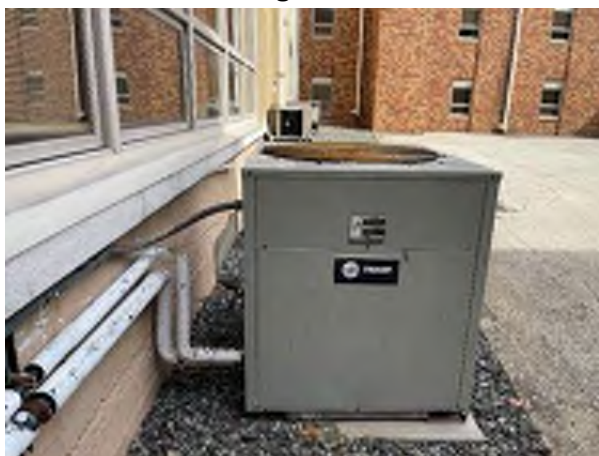
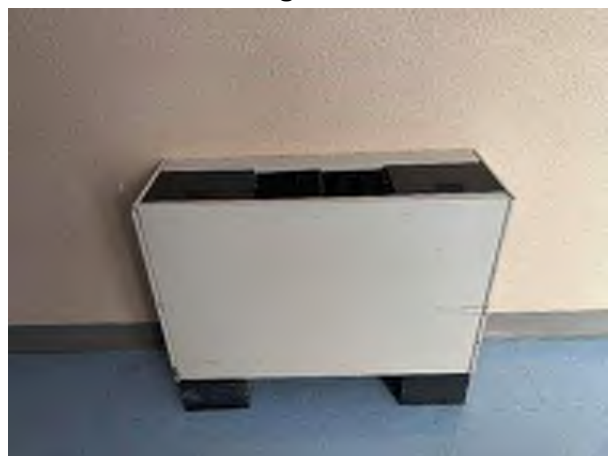
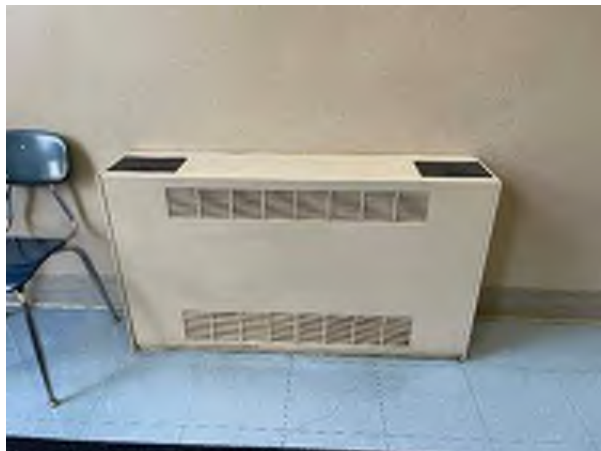
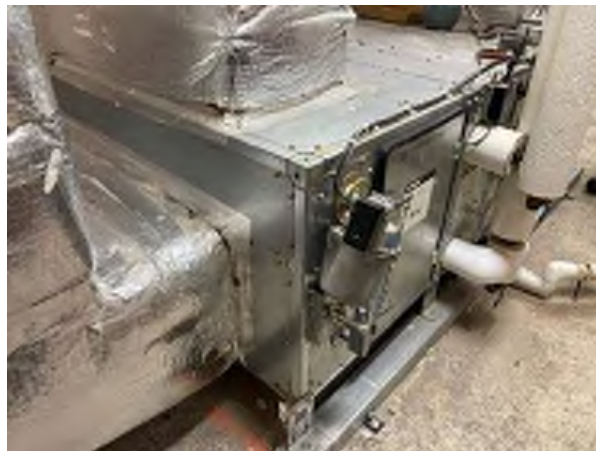
The building's ventilation is primarily through mechanical ventilation. The building is served by unit ventilators for classrooms and AHUs for larger spaces in the buildings. Select spaces in the building also have PTAC and heat pumps. Some AHUs in the building were recently upgraded while the existing unit ventilators are in fair working condition. The units are however being recommended for replacement given their age. The rate of component failure is high towards the end of a HVAC system's lifecycle. Newer systems will also be more energy efficient.

Figures 3 through 8 show the different type of installed HVAC systems.

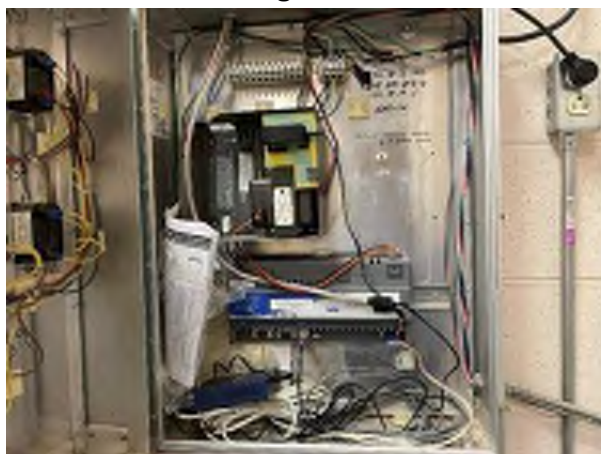
Figure 9

The HVAC equipment installed is controlled by a DDC JCI Metasys system located in the boiler room shown in Figures 9 and 10. Some of the large valves have pneumatic control served by one compressor shown in Figure 11. Additionally, field controllers installed in select mechanical spaces control the large AHUs. One such control panel is shown in Figure 12.

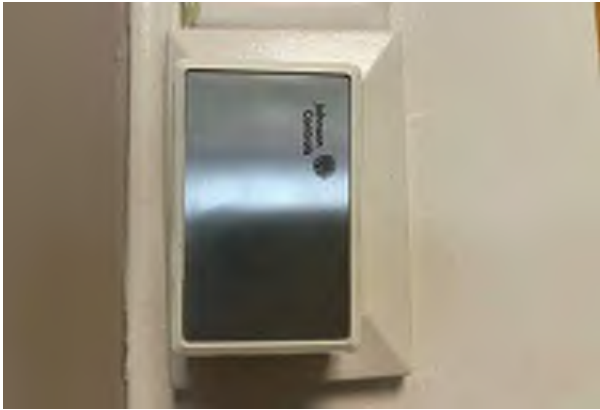
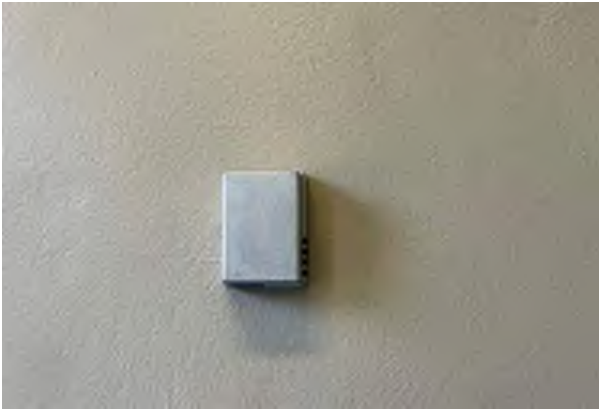
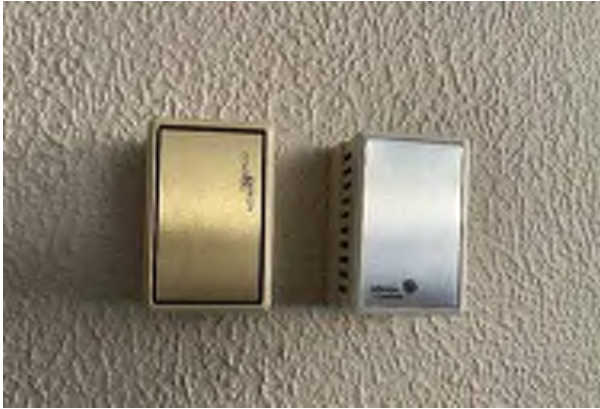
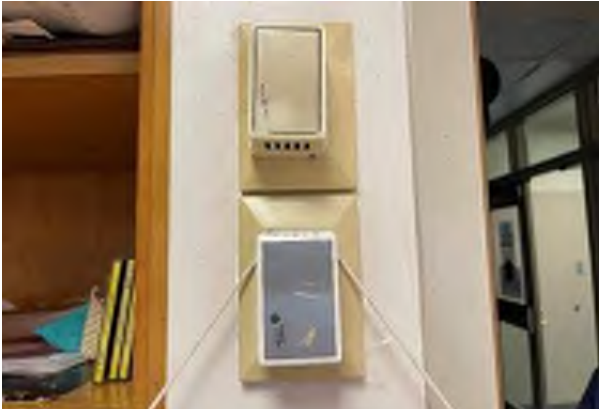
Figures 13 through 16 show the typical thermostats that are installed in the building. In some instances, the old thermostats were left in place and new thermostats were installed next to the old units. It is recommended the existing thermostats should be considered for upgrade since new smart thermostats provide more data points. New smart thermostats have additional built-in features that allow for deeper space setbacks and efficient space comfort management. It is also recommended the abandoned thermostats be removed and disposed of properly.

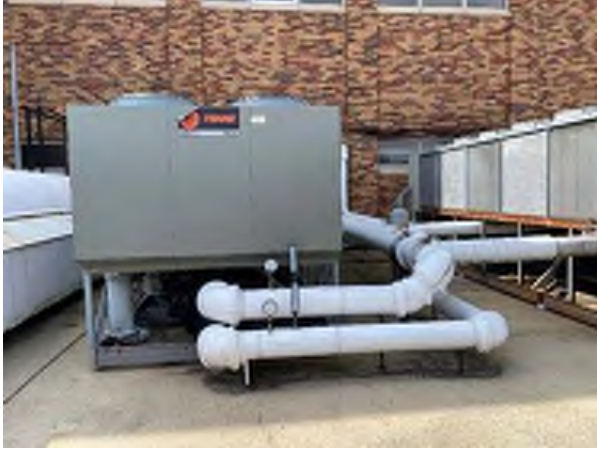
Air condition is provided by two air-cooled chillers located on the ground level. One of the Trane chillers is at the end of its useful life and should be considered for replacement. Figure 17 shows the newer chiller and Figures 18 through 21 show the old chiller.

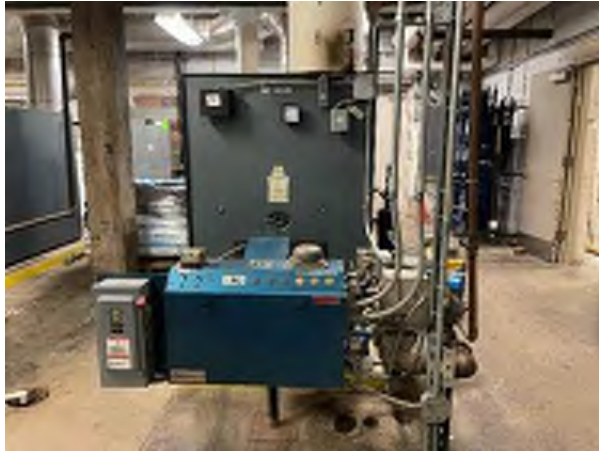
**Figure 22**

Two boilers are installed to provide hot water for the heating of the building, shown in Figures 22 and 23. The Weil-McLain boilers are dual-fuel, of identical capacity and are in good working condition.

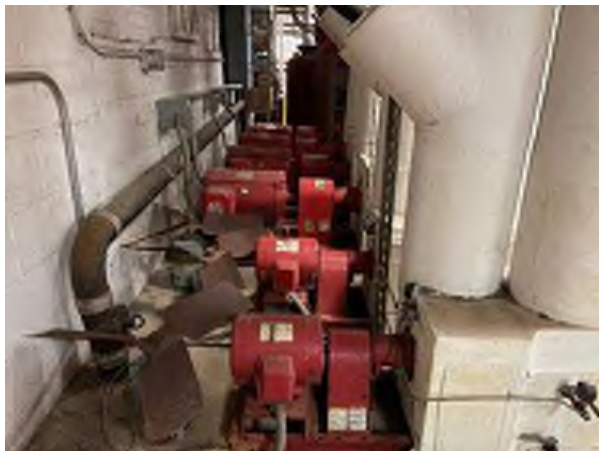
**Figure 24**

The conditioned water is circulated to unit ventilators and AHUs utilizing pumps located in the boiler room. The overall circulation system is in good condition and is shown in Figures 24 and 25. The existing pump motors are standard efficiency and shall be considered for upgrade to higher efficiency motors.

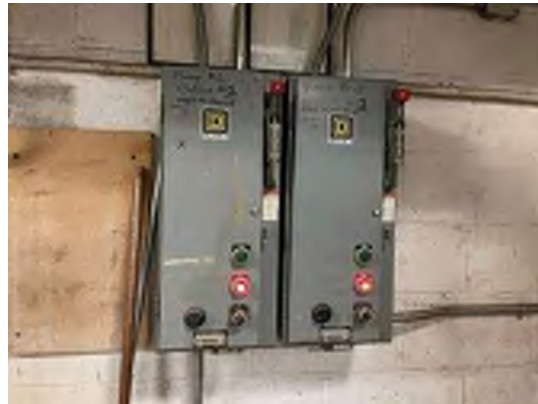
**Figure 26**

The chilled water system pumps were observed to be operating on the day of the audit when the building was unoccupied. A VFD based system will allow for scaling back water circulation during unoccupied hours.

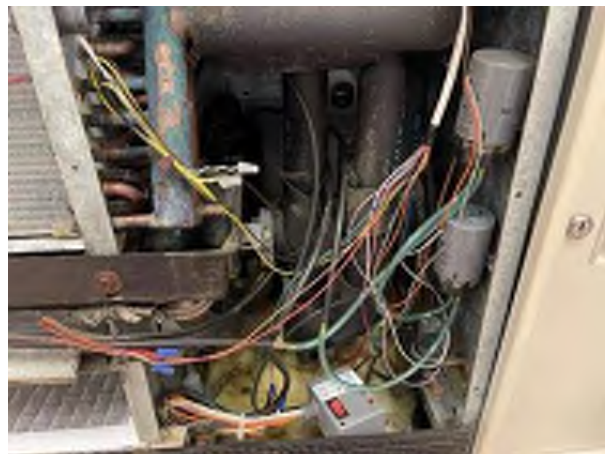
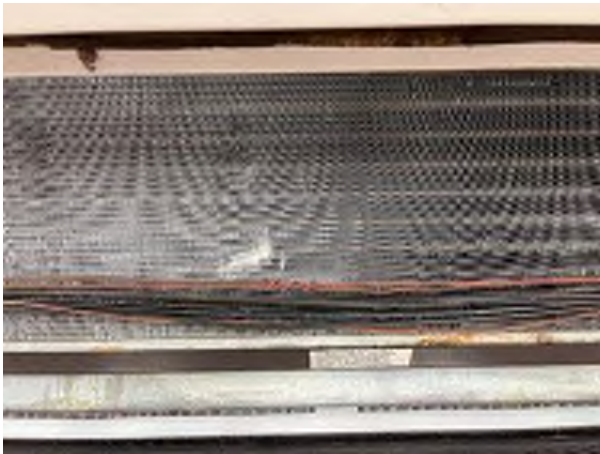
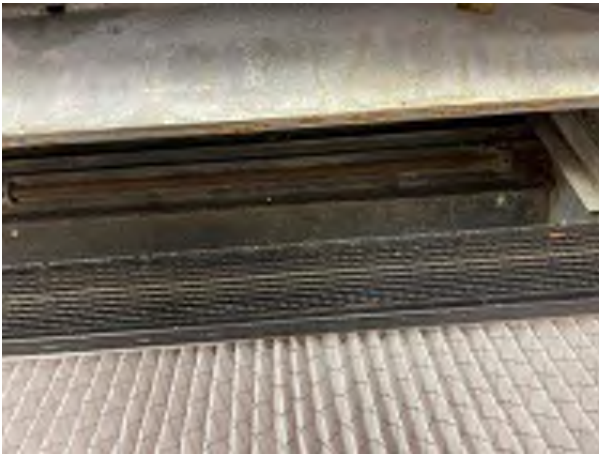
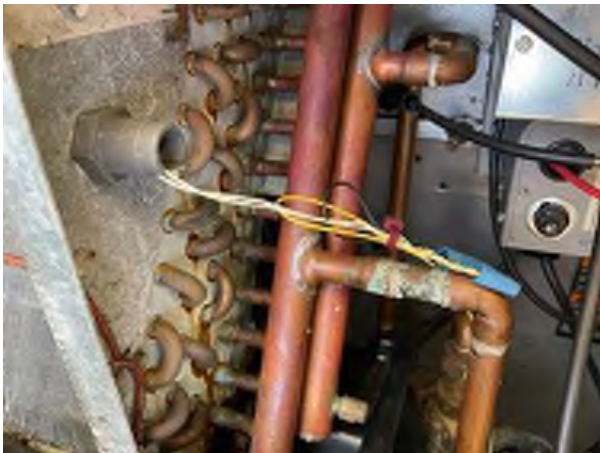
The existing unit ventilations are in fair to poor condition and nearing the end of its useful life. It is recommended these units be upgraded to avoid high maintenance expenditure and downtime. Figures 27 through 33 show some of the observations made on the sample unit ventilators inspected during the audit. Damaged fin coils and corrosion on pipes and tubes was consistent in the unit ventilators opened for inspection.

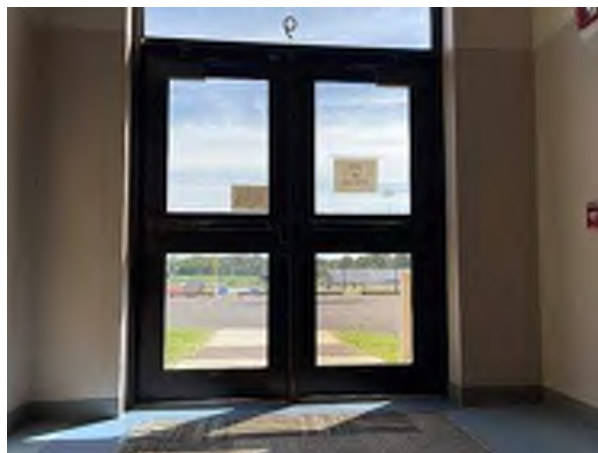
**Figure 35**

Some building envelope opportunities were identified during the site audit. The conditions observed onsite are shown in Figures 34 and 35. The useful life of weather-strips will vary with usage of the doors they are installed on. The air gap on the door on Figure 34 appears to be minimal while it is clearly visible on the door in Figure 35.

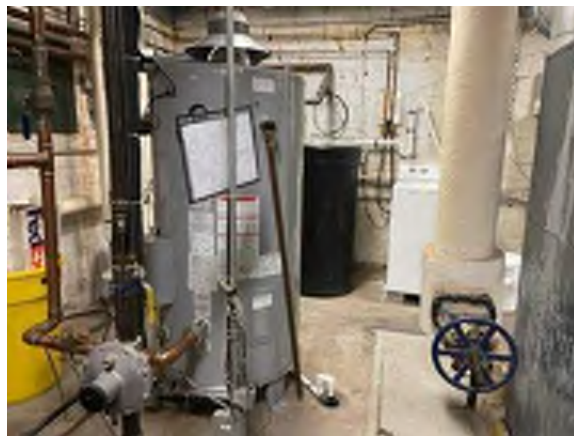
**Figure 36**

Domestic hot water is supplied to the kitchen and restrooms by one AO Smith boiler rated at 250,000 Btu/hr located in the boiler room and shown in Figure 36.

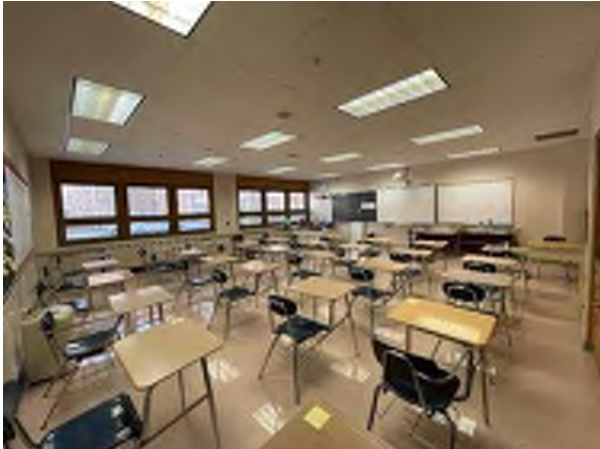
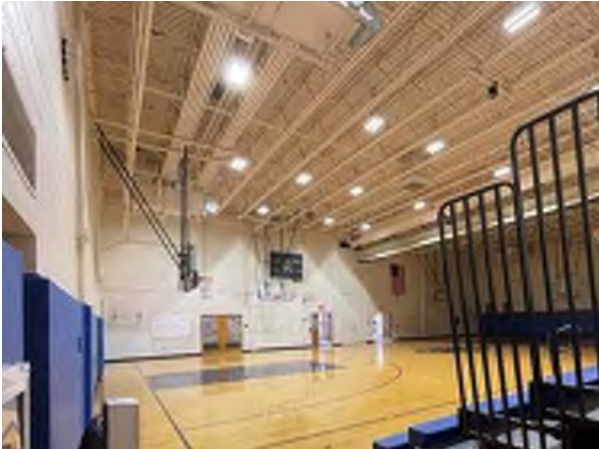
A sizeable quantity of fixtures in the building are T-8 fixtures with electronic ballasts. Some spaces such as the Main and Aux Gymnasiums have been converted to LED. The T-8 fixtures are generally in good condition; nevertheless, upgrades to LED systems should be considered to reduce overall electric energy consumption in the building.

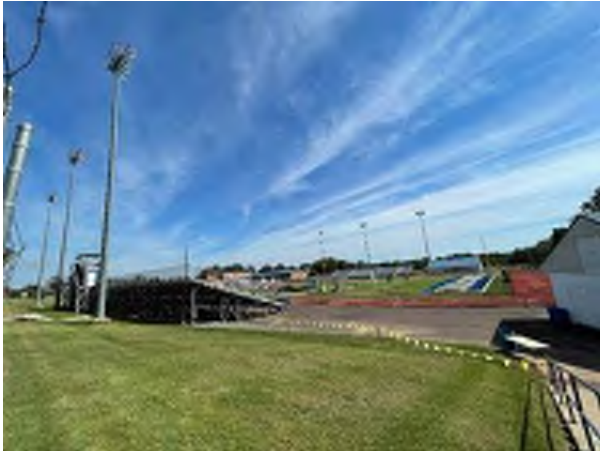
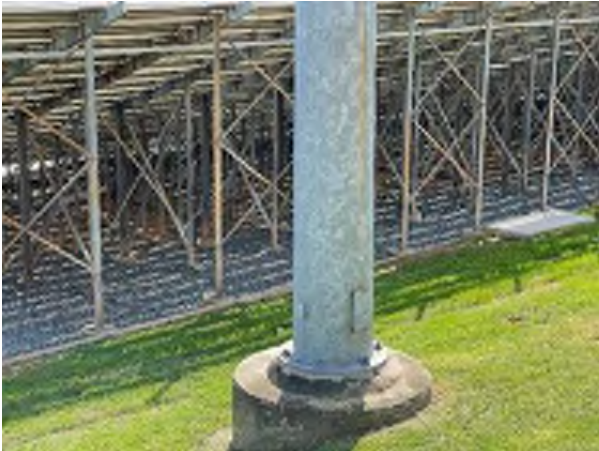
The stadium lights next to the 8th Grade Center were evaluated for upgrades. The poles were in good condition and need not be replaced as part of an upgrade to LED.
