# Spring-Ford Area School District

## Investment Grade Audit Report

**Submitted by:**  
Johnson Controls, Inc.

**August 2022**

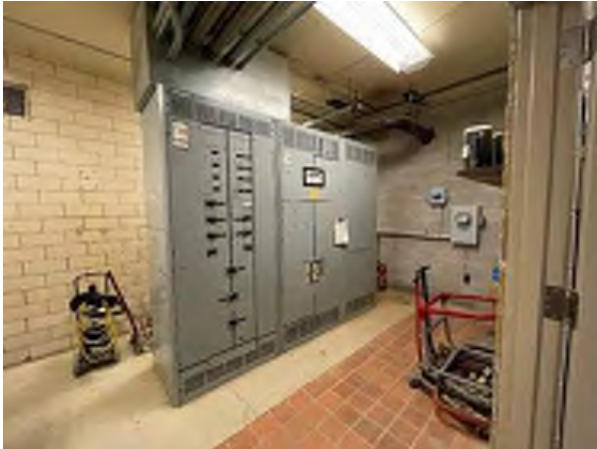
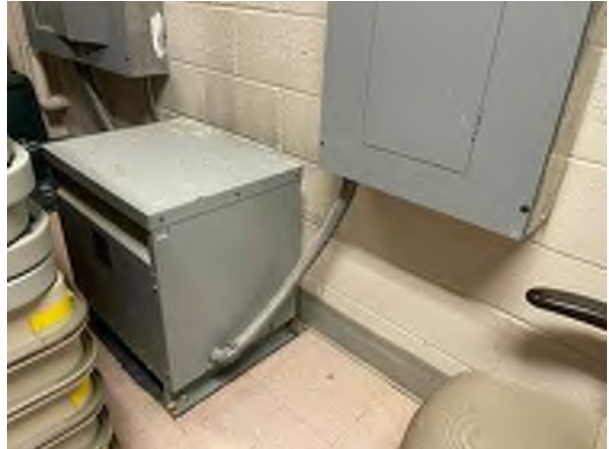
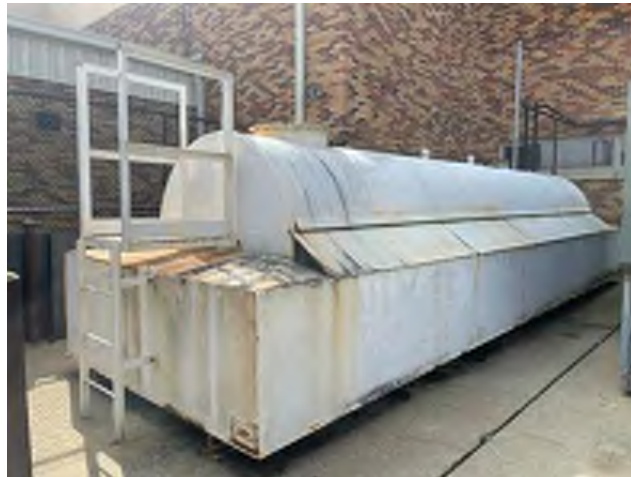
On the electric side, the building is provided with secondary, three-phase service by PECO and have a total capacity of 2,000 amps. There are six step-down transformers located in the electrical closets in the building. The building also has natural gas service for the supplemental boiler and kitchen use. There is also an above ground fuel storage tank located on premises.

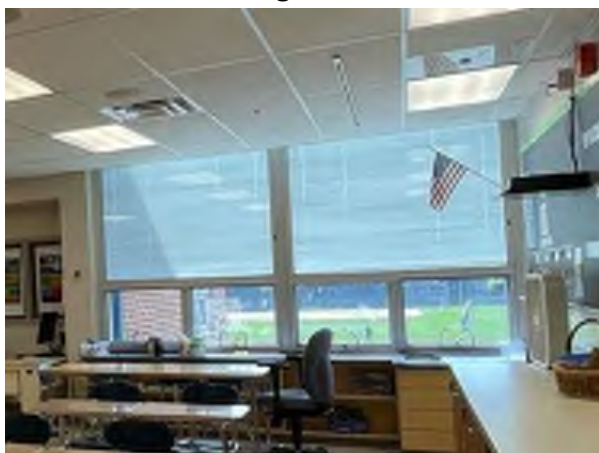
**Figure 1**

The windows that are installed are double-pane, mostly awning style in aluminum frames. Top sections of the windows systems are fixed and inoperable. Windows in the building are in fair to good condition and are shown in Figures 1 and 2.

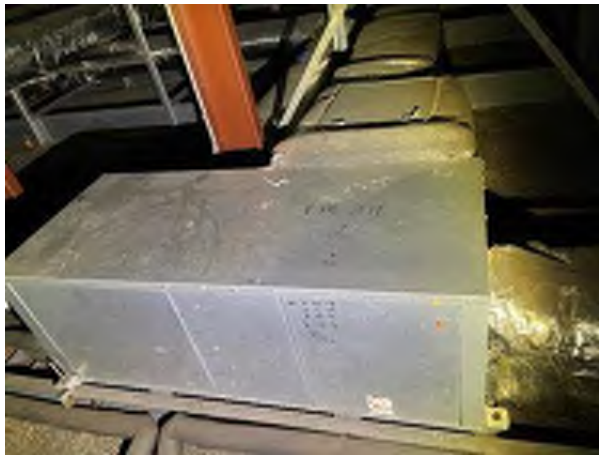
**Figure 3**

The building's ventilation is primarily through mechanical ventilation. The building is served by heat pumps, heat recovery units, one makeup air unit and unit heaters. These systems work in conjunction with relief vents and exhaust fans in the building to ensure proper air circulation. Many of the equipment are in good to fair condition given their age. Figures 3 through 6 show the different type of installed HVAC systems.

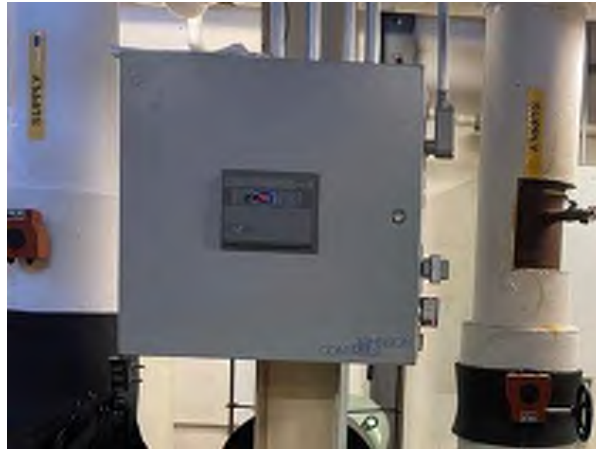
Figure 7

The HVAC equipment installed is controlled by a DDC JCI Metasys system located in the boiler room shown in Figure 7.

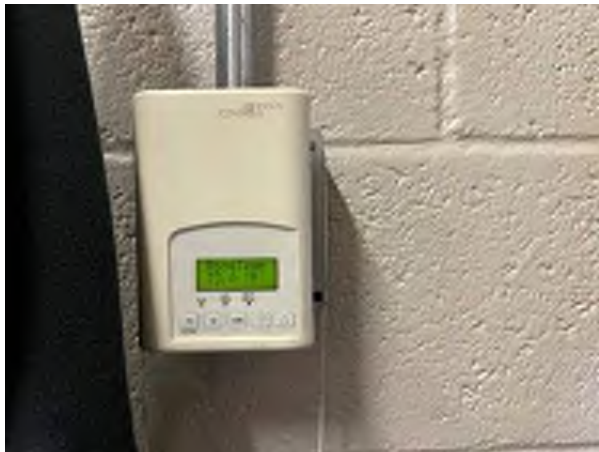
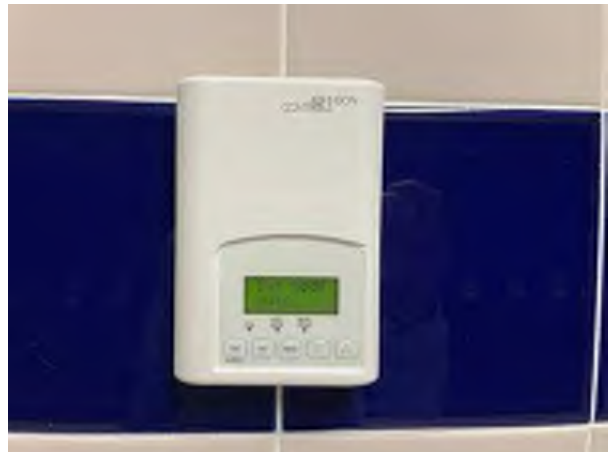
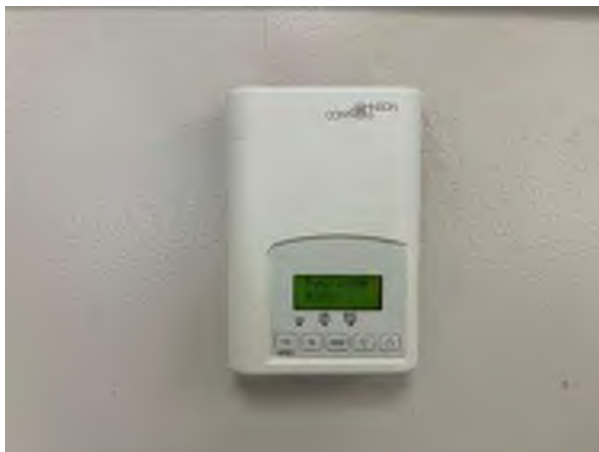
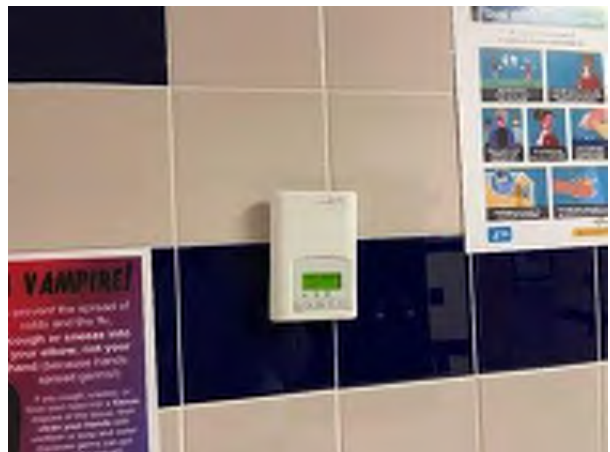
Figures 8 through 11 show the typical thermostats that are installed in the building. These thermostats are good working condition, but it is recommended the existing thermostats be considered for upgrade since new smart thermostats provide more data points. New smart thermostats have additional built-in features that allow for deeper space setbacks and more efficient space comfort management.

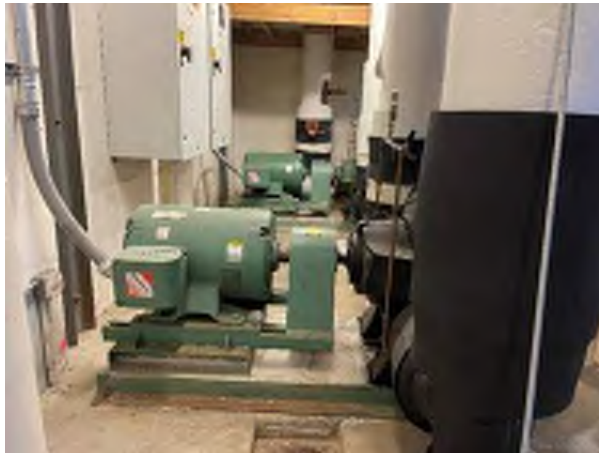
**Figure 12**

The building is served by a geothermal system with one boiler for supplemental heating. The overall system is generally in good condition and is shown in Figures 12 and 13. The existing circulation pumps are high efficiency and the volume of water circulating in the loop is varied through the use of VFDs shown in Figure 14. Select storage spaces in the building have dedicated unit heaters.

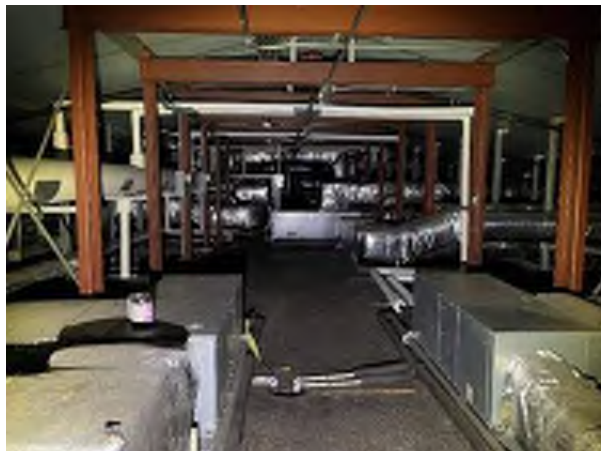
Figure 15

Air conditioning is provided to most spaces of the building by water source heat pump systems located in the attic and is shown in Figures 15 and 16.

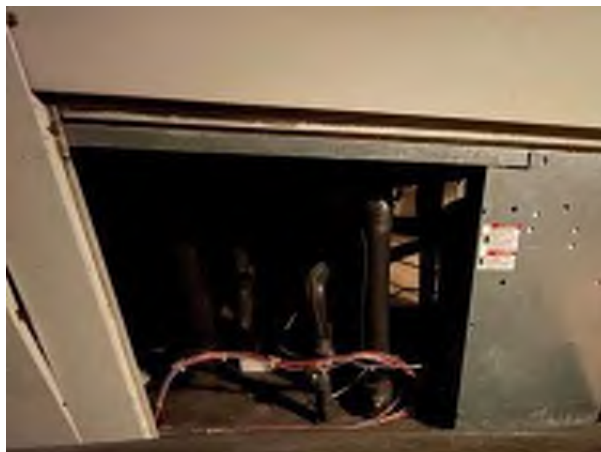
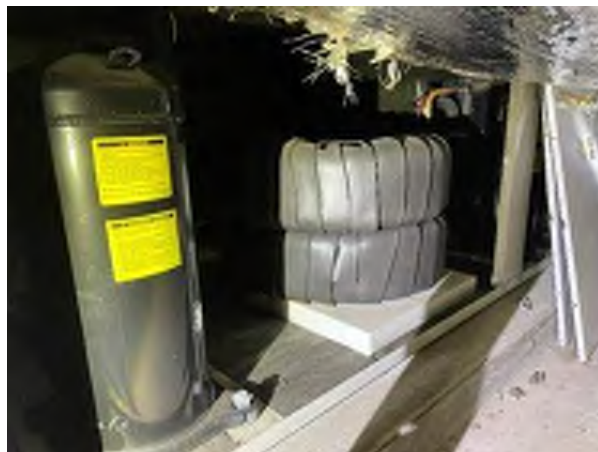
In addition to external observations, one of the heat pumps' paneling was opened to inspect internal conditions. The system appeared to be in good working condition and no leaks were observed.

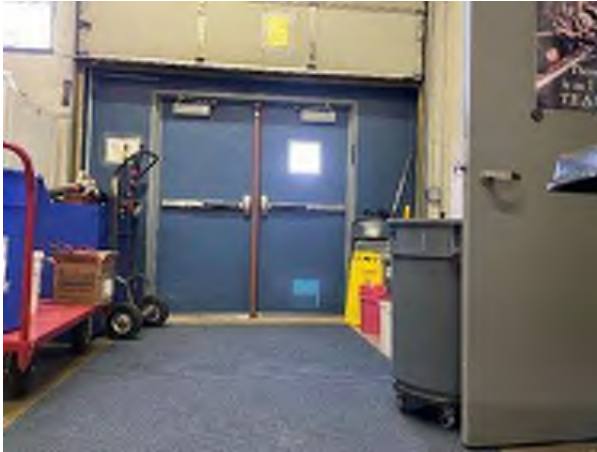
Figure 19

A sample of the doors observed onsite are shown in Figures 19 and 20. The useful life of weather-strips will vary with usage of the doors they are installed on. Some air gaps were observed onsite, and it is recommended the existing weather-strips be replaced.

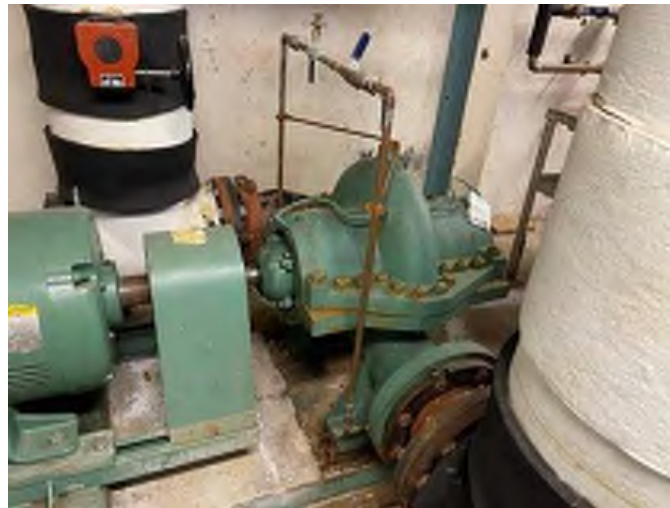
Figure 21

Most heat transfer systems in the building are well insulated. The uninsulated pipes on the geothermal side of the system is starting to show signs of corrosion; shown in Figure 21. It is recommended these bare pipes and valves be insulated to prevent leaks in the future. Other minor opportunities for insulation were observed on the domestic hot water piping.

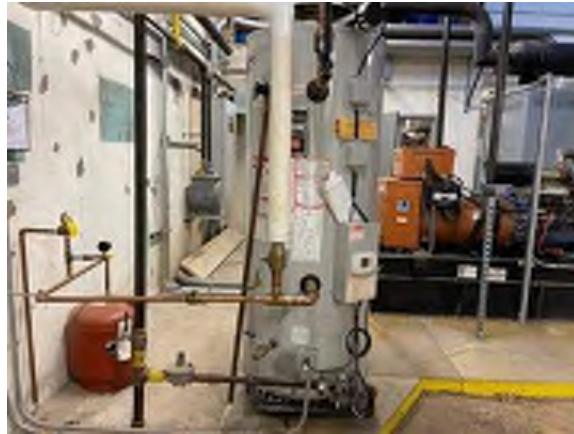
Figure 22

Domestic hot water is supplied to the kitchen and restrooms by one Bradford White boiler rated at 505,000 Btu/hr located in the boiler room and shown in Figure 22.

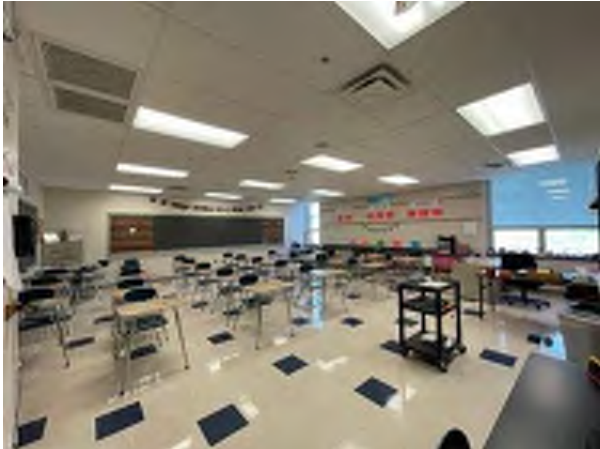
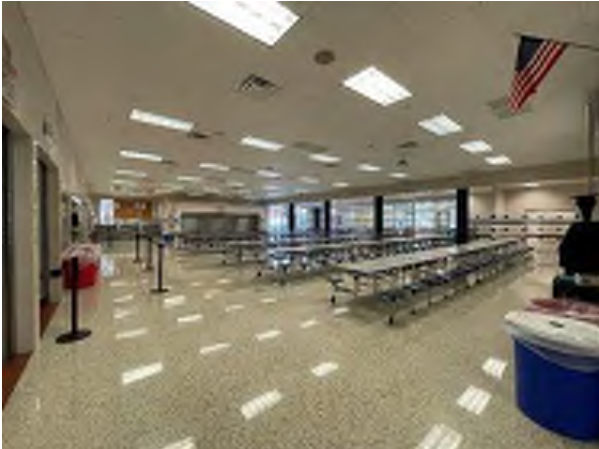
A sizeable quantity of fixtures in the building are T-8 fixtures with electronic ballasts. Some spaces such as the Main and Aux Gymnasiums have been converted to LED. The T-8 fixtures are generally in good condition; nevertheless, upgrades to LED systems should be considered to reduce overall electric energy consumption in the building.

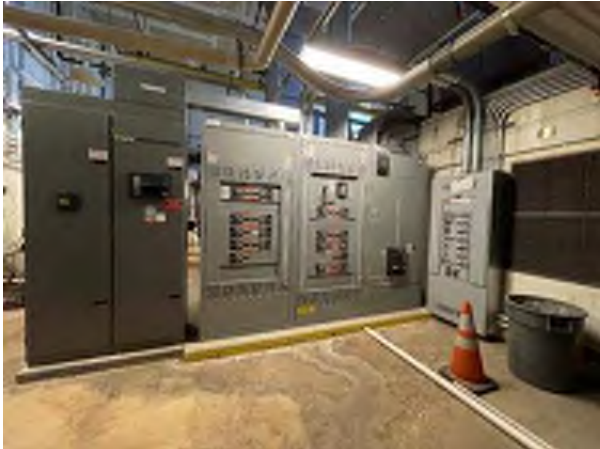
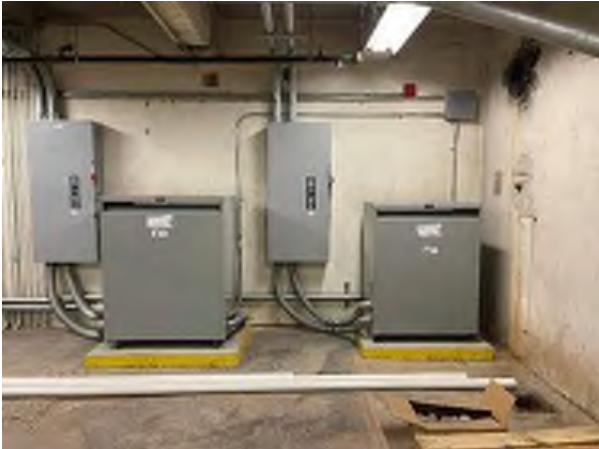
On the electric side, the building is provided with secondary, three-phase service by PECO and have a total capacity of 3,200 amps. There are six step-down transformers located in the electrical closets in the building. The building also has natural gas service for the supplemental boiler and kitchen use.

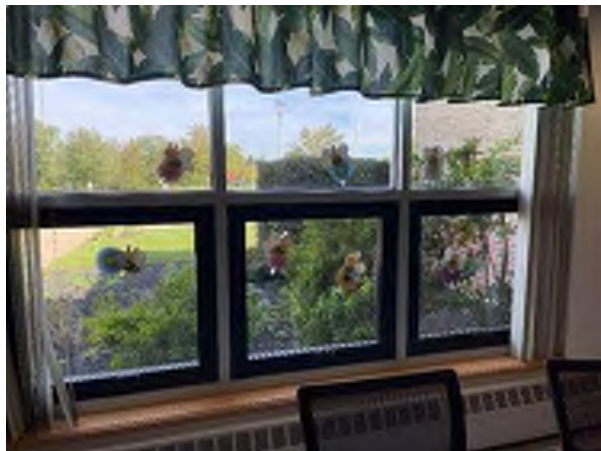
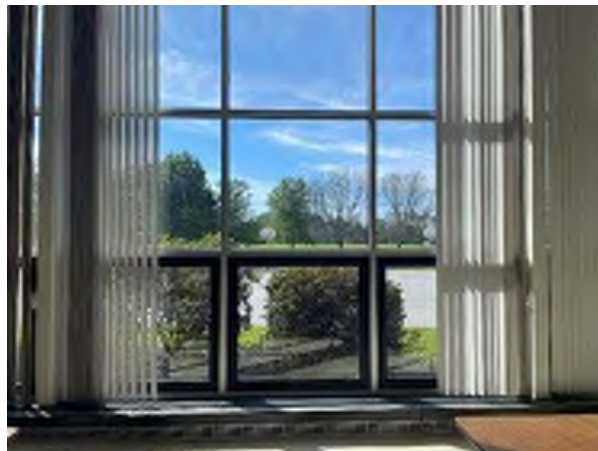
The windows that are installed are double-pane, mostly awning style in aluminum frames. Top sections of the windows systems are fixed and inoperable. Windows in the building are in fair to good condition and are shown in Figures 1 and 2.

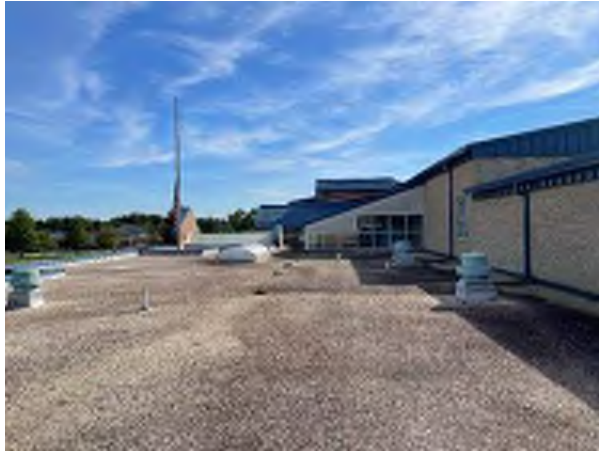
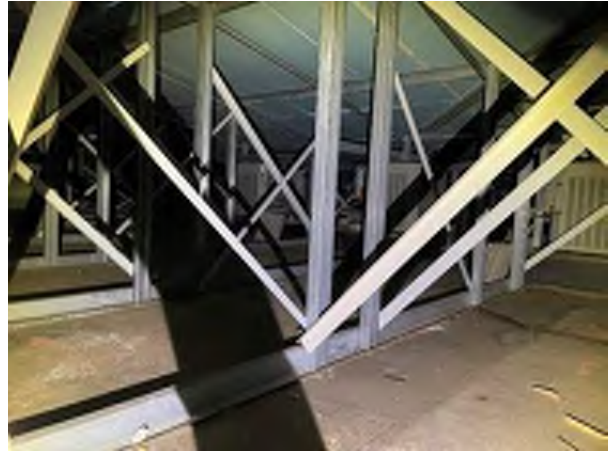
The roof installed is mostly pitched metal with small sections of flat roof for access. Portions of the pitched metal section have mechanical equipment in the space between the metal roof and membrane.

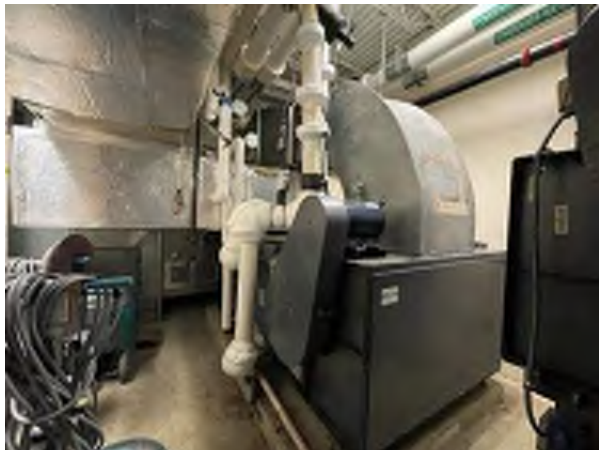
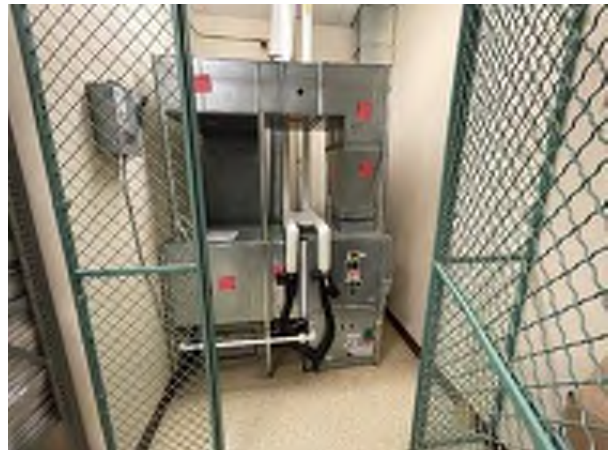
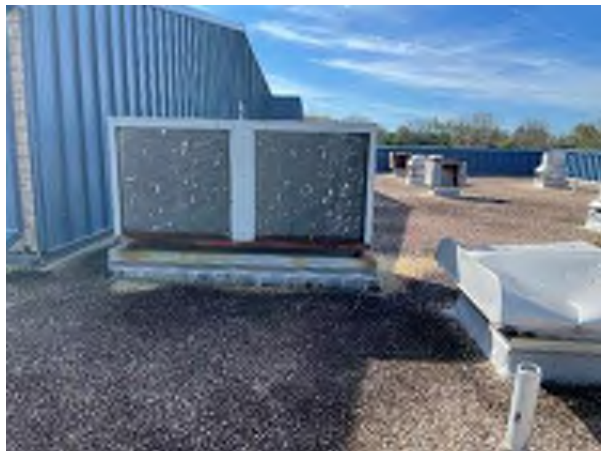
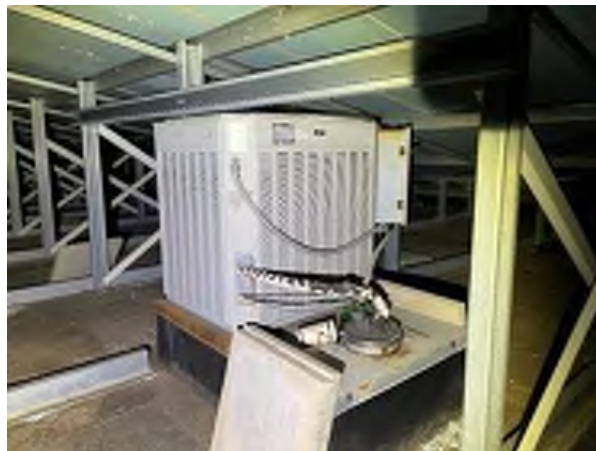
The building's ventilation is primarily through mechanical ventilation. The building is served by heat pumps, AHUs and unit heaters in select areas like hallways. The systems are currently in fair working condition. The units are however being recommended for replacement given their age. The rate of component failure is high towards the end of a HVAC system's lifecycle. Newer systems will also be more energy efficient. If replacement is not economical currently, a deep retro-commissioning is recommended to replace aging components, restore equipment performance, and extend the useful life of the equipment. Figures 5 through 8 show the different type of installed HVAC systems.

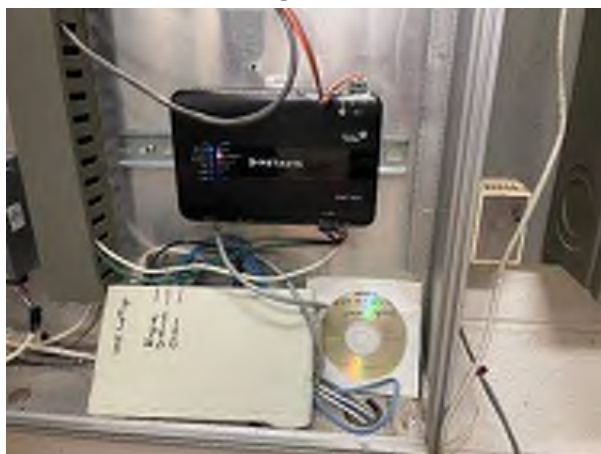
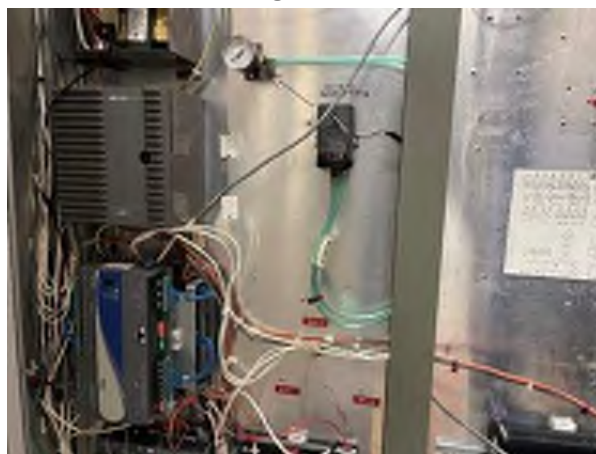
The HVAC equipment installed is controlled by a DDC JCI Metasys system located in the boiler room shown in Figures 9 and 10. Some of the large valves have pneumatic control served by one compressor shown in Figure 11. Additionally, field controllers installed in select mechanical spaces control the large AHUs. One such control panel is shown in Figure 12.

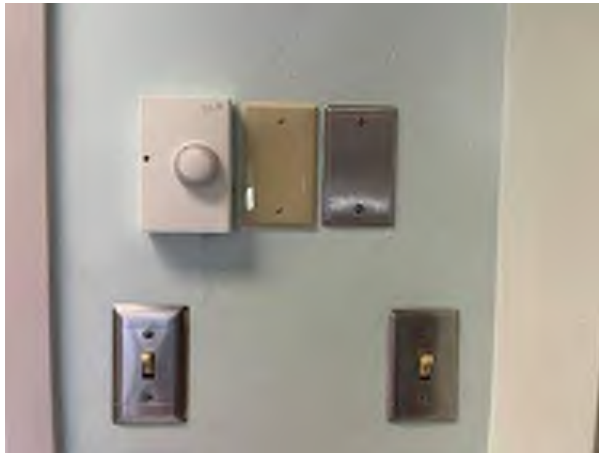
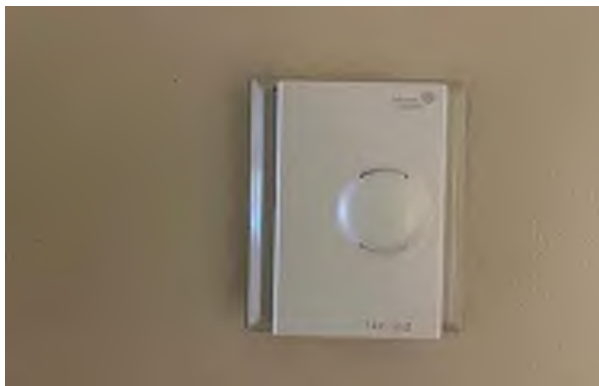
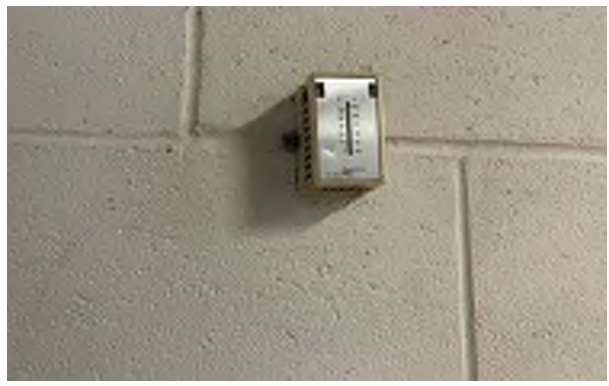
Figures 13 through 16 show the typical thermostats that are installed in the building. The thermostats are of varying vintage manufactured by JCI. Figure 14 shows a CO<sub>2</sub> sensor next to thermostat in the cafeteria. It is recommended the existing thermostats should be considered for upgrade since new smart thermostats provide more localized control and also have additional built-in features that allow for deeper space setbacks and efficient space comfort management.

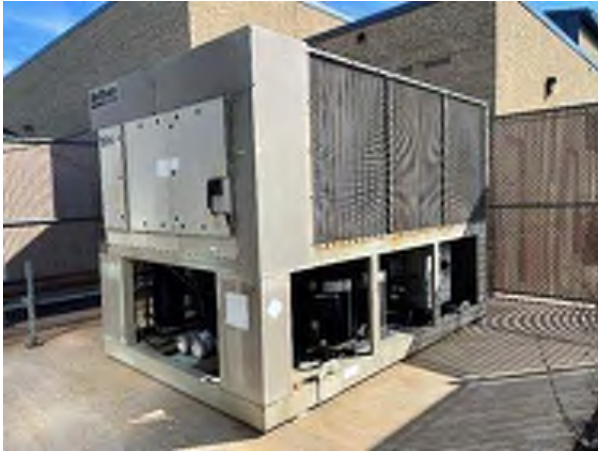
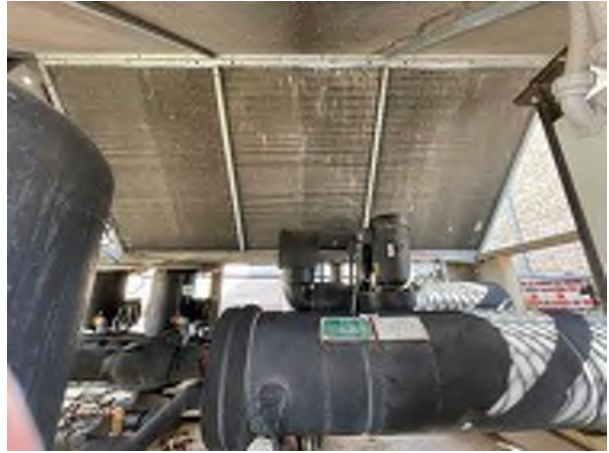
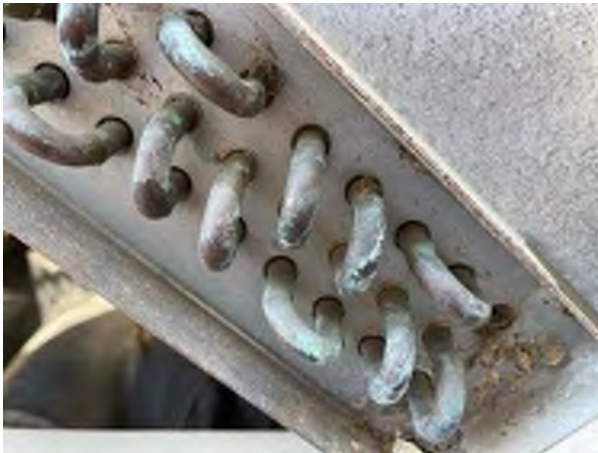
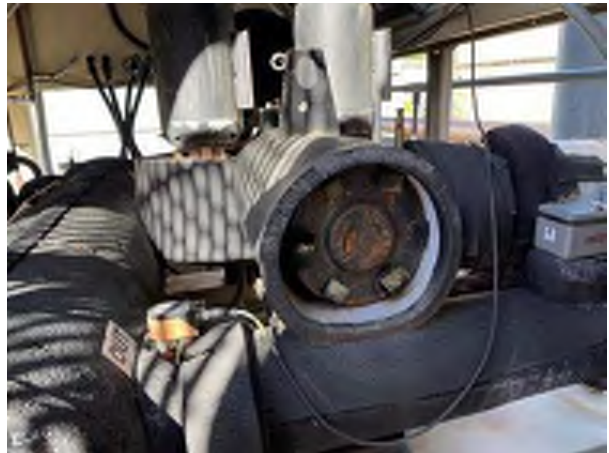
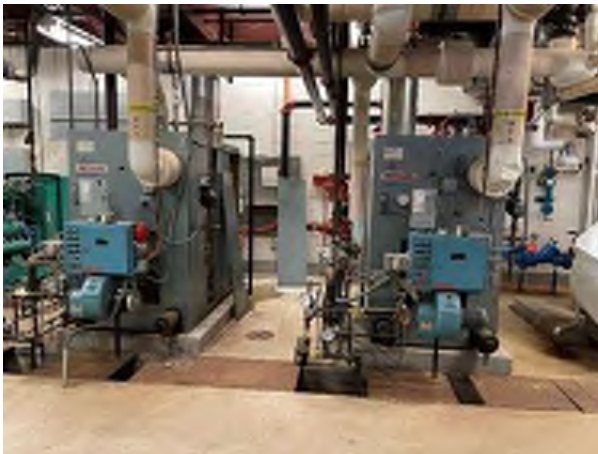
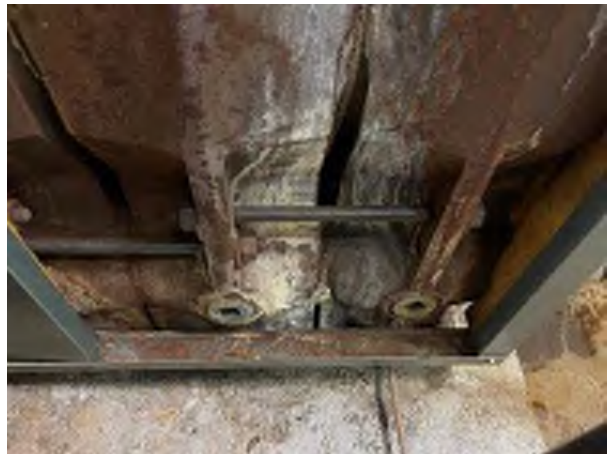
The building is served by two systems; larger spaces are condition by AHUs supported by a boiler plant and a chiller plant and shown in Figures 17 through 22. The chiller plant and boiler plant are in fair condition and should be considered for upgrades.

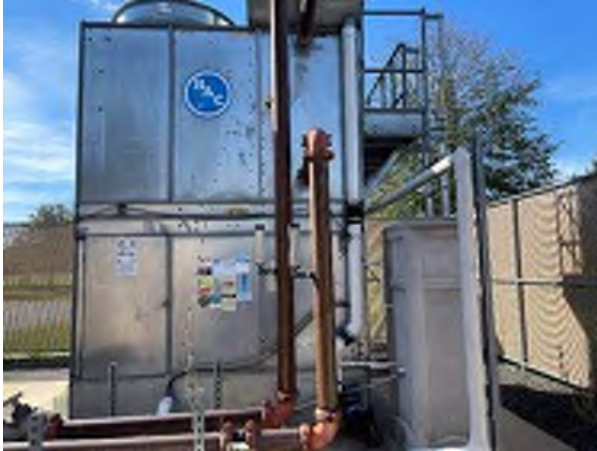
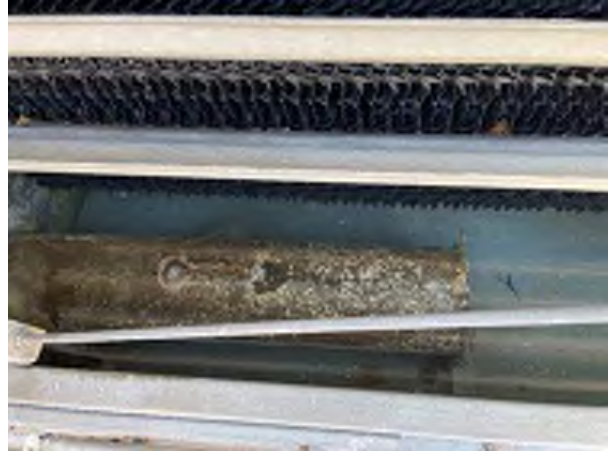
Certain wings in the building are conditioned by water source heat pumps serviced by a cooling tower which is in fair to poor condition and shown in Figures 23 through 24.

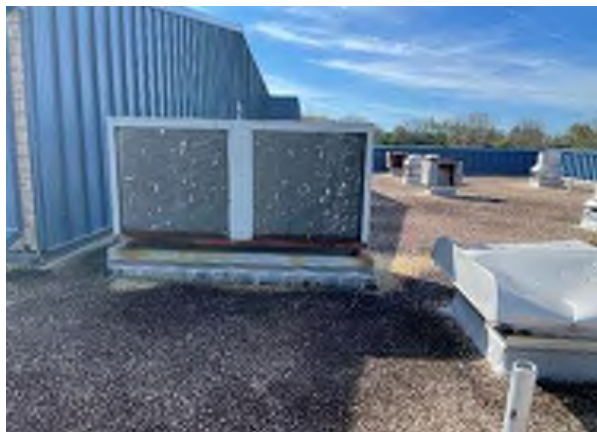
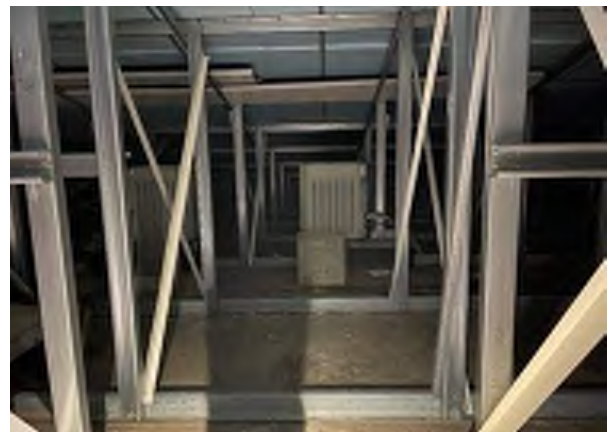
The water source heat pumps and other split units on the roof have R-22 refrigerant and should be considered for upgrade to more environmentally friendly types of systems. The overall systems are in fair to poor condition and is shown in Figures 27 and 28.

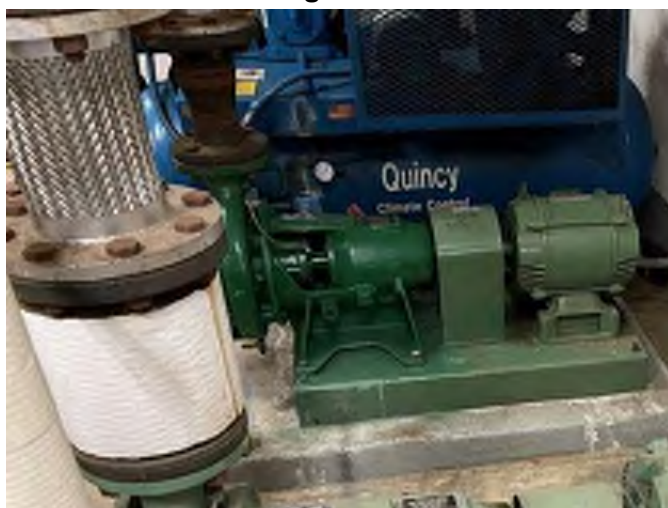
**Figure 29**

Most heat transfer systems in the building are well insulated. Minor opportunities for insulation were observed during the audit and is shown in Figure 29.

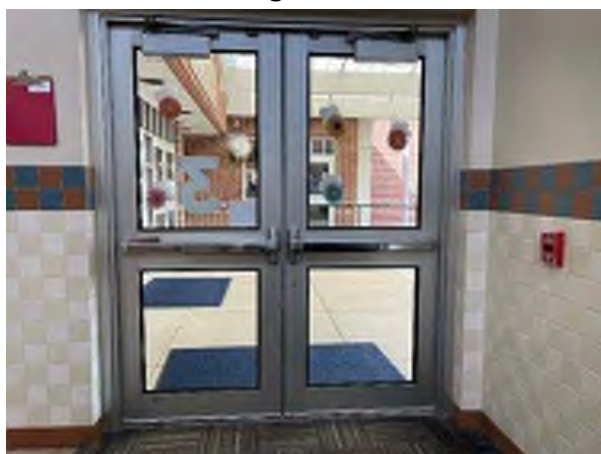
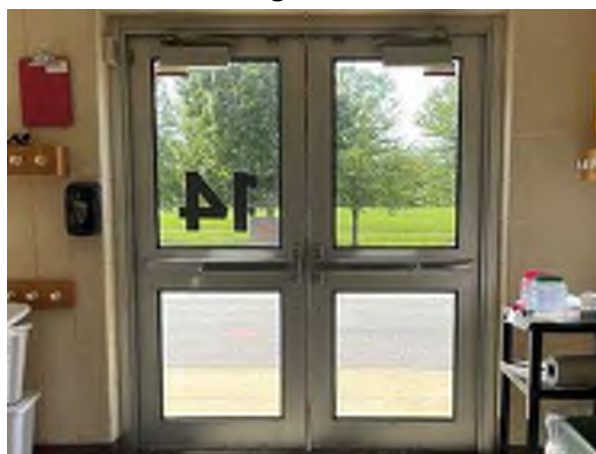
Building envelope opportunities were identified during the site audit and is shown in Figures 30 and 31. The useful life of weather-strips will vary with usage of the doors they are installed on. The existing door weather-strips were most likely installed when the building was built in 1991.

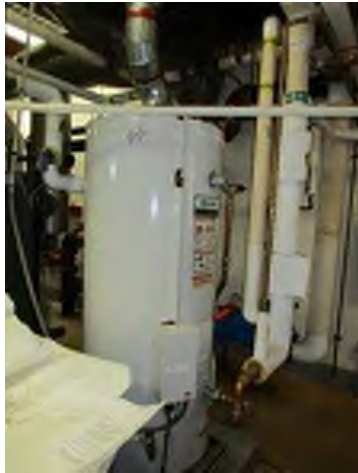
Figure 32

Domestic hot water is supplied to the kitchen and restrooms by one AO Smith boiler rated at 390,000 Btu/hr located in the boiler room and shown in Figure 32.

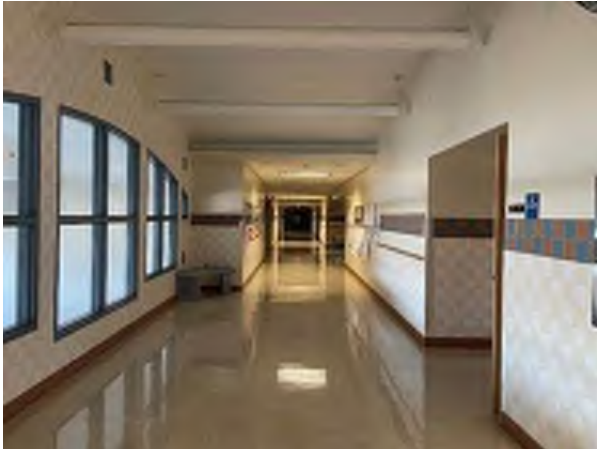
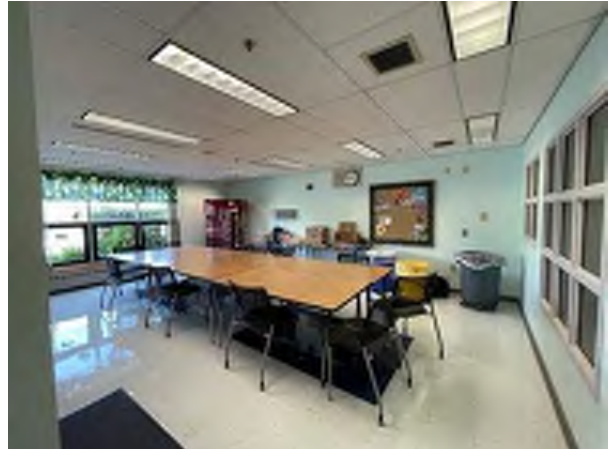
A sizeable quantity of fixtures in the building are T-8 fixtures with electronic ballasts. Some spaces such as areas of the library have already been converted to LED. The T-8 fixtures are generally in good condition; nevertheless, upgrades to LED systems should be considered to reduce overall electric energy consumption in the building.

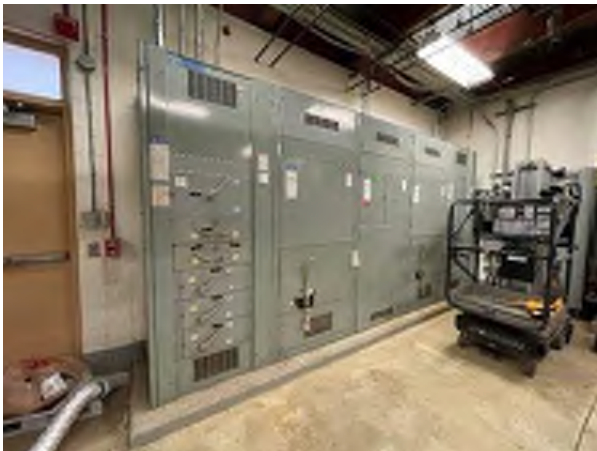
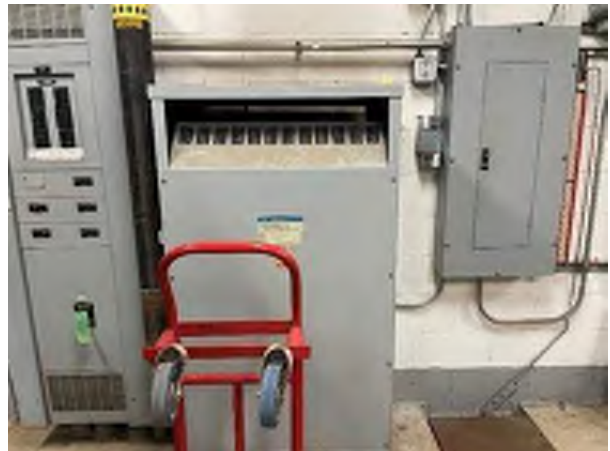
On the electric side, the building is provided with secondary, three-phase service by PECO and have a total capacity of 800 amps. There are two step-down transformers located in the boiler room. The building also has natural gas service for the supplemental boiler and kitchen use.

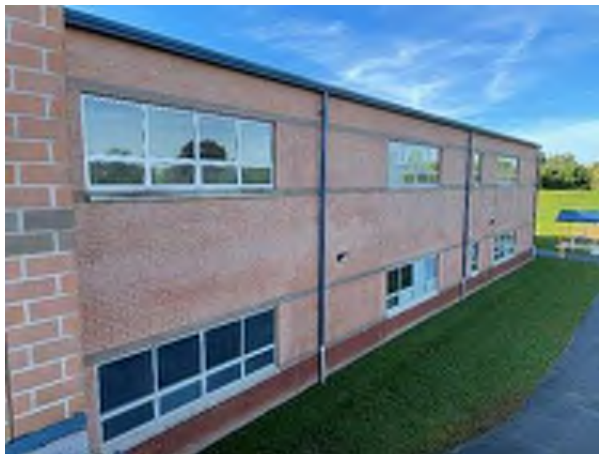
**Figure 1**

The windows that are installed are double-pane, mostly hopper style in aluminum frames. Windows in the building are in good condition and are shown in Figures 1 and 2. Select areas of the building have curtain wall windows.

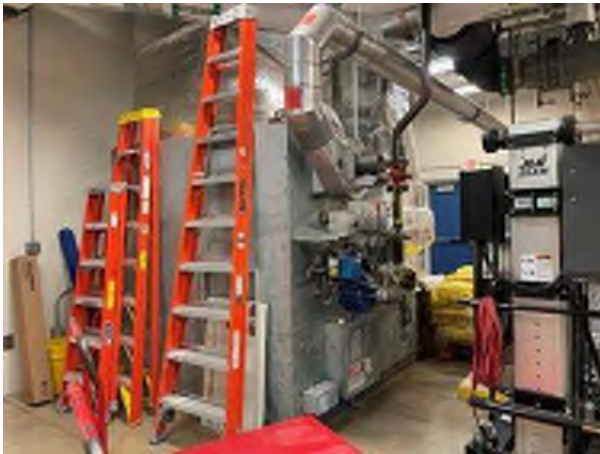
Figure 3

The building's ventilation is primarily through mechanical ventilation. The building is served by heat pumps, heat recovery units, one AHU and unit heaters. The units that serve large spaces and can vary the amount of air flow to these spaces for energy efficient operation. These systems along with the unit ventilators work in conjunction with relief vents and exhaust fans in the building to ensure proper air circulation. Figures 3 and 4 show the different type of installed HVAC systems.

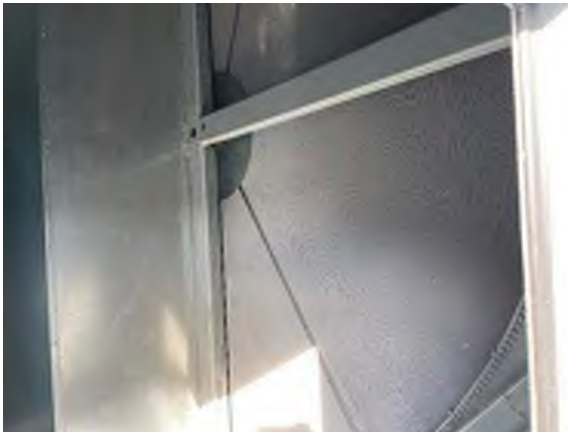
Figure 6

Many of the equipment are in good condition given their age. One of the heat recovery units was opened and it appeared to be in good condition as shown in Figures 6 and 7. A slight increase in efficiency is expected from retro-commissioning these units.

It is recommended tools and spare parts be stored outside the heat recovery units to prevent accidental damage to the unit during operation.

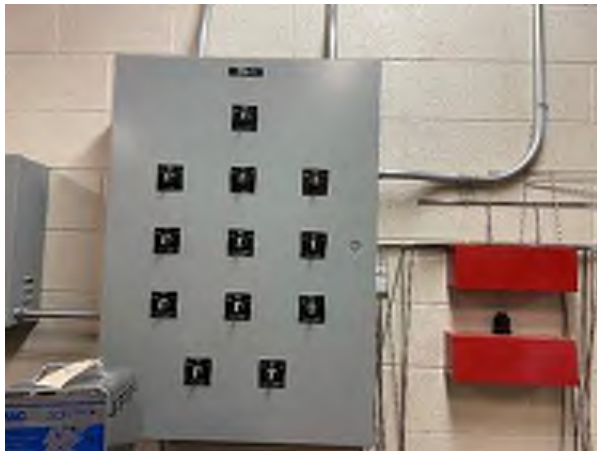
**Figure 10**

The HVAC equipment installed is controlled by a DDC JCI Metasys system located in the boiler room shown in Figures 10 and 11.

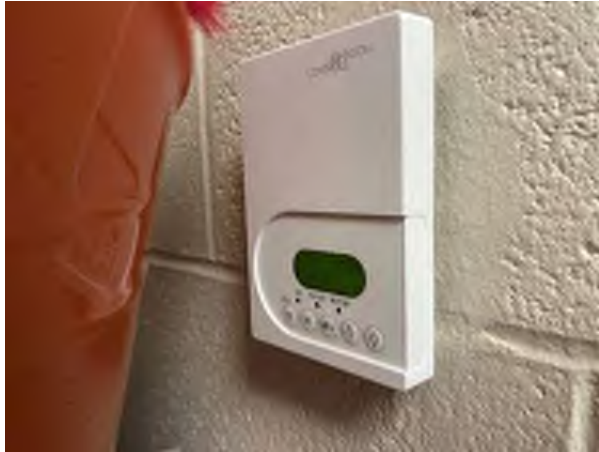
Figure 12

Figures 12 through 15 show the typical thermostats that are installed in the building. Most thermostats are of similar vintage and are JCI T600HPP and TE-6700 thermostats. It is recommended these two types of units should be considered for upgrade to new smart thermostats that provide more localized control. New smart thermostats also have additional built-in features that allow for deeper space setbacks and efficient space comfort management.

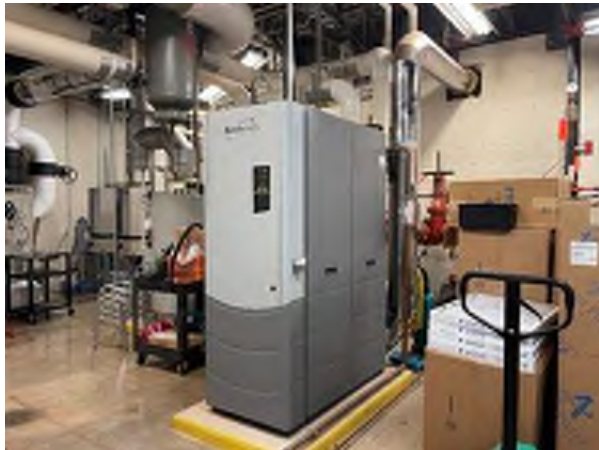
Figure 16

The building is served by a geothermal system with one boiler for supplemental heating. The overall system is generally in good condition and is shown in Figures 16 and 17. The existing circulation pumps are high efficiency and the volume of water circulating in the loop is varied through the use of VFDs. Select storage spaces in the building have dedicated unit heaters.

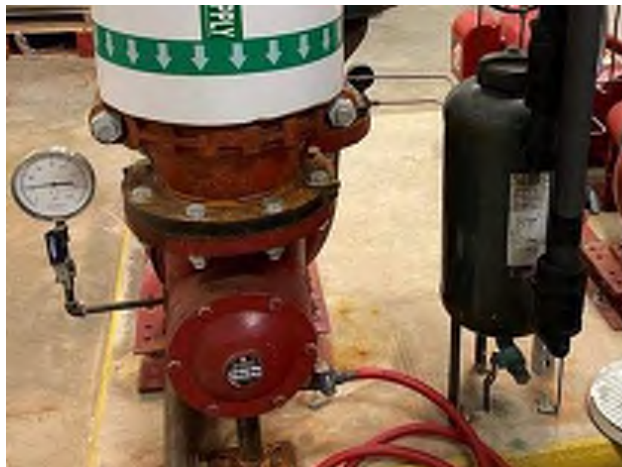
Figure 18

The uninsulated pipes on the geothermal side of the system is starting to show signs of corrosion; shown in Figure 18. It is recommended these bare pipes and valves be insulated to prevent leaks in the future.

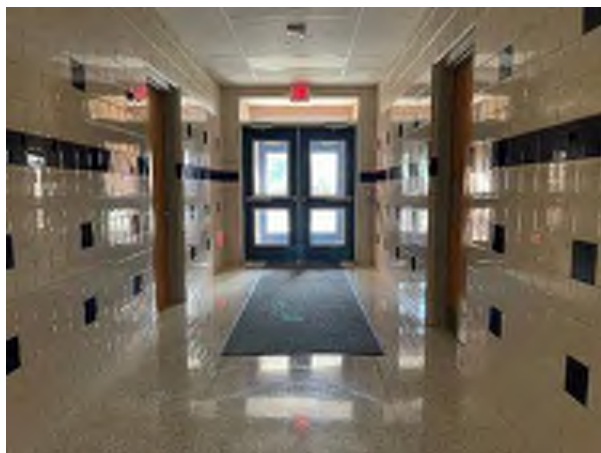
Figure 19

There is generally good building envelope and is shown in Figures 19 and 20. The useful life of weather-strips will vary with usage of the doors they are installed on. The existing door weather-strips were most likely installed when the building was built in 2007. The next couple of years will be a good time to replace existing weather-strips to continue to maintain a tight building envelope.

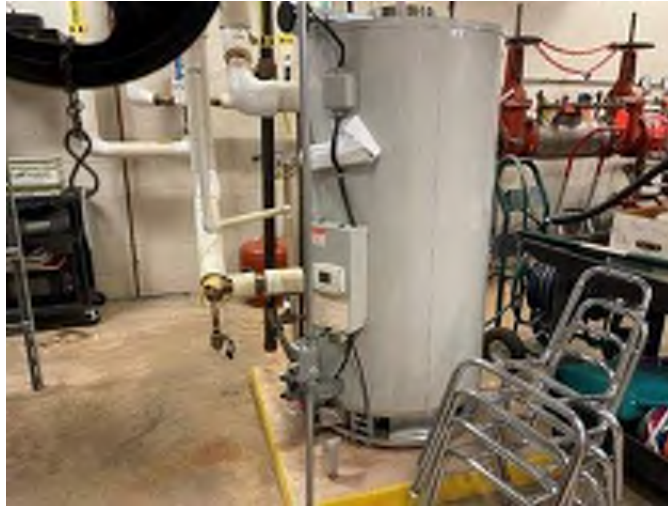
**Figure 21**

Domestic hot water is supplied to the kitchen and restrooms by one Bradford White boiler rated at 505,000 Btu/hr located in the boiler room and shown in Figure 21.

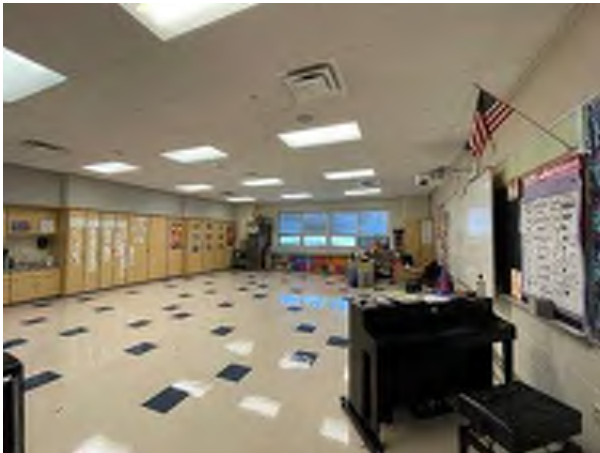
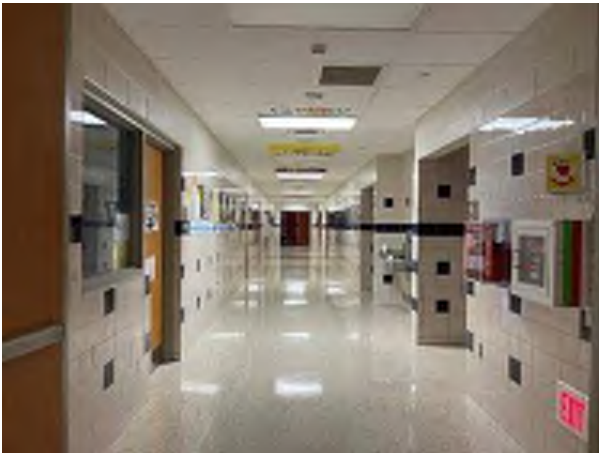
A sizeable quantity of fixtures in the building are T-8 fixtures with electronic ballasts. The fixtures are generally in good condition; nevertheless, upgrades to LED systems should be considered to reduce overall electric energy consumption in the building.

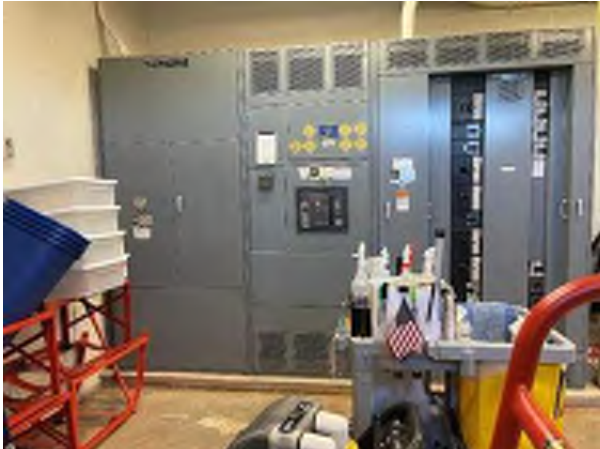
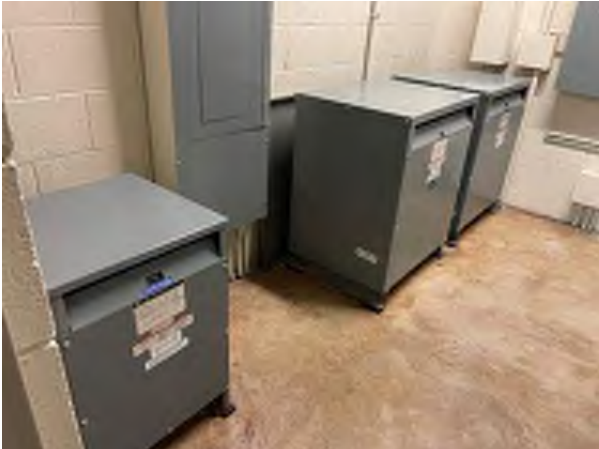
On the electric side, the building is provided with secondary, three-phase service by PECO and have a total capacity of 3,000 amps. There are ten step-down transformers located in electrical closets in the building. The building also has natural gas service for the supplemental boiler and kitchen use.

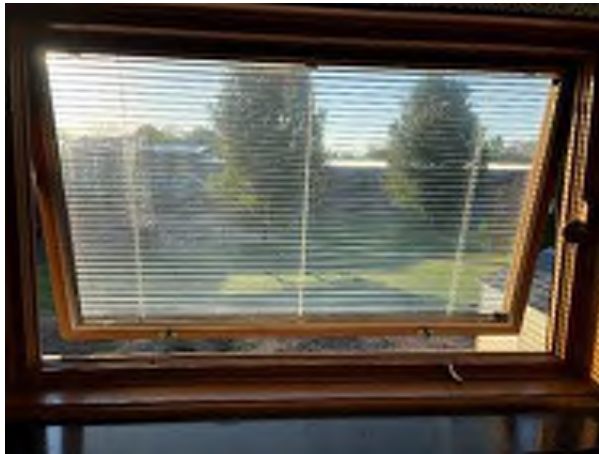
**Figure 1**

The windows that are installed are double-pane, awning style in aluminum exterior frames and interior wood finish that are in fair condition, shown in Figures 1 and 2.

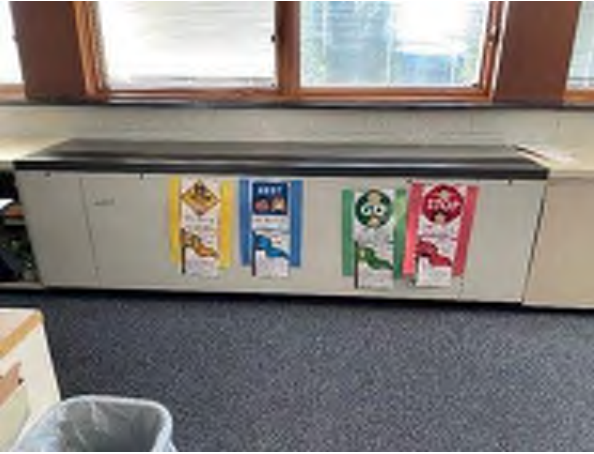
Figure 3

The building's ventilation is primarily through mechanical ventilation. The building is served by AHUs, fan coil units and unit ventilators. The AHUs serve large spaces and can vary the amount of air flow to these spaces for energy efficient operation. These systems along with the unit ventilators work in conjunction with relief vents and exhaust fans in the building to ensure proper air circulation. Figures 3 through 6 show the different type of installed HVAC systems.

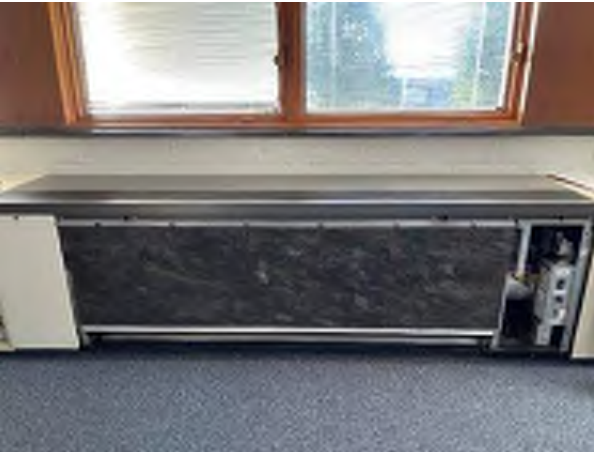
Figure 7

Many of the equipment are in fair to good condition given their age. A sample set of unit ventilators were opened and these appeared to be in good condition as shown in Figures 7 through 10. A slight increase in efficiency is expected from retro-commissioning these units.

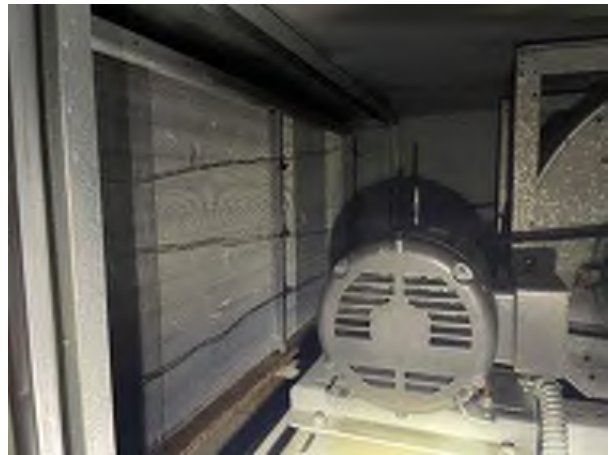
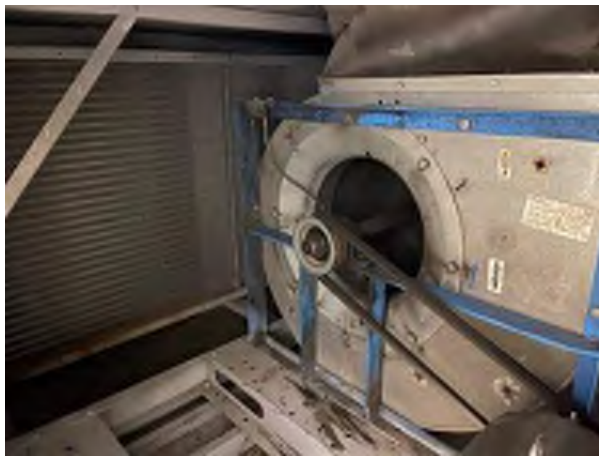
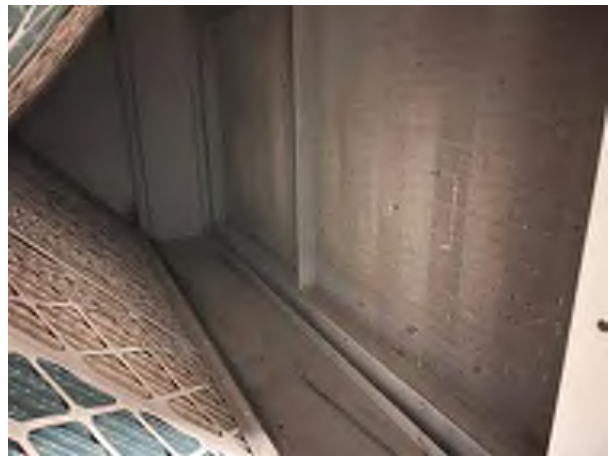
The AHUs will benefit more from retro-commissioning thereby increasing overall system performance and extend its useful life. Figures 11 through 14 are of some of retro-commissioning observations made during the site audit.
