# Spring-Ford Area School District

## Investment Grade Audit Report

**Submitted by:**  
Johnson Controls, Inc.

**August 2022**

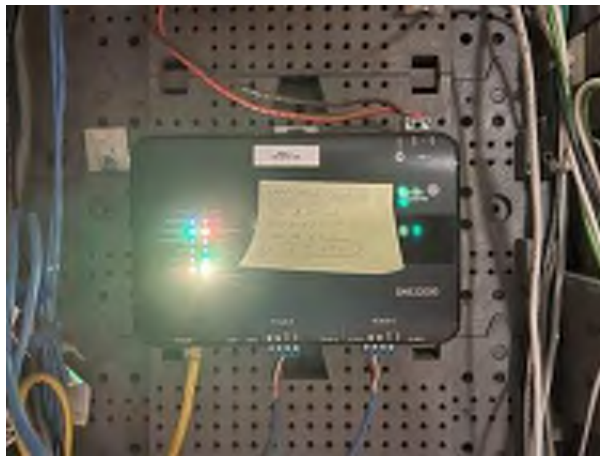
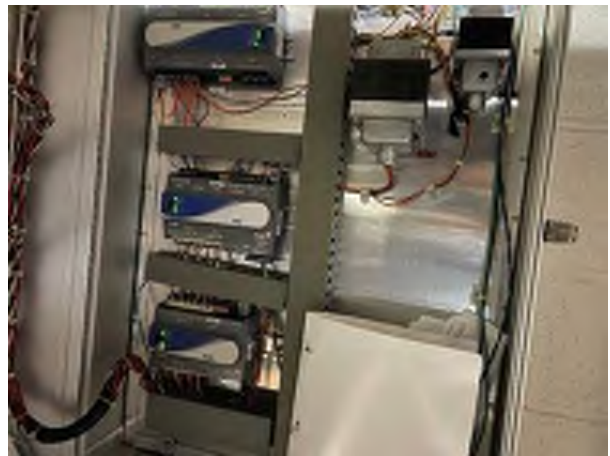
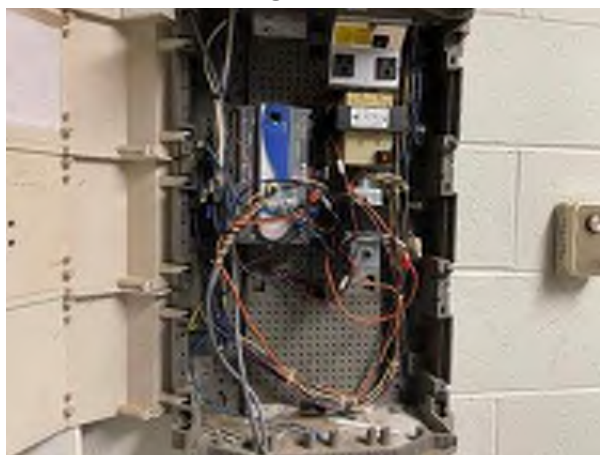
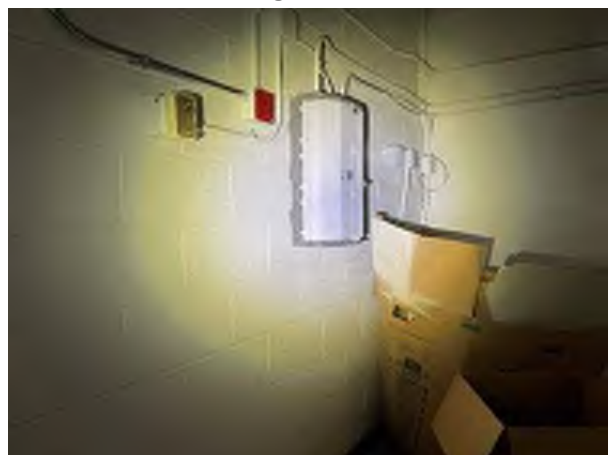
The HVAC equipment installed is controlled by a DDC JCI system located in the boiler room shown in Figures 15 and 16. Additional field controllers are located within each unit ventilator as shown in Figure 16 and in mechanical spaces in the building as shown in Figure 17 and 18.

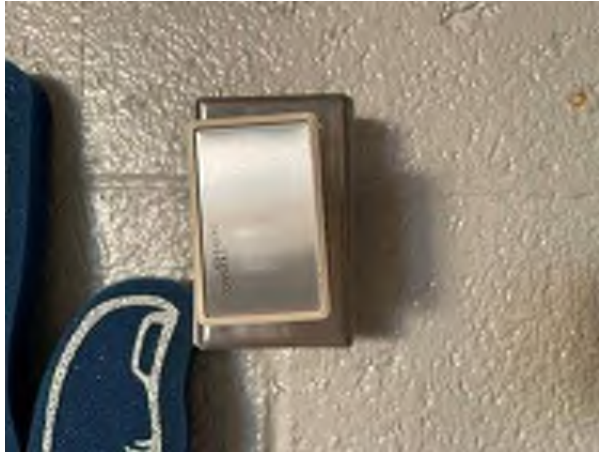
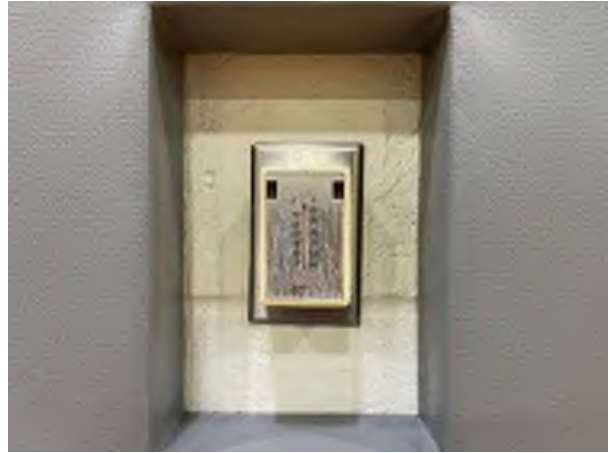
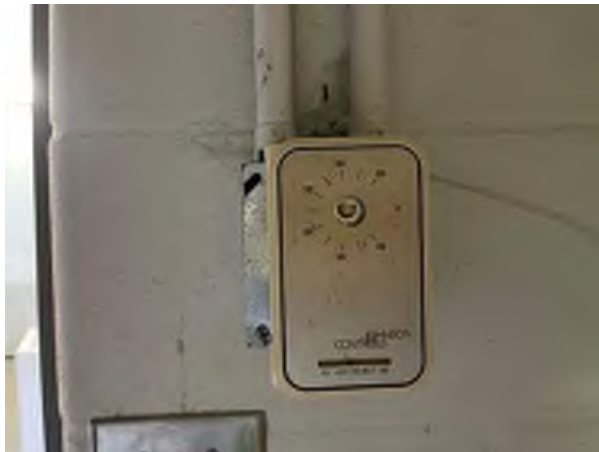
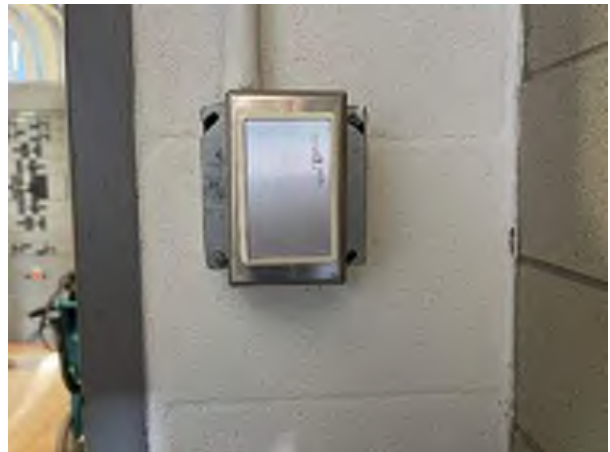
Figures 19 through 22 show the typical thermostats that are installed in the building. Most thermostats are of similar vintage and are JCI T-5002 Room Temperature Transmitter. Given the vintage of these units, they should be considered for upgrade to new smart thermostats that provide more data points. This will allow for deployment of deeper space setbacks and more efficient space comfort management.

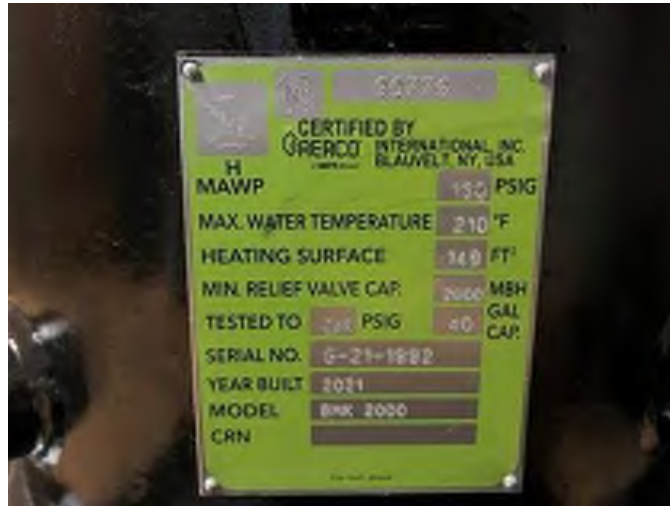
During JCI's site audit, the boilers serving the building were in the process of being replaced. Only one boiler was installed and connected at the time of the audit. In reviewing the mechanical drawings in the boiler room, it is understood there will be a total of two 2,000 MBH Aerco condensing boilers installed to serve the building. Figure 23 shows the nameplate of the newly installed Aerco boiler.

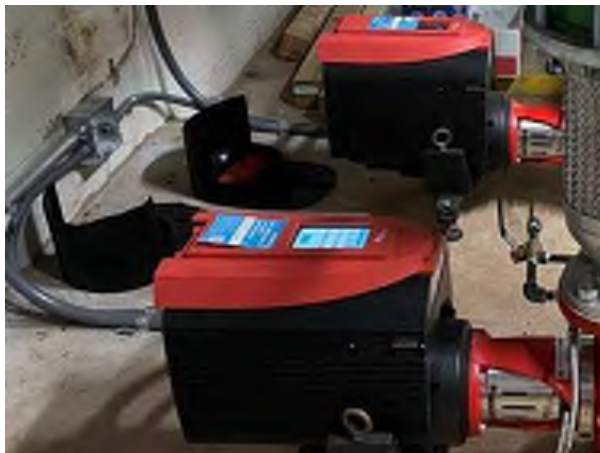
Figure 24 shows the new hot water pumps installed in the boiler room. These Armstrong pumps are high efficiency and allow for deeper energy saving through highly efficient parallel pump operation. At the time of the audit, these pumps were set to “hand” operation as the boiler plant was in the Installation Phase during the time of the audit.

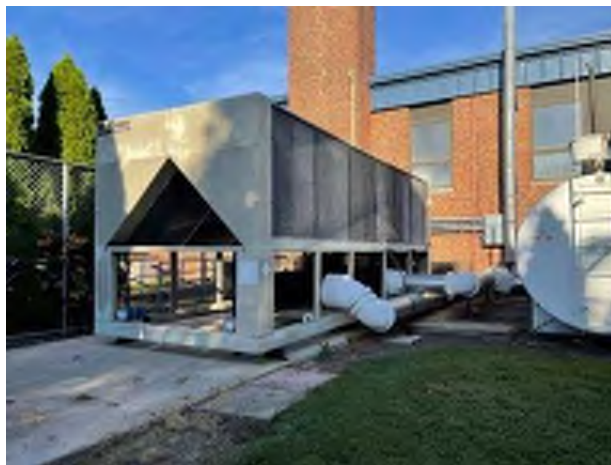
Figure 27

Air conditioning is provided to most spaces of the building by an air-cooled chiller that appears to be a fair to good condition and is shown in Figure 27. The chiller plant will benefit from minor retro-commissioning including inspection and verification that the condenser fan motors are operating freely and as intended.

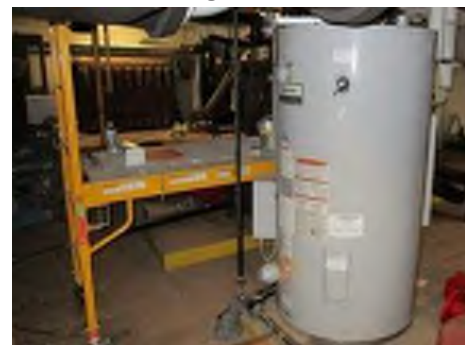
Figure 32

Domestic hot water is supplied to the kitchen and restrooms by one AO Smith burner rated at 199,000 Btu/hr, located in the boiler room and shown in Figure 32.

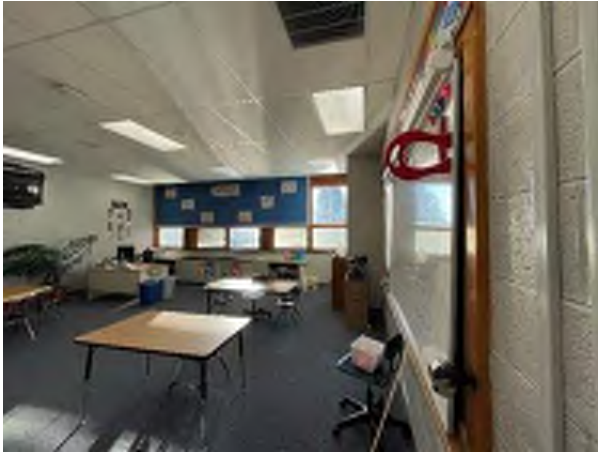
Figure 37

A sizeable quantity of fixtures in the building are T-8 fixtures with electronic ballasts. Some spaces such as the main gymnasium have been converted to LED. The T-8 fixtures are generally in good condition; nevertheless, upgrades to LED systems should be considered to reduce overall electric energy consumption in the building.

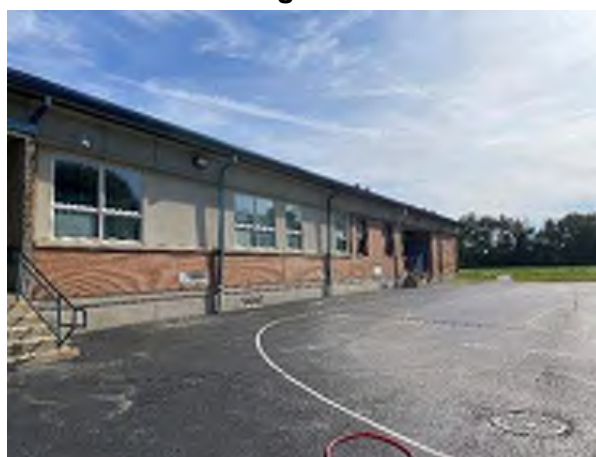
**Figure 2**

The windows that are installed are double-pane, mostly awning style in aluminum frames with interior frames in wood. Top sections of the windows systems are fixed and inoperable. Windows in the building are in good condition and are shown in Figures 1 and 2.

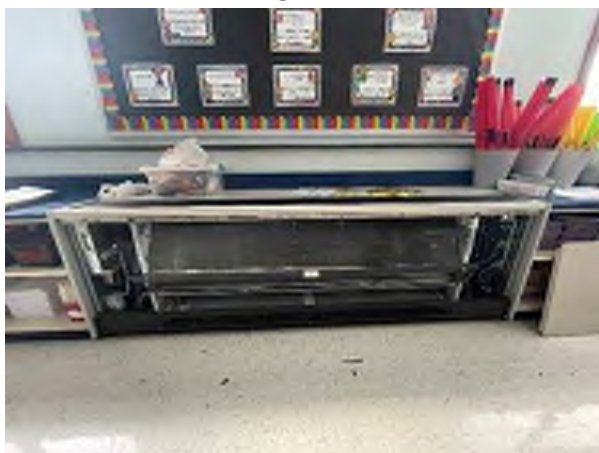
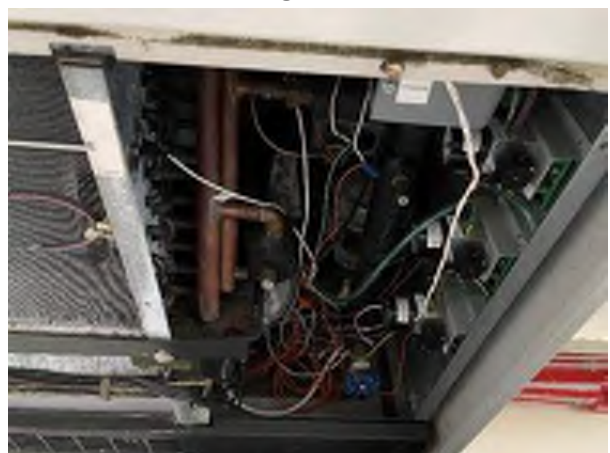
The building's ventilation is primarily through mechanical ventilation. The building is served by AHUs, fan coil units and unit ventilators. The AHUs serve large spaces and can vary the amount of air flow to these spaces for energy efficient operation. These systems along with the unit ventilators work in conjunction with relief vents and exhaust fans in the building to ensure proper air circulation. Figures 5 and 6 show the different type of installed HVAC systems.

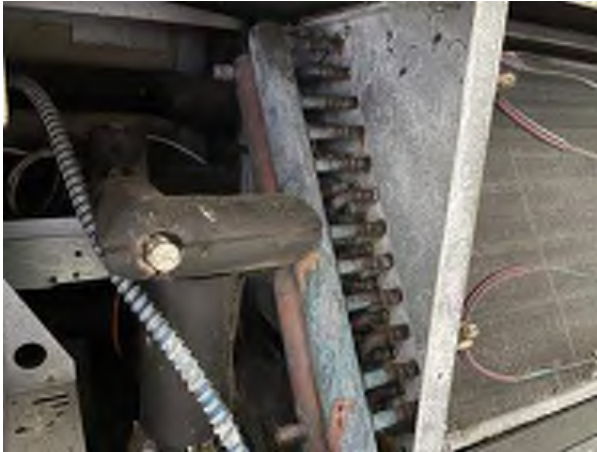
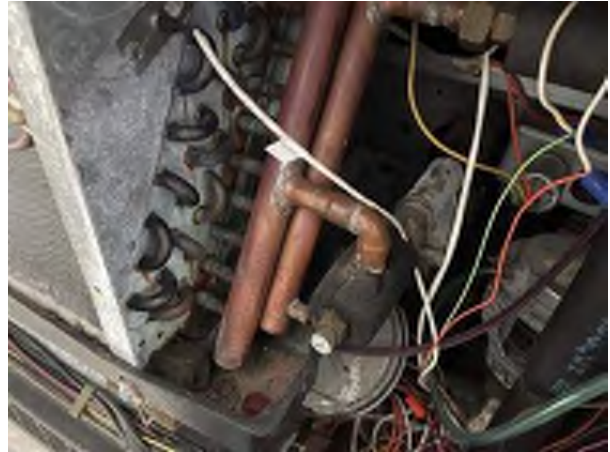
A sample set of unit ventilators were opened and these appeared to be in fair to poor condition and are nearing the end of its useful life. It is recommended these units be upgraded to avoid high maintenance expenditure and downtime. Figures 7 through 14 show some of the observations made on the sample unit ventilators inspected during the audit. Damaged fin coils and corrosion on pipes and tubes was consistent in the unit ventilators opened for inspection.

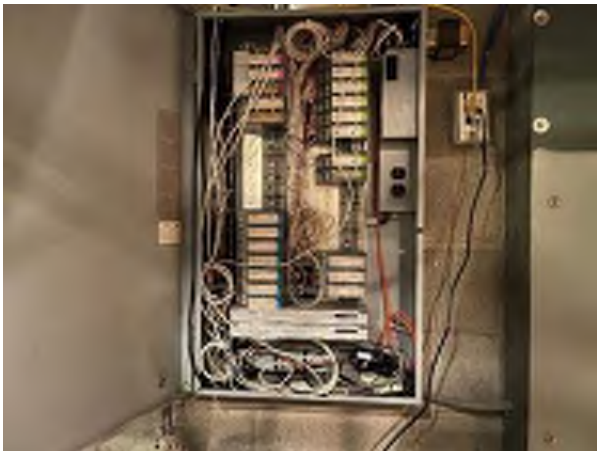
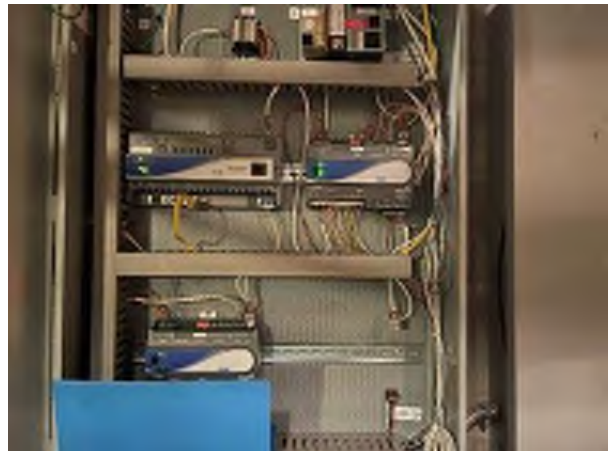
The HVAC equipment installed is controlled by a DDC Siemens Apogee system which appears to be integrated into a JCI supervisory controller, both of which are located in the boiler room and shown in Figures 9 and 10. Additional field pneumatic controllers are located mechanical rooms and within unit ventilators. The compressor providing air to the pneumatic controls and a large valve controller are shown in Figure 11 and 12.

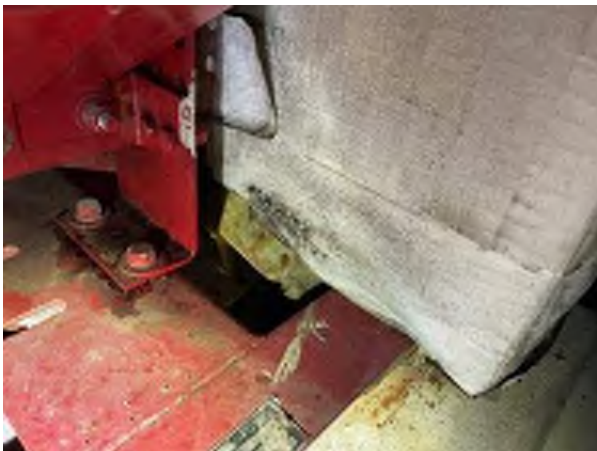
During the audit JCI noticed evidence of flooding in the basement of the building shown in Figure 13 and 14. While it is unclear how often flooding happens in the basement, high water levels can contribute to humidity issues. The thermostats in the building should be considered for upgrade (as part of a DDC upgrade) to new smart thermostats that provide humidity monitoring in addition temperature control. This will firstly help identify specific areas in the building that have humidity issues and allow for deployment of localized mitigation strategies including closing outside dampers and localized dehumidification.

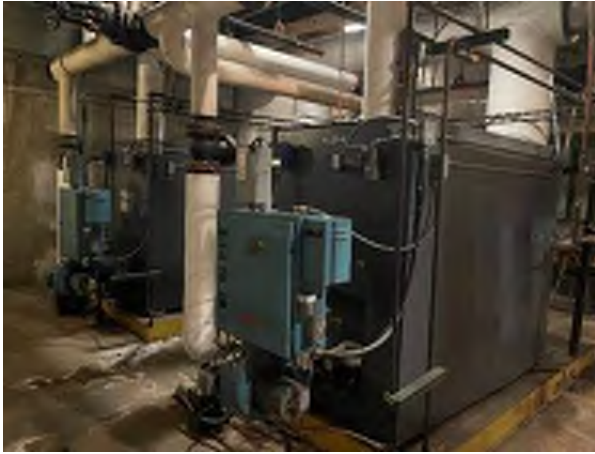
Figure 15

Two boilers are installed to provide hot water for the heating of the building, shown in Figure 15. The burner system for the boiler is shown in Figure 16. The Weil-McLain boilers have Webster burners, are dual-fuel and are of identical capacity and in good working condition.

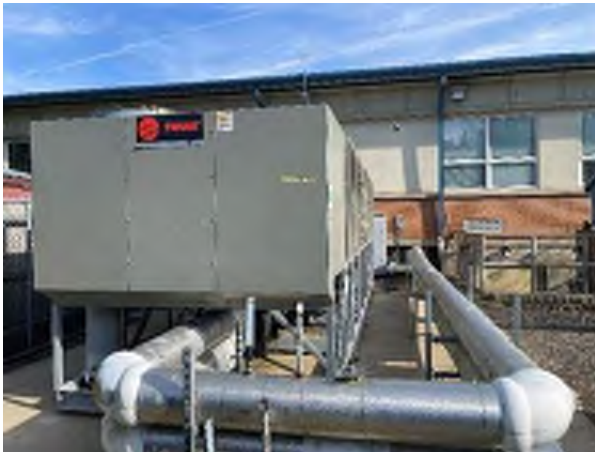
Figure 17

Air condition is provided by a ground mounted air-cooled chiller shown in Figure 17. The Trane chiller has a fair amount dust/debris build-up as shown in Figure 18 and will likely see increased efficiency from retro-commissioning.

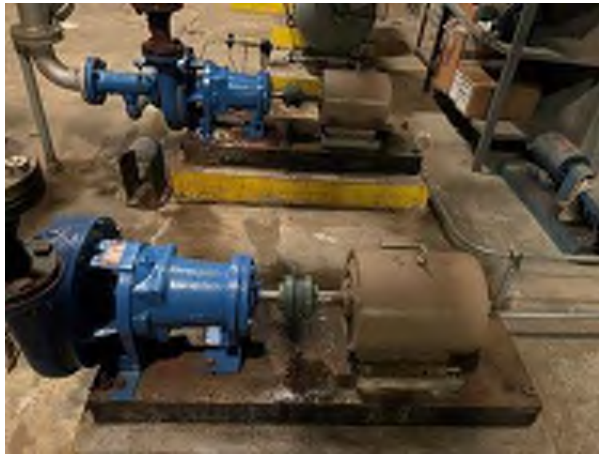
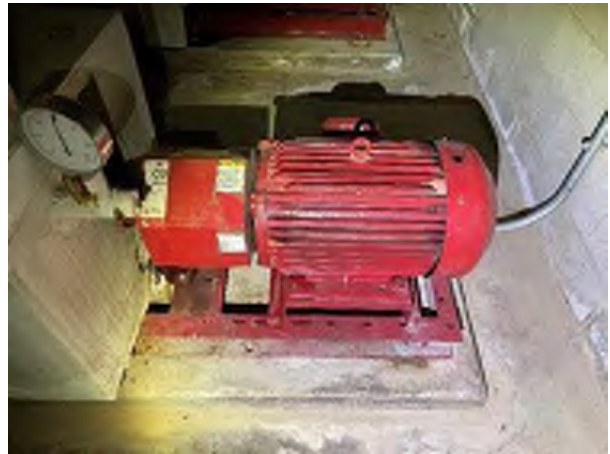
The conditioned water is circulated to unit ventilators and AHUs using pumps located in the boiler room. The overall circulation system is in fair condition and is shown in Figures 19 and 20. The existing pump motors are standard efficiency and shall be considered for upgrade to higher efficiency motors.

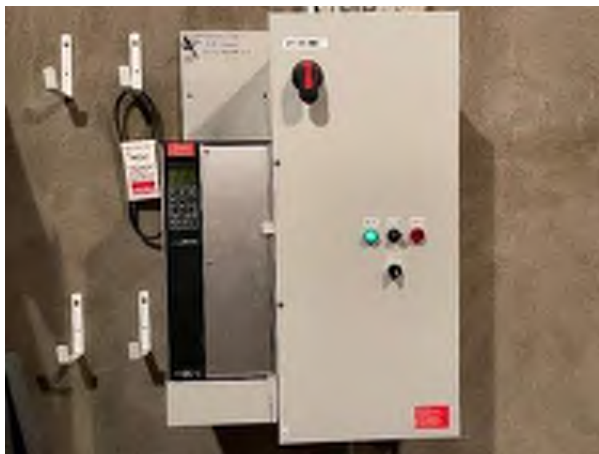
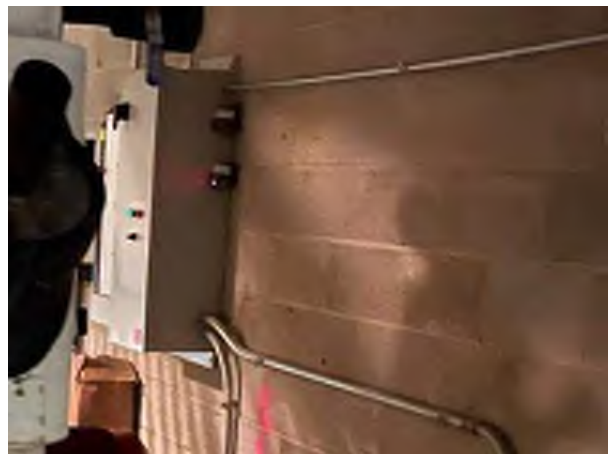
Both existing hot water and chilled water pumps have VFDs to allow for scaled back operation of the water loops during unoccupied and low-demand periods of time. These VFDs for the hot water and chilled water systems are shown in Figure 21 and 22.

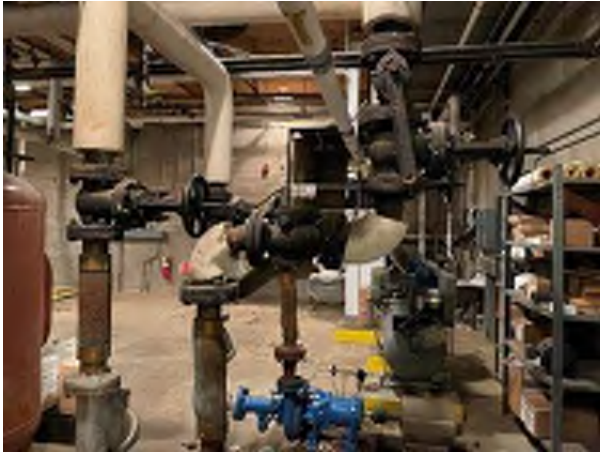
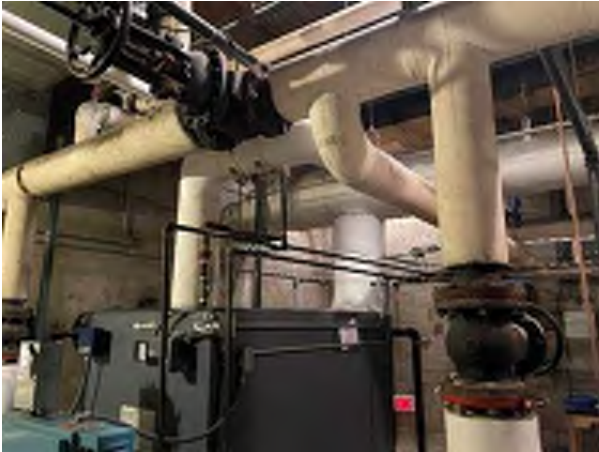
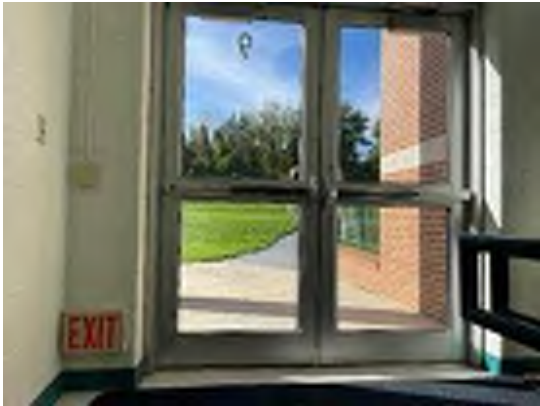
A fair amount of building envelope and insulation opportunities were observed during the site audit. In general, all water damaged insulation should be replaced as their integrity has been compromised. A sample of the opportunities identified during the audit and are shown in Figures 23 through 25.

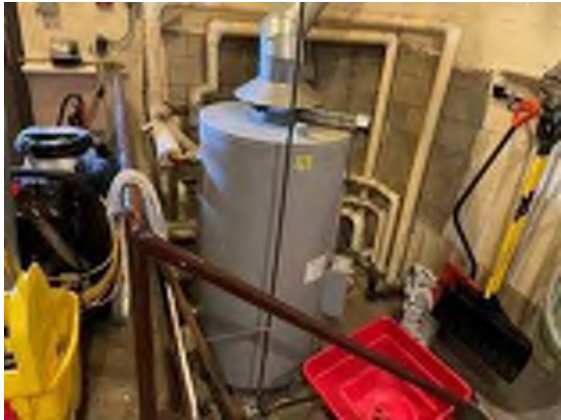
Figure 26

Domestic hot water is supplied to the kitchen and restrooms by one AO Smith burner rated at 199,000 Btu/hr located in the boiler room and shown in Figure 26.

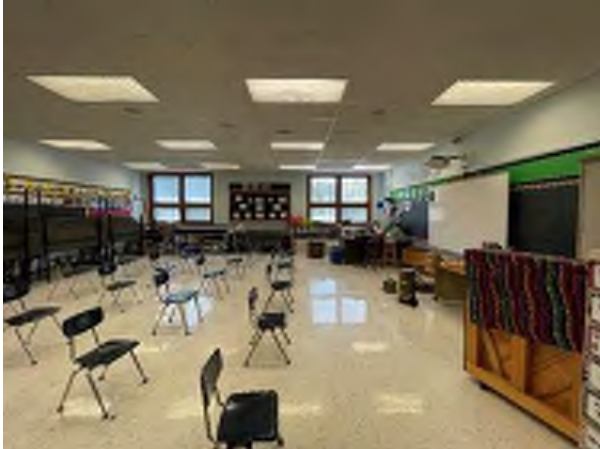
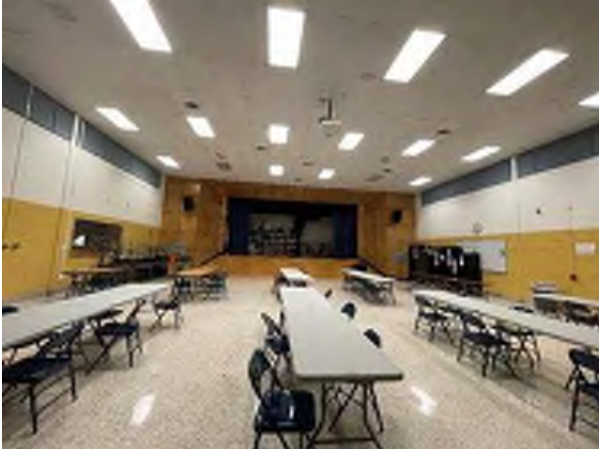
A sizeable quantity of fixtures in the building are T-8 fixtures with electronic ballasts. The fixtures are generally in good condition; nevertheless, upgrades to LED systems should be considered to reduce overall electric energy consumption in the building.

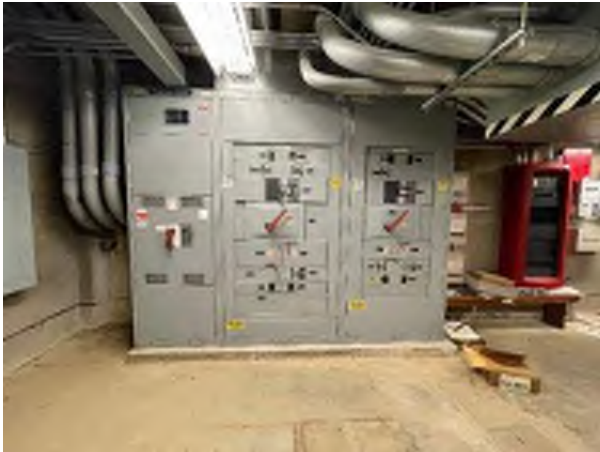
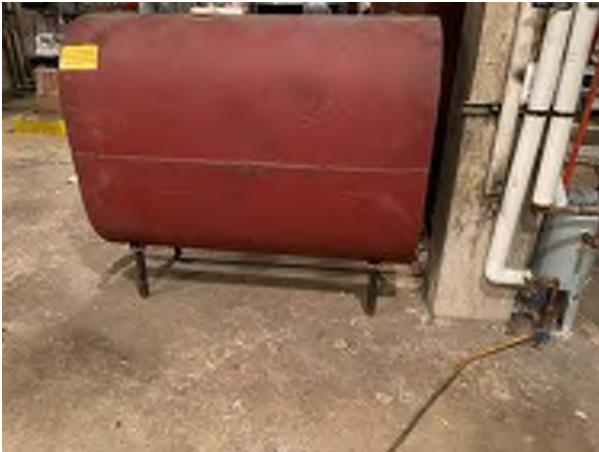
On the electric side, the building is provided with secondary, three-phase service by PECO and have a total capacity of 2,000 amps. The building also has natural gas service for the boilers and kitchen use. The building also has a 275-gallon fuel storage tank in the boiler room.

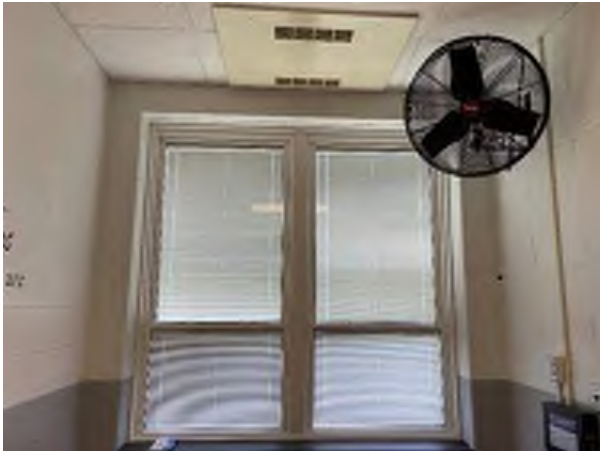
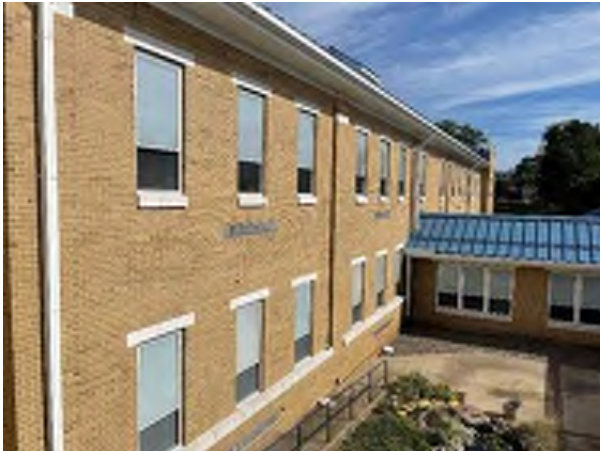
The windows that are installed are double-pane, single hung style in aluminum frames and are in good condition, shown in Figures 1 and 2.

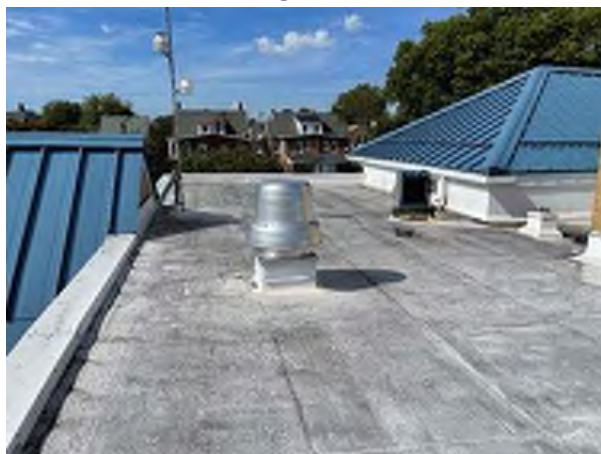
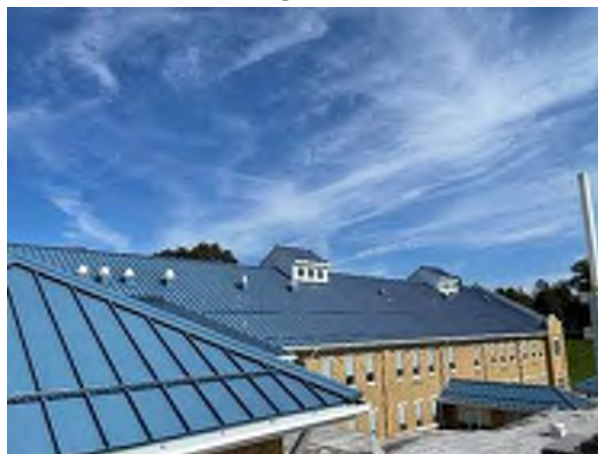
The roof installed is mostly pitched metal and appears to be in good condition. Small sections of the roof with mechanical equipment are flat roof.

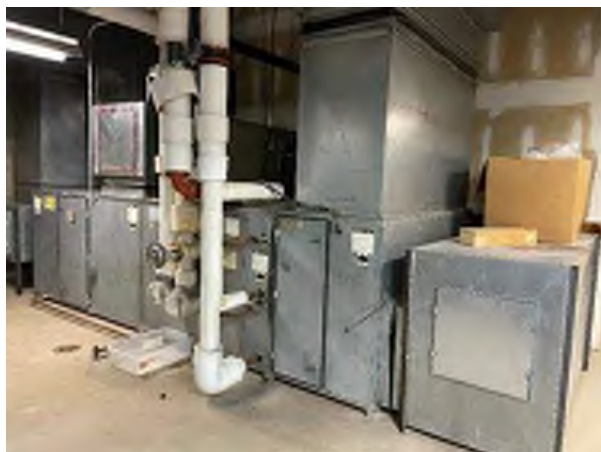
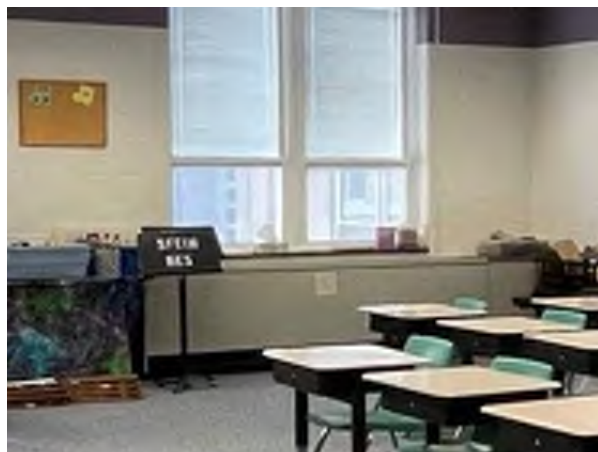
The building's ventilation is primarily through mechanical ventilation. The building is served by AHUs, fan coil units and unit ventilators. The AHUs serve large spaces and can vary the amount of air flow to these spaces for energy efficient operation. These systems along with the unit ventilators work in conjunction with relief vents and exhaust fans in the building to ensure proper air circulation. Figures 5 and 6 show the different type of installed HVAC systems.

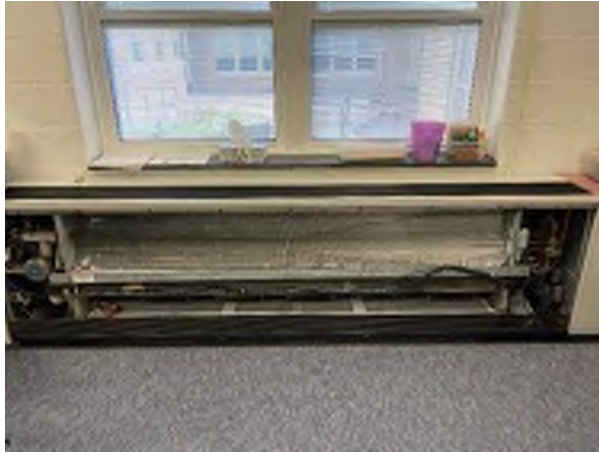
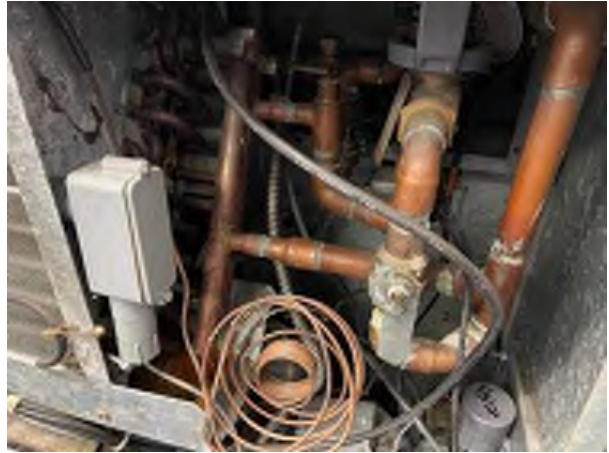
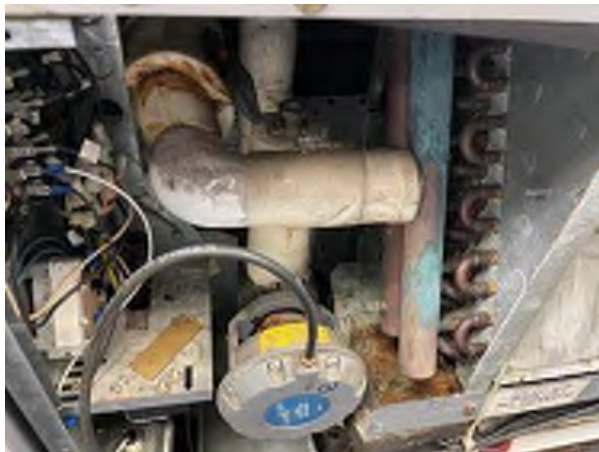
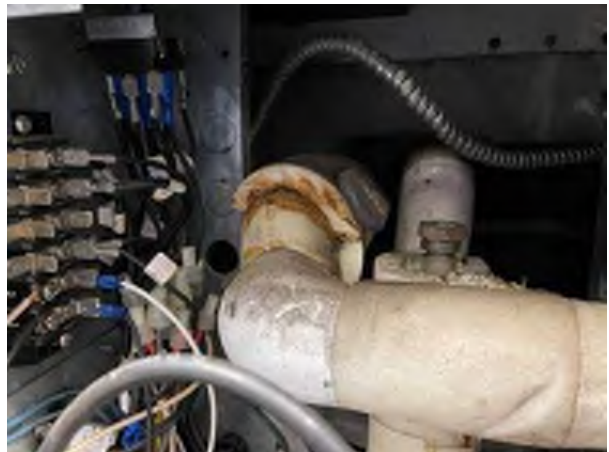
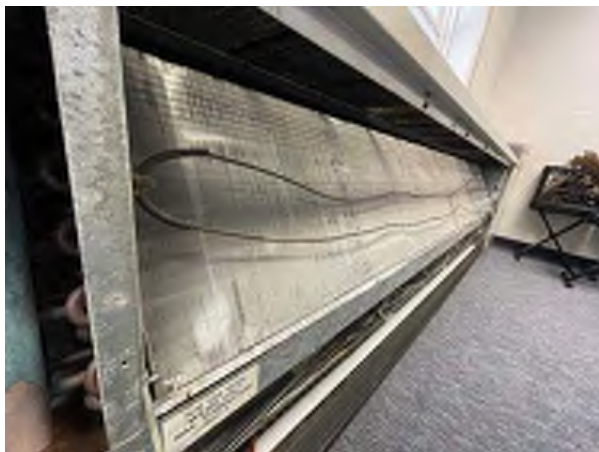
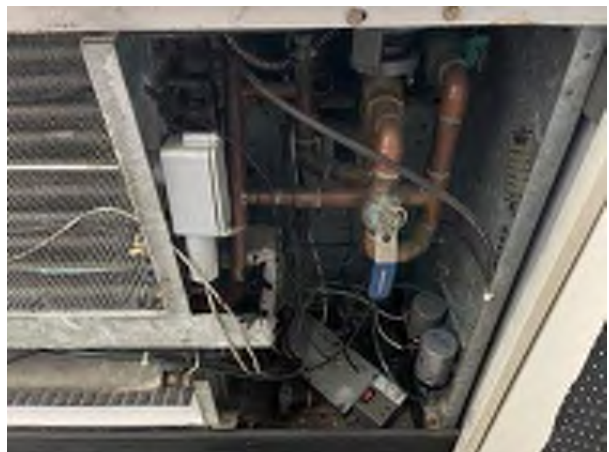
A sample set of unit ventilators were opened and these appeared to be in fair to poor condition and are nearing the end of its useful life. It is recommended these units be upgraded to avoid high maintenance expenditure and downtime. Figures 7 through 14 show some of the observations made on the sample unit ventilators inspected during the audit. Damaged fin coils and corrosion on pipes and tubes was consistent in the unit ventilators opened for inspection.

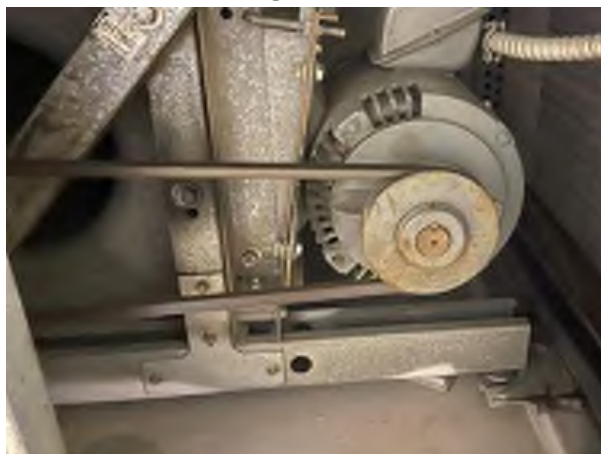
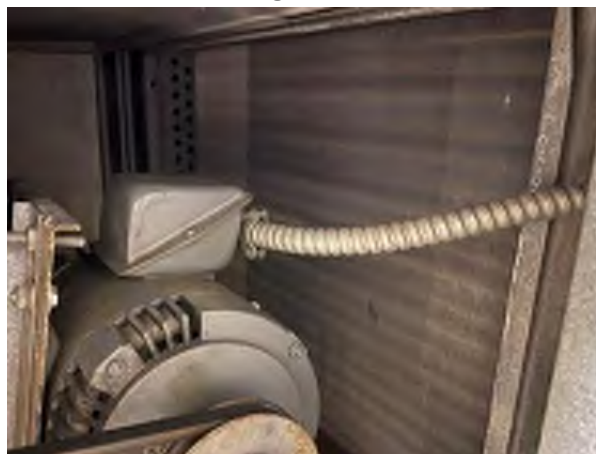
A sample set of AHUs were opened for inspection. While the AHUs in the building are generally in good condition, these units will also benefit from retro-commissioning.

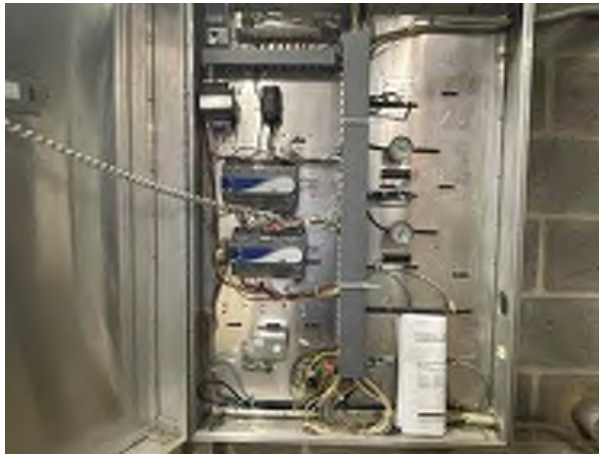
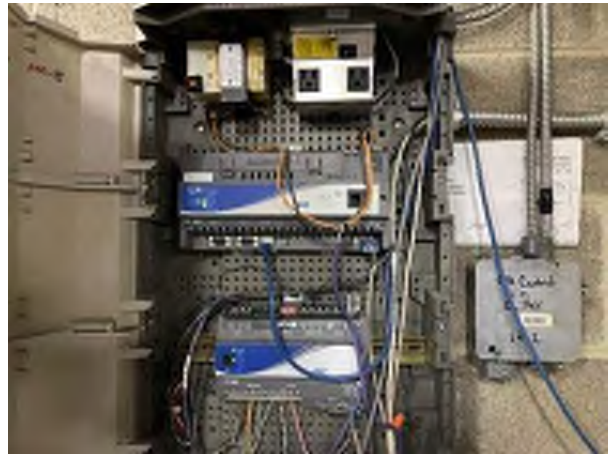
The HVAC equipment installed is controlled by a DDC JCI system located in the boiler room shown in Figures 17 and 18. Additionally, pneumatic controllers are located in mechanical rooms and within unit ventilators as shown in Figures 19 and 20. A compressor located in the boiler room provides air to the pneumatic controls in the building.

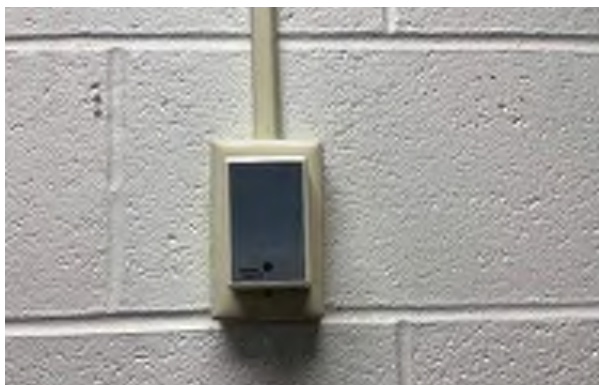
Figure 21

Figures 21 and 22 show the typical thermostats that are installed in the building. Most thermostats are of similar vintage and are Johnson Controls T-5002 Room Temperature Transmitter. While these temperature sensors are a recent install, they should be considered for upgrade (as part of a DDC upgrade) to new smart thermostats that provide more data points. New smart thermostats have additional built-in features that allow for deployment of deeper space setbacks and more efficient space comfort management.

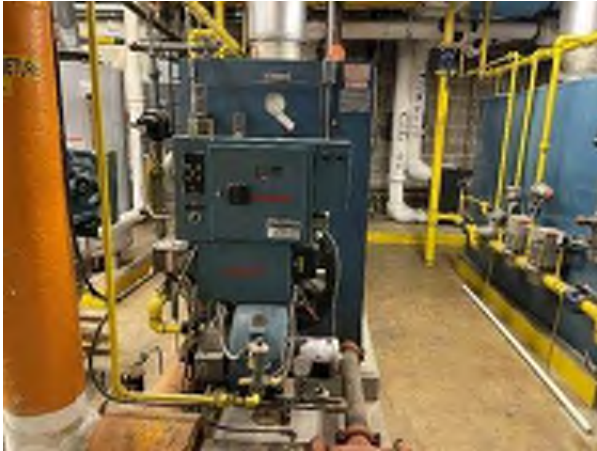
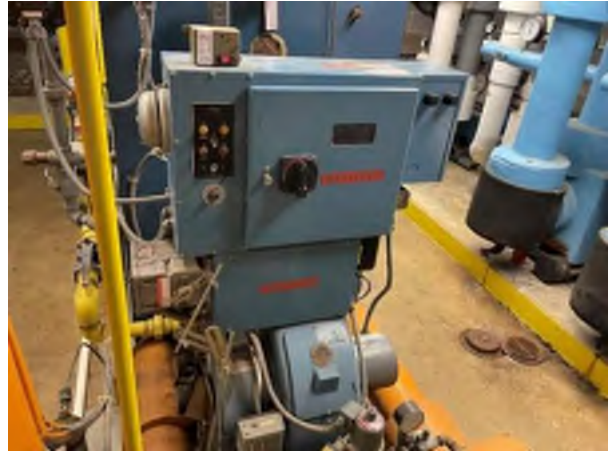
Two boilers are installed to provide hot water for the heating of the building, shown in Figures 23 and 24. The Burnham boilers that have Webster burners are gas-fired and are of identical capacity and in good working condition.

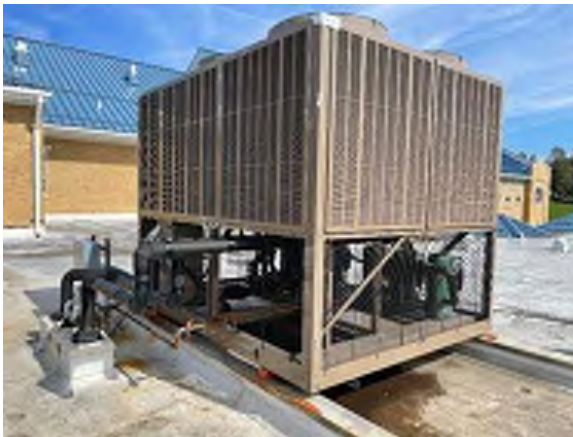
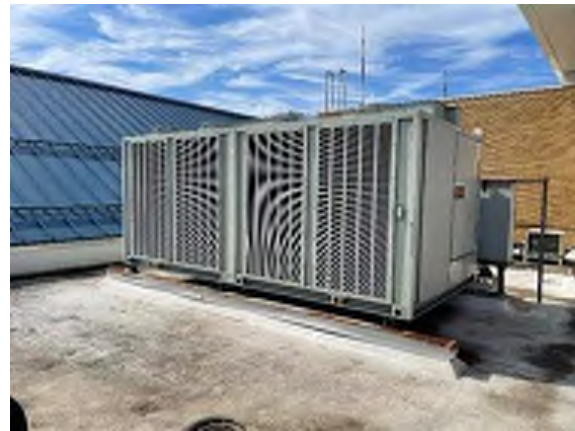
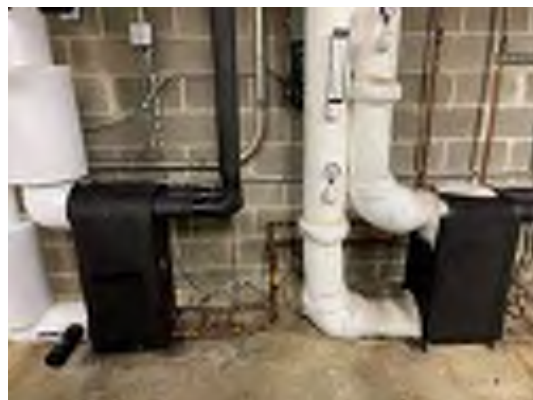
Air condition is provided by two air-cooled split-barrel chillers located on the roof with plate-and-frame heat exchangers located in the boiler room. These units are shown in Figures 25 through 27. The Trane chiller is at the end of its useful life and should be considered for replacement.

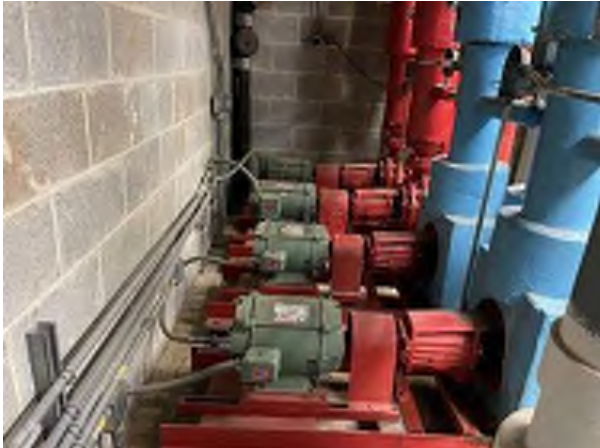
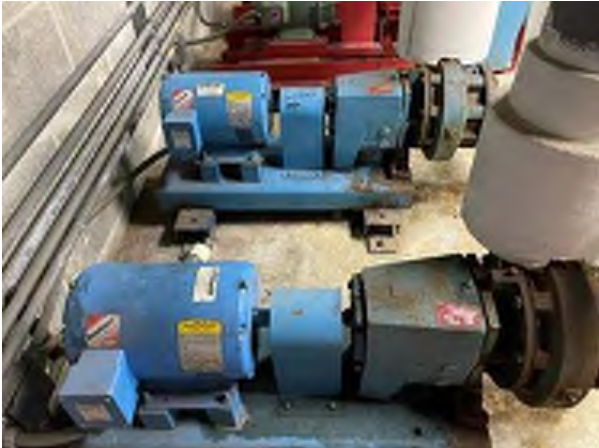
The conditioned water is circulated to unit ventilators and AHUs utilizing pumps located in the boiler room. The overall circulation system is in fair condition and is shown in Figures 28 and 29. The existing pump motors are standard efficiency and shall be considered for upgrade to higher efficiency motors.

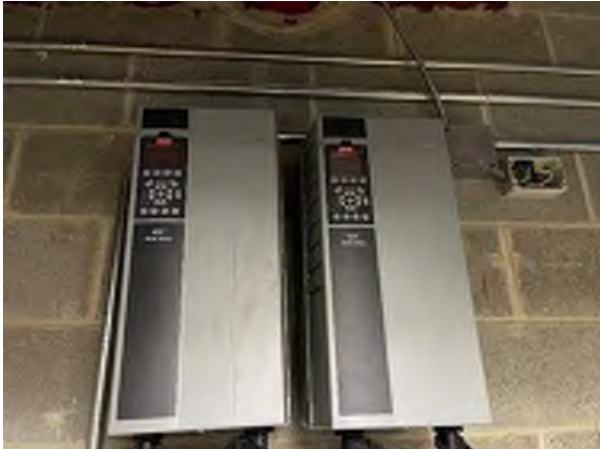
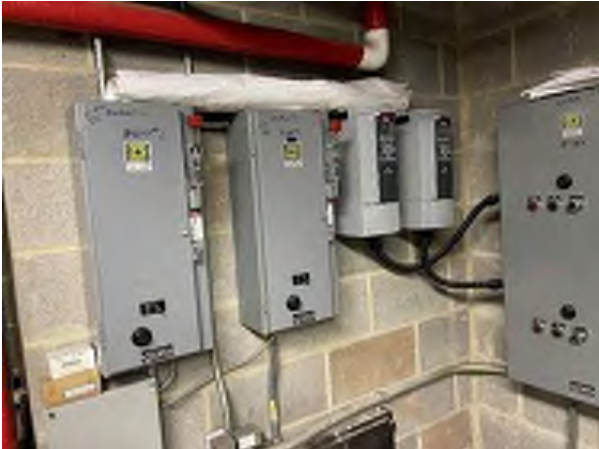
Both existing hot water and chilled water pumps have VFDs to allow for scaled back operation of the water loops during unoccupied and low-demand periods of time. These VFDs are shown in Figure 30 and 31.

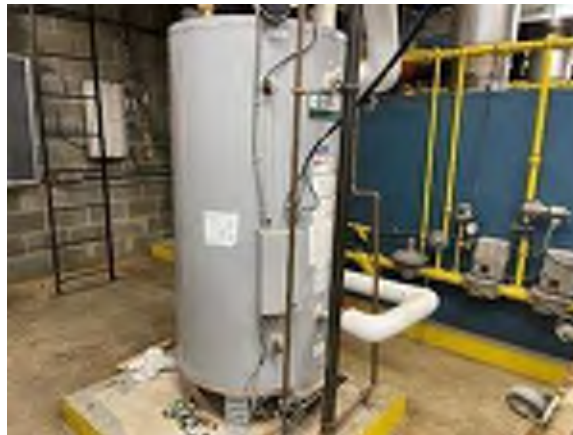
**Figure 34**

Domestic hot water is supplied to the kitchen and restrooms by one AO Smith burner rated at 199,000 Btu/hr located in the boiler room and shown in Figure 34.

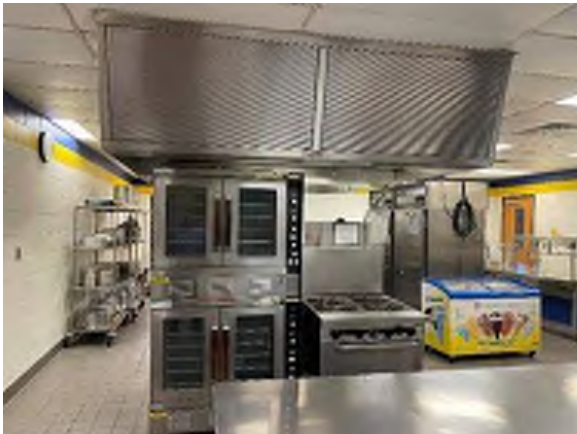
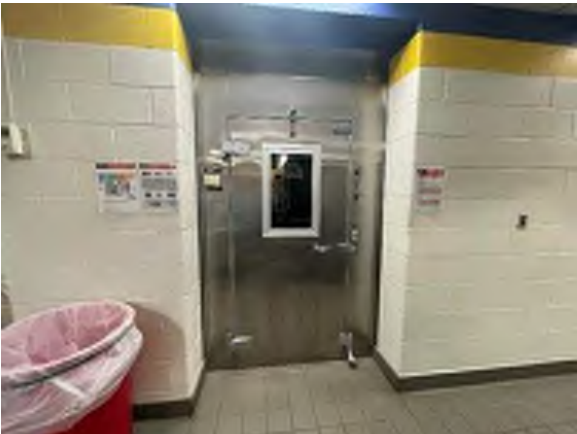
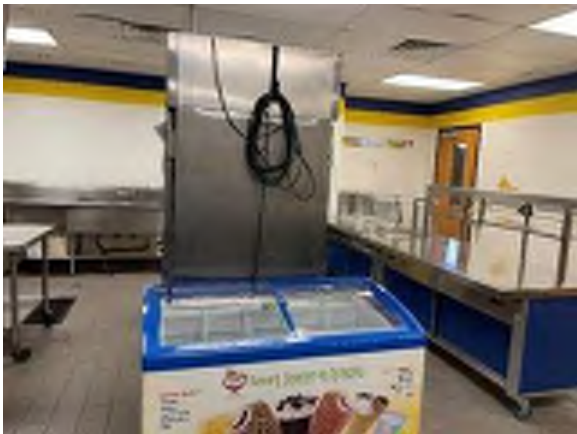
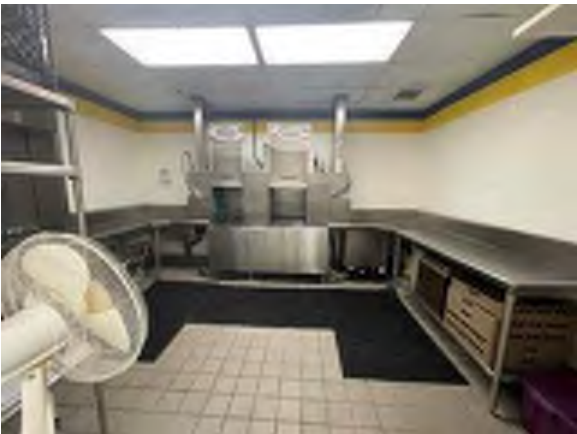
The building has a full functioning kitchen including a stove, pot/prep sinks and large refrigeration units. The kitchen exhaust hood is used each day when the school is in session, typically 7am to 2pm.

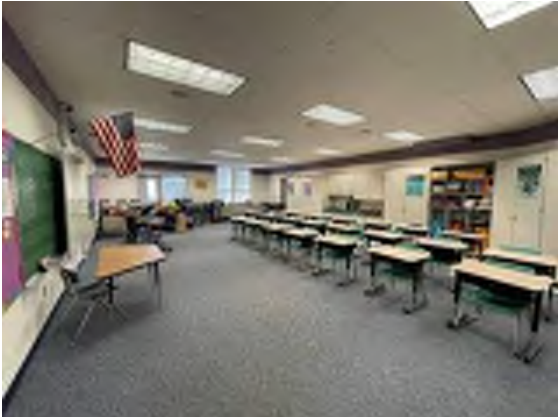
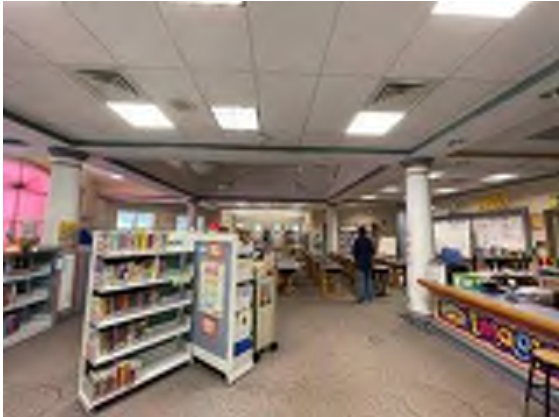
A sizeable quantity of fixtures in the building are T-8 fixtures with electronic ballasts. Some spaces such as the lobby and gym area have been converted to LED. The T-8 fixtures are generally in good condition; nevertheless, upgrades to LED systems should be considered to reduce overall electric energy consumption in the building.

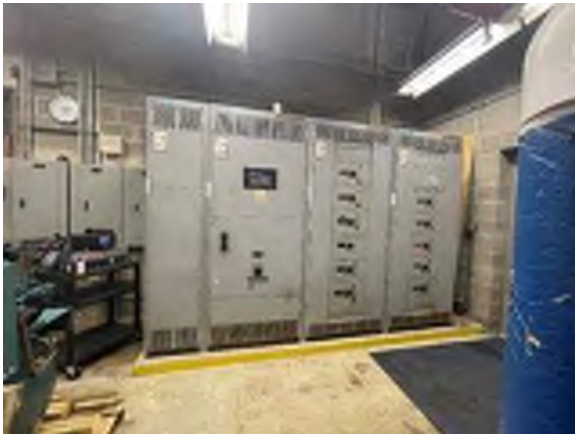
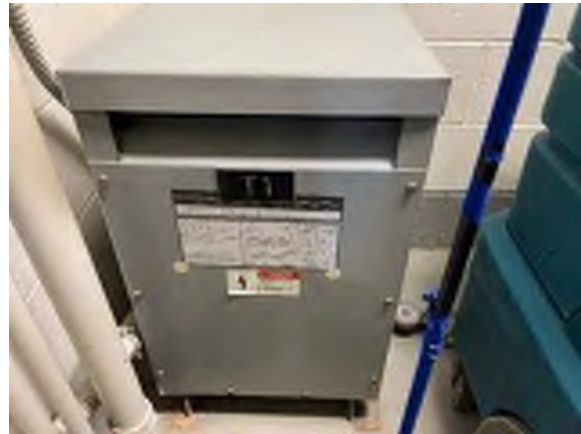
On the electric side, the building is provided with secondary, three-phase service by PECO and have a total capacity of 1,200 amps. The building also has natural gas service for the boilers and kitchen use.

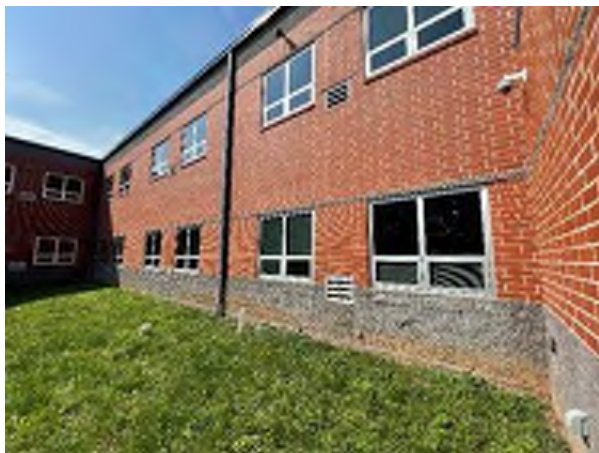
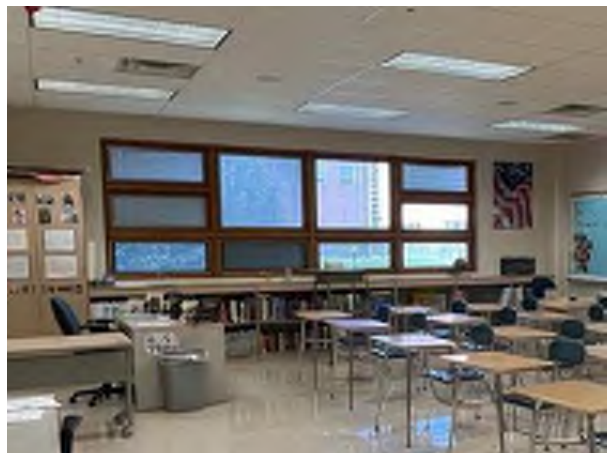
The majority of the windows that are installed are double-pane, awning style in aluminum frames, some with wood interior frames and are in good condition, shown in Figures 1 and 2.

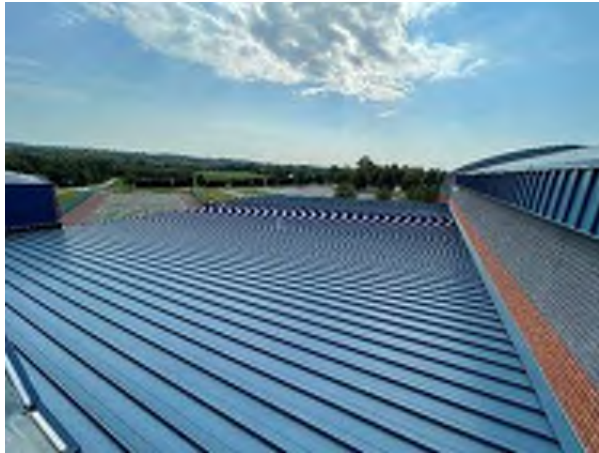
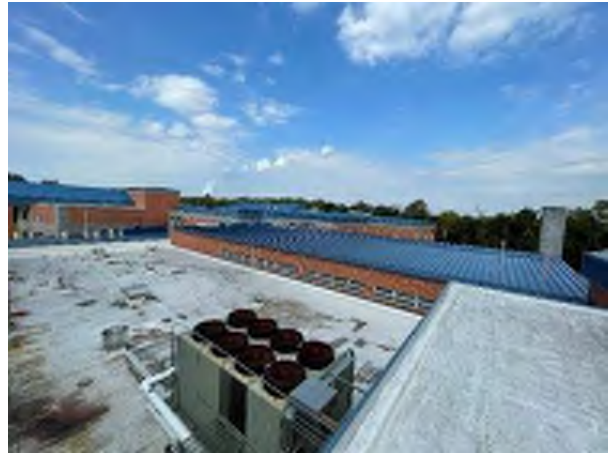
The roof installed is mostly pitched metal and appears to be in good condition. Small sections of the roof with mechanical equipment are flat roof and are in fair condition.
