# Spring-Ford Area School District

## Investment Grade Audit Report

**Submitted by:**  
Johnson Controls, Inc.

**August 2022**

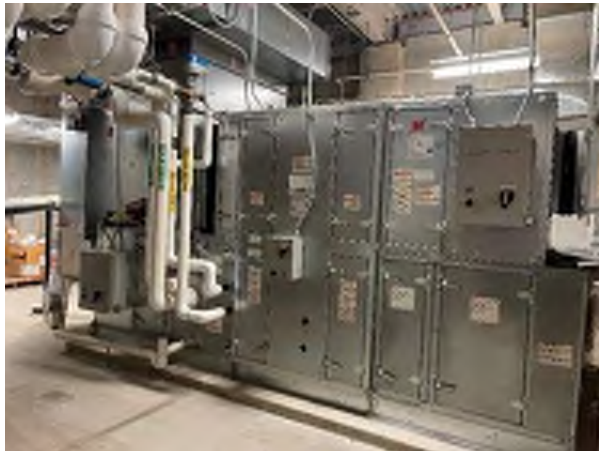
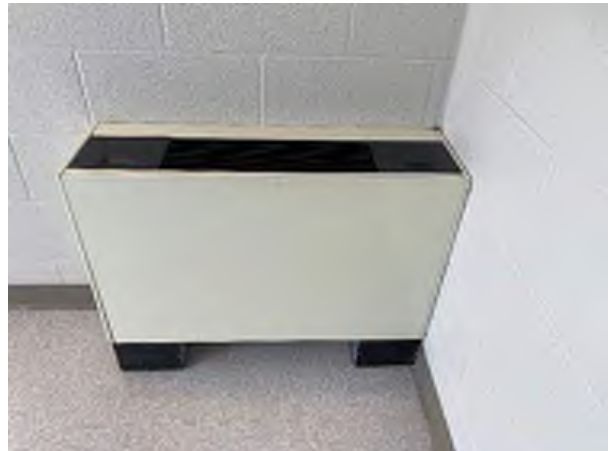
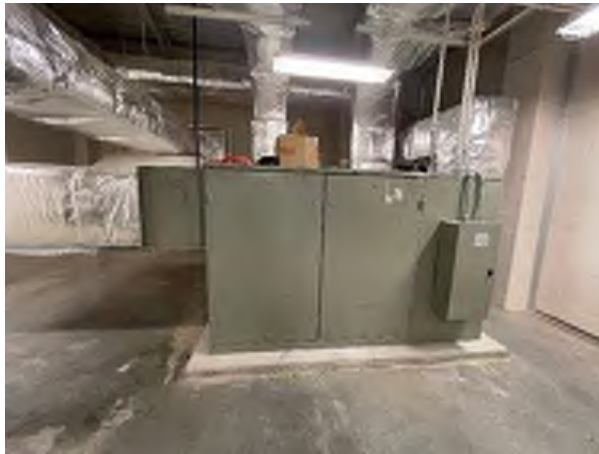
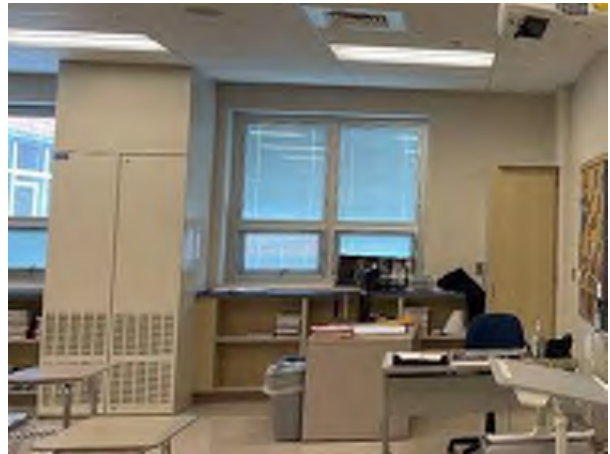
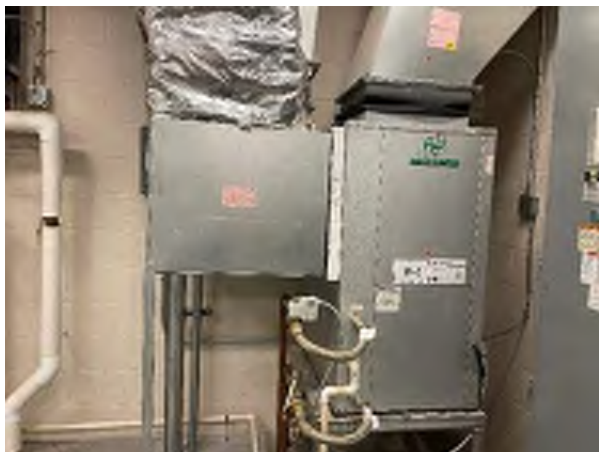
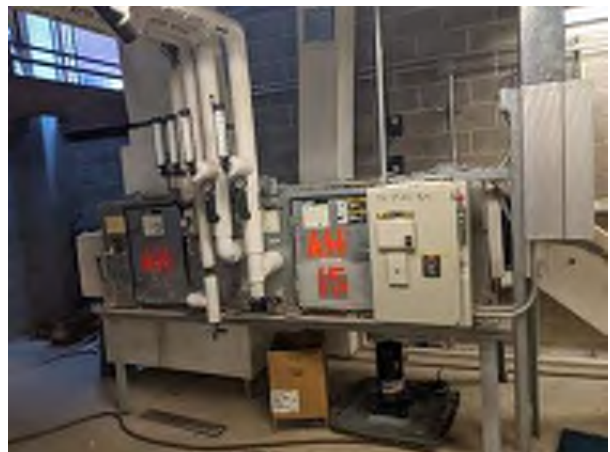
The building's ventilation is primarily through mechanical ventilation. The building is served by AHUs, fan coil units, heat pumps, energy recovery units, and unit ventilators. The AHUs serve large spaces and some wings of the building. The AHUs are constant volume and no VFDs were observed on the air-side equipment. These systems along with the unit ventilators work in conjunction with relief vents and exhaust fans in the building to ensure proper air circulation. Figures 5 through 10 show a sample of the installed HVAC systems.

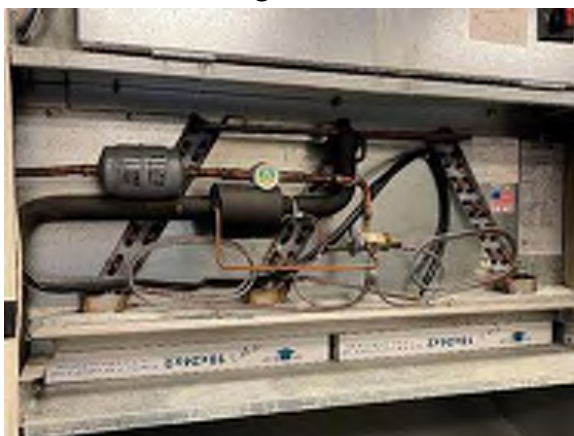
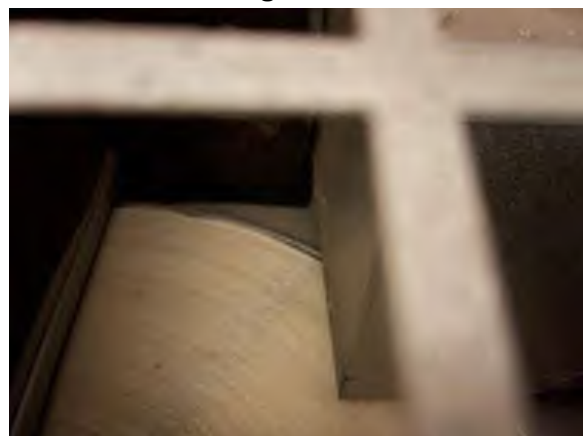
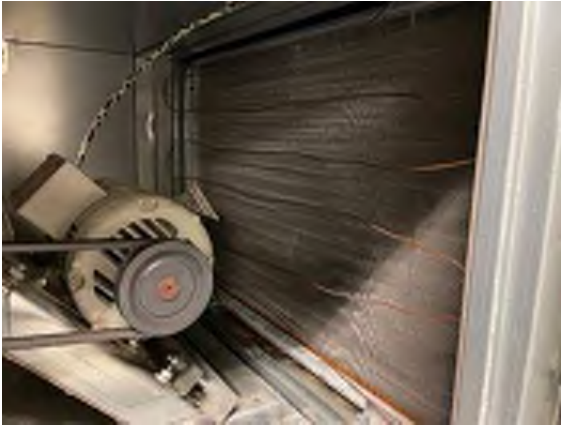
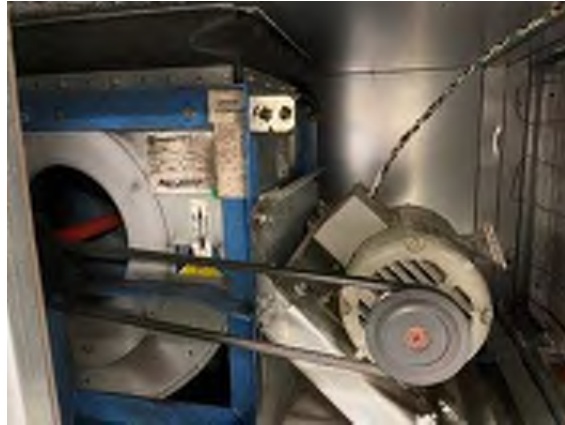
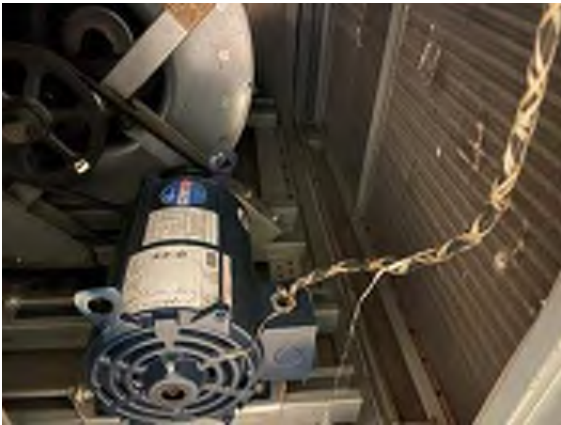
A sample set of air-side equipment were opened and these appeared to be in fair to good condition. It is recommended these units be retro-commissioned to restore system performance and extend its useful life. Figures 11 through 15 show some of the observations made during the audit. Some of the opportunities identified onsite include repairing damaged fin coils and cleaning heat wheels.

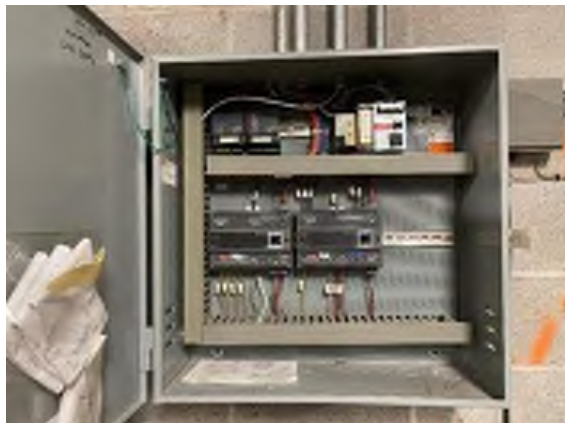
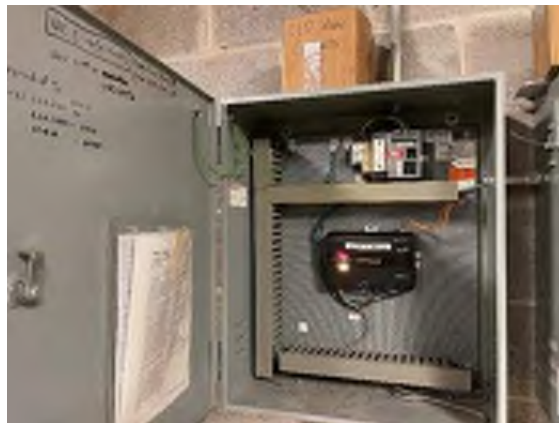
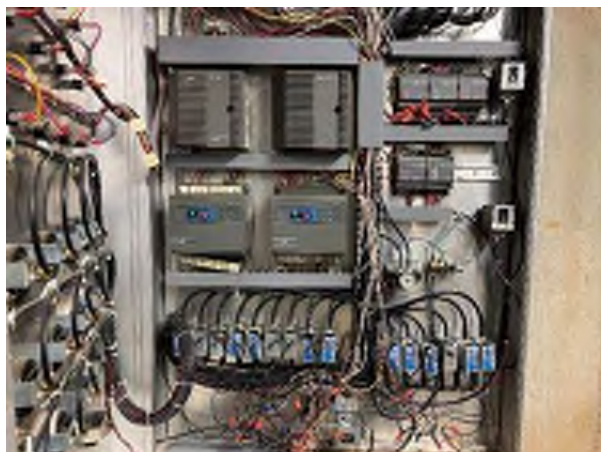
The HVAC equipment installed is controlled by a DDC JCI system located in the boiler room shown in Figures 17 through 20. Additional field pneumatic controls are serviced by a compressor located in the boiler room.

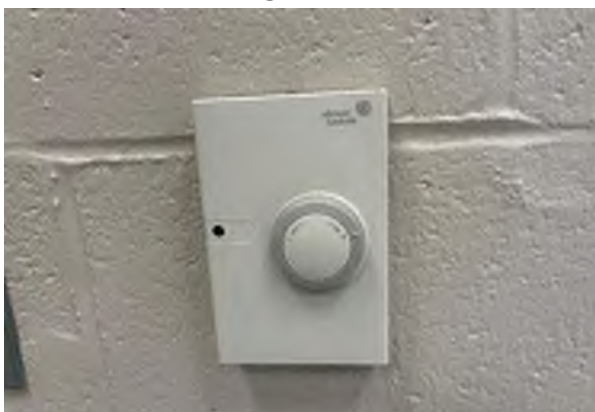
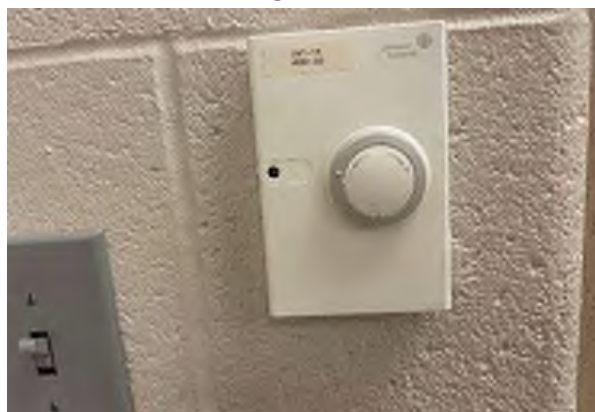
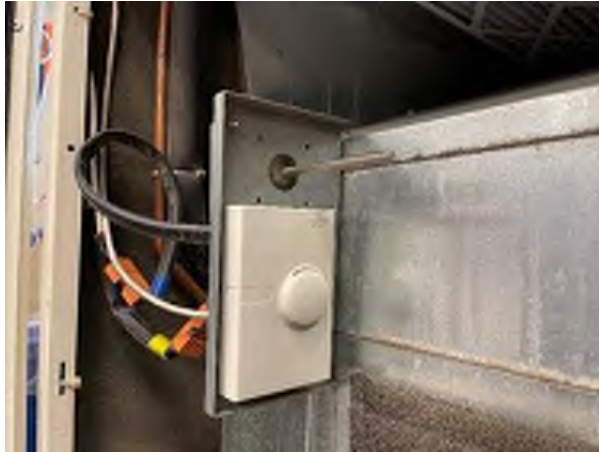
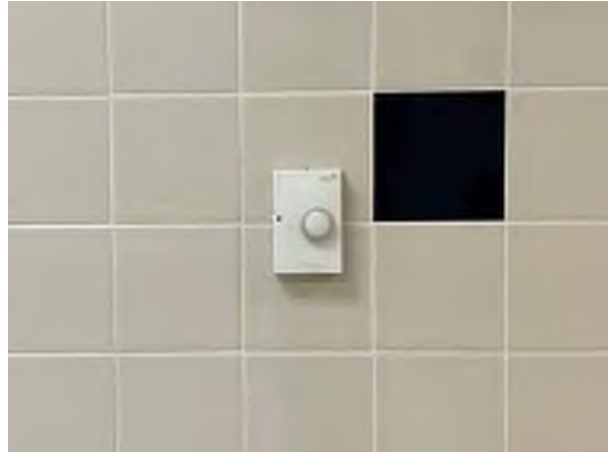
Figures 21 through 24 show the typical thermostats that are installed in the building. Most thermostats are of similar vintage and are Johnson Controls NS Series units. While these temperature sensors are a recent install, they should be considered for upgrade (as part of a DDC upgrade) to new smart thermostats that provide more data points. New smart thermostats have additional built-in features that allow for deployment of deeper space setbacks and efficient space comfort management.

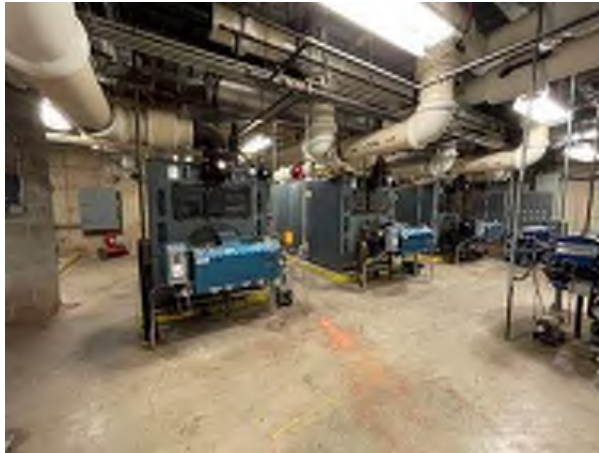
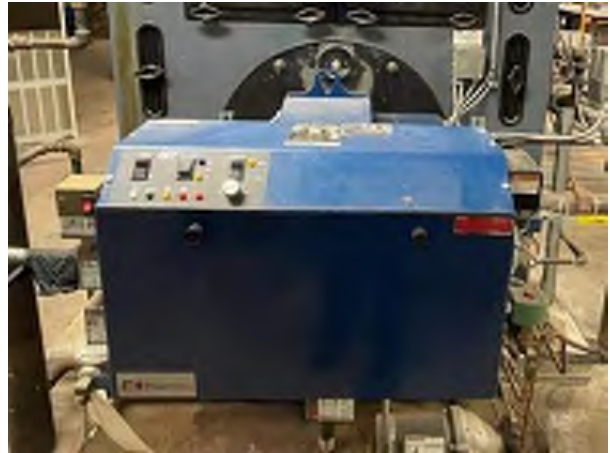
Four boilers are installed to provide hot water for heating the older wings of the building and are shown in Figures 25 and 26. All the Weil-McLain boilers have Powerflame burners that are dual-fuel, are of identical capacity and in fair condition given their age.

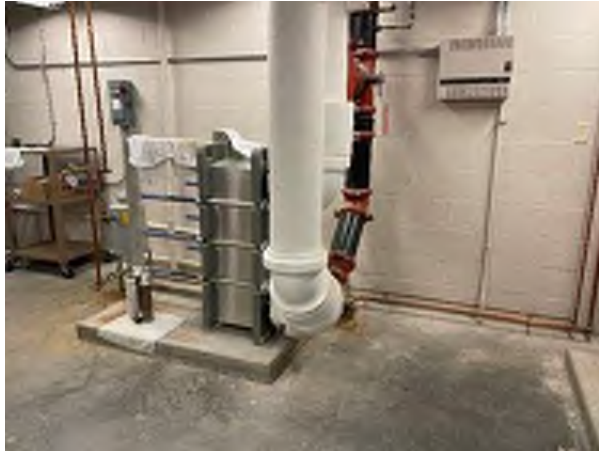
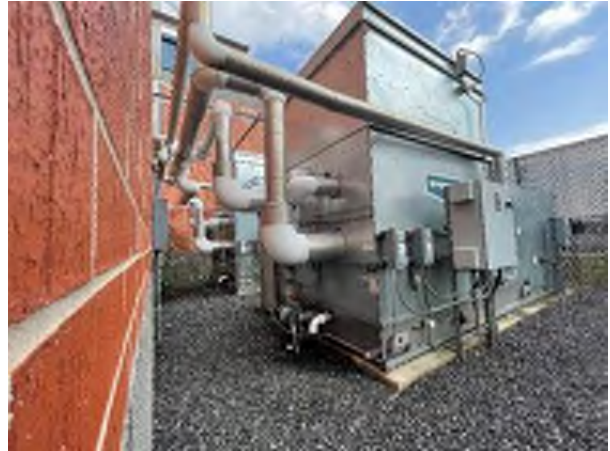
The newer wing of the building is served by water source heat pumps located within classrooms and mechanical rooms for both heating and cooling. The equipment that the water source heat pumps reject (or pick up) heat to/from are shown in Figure 27 and Figure 28.

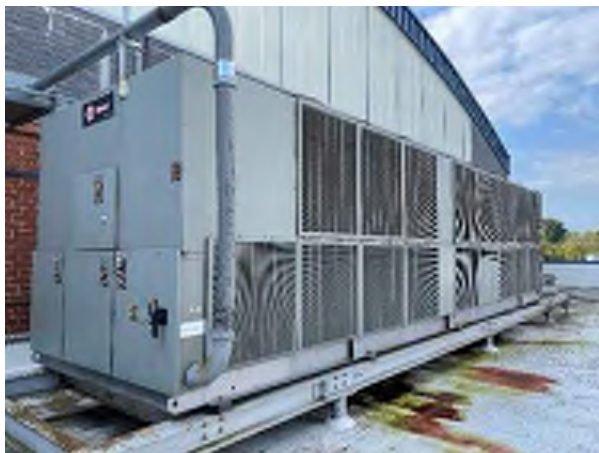
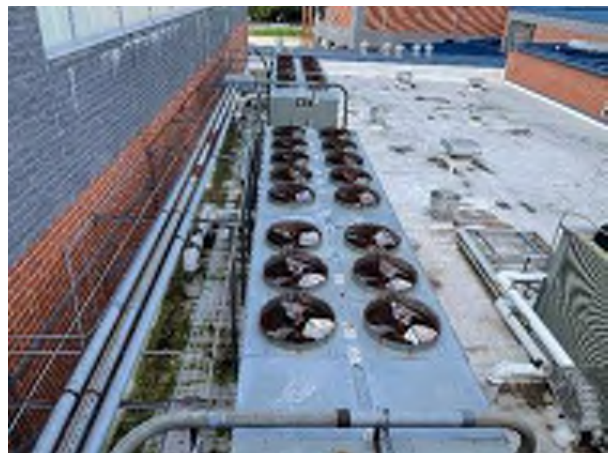
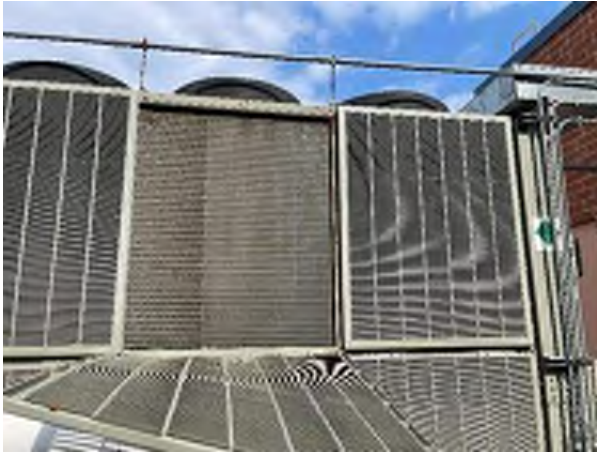
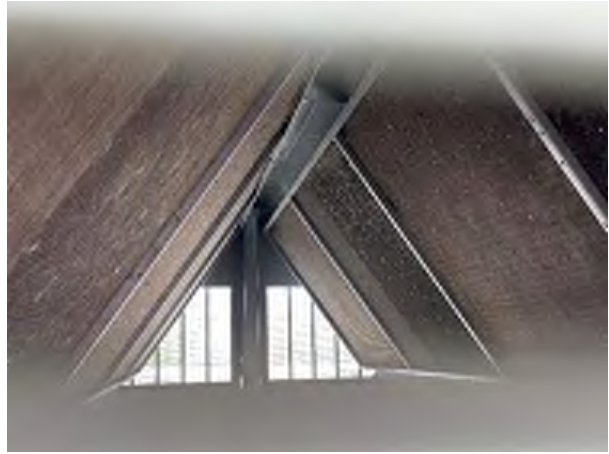
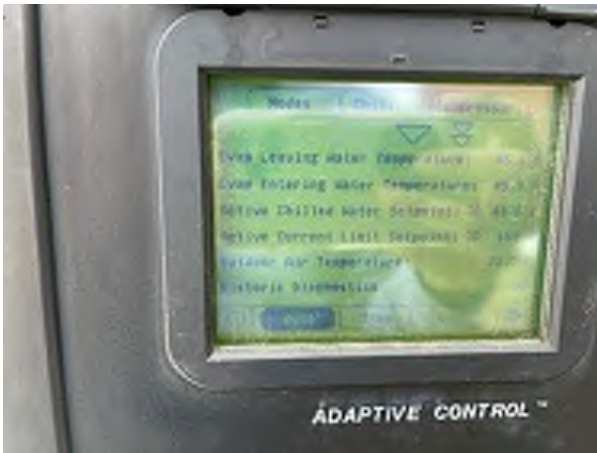
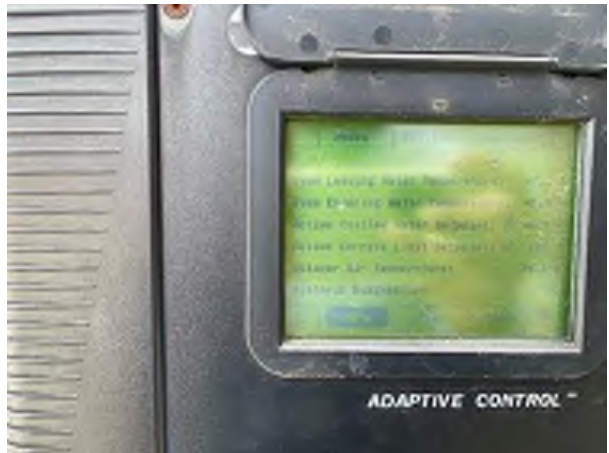
Air condition is provided to the old wing of the building by three air-cooled chillers located on the roof. These units and their operating parameters are shown in Figures 29 through 34. The controls pad on one of the units could not be accessed due to faulty touch sensors. Reviewing entering and leaving water temperatures on the other two Trane units showed inefficient operation. These Trane chillers will benefit from deep retro-commissioning which should help restore system performance and extend its useful life.

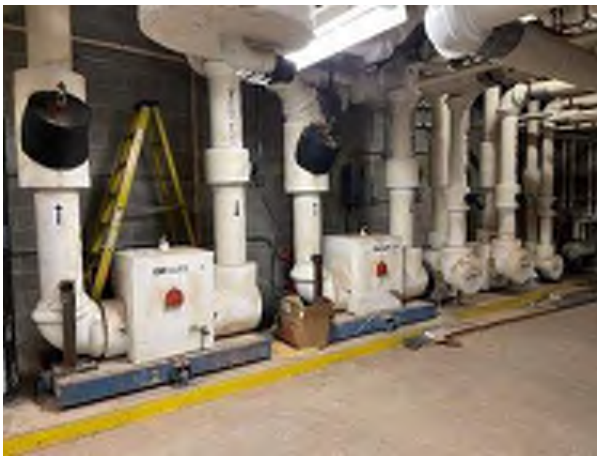
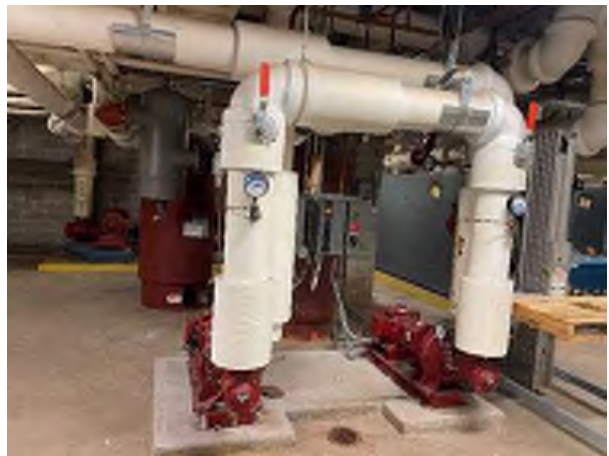
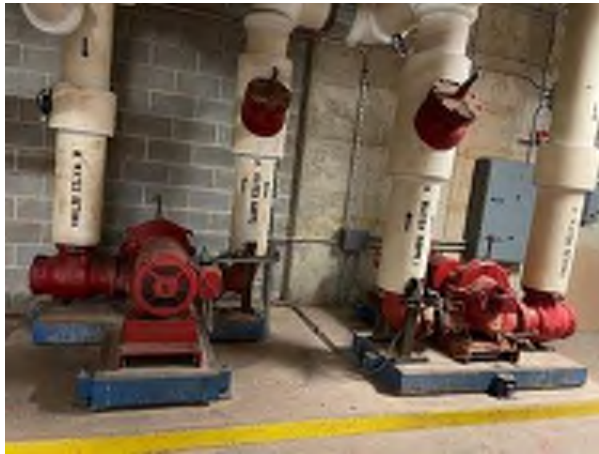
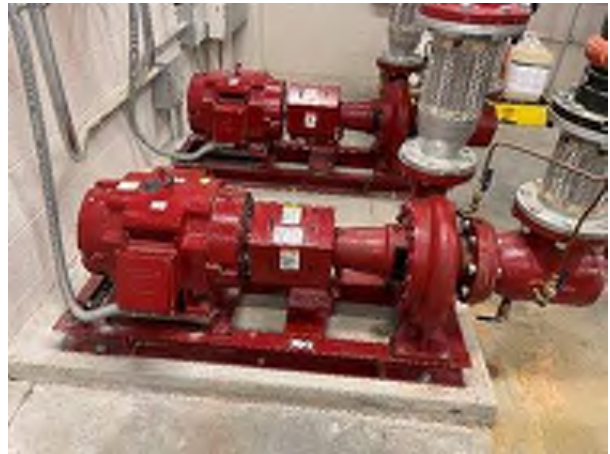
The conditioned water is circulated to unit ventilators and AHUs using pumps located various mechanical rooms. The overall circulation system is in fair to good condition and is shown in Figures 35 through 38. The existing pump motors are a mix of standard and premium efficiency.

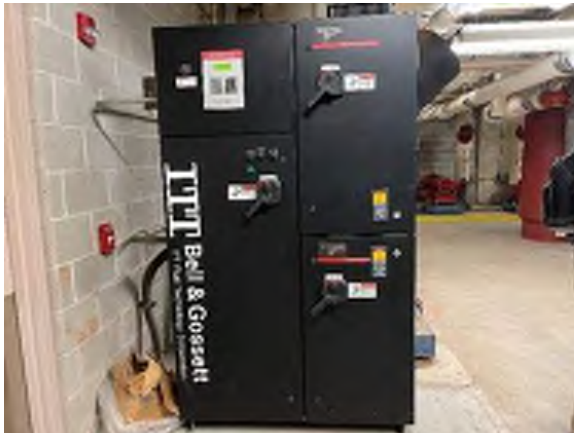
Figure 39

All existing heat distribution pumps have VFDs to allow for scaled back operation of the water loops during unoccupied and low-demand periods of time. The chilled water pumps are on a Bell&Gossett VFD package system, shown in Figure 39. There is a VFD on the primary hot water loop and is shown in Figure 40. At the time of the audit, it was unclear why this VFD was installed. This VFD was set to bypass mode to have the primary loop pump run constantly.

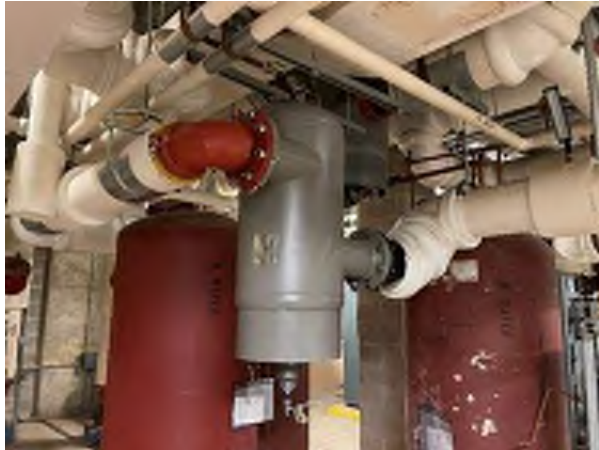
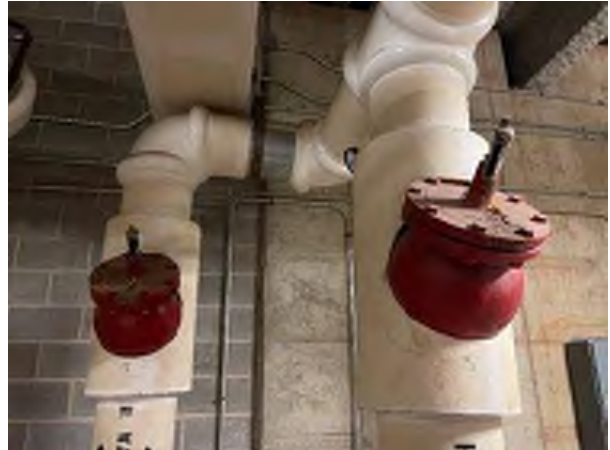
Pipe and valve insulation opportunities were identified during the audit and shown in Figures 43 and 44. Some weather-stripping opportunities were also identified during the audit; one such example is shown in Figure 45. The useful life of weather-strips will vary with usage of the doors they are installed on. The existing door weather-strips were most likely installed when the building was built in 1999 and 2010. The existing weather-strips should be considered for replacement to continue to maintain a tight building envelope.

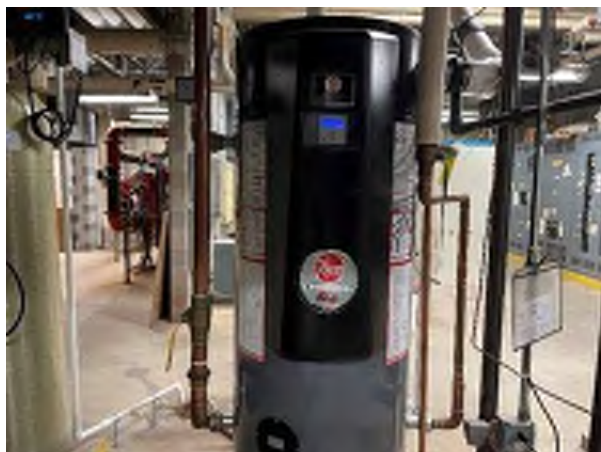
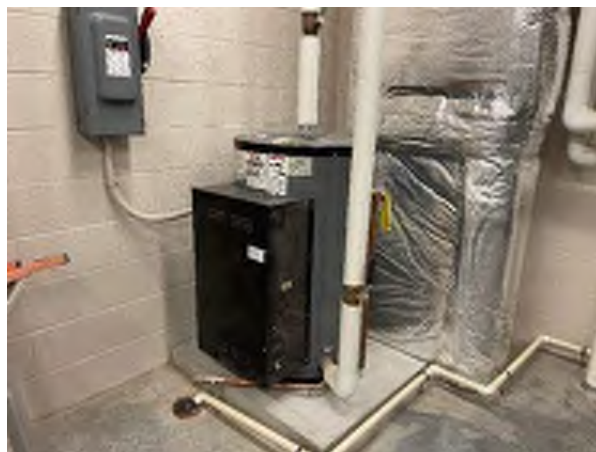
Domestic hot water is supplied to the kitchen and restrooms by one super duty condensing high efficiency natural gas-fired boiler rated at 500,000 Btu/hr and one kW boiler located in two mechanical rooms and shown in Figures 46 and 47.

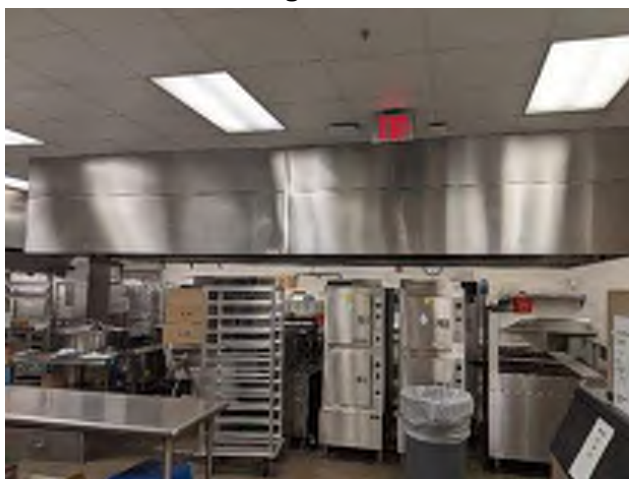
**Figure 48**

The building has a full functioning kitchen including a stove, pot/prep sinks and large refrigeration units. The kitchen exhaust hood is used each day when the school is in session, typically 7am to 2pm.

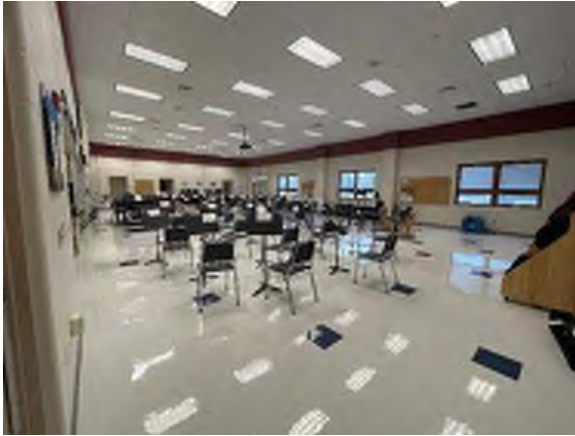
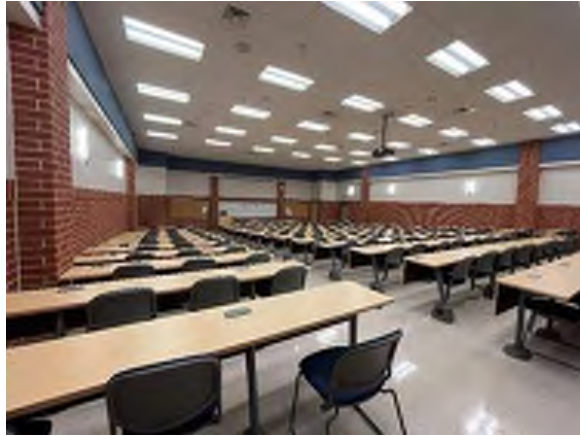
A sizeable quantity of fixtures in the building are T-8 fixtures with electronic ballasts. Some spaces such as the lobby area and the main gym have been converted to LED. The T-8 fixtures are generally in good condition; nevertheless, upgrades to LED systems should be considered to reduce overall electric energy consumption in the building.

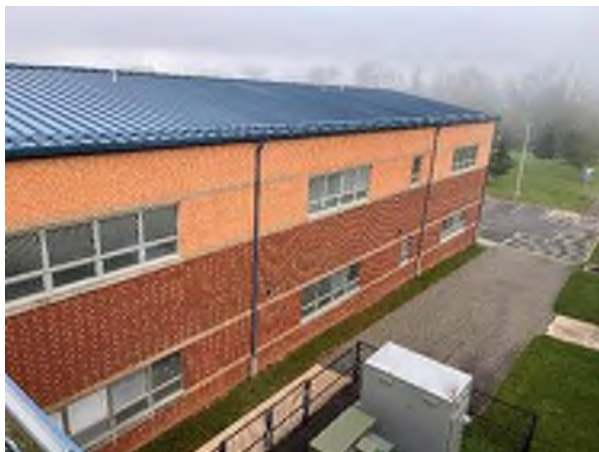
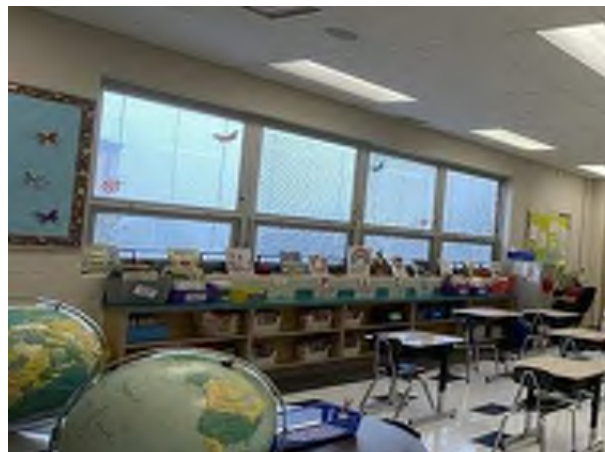
The windows that are installed are double-pane, mostly hopper style in aluminum frames. Windows in the building are in good condition and are shown in Figures 1 and 2. Select areas of the building have curtain wall windows.

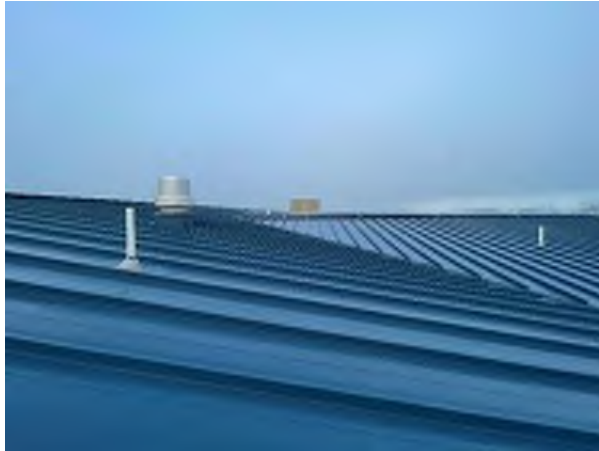
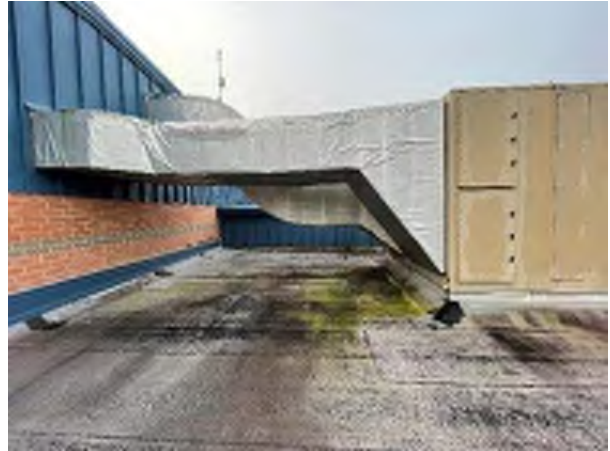
The roof installed is mostly pitched metal with small sections of flat roof for mechanical equipment. From visual inspections, the pitched metal roof appears to be in good condition and the flat sections in fair condition.

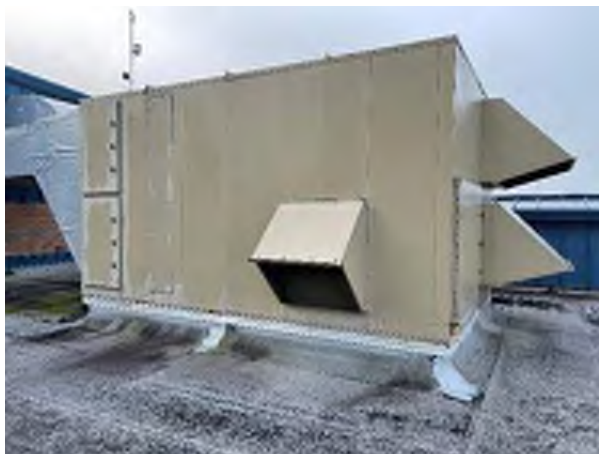
**Figure 5**

The building's ventilation is primarily through mechanical ventilation. The building is served by heat pumps, heat recovery units, and unit heaters. The units that serve large spaces and can vary the amount of air flow to these spaces for energy efficient operation. These systems work in conjunction with relief vents and exhaust fans in the building to ensure proper air circulation. Figures 5 through 8 show the different type of installed HVAC systems.

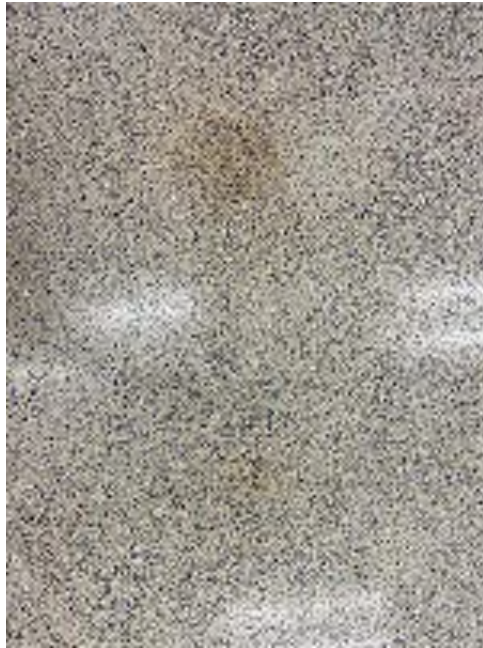
Figure 10

During the audit, leaks from valves connected to the heat pumps were directly observed. A few floor and ceiling stains from the water leaks were observed during the audit. Water stains can be seen on the ceiling grid on Figure 9 and floor stains are shown in Figure 10. These leaks present a slip hazard through wet floors.

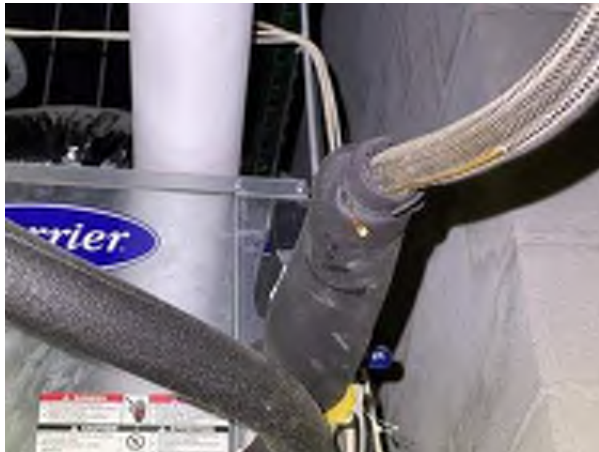
The water leaks also present an electric hazard when dripping on ceiling mounted light fixtures. Figure 11 show a leak observed onsite and Figure 12 shows the water settled in the grooves of the light fixture close to the leaky valve.

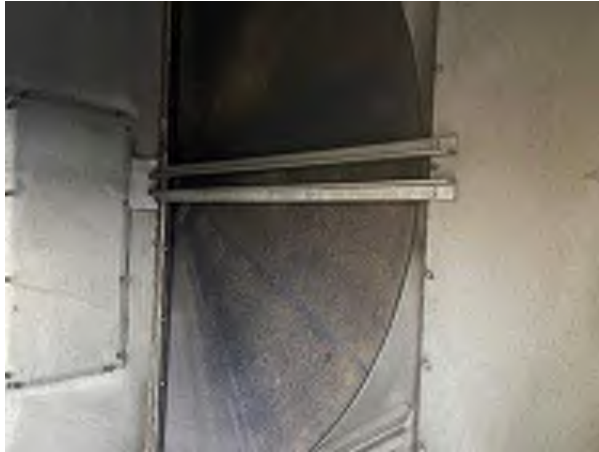
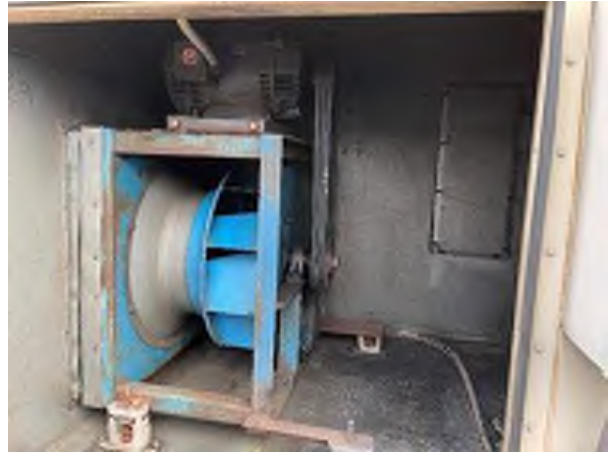
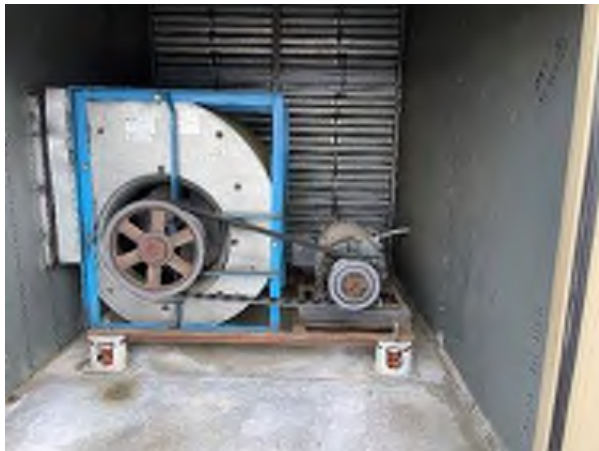
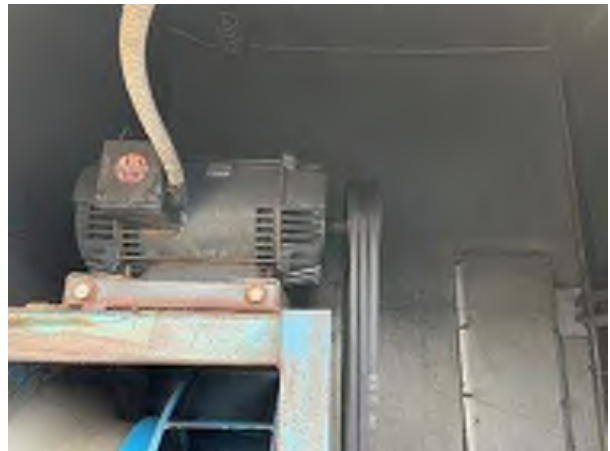
Other than the leaks from faulty valves, many of the equipment are in good condition given their age. One of the heat recovery units were opened and inspected. These units will benefit from deep retro-commissioning. Opportunities to restore system performance and increase equipment including verifying motor shaft alignments and cleaning heat wheels inside the unit. Audit observations are shown in Figure 13 through 16.

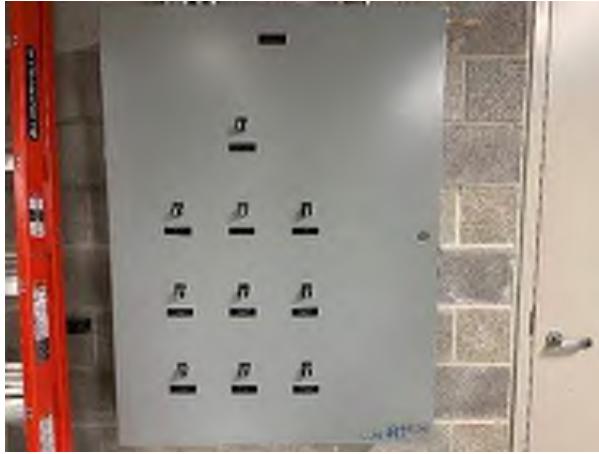
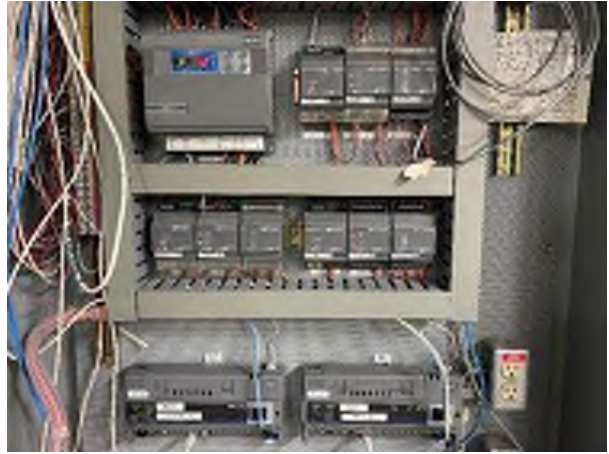
The HVAC equipment installed is controlled by a DDC JCI Metasys system located in the boiler room shown in Figures 17 and 18.

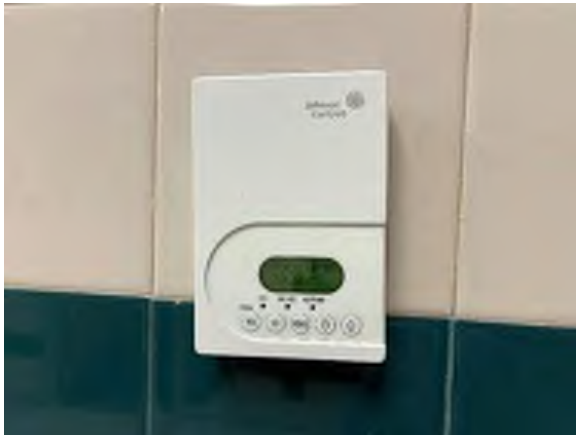
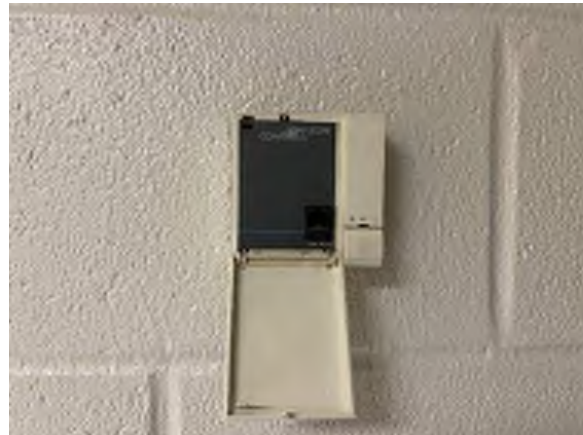
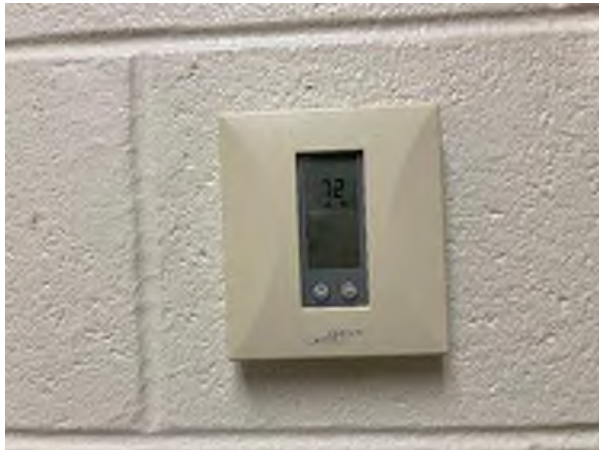
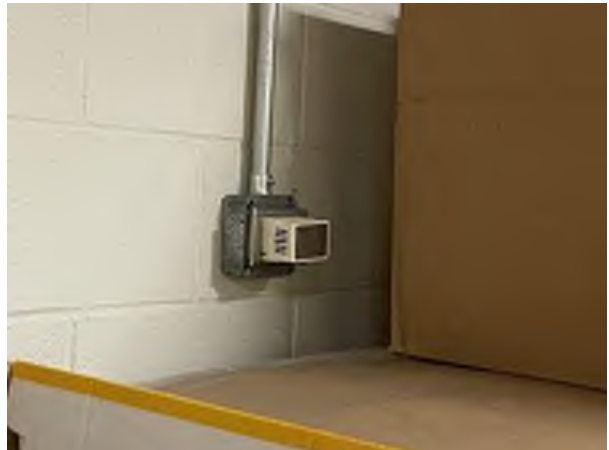
Figures 19 through 22 show the typical thermostats that are installed in the building. The thermostats are of varying vintage. It is recommended the existing thermostats should be considered for upgrade to standardize to smart thermostats. New smart thermostats also have additional built-in features that allow for deeper space setbacks and efficient space comfort management.

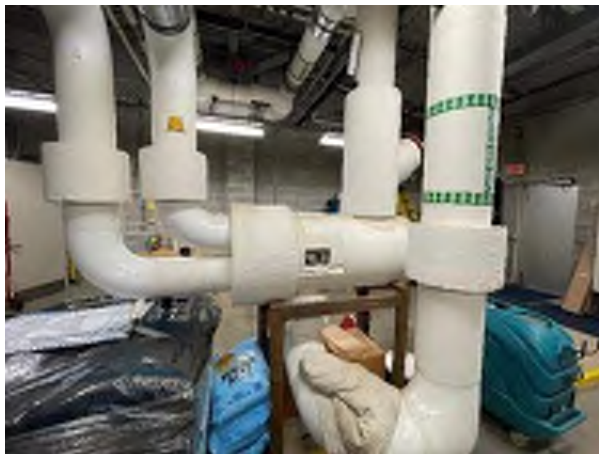
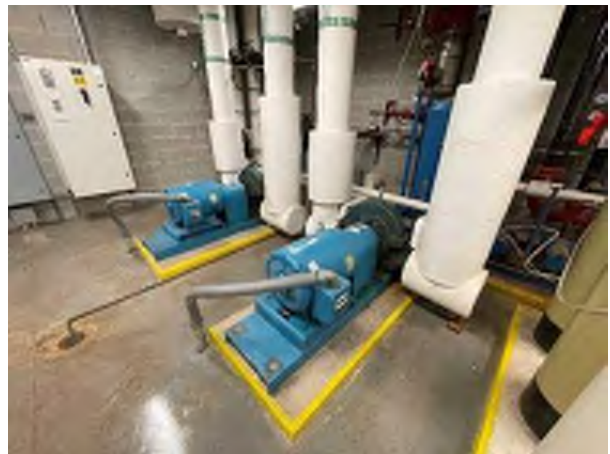
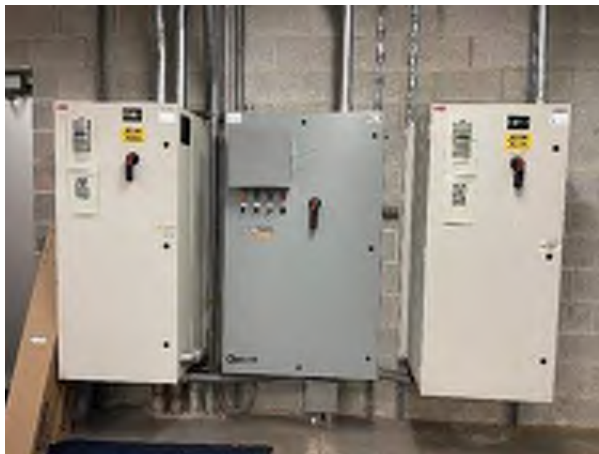
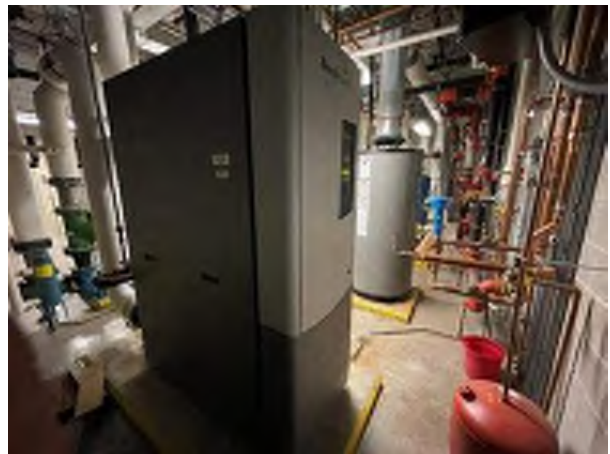
The building is served by a geothermal system with one boiler for supplemental heating. The overall system is generally in good condition and is shown in Figures 23 through 26. The existing circulation pumps are high efficiency and the volume of water circulating in the loop is varied through the use of VFDs. Select storage spaces in the building have dedicated unit heaters. Air conditioning is provided to most spaces of the building by the ceiling installed water source heat pump systems.

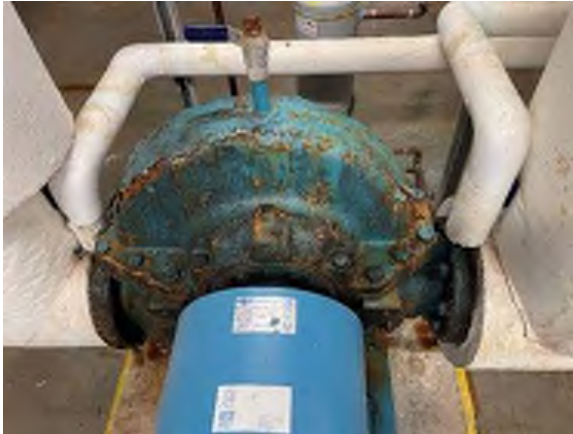
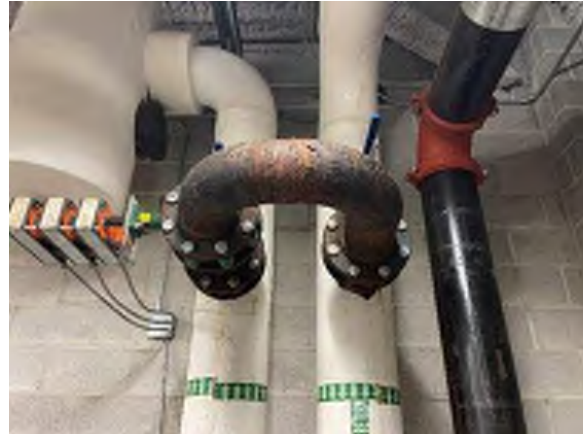
The water distribution system on the geothermal side has corrosion from condensation on pipes, impellers, and exposed surfaces; shown in Figure 27 and 28. Condensation has also damaged nearby insulation. It is recommended these bare pipes and impellers be insulated to prevent further deterioration and avoid leaks in the future. Valve insulation opportunities were also identified during the audit. Insulation opportunities were also identified on exterior duct work on which existing insulation had deteriorated, shown in Figures 29 and 30.

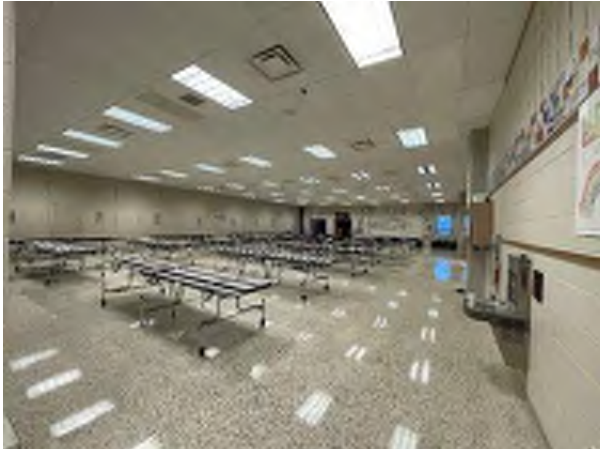
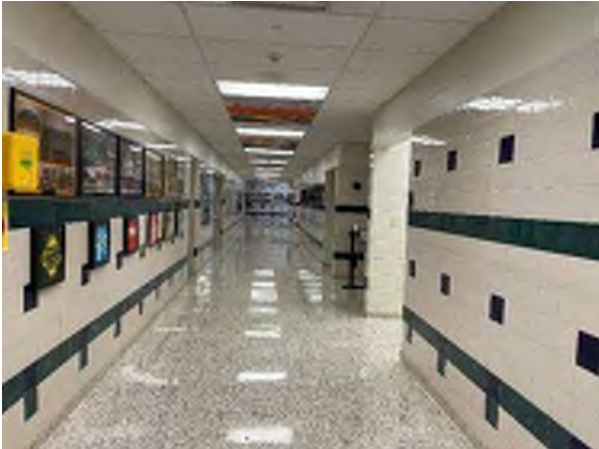
A sizeable quantity of fixtures in the building are T-8 fixtures with electronic ballasts. Some spaces such as the main gymnasium and areas of the library have been converted to LED. The T-8 fixtures are generally in good condition; nevertheless, upgrades to LED systems should be considered to reduce overall electric energy consumption in the building.

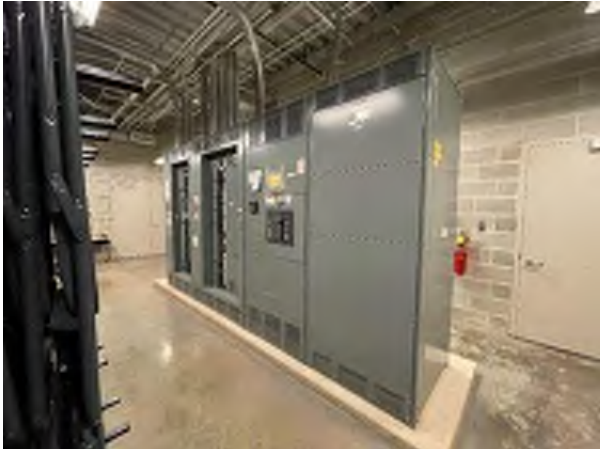
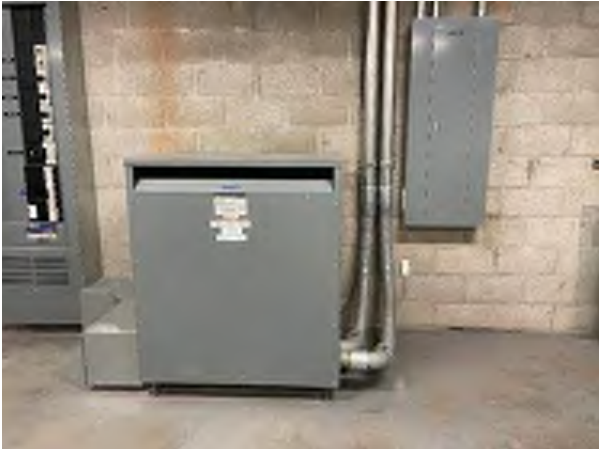
On the electric side, the building is provided with secondary, three-phase service by PECO and have a total capacity of 3,000 amps. There are two step-down transformers located in an electrical closet in the building. The building also has natural gas service for the supplemental boiler and kitchen use.

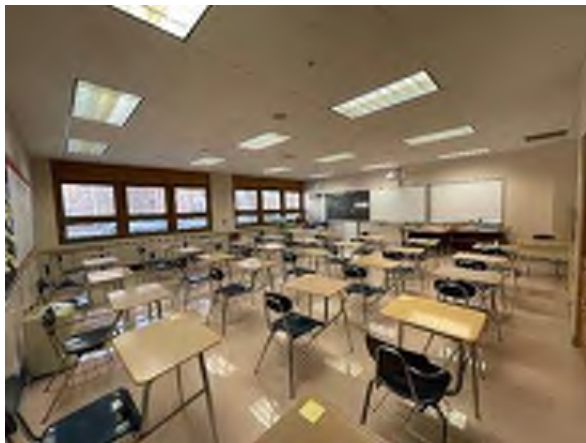
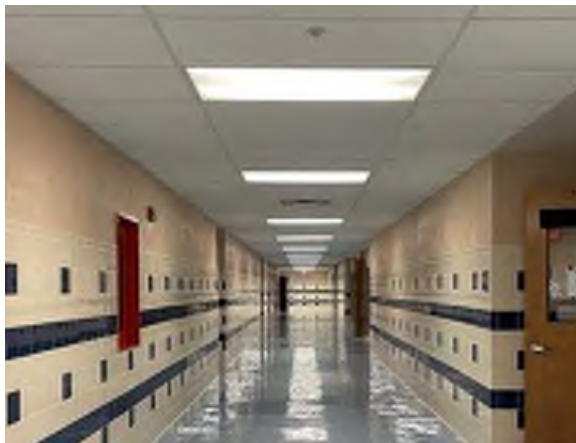
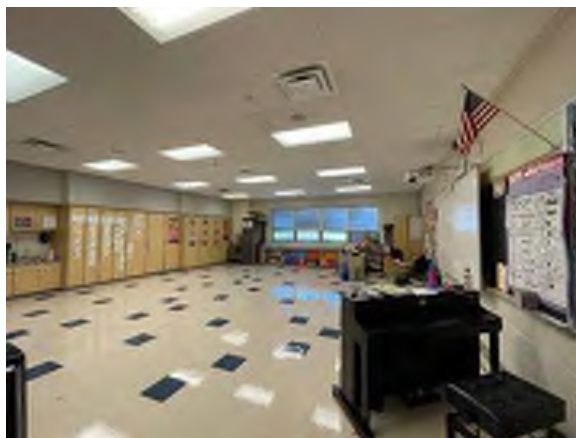
The existing linear fluorescent lighting systems throughout SFASD's facilities utilize T8 lamps operating on early generation electronic ballasts. At most facilities, the luminaires are, generally, still in excellent condition. Maintenance practice appears good with few lamp or ballast burnouts observed. Light levels are generally adequate when compared to current recommended practice.

There are few occupancy/vacancy sensors installed across the district.

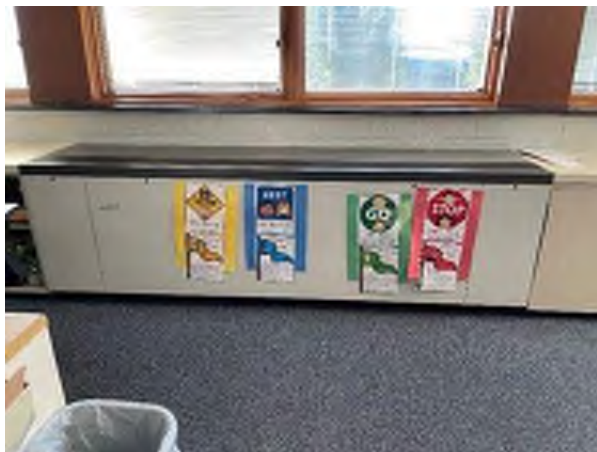
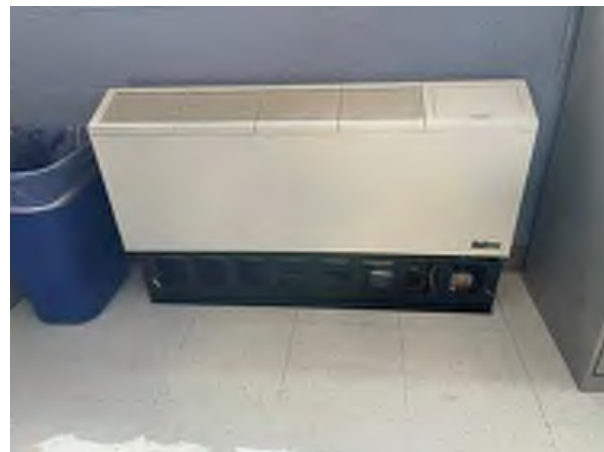
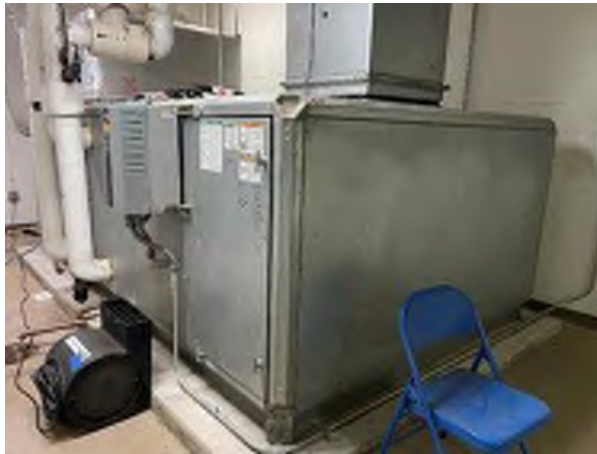
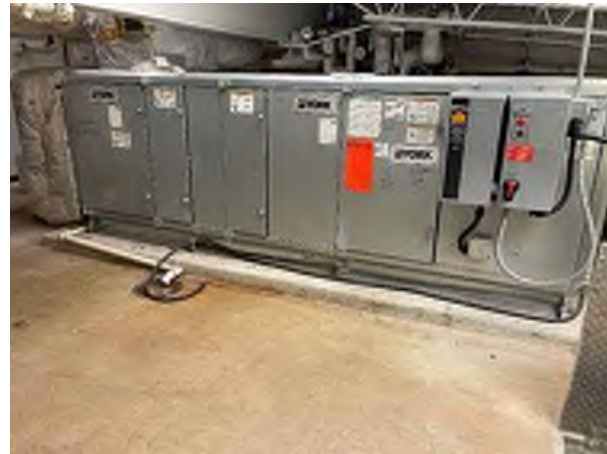
Figures 1 through 4 show the different type of installed HVAC systems.

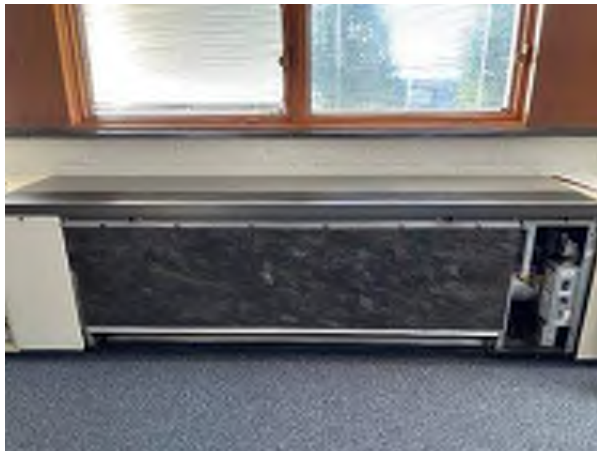
Figure 5

Most of the equipment is in fair to good condition given their age. A sample set of unit ventilators were opened and appeared to be in good condition as shown in Figures 5 through 8.
