# Spring-Ford Area School District

## Investment Grade Audit Report

**Submitted by:**  
Johnson Controls, Inc.

**August 2022**

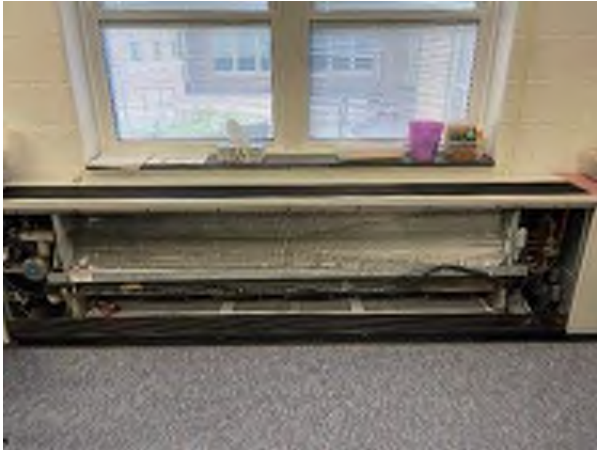
Figure 3

A sample set of unit ventilators were opened. They appeared to be in fair to poor condition but are nearing the end of useful life. It is recommended these units be upgraded to avoid high maintenance expenditure and downtime. Figures 3 through 6 show some of the observations made on the sample unit ventilators inspected during the audit. Damaged fin coils and corrosion on pipes and tubes was consistent in the unit ventilators opened for inspection.

- Replace existing unit ventilators with new fan coil units. Seal existing unit ventilator outside air openings and modify cabinetry as needed for new unit configuration.
- Add a DOAS unit with Energy Recovery Wheel, heating and cooling capabilities to provide ventilation and comfort to the classrooms.
- Modify existing piping throughout the school, and ceilings as required.
- Upgrade boiler plant by replacing boiler and associated pumps.
- Upgrade chiller plant by replacing chiller and associated pumps.
- Integrate new equipment added as part of this scope with existing DDC system.
- Refurbish six existing AHUs serving kitchen, café, library, office, stage, and gym.

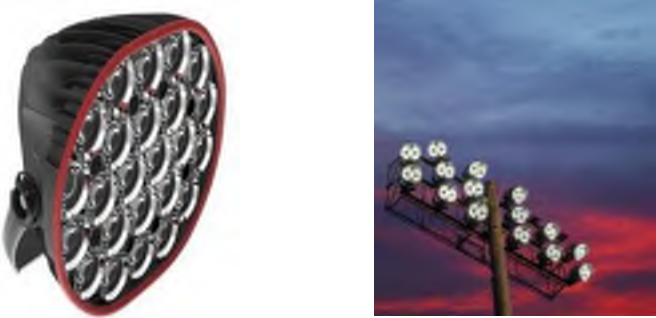
**Figure 1: Sample Stadium Light Fixture**

JCI has identified opportunities for energy savings through the installation of new high efficiency lighting similar to those shown in Figure 1. JCI proposes to replace these fixtures with new LED fixtures that will produce a brighter and sharper light which will enhance player’s visibility and safety.

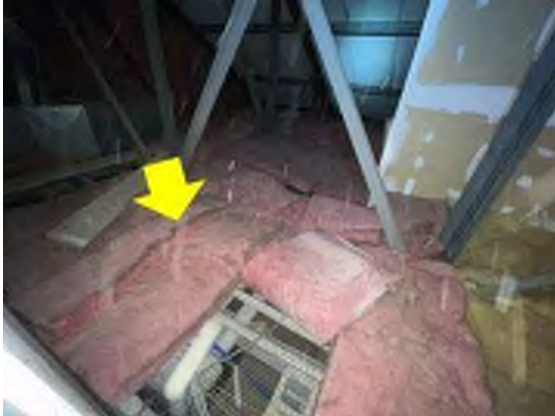
Attic Air Barrier Retrofit – chicken wire supporting unfaced fiberglass is a building envelope flaw. Dirt build-up at fiberglass intersections is a clear sign of air permeable fiberglass “filtering” air leaking through the thermal envelope of the building (Royersford ES).

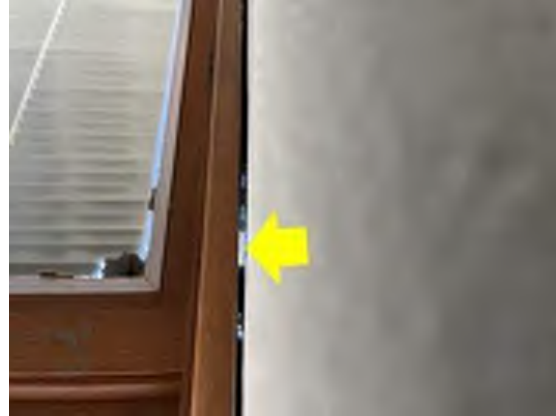
Caulking – missing sealants at the window casing are leading to a clear air leakage pathway as seen by daylight (Limerick ES).

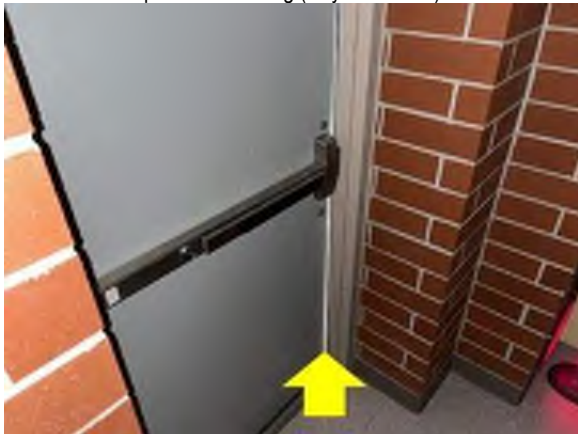
Door Weather-Stripping – weather-stripping was improperly installed at the sides of the door as seen by clear daylight at the perimeter of the door (Spring-Ford Area HS).

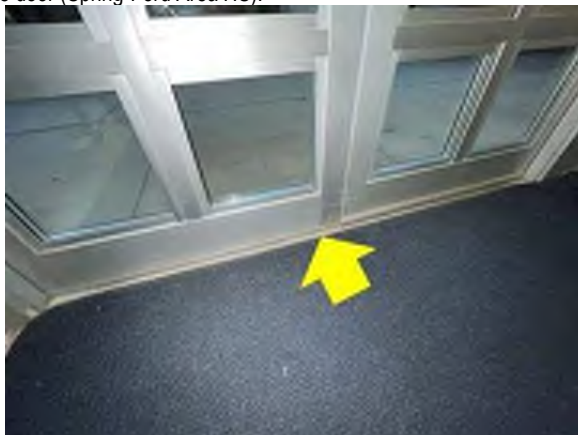
Door Weather-Stripping – a missing door sweep next to an existing door sweep needs to be installed to prevent drafts at the bottom of the door assembly (Royersford ES).

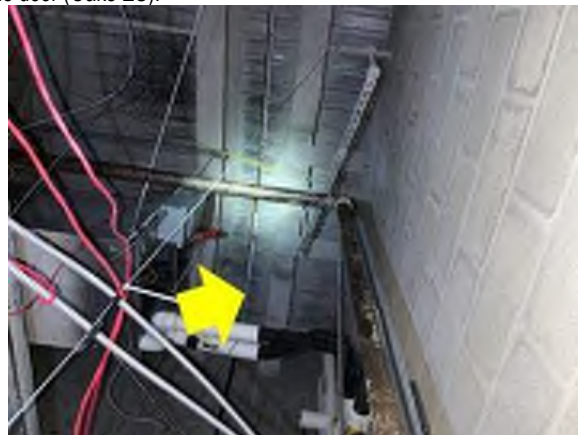
Roof Insulation – roof assemblies were connected but insulation is not continuous. It is believed that condensation forms at these intersections and drips onto drop ceiling below; enhancing the thermal barrier (5th-7th Grade Center).

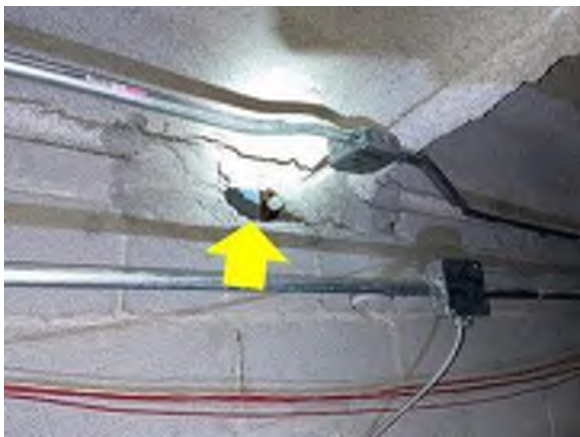
Roof-Wall Intersection Air Sealing – the exterior flashing and finishes at the roof-wall intersection are not constructed to stop air leakage (Upper Providence ES).

**Roof-Wall Intersection Air Sealing** – the roof-wall intersection is regularly an area that allows unwanted air leakage through the building shell. This is the primary area of unwanted air leakage throughout the school buildings in the SFASD. Exterior flashing and finish details at this area are not constructed to stop air leakage (exterior flashings are for water control, not air control); unsealed exterior flashing details combine with interior gaps in the framing between the roof and wall assembly to allow infiltration/ exfiltration.

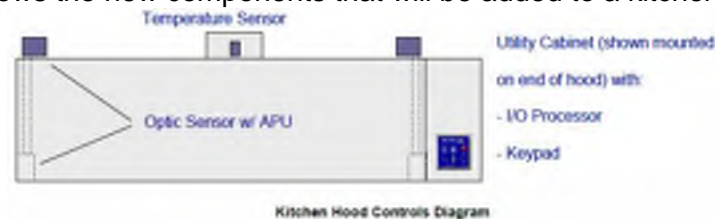
The figure below shows the new components that will be added to a kitchen hood system.

JCI will provide Melink (or equal) kitchen hood system for the kitchens at all school buildings in the RFP. This measure will reduce annual energy costs and maintenance. In addition, time of day scheduling, manual timer controls are added to reduce the operation time of the exhaust fans. The new kitchen hood control system will automatically control the speed of the exhaust and makeup fans to setback when not in use thereby saving energy. Installation to be performed in accordance with mechanical, electrical, fire, local, state, and national installation and operational codes.
