IMAGINING POSSIBILITIES

FOR TRUMBULL'S SCHOOL FACILITIES

TRUMBULL, CT

BOE Progress Update

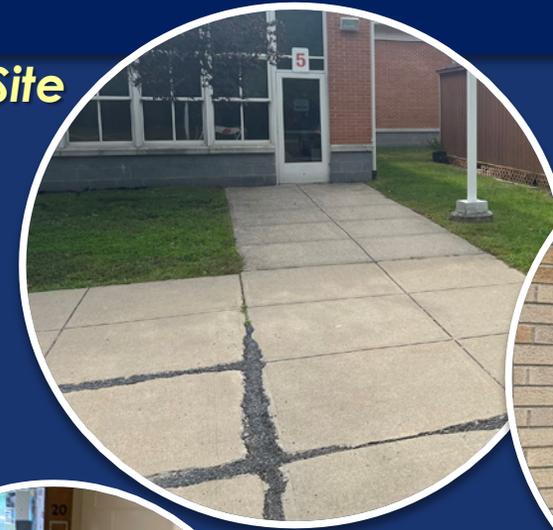
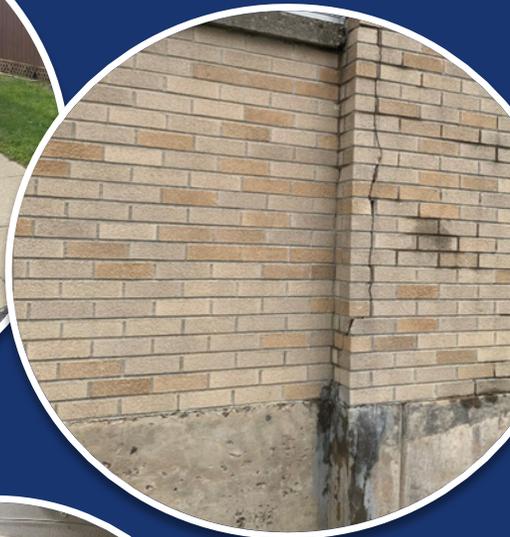
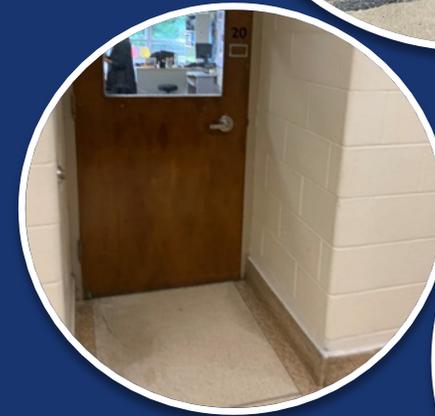
Site ~ Site traffic, parking and perimeter security concerns for site (pedestrian and vehicular safety), play areas exposed at times, limited universal accessibility (parking, sidewalks, and play), poor or no definition of school boundary, some surfaces past their useful life (parking, sidewalks, and play).

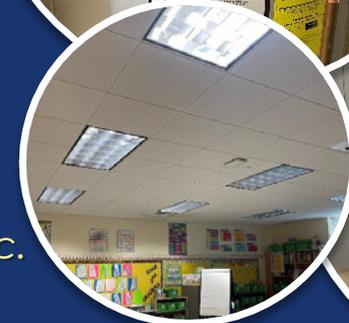
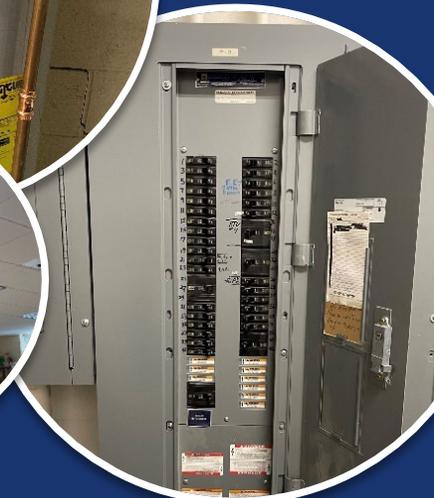
Building Systems ~ For buildings constructed prior to 2000 ~ majority of plumbing systems and fixtures are fair condition but past their useful life, electrical lighting and power distribution end/past useful life.

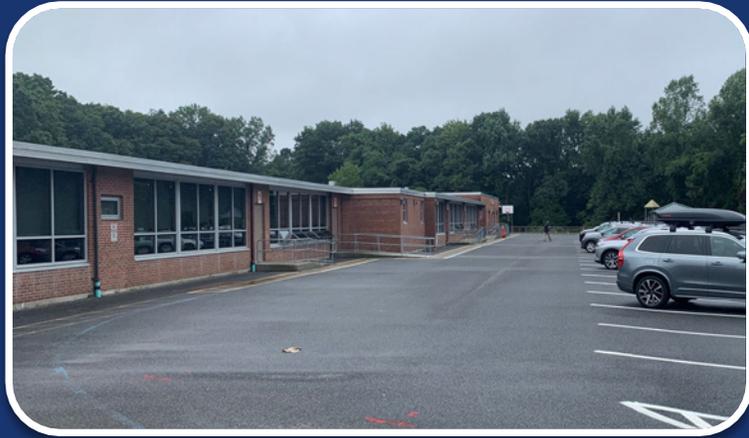
Booth Hill Elementary School ~ Former closets now intervention rooms, poor site circulation (bus/parent), poor climate control, poor visibility from admin.

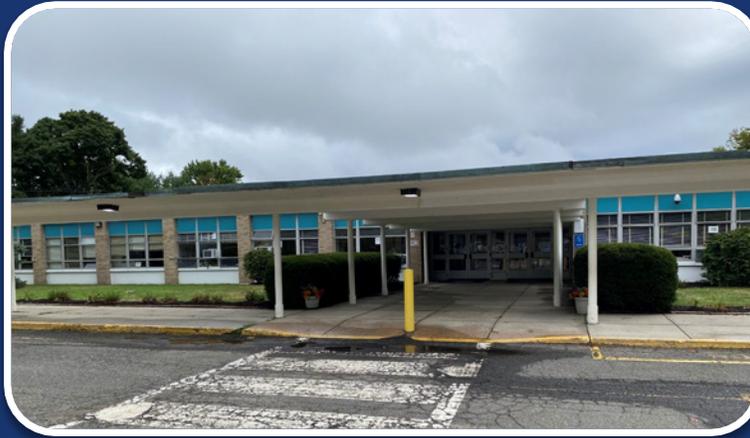
Daniels Farm Elementary School ~ Sister school to Booth Hill, similar challenges, roof and envelope water infiltration has led to accelerated deterioration of envelope.

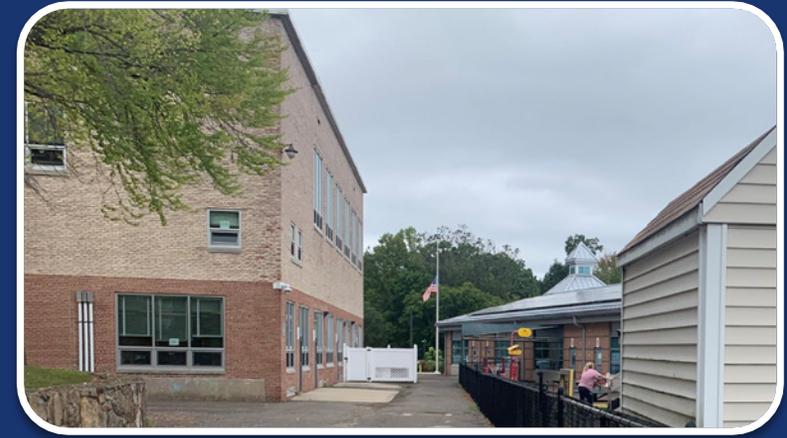
TECEC ~ Currently share space with Middlebrook E.S. ~ operational and logistical challenges, play areas in need of updating, climate control concerns, requested more program space.

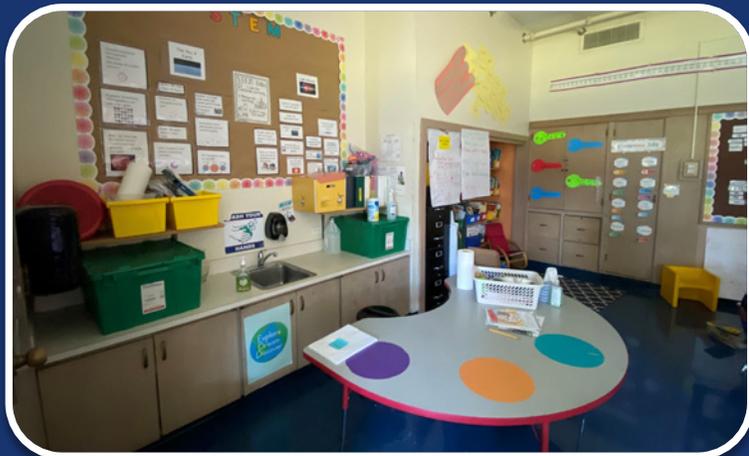
Middlebrook Elementary School ~ site circulation concerns (pedestrian, bus, parent), poor lighting levels & climate control, desire for dedicated core space (gym, café, presentation), specialized ed.

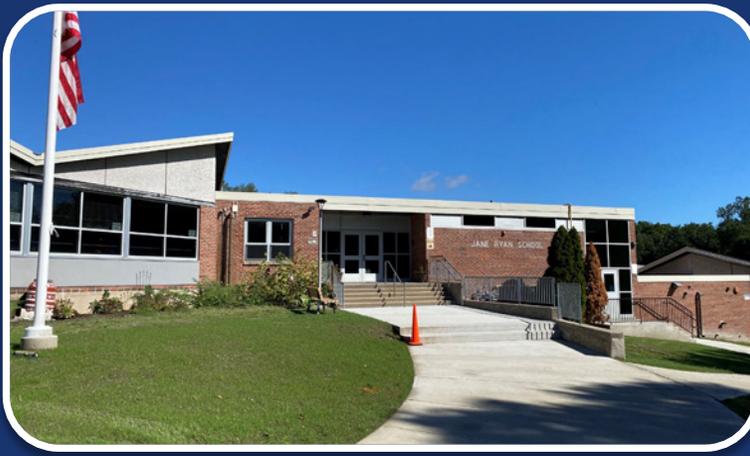
Jane Ryan Elementary School ~ Main entry to school not accessible, capacity concerns ~ loss of music/maker space for gen classroom, accessibility compliance issues throughout.

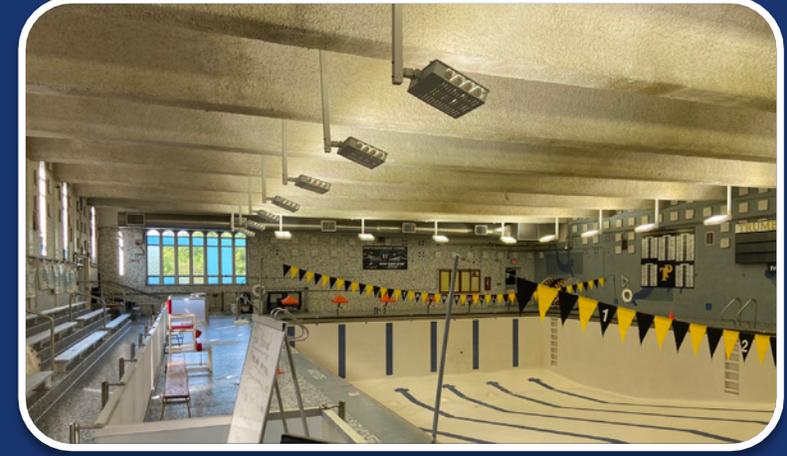
Hillcrest Middle School ~ Lack of required functioning/proper program space throughout (S.E., labs, admin., etc.), pool space not used, travel distance challenging, poor climate control, poor site boundary.

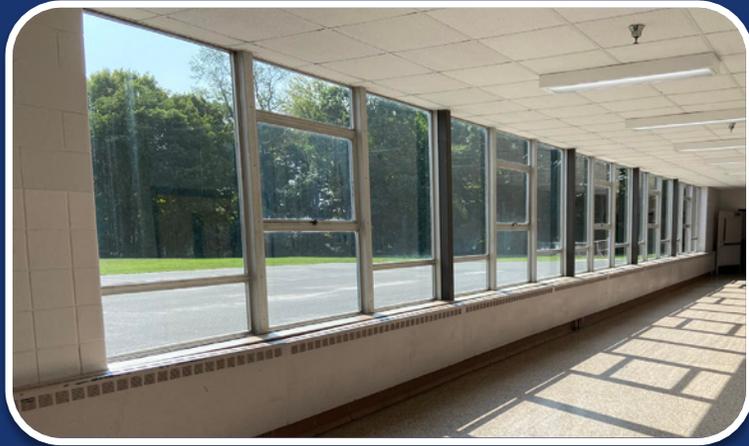
Madison Middle School ~ Poor climate control due to building envelope, good layout but program space needs updating, media center poor location, more dedicated S.E. space.

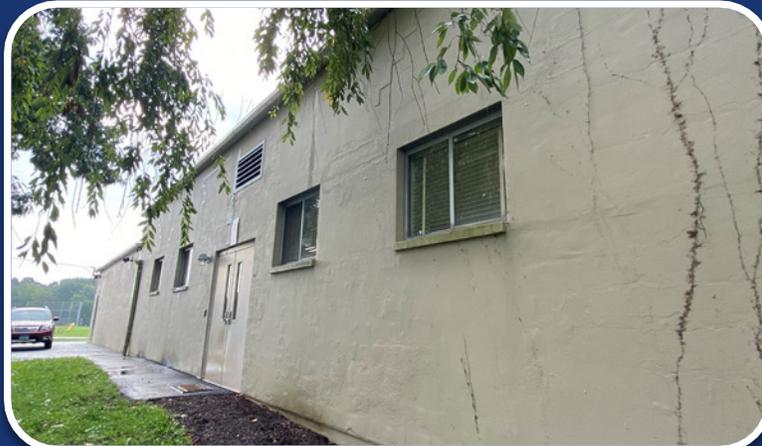
REACH ~ Overall poor condition of building, building envelope leaks (water/air), limited accessibility compliance, min. access to natural daylight, need more dedicated program space.

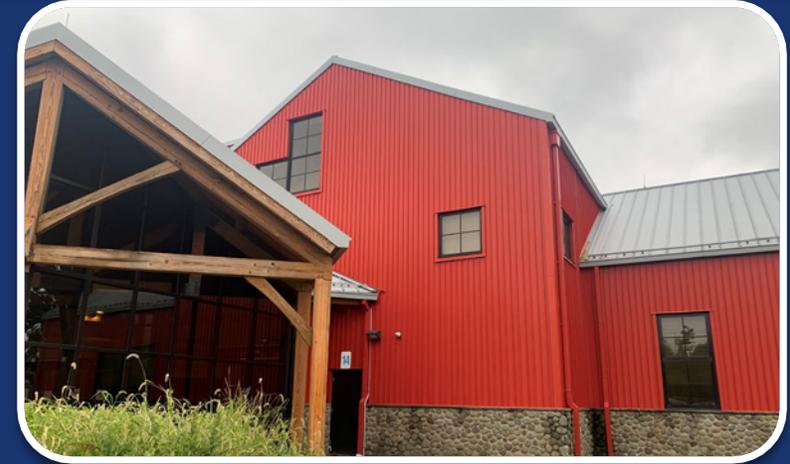
Agriscience ~ Greenhouse requires update/replacement, persistent roof leaks and moisture infiltration causing accelerated deterioration, renovate obsolete program space.

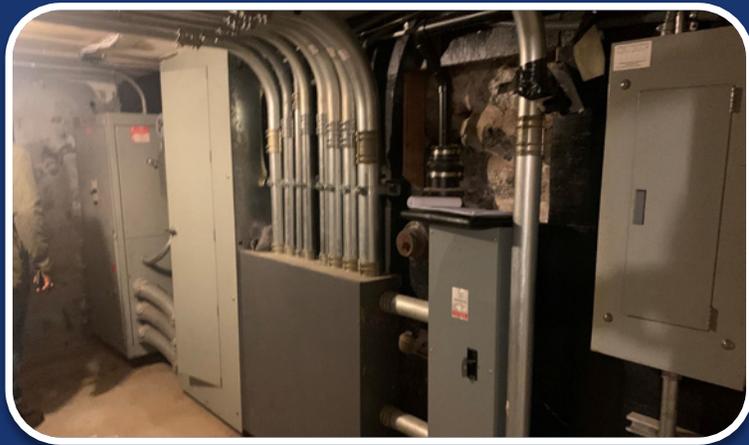
Long Hill Administration ~ Generally in poor condition, building reinvented several times, multiple different vintages of construction & building systems, satisfies program need but limited accessibility throughout, poor public entry

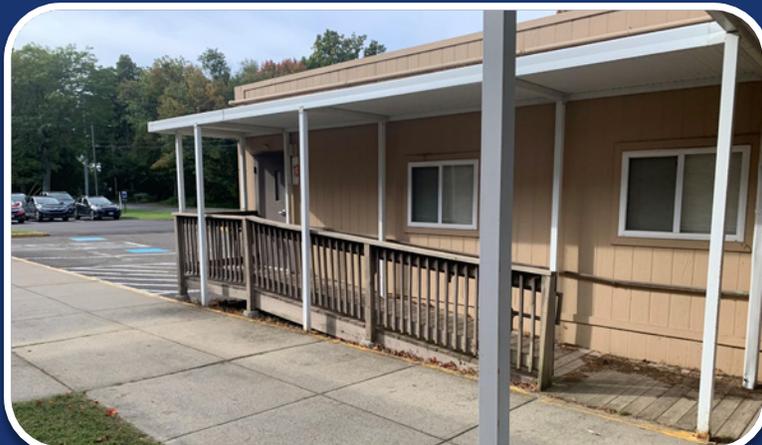
Tashua Elementary School ~ Obsolete modulares should be removed (safety hazard), building well maintained but overall systems/finishes past useful life, toilets rooms poor and too few, access to more nat. daylight.

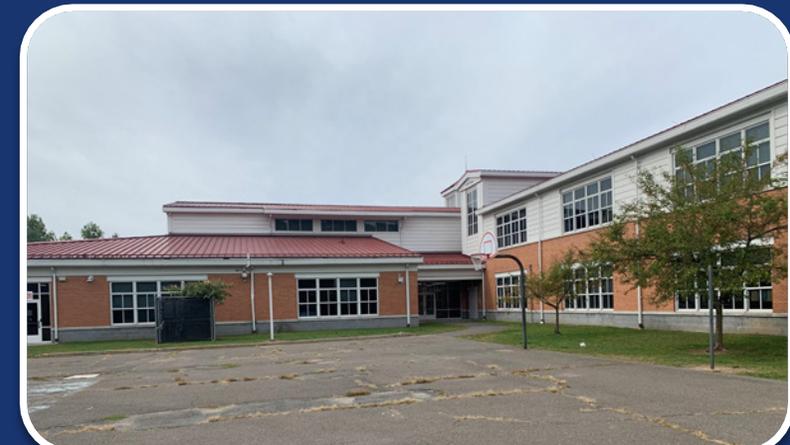
Frenchtown Elementary School ~ Ingress/Egress to site poor & congested at times, site play/paved areas have accelerated deterioration, some building envelope concerns with moisture infiltration, S.E. program space need.

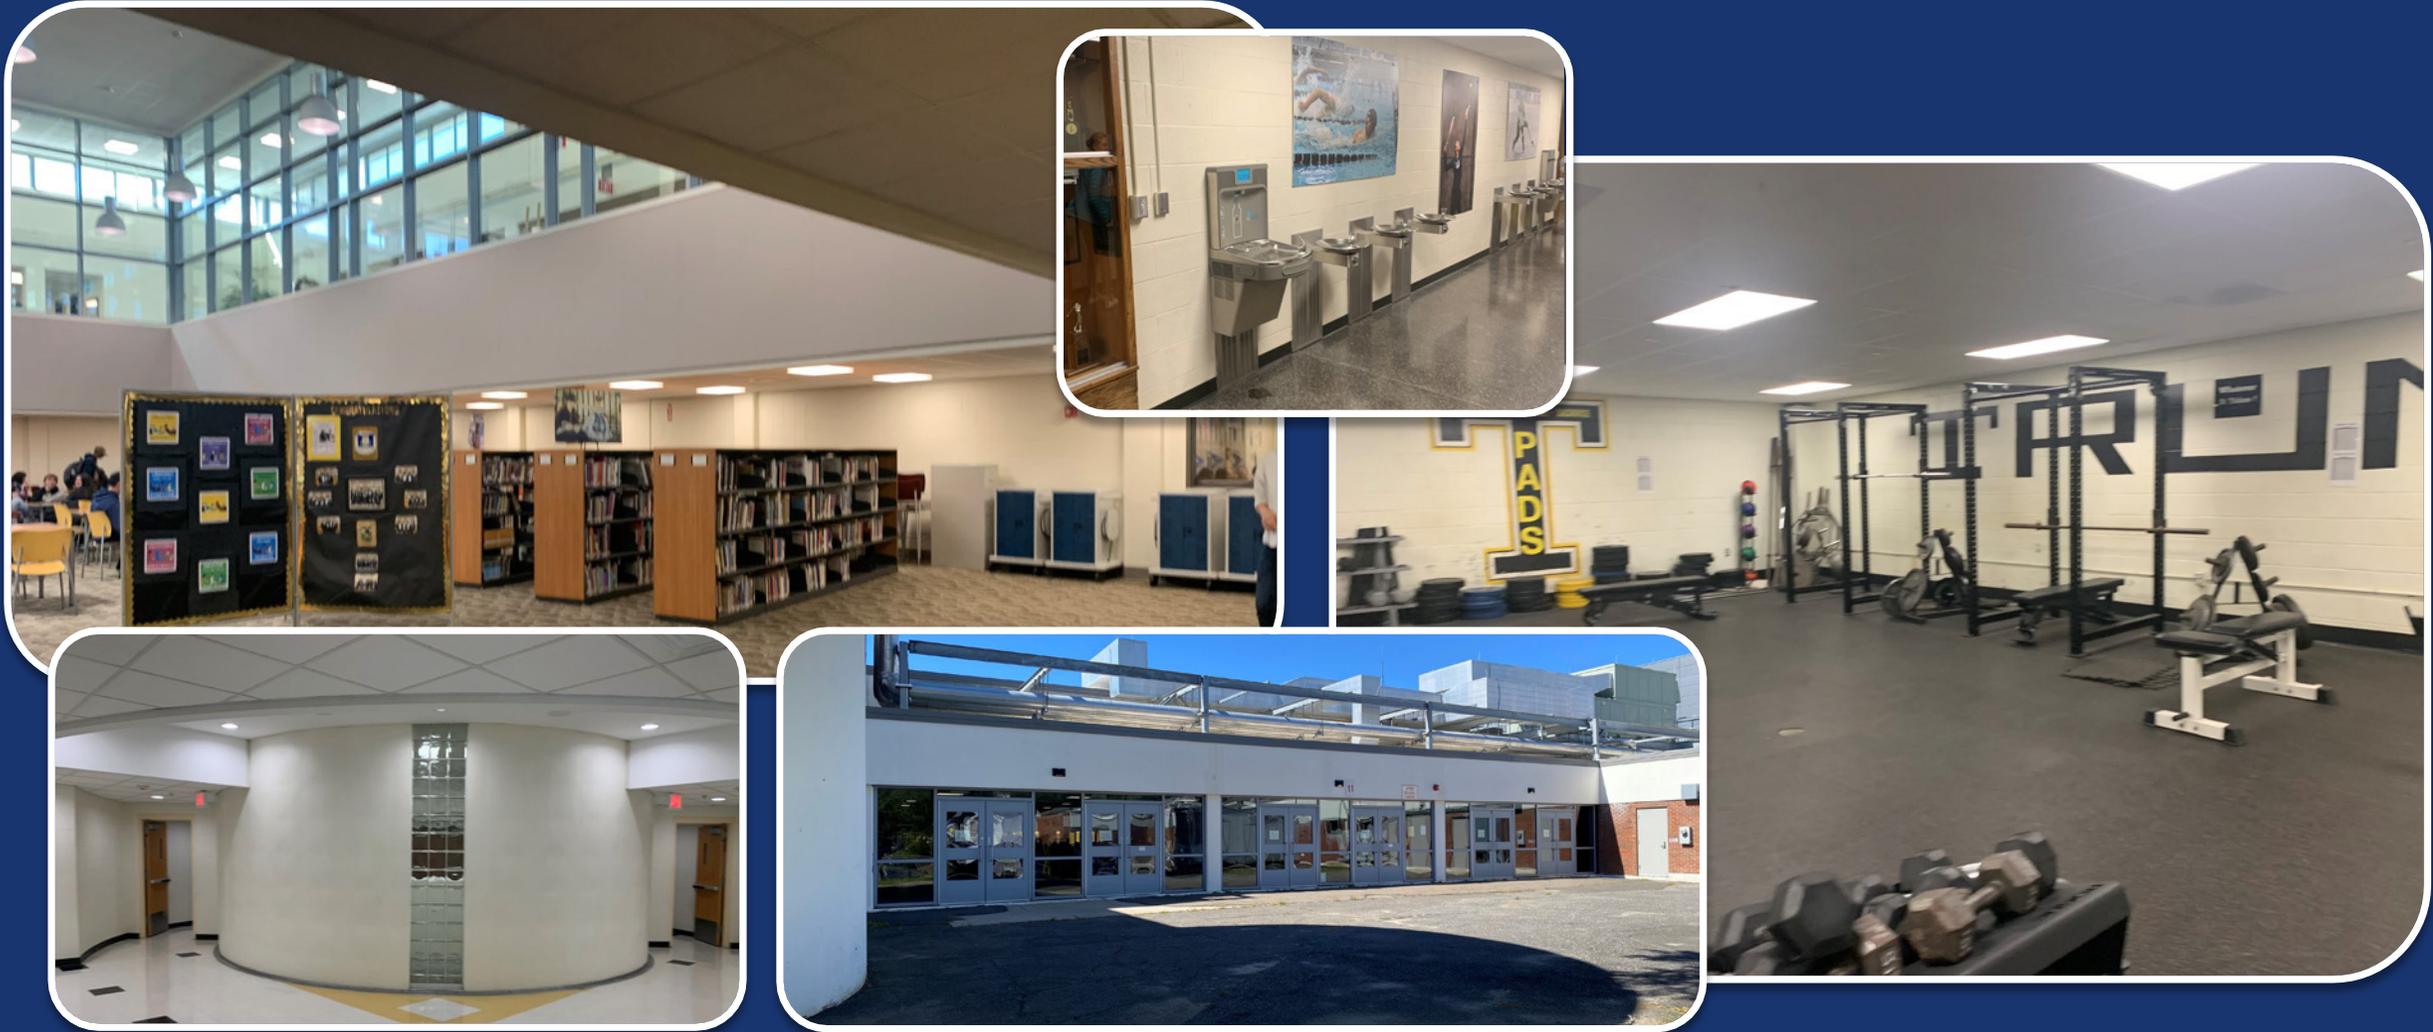
Trumbull High School ~ Revisit and identify portions of work that were not completed during last renovation (doors, terrazzo repairs, portables, etc.), investigate optimizing media center area of school, coordinate efforts with planned wellness center/weight room expansion, optimize underutilized areas near and adjacent to cafeteria, reinvent dedicated rooms for obsolete programs).
