Hilltop Elementary School

Building Review October 19, 2022

ASSESSMENT FINDINGS

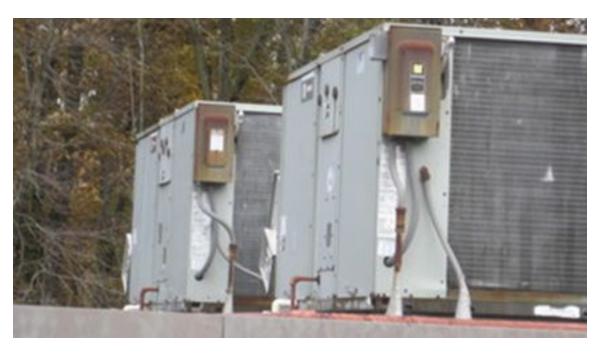
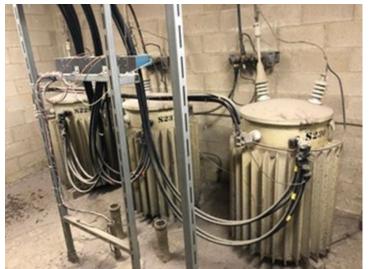
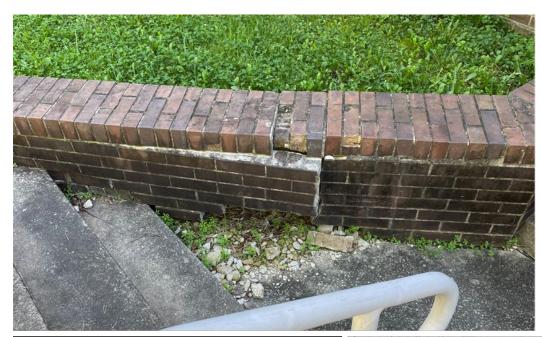
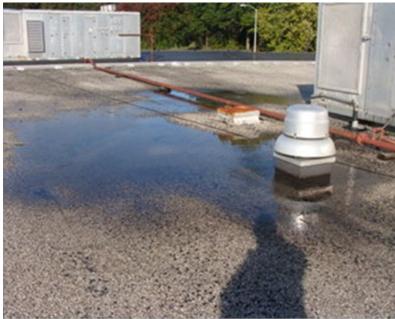
As with most schools built in the 1970's, Hilltop Elementary School has HVAC and electrical systems that have reached or exceeded their useful life.

The current HVAC system is a rooftop and is not an OSDM compliant system.

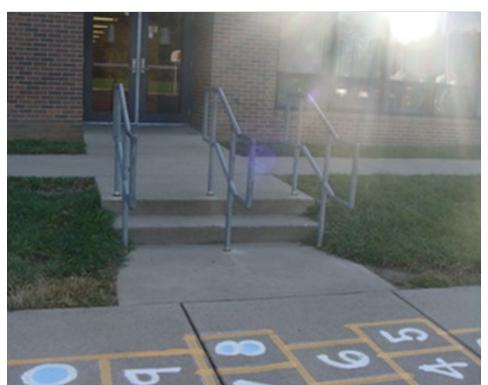
Though well maintained, many of the general finishes are beginning to show signs of wear. Some classroom features are limited in terms of quantities, such as classroom casework (storage).

Some building components are inadequate or non-existent. Interior lighting levels are below benchmark standards in some spaces, there is no fire suppression system, and although a single-story building, Hilltop does have some accessibility challenges (ADA), limitations and barriers.

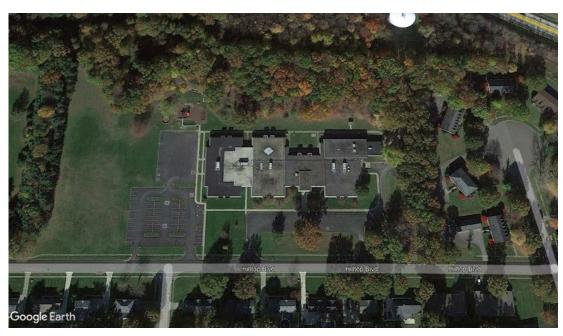
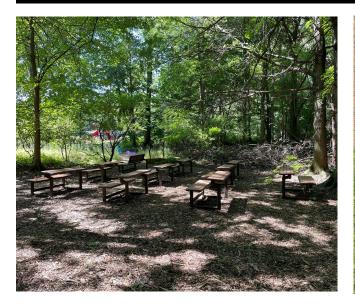
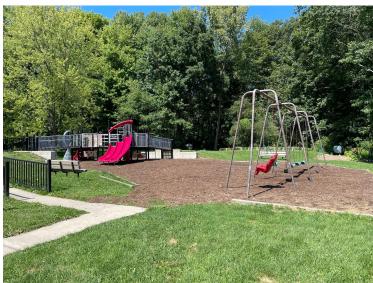
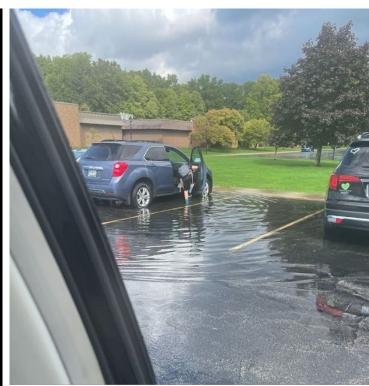
Hilltop's setting is very 'park-like' with generous greenspace and acreage that is very suitable for outdoor learning and community use.

Site challenges include routine flooding due to storm drains backing up during heavy rain events, lack of parking spaces and exterior lighting, and traffic back-ups onto Hilltop Road during arrival and dismissal times.

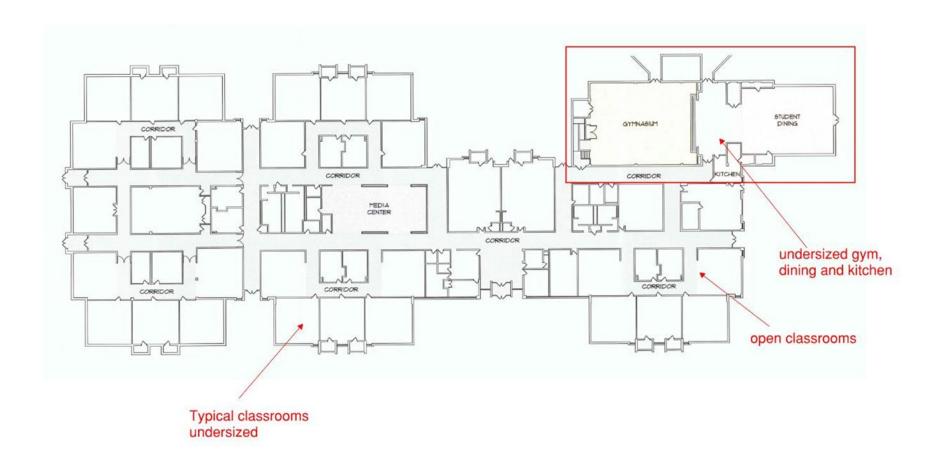
- Typical classrooms are undersized compared to Ohio School Design Manual Standards
- Open classrooms throughout the facility are a safety concern in a security lock down situation
- Most large group spaces are undersized for the current enrollment when compared to state standards
