Canfield Village Middle School

Building Review
November 16, 2022

ASSESSMENT FINDINGS

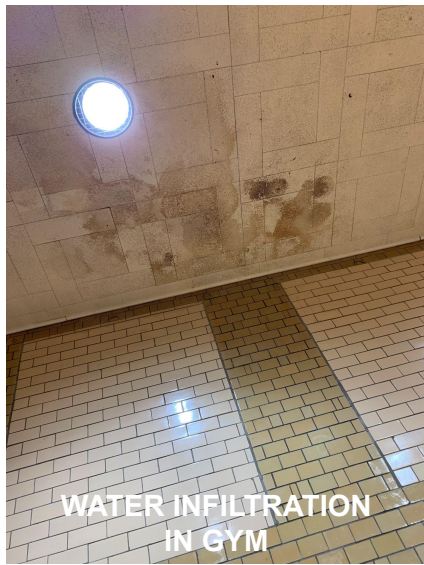
WATER INFILTRATION
IN GYM

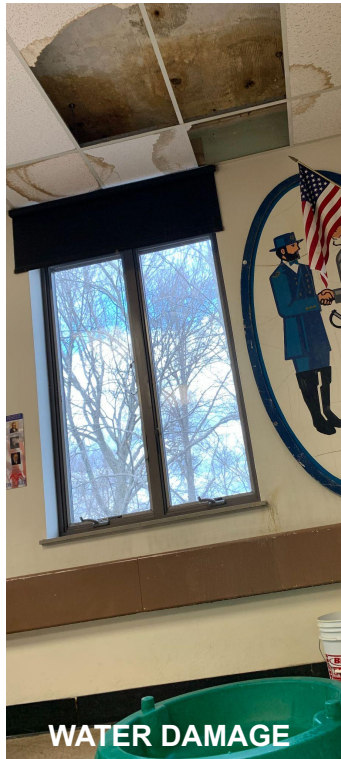
WATER DAMAGE

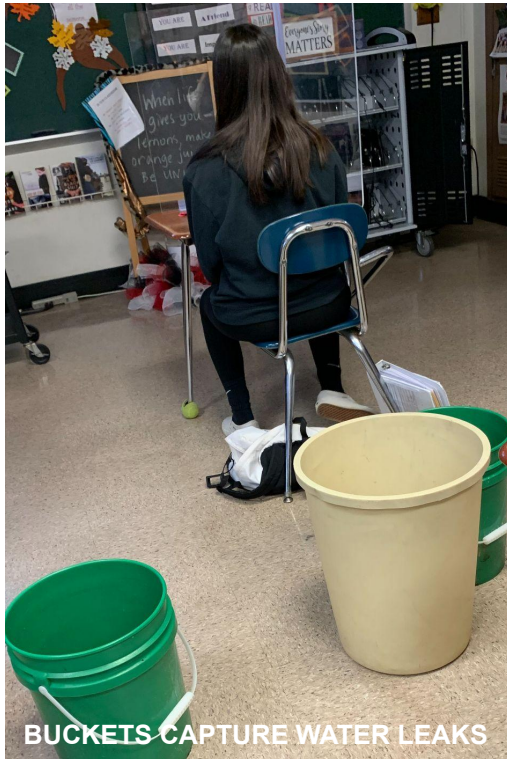
BUCKETS CAPTURE WATER LEAKS

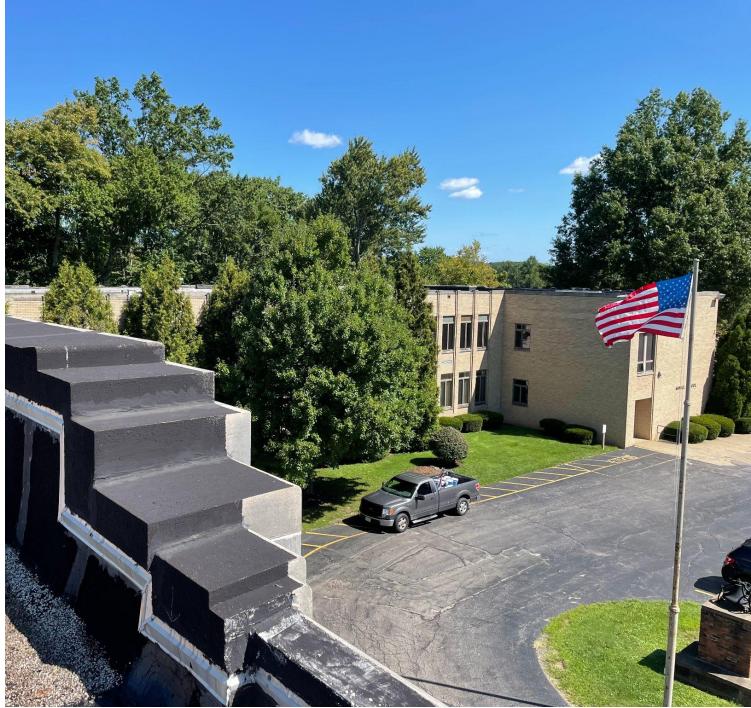
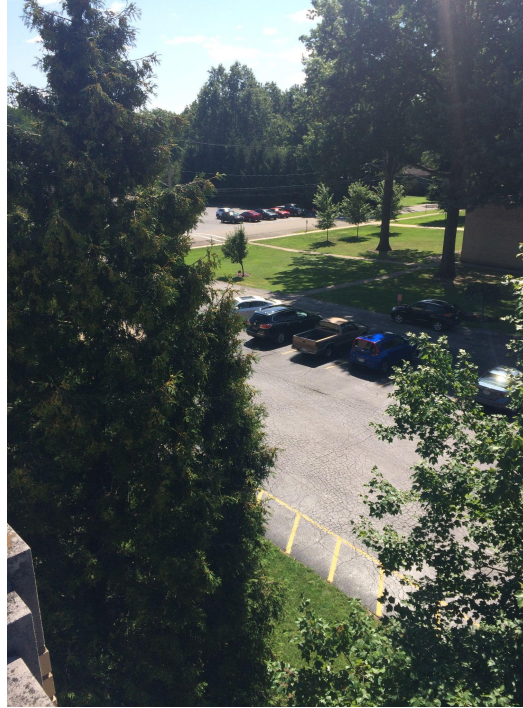
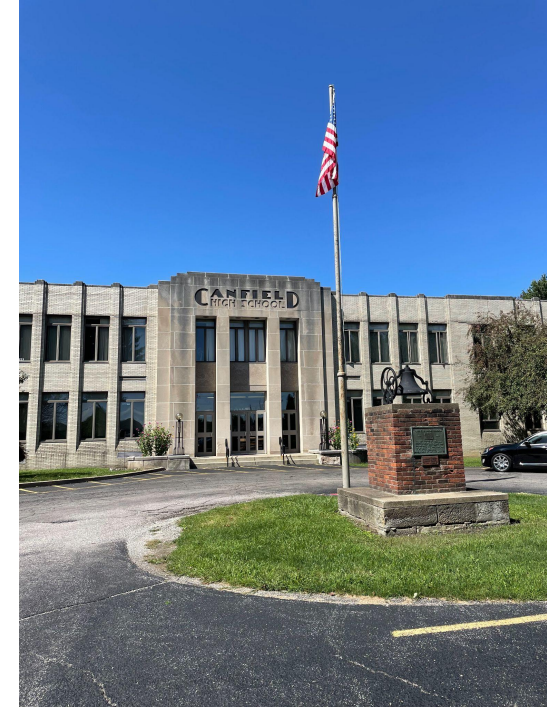
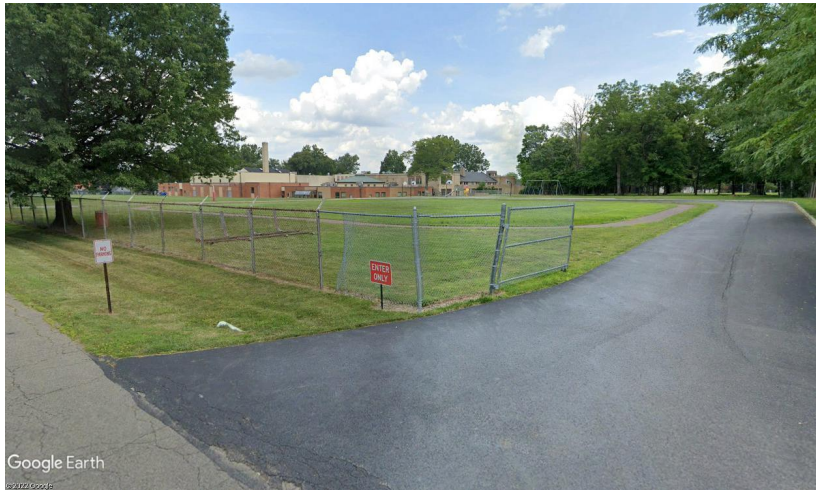
ASSESSMENT - SITE ANALYSIS

CVMS sits on a relatively flat 9 acre site that features moderate tree and shrub type landscaping. The site is suitable for outdoor learning, but is undersized compared to OSDM recommendations of 28 acres for the current enrollment.

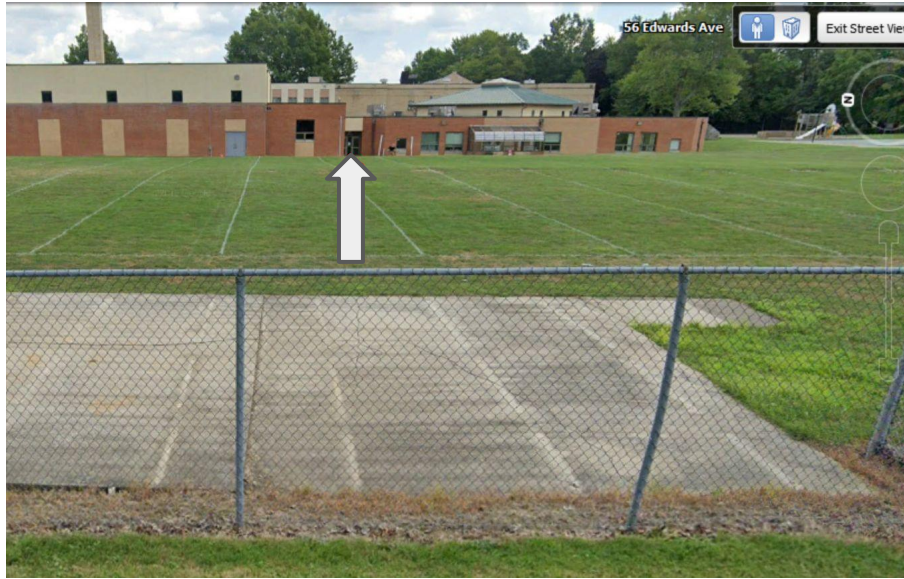
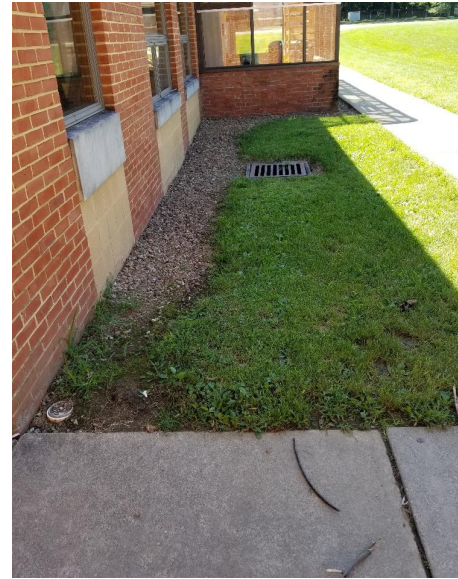
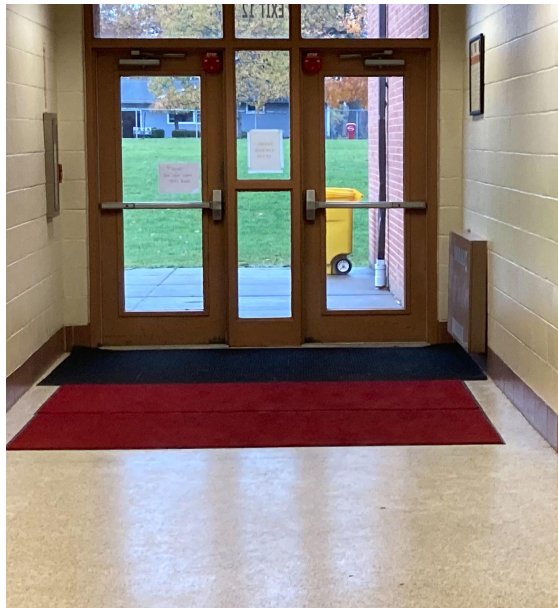
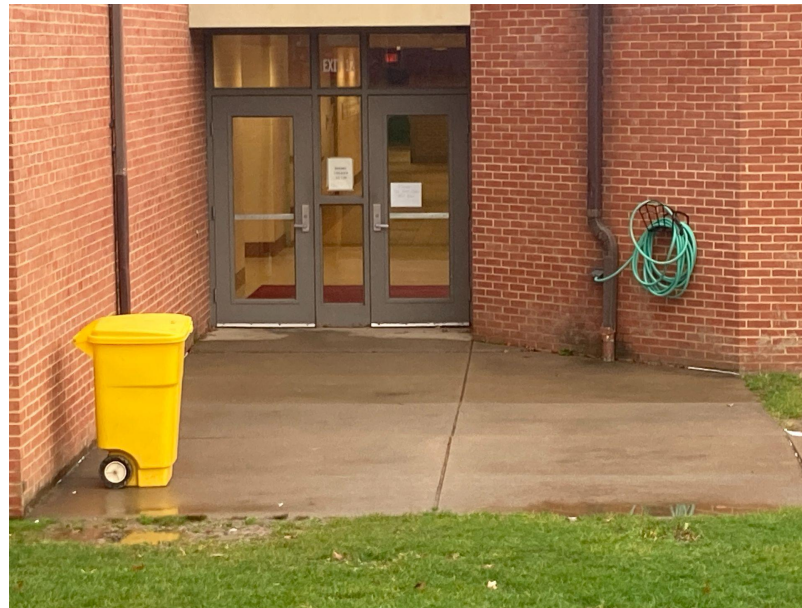
ASSESSMENT - SITE ANALYSIS

The west side of the site gently slopes toward the building, which has caused flooding over the years into the 1992 addition by the west entrance doors. Five major flood incidents have occurred over the last 25 years. The last, in 2019, resulted in significant interior damages and necessary repair/renovation work.

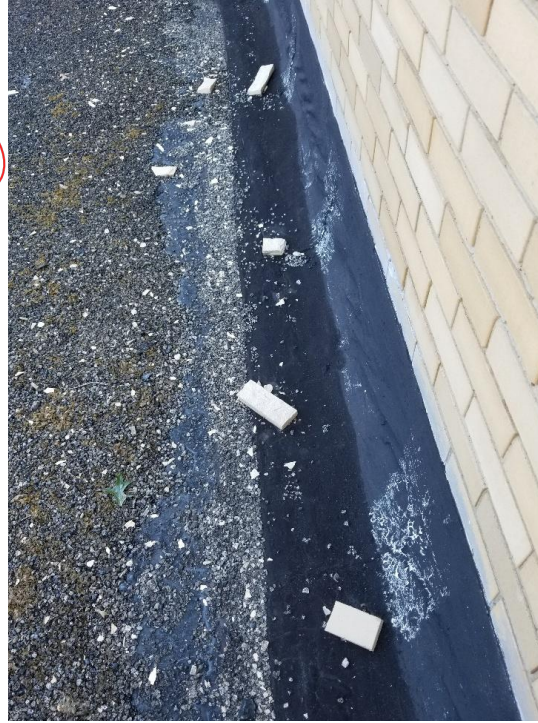
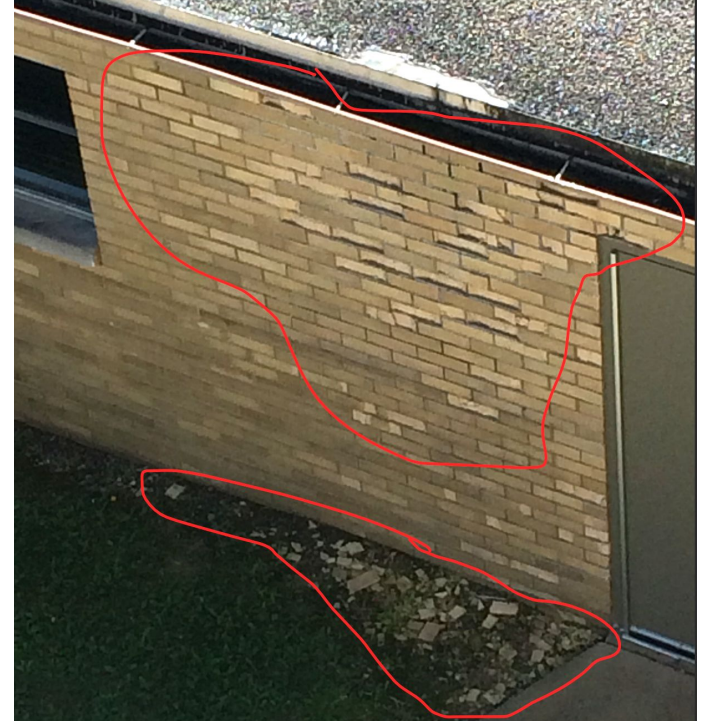
ASSESSMENT - BUILDING CONDITION

BUILDING ENVELOPE:

Exterior facade is in poor condition. Water has infiltrated behind the brick and is causing deterioration in multiple areas of the building. This includes cracking, shifting, spalling and falling of the brick.

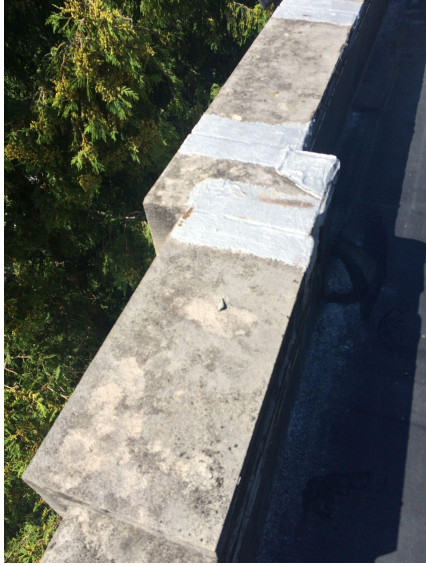
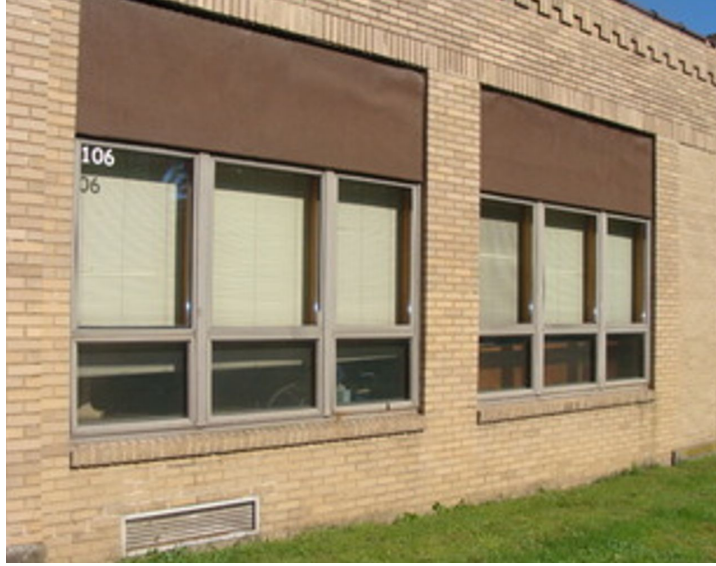
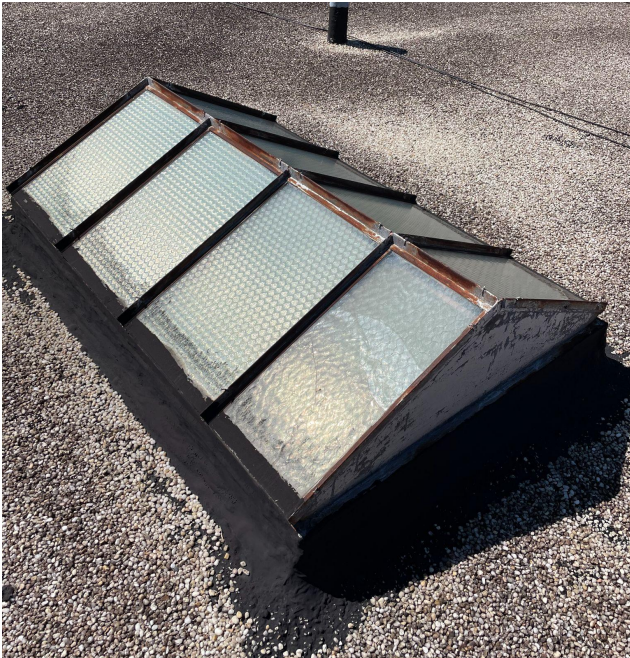
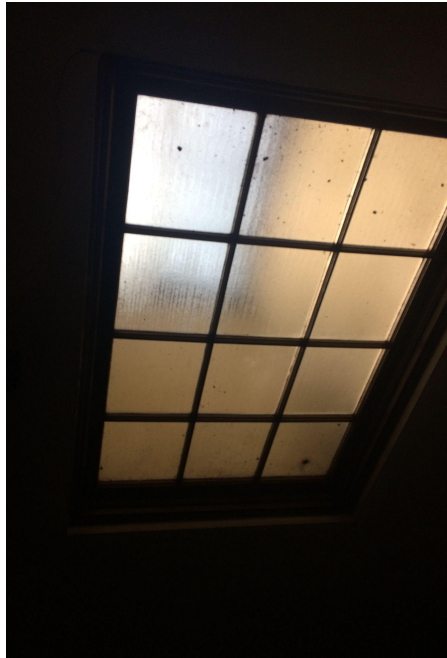
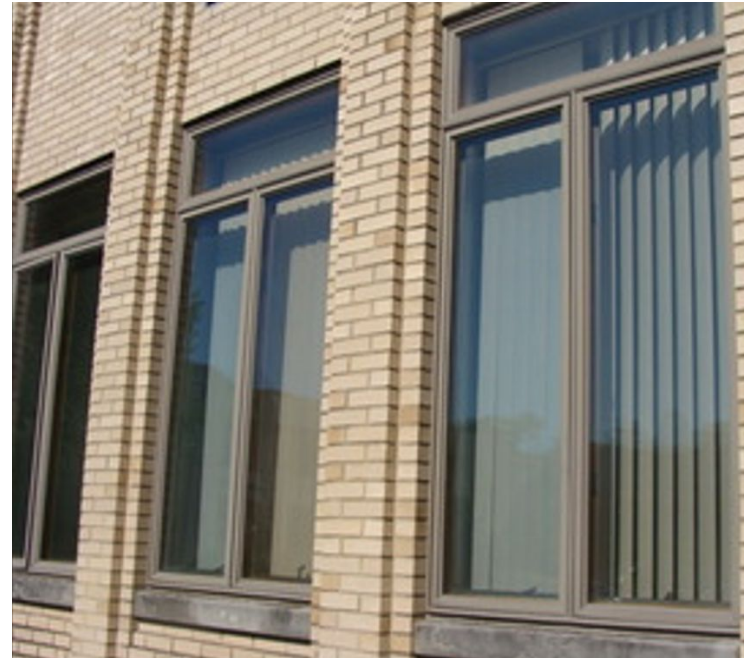
ASSESSMENT - BUILDING CONDITION

BUILDING ENVELOPE:
The windows, coping joints, and skylights are in poor condition and contribute to the water and air infiltration. These are also a source of energy loss to the building.

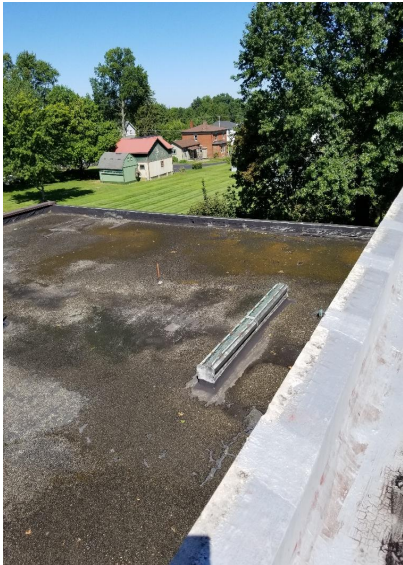
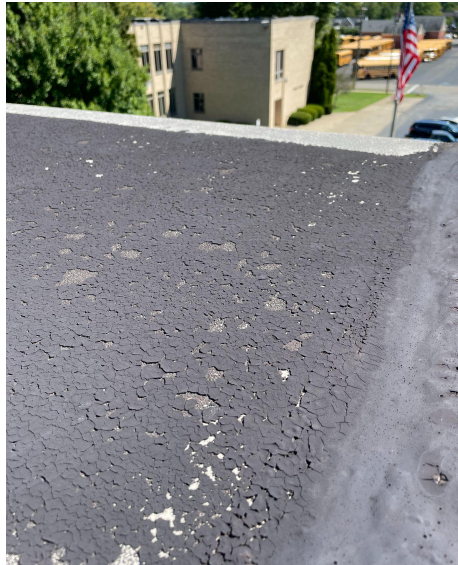
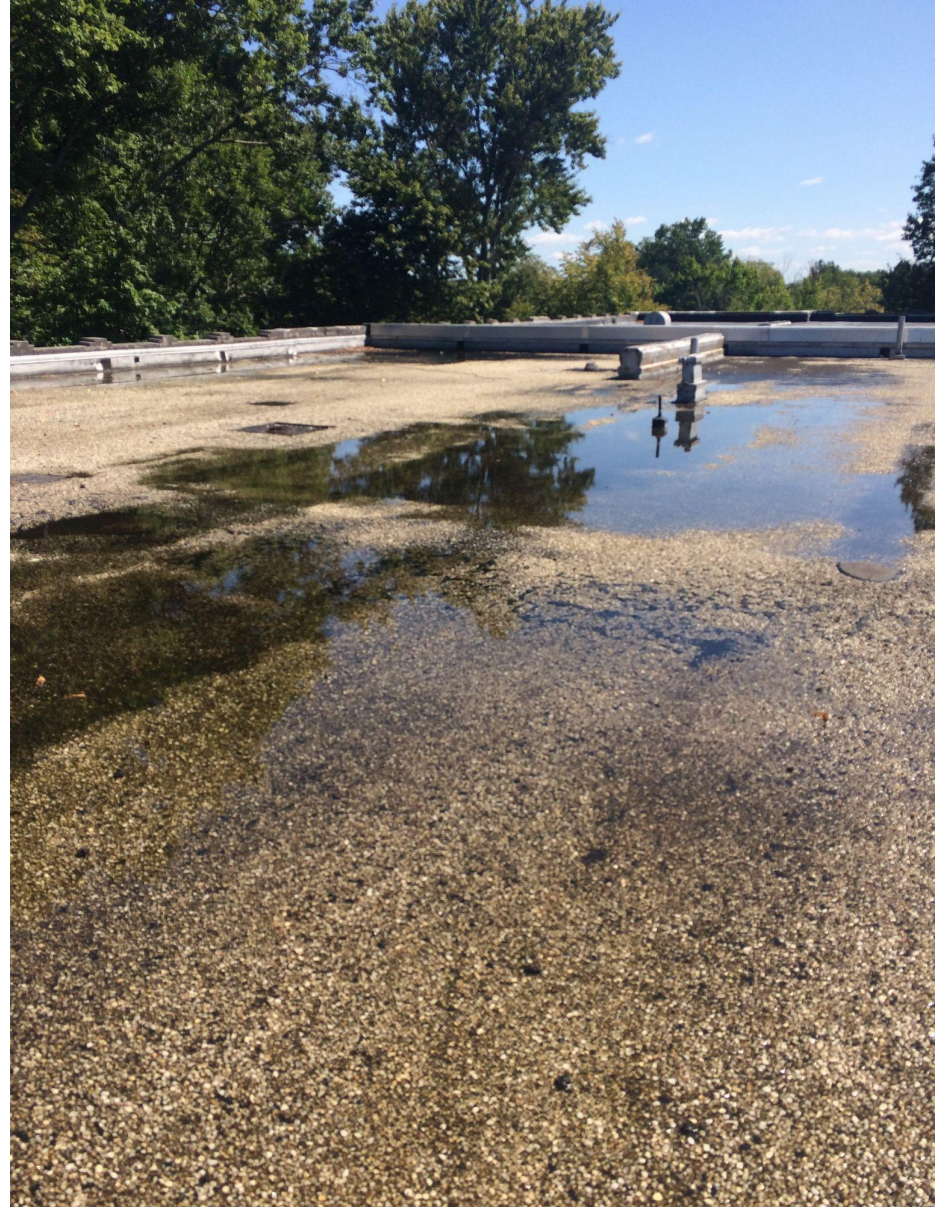
BUILDING ENVELOPE - ROOFING:

A variety of roof systems are present, some of which are in poor condition, and are experiencing leaking, ponding and deterioration.

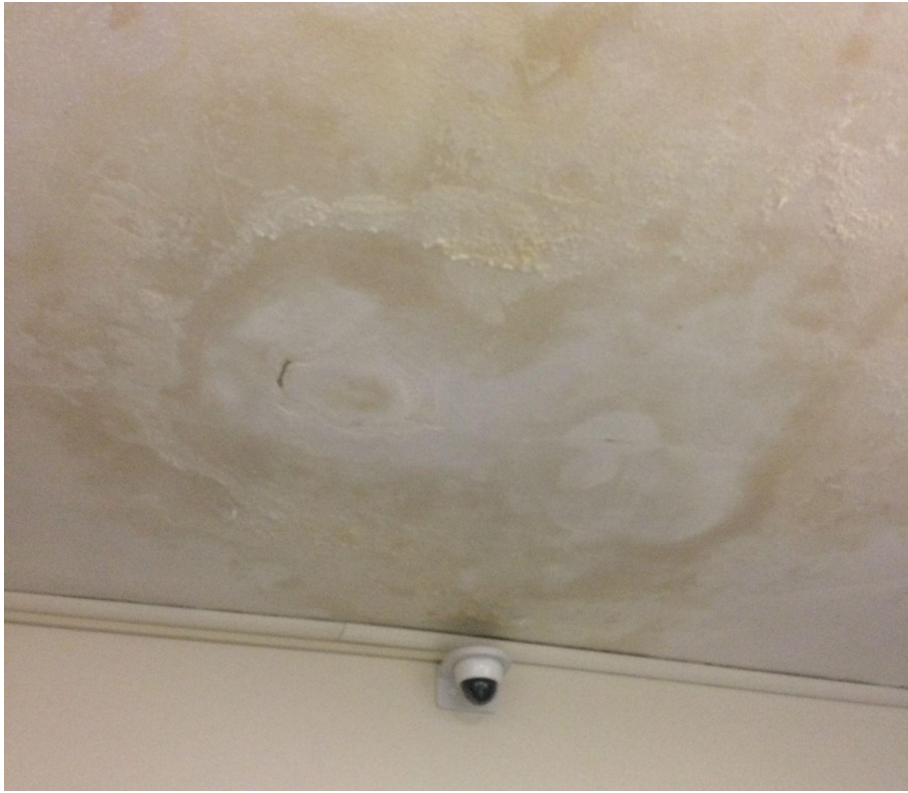
GENERAL FINISHES:

As expected with a 100 year old building, many of the general finishes are worn, dated and have exceeded their useful life. Additionally, water infiltration has caused damage to components such as plaster and screw-in panel ceilings.

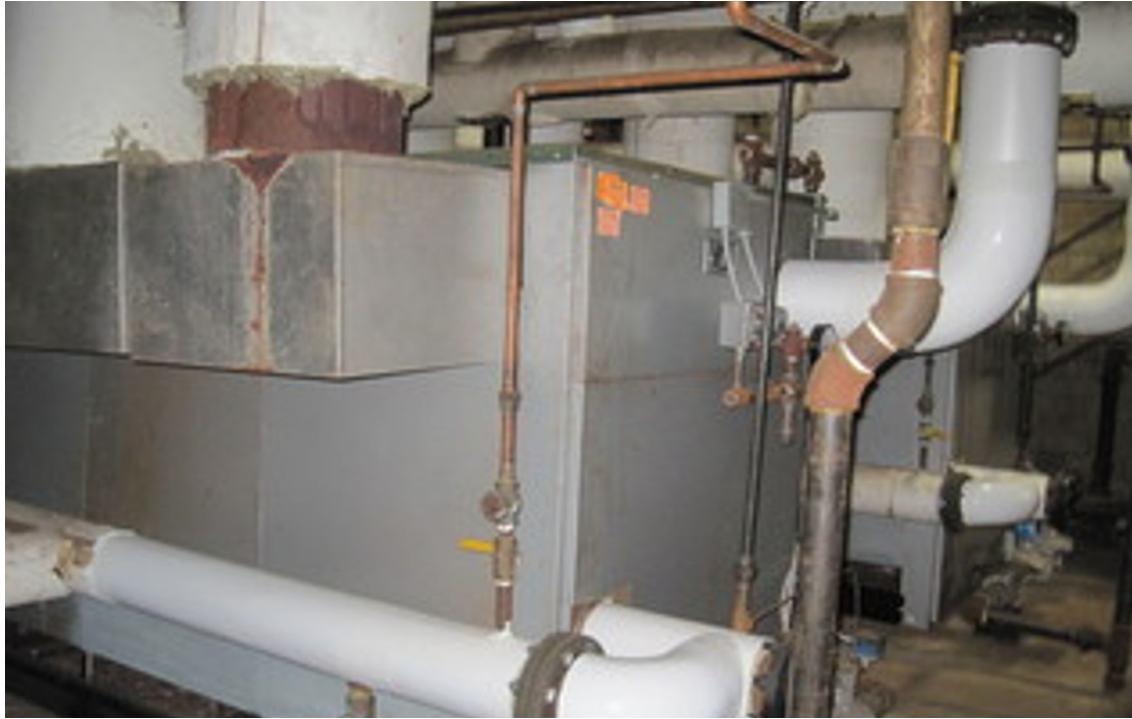
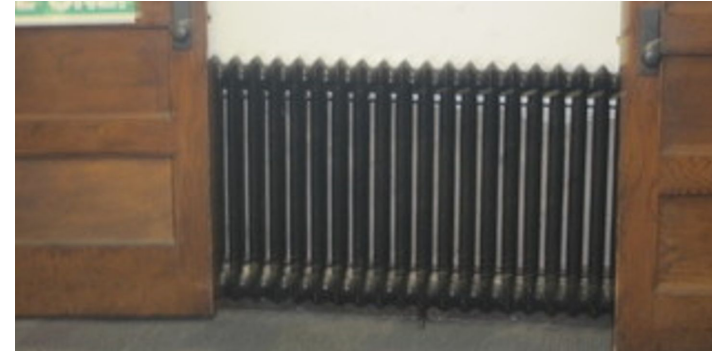
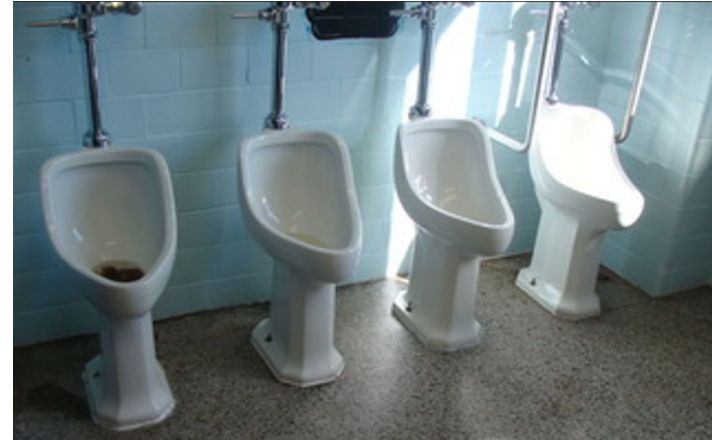
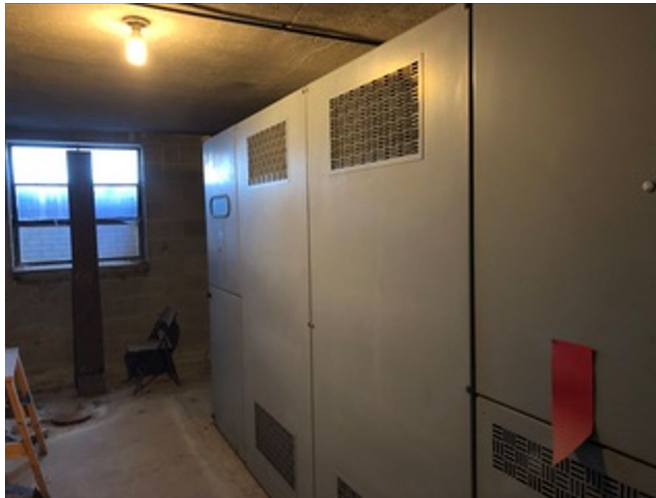
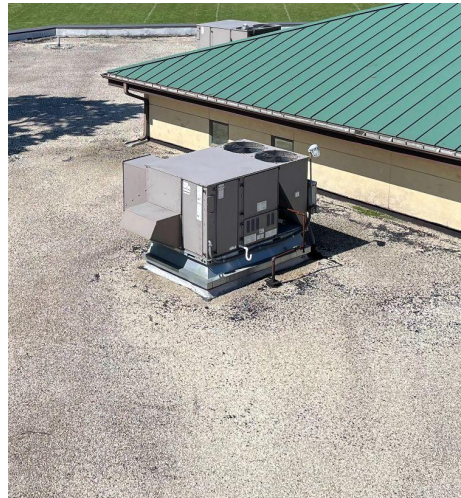
BUILDING SYSTEMS (HVAC, ELEC., PLUMBING):

Overall, the HVAC and electrical systems have reached or exceeded their useful life. Some select areas of the building have AC, but most classrooms do not. The majority of the spaces are not provided with proper outdoor fresh air requirements per code.

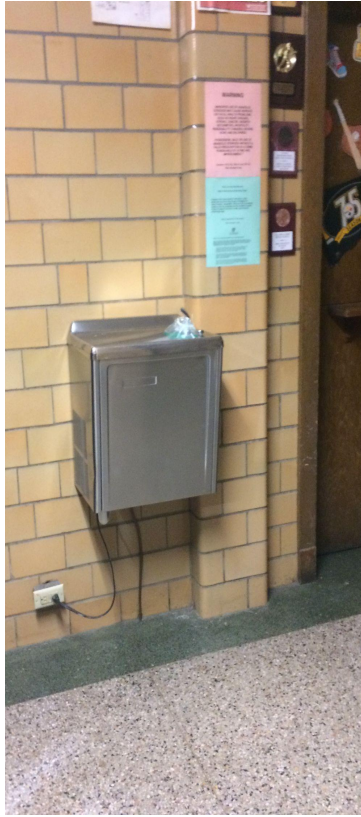
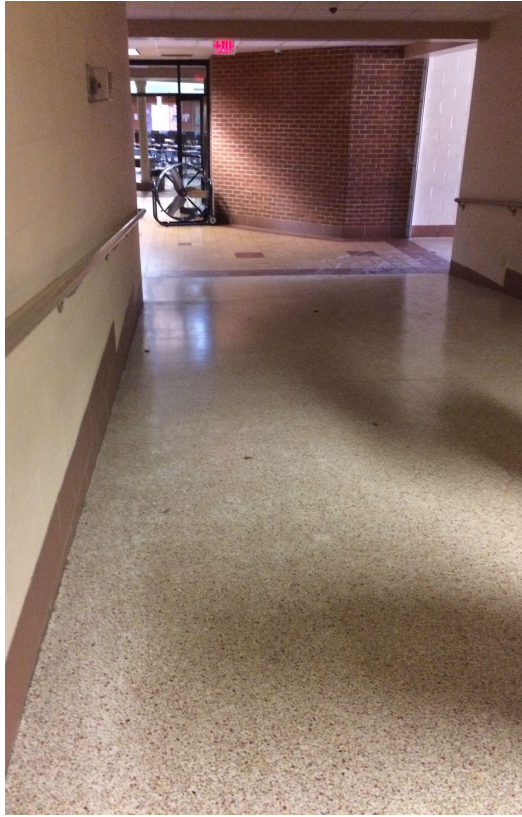
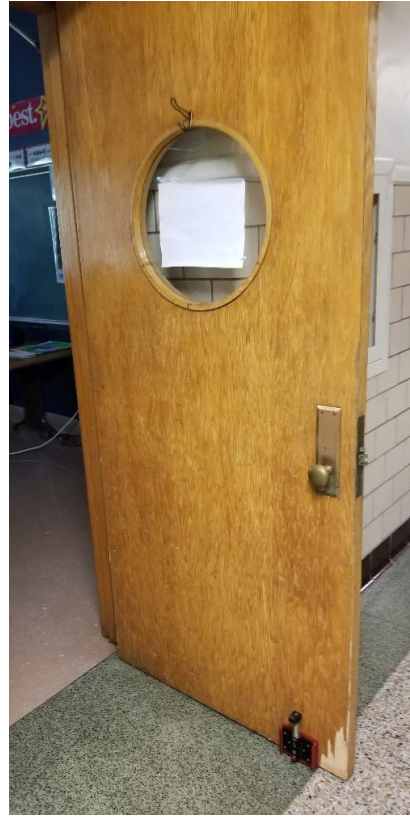
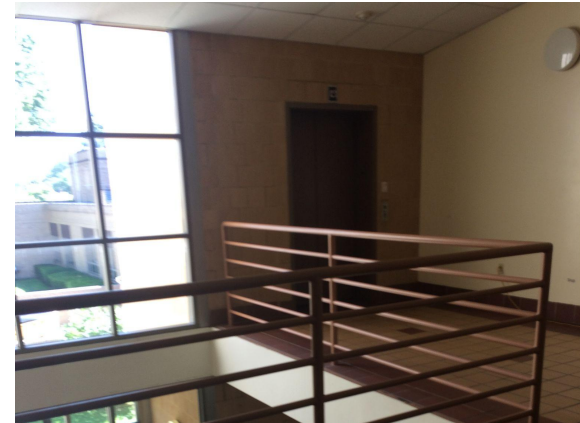
ADA ACCESSIBILITY:

Although there is an elevator in the building, there are many barriers in the facility and on-site. Adequate handicapped parking is not provided, most exterior and interior doors are not equipped with ADA hardware. Ramps and stairs do not meet all ADA requirements, and space allowances and reach ranges are not compliant.

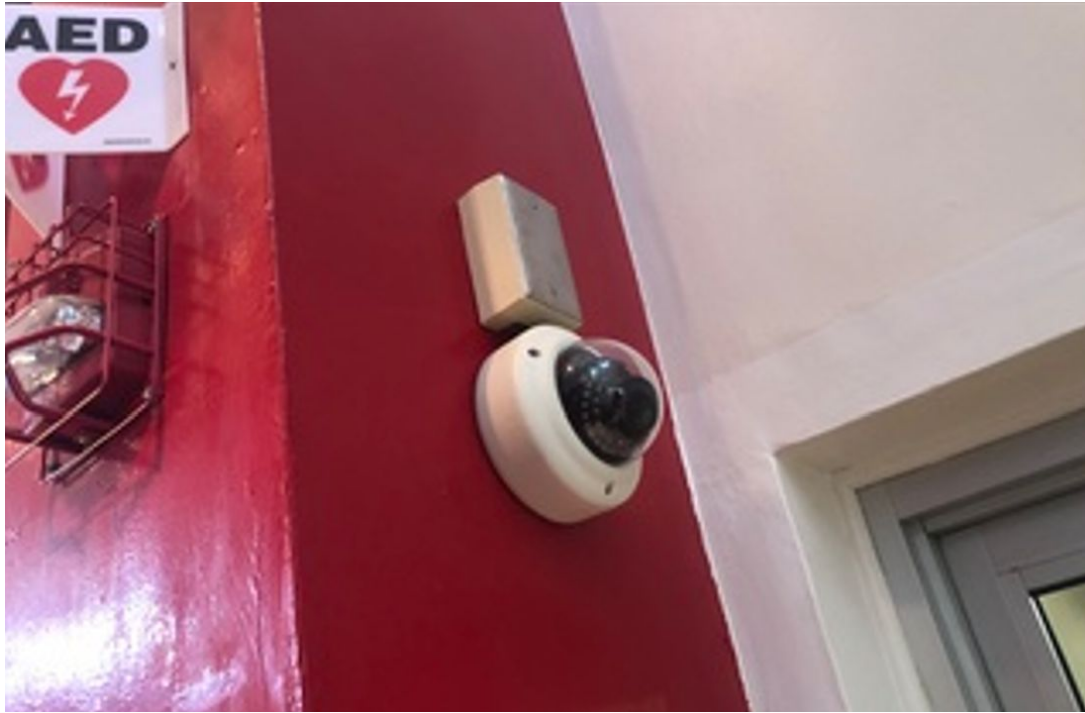
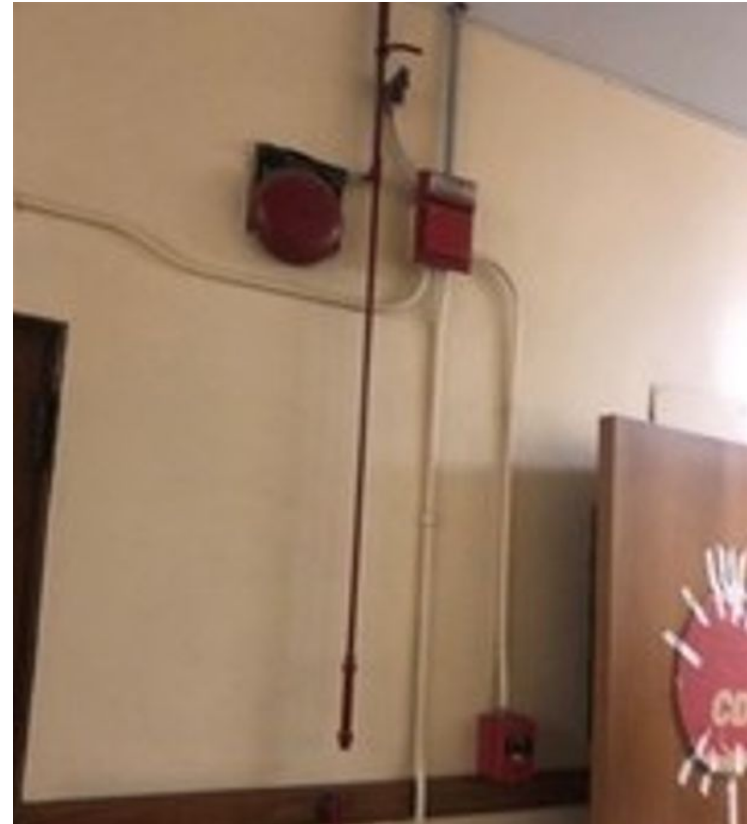
ANCILLARY SYSTEMS: Many building support systems are inadequately provided and do not meet current code and OSDM standards such as security and emergency lighting. Others are non-existent, such as a sprinkler system.

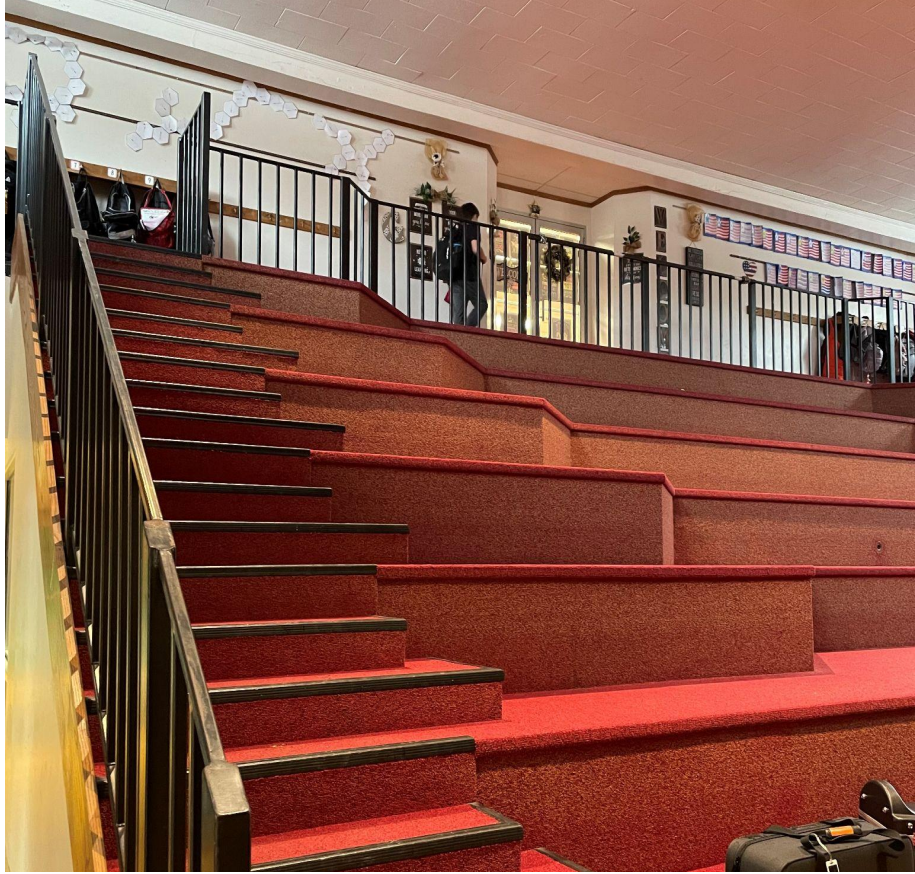
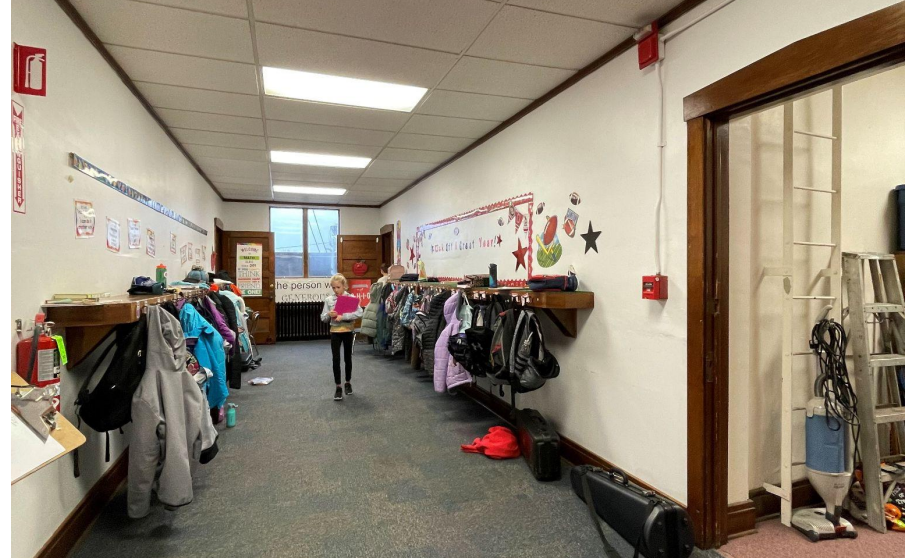
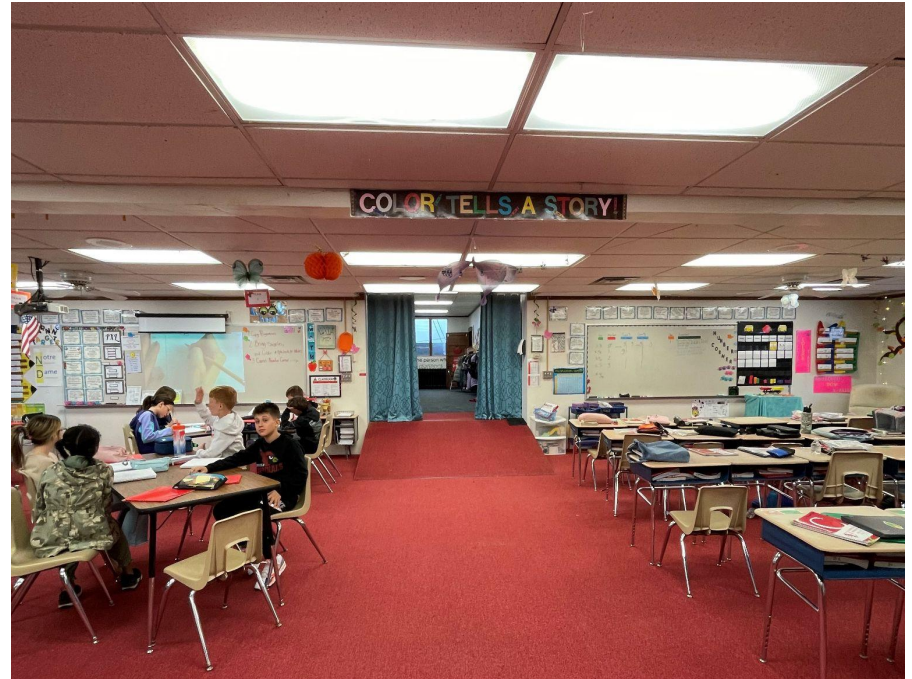
LAYOUT: Students and staff must travel through an educational space/classroom in order to gain access to other educational spaces/classrooms.
