Canfield High School

Building Review
December 7, 2022

ASSESSMENT FINDINGS

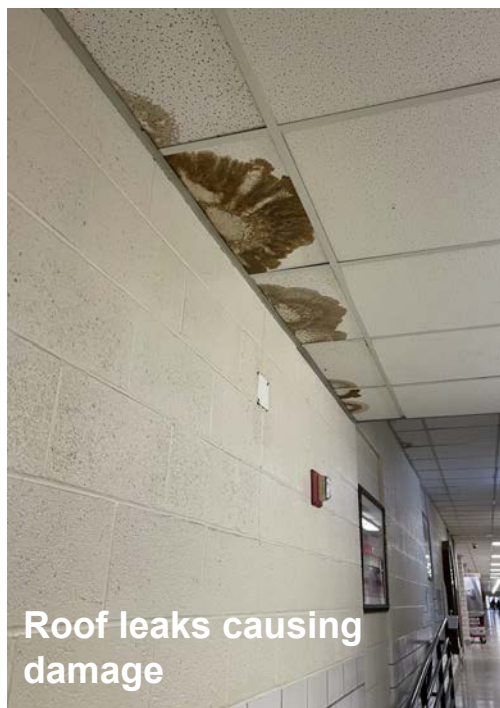
Roof leaks causing damage

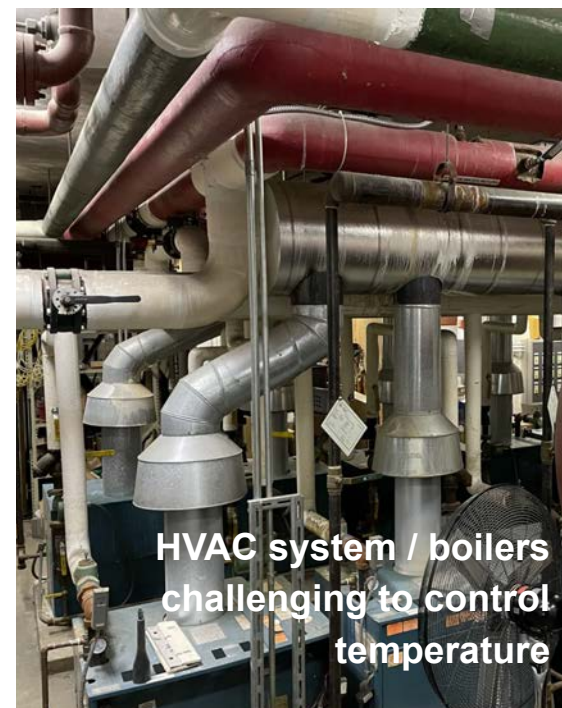
HVAC system / boilers challenging to control temperature

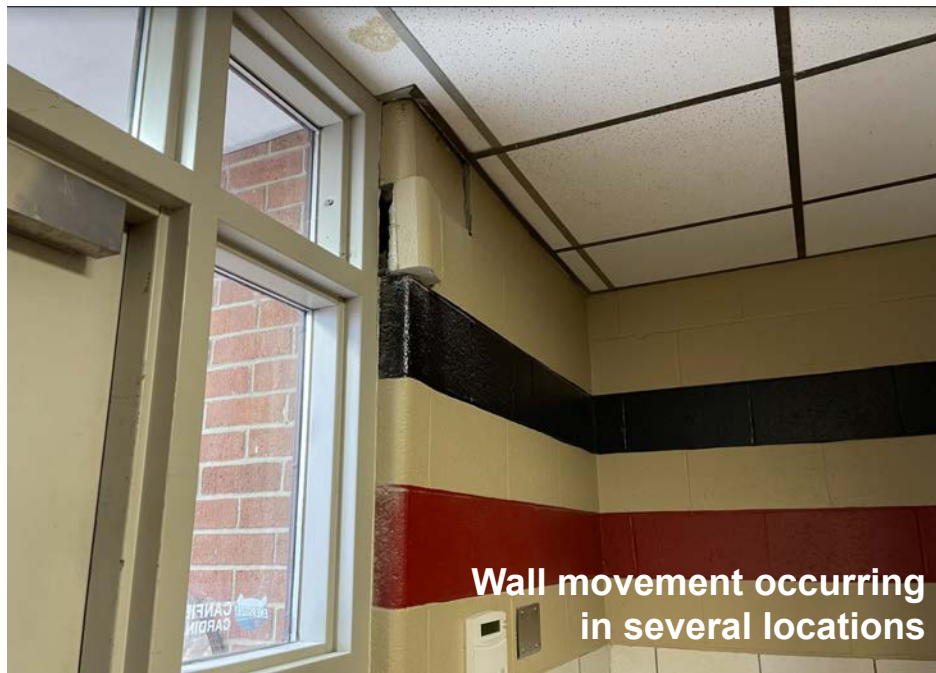
Wall movement occurring in several locations

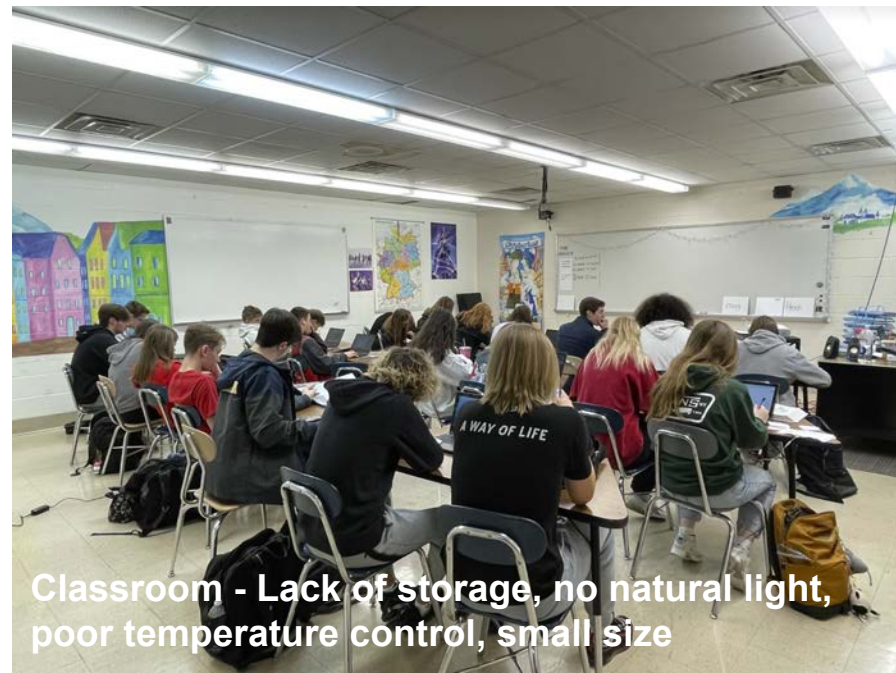
Classroom - Lack of storage, no natural light, poor temperature control, small size

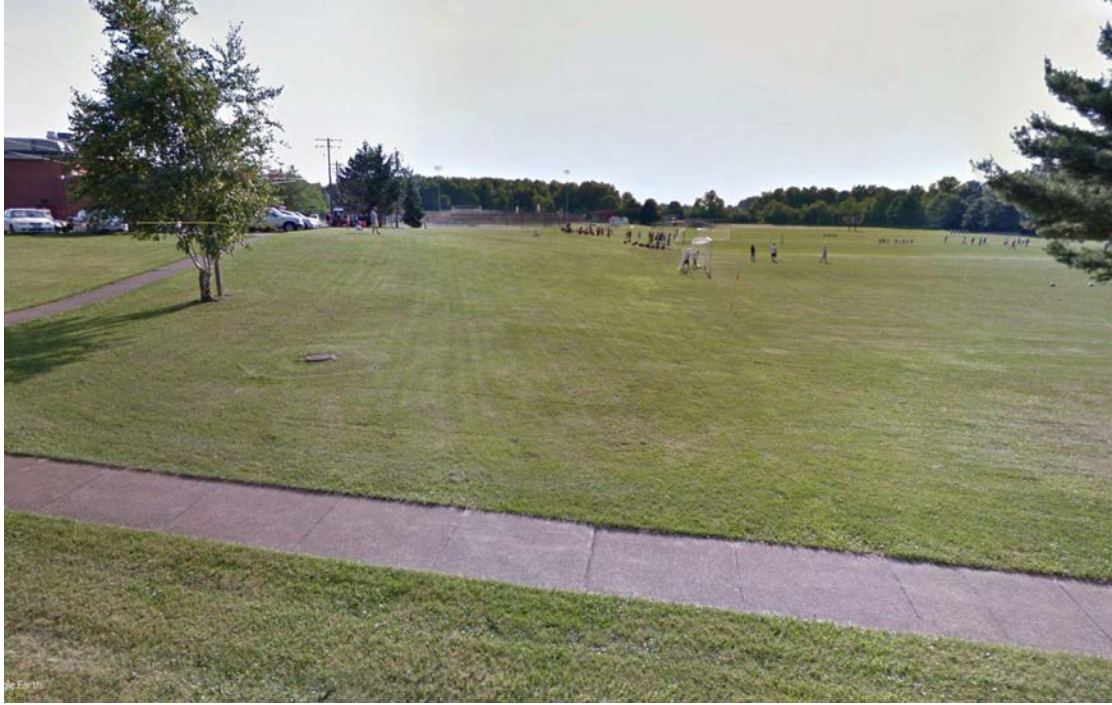
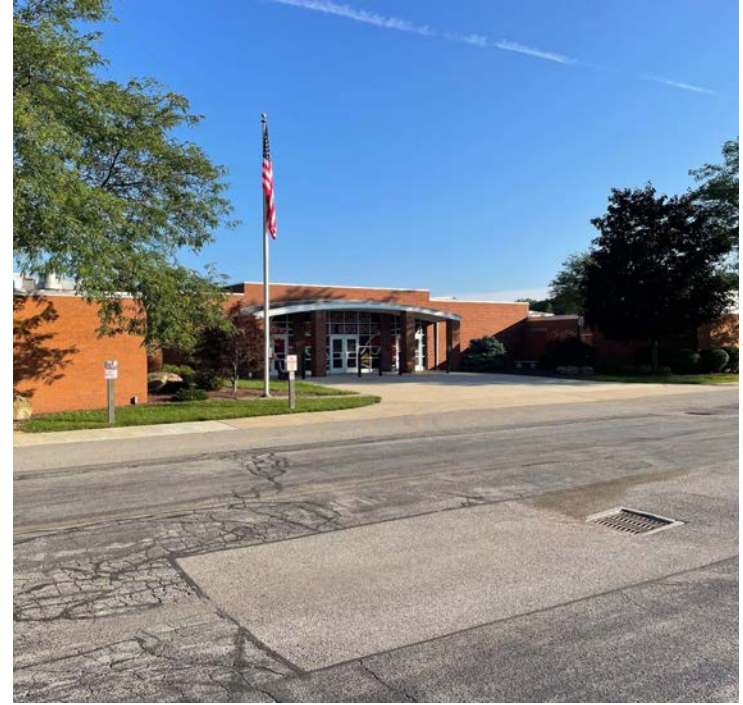
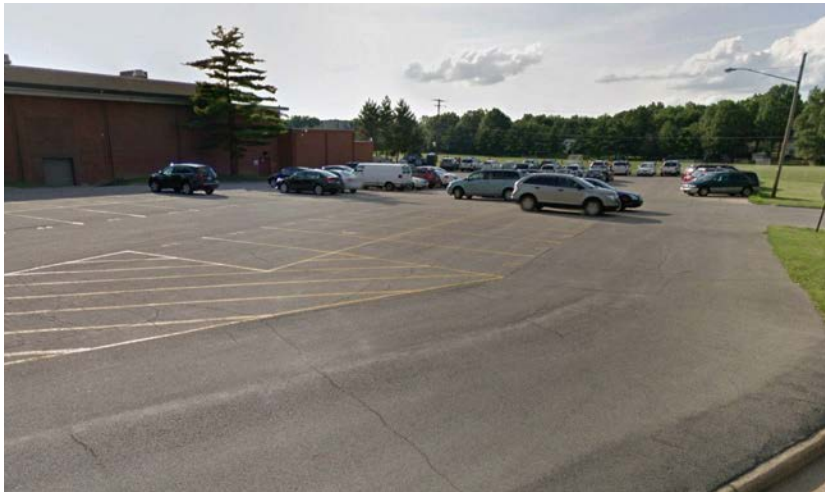
ASSESSMENT - SITE ANALYSIS

CHS sits on a slightly sloped 45 acre site that features limited tree landscaping. The site is suitable for outdoor learning, and exceeds OSDM recommendations of 42 acres for the current enrollment.

Site slopes downward to the parking lot area, creating ponding of water in the parking lot, which when freezes, becomes a potentially hazardous condition.

The overall condition of the asphalt parking is in poor / deteriorating condition, and the concrete sidewalks range in condition from good to poor.

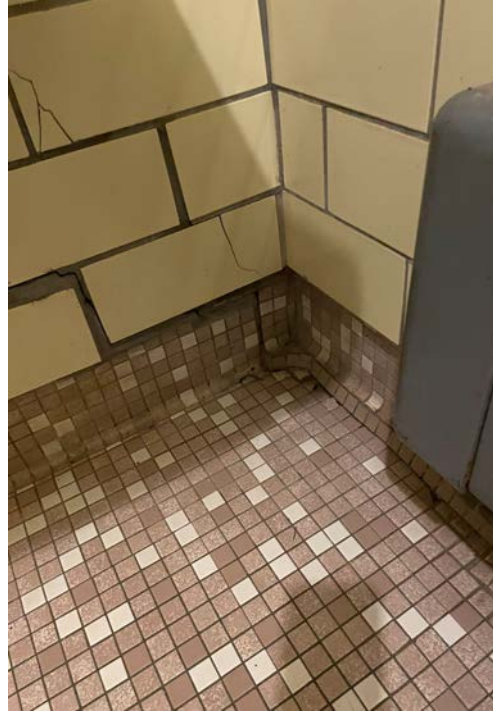
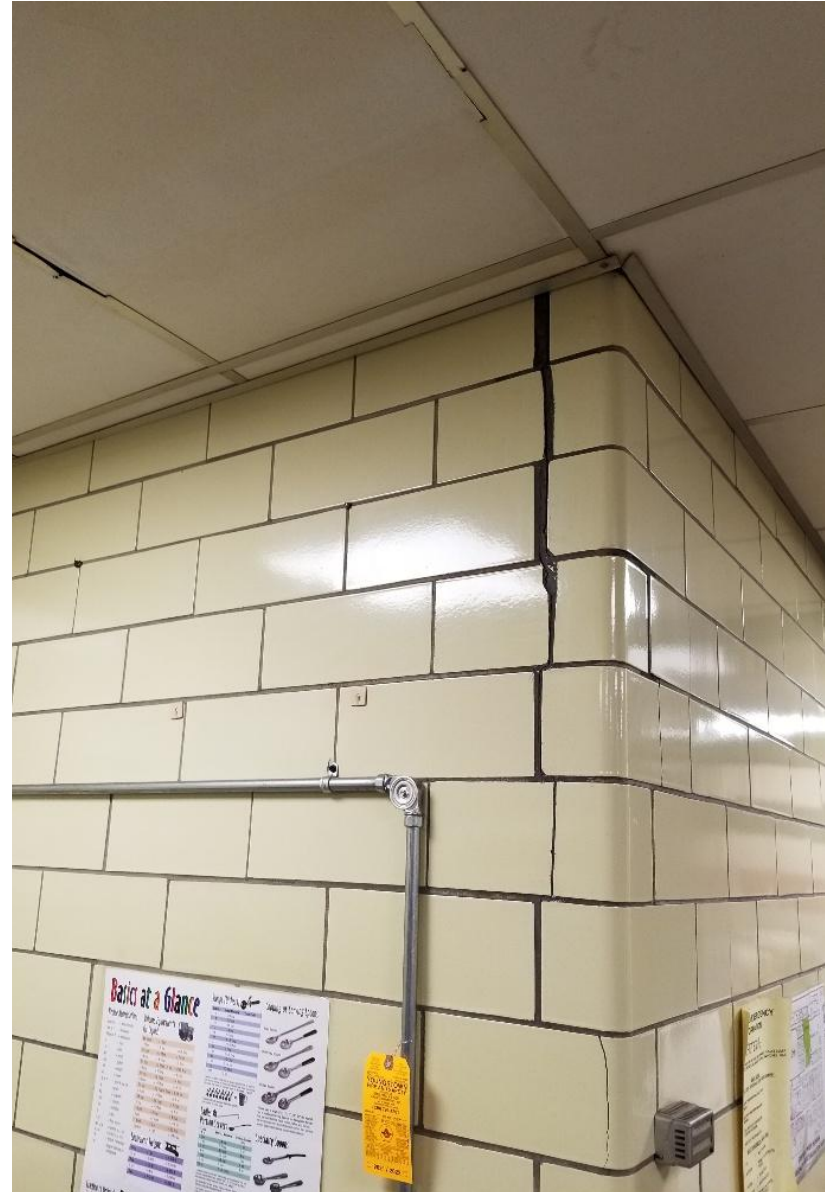
FLOOR/WALL SEPARATION & SETTLEMENT:

Areas of significant wall cracking have occurred in the general vicinity of the kitchen area which appears to be from foundation settlement. Additional areas on the east side of the building were observed and areas of wall and floor separation in Room 110.

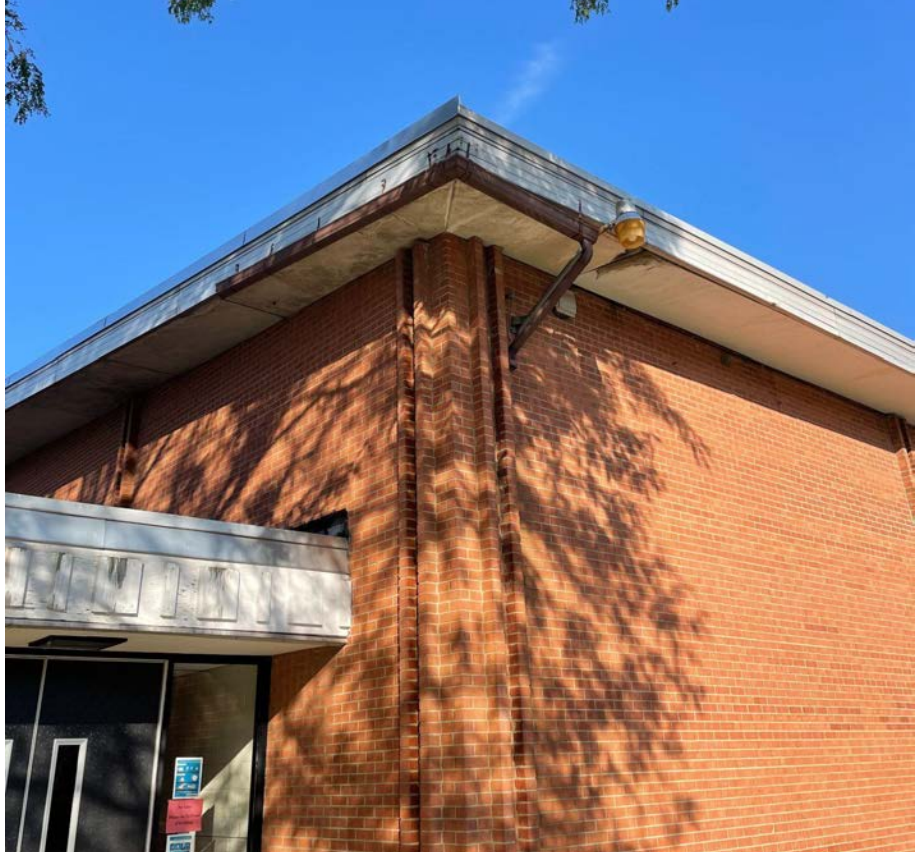
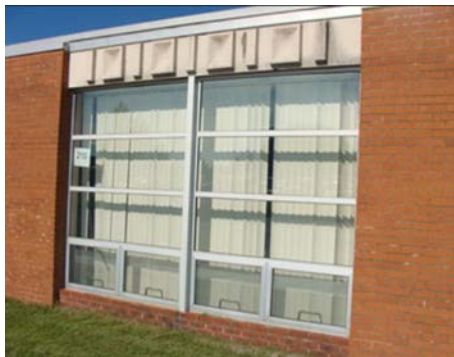
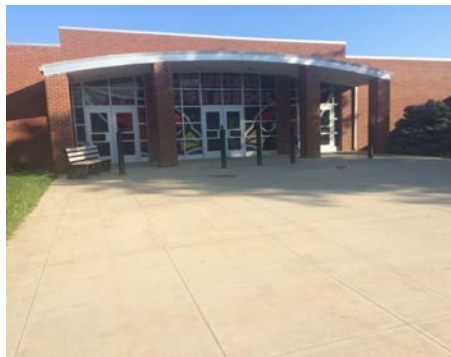
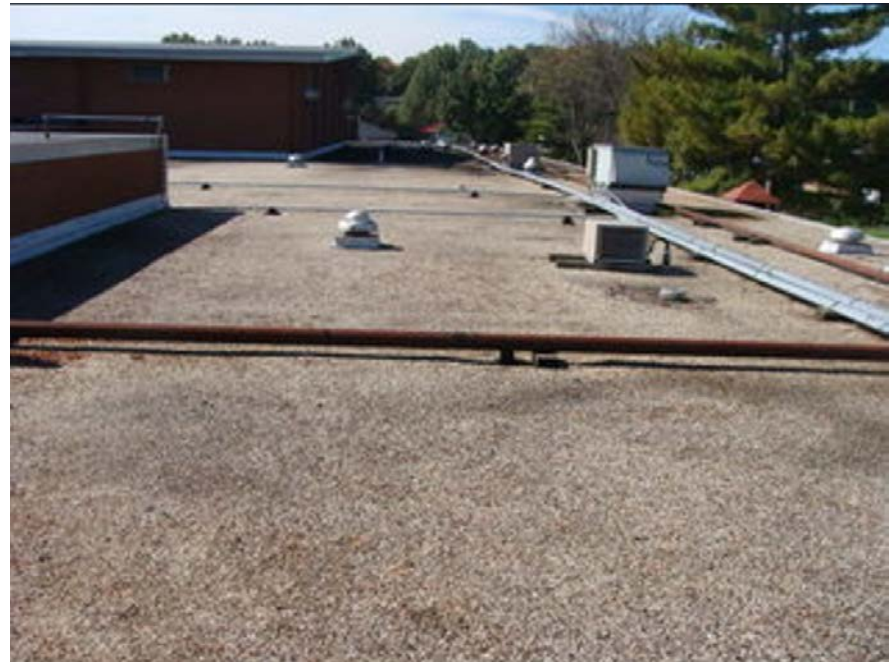
BUILDING ENVELOPE:

The overall condition of the exterior masonry and roof ranges in condition from good to poor condition. Some areas of roof have been replaced recently, while there are several other locations in poor condition with active leaking. The majority of windows and doors have reached/exceeded their natural life span and are due for replacement.

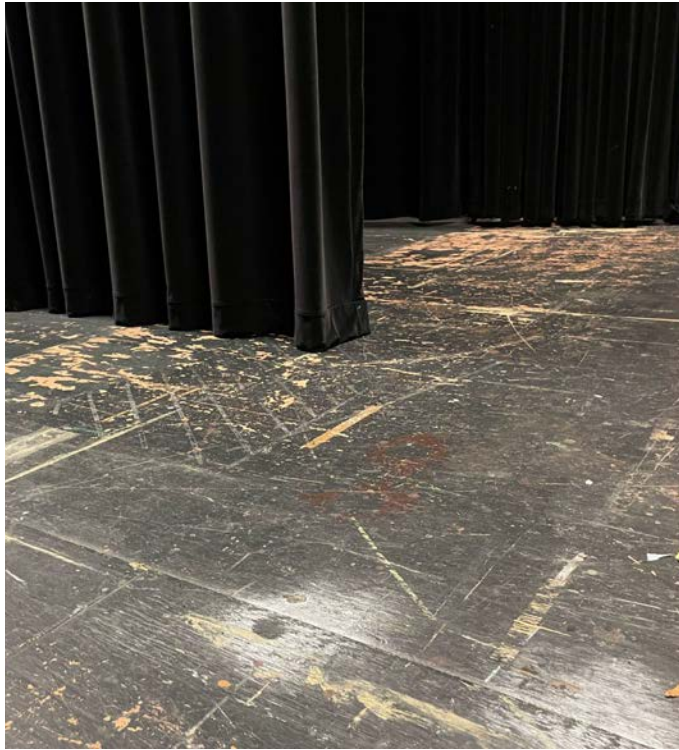
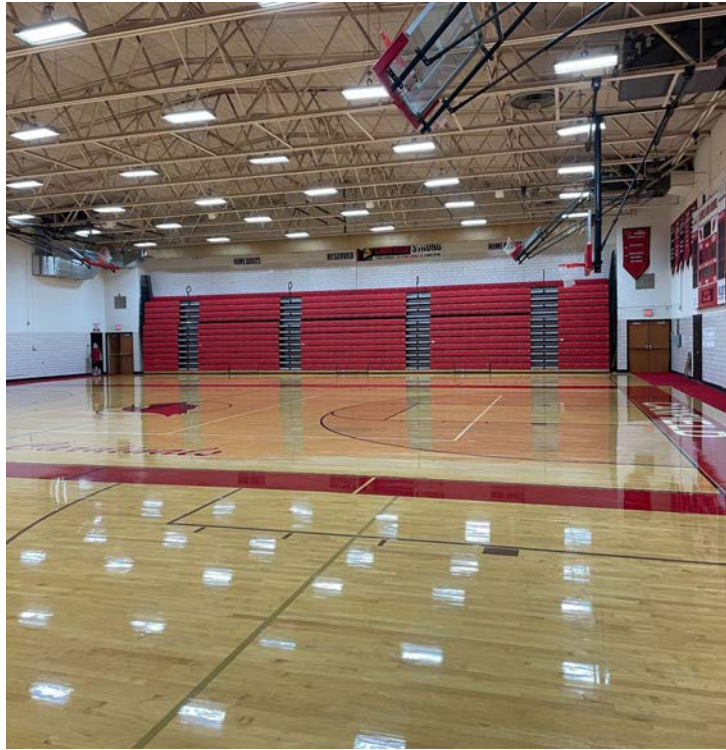
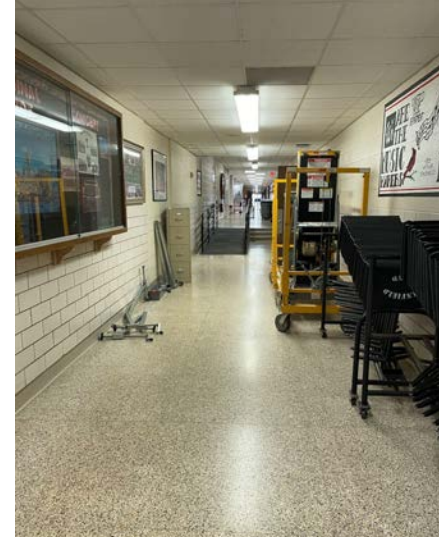
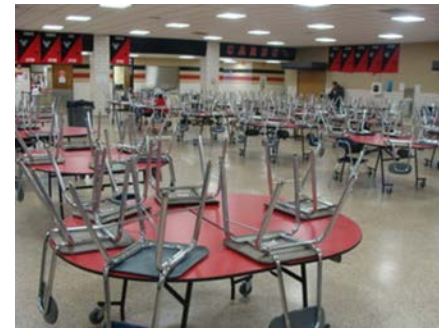
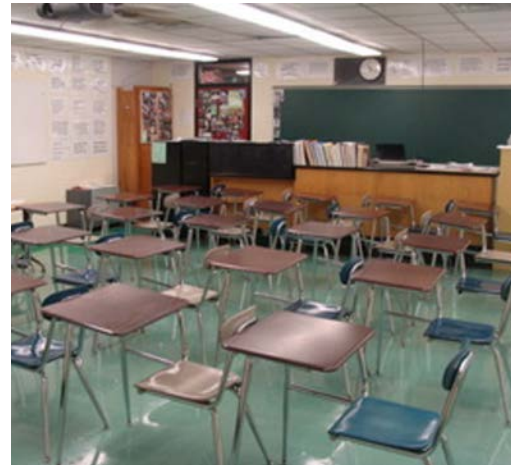
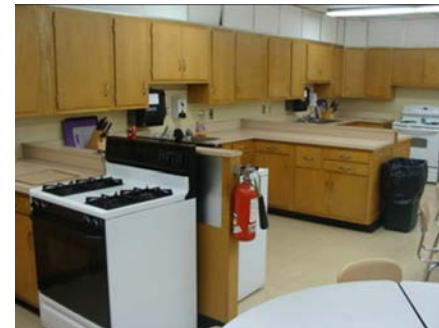
GENERAL FINISHES:

The finishes throughout the building range in terms of quality of materials, age and condition, from good to poor.

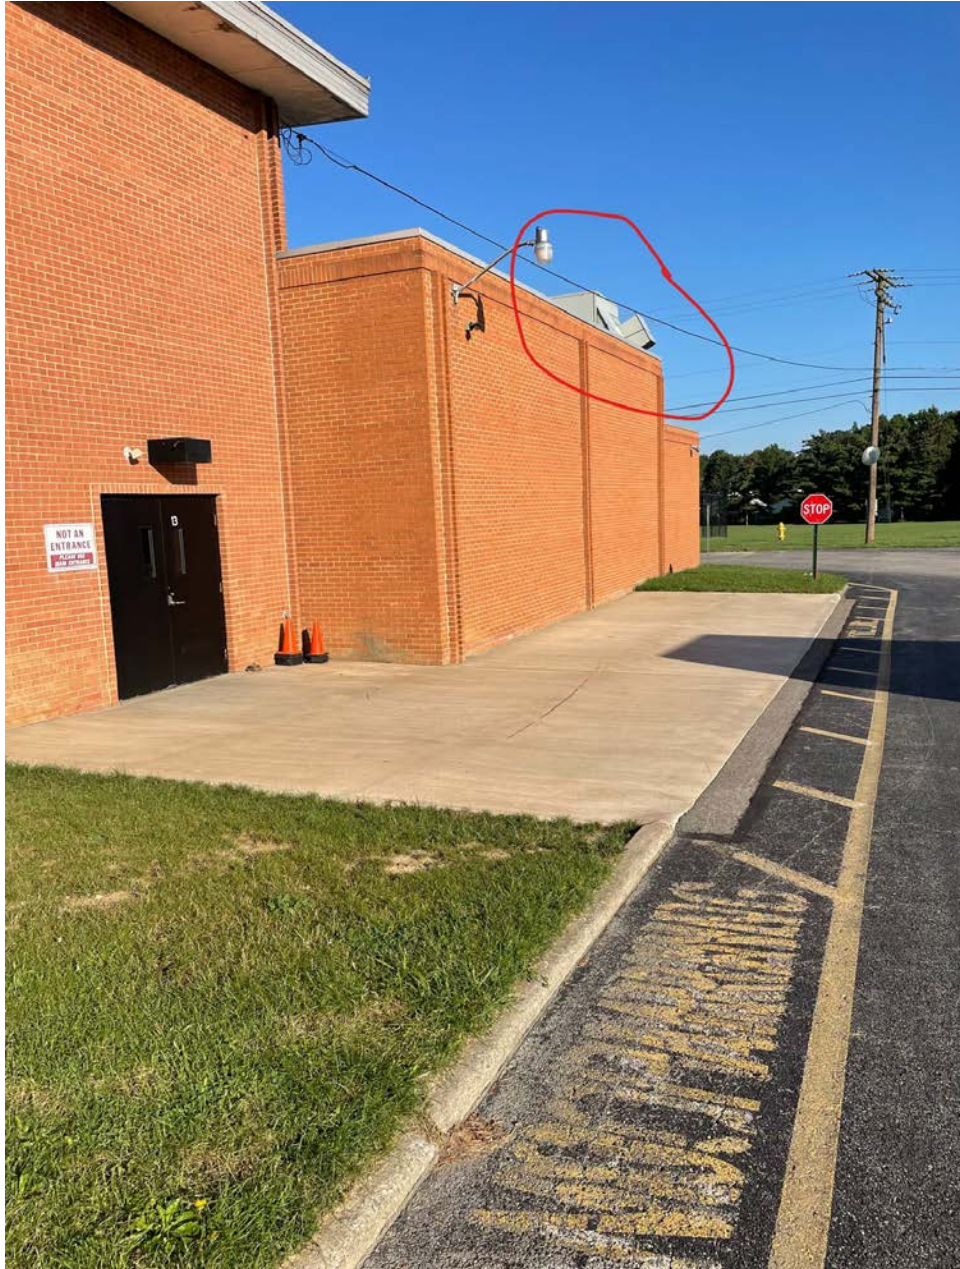
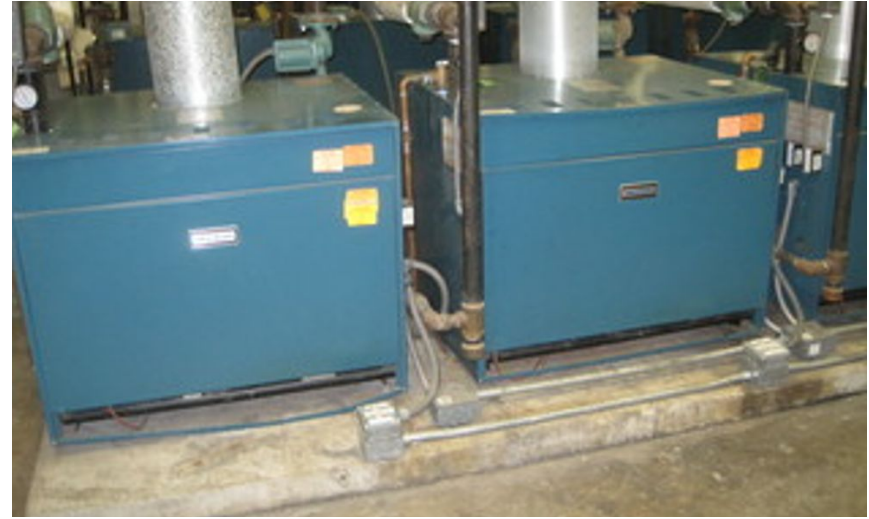
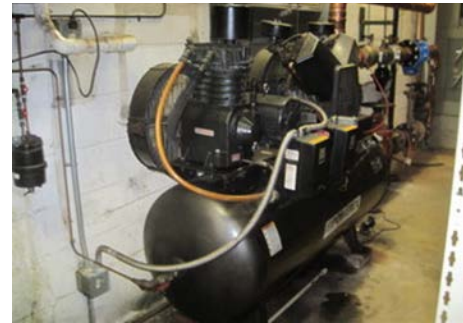
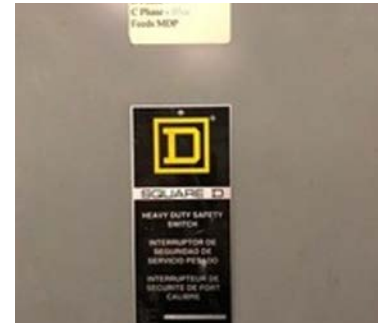
BUILDING SYSTEMS (HVAC, ELEC., ETC.): The district has recently embarked on a 3-year replacement project of all Roof-Top Units (RTU's). However, other HVAC system components as well as electrical system components are outdated and do not meet all code and OSDM requirements.

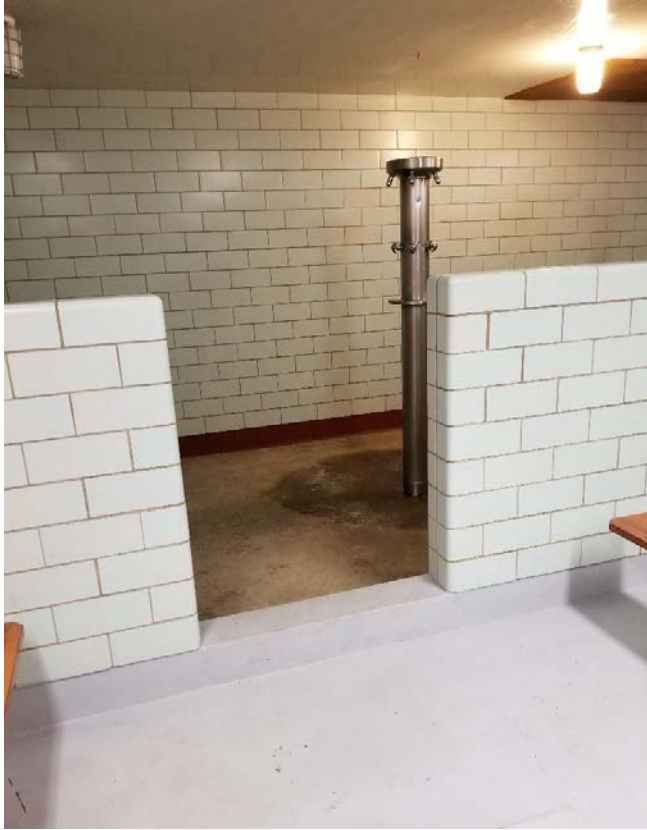
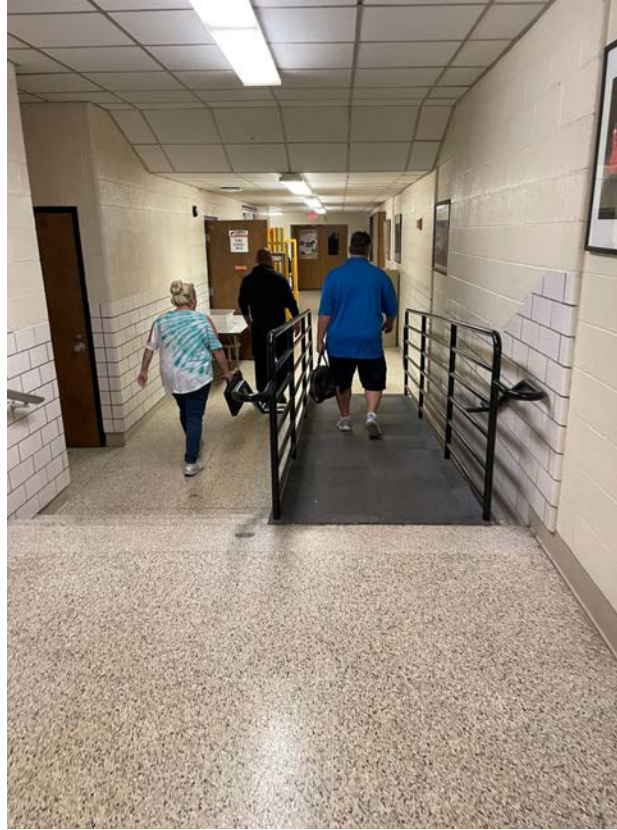
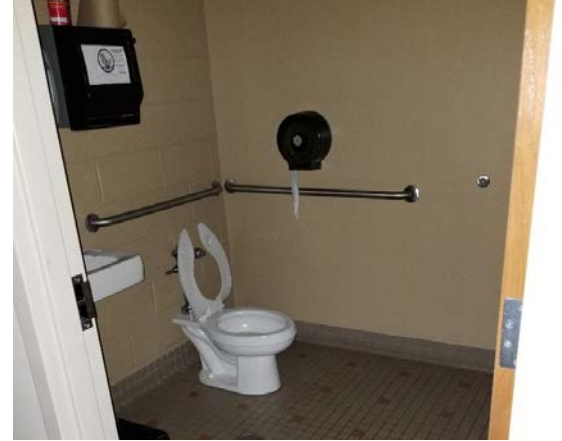
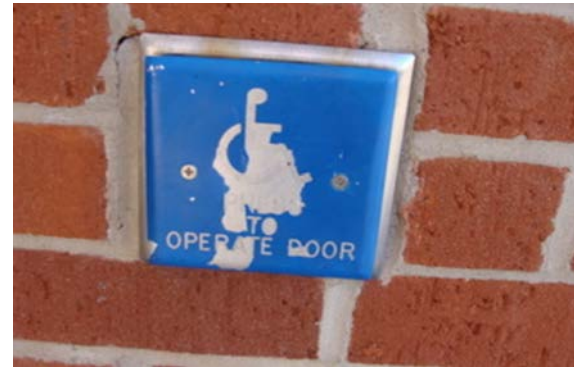
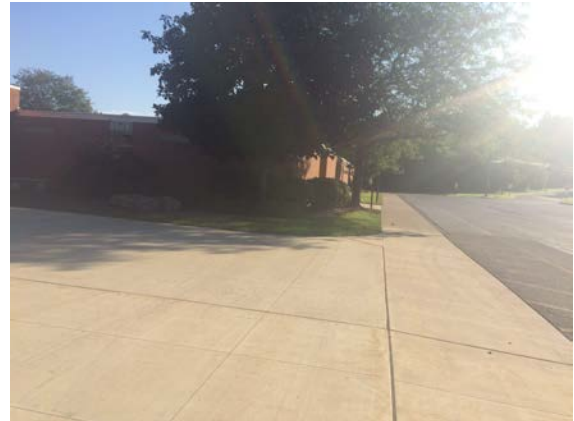
ADA ACCESSIBILITY:

Many ADA improvements have been incorporated into the building in order to meet ADA requirements, such as ramps, ADA power assist door, and ADA restrooms. However, there are still ADA barriers present in this building, such as accessible locker room showers and some space allowances and reach ranges are not compliant.

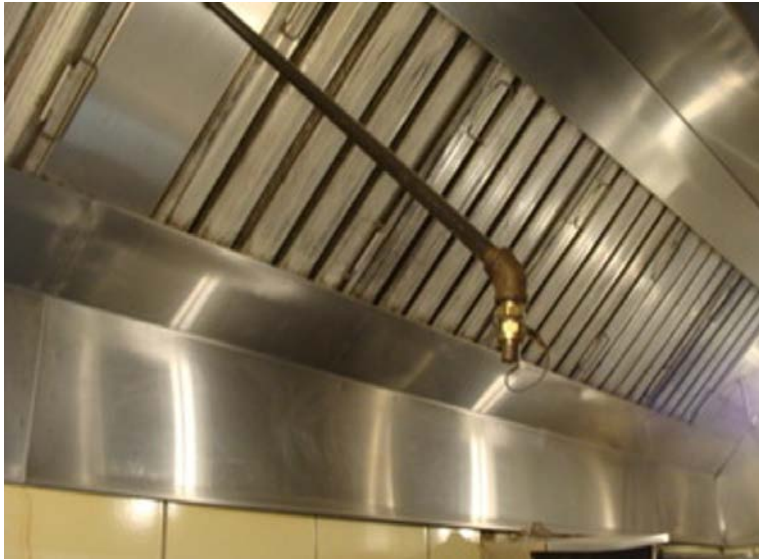
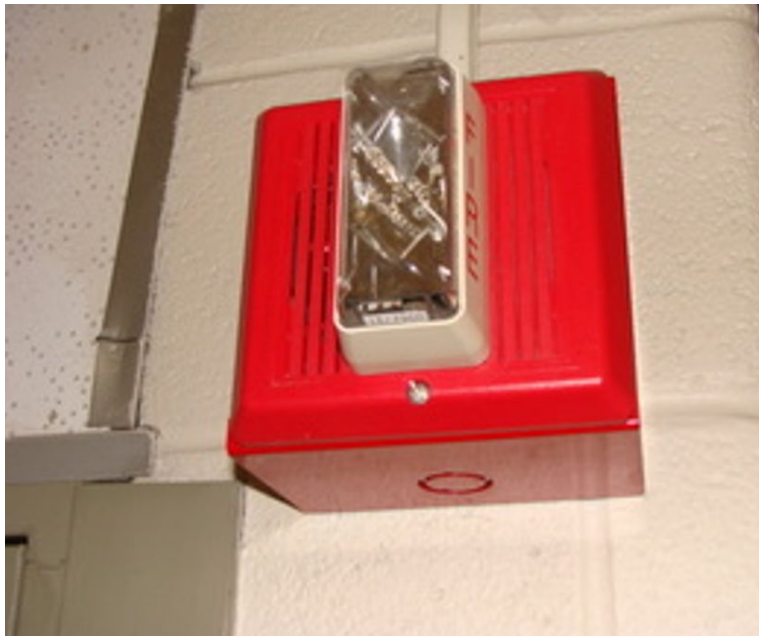
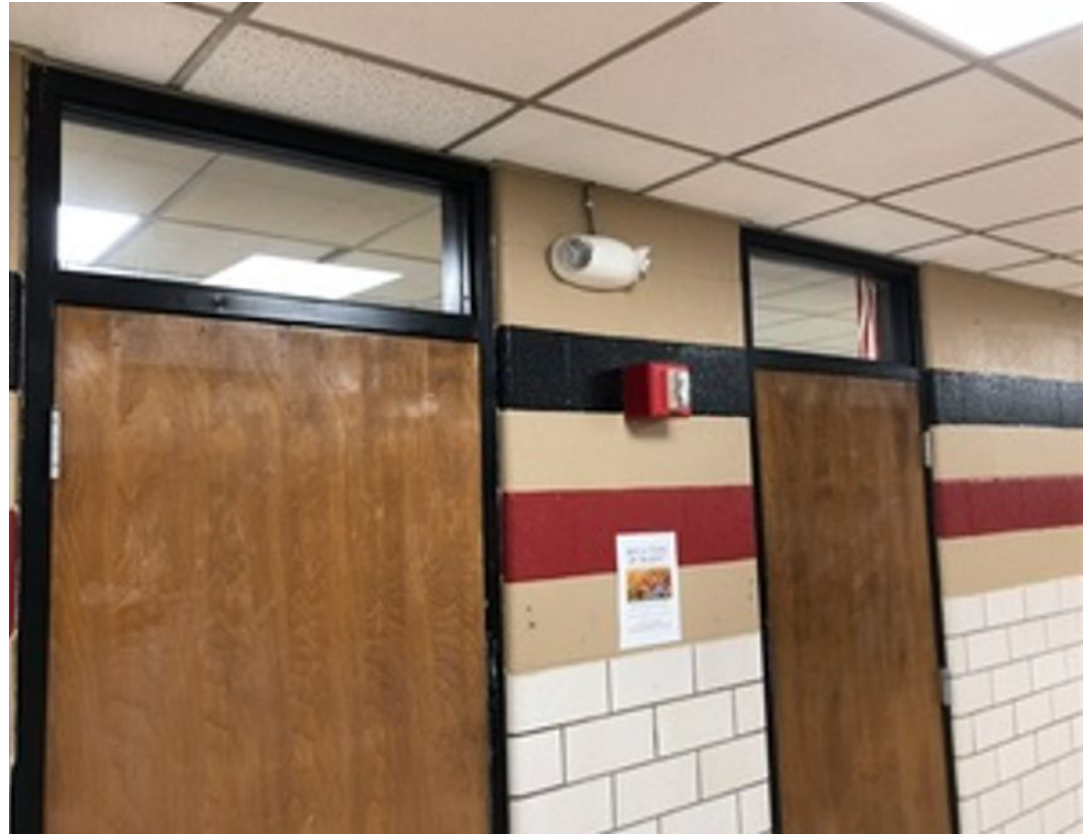
ANCILLARY SYSTEMS:

Many building support systems are inadequately provided, some do not meet current code and OSDM standards such as emergency lighting & fire alarms systems, and others are non-existent, such as a sprinkler system.
