## UPPER ADAMS SCHOOL DISTRICT

# District Wide Feasibility Study

June 2016  
CRA Project No. 2832

**Crabtree, Rohrbaugh & Associates  
Architects**

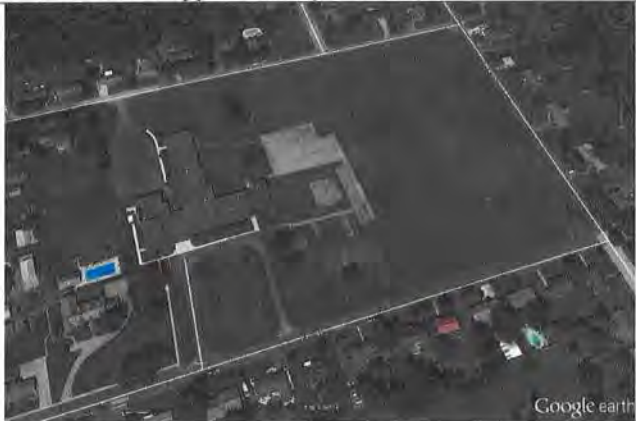
An aerial photograph showing a school campus with several buildings, parking lots, and surrounding residential areas. The text "Google earth" is visible in the bottom right corner of the image.
<u>General Condition of Site:</u>	The overall general conditions of the site are good.
<u>Topography:</u>	Majority of site is level. Some moderate sloping conditions at the building pad down to play areas. Site topography accommodates adequate drainage.

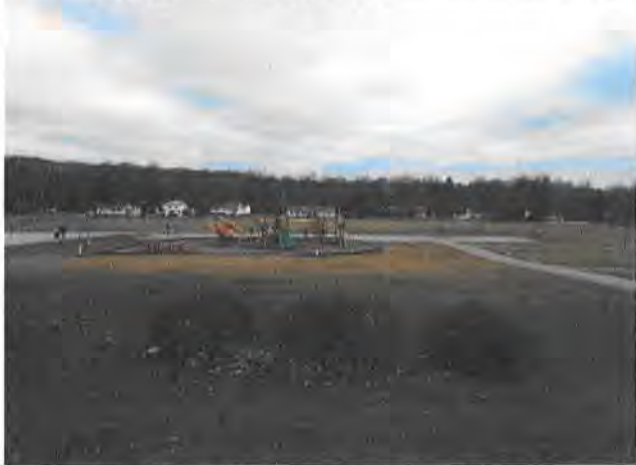
A ground-level photograph of a school playground area. The playground has colorful equipment and is surrounded by a paved area. In the background, there are trees and a cloudy sky.
<u>Site Circulation:</u>	Staff, student, and public entry is separate from delivery services. Separation of bus and parent / student drop-off vehicular traffic appears adequate. Bus drop-off is at the rear of the building and parent / student drop-off in front.

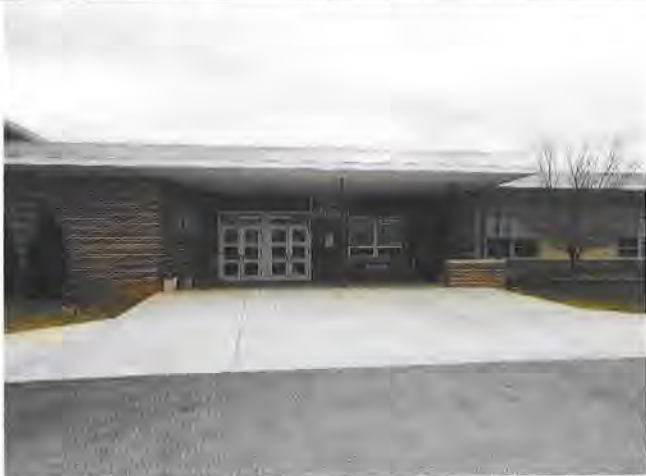
<u>Roof System:</u>	The building roof consists of rubber membrane and appears to be in fair overall condition.

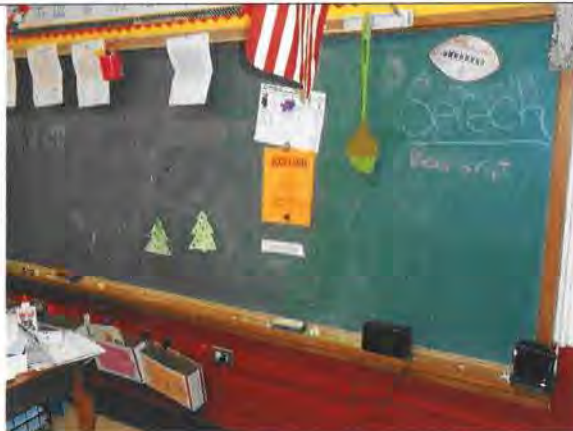
Chalkboards, whiteboards, and smart boards are in good condition. Many chalkboards were resurfaced in the 1989 renovation.

*Existing chalkboards should be replaced to match the other marker boards in the building due to the potential for chalk dust to lead to allergies and computer issues. However, it appears that the chalkboards are not used extensively given the smart boards.*

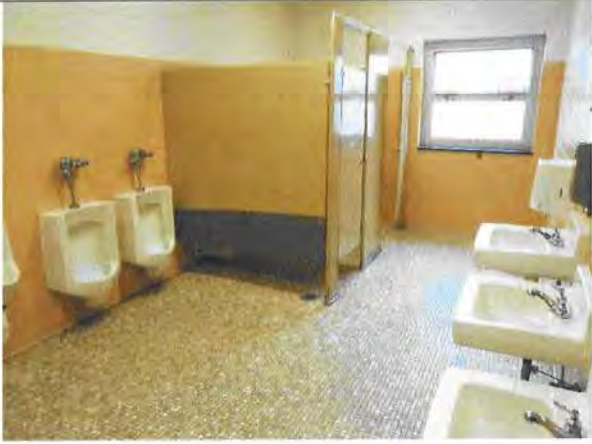
Many toilet rooms throughout are currently non-compliant per current accessibility codes. Toilets in the Nurse's suite are not in compliance with ADA. Individual toilet rooms within a few of the classrooms are too small and do not meet ADA. Toilet fixtures appear to be in fair condition yet dated. Metal toilet partitions appear to be in fair to poor condition with some loose dividers and missing accessories.

*Fixture replacement and interior finish upgrades and ADA clearance compliance with any proposed building improvement project.*

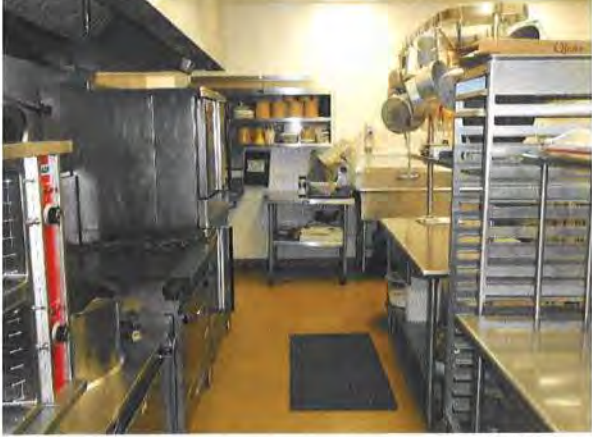
<p><u>Kitchen Equipment:</u></p>	<p>The Kitchen equipment appears to be in good condition with some of the equipment installed with the 1989 renovations.</p>

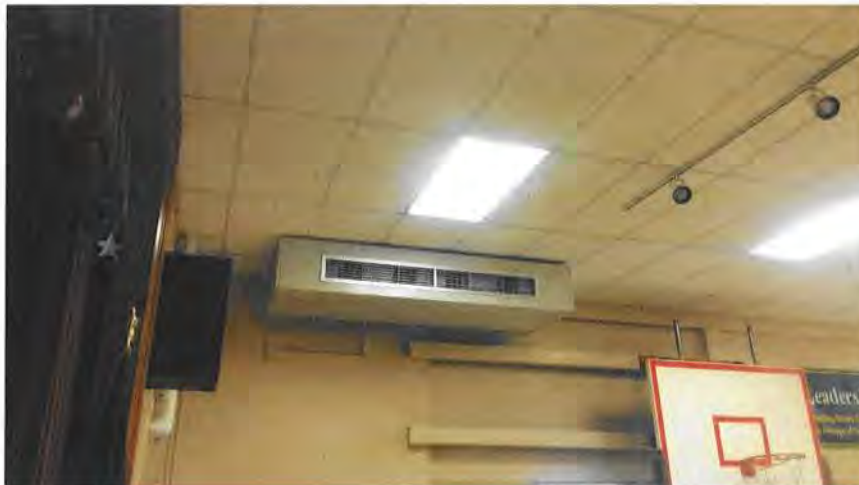
- The HVAC system was installed in 2007 and is in good condition.

- The system is a 2-pipe heating only system with unit ventilators.
- Heating hot water is generated by a pair of natural gas-fired Thermal Solution boilers. They were installed in 2007 and are in good condition.

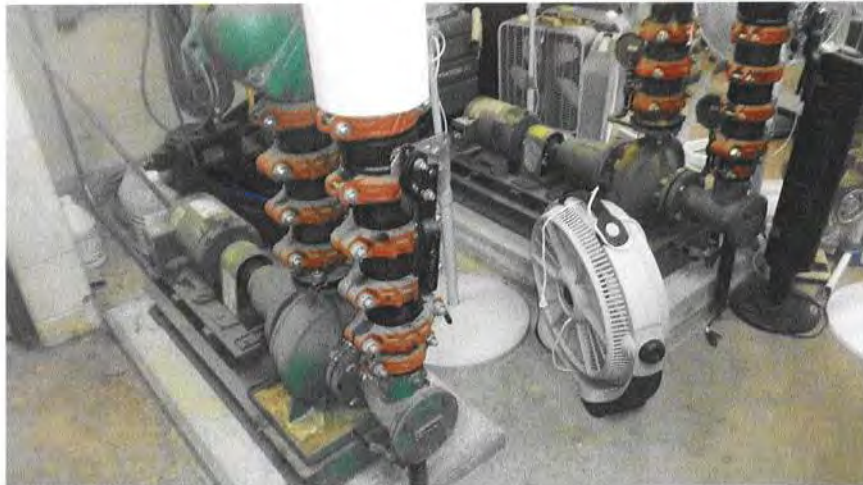
- Heating hot water is circulated throughout the building by a pair of base-mounted pumps. In-line pumps are installed to maintain flow through the boilers. The pumps appear to be in good condition.

- Heating hot water is distributed throughout the building through copper piping. The piping is insulated and was reported to be in good condition. The piping is located above the ceilings and is accessible.

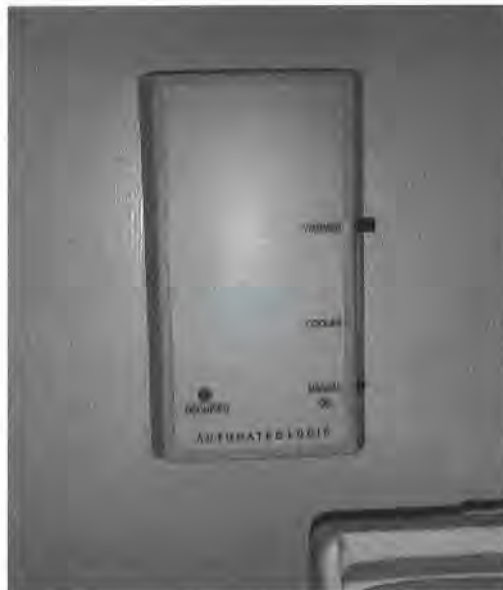
- The building is controlled by a central DDC automatic temperature control system. The system was installed in 2007 and is in good condition. It is part of the district wide Automated Logic control system. There are some actuators which are still pneumatically driven.

- Recommendations:
  - None.

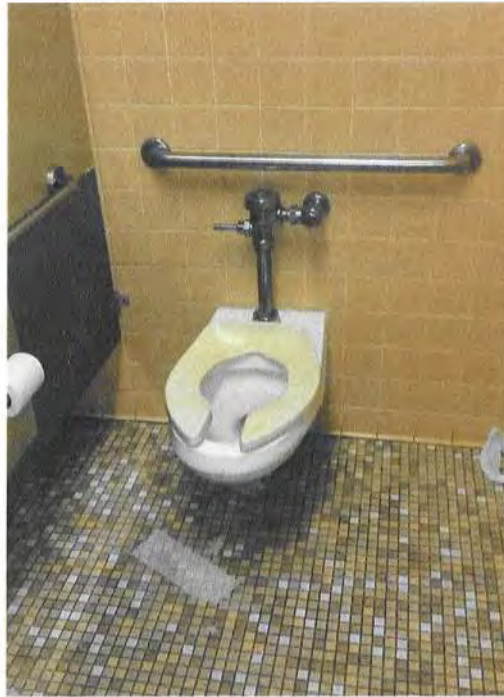
- Water closets are wall-mounted fixtures with manual flush valves.

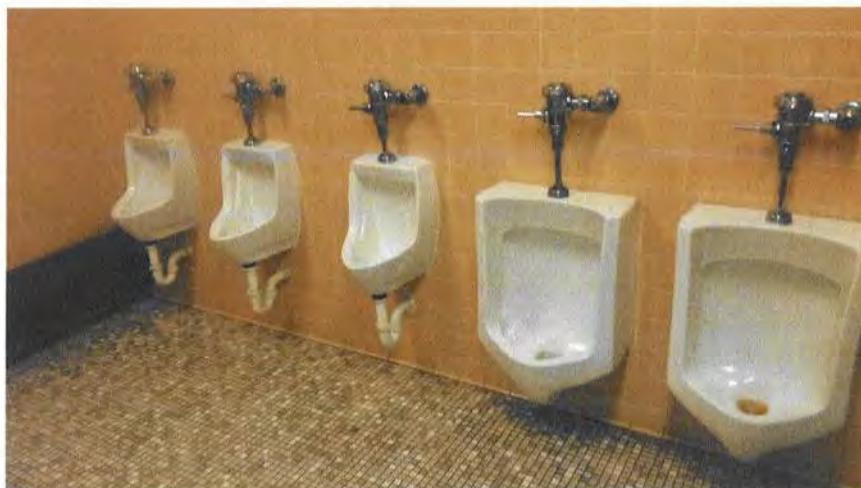
- Urinals are wall-mounted fixtures with manual flush valves.

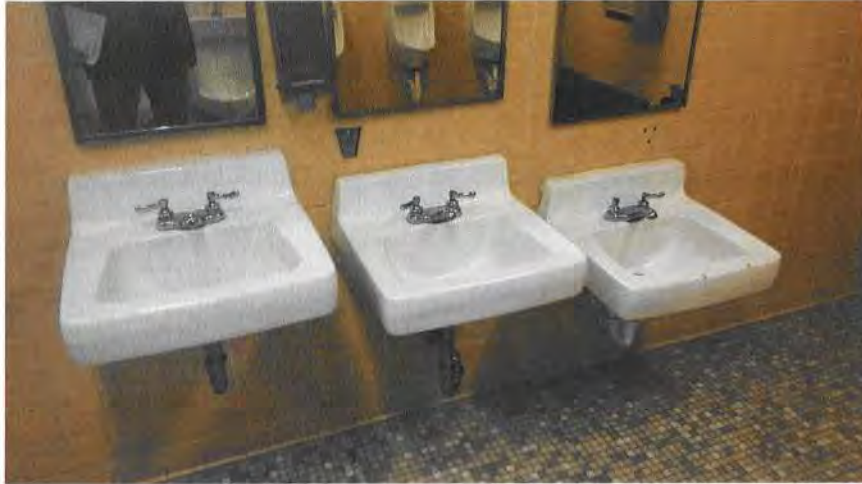
- Lavatories are wall-mounted fixtures with lever handles.

- All fixtures were original to their period of construction except for a few which were replaced. Fixtures appeared to be in fair to good condition.
- Based on the age of the fixtures, we assume that they do not meet current Code required flow rates.
- Fixtures did not appear to have anti-scald valves to meet current Code requirements.
- Recommendations:
  - None.

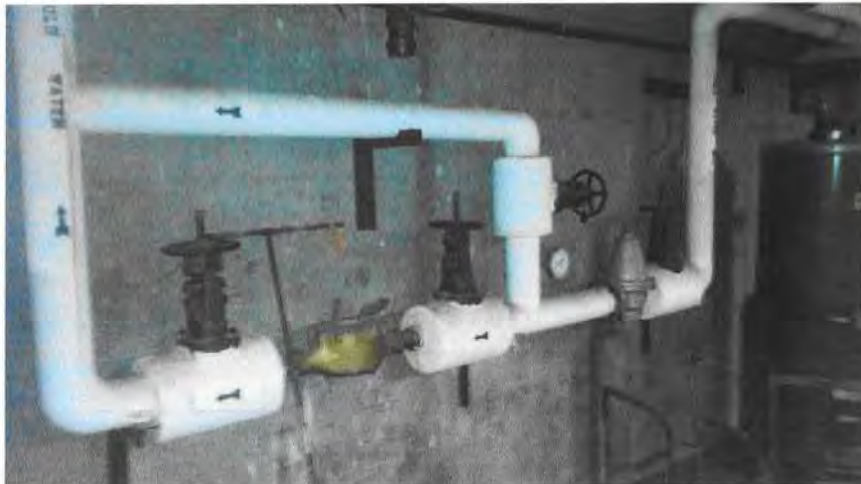
- Domestic water is provided by the Arendtsville Municipal Authority.
- There is a 3" water service into the building. It is not protected by a backflow preventer. However, a pressure reducing valve is installed.

- Domestic water piping is distributed throughout the building in copper piping. It is original to the period of construction and was reported to be in fair condition.

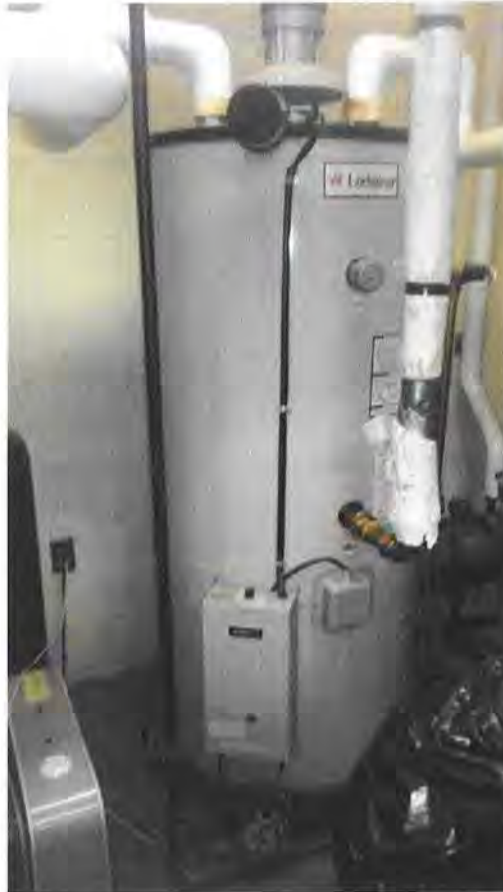
- Domestic hot water is generated by natural gas-fired storage type units.
- The kitchen unit was installed in 2005 and stores water at 140 degrees F.
- The remainder of the building is served by a unit that was installed in 2007 and stores water at 120 degrees F.

- There are no mixing valves in the system but there is a recirculating system.
- Recommendation:
  - Consider storing water at 140 degrees F and adding a mixing valve.

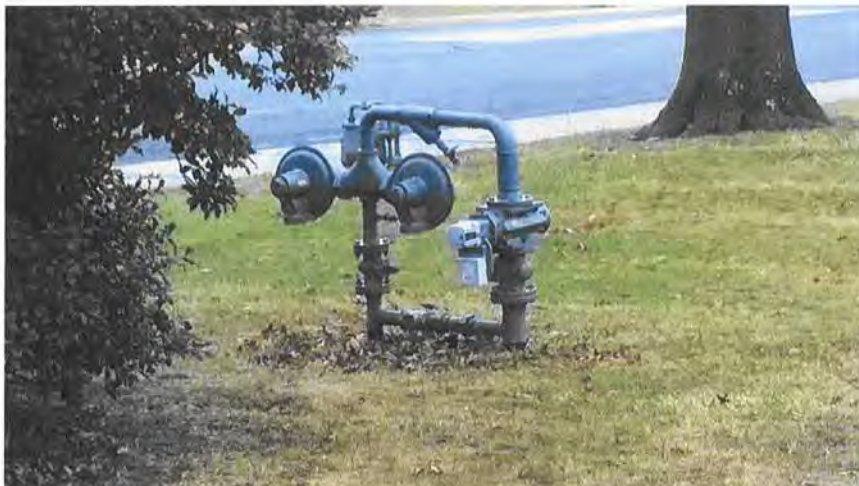
- The building is served by Columbia Gas.

- Natural gas is provided for the boilers, water heaters, kitchen, and emergency generator.
- Natural gas is distributed through black steel piping.
- Maintenance staff reported no issues with this system.
- Recommendations:
  - None.

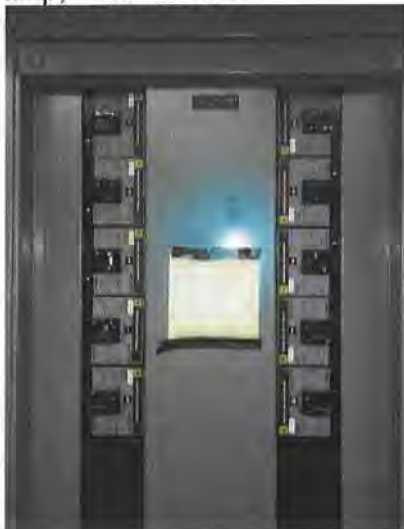
- Electric service is provided by Met Ed.
- The service size is 800 amp, 120/208 volt.

- Distribution equipment is manufactured by Square D and was installed in 1988. It is in fair to good condition with no issues reported.
- The transformers are pole-mounted with an overhead service.

- Recommendations:
  - None.

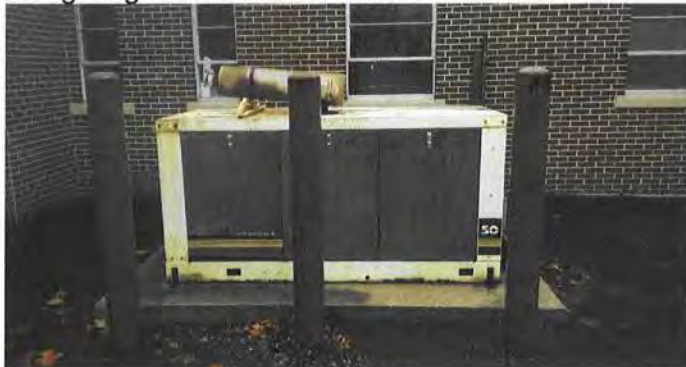
- The building is served by a natural gas-fired 50 KW emergency generator manufactured by Kohler. The generator is outdoors. It was installed in 1988 and is in fair condition.
- The unit serves lighting and walk-in coolers.

- Recommendation:
  - Replace the unit to incorporate additional emergency items such as heating system, wiring closets, etc.

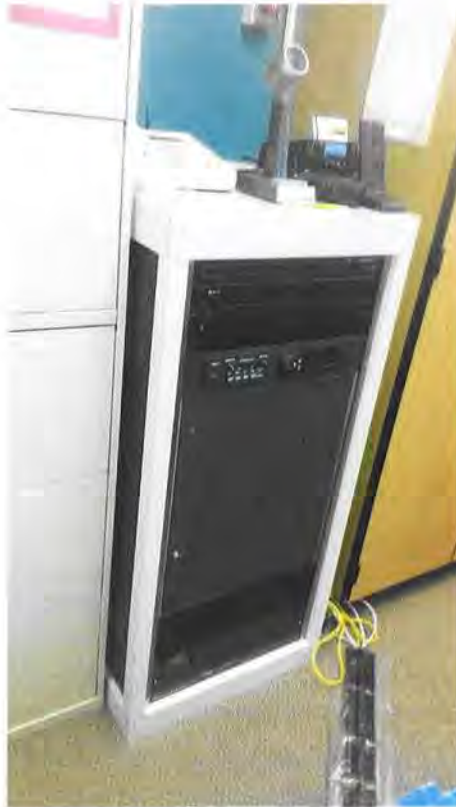
- The entire building is served by a paging and intercom system.
- The head end is located in the office.

- The system was installed 6 to 7 years ago and is in good condition.
- Recommendations:
  - None.

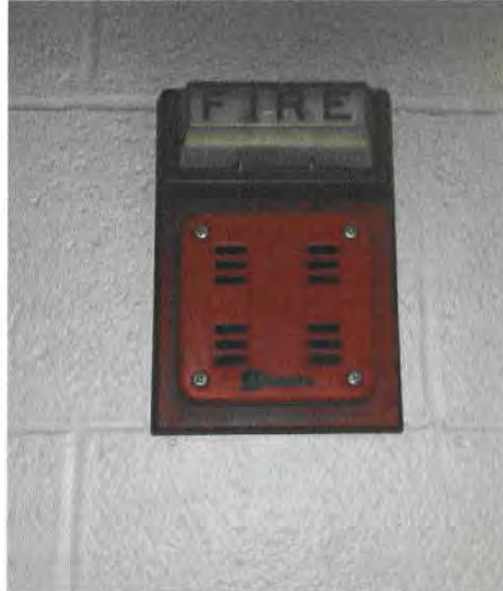
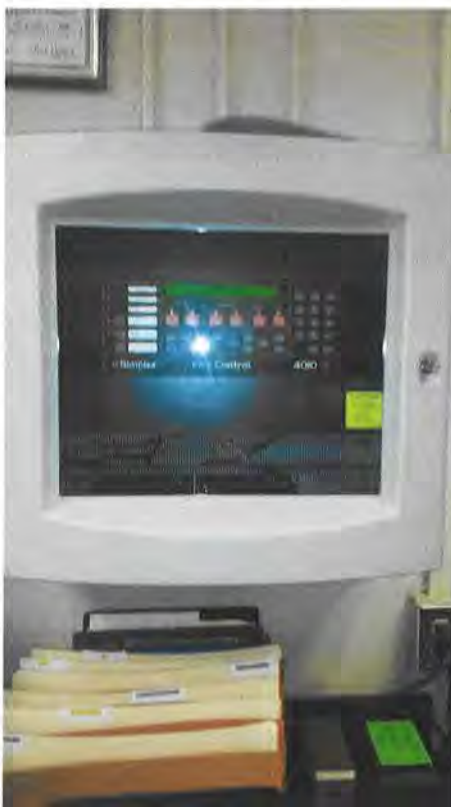
- The system is manufactured by Simplex.

- The fire alarm control panel was replaced in 2013. The terminal devices were installed in 1988.

- The system does not dial out in the case of an event.
- Maintenance reported no issues with the system.
- Recommendations:
  - None.

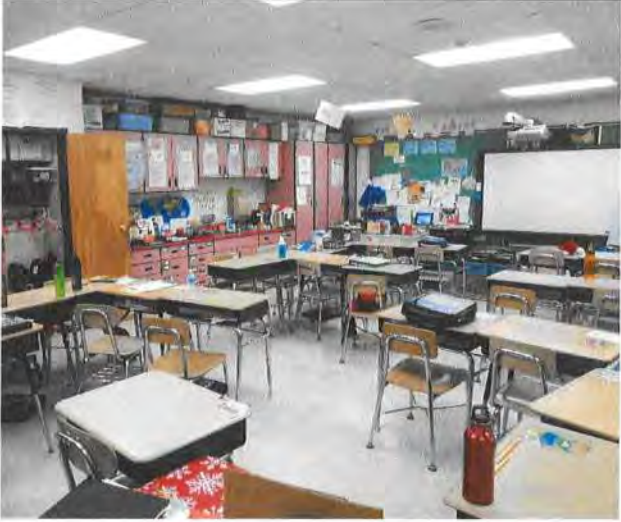
<p><u>Regular Classrooms:</u></p>	<p>The average classroom size is approximately 850 SF.</p>

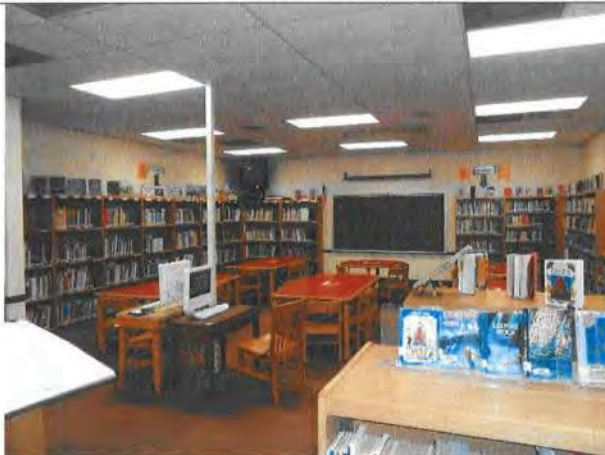
Library:  
± 1,080 SF

The designed Library is approximately 1,080 SF. Per PDE guidelines, the Library is adequately sized for the current building capacity.

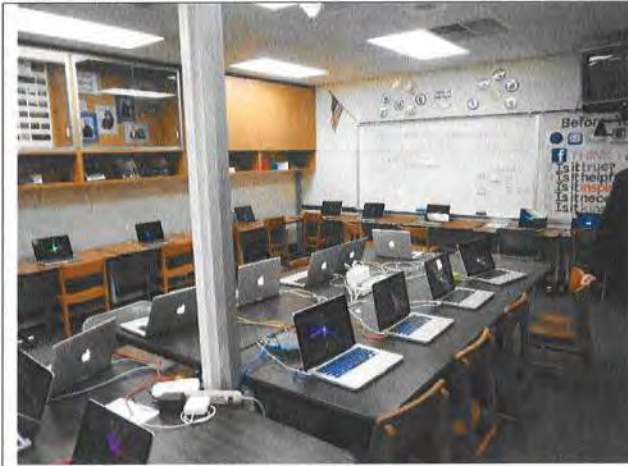
Computer Rooms:  
± 450 SF

There is one (1) computer room located in the building adjacent the Library. The space is inadequate to accommodate the current building capacity.

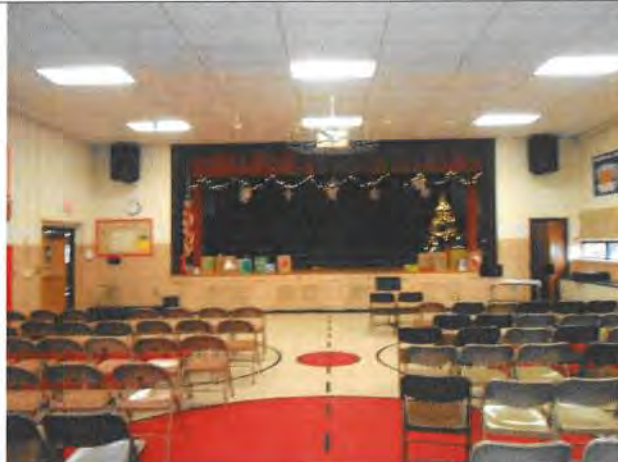
Gymnasium/ Multipurpose:  
± 2,418 SF

The Gymnasium / Multi-purpose Room is approximately 2,418 SF. The Platform is approximately 780 SF. The platform area is not accessible for persons with disabilities. The size of the Gymnasium is inadequate for an Elementary sized gym use and lacks current design guidelines for structural height.

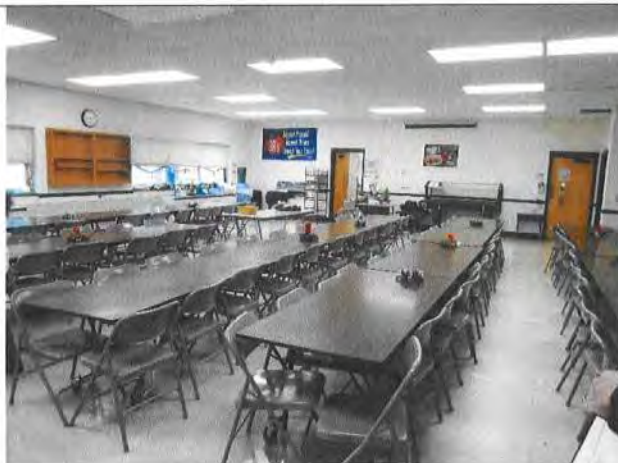
Cafeteria:  
± 1,485 SF

A separate Cafeteria exists, is approximately 1,485 SF and is adequately sized for the current building capacity.

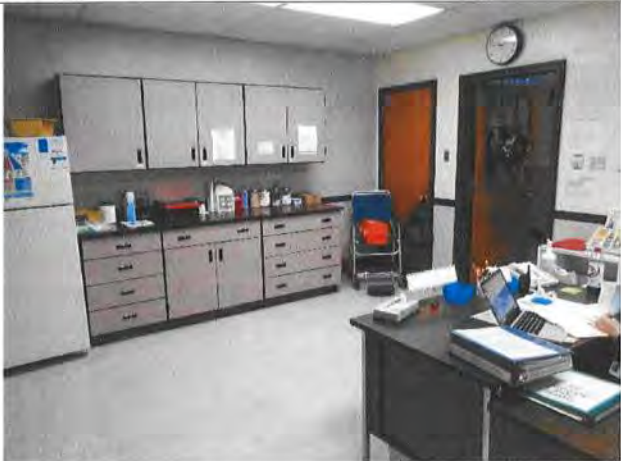
<p><u>Administration / Nurse:</u> ± 546 SF</p>	<p>The Administration area is approximately 546 SF and is inadequate per current design guidelines. The Nurses Suite is approximately 792 SF.</p>

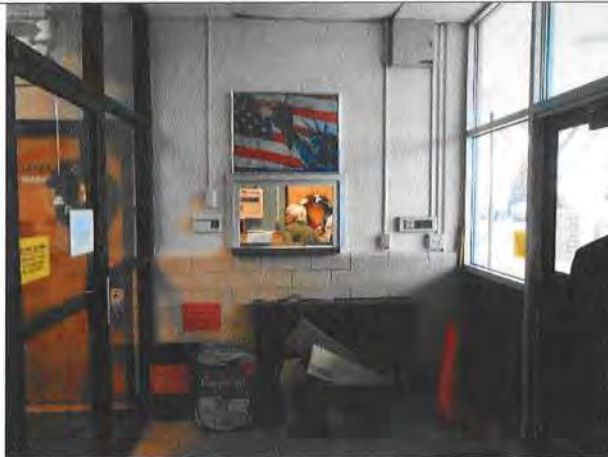
Security:

Main entrance does not have a locked secured vestibule pursuant to current design guidelines.

*Reconfigure Administration space to create a locked secured vestibule per current design guidelines.*

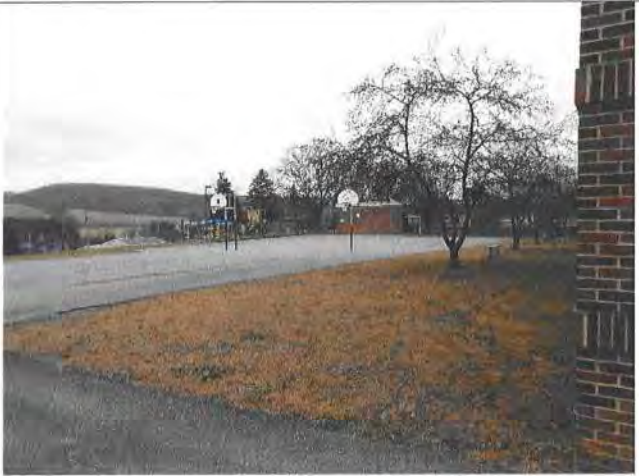
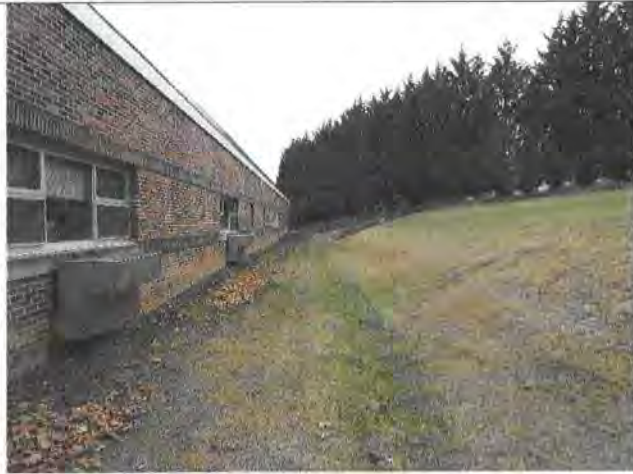
<u>General Condition of Site:</u>	The overall general conditions of the site are good.
<u>Topography:</u>	The building pad and parking areas of the site are level. Some moderate sloping conditions begin at the south side of the building's hard surface play area down to the fields. Site topography accommodates adequate drainage, even around the rear of the building as swales are evident to drain the water runoff.

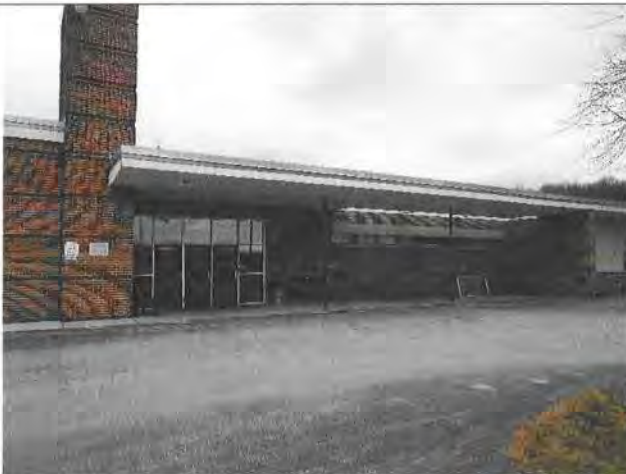
Accessibility, Walkways and Curbing:

Majority of the walkways around the immediate building entrances are ADA accessible and appear to be in fair condition with some evidence of wear and cracking in certain locations. A steep bituminous pedestrian walkway exists from below Rampike Hill Road up to the front entrance. This walkway is non-ADA compliant.

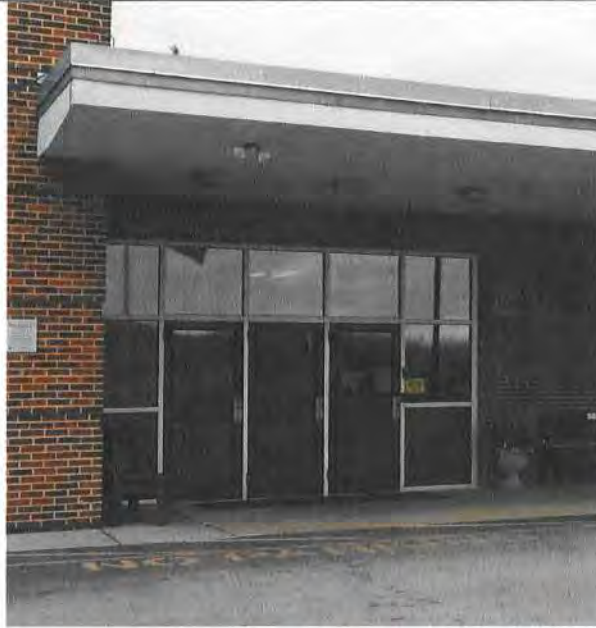
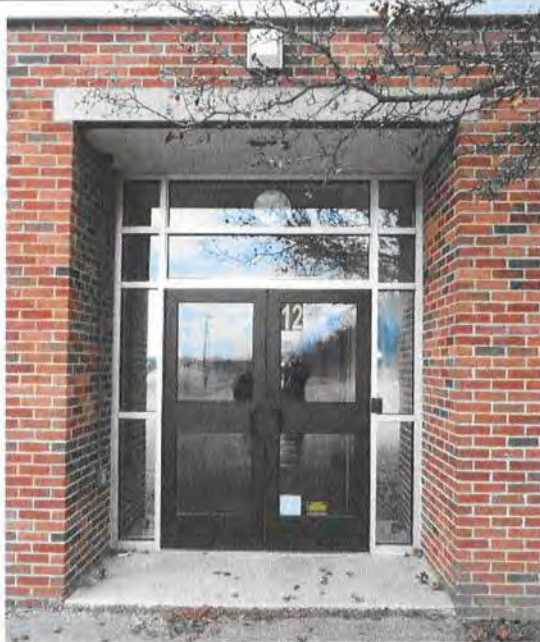
Windows: Windows in the original building are aluminum frame with single pane glass and in poor condition. Windows in the 1989 addition are aluminum frame with insulated glass and appear to be in fair condition.

*Replacement of all exterior aluminum and hollow metal doors with any proposed building improvement project.*

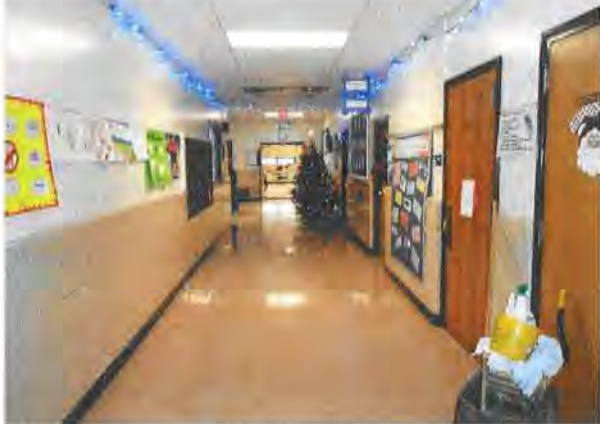
Interior Walls: Interior wall materials include painted plaster walls and glazed block wainscot in the original building corridors. Painted CMU is located in the 1989 addition.

Classrooms consist of painted plaster walls and painted CMU. Wall finishes appear to be in good condition.

<p><u>Recommendations:</u></p> <p><i>Repainting of majority of the building areas due to dated appearance with any proposed building improvement project. Explore options to rehabilitate the glazed tile wainscot.</i></p>

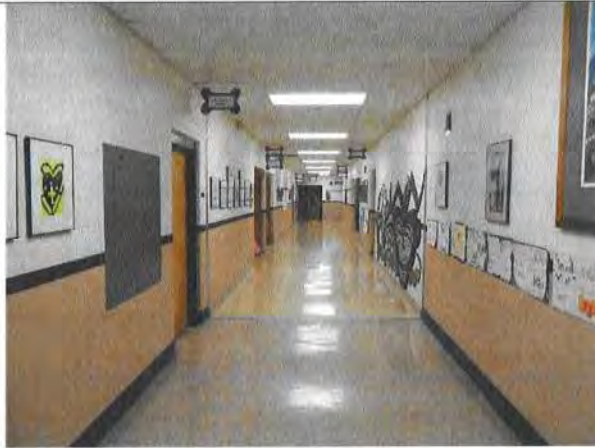
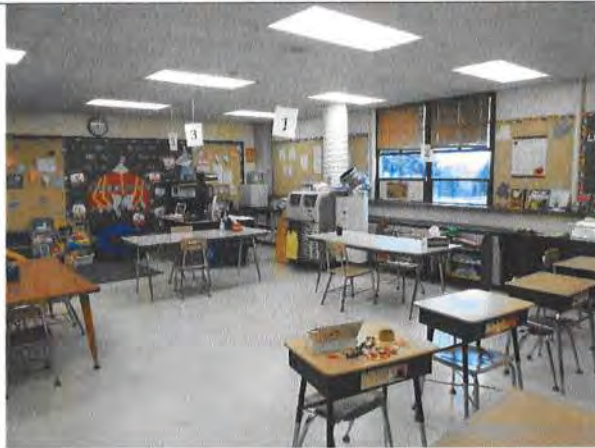
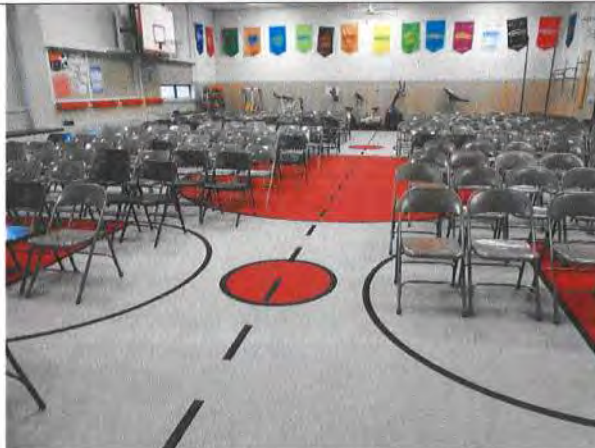
<p><u>Ceilings:</u></p>	<p>Ceiling materials include acoustical tile ceilings, gypsum wallboard, and exposed roof deck.</p>
<p><u>Flooring:</u></p>	<p>Flooring materials consist of terrazzo in the corridors in the 1989 addition, vinyl composition tile (VCT) is located in the original building corridors. The terrazzo is in good condition, the VCT is in fair condition with many areas in need of replacement.</p> <p>VCT is located in the following areas – classrooms, Art Room, Cafeteria and in fair condition.</p> <p>Carpeting is located in the following areas - Library, Administration, Band, Computer and a few Special Needs classrooms. The carpeting in each space is in fair condition.</p> <p>The Gymnasium flooring consists of a poured synthetic system and is in good condition.</p> <p>The Kitchen flooring consists of a quarry tile and is in fair condition.</p> <p>The student toilet flooring consists of a poured seamless synthetic system in the original construction and is in good condition. Student toilet flooring in the 1989 addition is ceramic tile and is in good condition.</p> <p><u>Recommendations:</u></p> <p><i>Replace the VCT and Carpet floor finishes throughout the building with any proposed building improvement project.</i></p>

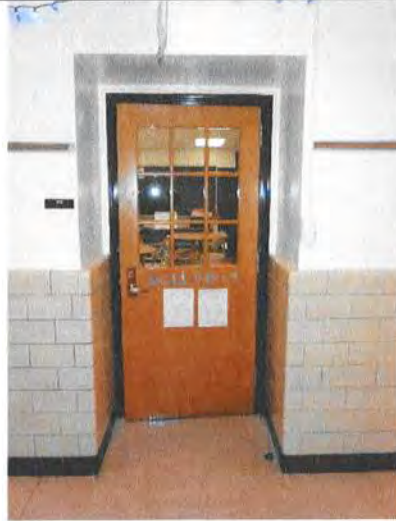
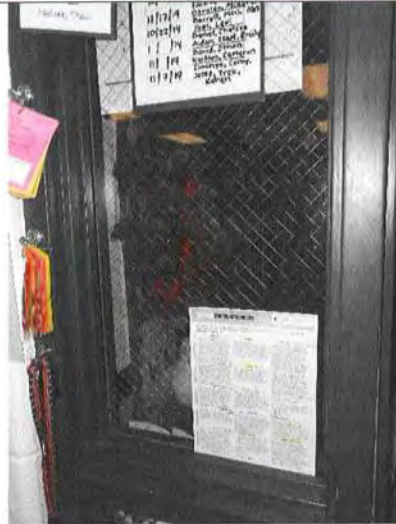
Doors: Wood, hollow metal, and aluminum doors with hollow metal/aluminum frames appear to be in good condition. Wire glass frames exist in some areas and would need to be replaced with any renovation project. Even though interior classroom doors have ADA compliant lever set hardware, ADA clearance requirements are not met at entrances to many general classrooms in the building.

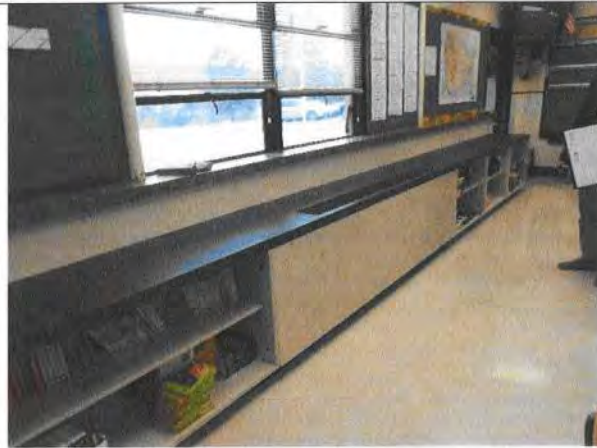
Casework: Built-in metal and laminate casework in classrooms in the original and 1989 construction is in good to fair condition.

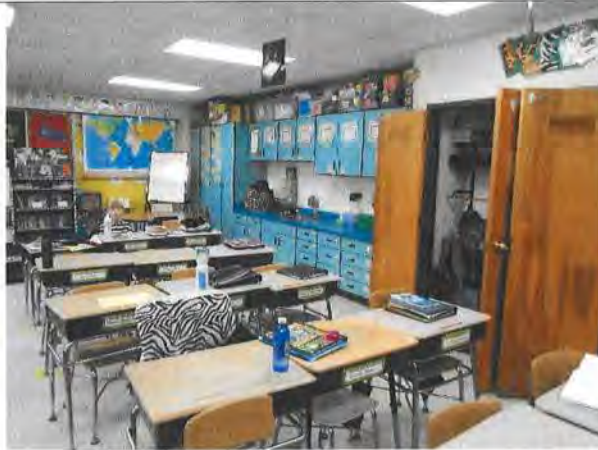
Interior Finishes:

Chalkboards, whiteboards, and smart boards are in fair condition. Many chalkboards were resurfaced in the 1989 renovation.

*Existing chalkboards should be replaced to match the other marker boards in the building due to the potential for chalk dust to lead to allergies and computer issues. However, it appears that the chalkboards are not used extensively given the smart boards.*

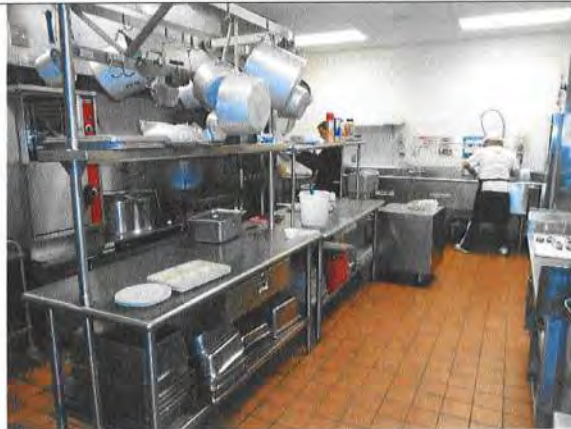
**Kitchen Equipment:**

The Kitchen equipment appears to be in good condition with some of the equipment installed with the 1989 renovations.

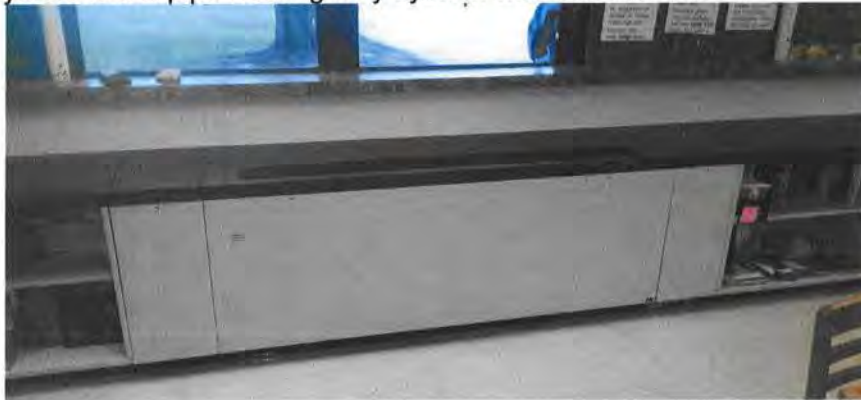
- The HVAC system was installed in 2007 and is in good condition.
- The system is a 2-pipe heating only system with unit ventilators.

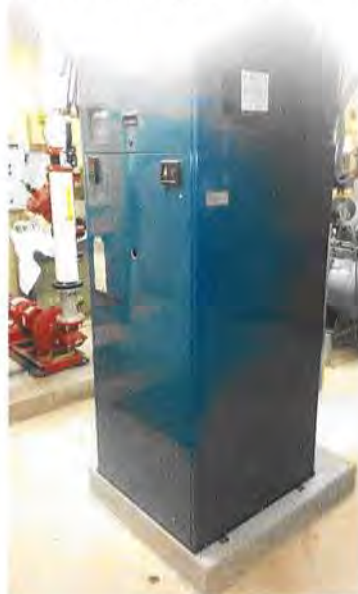
- Heating hot water is generated by a pair of natural gas-fired Thermal Solution boilers. They were installed in 2007 and are in good condition.

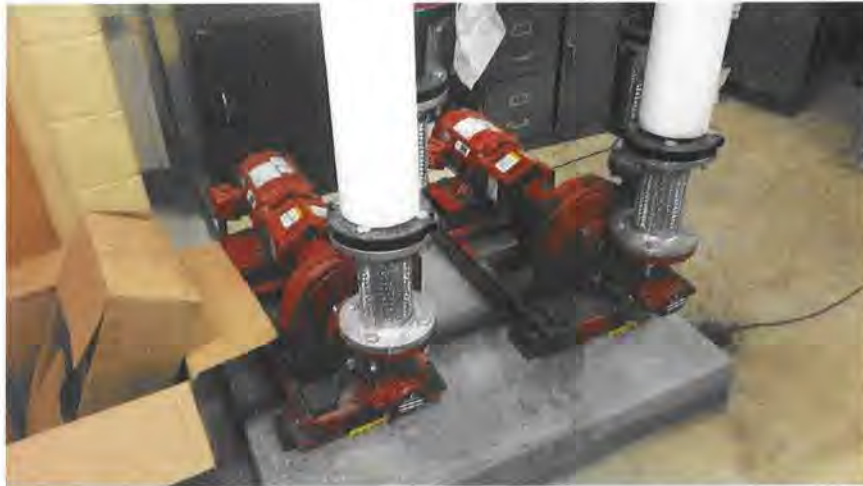
- Heating hot water is distributed throughout the building through copper piping. The piping is insulated and was reported to be in good condition. The piping is located above the ceilings and is accessible.
- Recommendation:
  - ASHRAE Handbook HVAC Applications (2007) table 4 on page 36.3 lists service life estimates for boilers are 30 years, pumps as 20 years, ductwork as 30 years, rooftop units as 15 years, coils as 20 years, and electronic controls as 15 years, and pneumatic controls as 20 years.

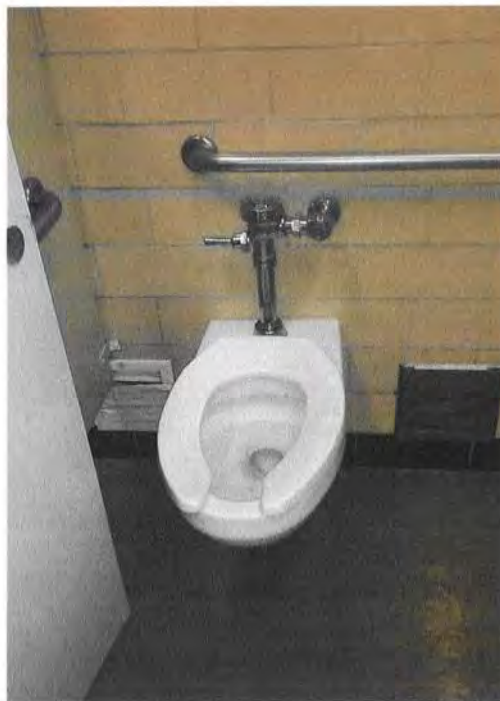
- Water closets are wall-mounted fixtures with manual flush valves.

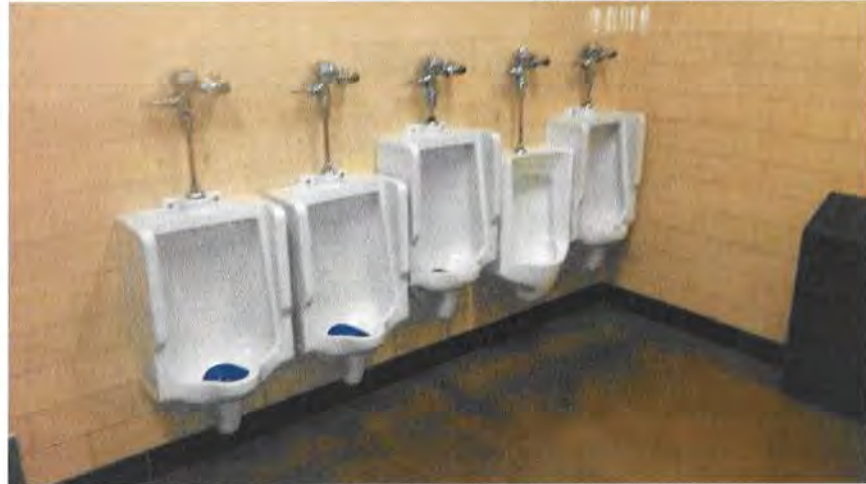
- Urinals are wall-mounted fixtures with manual flush valves.

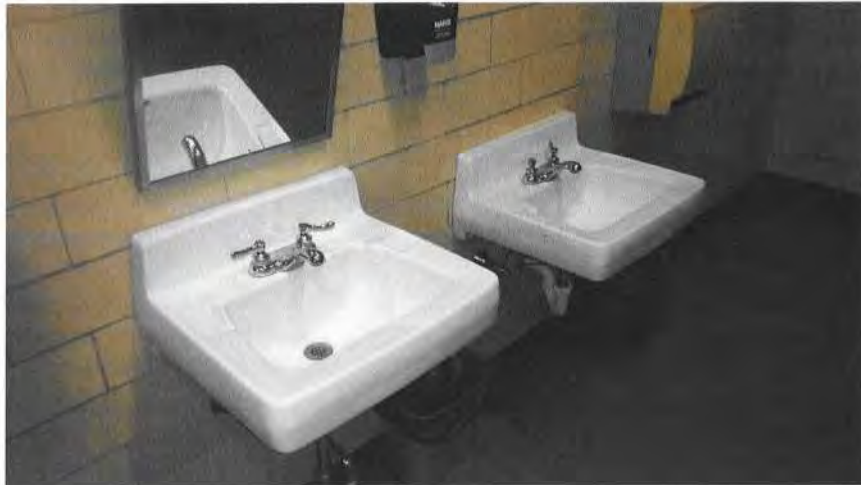
- Lavatories are wall-mounted fixtures with lever handles.

- All fixtures were original to their period of construction except for a few which were replaced. Fixtures appeared to be in fair to good condition.
- Based on the age of the fixtures, we assume that they do not meet current Code required flow rates.
- Fixtures did not appear to have anti-scald valves to meet current Code requirements.
- Recommendations:
  - None.

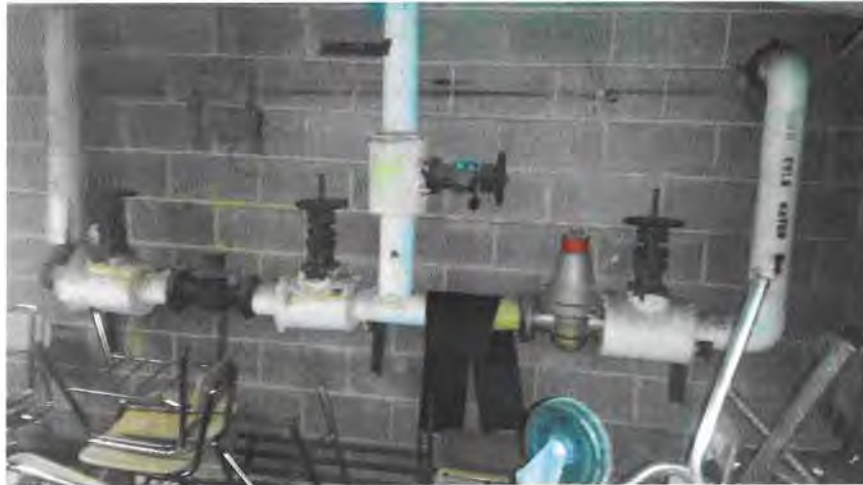
- Domestic water piping is distributed throughout the building in copper piping. It is original to the period of construction and was reported to be in fair condition.
- Domestic water piping is insulated and is located above the ceilings.
- Recommendation:
  - Perform pipe inspections in various areas of the system to determine the condition of the piping system for future use.

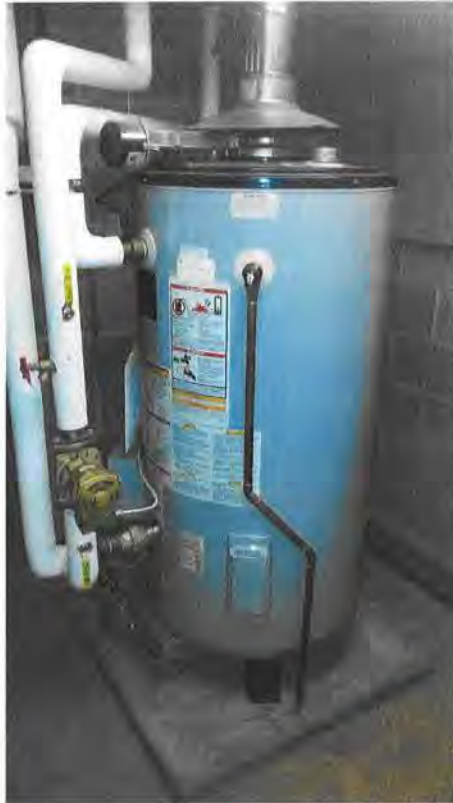
- The remainder of the building is served by a unit that was installed in 2007 and stores water at 120 degrees F.
- There are no mixing valves in the system but there is a recirculating system.
- Recommendation:
  - Consider storing water at 140 degrees F and adding a mixing valve.

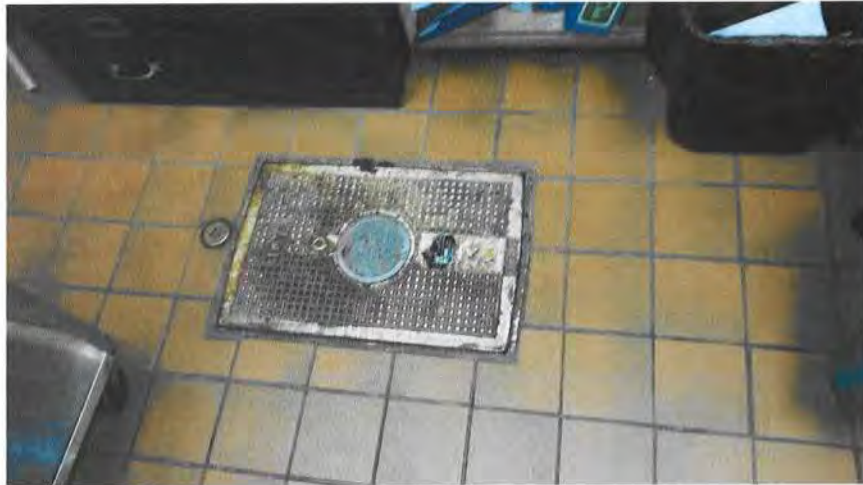
- Recommendation:
  - Perform a camera review of the underground sanitary mains to determine any pipe issues.

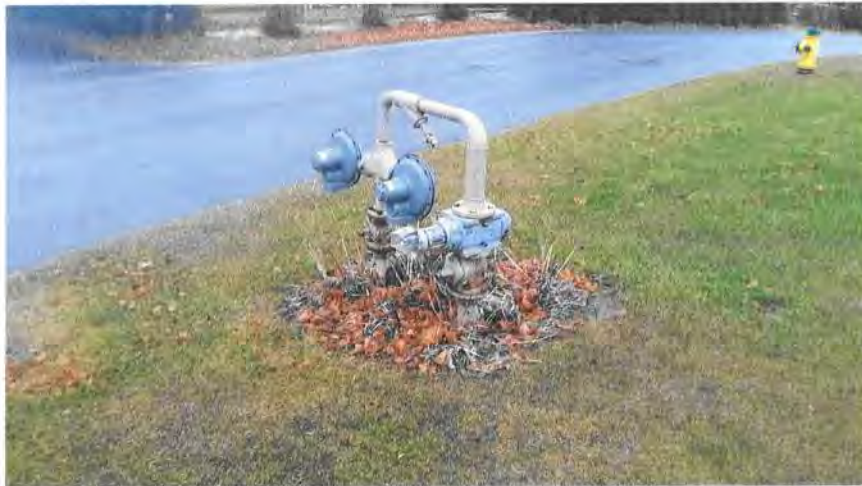
- Natural gas is provided for the boilers, water heaters, kitchen, and emergency generator.
- Natural gas is distributed through black steel piping.
- Maintenance staff reported no issues with this system.
- Recommendations:
  - None.

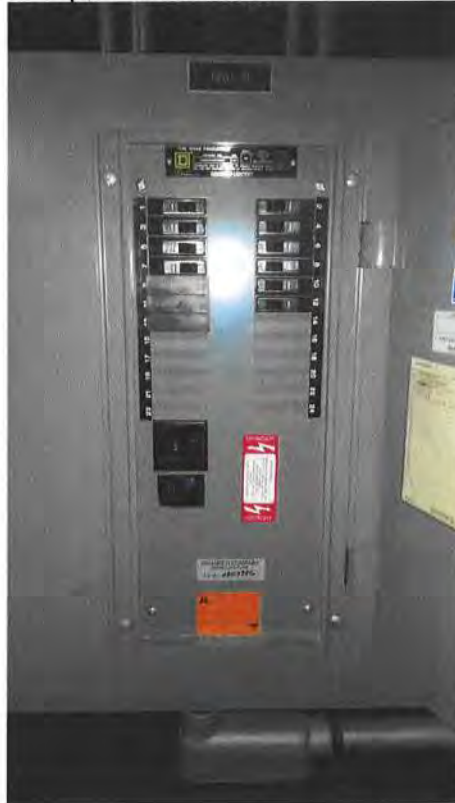
- Distribution equipment is manufactured by Square D and was installed in 1988. It is in fair to good condition with no issues reported.
- The transformers are pole-mounted with an overhead service.

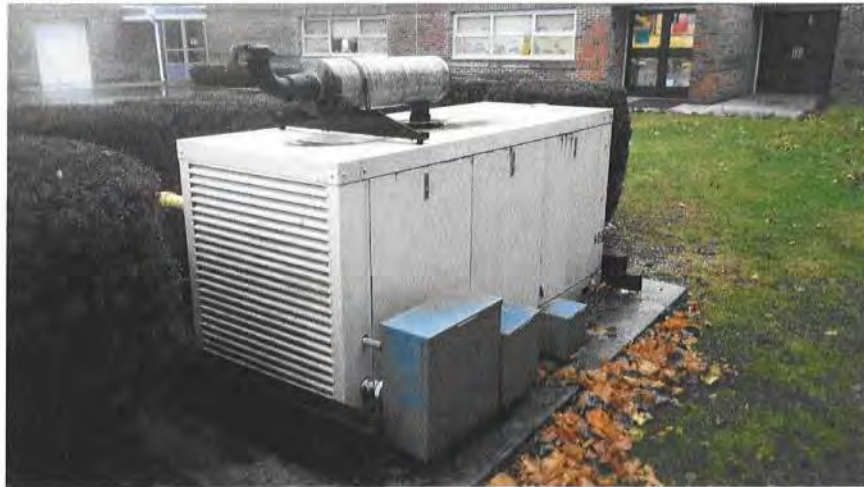
- The unit serves lighting and walk-in coolers.
- Recommendation:
  - Replace the unit to incorporate additional emergency items such as heating system, wiring closets, etc.

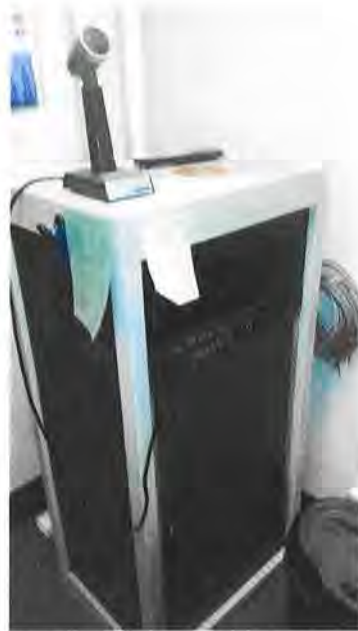
- The entire building is served by a paging and intercom system.
- The head end is located in the office.

- The system was installed 6 to 7 years ago and is in good condition.
- Recommendations:
  - None.

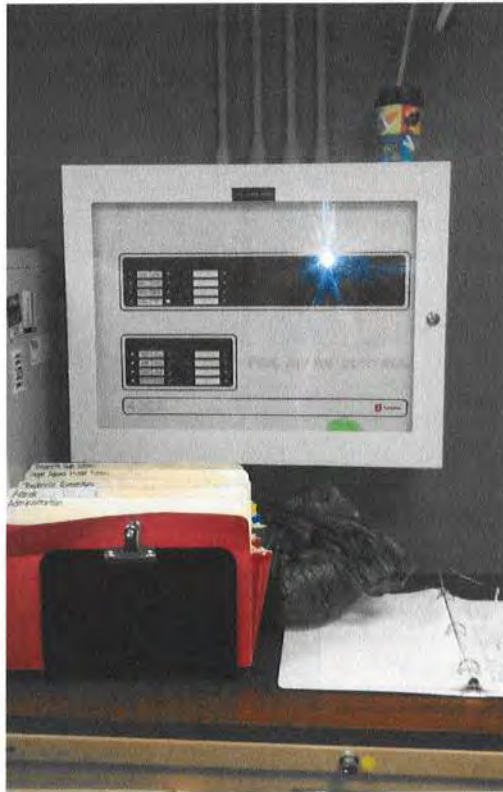
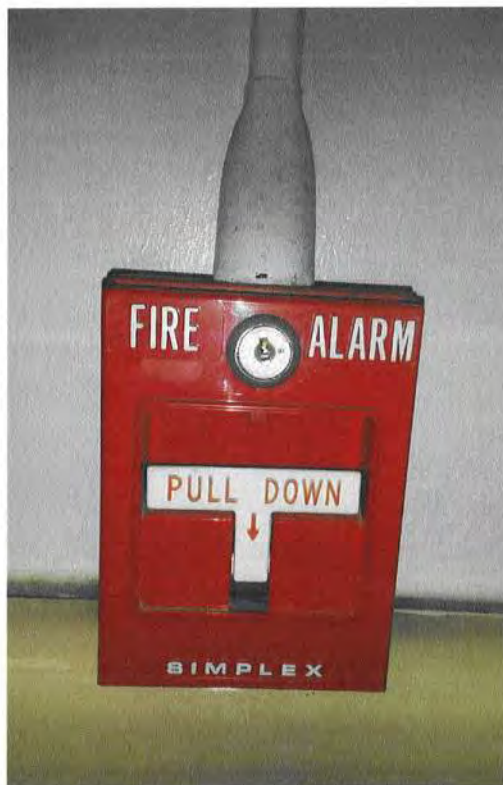
- The system is manufactured by Simplex.
- The fire alarm control panel was replaced in 2012. The terminal devices were installed in 1988.

- The system does not dial out in the case of an event.
- Maintenance reported no issues with the system.

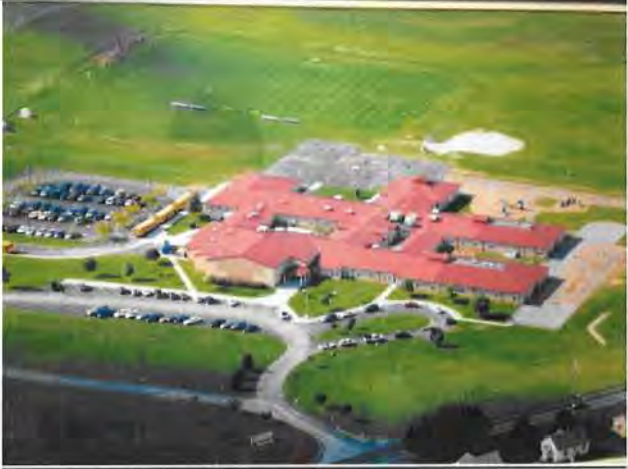
<p><u>Site Circulation:</u></p>	<p>Staff, student, and public entry is separate from delivery services. Separation of bus and parent student traffic is inadequate. The District states that the parent/student drop-off gets backed up as the loop is not large enough to accommodate the building capacity and the parking is not large enough to accommodate on-site parent events or activities.</p>
<p><u>Site Entrance:</u></p>	<p>Main entrance is on the SE facade and is accessed from Biglerville Road. Access and egress to / from the site is via the same location. At times this concept could create a traffic backlog of vehicles entering / leaving the site.</p>
