## UPPER ADAMS SCHOOL DISTRICT

# District Wide Feasibility Study

June 2016  
CRA Project No. 2832

**Crabtree, Rohrbaugh & Associates  
Architects**

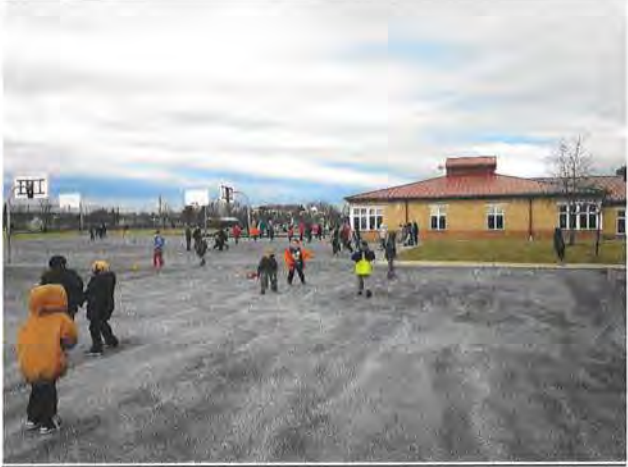
<p><u>Play areas:</u></p>	<p>Hard surface and soft surface play areas are located on the north part of the site and appear to be in good condition. Additional mulching recommended at soft play landing areas. Play equipment appears in good condition.</p>

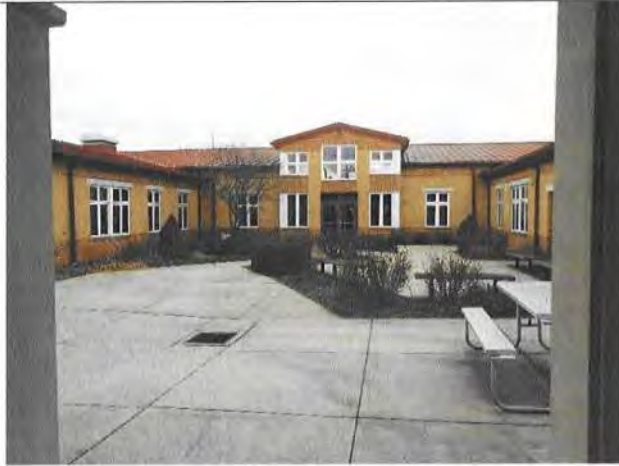
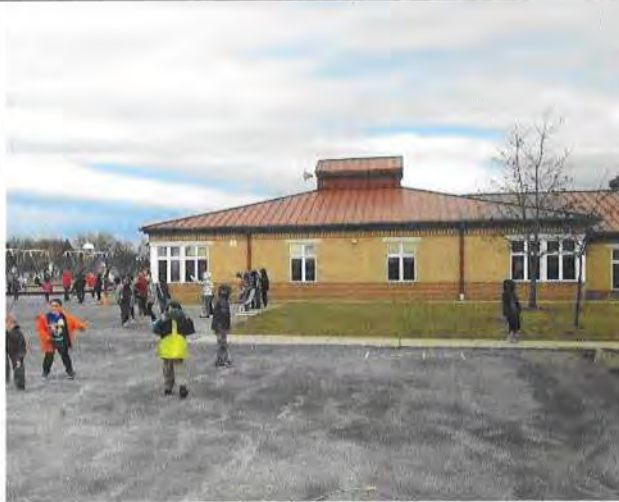
Steel frame building with load bearing masonry walls generally appear to be in good condition.

The building roof consists of pitched metal roof and membrane and appears to be in good overall condition.

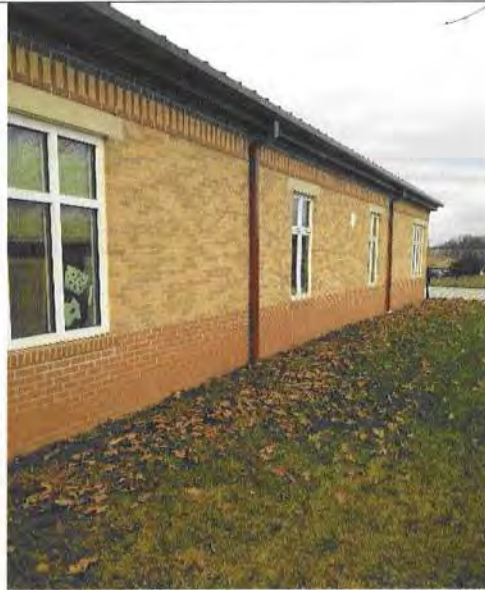
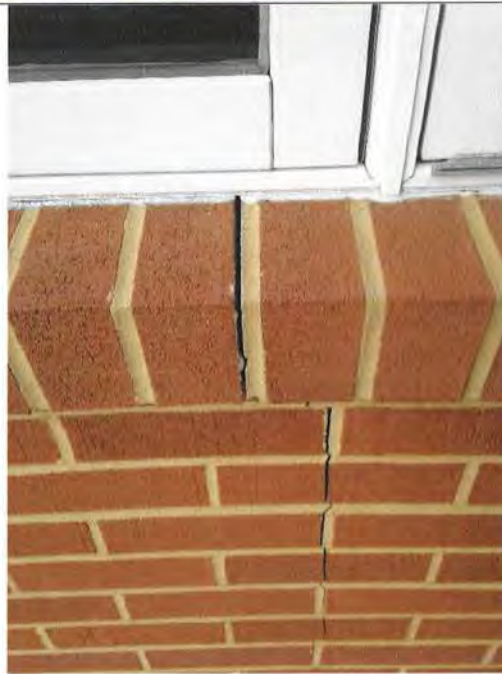
Exterior walls are various patterns and colors of masonry veneer around the entire building perimeter and appear to be in good condition. Some evidence of building settlement in a few areas. Some cast stone window heads have shown evidence of minor cracking which is a non-structural concern.

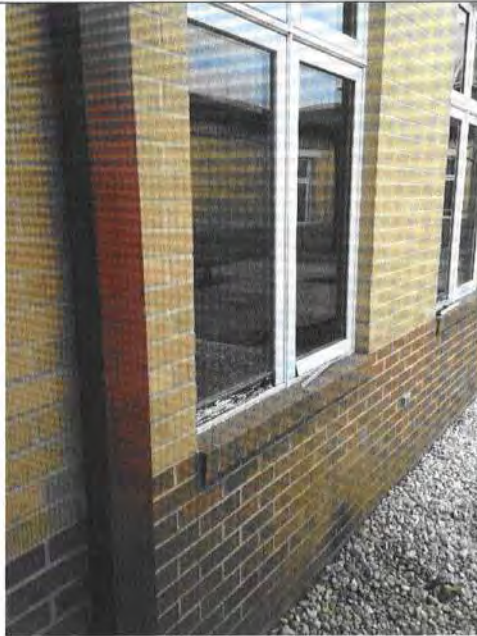
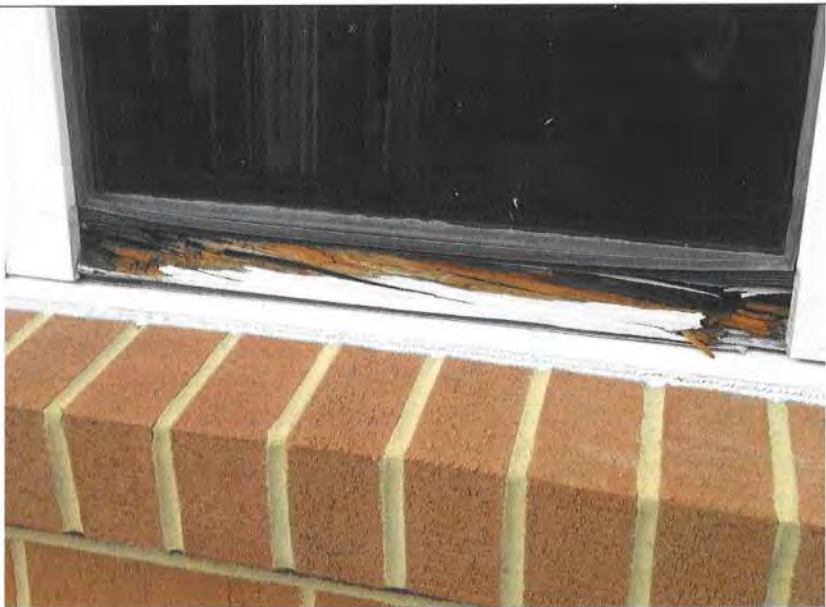
Windows: Existing vinyl clad windows are in fair condition. However there are areas where the vinyl wrapped wood has completely dry rotted and is in need of repair if not complete replacement.

*Complete replacement of window systems where frames have deteriorated to a dry rot condition.*

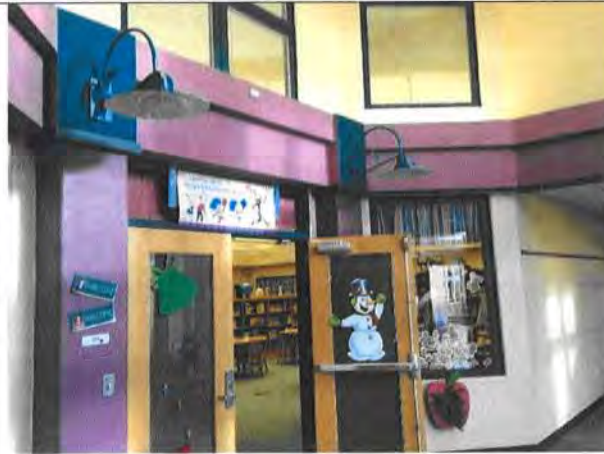
Interior wall materials include painted CMU and gypsum wallboard horizontal decorative banding. Wall finishes are in good condition yet few areas of water stains most likely due to roof or mechanical leaks.

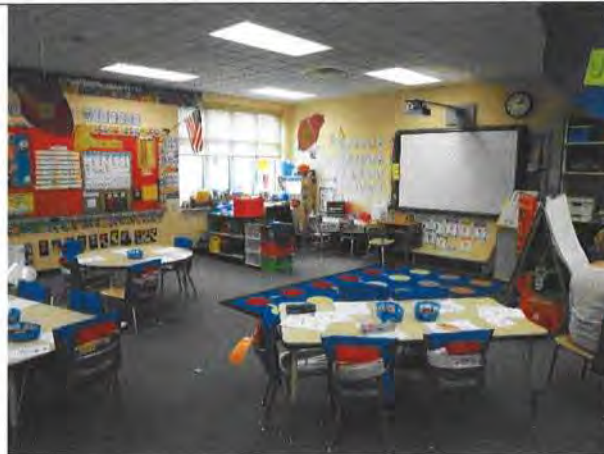
Ceilings: Ceiling materials include acoustical tile ceilings, gypsum wallboard, and exposed roof deck. Some evidence of water stains on ceiling tile in a few areas.

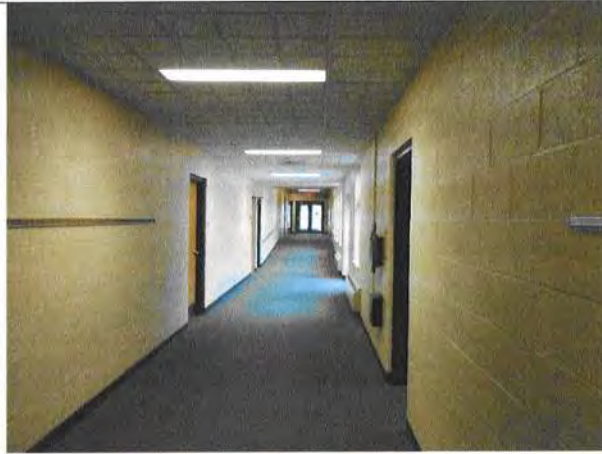
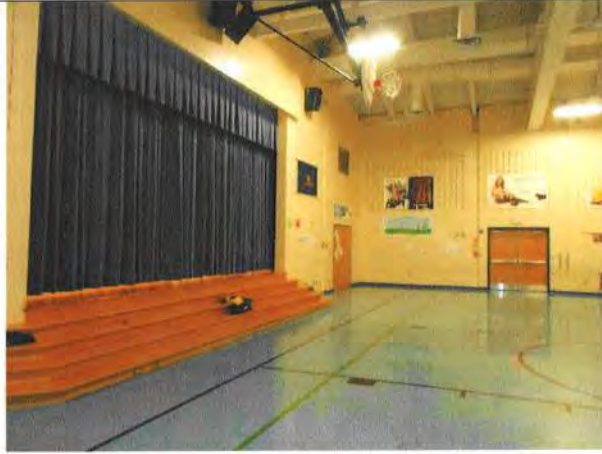
Flooring: Flooring materials consist of carpeting in a majority of the building, ie: classrooms, corridors, Library, faculty room, etc. Poured synthetic flooring system is located in the Gymnasium. VCT is located in classroom sink and cubby locations. The carpet in the above noted locations is showing evidence of wear, some staining but otherwise in good condition.

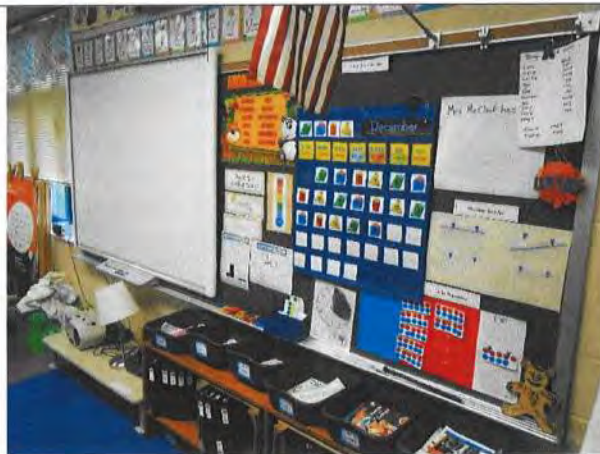
Chalkboards, whiteboards, and smart boards are in good condition.

*Existing chalkboards should be replaced to match the other marker boards in the building due to the potential for chalk dust to lead to allergies and computer issues. However, it appears that the chalkboards are not used extensively given the smart boards.*

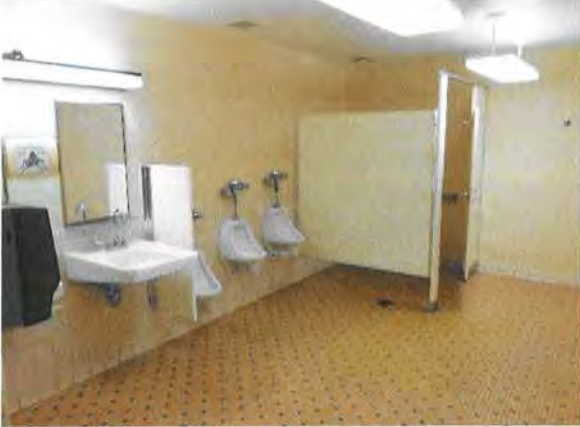
<u>Toilet Rooms:</u>	Many toilet rooms throughout are currently compliant per current accessibility codes and are in good condition.

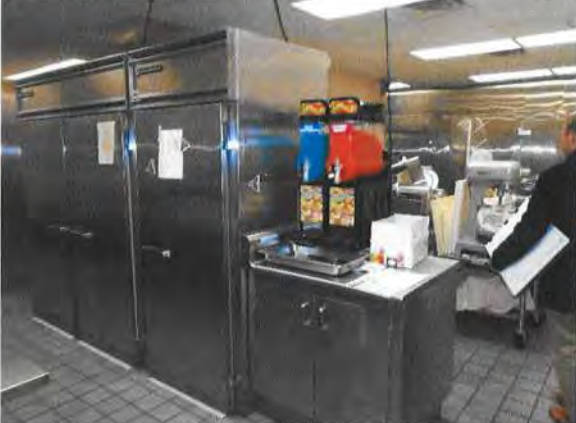
<u>Kitchen Equipment:</u>	The kitchen equipment appears to be in good condition.

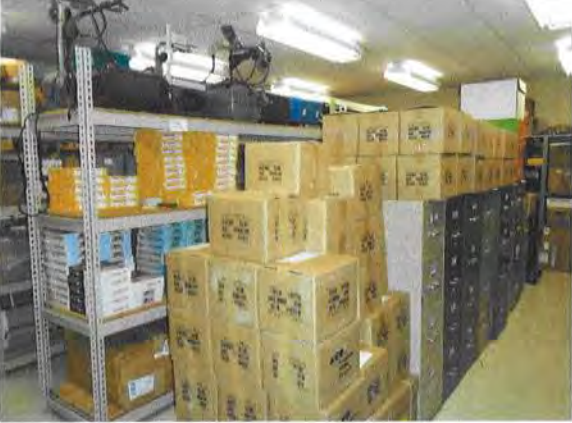
<u>Miscellaneous Storage:</u>	Building storage appears inadequate for the building size and quantity.

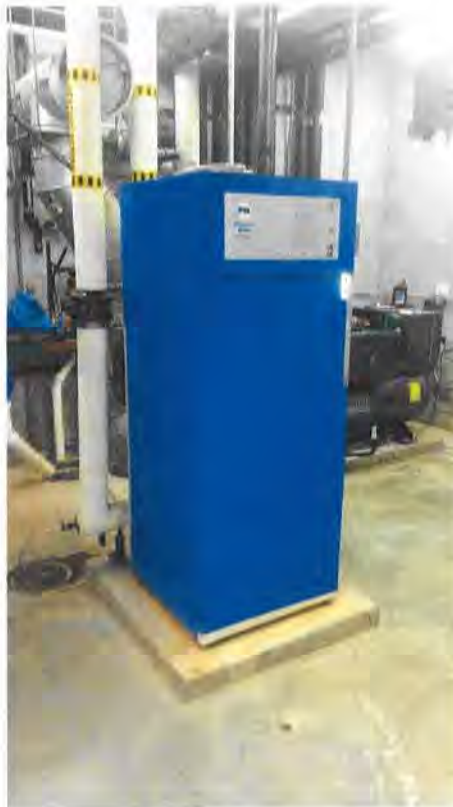
- The HVAC system is VAV with hot water tempering coils. Air is distributed through indoor air handling units. The systems are original to their areas of construction (1993 and 2007). The systems are in good condition.
- Heating hot water is generated by three natural gas-fired Paterson Kelley boilers. Burners were replaced last year and resolved some ongoing issues that they were experiencing. The boilers are in good condition.

- Heating hot water is circulated throughout the building by a pair of base-mounted pumps. In-line pumps are installed to maintain flow through the boilers. The pumps appear to be in good condition.

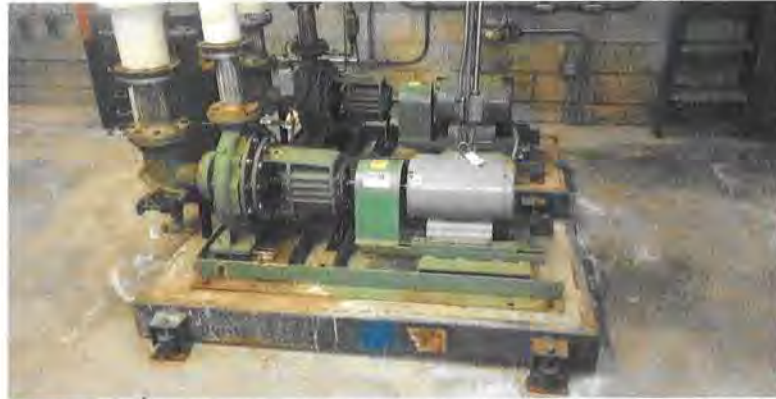
- Heating hot water is distributed throughout the building through copper piping. The piping is insulated and was reported to be in fair condition. The piping is located above ceilings and is accessible. The one issue that maintenance reported was leaking at dielectric fittings.
- Recommendations:
  - ASHRAE Handbook HVAC Applications (2007) table 4 on page 36.3 lists service life estimates for boilers are 30 years, pumps as 20 years, ductwork as 30 years, rooftop units as 15 years, coils as 20 years, and electronic controls as 15 years, and pneumatic controls as 20 years.
  - Replace boilers in the next 10 years.
  - Replace dielectric fittings
  - Replace air handlers in the next 10 years.

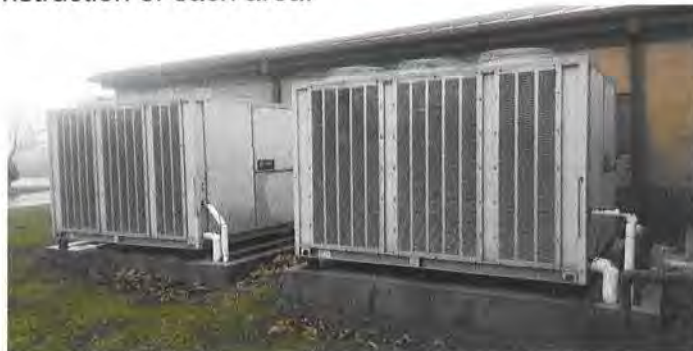
- The entire building is air conditioned through the VAV air handling units. The units are provided with DX coils connected to condensing units. They are original to the period of construction of each area.

- Recommendation:
  - Replace condensing units in the next 10 years.

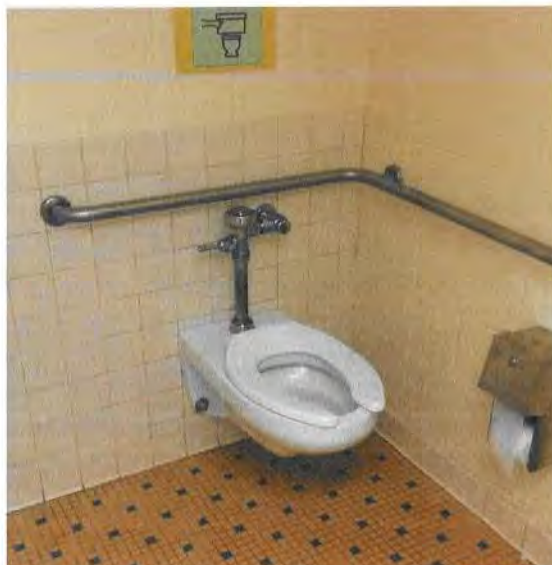
- Water closets are wall-mounted fixtures with manual flush valves.

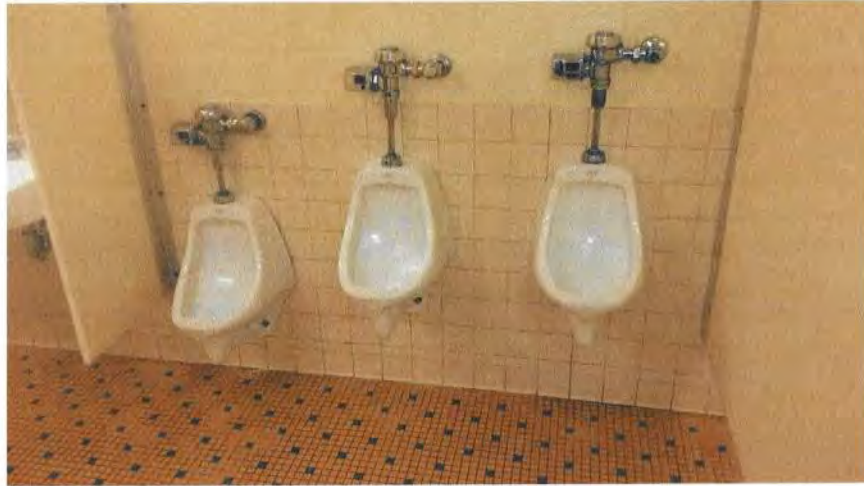
- Urinals are wall-mounted fixtures with manual flush valves.

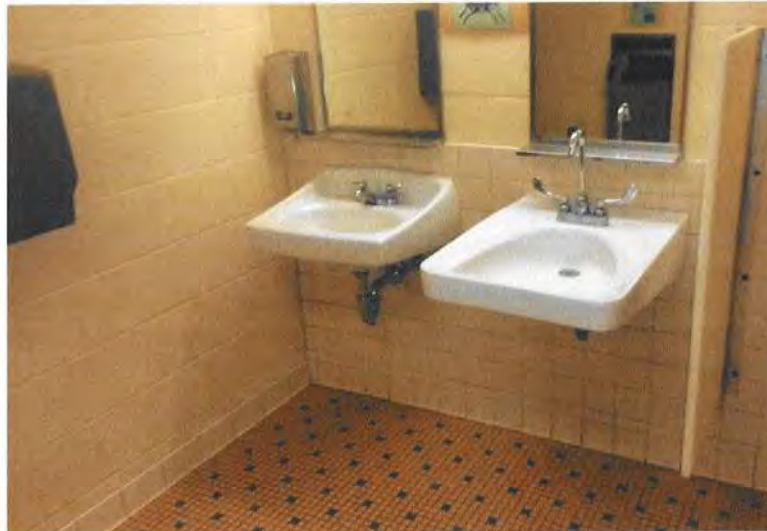
- Lavatories are wall-mounted fixtures with lever and wrist blade handles.

- All fixtures were original to their period of construction except for a few which were replaced. Fixtures appeared to be in fair to good condition.
- Based on the age of the fixtures, we assume that they do not meet current Code required flow rates.
- Fixtures did not appear to have anti-scald valves to meet current Code requirements.
- Recommendations:
  - None.

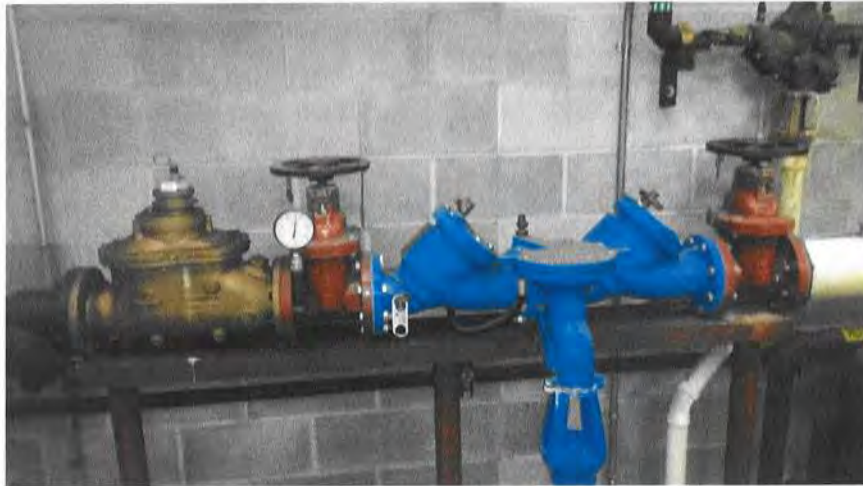
- Domestic water piping is distributed throughout the building in copper piping. It is original to the period of construction and was reported to be in fair to good condition.
- Domestic water piping is insulated and is located above ceilings.
- Water is conditioned with a water softening system. The system was installed in 1993 and was reported to be in fair to good condition.

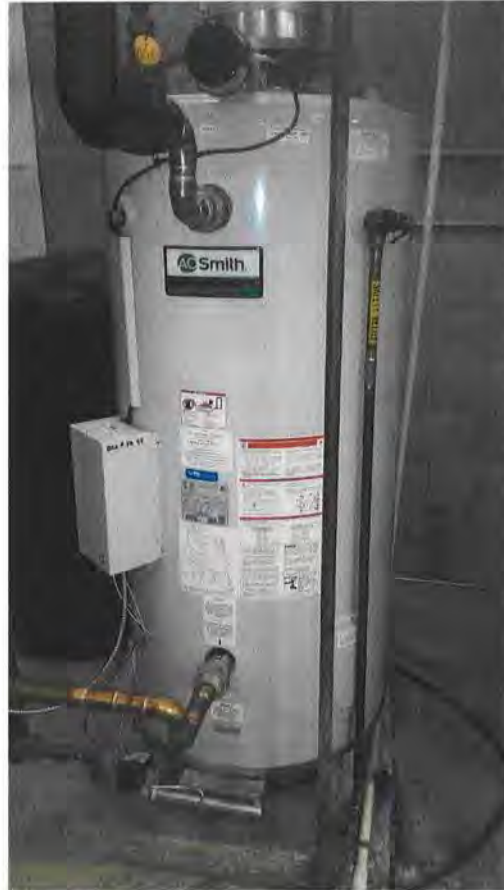
- The kitchen unit was installed in 2009 and stores water at 140 degrees F.
- The remainder of the building is served by two units (1993 and 2014) and store water at 120 degrees F.
- There are no mixing valves in the system but there is a recirculating system.
- Recommendation:
  - Consider storing water at 140 degrees F and adding a mixing valve.

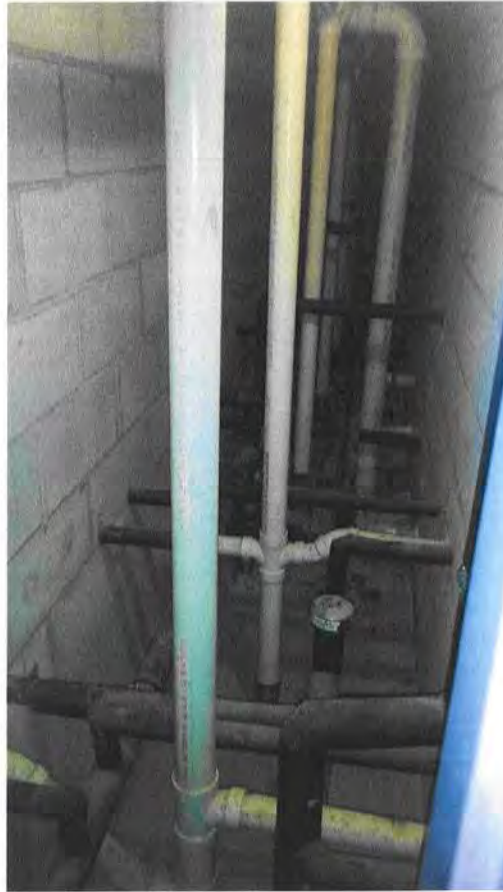
- The waste piping was installed at the time of construction for each area and was reported by maintenance staff as being in good condition. The system is only snaked when there is an issue.
- Kitchen sinks are piped directly allowing bacteria to travel up waste pipe into the sink.
- A steel in-floor type grease interceptor is in the kitchen.

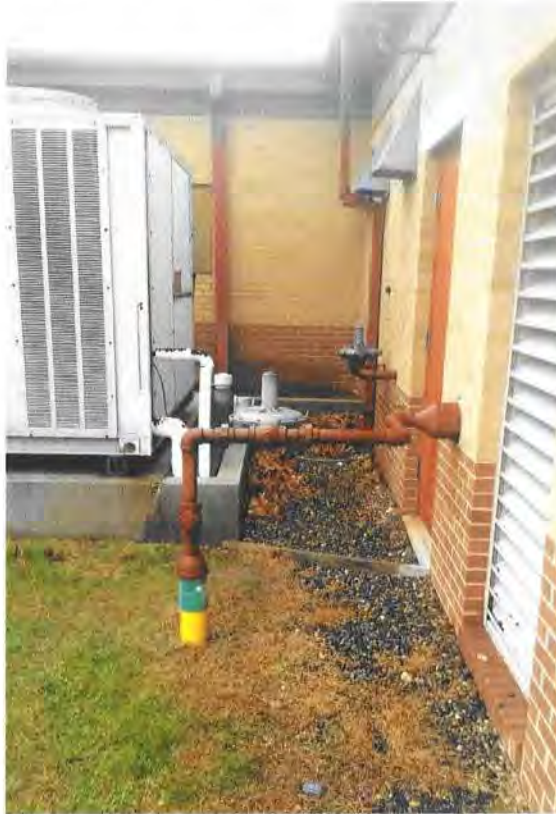
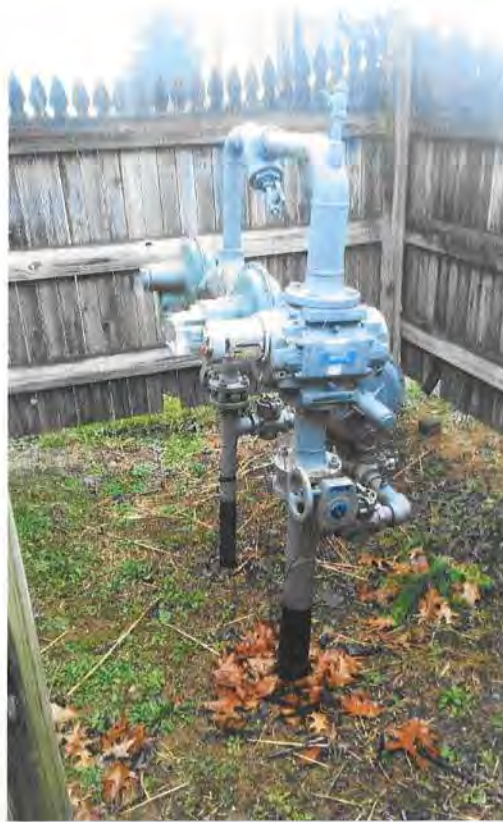
- The building is served by Columbia Gas.

- Natural gas is provided for the boilers, water heaters, kitchen, and emergency generator.
- Natural gas is distributed through black steel piping.

- Maintenance staff reported no issues with this system.
- Recommendations:
  - None.

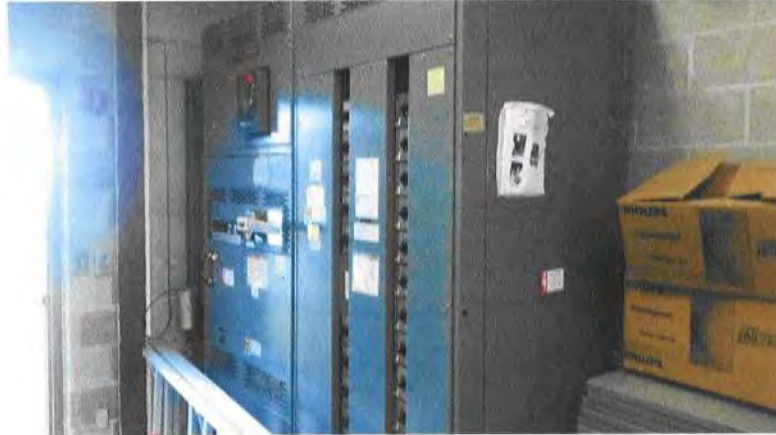
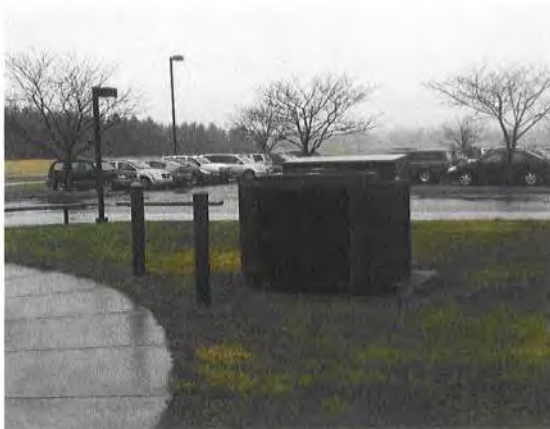
- Electric service is provided by Met Ed.

- The service size is 1600 amp, 480/277 volt.

- Distribution equipment is original to the time of construction for each area and was reported to be in fair to good condition with no issues.
- The transformer is pad-mounted with an underground service.

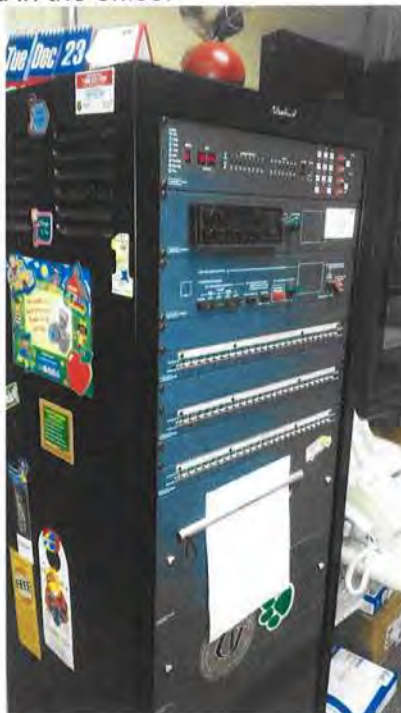
- The entire building is served by a paging and intercom system.
- The head end is located in the office.

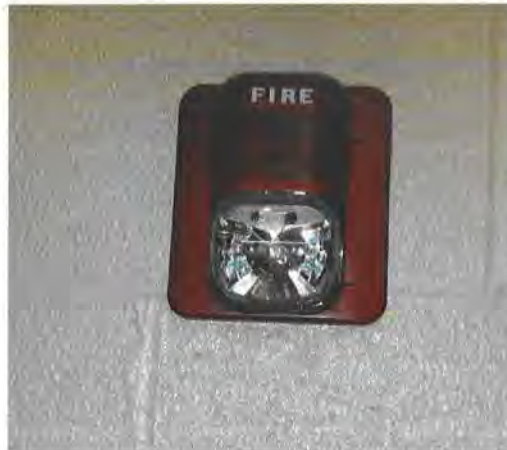
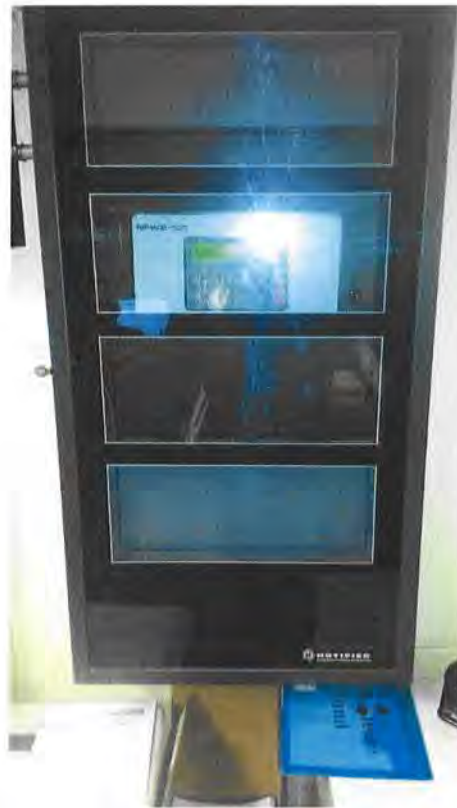
- The fire alarm system is original to the time of construction for each area of the building. Maintenance reported no issues with the system.

- The system does not dial out in the case of an event.

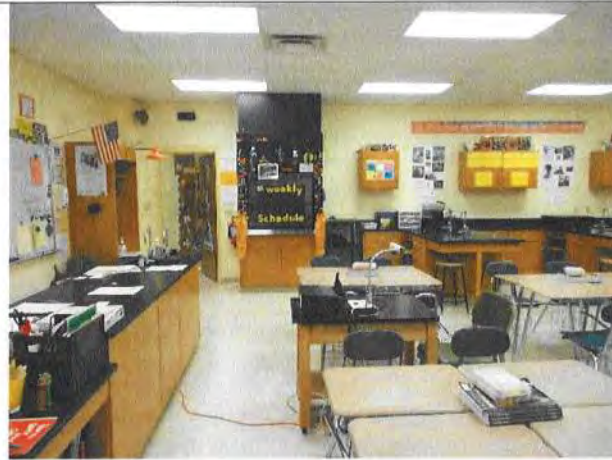
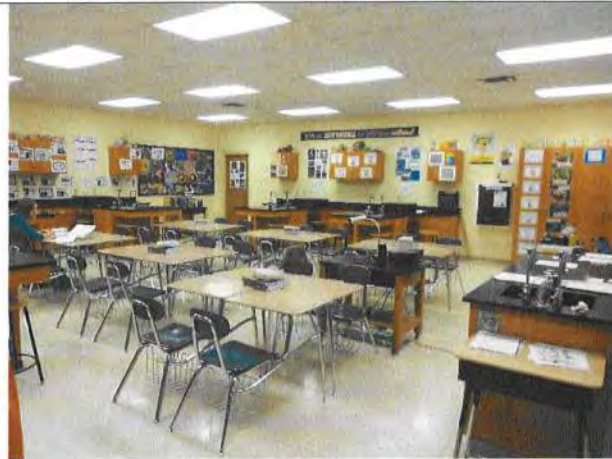
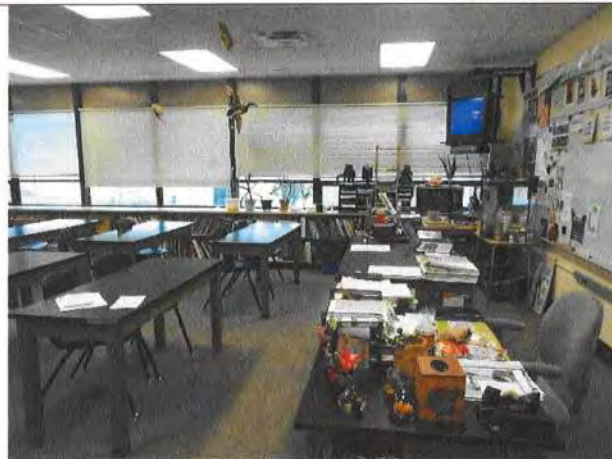
<p><u>Business Computer Classrooms:</u> ± 900 SF</p>	<p>There are three (3) Business computer rooms located in the building, each approximately 900 SF.</p>
<p><u>Science Labs / Classrooms:</u> ± 800 – 1,100 SF</p>	<p>There are seven (7) Science Lab/Classrooms. Four HS Science labs are approximately 1,100 SF. Three MS spaces are approximately 800 SF. The MS science spaces are undersized per current design guidelines, appear dated and in fair condition.</p>

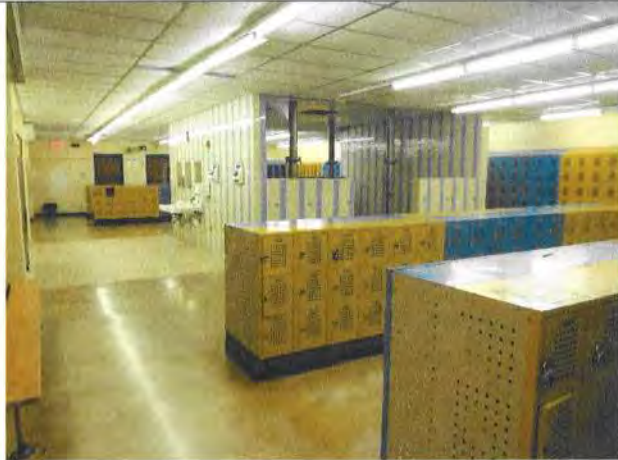
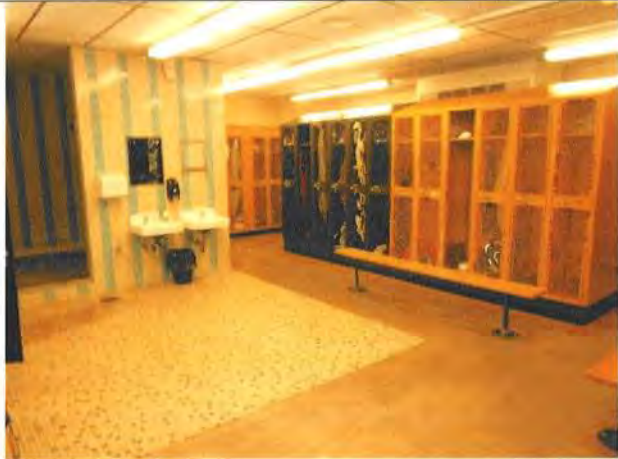
<p><u>Locker Rooms:</u> ± 5,100 SF</p>	<p>The Boy's and Girl's Locker Rooms are approximately 2,400 SF each. Both spaces are in fair to poor condition, appear dated and in need of update. Team Rooms are approximately 800 SF, in fair condition, appear dated and in need of update.</p>

Recommendations:  
*Retrofit Boy's and Girl's Locker rooms and Team Rooms with new engineering systems as required, new student and athletic lockers and updated finishes.*

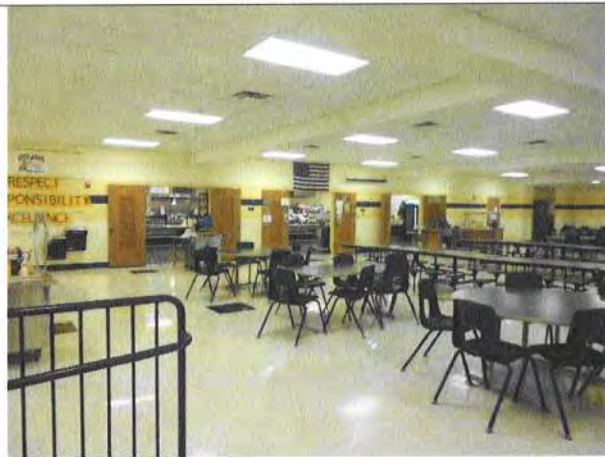
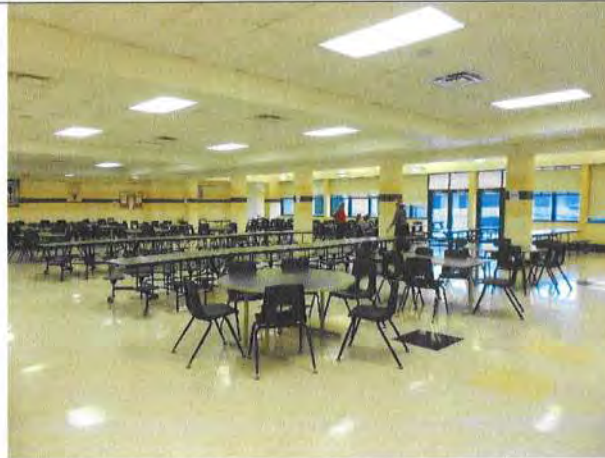
The Cafeteria / Kitchen are shared by grades 7-12. The Cafeteria / Food Court space is approximately 4,700 SF and per Code, adequate in size to support the number of daily servings. The space overall appears to be in good condition.

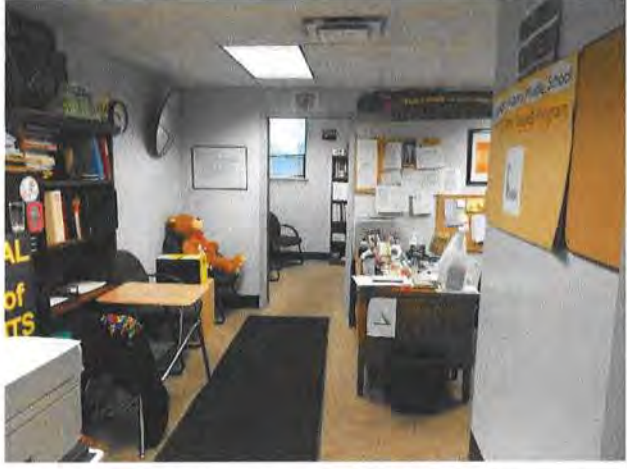
<p><u>MS Administration:</u> ± 400 SF</p>	<p>The MS Administration office is approximately 400 SF and is located in a converted Guidance office. The space is very inadequate to accommodate the MS capacity. The office does not accommodate the number of program spaces required to operate the MS on a daily basis. There is no centralized location for the MS Administration nor centralized entrance point into the MS building.</p>

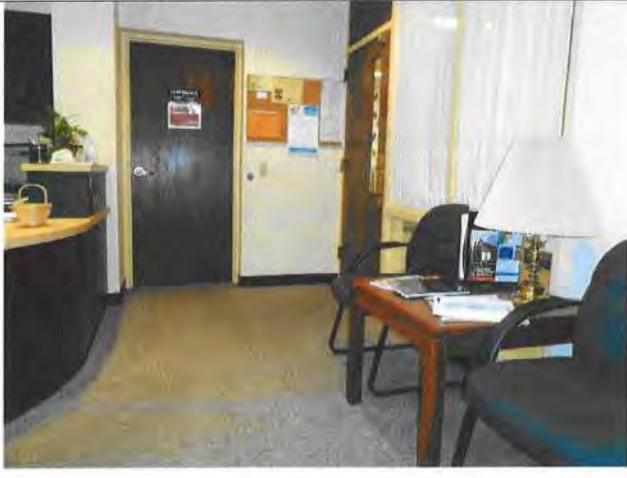
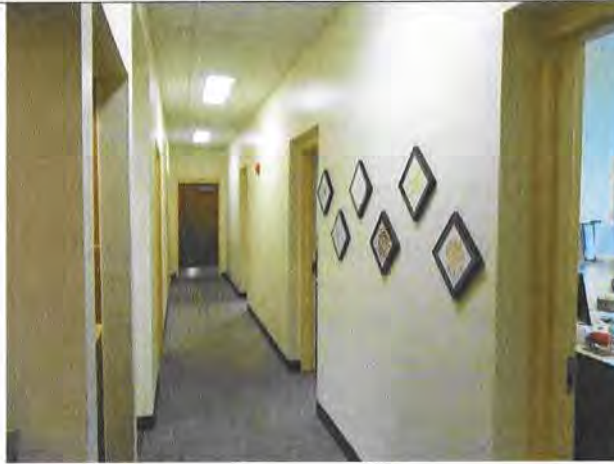
<p><u>District Administration Office:</u> ± 4,100 SF</p>	<p>The DAO is approximately 4,100 SF. The office appears dated, lacks sufficient entrance security and inadequate space to support the required functions.</p>

*Reconfigure DAO to accommodate a locked secured vestibule so visitors entering the building must pass from the vestibule into the Main office first before being allowed into the building circulation.*

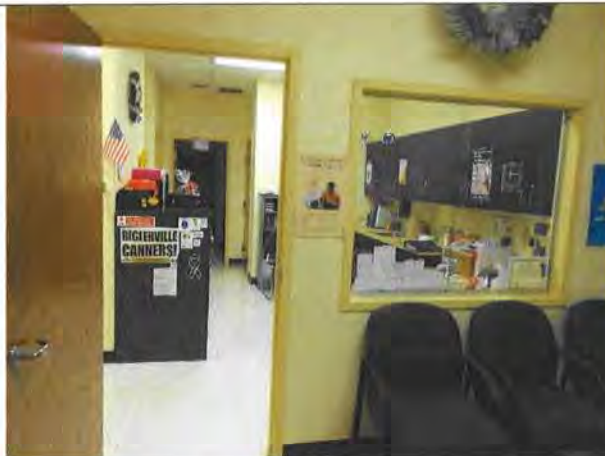
The Nurse's area is approximately 900 SF and is in good condition. The space appears to accommodate all required programmatic functions.

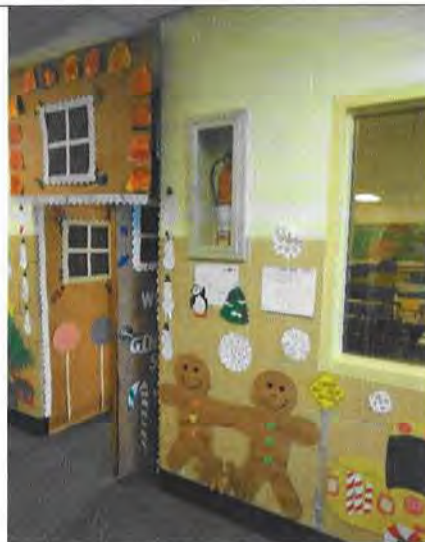
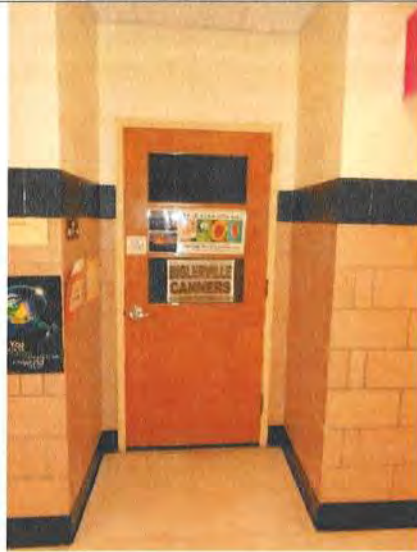
- 1) Fire extinguisher cabinets are mounted too high for ADA accessibility.
- 2) Recessed classroom doors do not provide proper width for accessibility.
- 3) Some toilet stalls do not meet current ADA accessibility requirements.

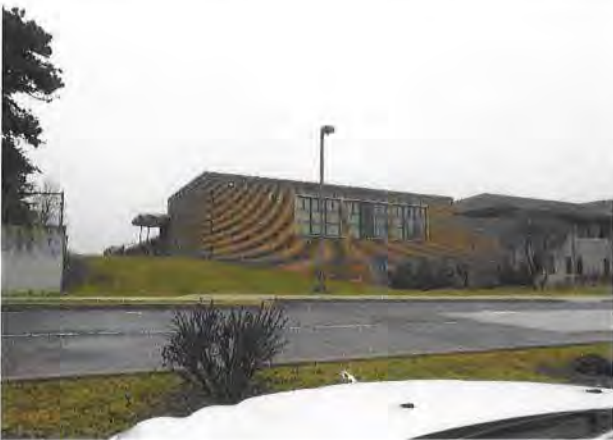
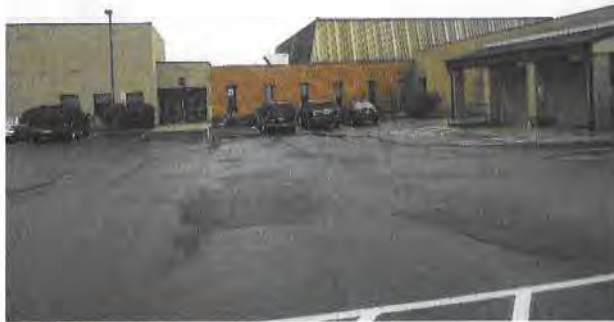
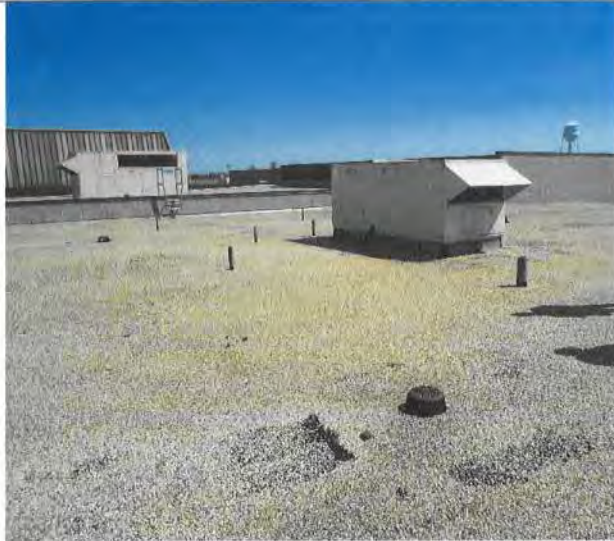
The building roofs consist of pitched shingle, flat ballasted membrane and metal panel. The older original roof sections of the building appear to be in fair conditions with ongoing capital maintenance repairs and replacement.

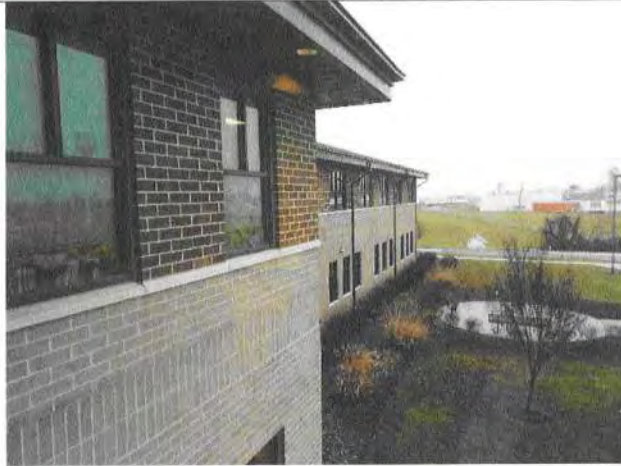
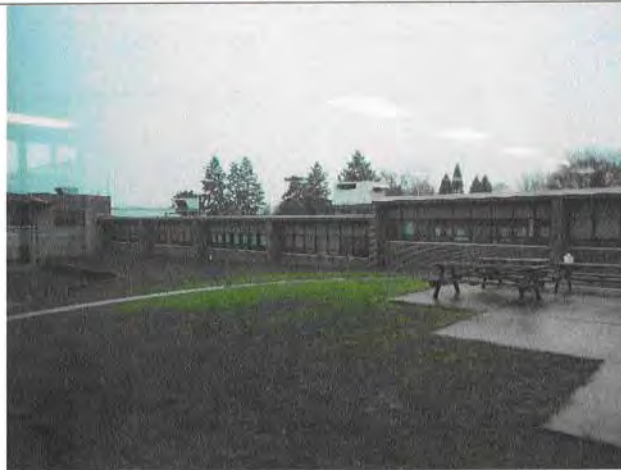
Exterior walls are various patterns and colors of masonry veneer around the entire building perimeter and both original and 2000 construction appear to be in good condition.

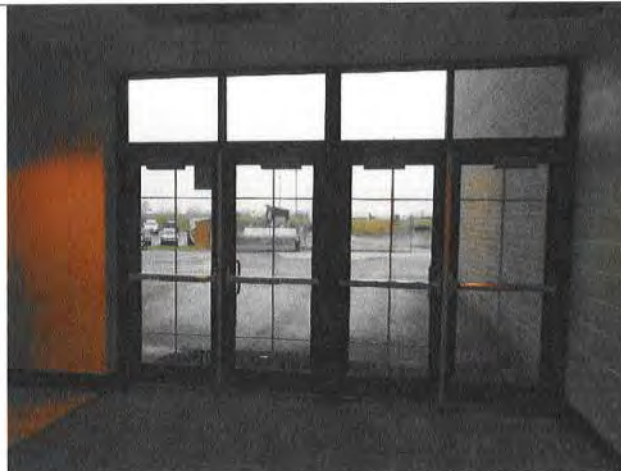
Exterior doors are aluminum and hollow metal. Overall, all doors are in good to fair condition.

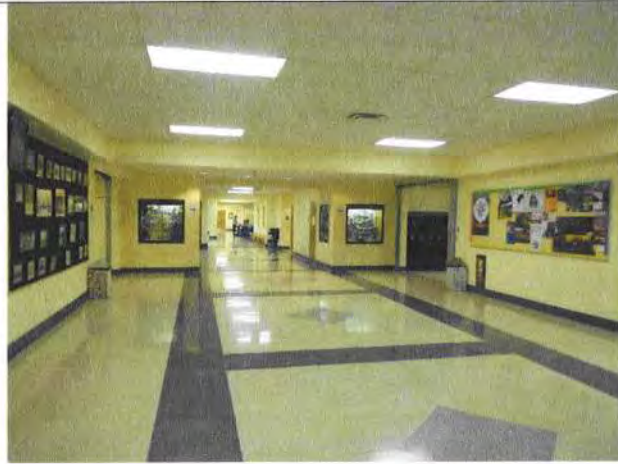
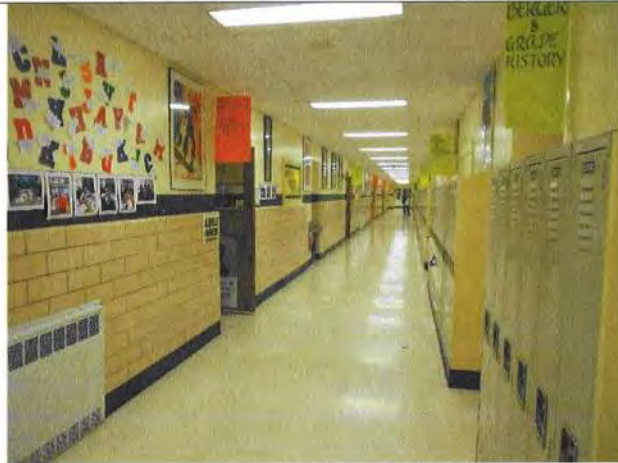
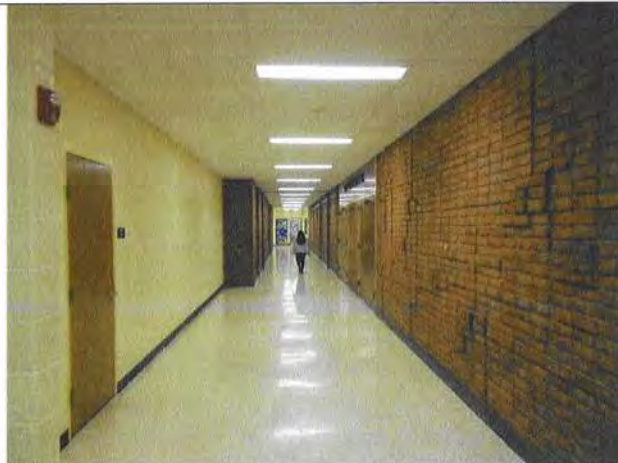
<p><b>Interior Envelope</b></p>	
<p><u>Interior Walls:</u></p>	<p>Interior wall materials include painted concrete masonry units (CMU) in the HS building. The MS corridors consist of painted plaster above a glazed tile wainscot. Exposed masonry veneer line the walls adjacent the District Offices. Overall, wall finishes are in good condition with no sign of any water damage throughout the building.</p>

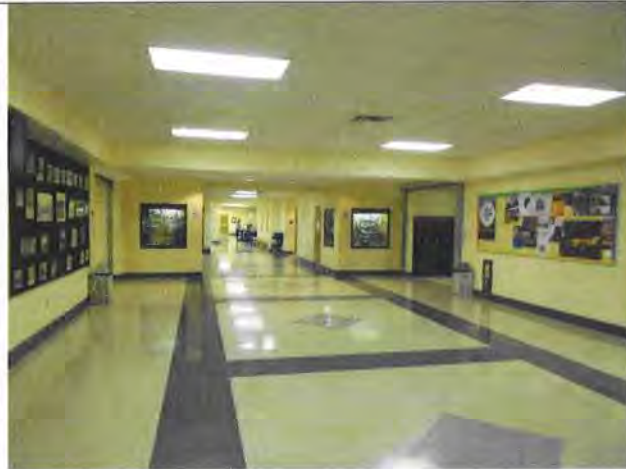
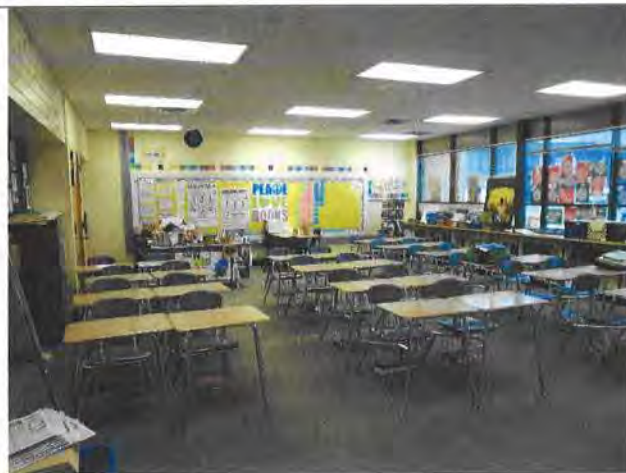
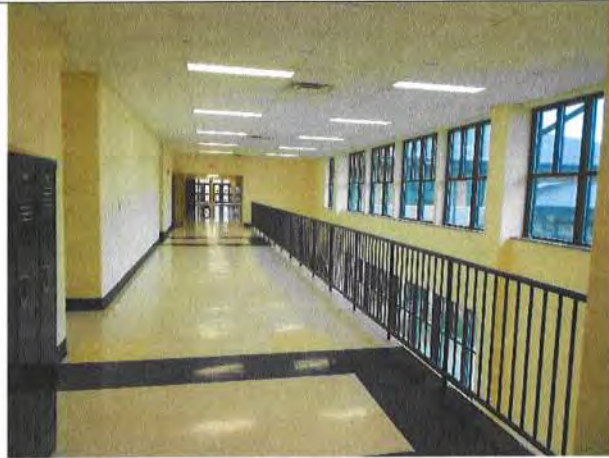
school corridor area, Library, faculty room, etc. The carpet in the above noted locations is showing evidence of wear, some staining but otherwise in good to fair condition.

Vinyl floor tile (VCT) is located in the HS classrooms, Cafeteria, Art and Music areas and corridors throughout the building with exception of the areas noted above and the HS main entrance which is a poured terrazzo floor system. The VCT flooring appears to be in good to fair condition with some evidence of wear, discoloration and replacement of tile in some areas.

Ceramic tile is located in student toilets. The ceramic tile in the MS toilets is in poor condition.

*Remove existing classroom carpet and replace with VCT.*

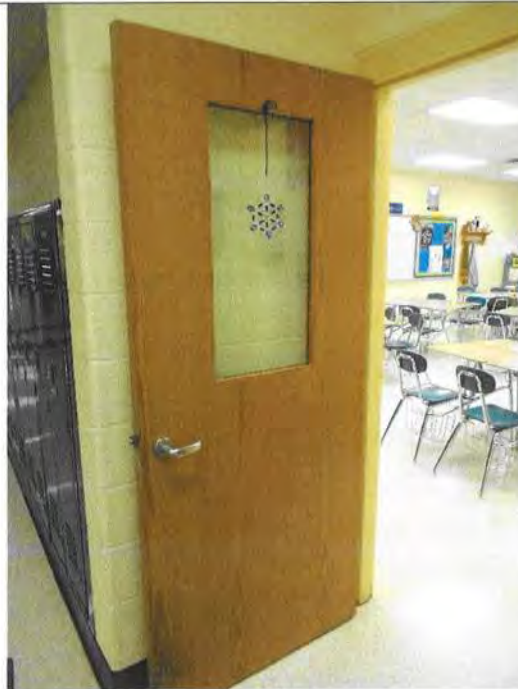
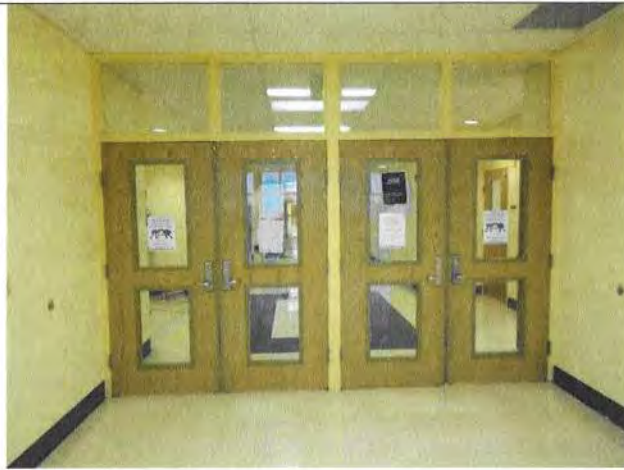
Doors: Wood, Hollow metal, and aluminum doors with hollow metal/aluminum frames are in good condition. Much of the door glass consists of wire frame which with current building codes is no longer permitted. Majority of the doors do have ADA compliant lever sets.

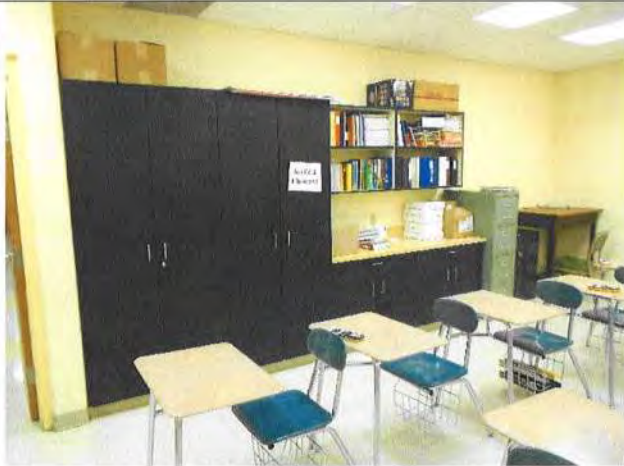
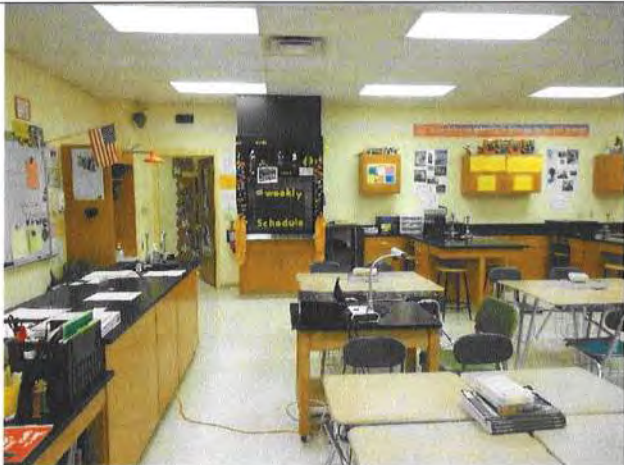
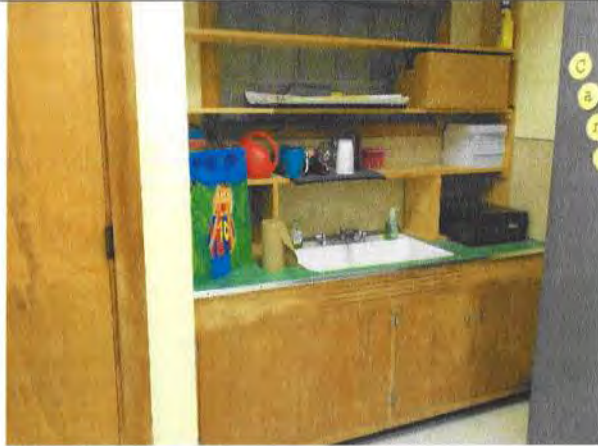
Casework: Built-in casework in HS classrooms and science labs is in good condition. The casework in the MS classrooms is in fair to poor condition.

*Replace MS classroom casework with any building improvement project.*

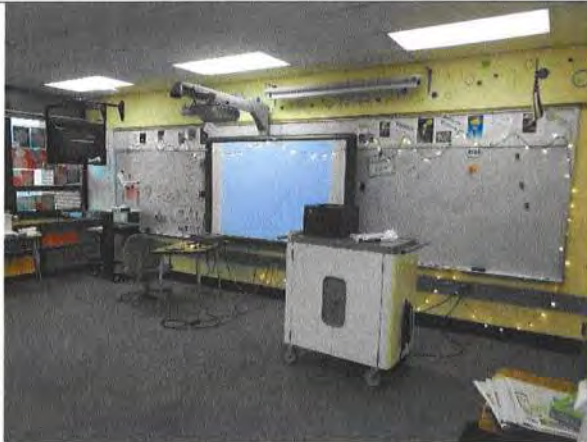
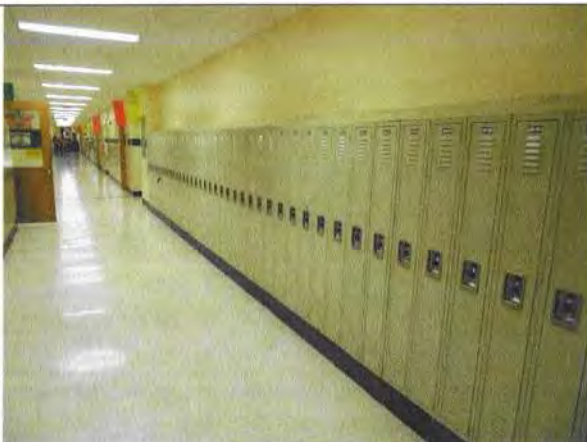
The MS corridor lockers are small, inefficient and do not accommodate students books, supplies and backpacks.

<p><u>Recommendations:</u></p> <p>Replace MS corridor student lockers with a wider capacity type with any building improvement project.</p>
<p><u>Toilet Rooms:</u></p>	<p>Many MS toilet rooms are non-compliant per current accessibility codes, dated and are in fair to poor condition.</p> <p>The main locker room toilets are non-compliant per current accessibility codes, dated and are in fair to poor condition.</p> <p>The HS toilet rooms meet current accessibility guidelines and are in good condition.</p>

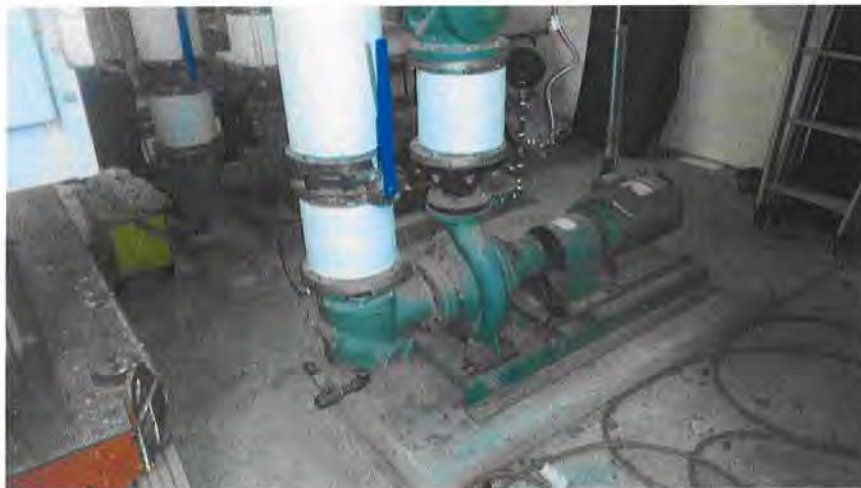
- Heating hot water is distributed throughout the building in copper piping. During the 2001 construction project, some of the piping from 1973 was reused. This piping was reported to have minor leaking. The piping is insulated and is located above ceilings and is accessible.
- Maintenance staff indicated that they have a power issue which has resulted in burning out motor drives and compressors.
- Recommendation:
  - ASHRAE Handbook HVAC Applications (2007) table 4 on page 36.3 lists service life estimates for boilers are 30 years, pumps as 20 years, ductwork as 30 years, rooftop units as 15 years, coils as 20 years, and electronic controls as 15 years, and pneumatic controls as 20 years.
