## UPPER ADAMS SCHOOL DISTRICT

# District Wide Feasibility Study

June 2016  
CRA Project No. 2832

**Crabtree, Rohrbaugh & Associates  
Architects**

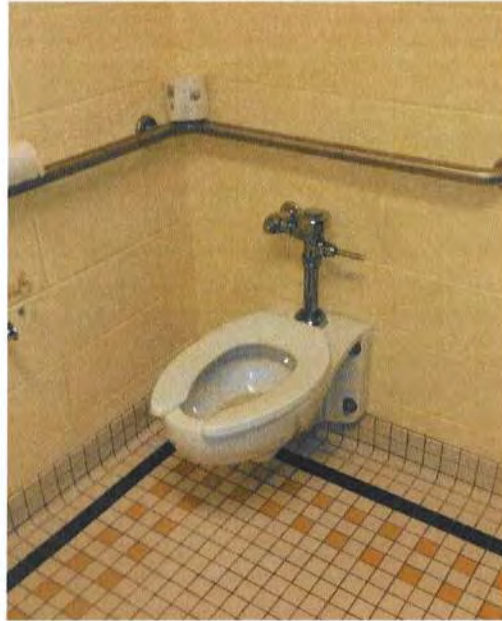
- Water closets are wall-mounted fixtures with manual flush valves.

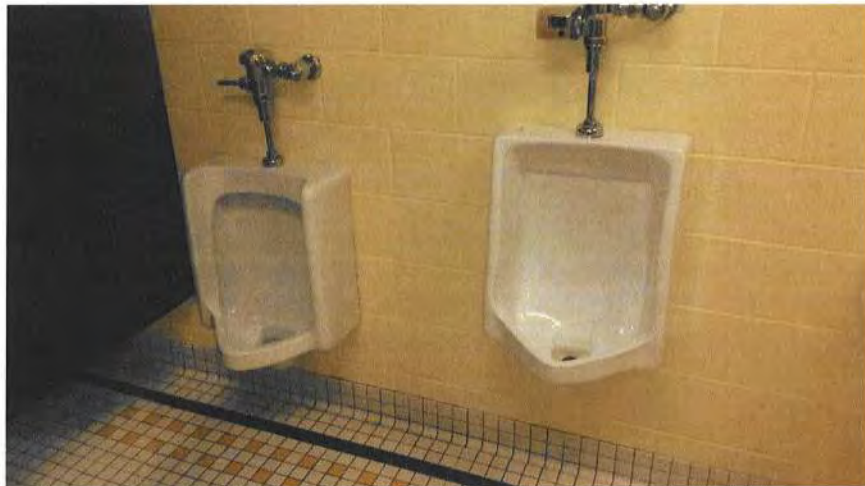
- Urinals are wall-mounted fixtures with manual flush valves.

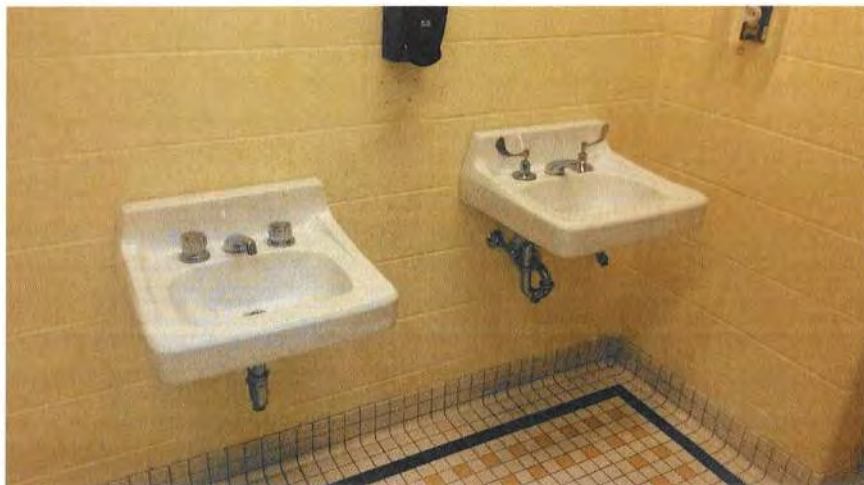
- Lavatories are wall-mounted fixtures with a variety of handles.

- All fixtures were original to their period of construction except for a few which were replaced. Fixtures appeared to be in fair to good condition.
- Based on the age of the fixtures, we assume that they do not meet current Code required flow rates.
- Fixtures did not appear to have anti-scald valves to meet current Code requirements.
- Recommendations:
  - None.

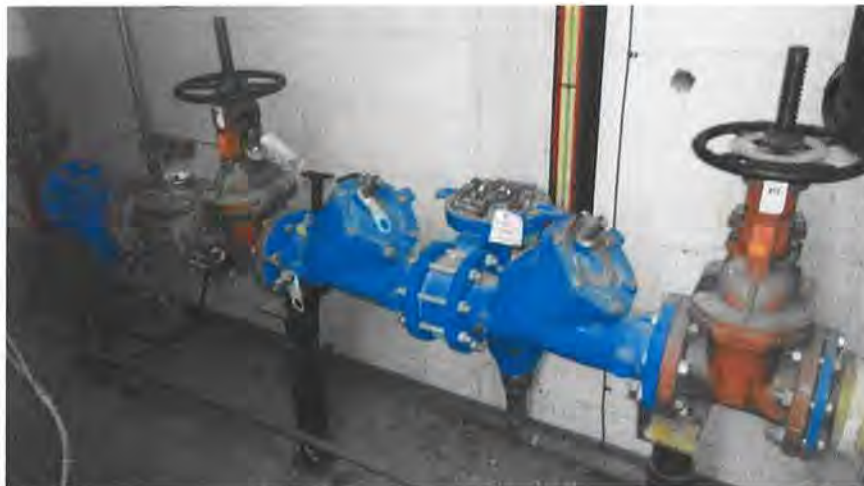
- Domestic water piping is distributed throughout the building in copper piping. It was reported to be in good condition.
- Domestic water piping is insulated and is located above ceilings.
- Domestic hot water is conditioned with a water softening system. The system was installed in 2001 and was reported to be in fair to good condition.

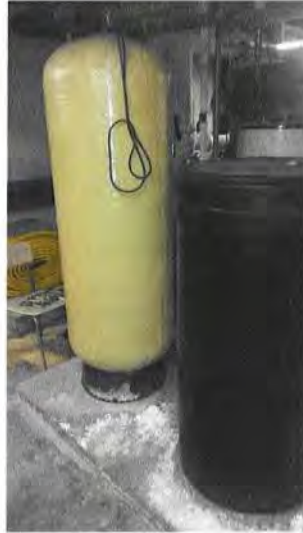
- Maintenance indicated that there are minor leaks in the hot water recirculation system.
- Recommendations:
  - None.

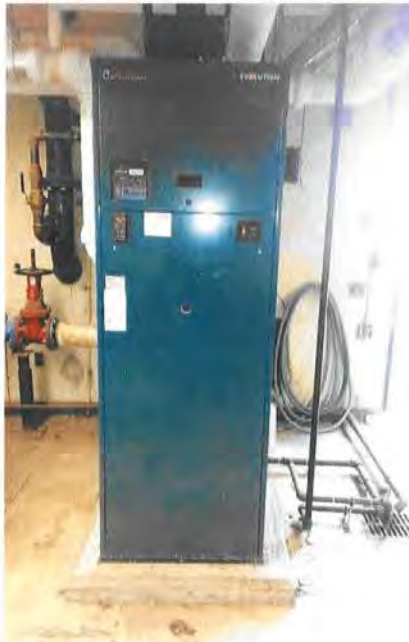
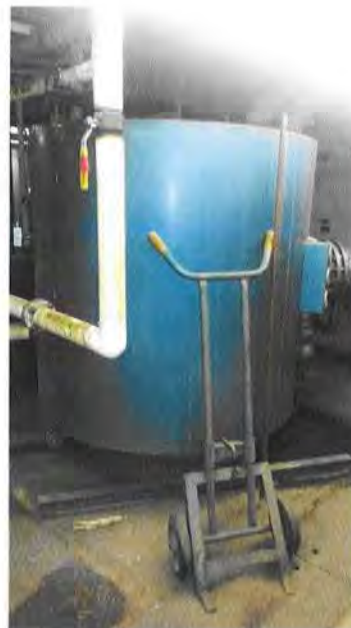
- Domestic hot water is generated by a boiler and storage tank. The boiler was installed in 2007 and the tank was installed in 1990. Both are in good condition with no issues reported.
- Water is stored at 140 degrees F and mixed down for distribution to the building.
- A hot water recirculation system also exists.

- Recommendation:
  - Drain and inspect the tank.

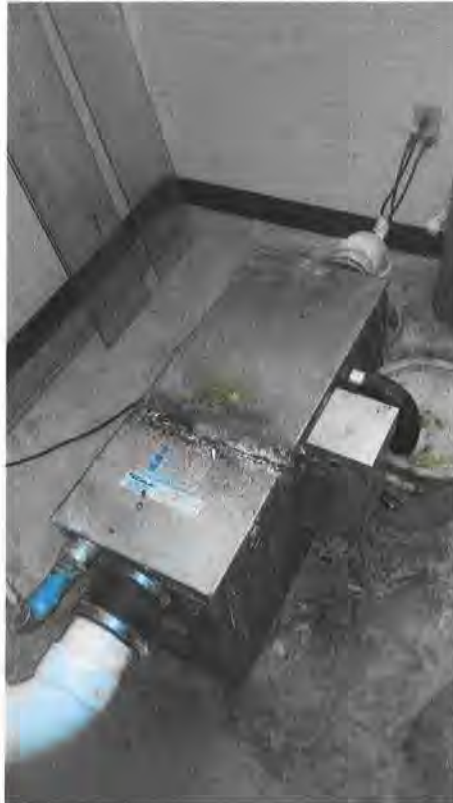
- Sewer is discharged to a public system maintained by Biglerville Borough.
- Waste piping is cast iron.
- The piping was installed at the time of construction for each area and was reported by maintenance staff as being in good condition. The system is only snaked when there is an issue.
- The kitchen waste piping is protected by an automatic type grease interceptor. It is cleaned once a year.

- Recommendations:
  - None.

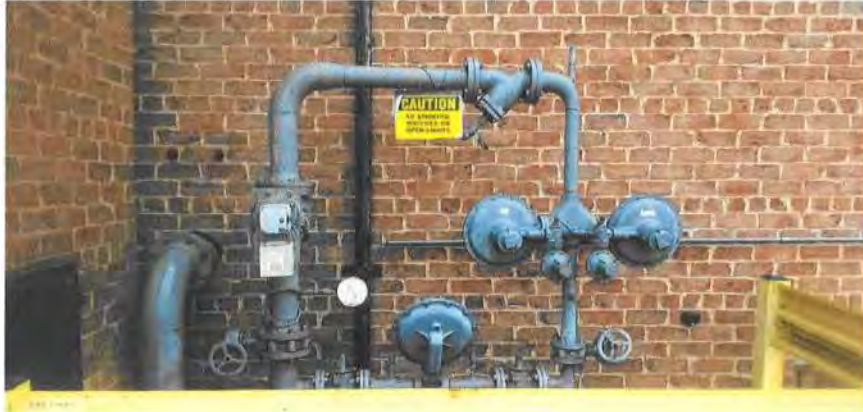
- The building is served by Columbia Gas.
- Natural gas is provided for the boilers, water heaters, rooftop units, kitchen, and emergency generator.
- Natural gas is distributed through black steel piping.
- Maintenance staff reported no issues with this system.

- Recommendations:
  - None.

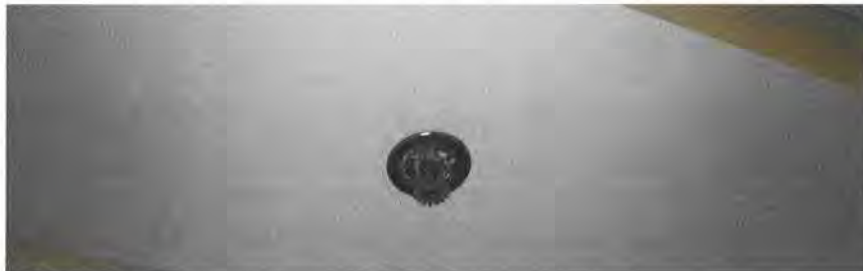
- The middle school basement and lobby area outside the auditorium are protected by an automatic sprinkler system. Maintenance staff reported no issues with this system. It is original to the periods of construction for these areas.

- Recommendation:
  - Extend system to the entire building.

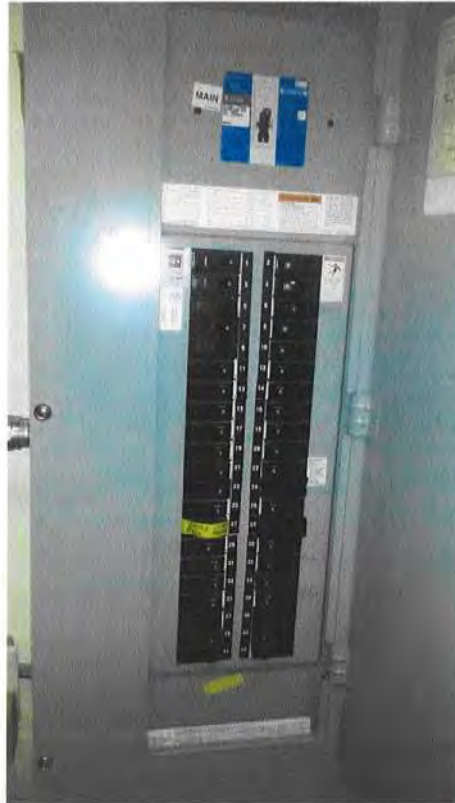
- Electric service is provided by Met Ed.

- The service size is 3000 amp, 480/277 volt.

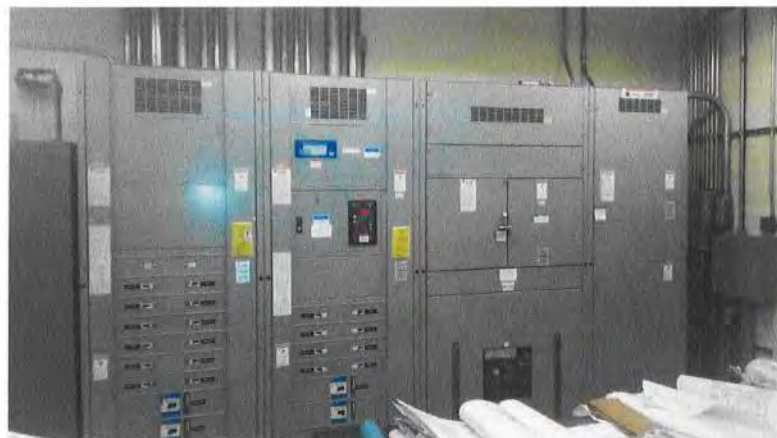
- Distribution equipment is manufactured by Cutlet Hammer and was installed in 2001. It is in good condition with no issues.
- The transformer is pad mounted with underground service.

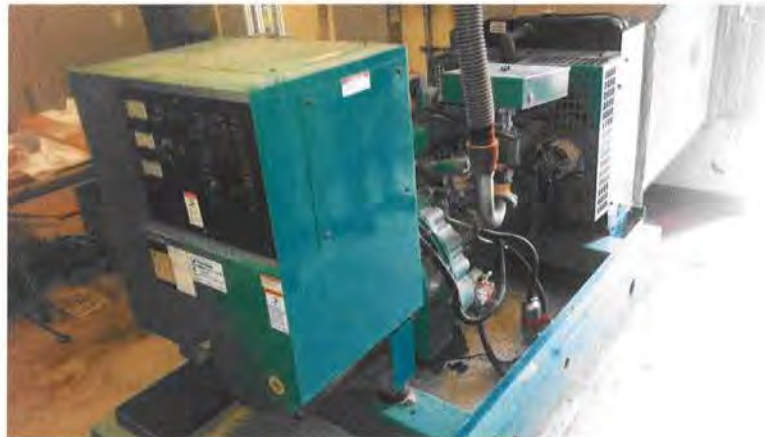
- The building is served by a 35 KW natural gas-fired emergency generator manufactured by Onan. The generator is indoors. It was installed in 2001 and is in good condition.
- The unit serves lights, walk-ins, computer servers.

- Recommendation:
  - Replace the unit to incorporate additional emergency items such as heating system, wiring closets, etc.

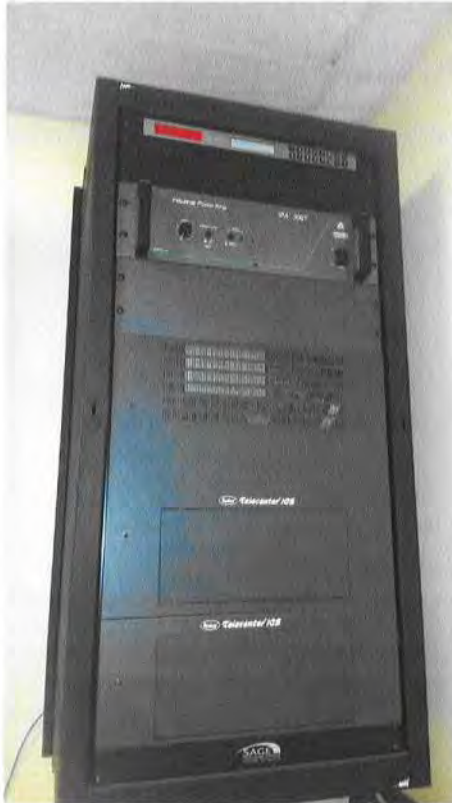
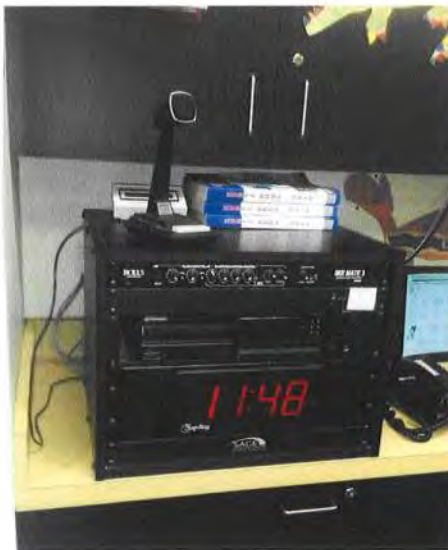
- The entire building is served by a paging and intercom system.

- The head end is located in the office.

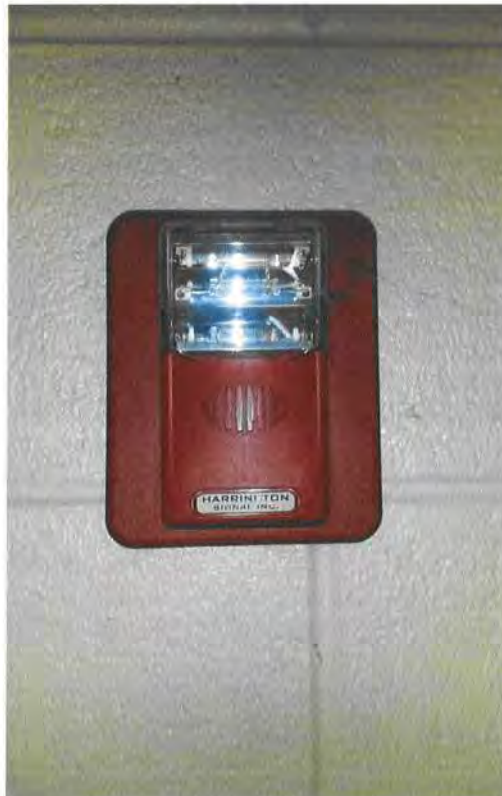
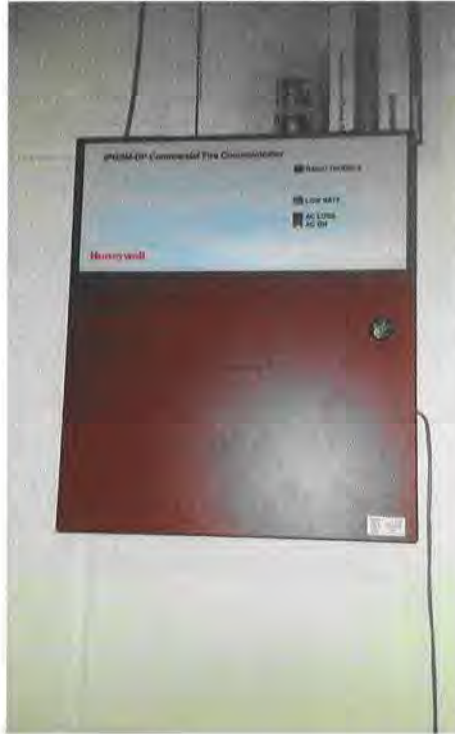
- The fire alarm system was installed in 2001 and is in good condition.

The system dials out to the County Controller in the case of an event.

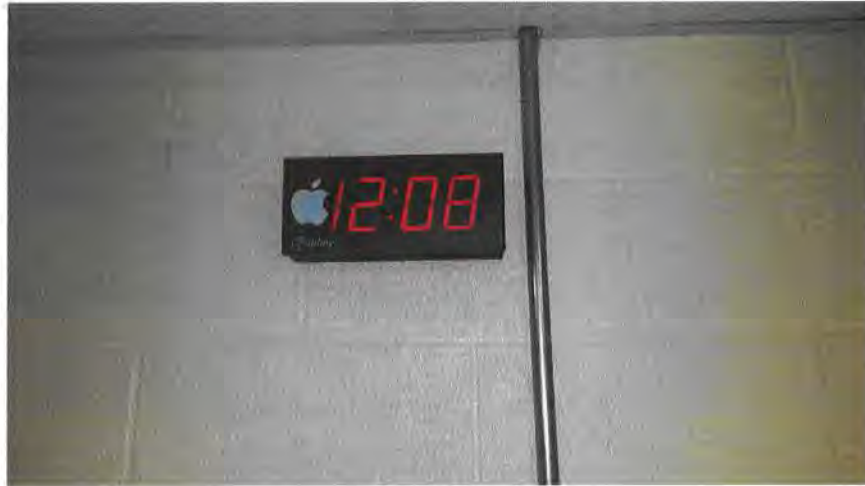
- The building has a master clock system that was installed in 2001 and is in good condition.
