Quality Environmental Solutions & Technologies, Inc.

Re: Ricciardi Elementary School

Per your request I have attached the photoionization detector (PID) readings we recorded on April 15 and 20, 2023. As we have discussed, a hand-held PID used in the field is a screening tool that detects total volatile organic compounds. There are no regulatory limits for total VOCs. On April 15th, the first day we performed any testing at Ricciardi, the results showed higher levels of VOCs than we found on the 19th. There was extensive remediation conducted between these dates. This included the removal of porous materials like wood, floor patch, and dirt/debris that likely absorbed the mastic remover. We believe that the lingering odor in the building was very likely caused by absorption into these porous materials. All readings reported were recorded in the identified location for a period of 3-5 minutes and are reported in parts per million (ppm).

Reconstruction to:
C.M. Riccardi Elementary School

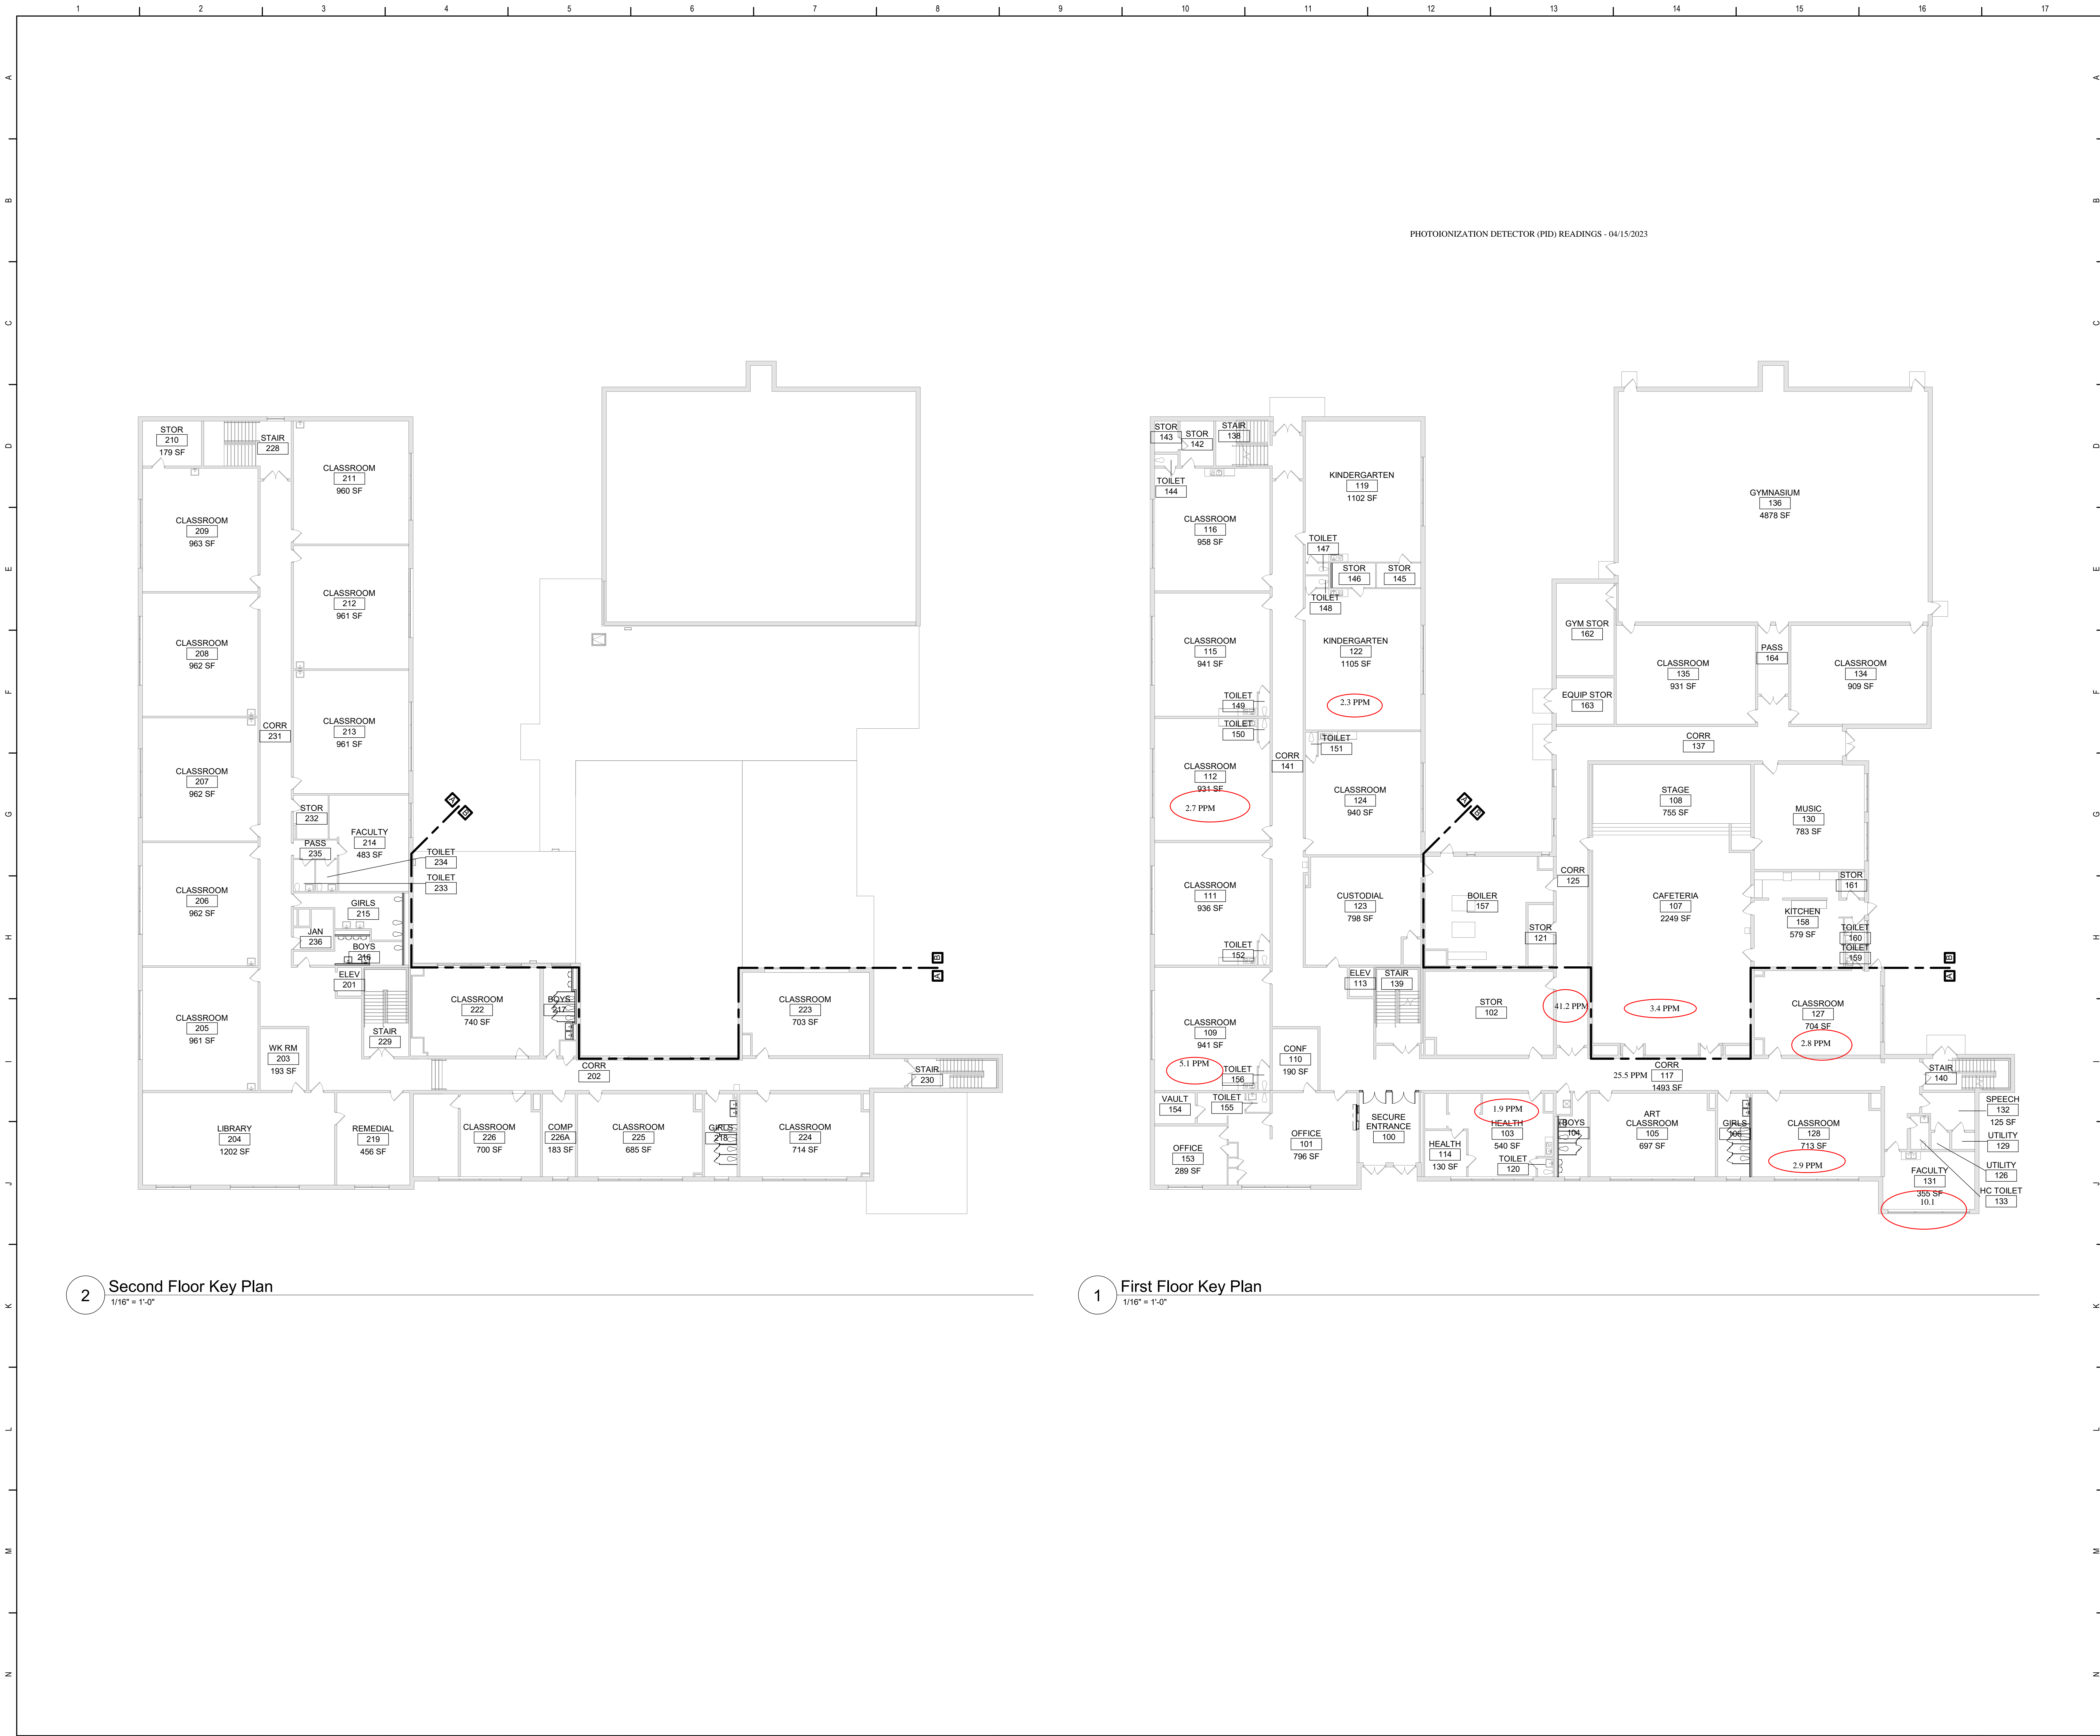
First and Second Floor Key Plans

The readings we recorded are annotated on the attached floor plans. They are encircled in red for each location. Please keep in mind that the readings taken on the 15th were early in the morning after the building had been closed up. In addition, the ventilation system went into night set back on Friday afternoon, so the building's ventilation system was not bringing in outside air. The levels of VOCs were significantly reduced from the 15th to the 19th. For example, the total VOC level in the section of the corridor between the cafeteria and boiler room was reduced from 41.2 ppm to 5.8 ppm. And these readings were taken before the over slab (commonly referred to as a rat slab) was removed via the use of drill hammers and hand tools. If additional remediation is needed, we will make the recommendations to your office as soon as possible,
