*Initial Draft Student Learning Environment Committee Report*

# **CGCSC Facilities Evaluation 2012**

## Current Condition of Facilities and Future Facility Needs

**CSO Architects**

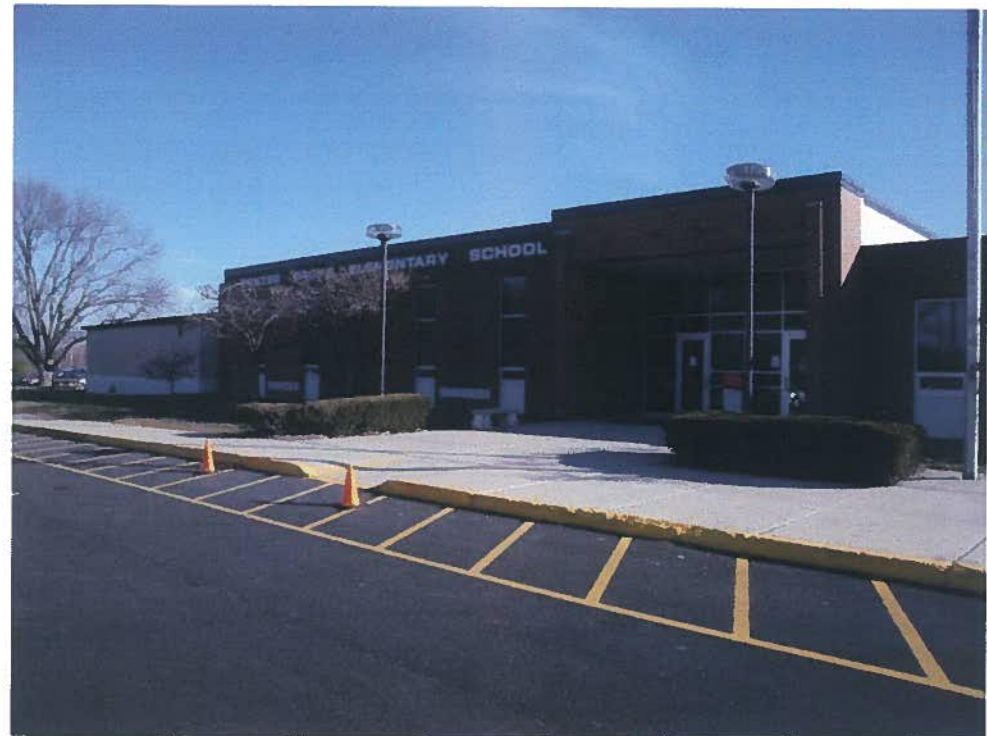
Main Entrance

| Maintenance/<br>Efficiency | | |
|---|---|---|
| <b>Exterior Building Walls</b> | ◐ | <ul style="list-style-type: none"> <li>• Brick veneer masonry in very poor condition</li> <li>• Major brick repair needed at pilasters</li> <li>• Upper portion of walls have cracked and open joints</li> <li>• Unit ventilator grilles have lintel problems and open sealant joint that need to be re-sealed</li> <li>• Lintel at main entrance has rust and movement of brick</li> </ul> |
