III. George Mason Master Plan and Technical Data

George Mason Elementary School

Existing Conditions Assessment

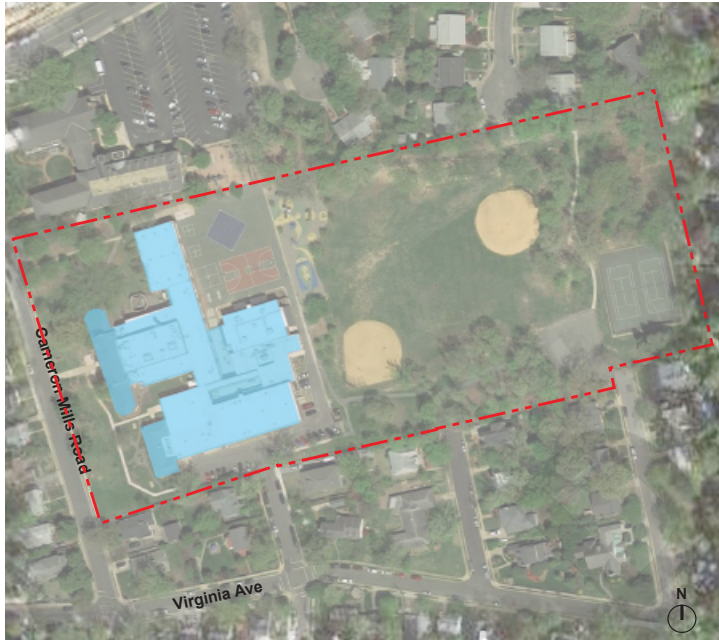
Map and Zoning Information

Address	2601 Cameron Mills Road
Tax Map	23.04
Zoning	R8
Lot Size	407,290
Current SF	50,935
FAR	0.35
Allowed SF	142,552
Setbacks	Front- 30'
	Side- 25', 1:1 ratio
	Rear- 25', 1:1 ratio
Max Height	40'
Parking	~27 reqd, ~28 exst

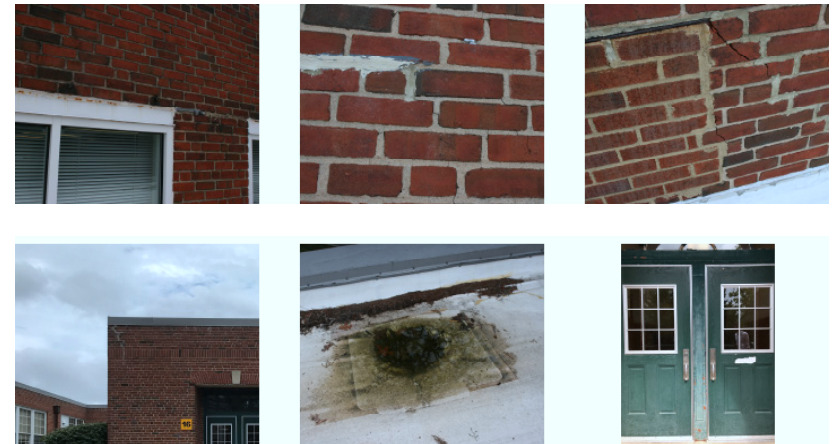
Existing Envelope Condition

The George Mason envelope is in poor condition. The two areas of largest concern are the windows and roof. School leaders reported concerns about the condition of the windows. Windows have been replaced in different areas of the building at different times, and there are unique issues related to each type. Older wood windows are water damaged and have non-thermal single pane glass. The newer replacement windows

are very poor quality, leak, and do not lock. School leaders also reported that the roof leaks often, and S27 observed that there is visible ponding at drain locations. Other issues to note are visible cracks in the masonry, exterior entrances are in poor condition with visible rust and flaking paint, as well as large undercuts that allow an unwanted thermal transfer. Floor slab and exterior settlement cracking can be seen from the interior of the building at the main entrance and in classrooms. Like Cora Kelly, George Mason also has a very high form factor, which has a negative impact on building energy efficiency and use

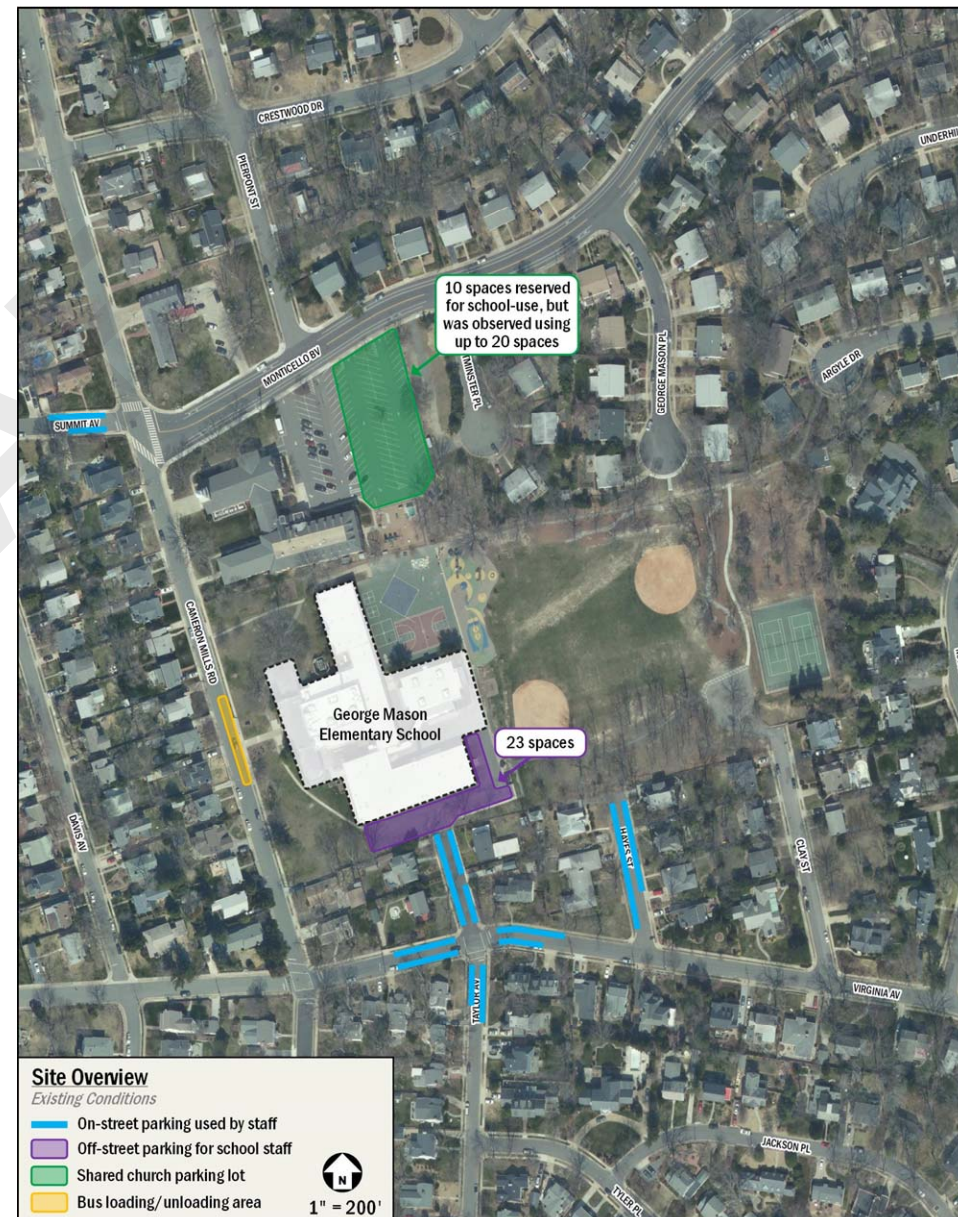
Figure 5
Existing Site Overview

At the time when Gorove/Slade our certified traffic engineering firm observed conditions at the existing location, George Mason ES served a total of 440 students. The site includes a 23-space surface parking lot with an additional 10 spaces reserved for school-use in the church parking lot adjacent to the site. The school is planned to increase its student population to include approximately 650 to 700 students in the future. Potential changes to arrival/dismissal operations and parking on the site are currently being evaluated. Figure 1 provides a map showing an overview of the George Mason ES site.

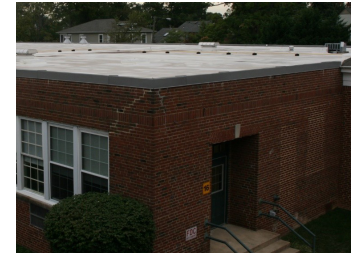
Around the exterior perimeter of the original building, there are a few cracks observed in the brick masonry. Many of these cracks were around openings and appeared to be related to thermal movement, restraint cracking, rust jacking of the lintels, and minor settlement of the building. (see photos #7 thru #10). In select locations, cracked mortar joints have been routed and repointed (see photos #7 and #8).

Photo #7
Typical Brick Deterioration & Repairs

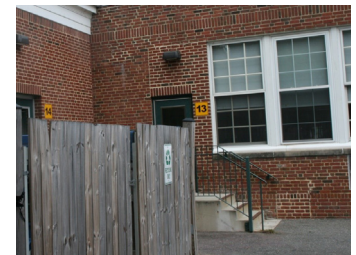
Photo #8
Typical Brick Deterioration & Repairs

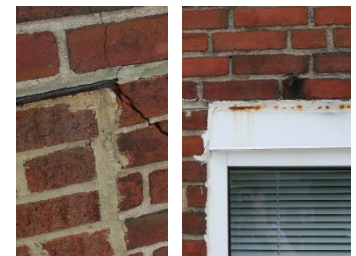
Photo #9, #10
Typical Brick Crack & Deterioration

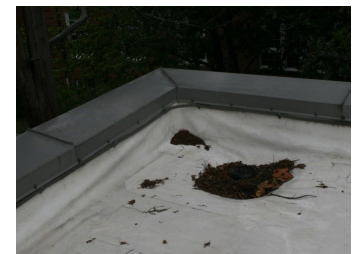
Several roof drains were observed clogged or filled with debris. This problem typically occurred where trees were in close proximity to the roof structure (see photos #11 and #12).

Photo #11
Clogged Roof Drain

Roof Drains appear to have been recently replaced and are in fair to poor condition. Storm piping that was observed throughout the building appears to be original which is 60+ years old and is past its rated useful life. Recommend replace all building original piping with new. Some roof drains were observed as being blocked with plants growing out of them recommend walking the roof and cleaning out all roof drains.

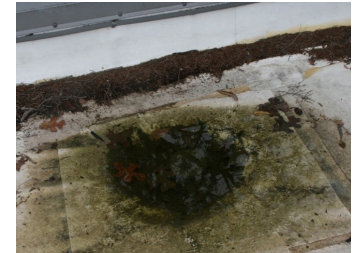
Photo #12
Clogged Roof Drain

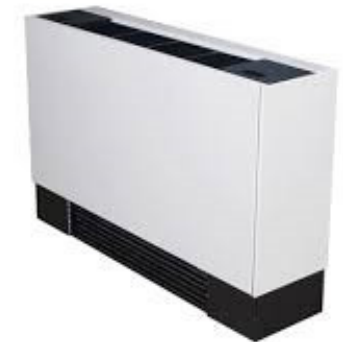
The HVAC system for this option shall utilize 4-pipe fan coil units for zone thermal comfort control and outside air handling units with fixed-plate energy recovery for delivery of code required outside air. A central air-cooled chiller, pumping system, and chilled water piping network will be utilized to circulate chilled water to each unit. Chiller shall be equal to Trane Stealth, tonnage to be determined. Chiller contains two refrigerant circuits. The boilers shall be gas-fired, high-efficiency condensing style boilers to reduce energy consumption. Boilers shall be equal to Viessmann Vitocrossal 300, 3,000 MBH, 2 each.

The ventilation (outside) air is de-coupled from the HVAC heating and cooling with each space (or zone) receiving outside air separately utilizing demand control ventilation. Each fan coil unit will be equipped with an ECM fan motor, 1" disposable MERV 8 filter, hydronic heating and cooling coil,

Figure 1
Fan Coil Units
