# Griffith Public Schools Multi-Year Capital Plan

Project Number: 217047.00

December 22, 2017

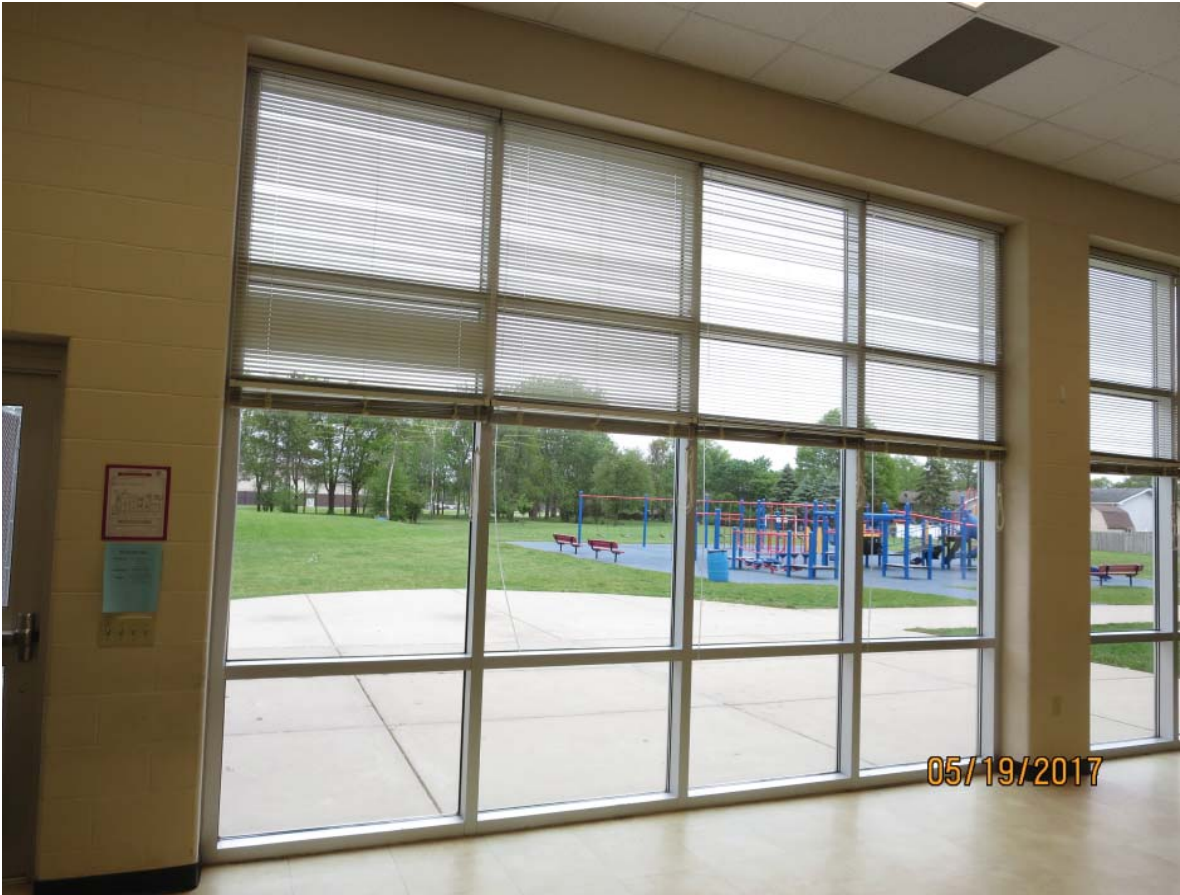
Cafe Window

| | | | | | Project Start | | | | | | | | | |
|---|---|---|---|---|---|---|---|---|---|---|---|---|---|---|
| Item 3-Replace Glass unit (broken Seal) | | | | Café Window | | | \$ 1,200.00 | | | | | | | |

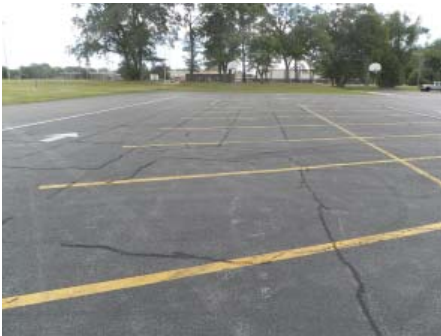
| Condition | Low to High<br>Priority<br>Level | Inspection<br>Frequency | Energy<br>Efficiency | Photo No. | Project Start | | | | | | | | | | |
|---|---|---|---|---|---|---|---|---|---|---|---|---|---|---|---|
| surface, seal coating, crack remediation | Satisfactory | | semi annual | 2782 | | | | | | | 12,000 | | | | |

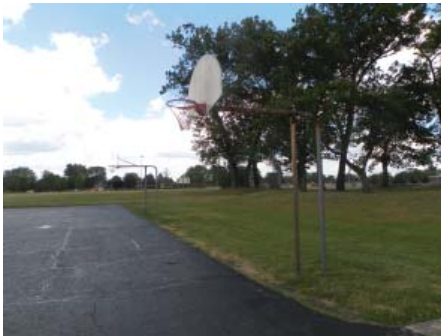
| Condition | Low to High<br>Priority<br>Level | Inspection<br>Frequency | Energy<br>Efficiency | Photo No. | Project Start | | | | | | | | | | |
|---|---|---|---|---|---|---|---|---|---|---|---|---|---|---|---|
| basketball goal replacement | Satisfactory | | semi annual | 2784 | | | | | | | 6,000 | | | | |

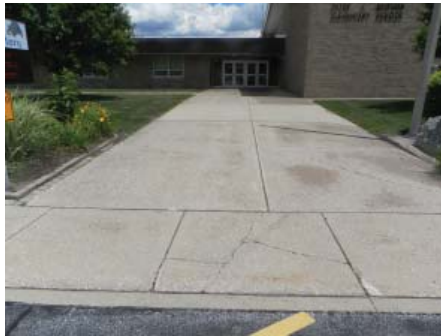
| Condition | Low to High<br>Priority<br>Level | Inspection<br>Frequency | Energy<br>Efficiency | Photo No. | Project Start | | | | | | | | | | |
|---|---|---|---|---|---|---|---|---|---|---|---|---|---|---|---|
| sidewalk replacement | Satisfactory | | semi annual | 2801 | | | | | | | 35,000 | | | | 34,000 |

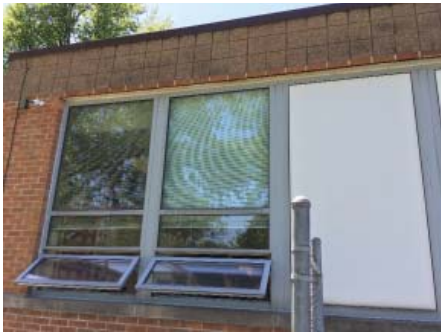
IMG\_3425.jpg

| | | | | | Project Start | | | | | | | | | |
|---|---|---|---|---|---|---|---|---|---|---|---|---|---|---|
| Item 13-Interior sealant needs replacement | | | | <a href="#">IMG 3414</a> | | | | | | \$ 8,005 | | | | |

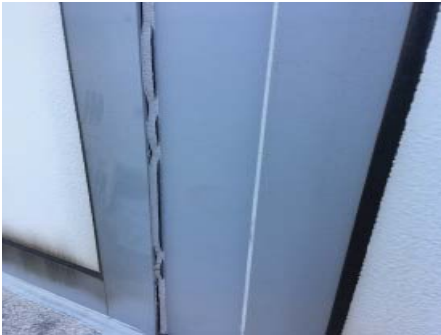
IMG\_3435.jpg

| | | | | | Project Start | | | | | | | | | |
|---|---|---|---|---|---|---|---|---|---|---|---|---|---|---|
| Item 19- Exterior sealant needs replacement | | | | <a href="#">IMG 3435</a> | | | | | | \$ 8,005 | | | | |

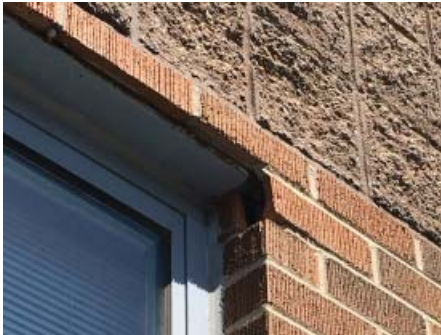
IMG\_3444.jpg

| | | | | | Project Start | | | | | | | | | |
|---|---|---|---|---|---|---|---|---|---|---|---|---|---|---|
| Item 15- Brick Repair; location as noted on plan (B4) | | | | <a href="#">IMG 3444</a> | | | \$ 551 | | | | | | | |

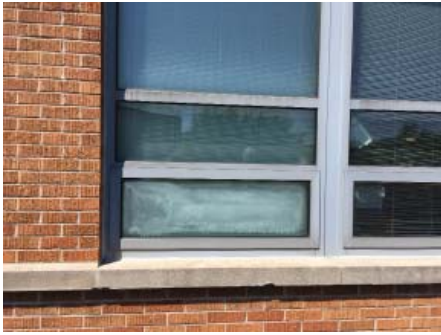
IMG\_3445.jpg

| | | | | | Project Start | | | | | | | | | |
|---|---|---|---|---|---|---|---|---|---|---|---|---|---|---|
| Item 3 -Replace glass unit with broken seal (A3 & A6) | | | | <a href="#">IMG 3445</a> | | \$ 762 | | | | | | | | |

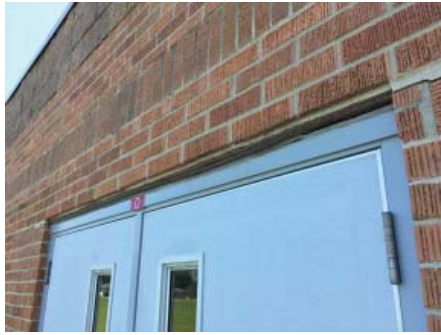
IMG\_3452.jpg

| | | | | | Project Start | | | | | | | | | |
|---|---|---|---|---|---|---|---|---|---|---|---|---|---|---|
| Item 23- Replace steel lintel and add weeps | | | | <a href="#">IMG 3452</a> | | | \$ 6,174 | | | | | | | |

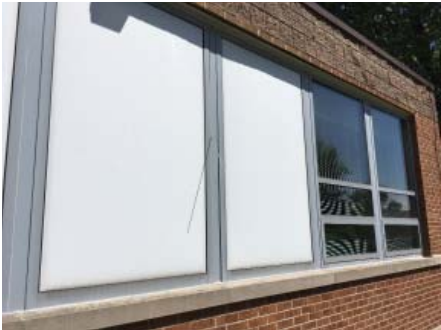
IMG\_3455.jpg

| | | | | | Project Start | | | | | | | | | |
|---|---|---|---|---|---|---|---|---|---|---|---|---|---|---|
| Item 19- Exterior sealant needs replacement | | | | <a href="#">IMG 3455</a> | | | | | | \$ 7,821 | | | | |

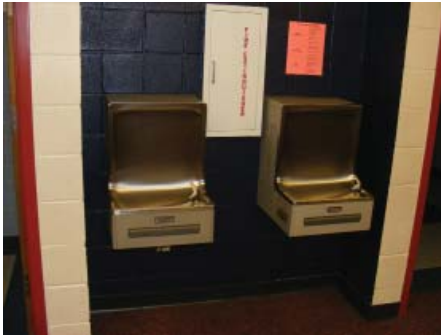
1326

| | | | | | | Project Start | | | | | | | | | |
|---|---|---|---|---|---|---|---|---|---|---|---|---|---|---|--|
| Replace drinking water coolers in 1958 Building | | | | | 1326/1331 | | \$ 7,500 | | | | | | | | |

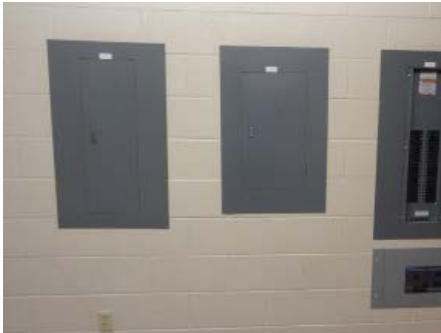
| | | | | Project Start | | | | | | | | | |
|---|---|---|---|---|---|---|---|---|---|---|---|---|---|
| Replaced in 1997 (16 panels) | | | DSC03111 | | | | | | | | | | |

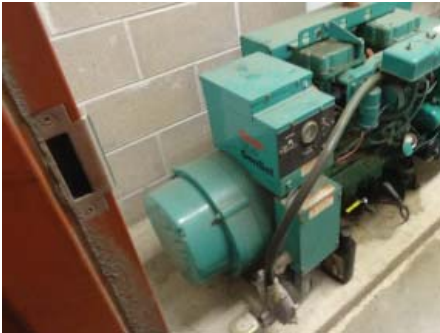
| | | | | Project Start | | | | | | | | | | |
|---|---|---|---|---|---|---|---|---|---|---|---|---|---|--|
| Emergency Generator: 11 (Replace every 20 years) | Marginal | monthly | DSC03126 | | | | | | | | | | | |

| | | | | Project Start | | | | | | | | | | |
|---|---|---|---|---|---|---|---|---|---|---|---|---|---|--|
| Replace existing Diesel with Natural Gas Generator | | | | | \$25,000 | | | | | | | | | |

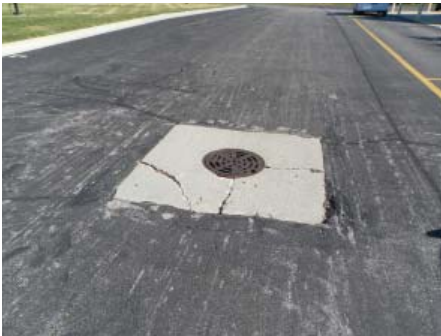
| | | | | | | Project Start | | | | | | | | | |
|---|---|---|---|---|--|---|---|---|---|---|---|---|---|---|---|
| area drain replacement | Marginal | | semi-annual | 2573 | | | 8,000 | | | | | | | | |

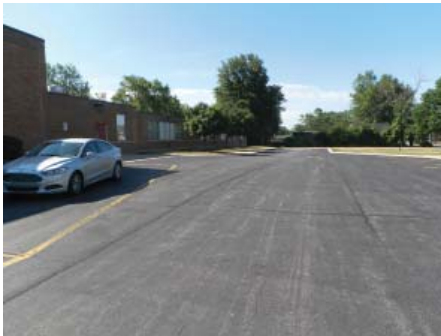
| | | | | | | Project Start | | | | | | | | | |
|---|---|---|---|---|--|---|---|---|---|---|---|---|---|---|---|
| surface, seal coating, crack remediation | Satisfactory | | semi-annual | 2574 | | | 10,000 | | | | 10,000 | | | | |

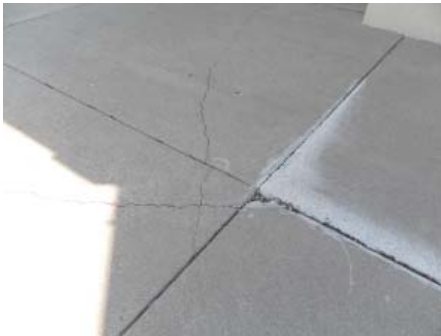
| | | | | | | Project Start | | | | | | | | | |
|---|---|---|---|---|--|---|---|---|---|---|---|---|---|---|---|
| sidewalk replacement | Satisfactory | | semi-annual | 2587 | | | | | | | 26,000 | | | | 21,615 |

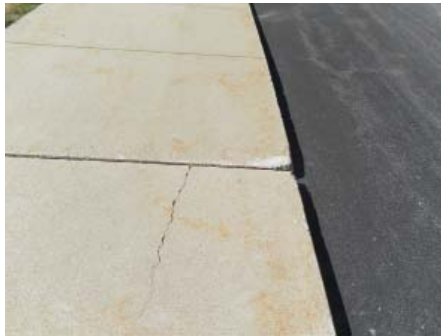
| | | | | | | Project Start | | | | | | | | | |
|---|---|---|---|---|--|---|---|---|---|---|---|---|---|---|---|
| curb replacement | Satisfactory | | semi-annual | 2594 | | | | | | | 3,560 | | | | 5,500 |

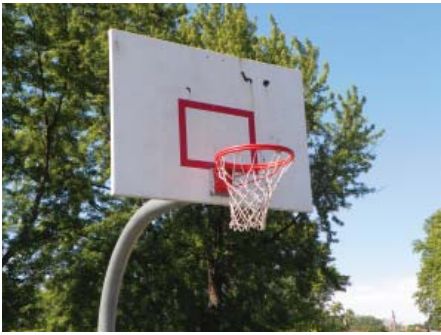
| | | | | | | Project Start | | | | | | | | | |
|---|---|---|---|---|--|---|---|---|---|---|---|---|---|---|---|
| basketball goals replacement | Satisfactory | | annual | 2625 | | | | | | | 4,000 | | | | |

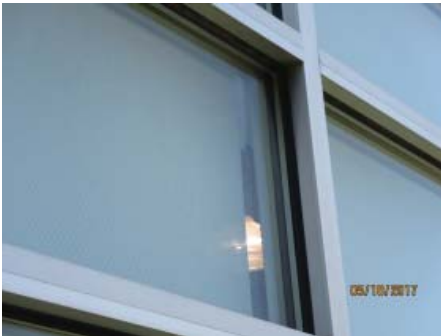
Wadsworth (3)

| | Condition | Low to High<br>Priority Level | Inspection<br>Frequency | Energy<br>Efficiency | Photo No. | Project Start | | | | | | | | | |
|---|---|---|---|---|---|---|---|---|---|---|---|---|---|---|---|
| Item 2-Repair Gasket at Window Unit | | | | | Wadsworth 3 | | \$ 350 | | | | | | | | |

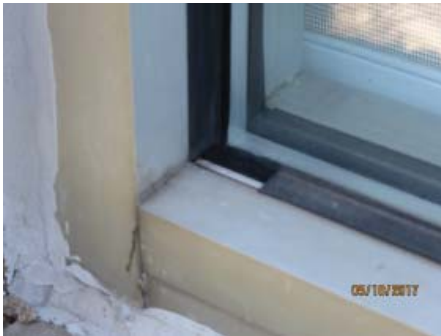
Wadsworth (4)

| Condition | Low to High Priority Level | Inspection Frequency | Energy Efficiency | Photo No. | 2017 | 2018 | 2019 | 2020 | 2021 | 2022 | 2023 | 2024 | 2025 | 2026 |
|---|---|---|---|---|---|---|---|---|---|---|---|---|---|---|
| Item 2-Repair Gasket at Window | | 2/Year | NA | Wadsworth 4 | | \$ 350 | | | | | | | | |

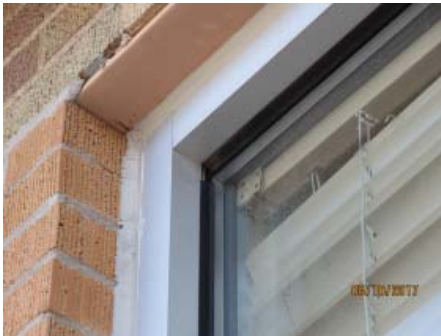
Wadsworth (9)

| | Condition | Low to High<br>Priority Level | Inspection<br>Frequency | Energy<br>Efficiency | Photo No. | Project Start | | | | | | | | | |
|---|---|---|---|---|---|---|---|---|---|---|---|---|---|---|---|
| Item 2-Repair Gasket at Window Unit | | | | | Wadsworth 9 | | \$ 350 | | | | | | | | |

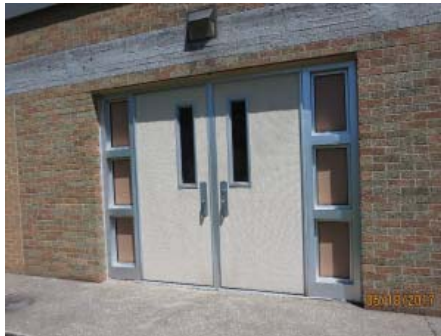
Wadsworth (18)

| | Condition | Low to High<br>Priority Level | Inspection<br>Frequency | Energy<br>Efficiency | Photo No. | Project Start | | | | | | | | | |
|---|---|---|---|---|---|---|---|---|---|---|---|---|---|---|---|
| Item 9-Repair dented Window panel | | | 5/year | | Wadsworth 18 | | | | | | \$ 1,000 | | | | |

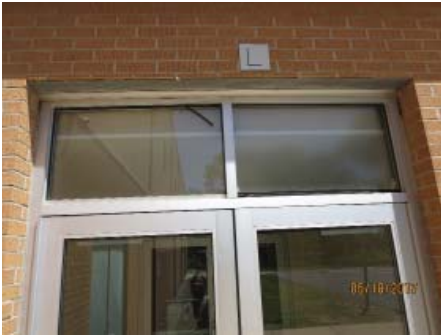
Wadsworth (27)

| | Condition | Low to High<br>Priority Level | Inspection<br>Frequency | Energy<br>Efficiency | Photo No. | Project Start | | | | | | | | | |
|---|---|---|---|---|---|---|---|---|---|---|---|---|---|---|---|
| Item 2-Repair Gasket at Window Unit | | | | | Wadsworth 27 | | \$ 500 | | | | | | | | |

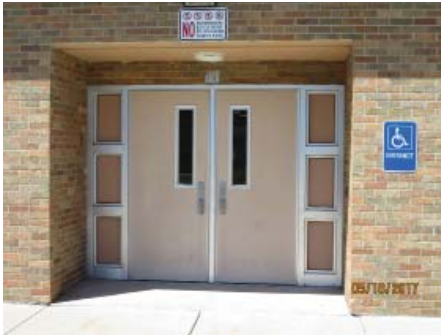
Wadsworth (33)

| Condition | Low to High Priority Level | Inspection Frequency | Energy Efficiency | Photo No. | 2017 | 2018 | 2019 | 2020 | 2021 | 2022 | 2023 | 2024 | 2025 | 2026 |
|---|---|---|---|---|---|---|---|---|---|---|---|---|---|---|
| Item 9-Repair/Replace dented door panel | | 5/Years | NA | Wadsworth 33 | | | | | | \$ 2,000 | | | | |

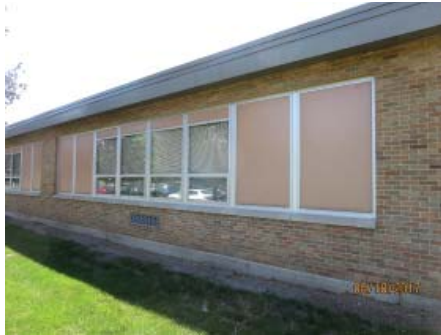
Wadsworth (38)

| Condition | Low to High Priority Level | Inspection Frequency | Energy Efficiency | Photo No. | 2017 | 2018 | 2019 | 2020 | 2021 | 2022 | 2023 | 2024 | 2025 | 2026 |
|---|---|---|---|---|---|---|---|---|---|---|---|---|---|---|
| Item 2-Repair Gasket at Window | | 2/Year | NA | Wadsworth 38 | | \$ 250 | | | | | | | | |

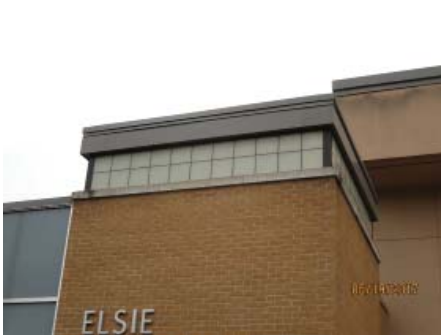
Wadsworth (62)

| Condition | Low to High Priority Level | Inspection Frequency | Energy Efficiency | Photo No. | 2017 | 2018 | 2019 | 2020 | 2021 | 2022 | 2023 | 2024 | 2025 | 2026 |
|---|---|---|---|---|---|---|---|---|---|---|---|---|---|---|
| Item 12-Window Head is leaking | | 2/Year | NA | Wadsworth 62 | | \$ 1,000 | | | | | | | | |

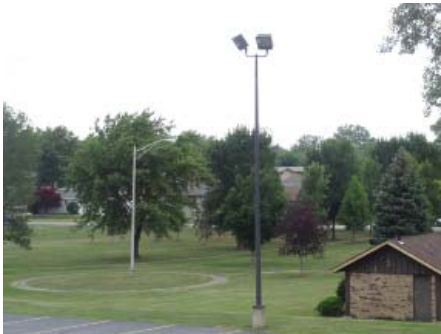
| | | | | | Project Start | | | | | | | | |
|---|---|---|---|---|---|---|---|---|---|---|---|---|---|
| Replace outdoor H.I.D. Light Fixtures with LED (pole) | | | DSC03205 | | | \$10,000 | | | | | | | |

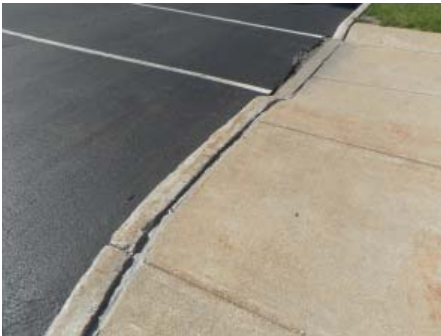
| Condition | Low to High<br>Priority<br>Level | Inspection<br>Frequency | Energy<br>Efficiency | Photo No. | Project Start | | | | | | | | | |
|---|---|---|---|---|---|---|---|---|---|---|---|---|---|---|
| curb replacement | Satisfactory | | semi-annual | 2530 | | \$ 1,500 | | | | \$ 2,500 | | | | |

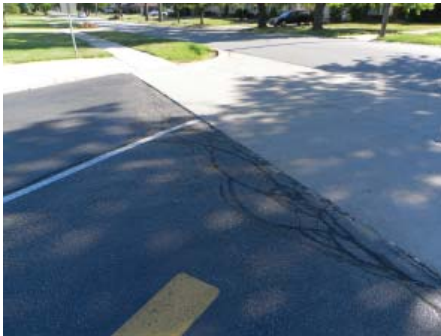
| Condition | Low to High<br>Priority<br>Level | Inspection<br>Frequency | Energy<br>Efficiency | Photo No. | Project Start | | | | | | | | | |
|---|---|---|---|---|---|---|---|---|---|---|---|---|---|---|
| milling and replacement | Satisfactory | | semi-annual | 2532 | | | | | partial | \$ 3,000 | | | complete | \$ 123,000 |

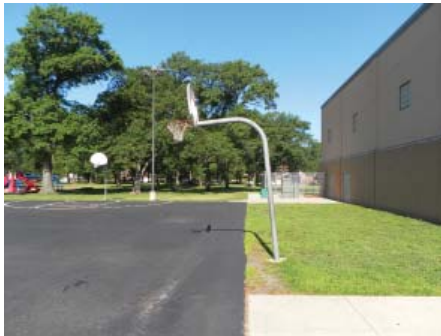
| Condition | Low to High<br>Priority<br>Level | Inspection<br>Frequency | Energy<br>Efficiency | Photo No. | Project Start | | | | | | | | | |
|---|---|---|---|---|---|---|---|---|---|---|---|---|---|---|
| basketball goal replacement | Satisfactory | | annual | 2541 | | | | | | \$ 4,000 | | | | |

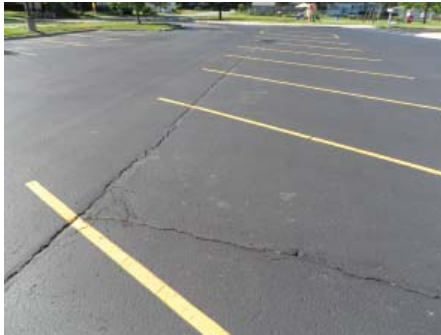
| Condition | Low to High<br>Priority<br>Level | Inspection<br>Frequency | Energy<br>Efficiency | Photo No. | Project Start | | | | | | | | | |
|---|---|---|---|---|---|---|---|---|---|---|---|---|---|---|
| crack remediation | Satisfactory | | semi-annual | 2568 | | \$ 5,000 | | | | | | | | |

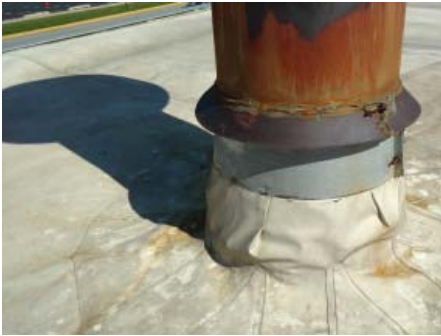
Area 3.jpg

| Replace hi-temp sealant at boiler stacks | | | | | Area 3 | \$ 950 | | | | | | | | |

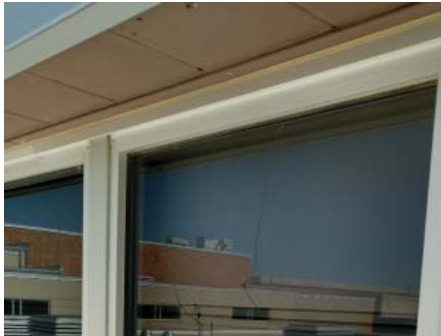
Area 9.jpg

| Broken insulated glazing panel | | | | | Area 9 | | \$ 2,000 | | | | | | | | |

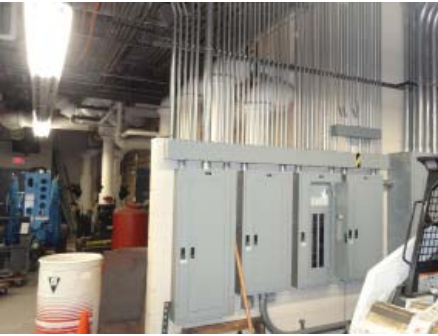
| Replaced 2011 | | | | DSC02634 | | | | | | | | | |

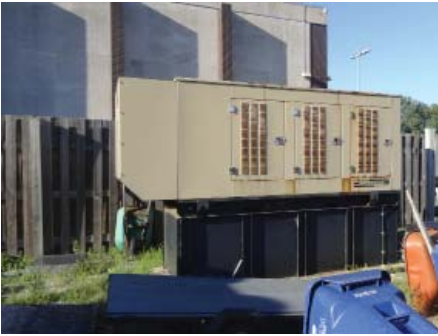
| Generator:    3        (Replace every 20 years, new 2011) | | | monthly | DSC02638 | | | | | | | | | |

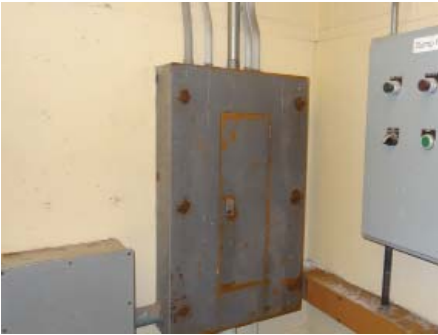
| Panels to be replaced - Approximately 15 panels need | Marginal | | | DSC02721 | \$100,000 | | | | | | | | |
| replaced throughout the building | | | | | | | | | | | | | |

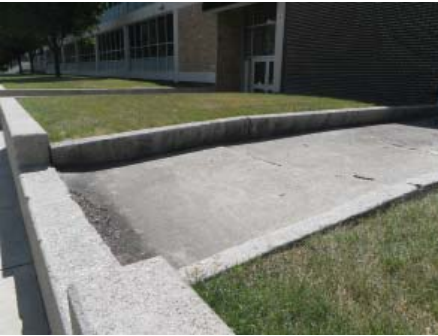
| Condition | Low to High<br>Priority<br>Level | Inspection<br>Frequency | Energy<br>Efficiency | Photo No. | 2017 | 2018 | 2019 | 2020 | 2021 | 2022 | 2023 | 2024 | 2025 | 2026 |
|---|---|---|---|---|---|---|---|---|---|---|---|---|---|---|
| retaining wall repairs/resurfacing | Satisfactory | | yearly | 2659 | | | | | | | | | | \$ 75,000 |

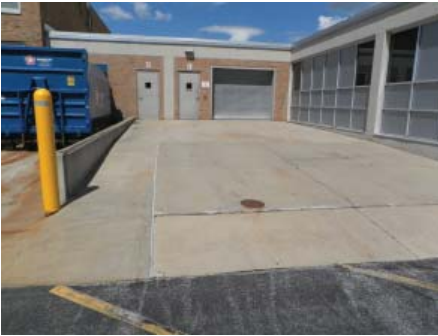
| Condition | Low to High<br>Priority<br>Level | Inspection<br>Frequency | Energy<br>Efficiency | Photo No. | 2017 | 2018 | 2019 | 2020 | 2021 | 2022 | 2023 | 2024 | 2025 | 2026 |
|---|---|---|---|---|---|---|---|---|---|---|---|---|---|---|
| loading dock pavement replacement | | | | 2675 | | | | | | \$ 20,430 | | | | |

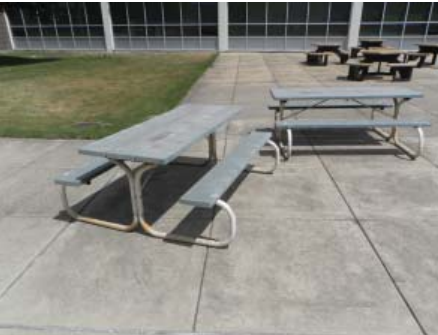
| Condition | Low to High<br>Priority<br>Level | Inspection<br>Frequency | Energy<br>Efficiency | Photo No. | 2017 | 2018 | 2019 | 2020 | 2021 | 2022 | 2023 | 2024 | 2025 | 2026 |
|---|---|---|---|---|---|---|---|---|---|---|---|---|---|---|
| site furnishings replacement | Satisfactory | | yearly | 2687 | | | | | | \$ 20,000 | | | | |

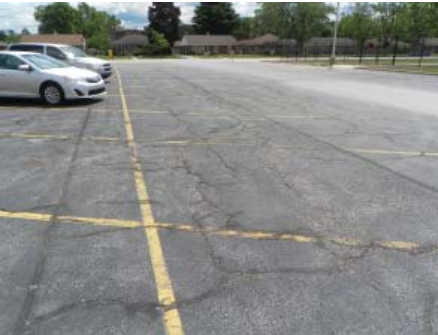
| Condition | Low to High<br>Priority<br>Level | Inspection<br>Frequency | Energy<br>Efficiency | Photo No. | 2017 | 2018 | 2019 | 2020 | 2021 | 2022 | 2023 | 2024 | 2025 | 2026 |
|---|---|---|---|---|---|---|---|---|---|---|---|---|---|---|
| surface, seal coating, crack remediation | Satisfactory | | semi-annual | 2698 | | \$ 11,000 | | | | | | | | |

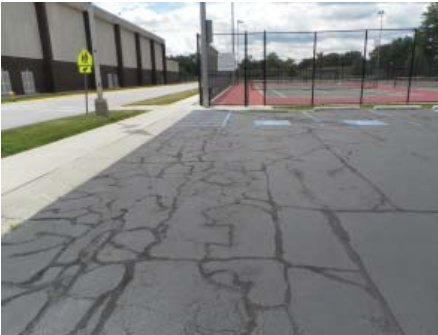
| Condition | Low to High<br>Priority<br>Level | Inspection<br>Frequency | Energy<br>Efficiency | Photo No. | 2017 | 2018 | 2019 | 2020 | 2021 | 2022 | 2023 | 2024 | 2025 | 2026 |
|---|---|---|---|---|---|---|---|---|---|---|---|---|---|---|
| milling and replacement | Satisfactory | | semi annual | 2713 | | | | | | \$ 140,000 | | | | |

| | Condition | Low to High | Inspection | Energy | Photo No. | Project Start | | | | | | | | | |
|---|---|---|---|---|---|---|---|---|---|---|---|---|---|---|---|
| surface, seal coating, crack remediation | Satisfactory | | semi-annual | | 2713 | | 6,000 | | | | 2,500 | | | | |
| milling and replacement | Satisfactory | | semi-annual | | 2713 | | | | | | 133,586 | | | | 75,440 |

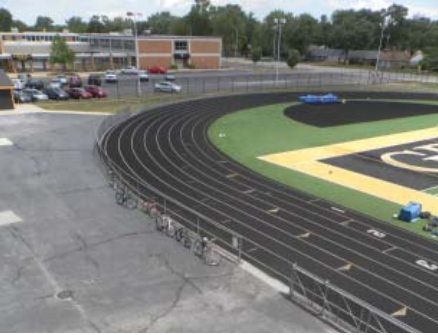
| | Condition | Low to High | Inspection | Energy | Photo No. | Project Start | | | | | | | | | |
|---|---|---|---|---|---|---|---|---|---|---|---|---|---|---|---|
| football field replacement | Satisfactory | | yearly | | 2743 | | | | | | | | | | 400,000 |

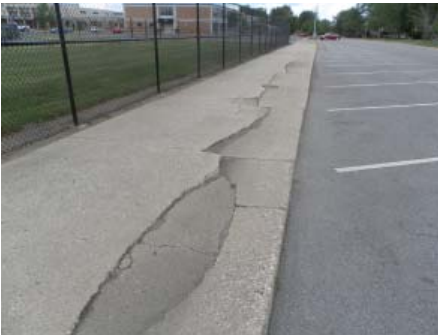
| | Condition | Low to High | Inspection | Energy | Photo No. | Project Start | | | | | | | | | |
|---|---|---|---|---|---|---|---|---|---|---|---|---|---|---|---|
| walk replacement | | | monthly | | 2761 | | 22,322 | | | | 9,378 | | | | 42,265 |

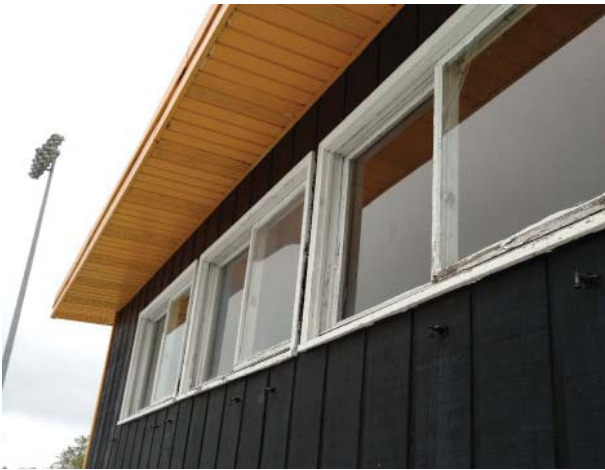
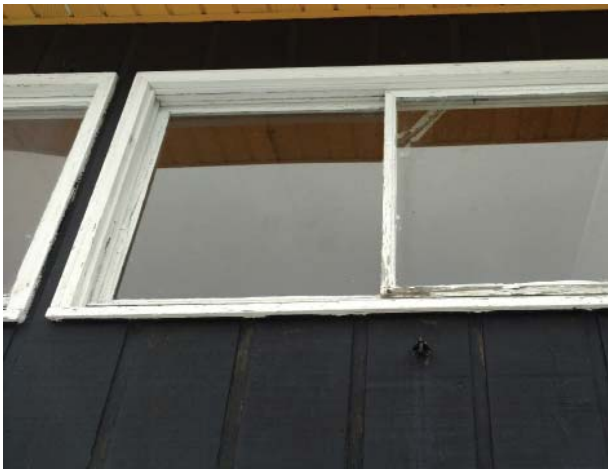
| | | | | | | Project Start | | | | | | | | | |
|---|---|---|---|---|---|---|---|---|---|---|---|---|---|---|--|
| Item 17-Replace w/Vinyl Windows-Insulated Glass | | | | | Guest Press 2 , 3 | \$ 9,200 | | | | | | | | | |

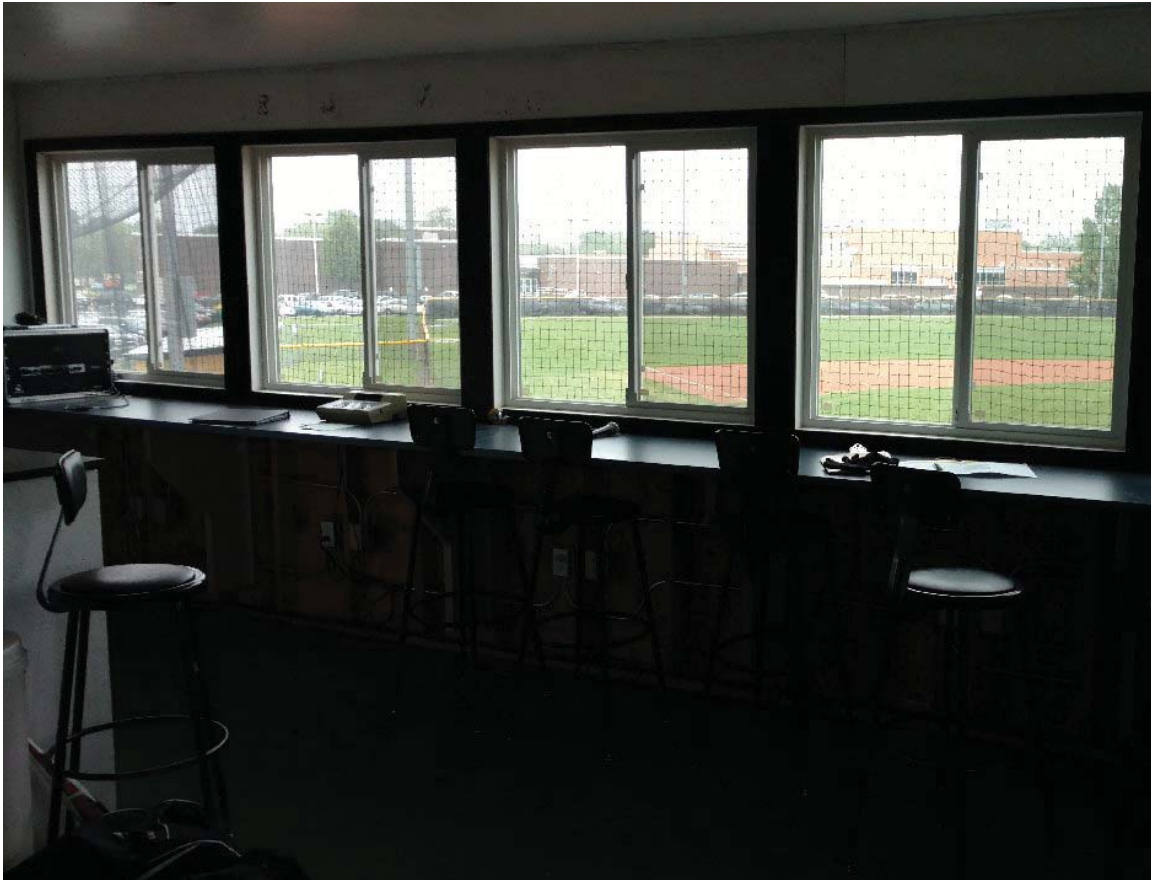
Baseball 1

**BASEBALL/SOFTBALL PRESS BOXES - WINDOW**
