FACILITIES MASTER PLAN 2012

Twin Hills School District
SEBASTOPOL, CALIFORNIA

persinger architects
and associates

TWIN HILLS UNION SCHOOL DISTRICT

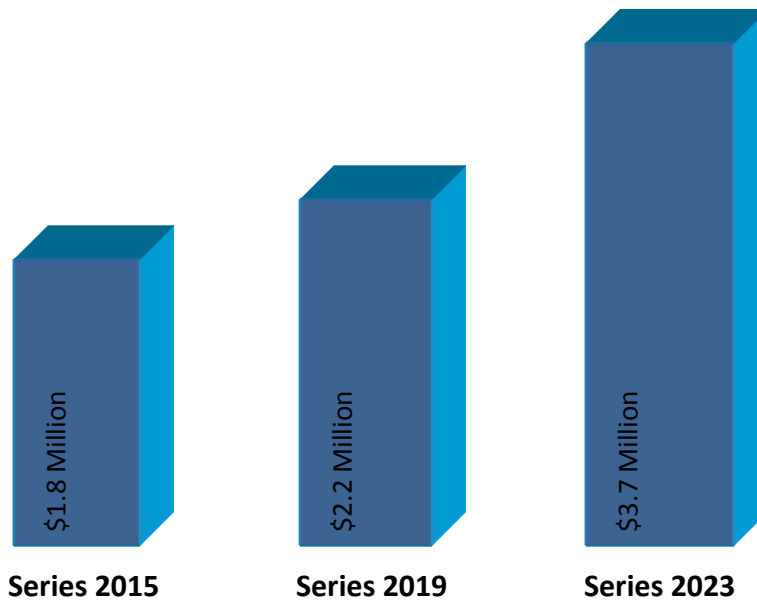
G.O. Bond Proceeds (from the report prepared by Caldwell Flores Winters, Inc.)

It is of import to the Master Plan to establish a schedule of projected funding. This funding would happen in part to a General Obligation (GO) Bond as a result of Prop 39. Additional funding would also become available as a result of projected growth and thus projected eligibility. The following two schedules mimic how this funding would offset project costs.

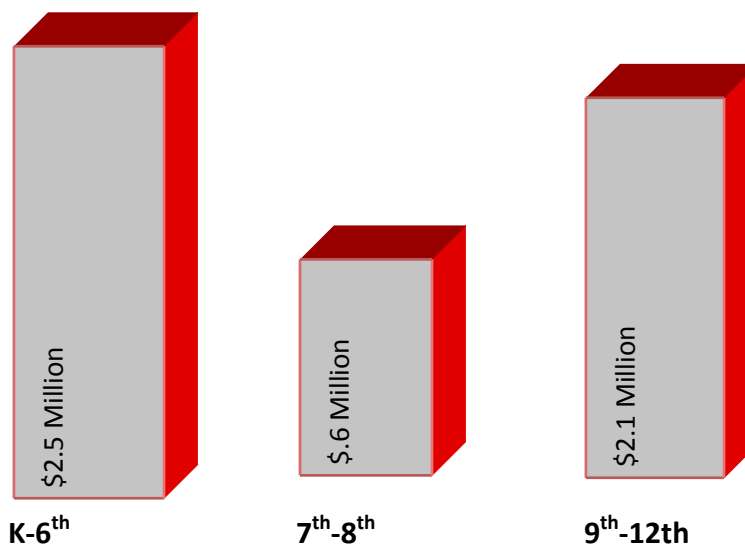
Projected Eligibility Dollars (by grade)

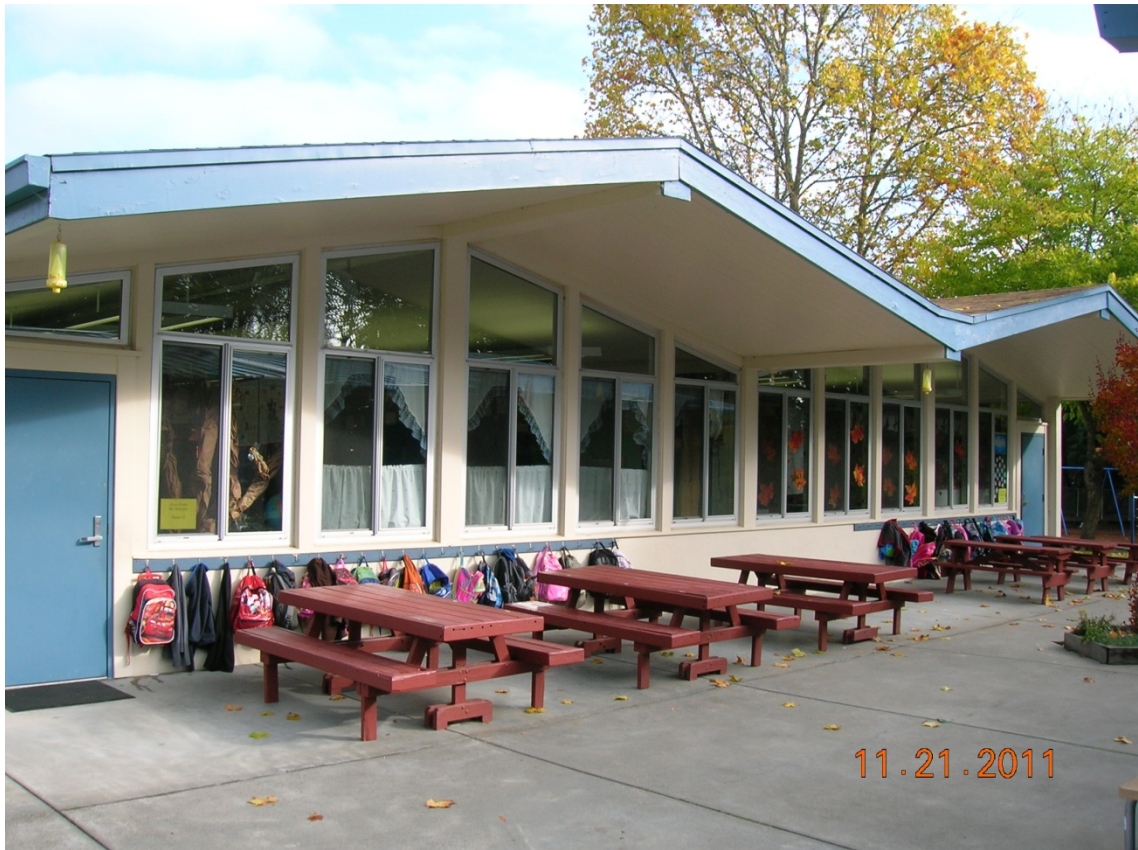
SK-3

The north and south walls of buildings A and B are void of solid wall panels as shown in SK-2 and SK-3. The absence of shear walls on the two ends of these buildings makes the structures susceptible to excessive lateral drift/deflection at these two wall lines during an earthquake. Excessive cyclic drift/deflection under lateral earthquake loads could break the window glazing leading to a potential life safety hazard.

Bldg. B - South Wall (Bldg. A similar)

It is therefore recommended that the window openings at the low ends of the saw-tooth roof be infilled with plywood panels and retrofitted with holdown devices into the foundation as required to meet current Code requirements. A more expensive option, which would allow the windows to remain, is to install a steel "moment" frame within the wall line or behind the windows.

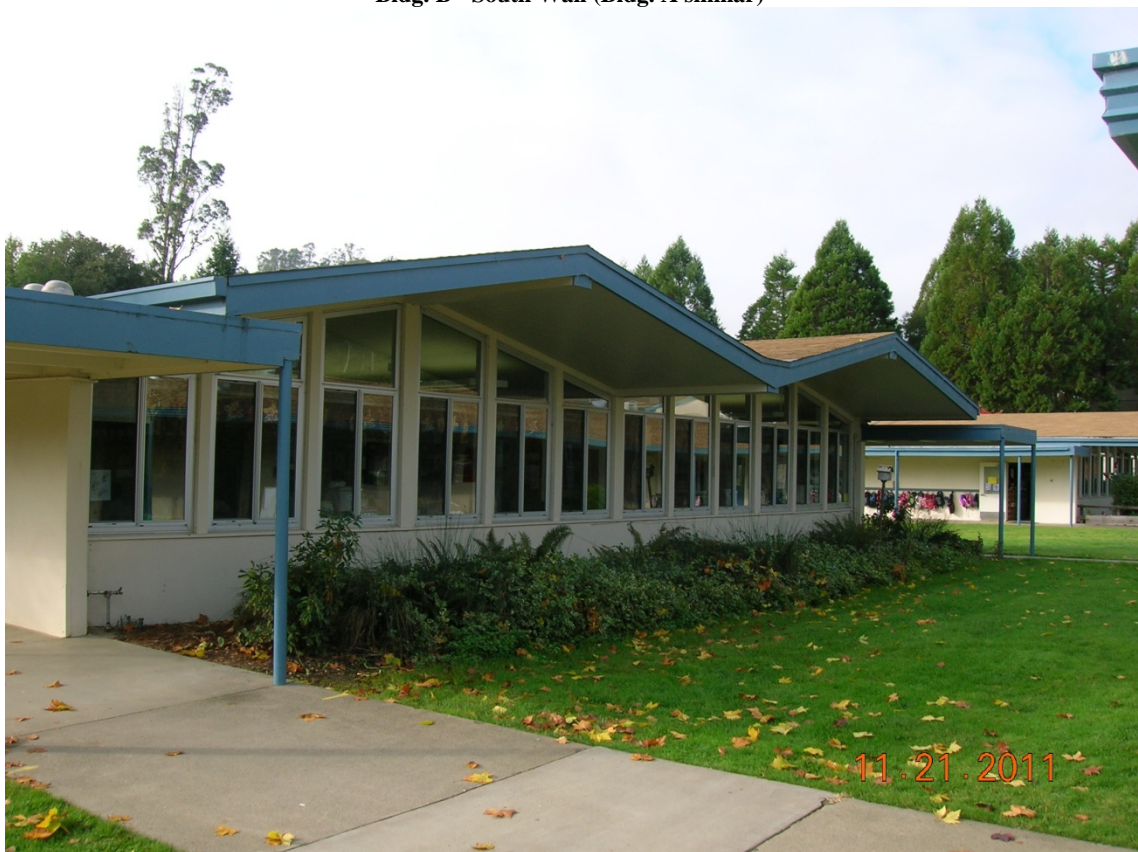
SK-4

Bldg. B - North Wall (Bldg. A similar)

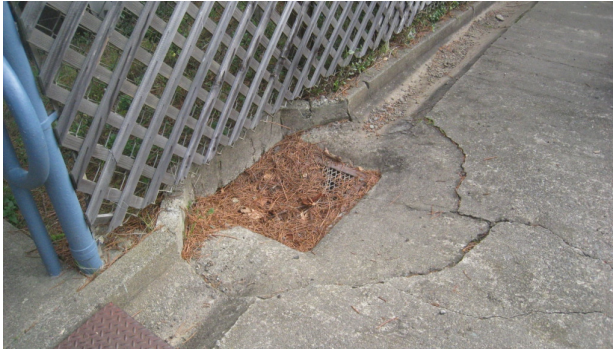
Photo 1

Due to the locations of numerous large trees with respect to the existing drainage structures, many of concrete valley gutters and drain inlets have cracked or heaved to elevations that cause localized ponding and disruptions in surface flow as shown in **Photos 1** and **3** of the Appendix.

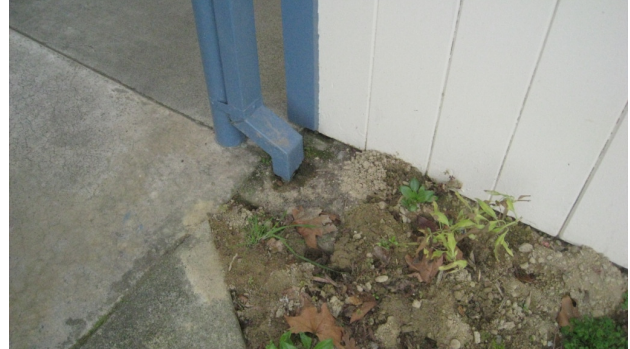
Photo 2

Several of the downspouts on the original buildings were observed to have been disconnected from the main storm drain system as shown in **Photo 2** of the Appendix. Many of the downspouts on more recent building additions discharge directly against the building foundations. In some cases runoff from downspouts and adjacent walkways flows directly below the buildings as shown in **Photos 5** and **6** of the Appendix because of poor site grading immediately adjacent to the buildings.

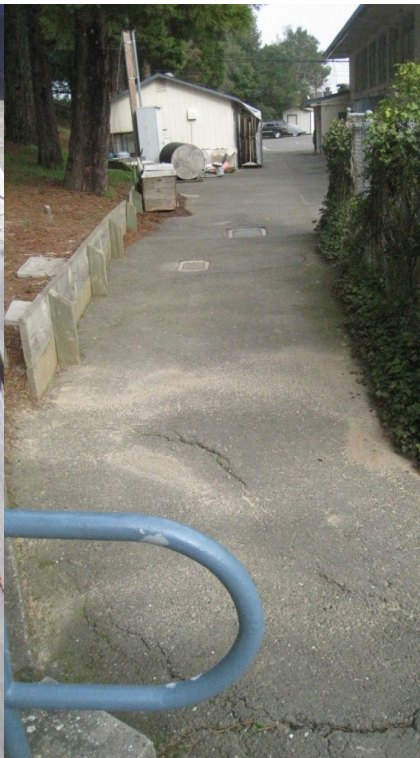
Photo 4

The majority of the concrete surrounding the original buildings is original and was most likely constructed prior to the development of ADA code and is currently installed with slopes that exceed current accessible code. Additionally, due to the locations of numerous large trees with respect to the existing walkways, several sections of concrete slab has cracked or heaved to elevations that cause tripping hazards. In some areas, tree roots have also adjusted the adjacent asphalt surface causing additional tripping hazards. Concrete heaving and other tripping hazards caused by tree roots are shown in **Photos 4, 7, 8, 9** and **10** of the Appendix.

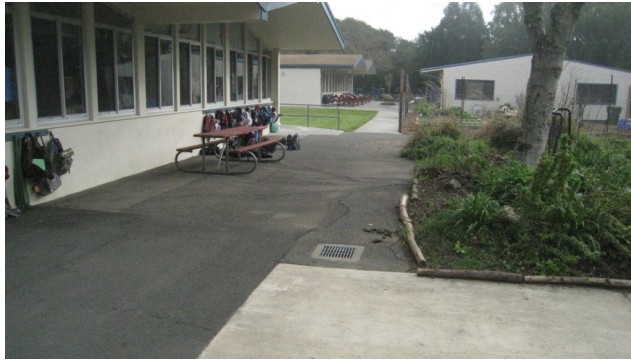
Photo 8

Site storm drain inlets shown in **Photo 8** and as identified in **Exhibit 1** located within pedestrian walkways were not equipped with ADA compliant inlets.

*Drain inlets as identified in **Exhibit 2** to have non ADA compliant grates should be removed and replaced as funds become available.*

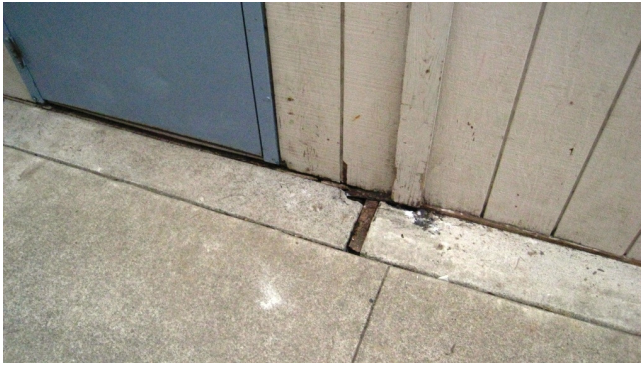
Photo 1

flows directly adjacent to or below the buildings as shown in **Photos 1** and **2** of the Appendix because of poor site grading immediately adjacent to the buildings. In some instances wood rot and mold were observed at the base of several modular buildings as shown in **Photos 3** and **4**. In other cases, site drainage is causing undermining of adjacent concrete flatwork as shown in **Photo 3**. Poor site drainage was also observed around both sheds north of the original classroom building as shown in **Photos 5** and **6** of the Appendix.

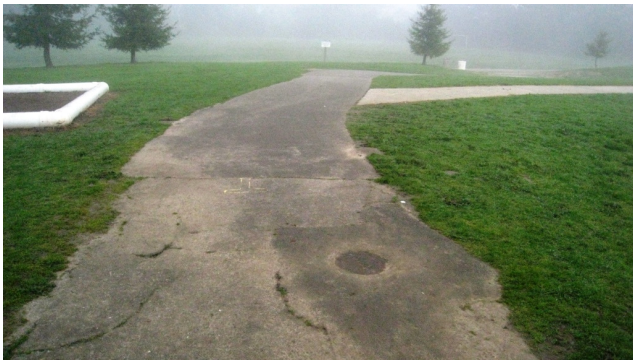
Photo 7

The majority of the original concrete surrounding the original building is original and was constructed with slopes that exceed current accessible code as shown in **Photos 9** through **12** of the Appendix. Additionally, due to the locations of numerous large trees with respect to the existing walkways, several sections of asphalt have cracked or heaved to elevations that cause tripping hazards. Asphalt heaving and other tripping hazards caused by tree roots are shown in **Photo 7** and **8** of the Appendix.

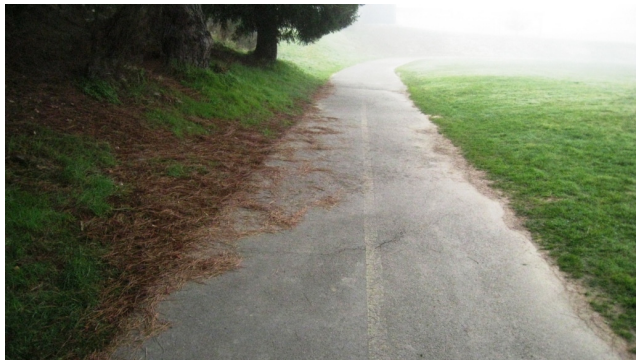
Photo 8

The asphalt within the lower track surface are showing signs of age including alligator cracking and spalling as shown in **Photo 8** of the Appendix.

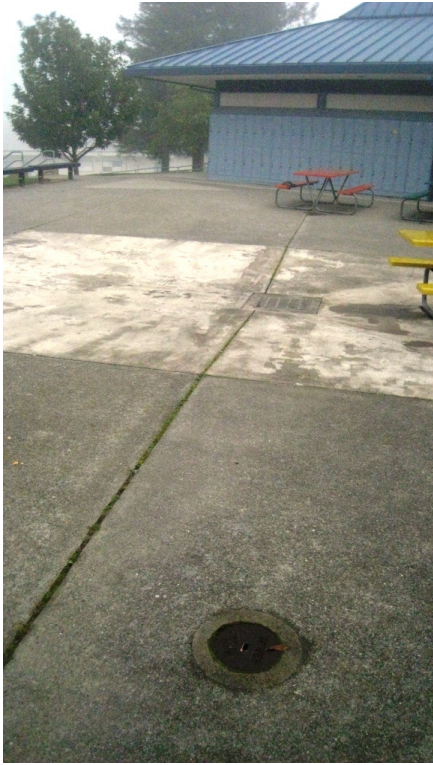
Photo 9

Overall, site accessibility with respect to ADA code was good, however some areas of the indicated path of travel exceeded allowable slopes per ADA code resulting in several of the buildings being inaccessible to persons with disabilities as defined by the current ADA code. Areas identified to have slopes in excess of those defined by ADA code are shown in **Photos 9** through **12** and **14** of the Appendix and identified in **Exhibit 1**.

Site storm drain inlets shown in **Photo 9** and **13** and as identified in **Exhibits 1** and **2** located within pedestrian walkways were not equipped with ADA compliant inlets.

*Drain inlets as identified in **Exhibits 1** and **2** to have non ADA compliant grates should be removed and replaced as funds become available.*

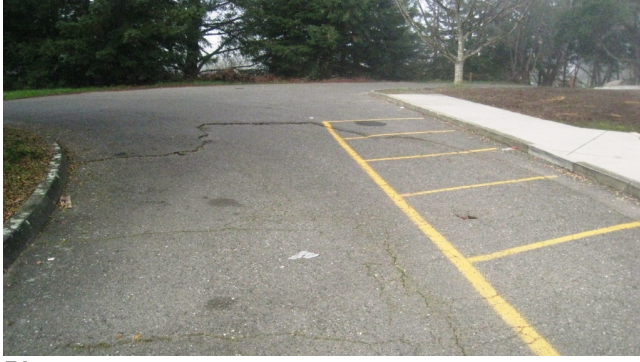
Photo 15

The asphalt within the drop-off area and lower parking lot are showing signs of their age including alligator cracking and spalling as shown in **Photos 15** and **16** of the Appendix.

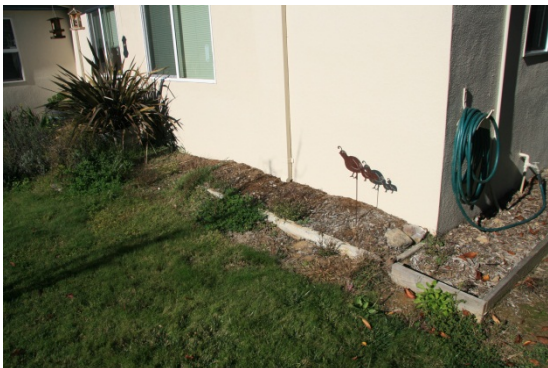
Remove soil around buildings

In many cases soil and/or mulch is mounded up against buildings. All soil and mulch should be graded to allow for a minimum 6" gap between all wooden construction elements even when covered in stucco.

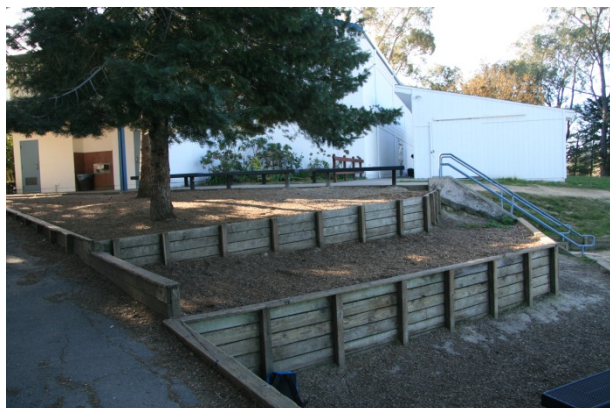
There are landscape areas throughout the school campus which are not currently planted and have no planning in place. They include foundation planting areas around buildings and several wooden terraces on the north side of the gymnasium. Ultimately it would be a campus improvement to plant these areas building on the theme of low maintenance, drought tolerant, long lived and functional plant palette.

Terrace planters needing planting

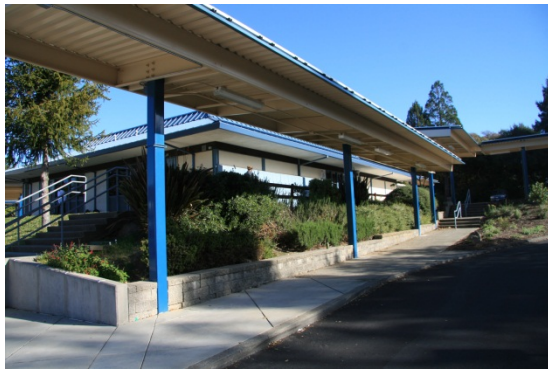
The sloped planter on the north side of the lower parking lot (under newly installed P.V. array) is densely planted with several woody and heavily hedged species. Rosemary along the lower retaining wall and New Zealand Flax (Phormium) at the western stairway have required aggressive hedging to keep the path clear.

Most species prefer full sun but are now shaded by the PV array at this location. This planter is irrigated with water intensive sprinklers though likely requires little watering because of drought tolerance and maturity. We recommend renovating this planter to carry the same native based, low maintenance, functional plant palette that is planned for the surrounding frontage and parking landscape areas and that the irrigation emission be upgraded to drip for long term water efficiency.

Suggested landscape renovation

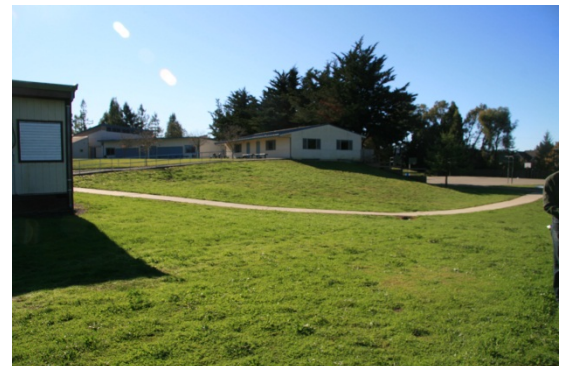
Slope for rainwater harvesting and terraced gardens

The sloped area between current campus infrastructure and sports fields is well suited for capturing site drainage and downspouts and infiltrating and filtering storm-water in rain gardens and bio-swales. Rain harvesting topography can be an elegant design feature and can tie in functionally to terraced gardens reducing the watering requirements. We can envision an overall design for the area which includes rainwater harvesting, garden terraces and a transition to terraced seat walls that serve as bleacher seating for the sports fields.

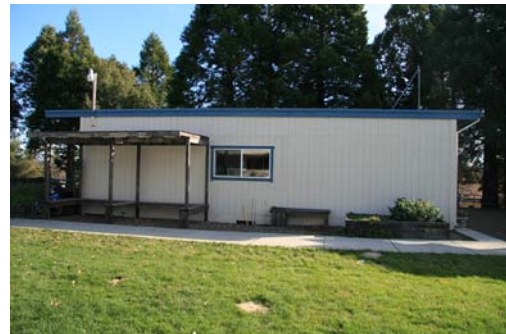
Passive climate control with shade trees and foundation shrubs would reduce the heat gain of currently exposed west and south facing glazing and walls. Of note are the structure in the northeast corner of the upper campus and the large expanse of south facing walls on the north side of the sports field. Shade trees would provide comfortable spectator seating.

Passive Climate Control for West Facing Glazing

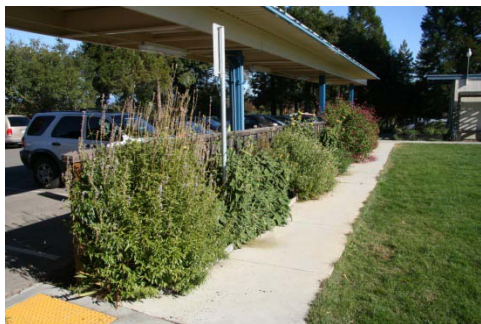
Entry Insectory Planter

The entry insectory planter is a focal point and a buffer planting. Though beautiful in its present form, it will require ongoing pruning and or some fastening to the fence in order to keep the path clear. Alternatively the pathway at the north end of the courtyard could be widened to better accommodate the mature form of the existing planting or some of the larger species could be transplanted to another campus location.

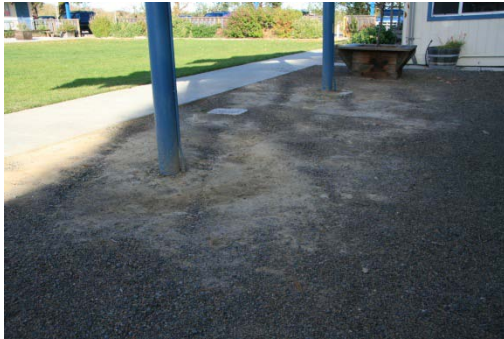
Gravel mulch, at the PV array installations and the connection between the grass courtyard and the sports fields needs to be amended by 2-3" or more, especially in areas of poor drainage. Some downspouts could be re-directed to improve drainage.

Areas needing amended mulch

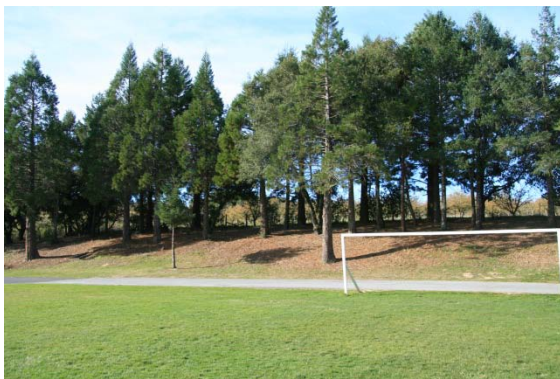
Possible location for Obstacle/ Ropes Course

Large conifers shade the west slope of the campus above the upper driveway. This area potentially provides an ideal setting for an obstacle/ ropes course including slack lines and other personal and team challenges and is well located with its adjacency to the sports fields.

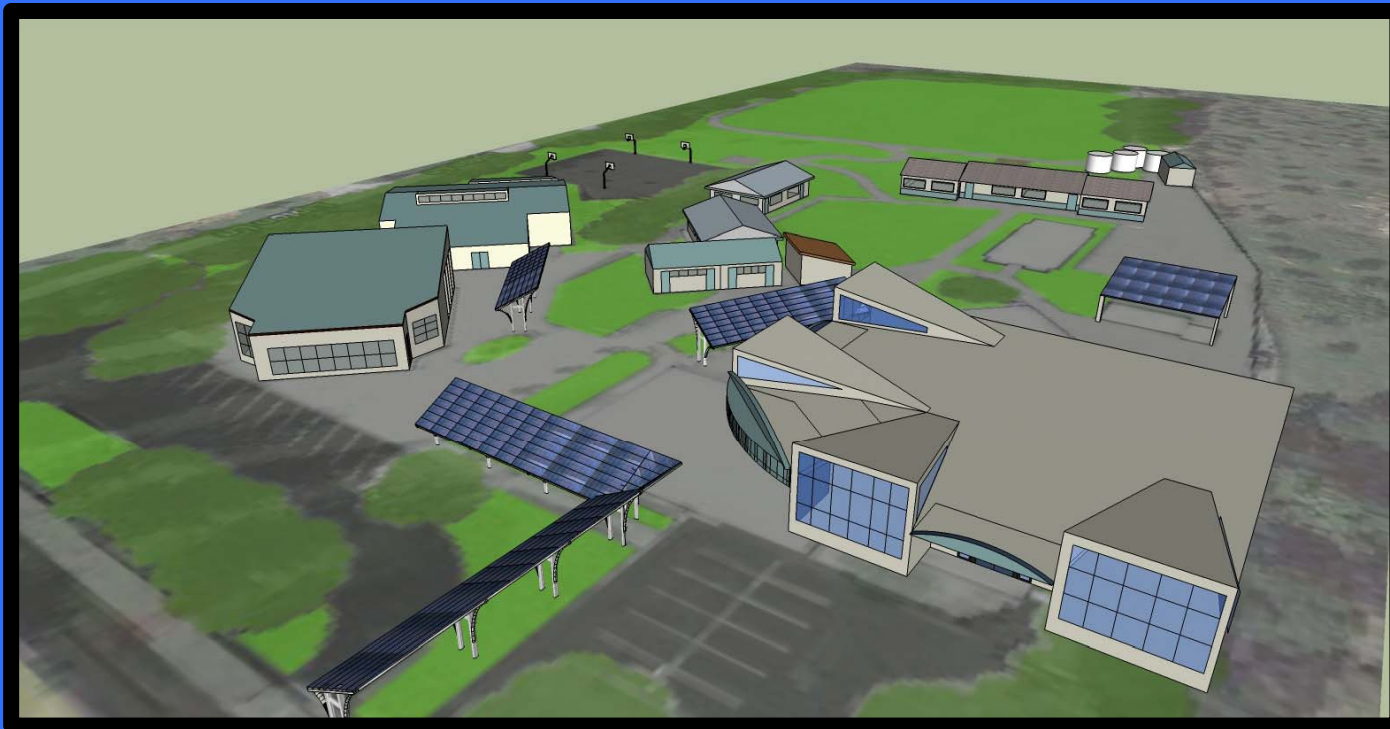
Twin Hills Middle School

Site Development

The following exhibits demonstrate in simple fashion what buildings would be demolished and replaced and what buildings would fall into modernization. Site modifications have not been shown on these exhibits.

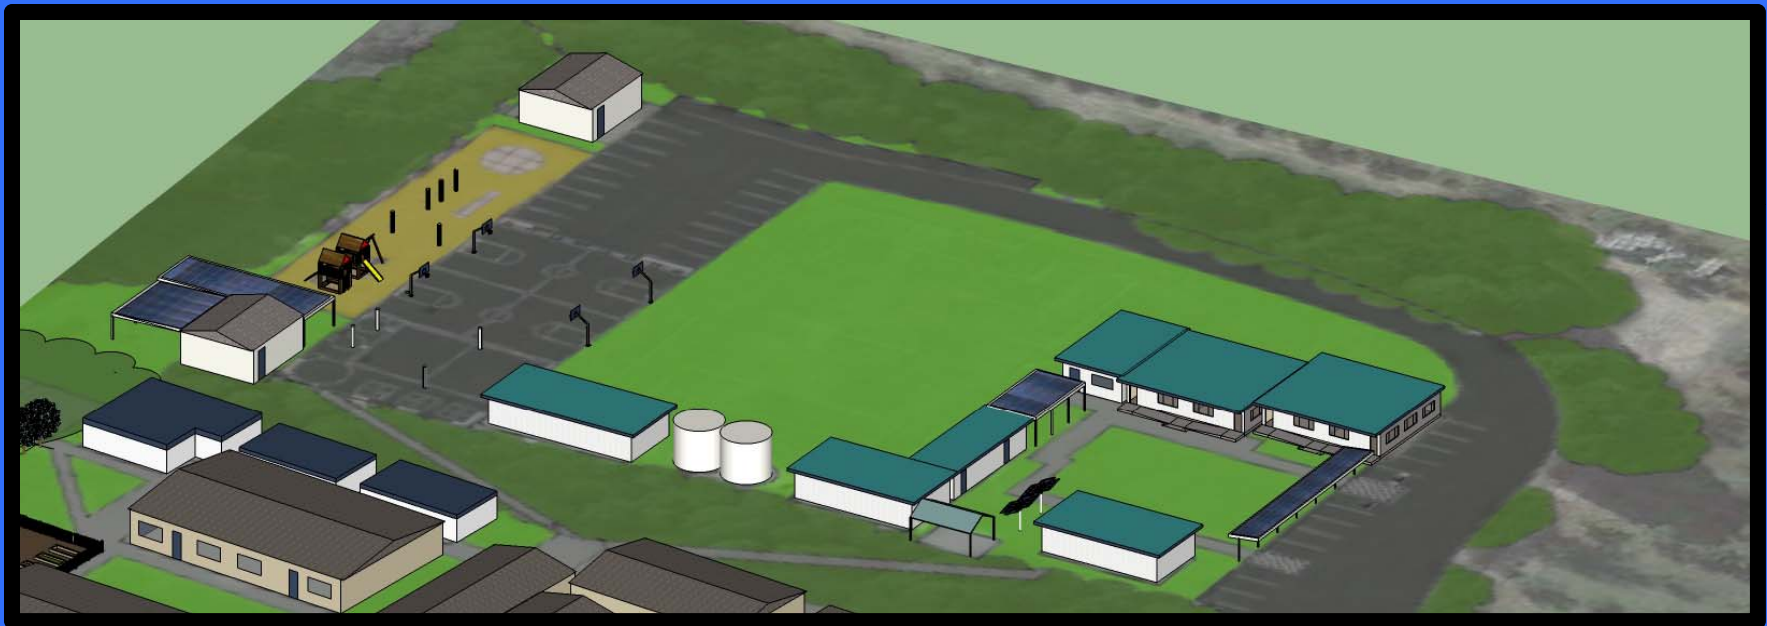
Orchard View

Site Development

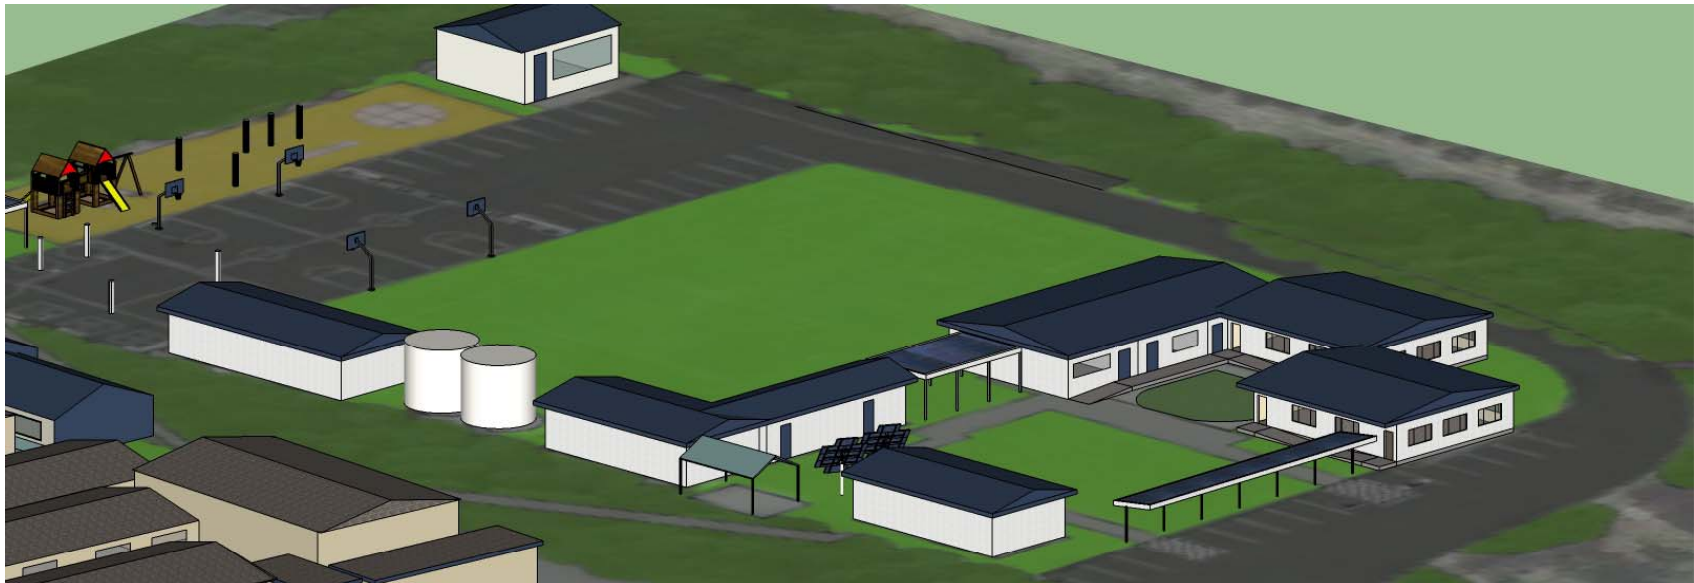
Orchard View

Site Development
