Re: Firgrove Elementary School – NGPA Wetland Verification Report
The Watershed Company Reference Number: 160932

Wetland Conditions Review

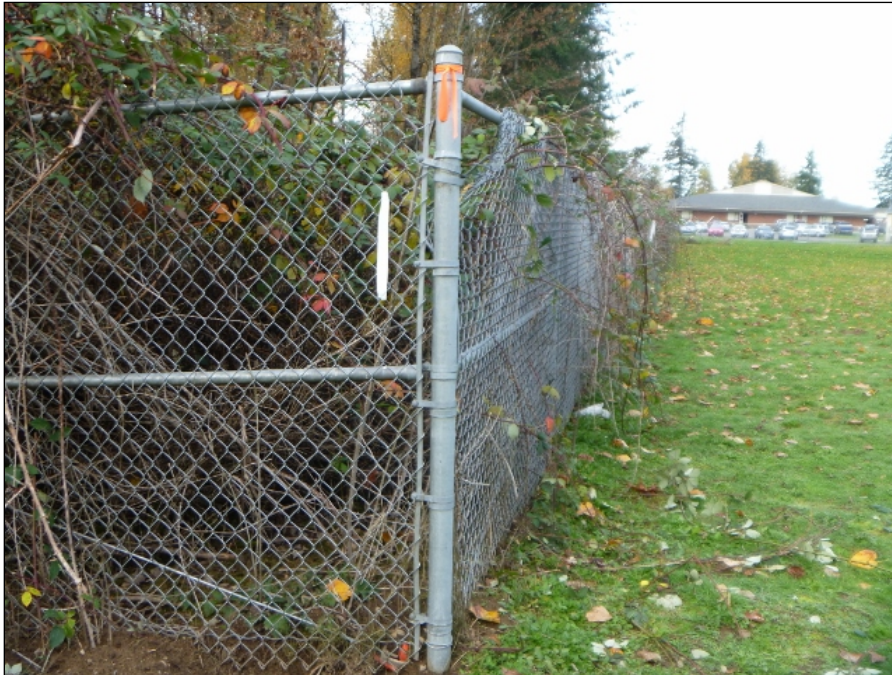
Photo 1. Six-foot tall chain link fence around the NGPA.

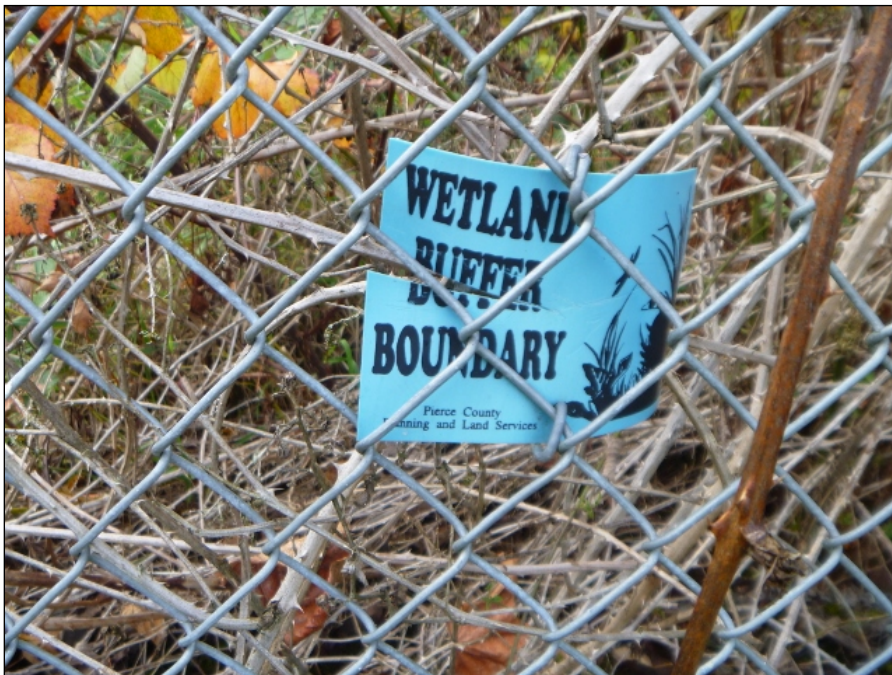
Photo 2. Posted 'Wetland Buffer Boundary' signs.

The NGPA is intact and meeting the wetland conditions stated in the Notice of Title. However, repair or replacement of some fencing and signage is recommended to fully comply with the intent of the NGPA. Bent or broken segments of the chain link fence should be repaired. New critical area signs should be posted at a 50-foot spacing.

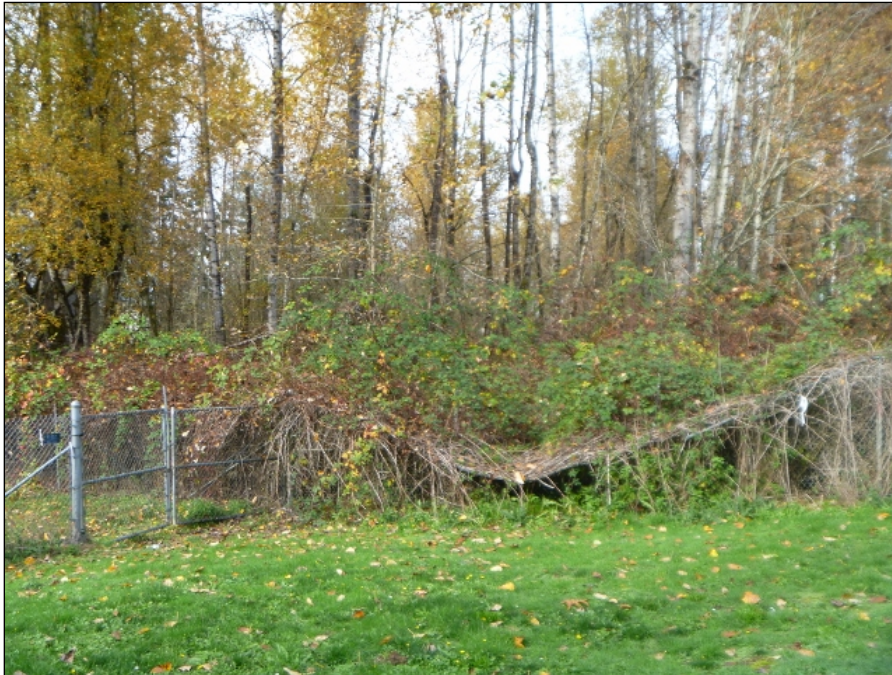
Response: A six-foot tall chain link fence with small critical area signs surrounds the onsite perimeter of the NGPA (see photos 1 and 2). The chain link fence is damaged or falling in a few locations (see photo 3) and should be repaired. No evidence of intrusion into the NGPA was observed. The NGPA is intact. However, critical area signs are small and cracked; posting current replacement critical area signs on a 50-foot spacing is recommended.

Photo 3. NGPA Fence damaged or failing in a few locations.

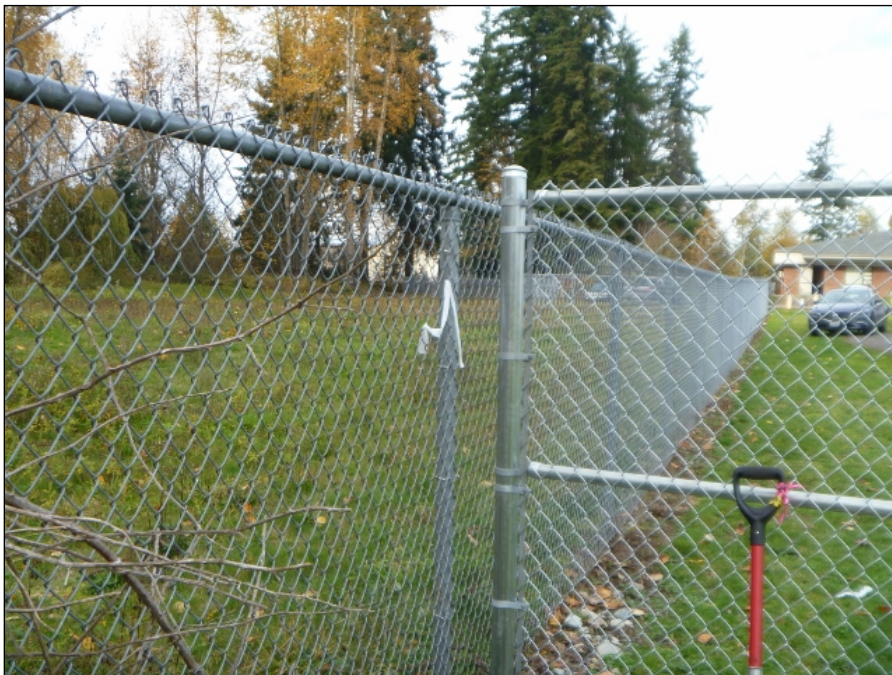
Photo 4. Fencing was placed further east than required to mark the NGPA.
