# INSPECTION REPORT

For the Property at:  
**615 NORTH 25TH ST**  
GRAND FORKS, ND 58203

RE: Report No. 6909  
615 North 25th St  
Grand Forks, ND  
58203

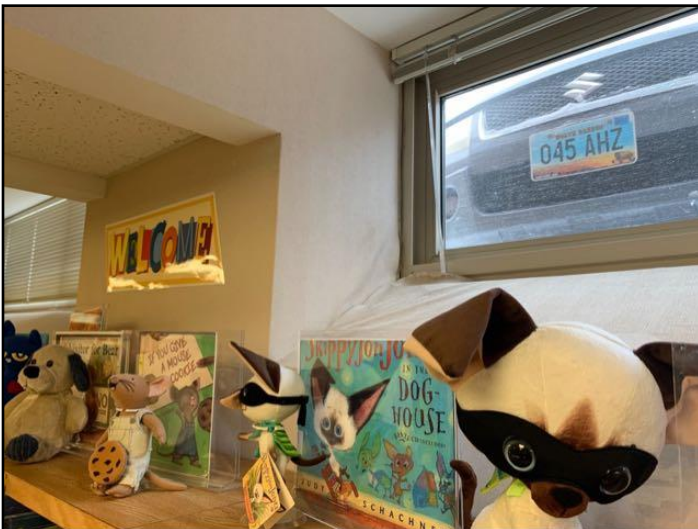
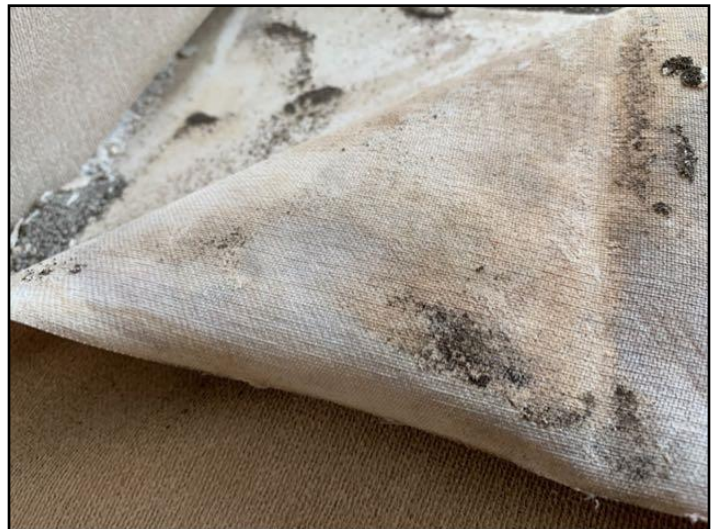
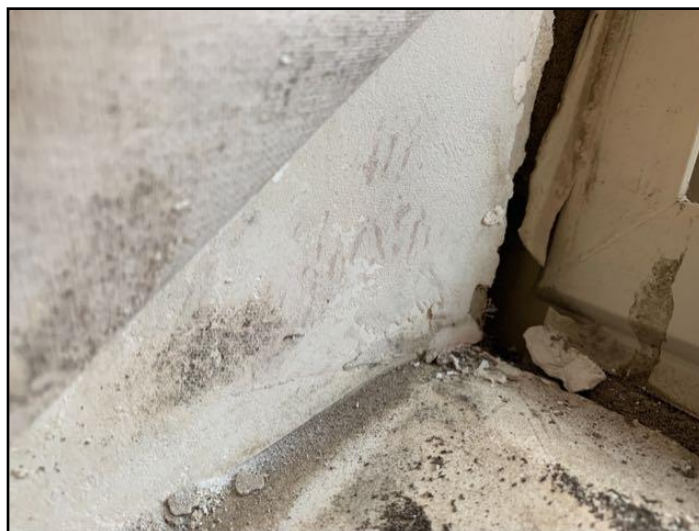
**Location:** West Wall Library

**Condition:** • Suspected fungal growth observed

**Condition:** • Containment shall be established near the impacted area on the exterior wall

**Condition:** • All content shall be removed from the exterior wall near the impacted area

**Condition:** • Wall paper and other building material impacted by fungal growth shall be removed.

**Condition:** • Any mold-damaged non-porous surfaces in the wall cavity shall be cleaned by HEPA vacuuming followed by damp wiping.

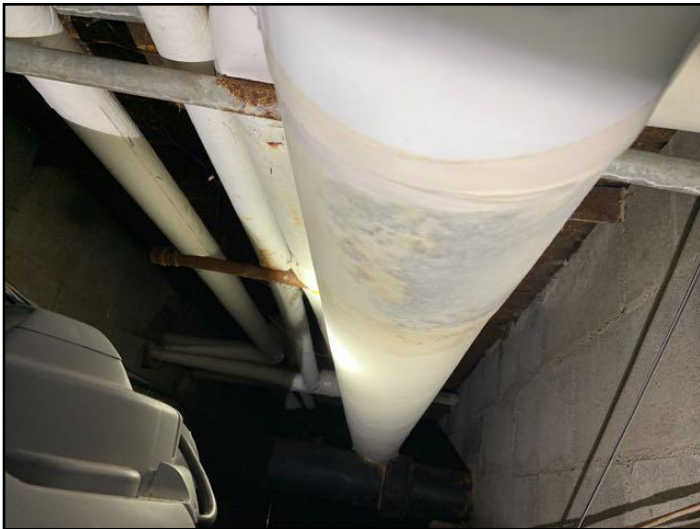
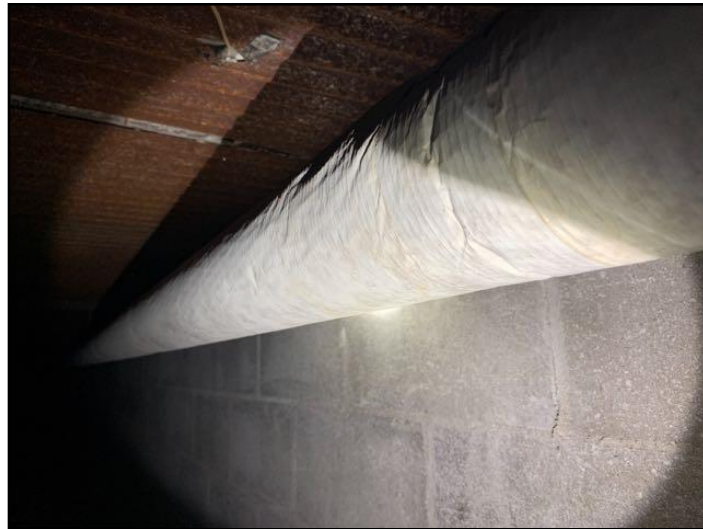
**Location:** Tunnel Near Classroom 2

**Condition:** • Suspected fungal growth observed

**Condition:** • Containment shall be established around tunnel access doors.

**Condition:** • Contractor shall remove pipe insulation impacted by or suspected to be impacted by fungal growth.

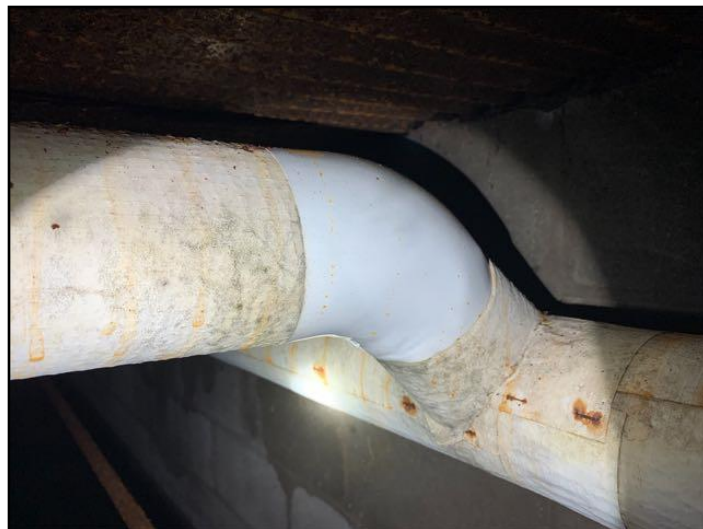
**Location:** Tunnel Near Classroom 8

**Condition:** • Suspected fungal growth observed

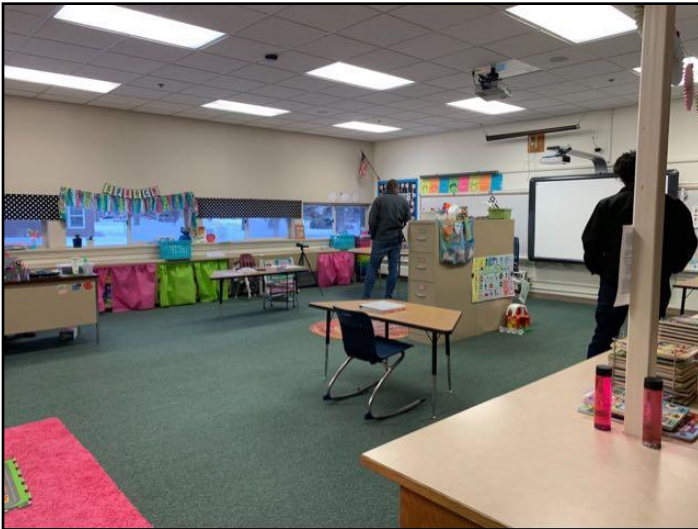
Classroom 10

Collecting total spore air samples
