GREENWICH BOARD OF EDUCATION  
GREENWICH PUBLIC SCHOOLS  
Greenwich, CT

**Agenda Item Title:** Old Greenwich School Education Specifications

Old Greenwich Elementary School Feasibility Study

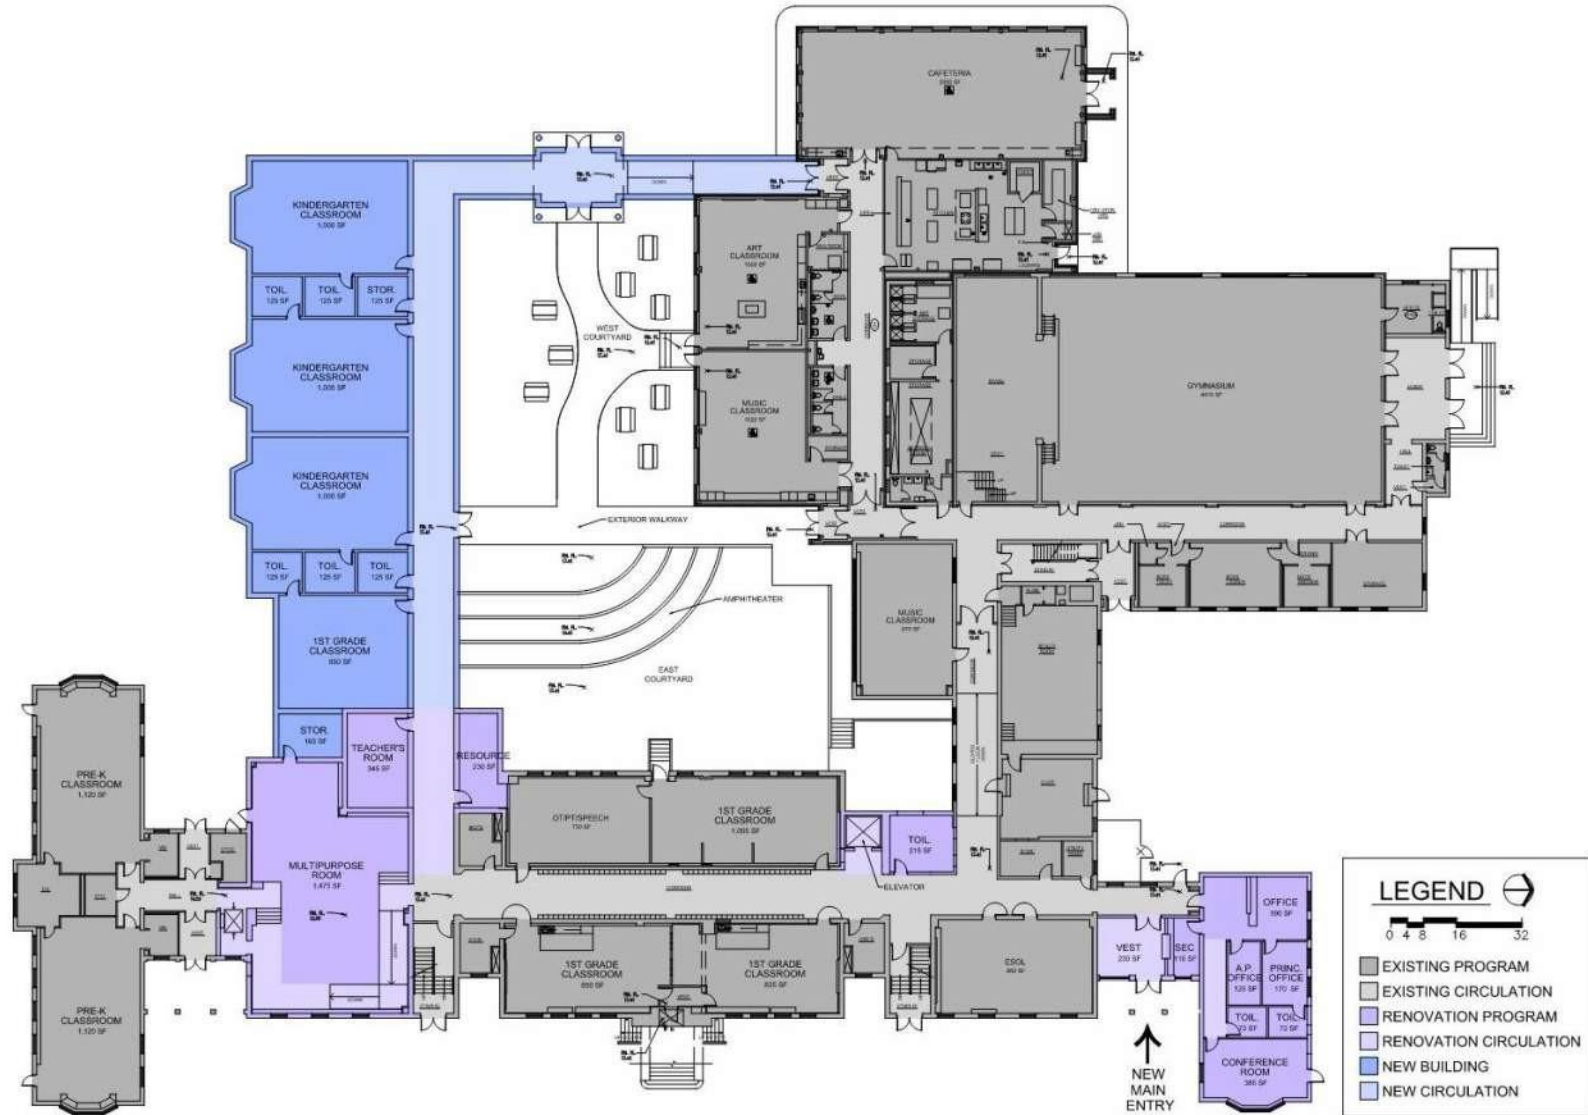
**OPTION A**  
AERIAL VIEW

EAST INTERIOR  
COURTYARD : OUTDOOR  
CLASSROOM / ASSEMBLY  
SPACE

WEST INTERIOR  
COURTYARD : DINING

RELOCATED AGE  
GROUP PLAY AREAS
