Darlington High sits on a 71 acre site near downtown Darlington that also houses the 9th grade academy, which sits at the corner of Spring and Blue Streets, and the Darlington County Administration Building. The site is bound by North Main Street in the back and Spring Street in the front of the campus.

# Darlington High School

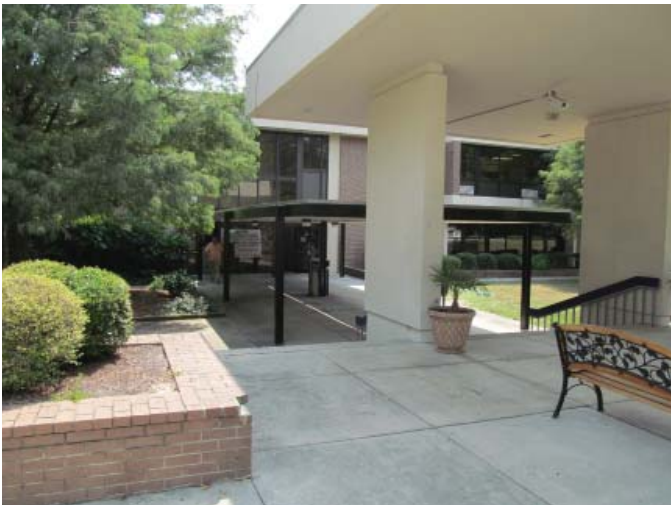
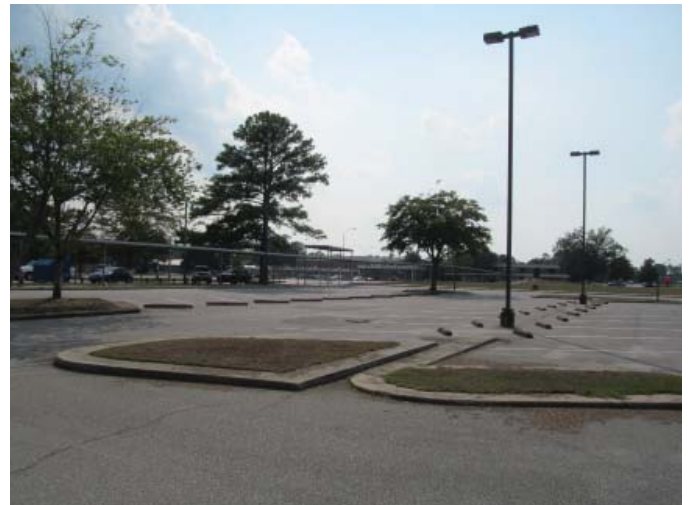
- Drainage goes towards the building causing moisture issues on brick and needs to be monitored/addressed
- ADA access to building entrances lacking
- Covered walk needed for access from band building and 9th Grade building to main campus building

The high school would benefit with relocating the 9th Grade Academy closer to the rest of the campus with the addition of a new academic wing. This would resolve some security issues and a separate entrance can still be maintained if desired. An additional connecting corridor to the cafeteria, gym, and administration area improves security and protects students and staff from the elements. A dedicated PE gym and a competition gym with lobby space would bring equity to the Darlington area to align with the basketball facility at Hartsville High School. These can tie into the new locker rooms being completed. Minor renovations such as replacement of non-compliant handrails and guardrails would occur and the ADA toilet situations would be addresses throughout the school as well as upgrades to finishes in some of the existing spaces.

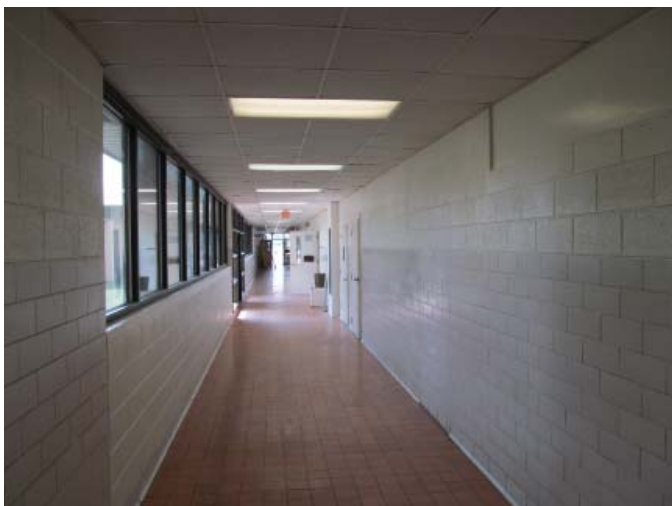
- Some hardware and ADA issues at exterior doors
- In need of energy efficient windows

- Some interior doors not rated
