Principal	Corey Lewis
Grades	9-12
Staff	106
Current Enrollment	1,196
Site Size	26.60 Acres
Square Footage	224,140
Year Constructed	1962, 1964, 1967, 1970, 1972, 1973, 1975, 1993, 2011
Renovations	2011

## Hartsville High School

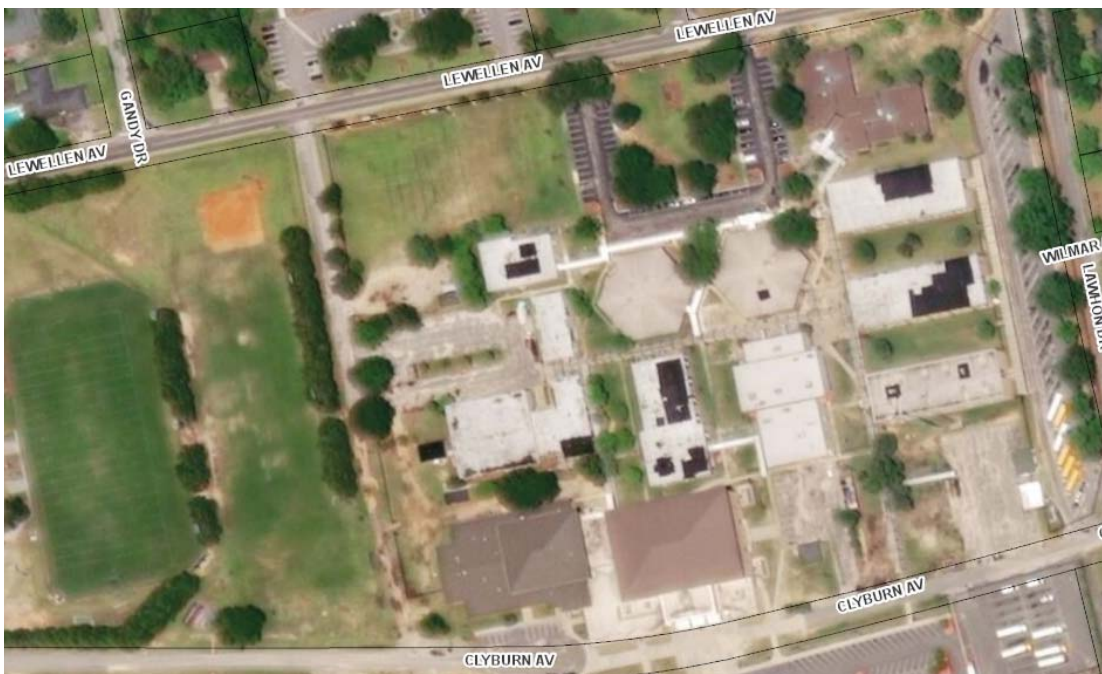
Hartsville High School sits on a 27 acre site which is relatively flat. Access to the site occurs from Lewelleyn Avenue at the front and Washington Street at the rear. Storm water drainage is poor. The campus layout, typical of the designs associated with high schools built from the mid 1960's through the late 1970's, is based on a college campus design with multiple buildings connected by an array of covered walks and sidewalks. Campus buildings have been added as needs from 1964 through 2011. Renovations have periodically occurred based on need and not through a planned process such as a master plan.

Access to the main entrance of the school is not easily identifiable as it occurs through a neighborhood rather than a main vehicular artery. The Washington Street vantage is the more prevalent of the entrances.

Campus layouts like that of Hartsville High School, create security issues as doors to all buildings typically must remain unlocked to allow access to students and staff. Traversing the campus in inclement weather is also problematic as rain, cold and wind are not only an inconvenience to students and staff but also add additional safety hazards with slip/fall risks.

Athletic facilities are located both on the campus proper and offsite. On site facilities include: PE/practice gymnasium; competition gymnasium; softball complex; football/soccer practice fields; and band practice/PE field. Offsite facilities include the competition football/soccer stadium and baseball field.

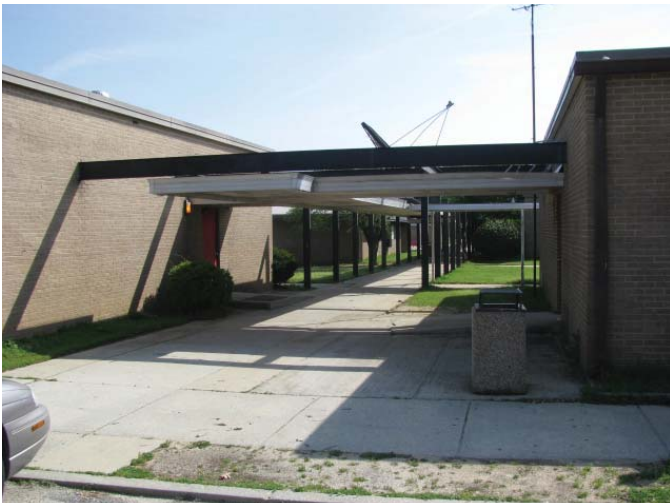
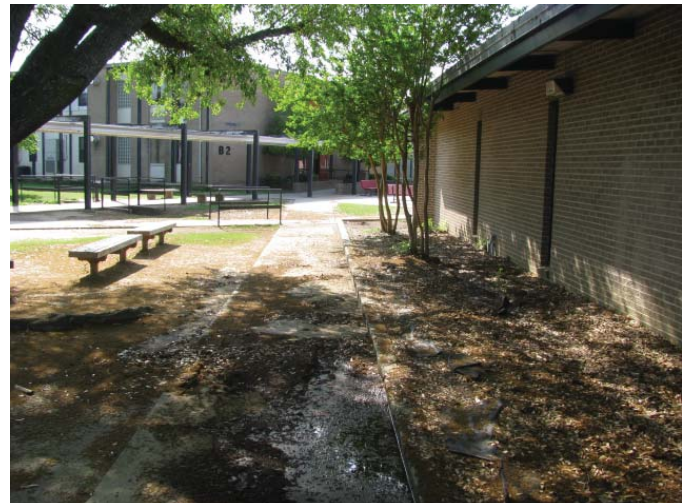
- Site drainage an immediate concern
- Reworking and striping of parking lots and drives recommended

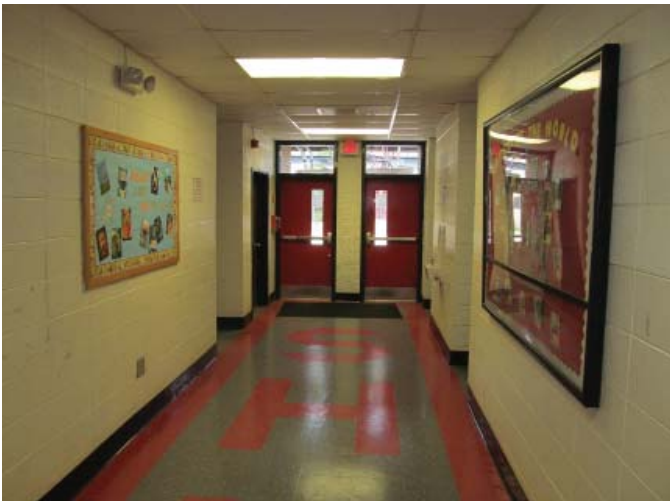
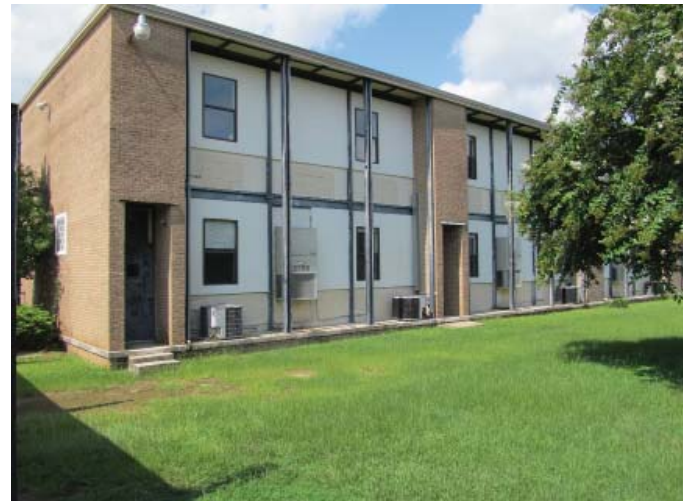
- Exterior doors have hardware and ADA issues
- Windows not energy efficient and some need replacement
- Roofs throughout district are in the process of or have been recently replaced
- Brick needs to be tuck-pointed

- Some interior doors not rated
- ADA restrooms needed
- Renovation of classrooms to include finishes is recommended
