Darlington County School District
Darlington, South Carolina
August 8, 2012

Darlington Area Schools - Building Evaluations

School Name: **Darlington High School** Observed By: Creed/Carter
Principal: Dr. Greg Harrison
Grade Levels: 9th – 12th
Site Size: Approximately 55 Acres
Student Population: 1075 (Approximate Student Population)
Staff Size: 120 (Approximate Staff Size)

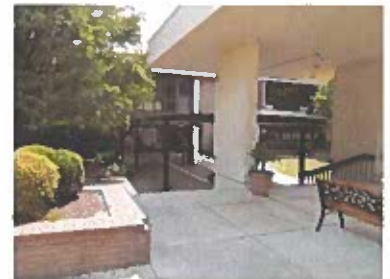
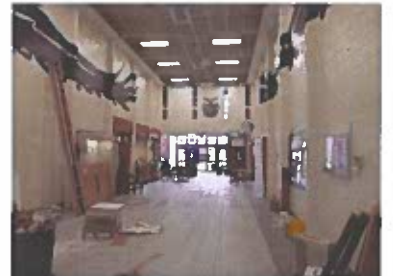
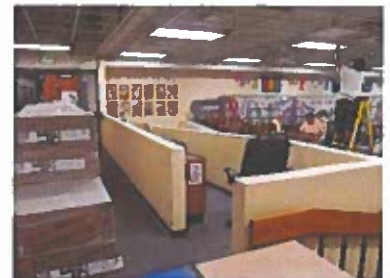
Building 1: Two Story Classroom Building

Footings: Spread
 Structure: Steel Bar Joist on Load Bearing
 Masonry
 Exterior Walls: Brick Veneer/concrete
 Fenestration: Aluminum Double Hung and fixed
 Storefront
 Exterior Doors: Hollow Metal Frames and Aluminum
 Storefront
 Elevated Floor: Composite slab on Steel Frame
 Roof System: 4-Ply Built-up Roof on light weight
 concrete deck
 Finishes: Terrazzo, carpet, Ceramic Tile.
 Recommend replacement of all carpet
 Plumbing Systems: Copper Supply/Cast Iron Waste
 Mechanical Systems:
 First Floor:
 Second Floor:
 Other:
 Electrical System: 240/480V System
 Fire Alarm: Recently upgraded
 Emergency Lights: Wall mounted battery backup

Utilities: City of Darlington
 Occupancy: Educational Type "E"
 Construction Type: II B Unprotected/Un-sprinkled
 Area Allowed: 14,500 sf
 Maximum Stories: Two (2) Stories
 Fire Rated Assemblies:
 Fire Barriers: Corridors - Not Rated (1 hr. req.)
 Structural Steel: No Ratings (1 hr. req.)
 Floor/Ceiling: No Ratings (1 hr. req.)

Roof/Ceiling	No Ratings	(1 hr. req.)
Fire Walls	Required	
Toilets:		
Toilet Counts	Appear to be adequate	
ADA Accessibility	Noncompliant

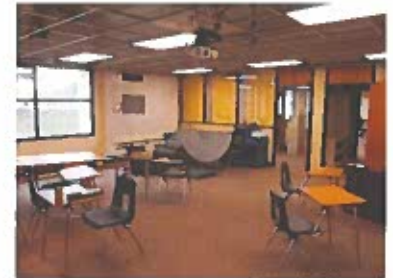
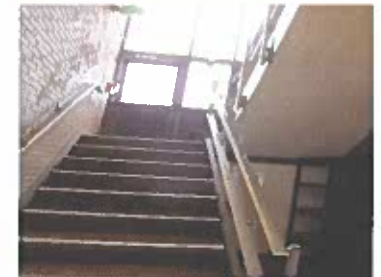
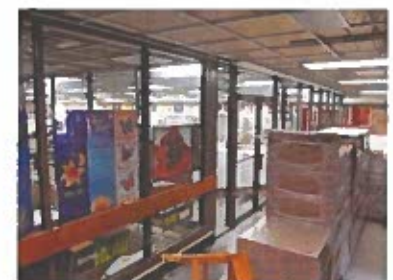
Building 2: Cafeteria/Kitchen

Footings:	Spread
Structure:	Steel Bar Joist on Load Bearing Masonry
Exterior Walls:	Brick Vencer / concrete
Fenestration:	Aluminum Double Hung and fixed Storefront
Exterior Doors:	Hollow Metal Frames and Aluminum Storefront
Roof System:	4-Ply Built-up Roof on light weight concrete deck
Finishes:	Terrazzo, quarry tile and ceramic tile
Plumbing Systems	Copper Supply/Cast Iron Waste
Mechanical Systems:	
First Floor:	
Second Floor:	
Other:	
Electrical System:	240/480V System
Fire Alarm:	Recently upgraded
Emergency Lighting:	Wall mounted battery backup

Utilities	City of Darlington	
Occupancy	Educational Type "E"	
Construction Type	II B Unprotected/Un-sprinkled	
Area Allowed	14,500 sf	
Maximum Stories	Two (2) Stories	
Fire Rated Assemblies:		
Fire Barriers	Corridors - No Ratings	(1 hr. req.)
Structural Steel	No Ratings	(1 hr. req.)
Floor/Ceiling	No Ratings	(1 hr. req.)
Roof/Ceiling	No Ratings	(1 hr. req.)
Fire Walls	Required	
Toilets:		
Toilet Counts	Appear to be inadequate	
ADA Accessibility	Noncompliant

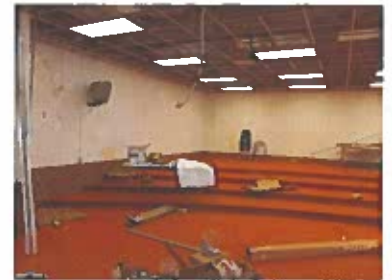
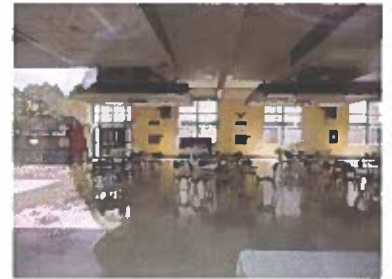
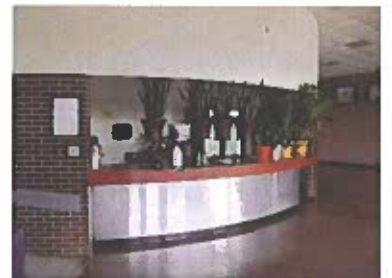
Building 4: Band/Choral

Footings:	Spread
Structure:	Steel Bar Joist on Load Bearing Masonry
Exterior Walls:	Load Bearing CMU/Brick Veneer
Fenestration:	Aluminum Double Hung and fixed Storefront
Exterior Doors:	Hollow Metal Frames and Aluminum Storefront
Roof System:	4-Ply Built-up Roof on light weight concrete deck
Finishes:	Average to poor. Floors-VCT and carpet
Plumbing Systems	Copper Supply/Cast Iron Waste
Mechanical Systems:	
Gym and Lobby:	No A/C, electric heat
Electrical System:	277/480V System
Fire Alarm:	
Emergency Lighting:

Utilities	City of Darlington
Occupancy	Educational Type "E"
Construction Type	II B Unprotected/Un-sprinkled
Area Allowed	14,500 sf
Maximum Stories	Two (2) Stories
Occupant Load	
Fire Rated Assemblies:	
Fire Barriers	None
Structural Steel	No Ratings Required
Roof/Ceiling	No Ratings Required
Fire Walls	No Ratings Required
Toilets:	
Toilet Counts	None
ADA Accessibility	Appear to be noncompliant
