Darlington County School District
Darlington, South Carolina
August 8, 2012

Hartsville Area Schools - Building Evaluations

School Name: North Hartsville Elementary Observed By: Cannon/Carter
Principal: Ms. Kristi Austin
Grade Levels: 1st – 5th Grades
Site Size: Approximately 12 Acres
Student Population: 720 (Approximate Student Population)
Staff Size: 70 (Approximate Staff Size)

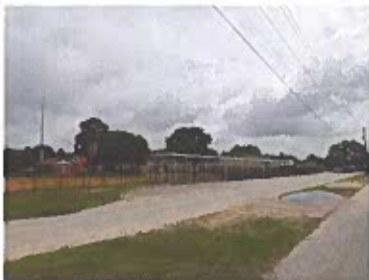
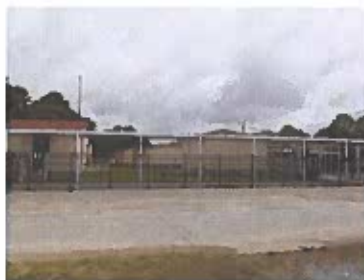
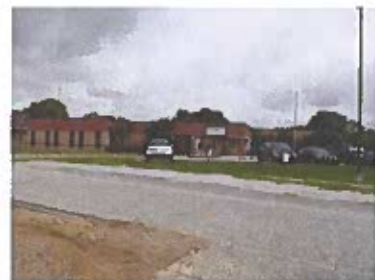
Building 1: (1st thru 3rd Grades)
 Year Const.: 1999
 Renovations: None
 Square Footage: 29,700 Single Story
 Total: 29,700 29,700

Footings: Spread
Structure: Steel Bar Joist on Load Bearing
 Masonry

Exterior Walls: Load Bearing CMU/Brick Veneer
Fenestration: Aluminum Double Hung and fixed
 Storefront

Exterior Doors: Hollow Metal Frames and Aluminum
 Storefront

Roof System: 4-Ply Built-up Roof on metal deck
Finishes: Average to Good. Floors-VCT
 Corridors and Classrooms; Acoustic
 ceilings; and Painted CMU walls

Plumbing Systems
Mechanical Systems:
 Classrooms: Wall Hung Bard Units
 Office: Packaged Roof Mounted Heat Pumps

Electrical System: 277/480V System
Fire Alarm: Recently upgraded
Emergency Lighting: Wall Mounted Battery Backup

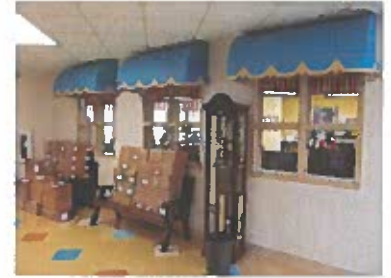
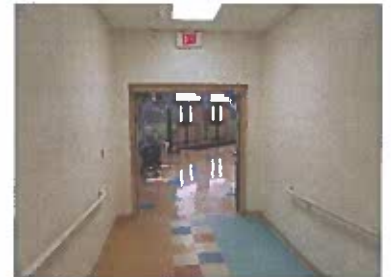
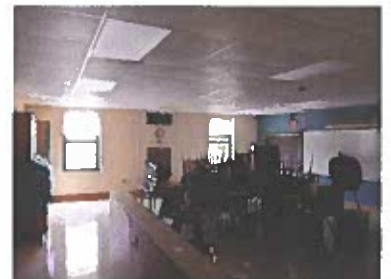
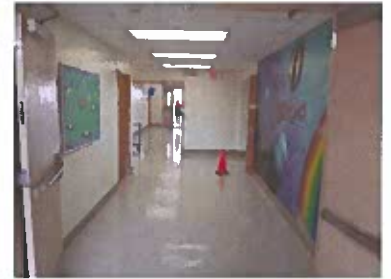
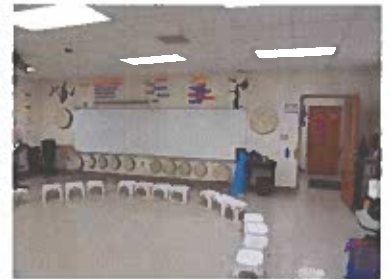
Building 2: (4th and 5th Grades)
 Year Const.: 1985
 Renovations: 1999
 Square Footage: 15,500 Single Story
 Total: 15,500 15,500

Footings: Spread
Structure: Steel Bar Joist on Load Bearing Masonry

Exterior Walls: Load Bearing CMU/Brick Veneer
Fenestration: Aluminum Double Hung and fixed Storefront

Exterior Doors: Hollow Metal Frames and Aluminum Storefront

Roof System: 4-Ply Built-up Roof on metal deck
Finishes: Average to Good. Floors-VCT Corridors and Classrooms; Acoustic ceilings; and Painted CMU walls

Plumbing Systems
Mechanical Systems: Copper Supply/Cast Iron Waste

Classrooms: Wall Hung Bard Units
Electrical System: 277/480V System
Fire Alarm: Recently upgraded
Emergency Lighting: Wall Mounted Battery Backup

Toilets:
Toilet Counts: Appear to be adequate
ADA Accessibility: Non-compliant

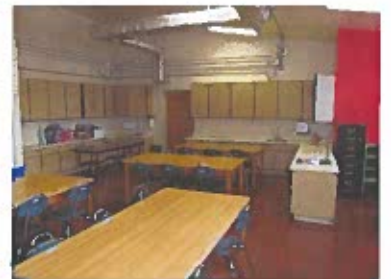
Building 3: (Cafeteria/Media/Computer/Resource)

Footings: Spread
 Structure: Steel Bar Joist on Load Bearing

Exterior Walls: Masonry
 Load Bearing CMU/Brick Veneer
 Fenestration: Aluminum Double Hung and fixed
 Storefront

Exterior Doors: Hollow Metal Frames and Aluminum
 Storefront

Roof System: New Metal Retrofit Roof System over
 4-Ply Built-up Roof on light-weight
 concrete deck on bulbbed tees.

Finishes: Average to Good. Floors-VCT
 Corridors and Classrooms; Acoustic
 ceilings; and Painted CMU walls
 Plumbing Systems: Copper Supply/Cast Iron Waste

Mechanical Systems:
 Classrooms: Wall Hung Bard Units
 Electrical System: 277/480V System
 Fire Alarm: Recently upgraded
 Emergency Lighting: Wall Mounted Battery Backup

Occupant Load:
 Fire Rated Assemblies:
 Fire Barriers: Ratings are questionable (1 hr. req.)
 Structural Steel: No Ratings Required
 Roof/Ceiling: No Ratings Required
 Fire Walls: None Required

Toilets:
 Toilet Counts: Appear to be adequate
 ADA Accessibility: Non-compliant
