**CROTON-HARMON UFSD
2015 BUILDING CONDITION SURVEY
DISTRICT OFFICE
SED # 66-02-02-03-1-010**

**Croton-Harmon UFSD
2015 Five Year Plan
District Office**

KSQ Project #1514002A0

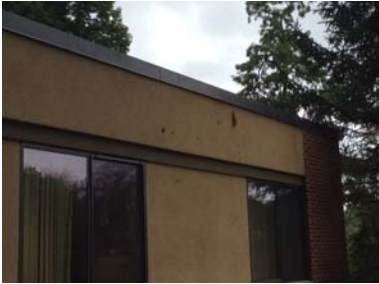
<p>EB 9 Exterior Stucco: Repair sections of wildlife damaged stucco to maintain water tightness of the building exterior.</p>

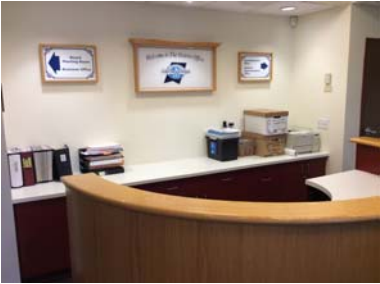
<p>BIR 13 Lobby Renovation: The built-in front desk in the lobby is no longer used. Renovation would include removal of desk and reorganization of seating to allow for part of the lobby to be used for needed additional file storage.</p>

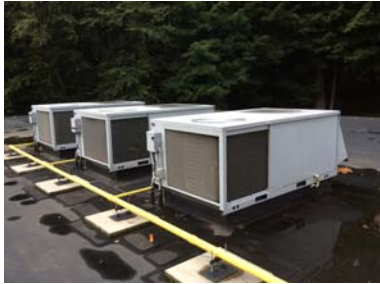
<p>M 14 Rooftop Units: Rooftop units are original to the building and near the end of their useful life. The units require frequent maintenance and parts replacement to remain operational. Replacement is recommended.</p>
