**OROVILLE UNION HIGH SCHOOL DISTRICT  
BOARD OF TRUSTEES**

## GEOLOGIC HAZARD REPORT

OROVILLE UNION HIGH SCHOOL DISTRICT  
2500 AND 2600 MITCHELL AVENUE  
OROVILLE, CALIFORNIA

**2500 AND 2600 MITCHELL AVENUE  
OROVILLE, CA  
APNs 013-250-062 AND 013-250-063**

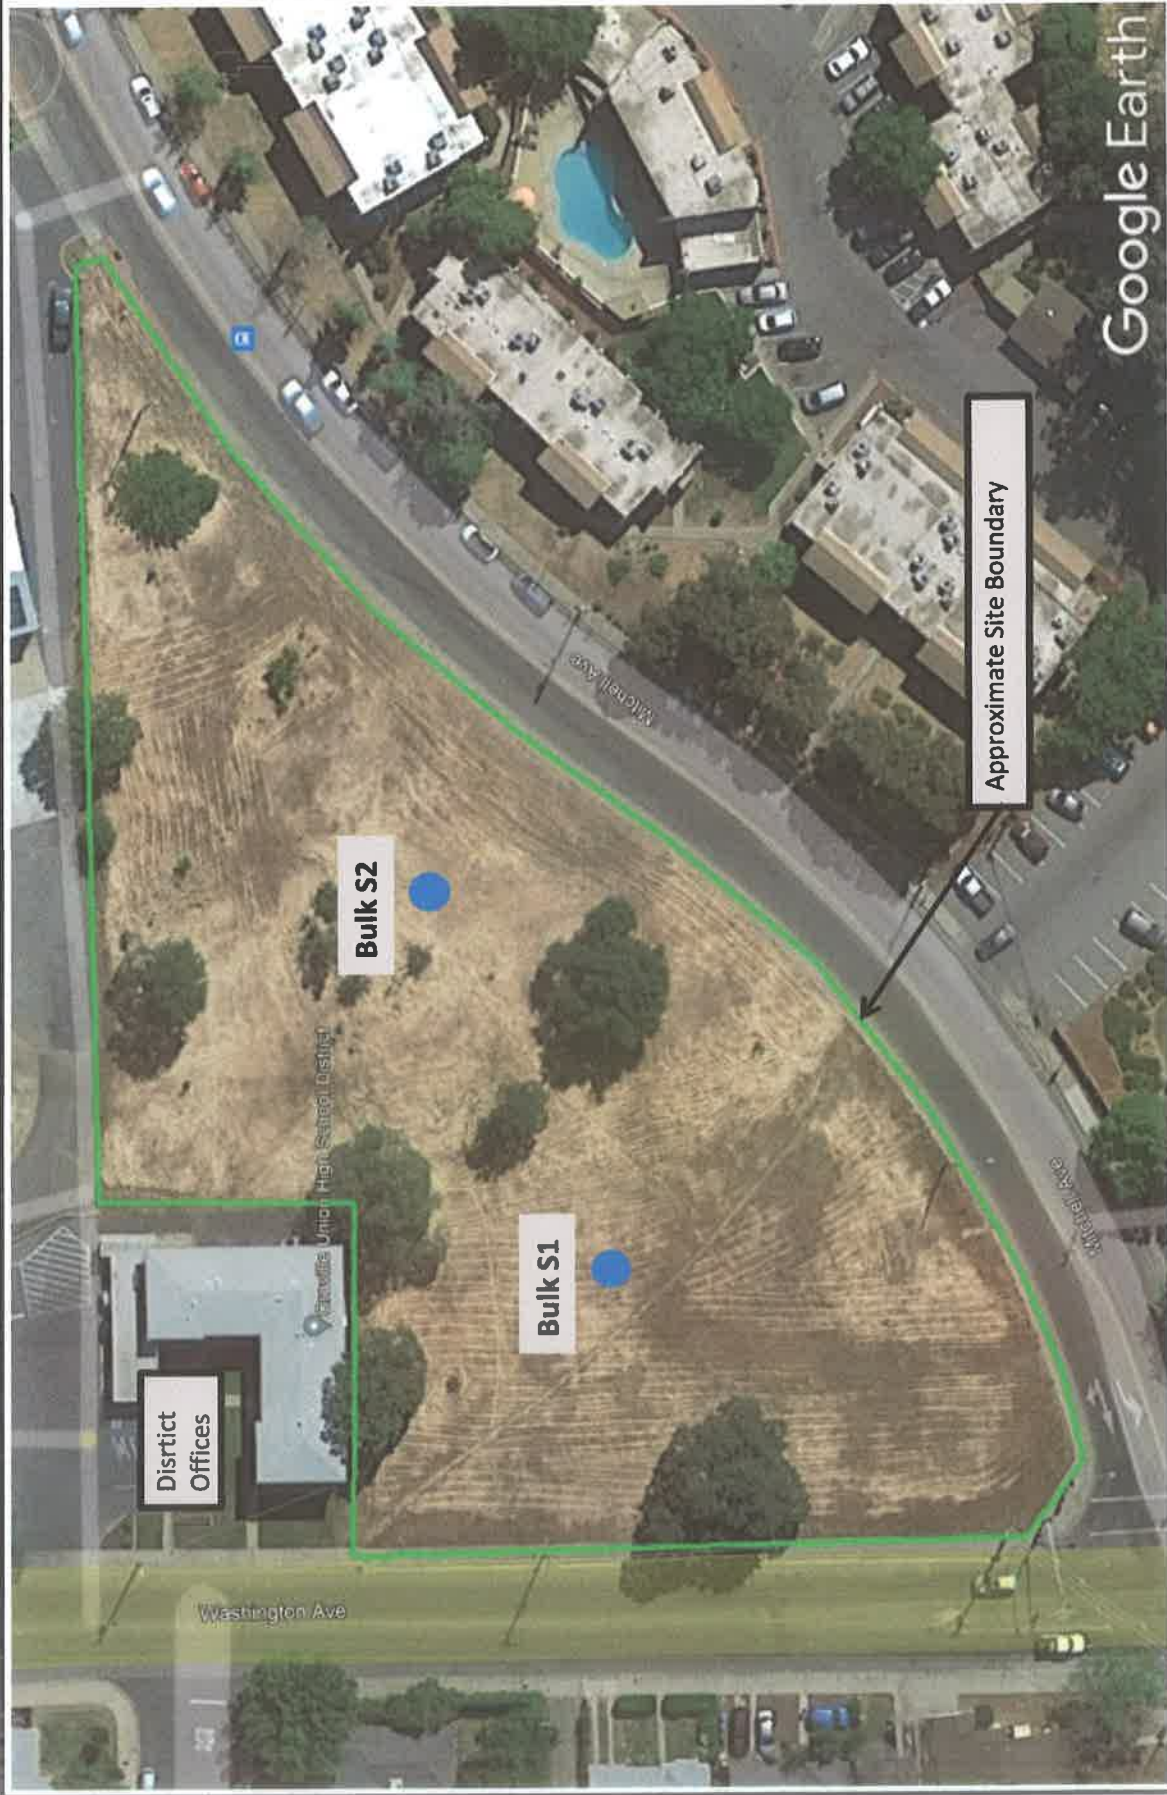
PLATE  
**3**

Perched groundwater was encountered in Bulk Sample S2, taken in the eastern portion of the property. This perched water was observed seeping into the 1-foot-deep excavation while the sample was collected.

**SAMPLE LOCATION MAP**  
OUSD PARCEL ACQUISITION  
2500 AND 2600 MITCHELL AVE..  
OROVILLE, CA

The bulk samples collected in the area encountered native materials consisting of reddish-brown to yellowish-brown Silty and Clayey Gravel with Sand and Cobbles. The cobbles were observed up to 8 inches in maximum dimension. These materials are consistent with the Laguna and Tuffs of Oroville Formations described above.
