The Academy of Charter Schools

CAMPUS MASTER PLAN 2022-2023

EXISTING CONDITIONS + SITE ANALYSIS

ELECTRICAL EXISTING CONDITIONS AND RECOMMENDATIONS

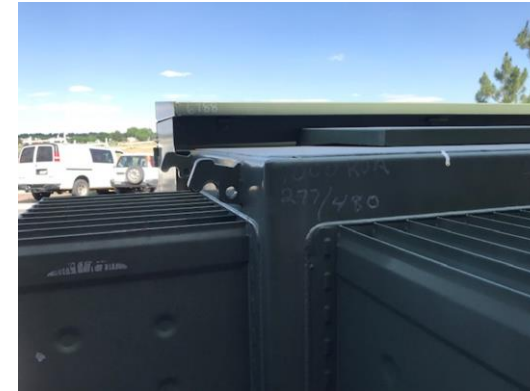
Utility Transformer

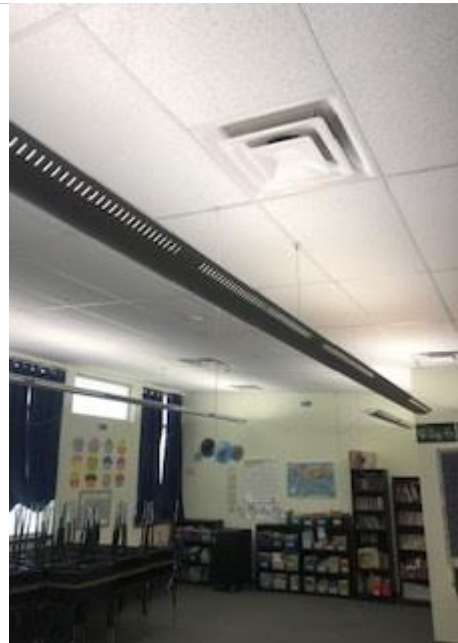
1. Suspended linears were observed in the classrooms with T8 lamps. Classrooms are well lit, with mostly indirect lighting.
 2. Recessed 2x4 fluorescent troffers with louvers were observed in corridor and commons areas.

Classroom Linears

- i. It is recommended that:
 1. classroom fluorescent fixtures continue to be re-lamped with LED lamps for energy savings.
 2. Consider replacing fluorescent 2x4 troffers with new LED fixtures. Fixtures will last longer and provide better illumination than existing louvered fixtures with new lamps.
 3. Consider replacing fluorescent downlights with new LED fixtures. Fixtures will last longer and provide better illumination than existing downlights with new lamps.
 4. Maintain existing exterior lighting, unless the staff members identify any areas where coverage or light levels should be improved.
- ii. Lighting controls will need to be fully replaced, with new automatic controls to meet Energy Code requirements, in any spaces with fixtures are replaced or relocated.

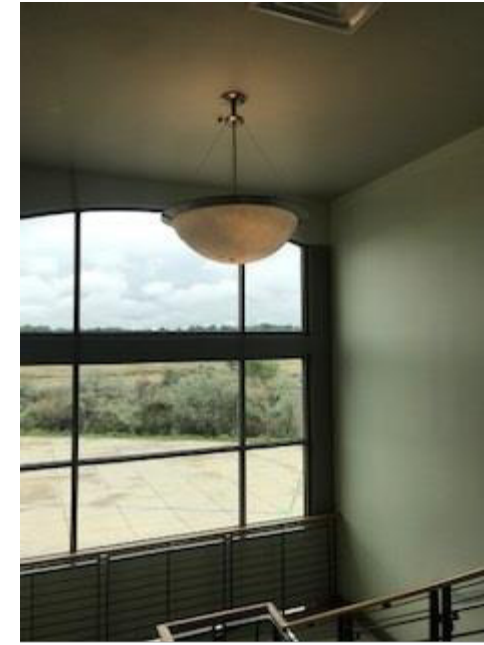
Decorative Suspended Fixtures

3. Large decorative suspended fixtures were observed in the stairwells. It was noted on site that these fixtures are difficult to keep clean.
 4. High bay fixtures were observed in the Gymnasium.

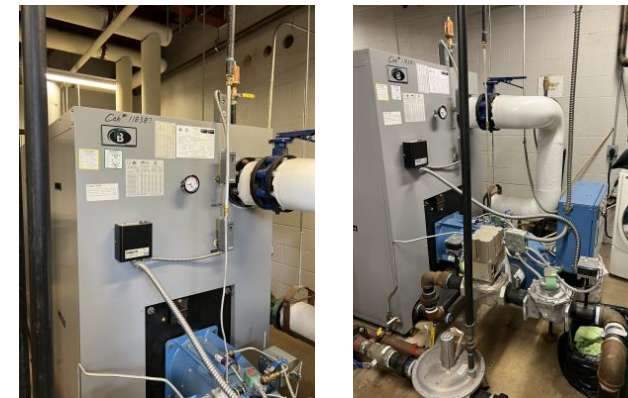
- The boilers are Peerless cast iron units, each with a maximum input rating of 3,978 mbh. These boilers were put into service within the last 3 years. These boilers should have a remaining serviceable life of approximately 25 to 30 years.

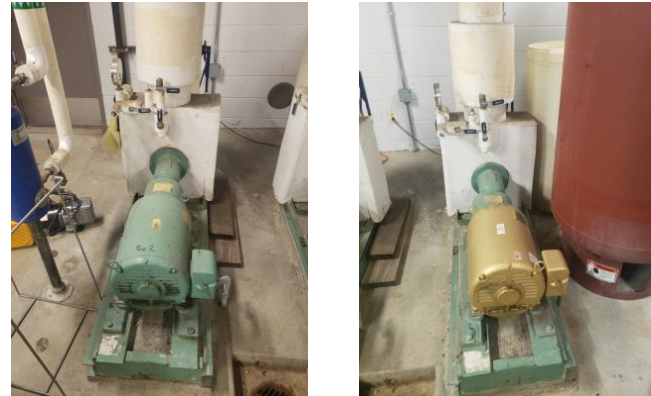
- The existing system pumps are constant flow, sized for 560 GPM and 95ft of head. The pumps appear to be original to the building. P-2 has had the motor replaced. As part of the below outlined scope; it is recommended that flows be taken at the system pumps to confirm the pump system is operating at full capacity. As the pumps are nearing the end of their serviceable life, replacement of the pumps should be considered with pumps incorporating variable frequency drives allowing for energy savings. The cost for pump replacement is approximately \$40,000.

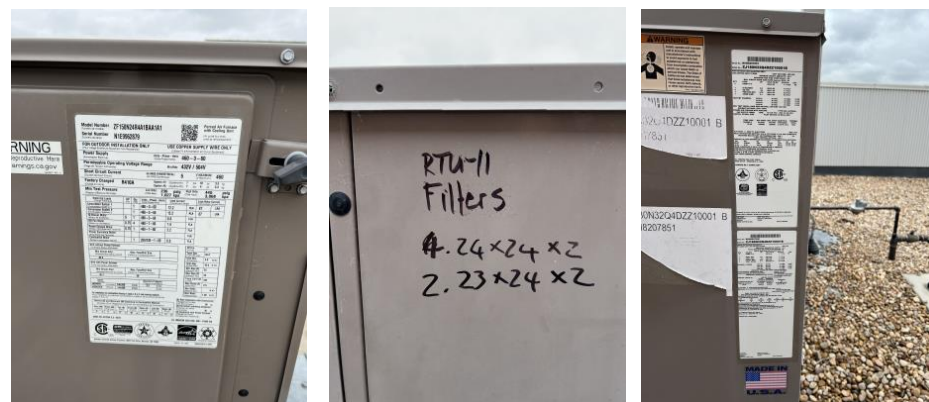
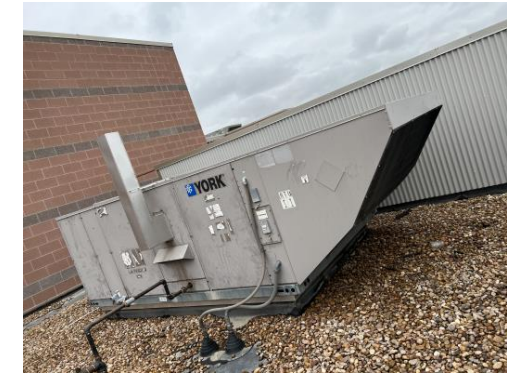
- There have been reported heating and cooling issue with the three (3) packaged rooftop units that were installed in 2009 with the addition. These units are 13 years old and are reported to be having issues maintaining space temperatures. It is recommended to replace all three units with similar capacity equipment.
 - RTU-10- serves the gym; 14,010 CFM, 35 Tons of cooling
 - RTU-11- serves the weight room and lockers; 5,360 CFM, 15 Tons
 - RTU-12- serves classroom addition; 5,960 CFM, 15 Tons
- The cost for replacing the 3 units with similar size equipment is approximately \$295,000.

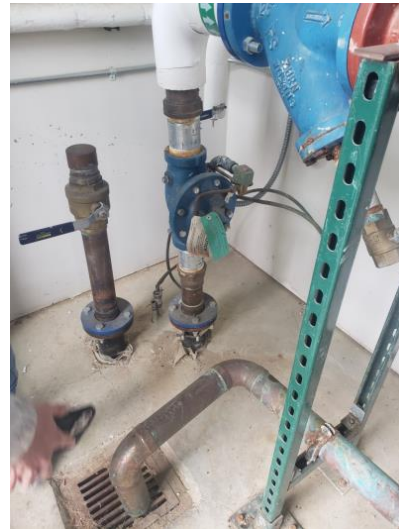
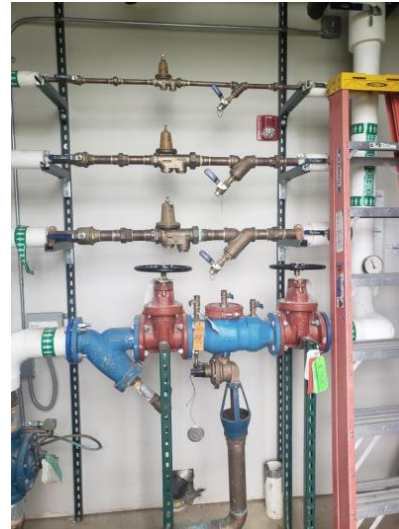
- Water pressure entering the building was approximately 132 psig. A pressure reducing station has been installed to reduce the distribution pressure within the building to approximately 70 psig. No system deficiencies were reported by school staff. Serviceable life for the backflow prevention device and pressure reducing valves is approximately 15 years. It is recommended that the facility begin planning for the replacement of these components within the next 5 years with an approximate cost of \$70,000.

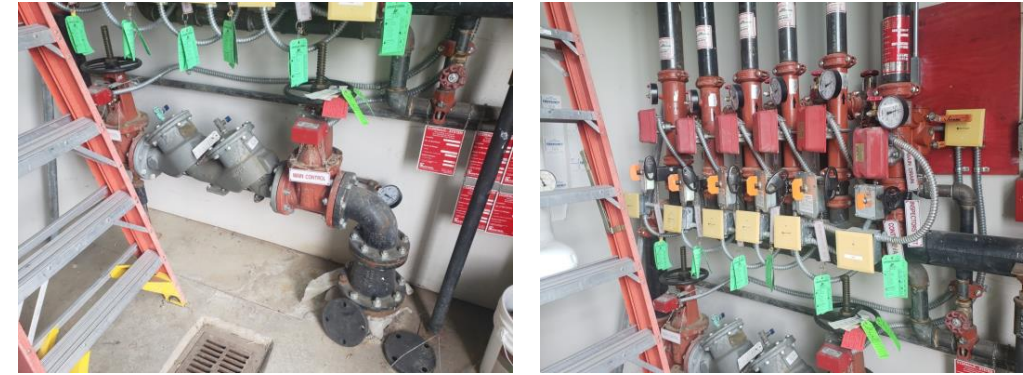
- A 6-inch fire service enters the building in the same space as the domestic water service. The fire service has been provided with a 4-inch double check valve assembly for backflow prevention. Six (6) fire sprinkler zones have been provided to provide automatic fire sprinkler coverage throughout the building. Each zone has been provided with a zone control valve with integral tamper switch and flow switch as part of a standard test and drain configuration. The isolation valves at the backflow prevention device have also been provided with tamper switches. Facility staff reported no concerns with the roof drainage system. Serviceable life for the backflow prevention device is approximately 15 years. It is recommended that the facility begin planning for the replacement of this device within the next 5 years with an approximate cost of \$10,000.

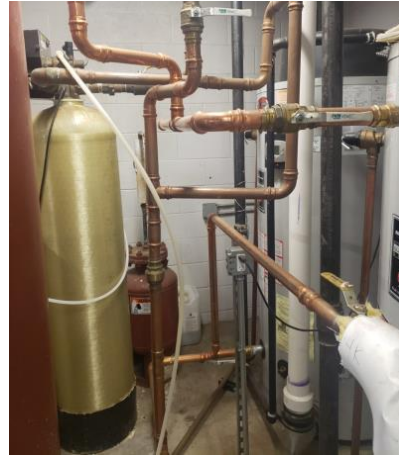
Facility staff indicated that hot water temperatures are inconsistent at fixture outlets. A review of the plan documentation indicates that the circulation loop connections vary in proximity to the final fixtures served. This may create excessive wait times for delivery of hot water to the fixture outlets. To overcome this issue, the circulation loops should be extended to within 2'-0" of the fixture supply connections or self-regulating heating cable should be installed on the hot water supply piping, not currently being circulated. This is not an urgent issue and should only be performed if major renovations are planned for the building, including toilet room finish and fixture upgrades.

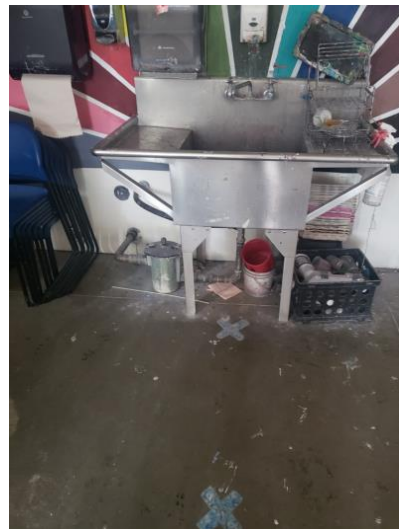
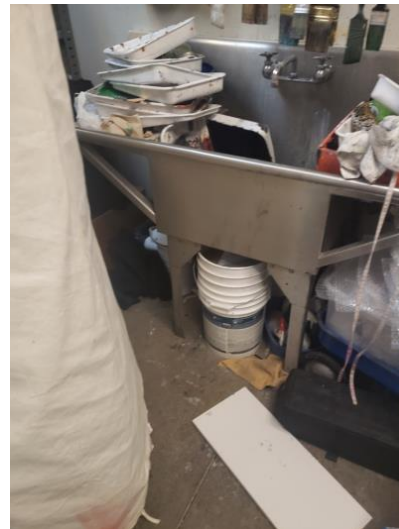
The art classroom has been provided with a single compartment sink and includes a solids interceptor on the drain line prior to discharging to the building drainage system. The interceptor installed is of limited capacity and should be serviced at least weekly as sink usage occurs. The Darkroom has been converted into what appears to be a scene shop for the stage. A single compartment sink has been provided in this space and has been fitted with a similar size solids interceptor.

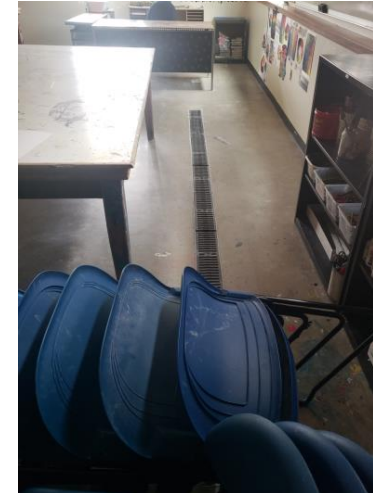
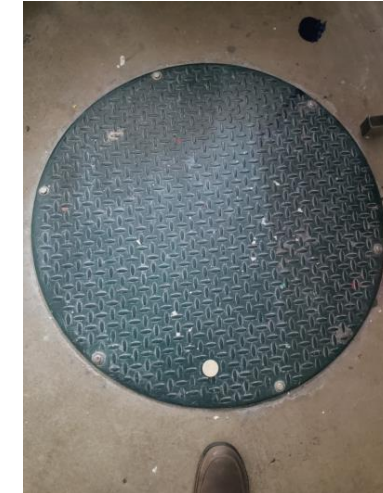
A trench drain has been installed to collect waste materials associated with pottery wheels or clay work surfaces. The trench drain grating did not appear to be heel-resistant and could allow for a trip hazard to exist. A hose bib has been installed adjacent to the sink allowing for washdown of the area and clearing of the trench when needed. New

grating is recommended for the trench drain sections with an approximate cost of \$1,000. A solids interceptor has been installed below the floor line and is accessible through a bolt-down cover. The bolt-down cover makes servicing the interceptor difficult and should be replaced with a keyed hatch with an approximate cost of \$3,500.

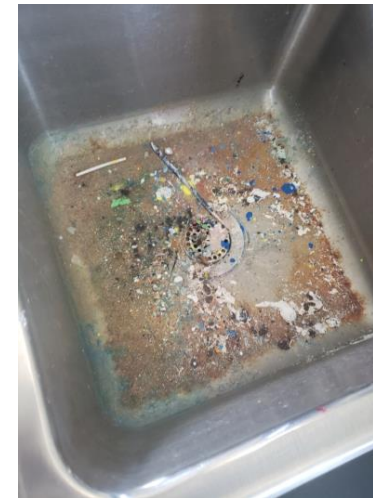
Science lab and science classroom sinks were all noted as being stainless steel. The sinks located within the chemistry classroom are showing signs of deterioration and should be replaced with an allowance of \$2,000 per sink bowl.

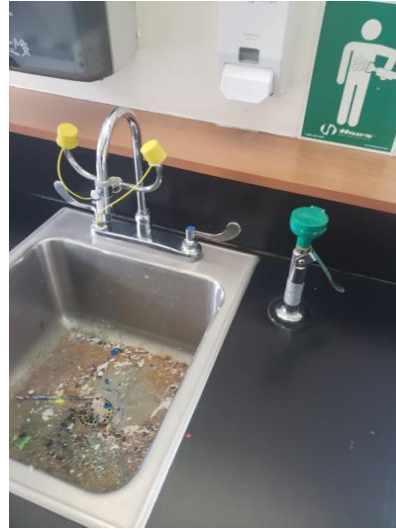
Where chemicals are being used, it is recommended that neutralization or dilution tanks be provided to protect the drainage system from corrosion caused by the disposal of materials that may damage the piping system. These devices would replace the standard P-traps currently installed. The cost for incorporating neutralization into the chemistry classroom and adjacent prep room would be approximately \$12,000.

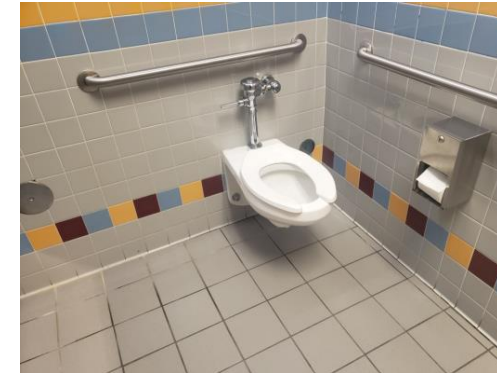
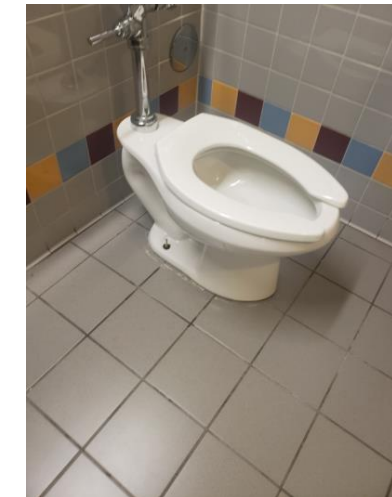
Plumbing fixtures throughout the facility are in good condition. Wall hung water closets have been provided at all the major toilet groups. Floor mounted water closets have been installed within staff toilet rooms and other areas where a single water closet has been installed. All flush valves are manual style. Closet bolts were exposed and bolt caps missing in several of the floor mounted locations.

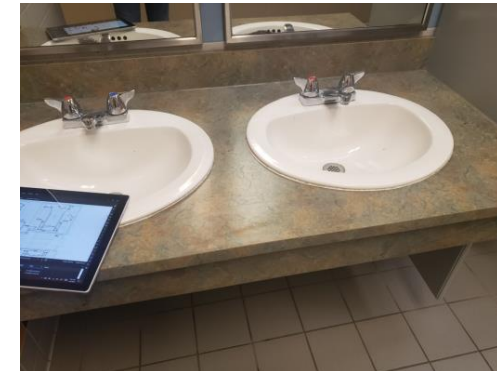
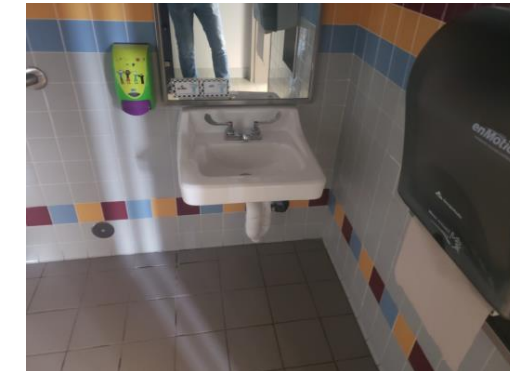
Wall mounted and counter style lavatories have been provided in a majority of the toilet rooms. Manual faucets have been provided. Point of use mixing valves do not appear to be present. A single wall hung lavatory has been replaced with a utility sink in Toilet room 181A. The utility sink is not considered accessible.

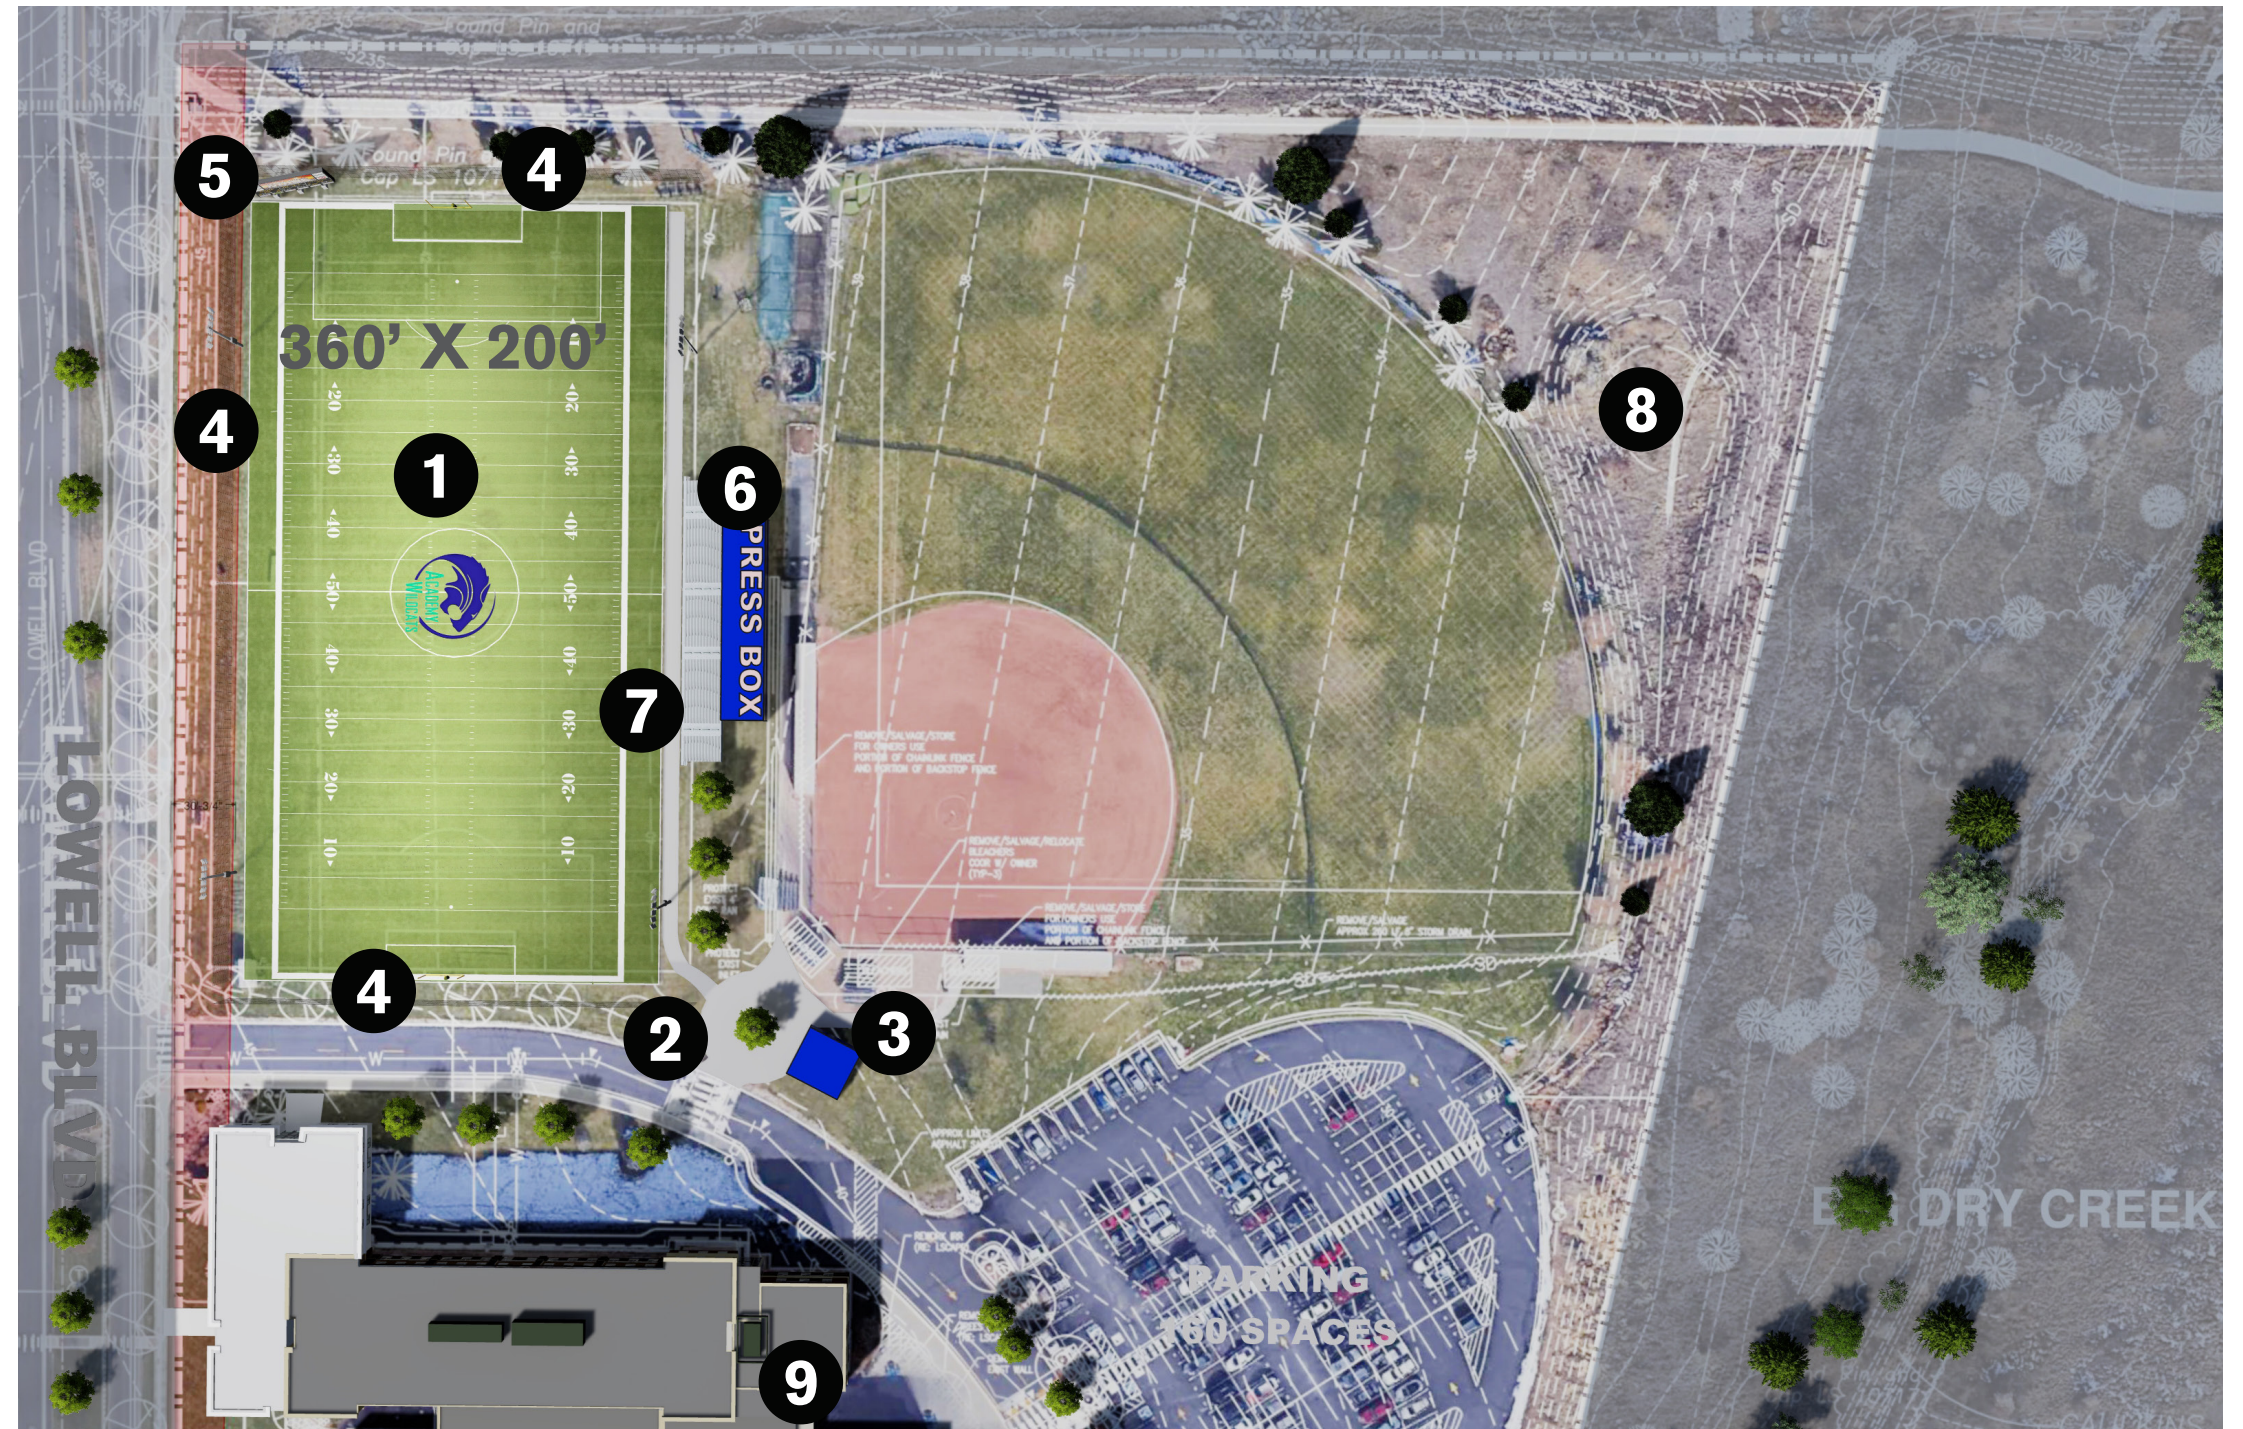
MEDIUM TERM GOALS SITE PLAN - ATHLETICS

- 1** Synthetic Turf Field, drainage, shock pad & crumb fill, regrade with retaining walls
- 2** New entry plaza
- 3** Concessions
- 4** 20-30' tall netting
- 5** New scoreboard with branding to 120th
- 6** New press box
- 7** Bleacher seating for 600 spectators
- 8** Stormwater detention pond increase
- 9** Use existing toilets within 500' of bleachers

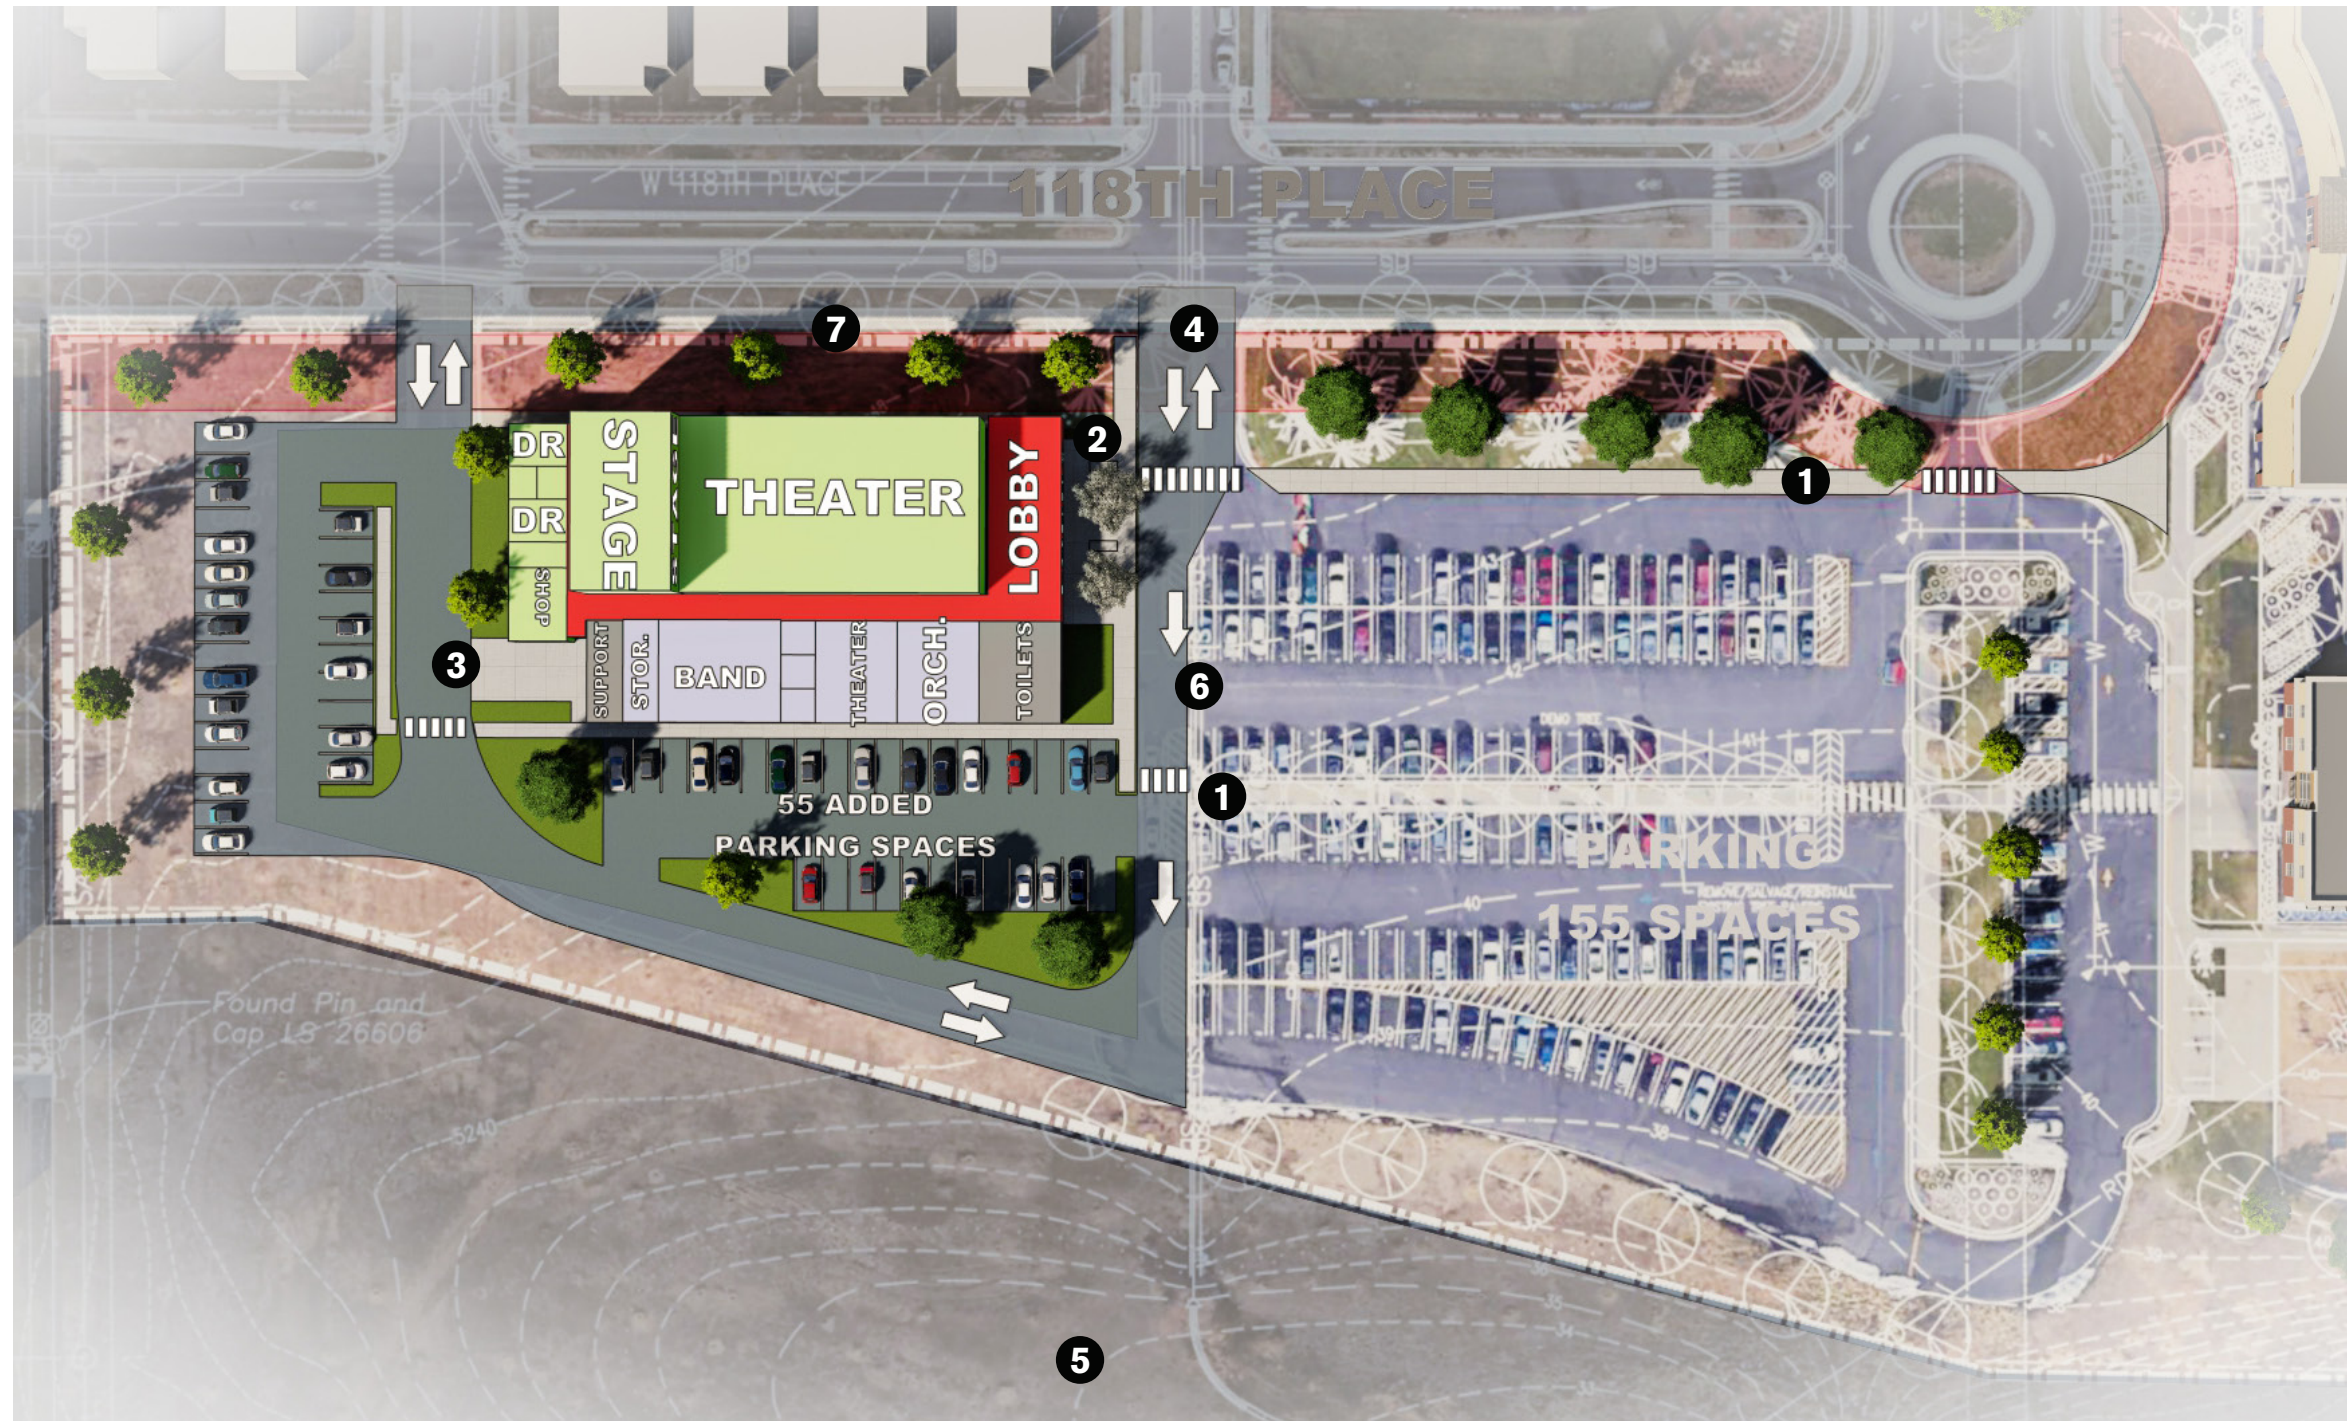
LONG TERM GOALS - COMMUNITY CENTER SITE PLAN

- 1** New pedestrian connection
- 2** Plaza / Main Entry
- 3** Loading area
- 4** Added IN lane, full movement
- 5** Increased stormwater detention pond
- 6** Existing parking net add of 40 spaces
- 7** New water meter / tap and sanitary connection

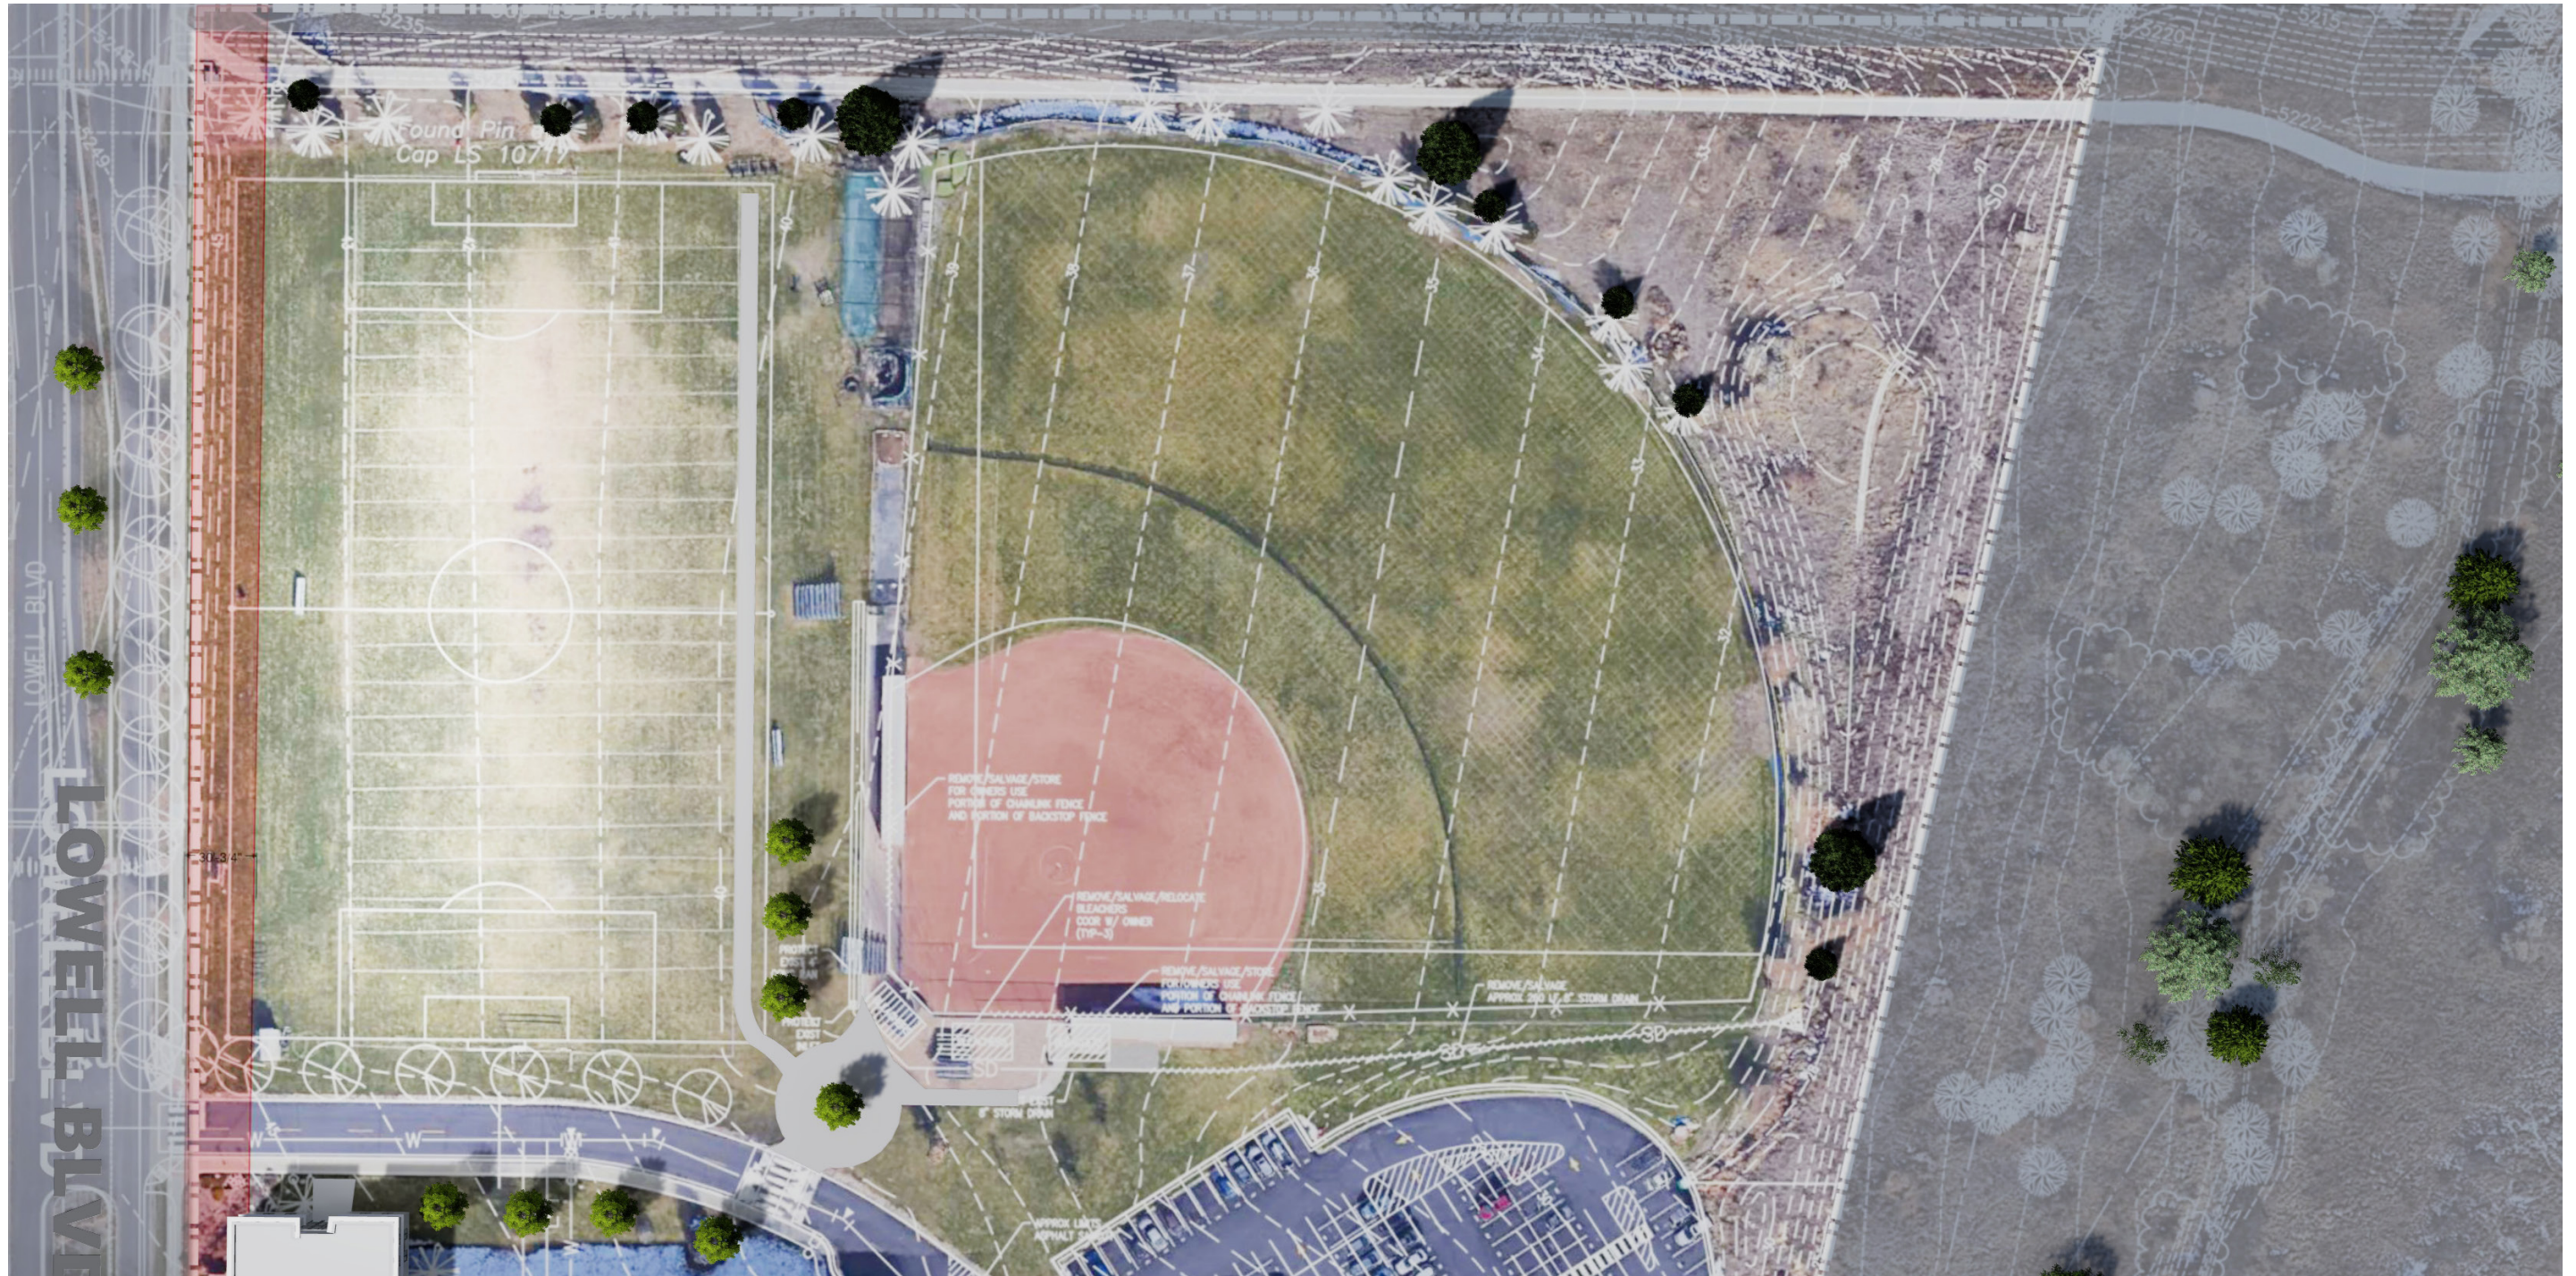
Limited Scope

- 1 Synthetic Turf Field, drainage, shock pad & crumb fill, regrade with retaining walls
- 2 Stormwater detention pond increase
