Dare County Schools
Ian Adams
3020 S. Wrightsville Avenue
Nags Head, NC

**Re: Limited Environmental Post Remediation Clearance Investigation with Airborne and Surface Fungal Sampling at First Flight Middle School, Kill Devil Hills, NC
LRC Project – 23-1831**

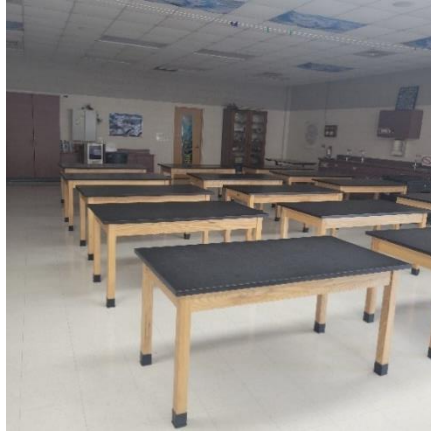
Classrooms inspected were visually clean unless otherwise noted. Areas measured with the moisture meter were in the dry range. HEPA filtered air scrubbers in place in classrooms were turned off prior to the collection of air samples.

Representative classroom

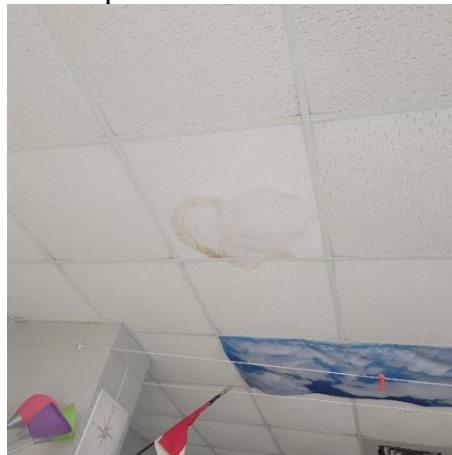
Staining was noted on some of the acoustic ceiling tiles throughout the building. Addressing the tiles was not a part of the scope of this remediation. These tiles should be removed and replaced as time allows and the areas above inspected. This clearance inspection was limited to the remediated areas of the structure.

Representative staining on an acoustic ceiling tile
