| OCTOBER 26, 2023

KAUFMAN ISD

LRFP COMMITTEE MEETING NO. 2

CAMPUS OVERVIEW - HELEN EDWARDS EARLY CHILDHOOD CENTER

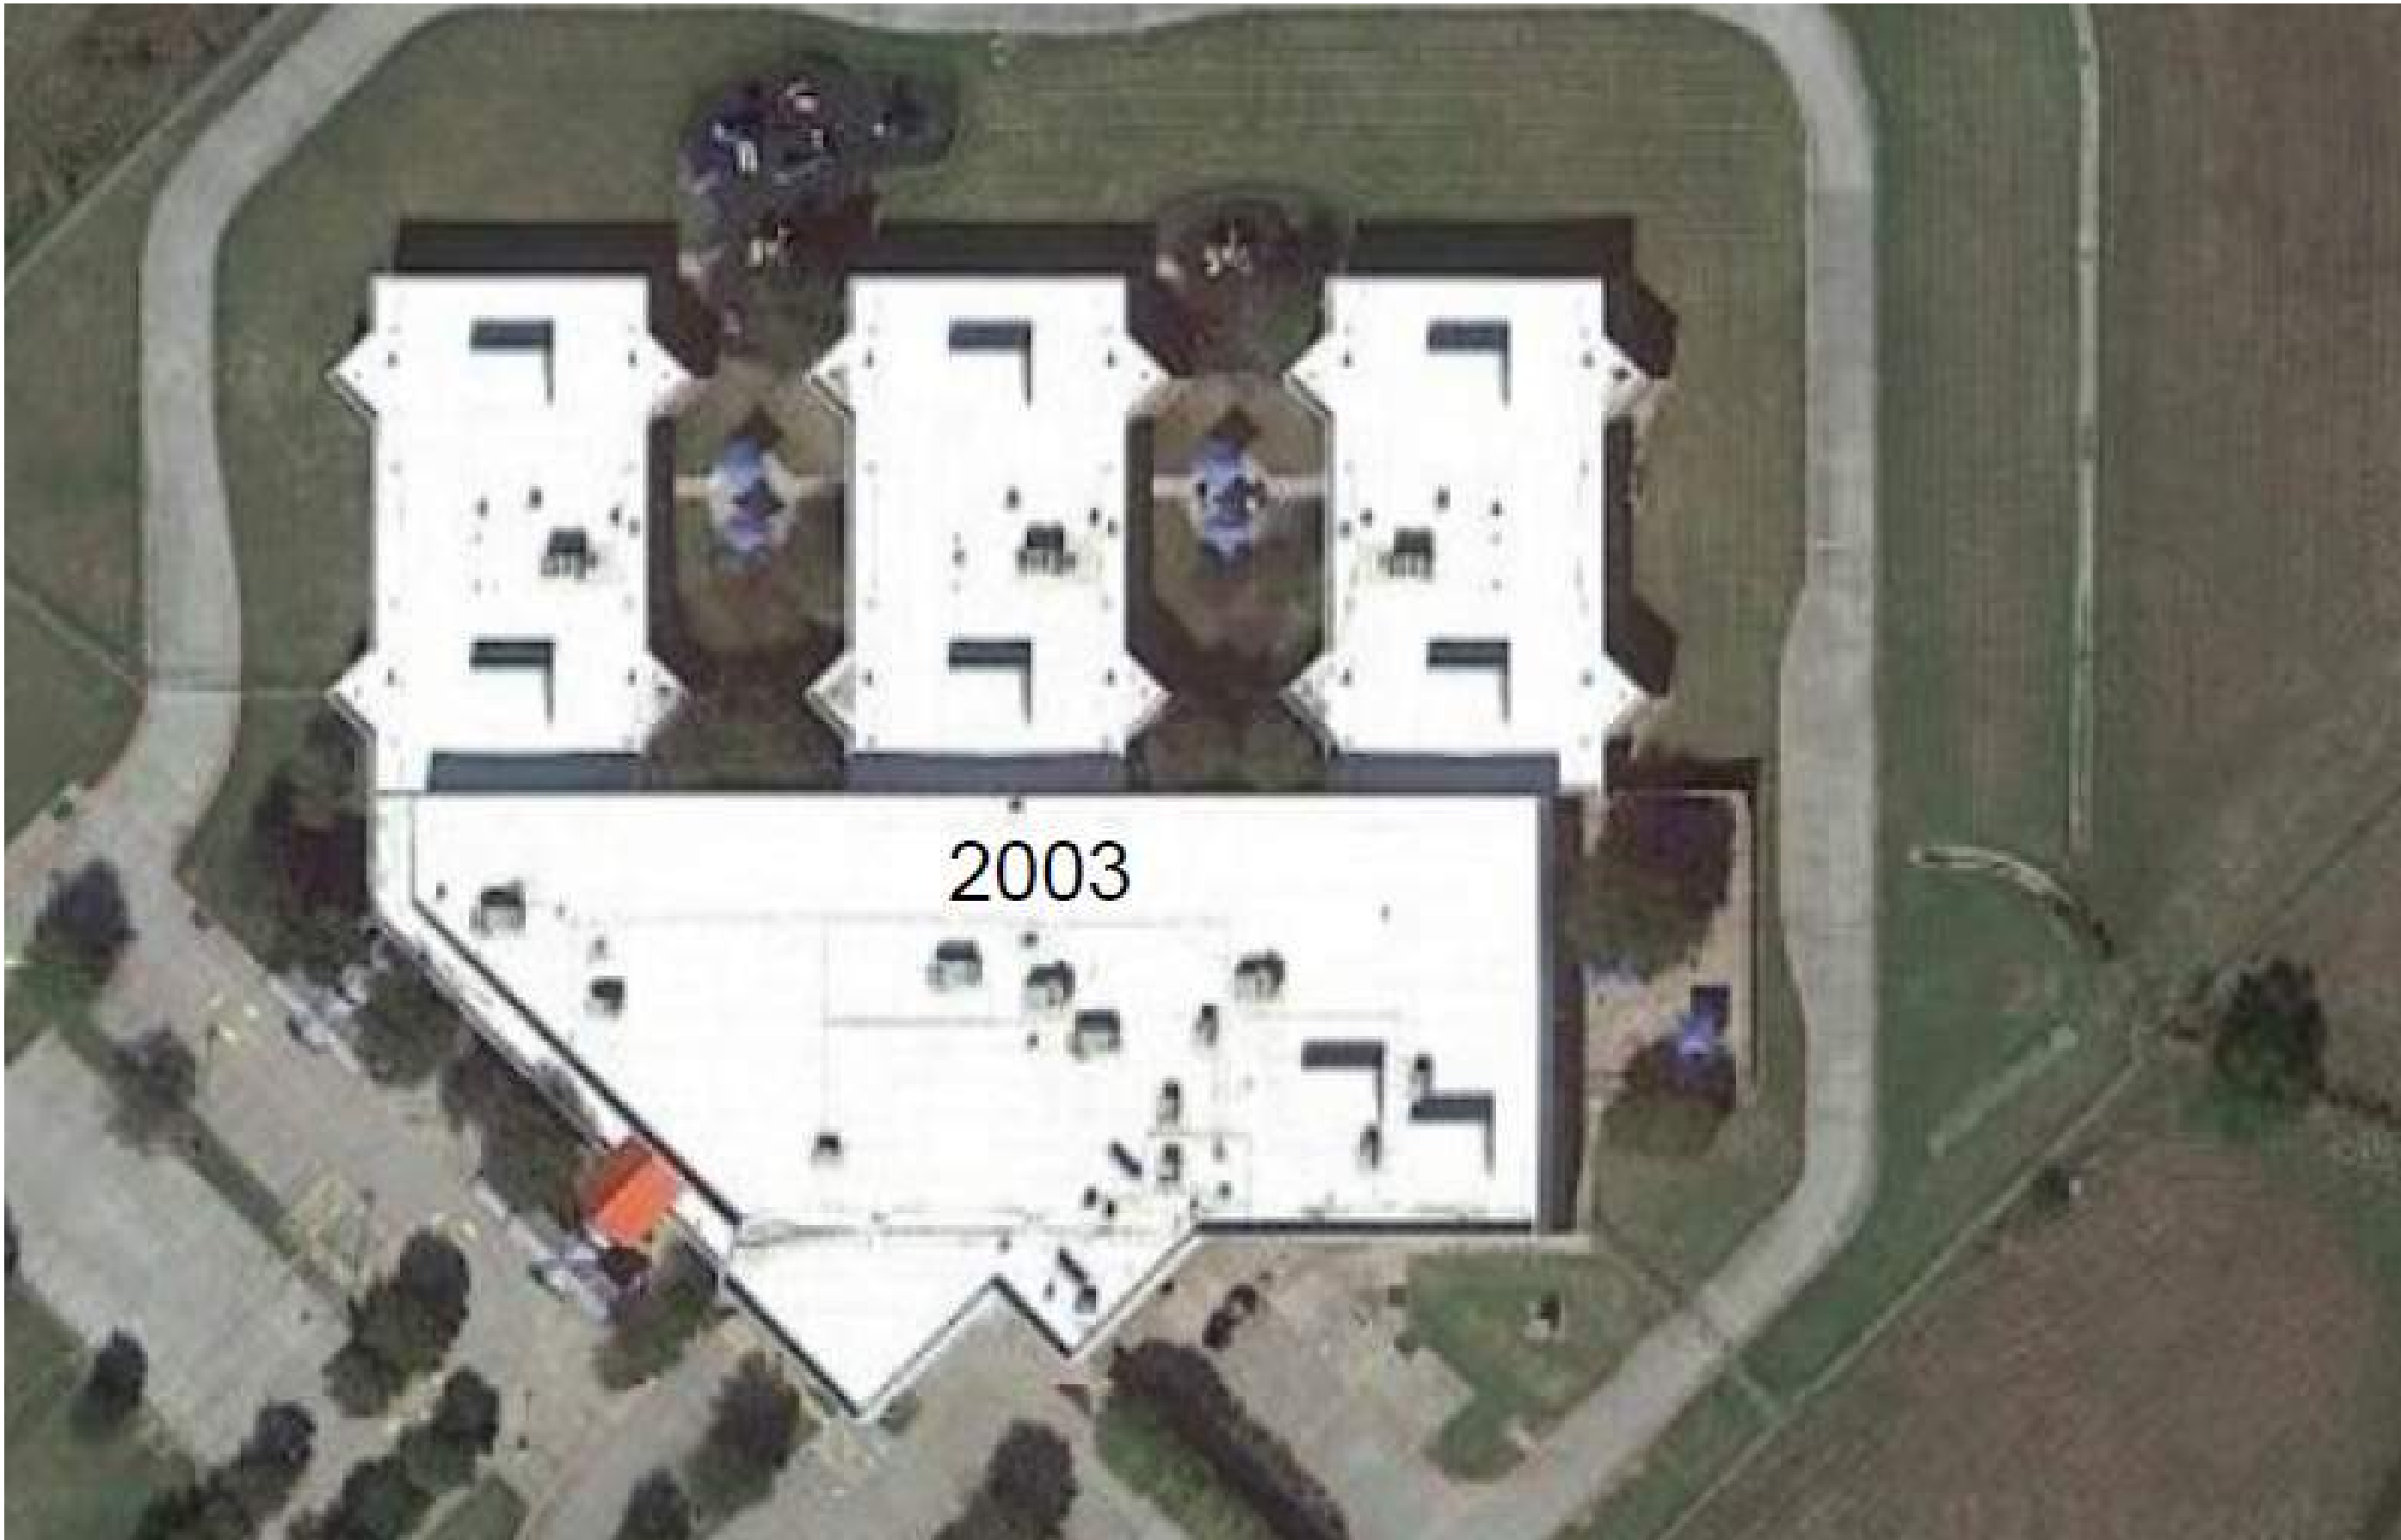
BUILT: 2003 | 2015 | 2016
TOTAL BUILDING AREA: 81,840 SF
EDUCATIONAL ADEQUACY SCORE (EAI): -5
AS USED FUNCTIONAL CAPACITY: 475
STUDENTS AT 90% EFFICIENCY
POTENTIAL FUNCTIONAL CAPACITY: 515
STUDENTS - GROSS

- Security fencing upgrades
- Covers on playgrounds
- Sidewalk repairs/replacement
- Paving repairs/replacement
- Irrigation control
- Erosion
- Site sealant
- Drainage, including at entries, paved play, site areas holding water or sloped to building

- Building sealant
- Clean brick
- Repair and Paint entry canopies
- Paint exterior metal
- Repair perimeter grade-beams

- Replace damaged ceiling
- Provide urinal screens
- Repaint door frames
- Repair cracking CMU & Sheetrock
- Security film

- Mechanical- 20 year replacement of DX Split System with fan-powered boxes and rooftop package units original to building
- Plumbing- water pressure issues
- Plumbing- sewer smells
- Network, Emergency Call and Security Camera Upgrades

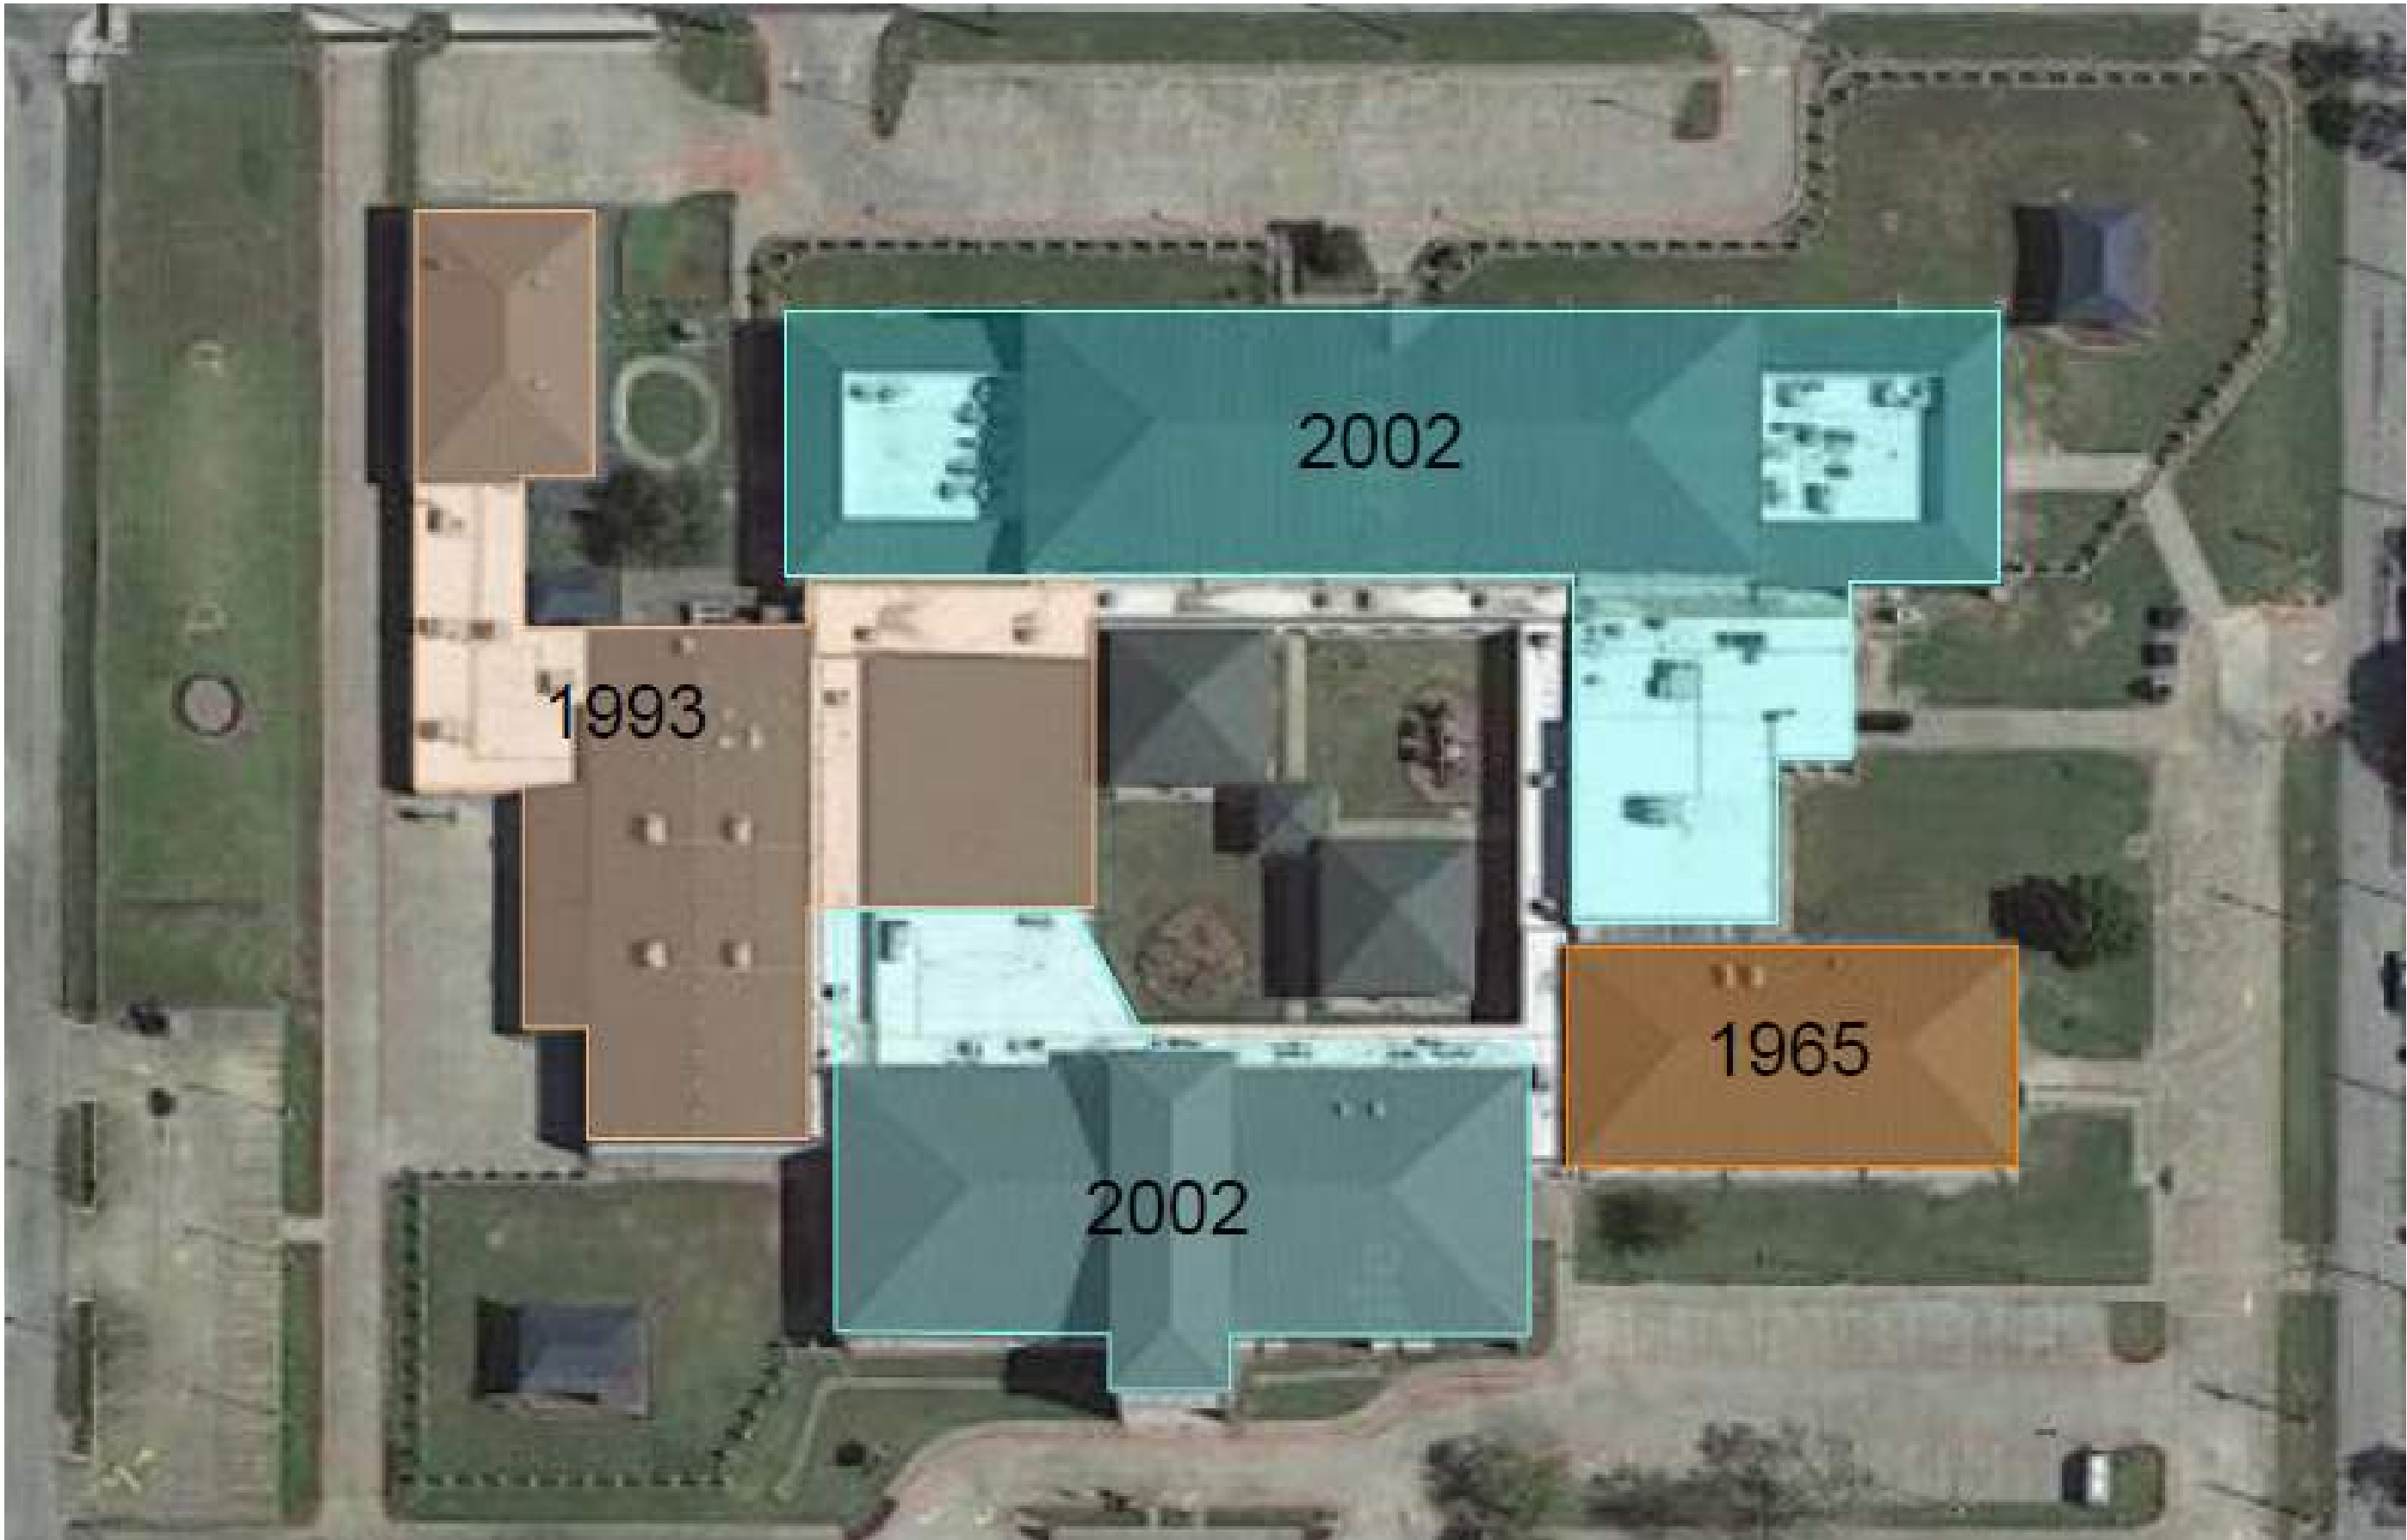
CAMPUS OVERVIEW - MONDAY ELEMENTARY SCHOOL

BUILT: 1965 | 1993 | 2002
TOTAL BUILDING AREA: 141,500 SF
EDUCATIONAL ADEQUACY SCORE (EAI): -26
AS USED FUNCTIONAL CAPACITY: 526
STUDENTS AT 60% EFFICIENCY
POTENTIAL FUNCTIONAL CAPACITY: 803
STUDENTS - GROSS

- Site circulation/Parking
- Sidewalk repairs/replacement/clean
- Paving repairs/replacement
- Irrigation control
- Erosion
- Site sealant
- Provide accessible ramp to Special Ed Department
- Replace retaining wall

- Building sealant
- Clean and seal/coat block
- Security Glass
- Remove unused devices
- Replace gutters downspouts, tie into storm line
- Paint exterior metal doors, frames, trim
- Repair perimeter grade beams where spalling and at form-ties

- Provide accessible handrails at stairs
- Update elevator
- Reseal control joints
- Flooring repair/replacement at expansion joints
- Replace damaged/sagging ceiling
- Repaint door frames
- Security film
- Add conditioning to vestibule
- Update Library

- Update & Expand Cafeteria
- Update Stem Lab
- Replace toilet partitions and counters at restrooms
- ADA Slope into some Restroom
- Repaint Gym
- Replace curtain, ceiling, and lighting and refinish floor at stage
- Replace water fountains ADA

- Mechanical- Remove unused mechanical units
- Mechanical- Replace rooftop units exceeding lifespan
- Electrical- Replace lighting
- Plumbing- Replace restroom sinks ADA
- Network, Emergency Call and Security Camera Upgrades

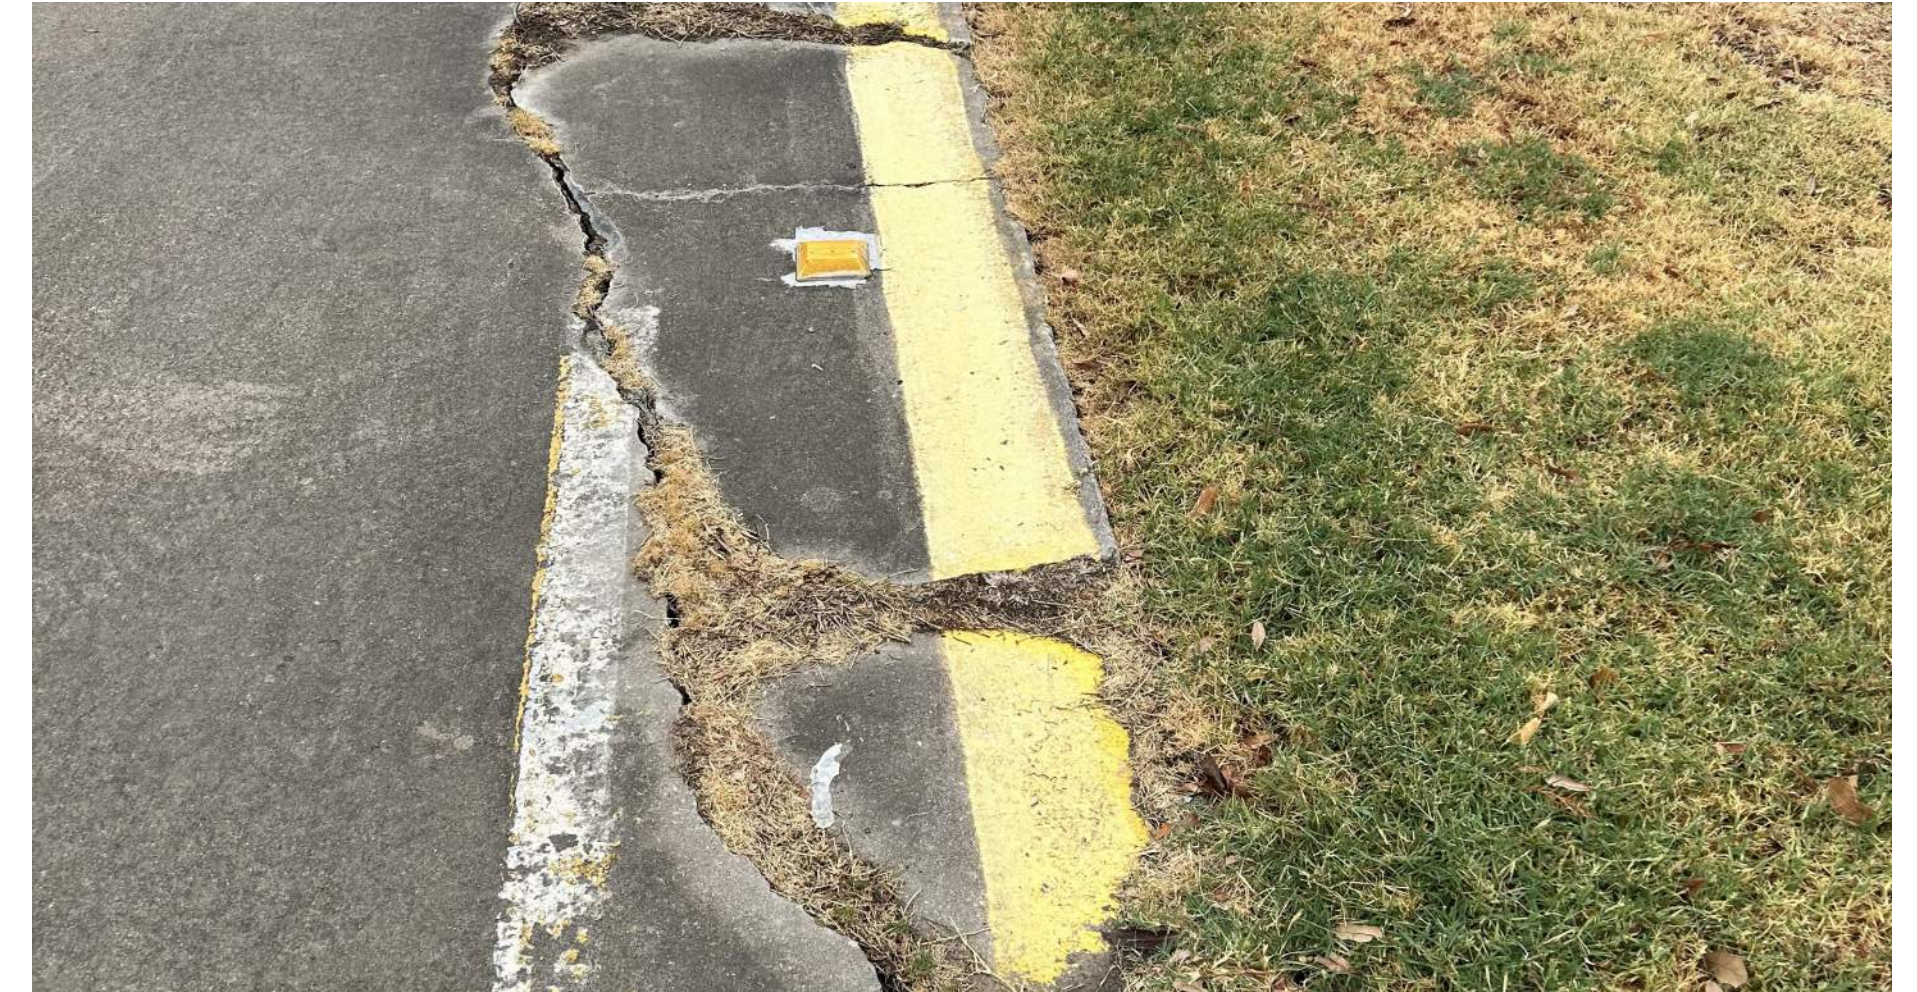
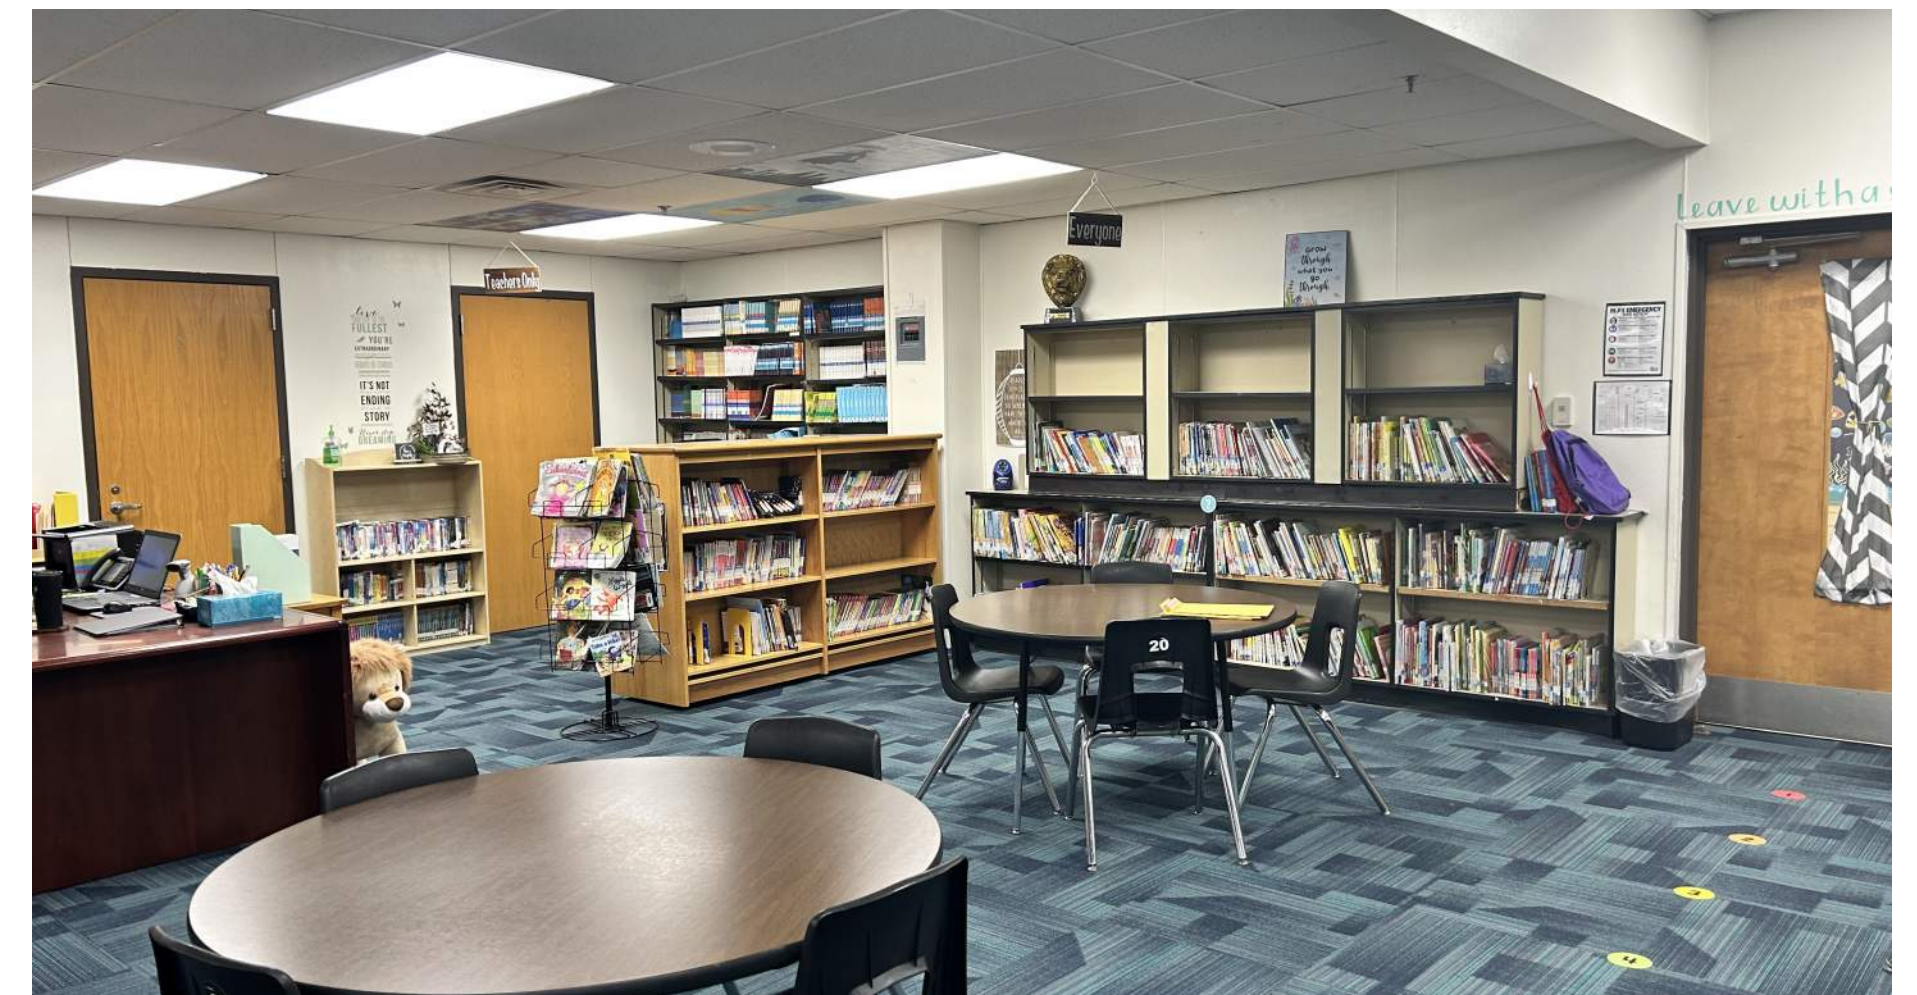
CAMPUS OVERVIEW - PHILLIPS ELEMENTARY SCHOOL

- Security Fencing
- Rework drainage/grading at all exits/entries, provide accessible ramps
- Replace canopies, rework entry at front door
- Sidewalk repairs/replacement/clean/regrade (significant degradation & movement)
- Paving repairs/replacement/Restripe/regrade (significant degradation & movement)
- Irrigation control
- Erosion
- Site sealant
- Replace exterior athletic equipment
- Covers for Playground
- Replace canopies
- Upgrade landscape around building, remove unused fencing
- Dumpster screen
- Low power to building above fire lane

- Building sealant
- Replace and reflash storefront
- Repair recoat plaster
- Clean reseal brick
- Security Glass
- Replace exterior windows
- Replace gutters/downspouts
- Paint exterior metal doors, frames, trim
- Repair brick corners where spalling and cracked
- Replace exterior canopies

- Remove unused exterior devices
- Replace door hardware that is not accessible
- Replace soffit at exterior bus drive
- Clean up courtyard

- Replace flooring, including terrazzo
- Replace 2x4 ceiling
- Replace wood doors and hardware not accessible
- Replace restrooms in older portions, upgrade to ADA
- Replace wood casework
- Rework surface-mounted power/data
- Replace water-fountains
- Replace classroom sinks
- Update library
- Replace gym, moisture, age, accessibility

- Electrical- Replace lighting
- Electrical- Replace exterior lighting
- Plumbing- ADA upgrades
- Network, Emergency Call and Security Camera Upgrades
- Replace HVAC units over lifespan

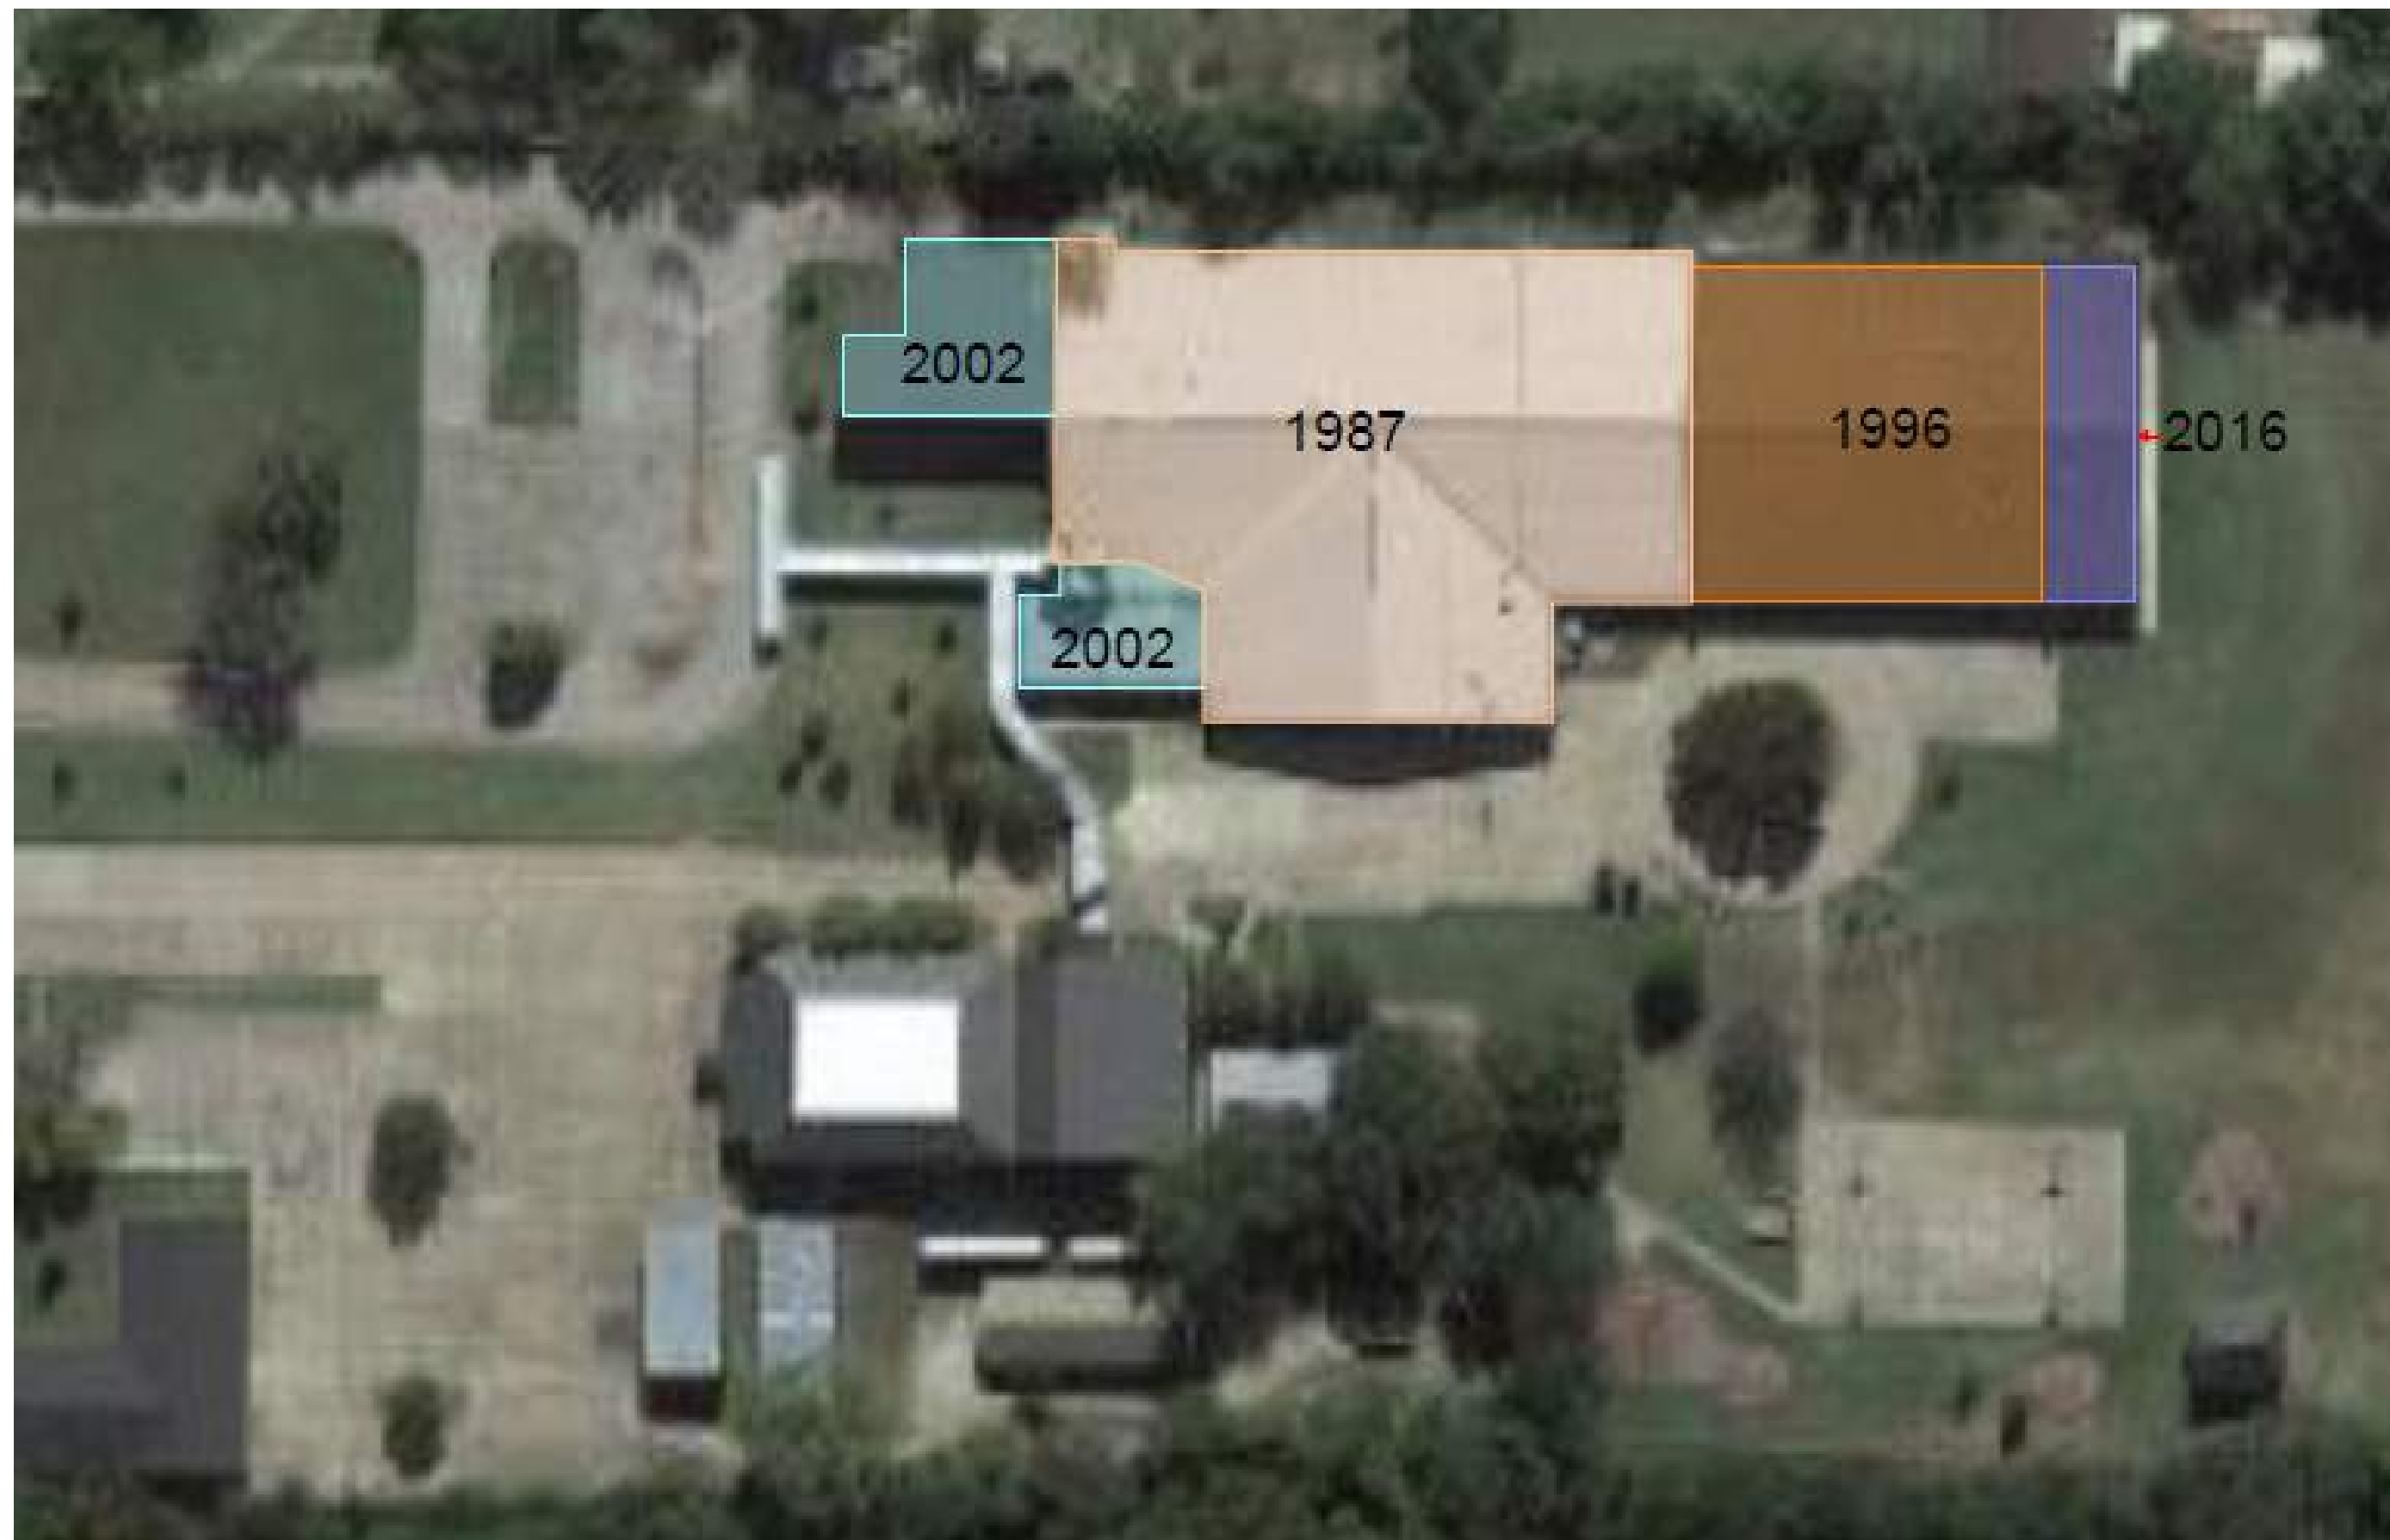
CAMPUS OVERVIEW - LUCILLE NASH ELEMENTARY SCHOOL

BUILT: 1987 | 1996 | 2002 | 2016

**Gym predates 1940*

- Replace exterior windows
- Replace sealant
- Repaint exterior steel doors and metal

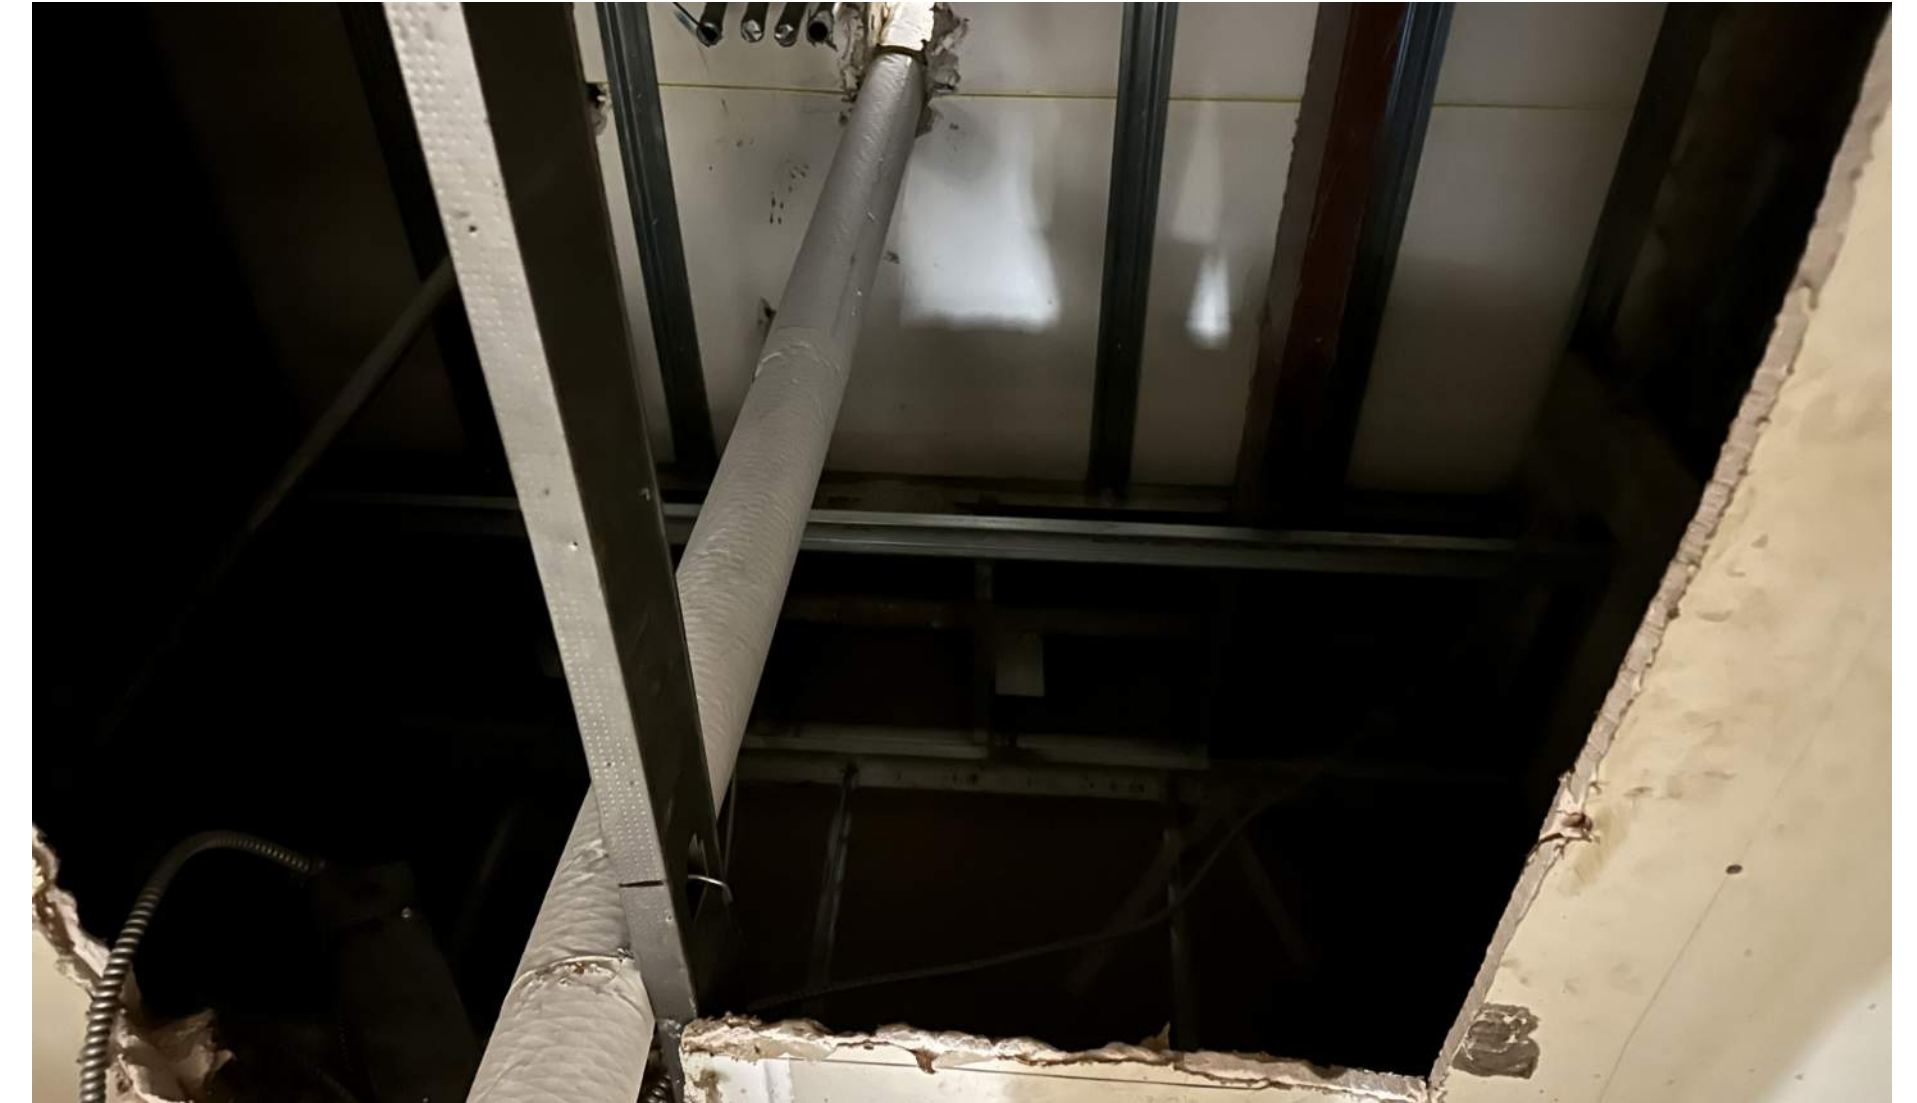
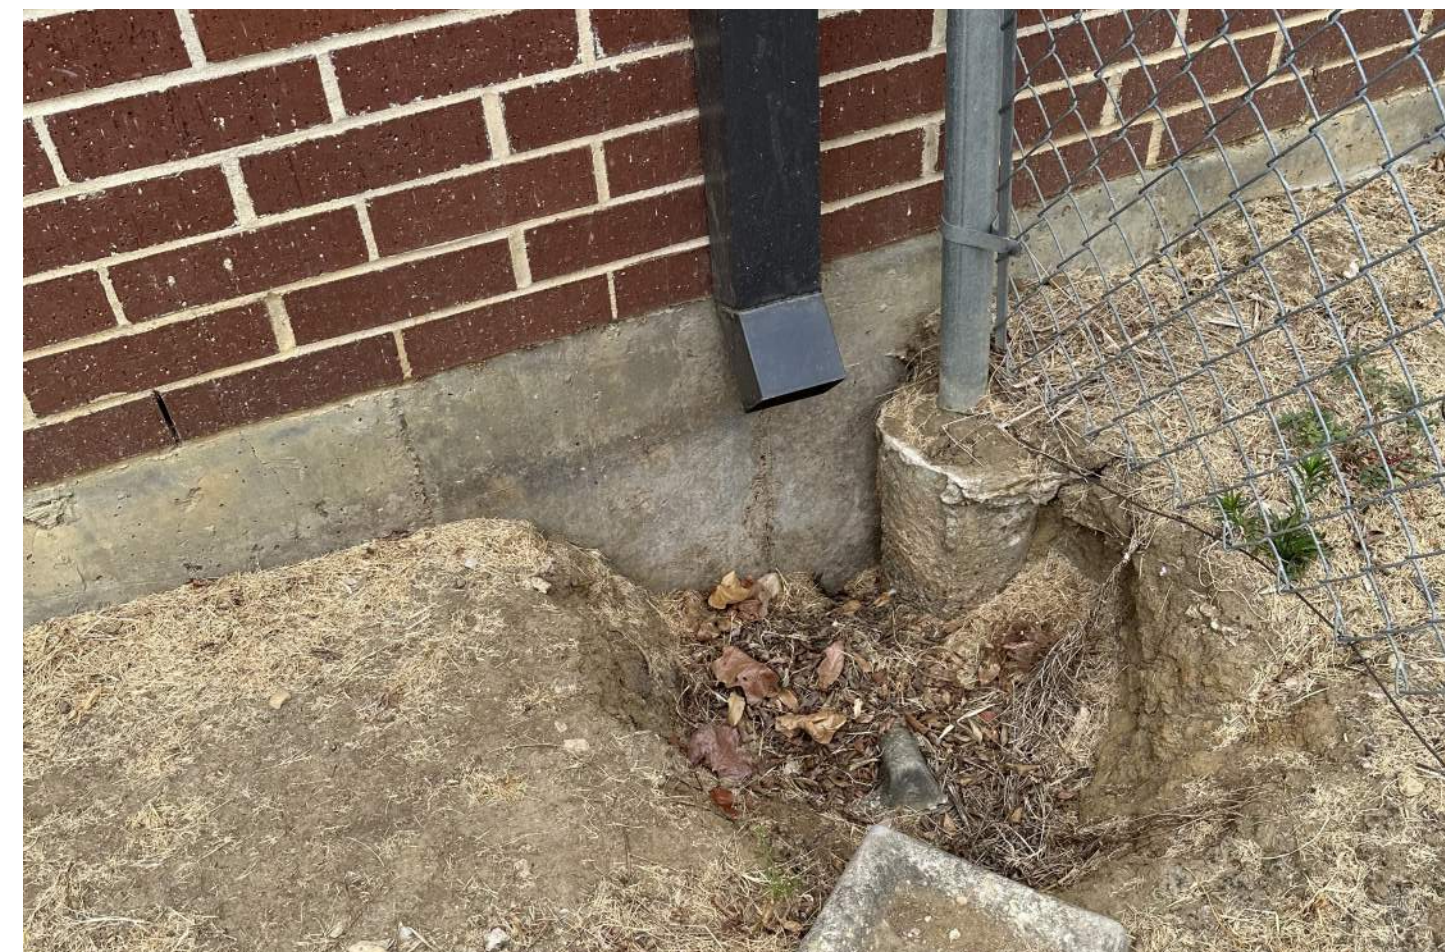
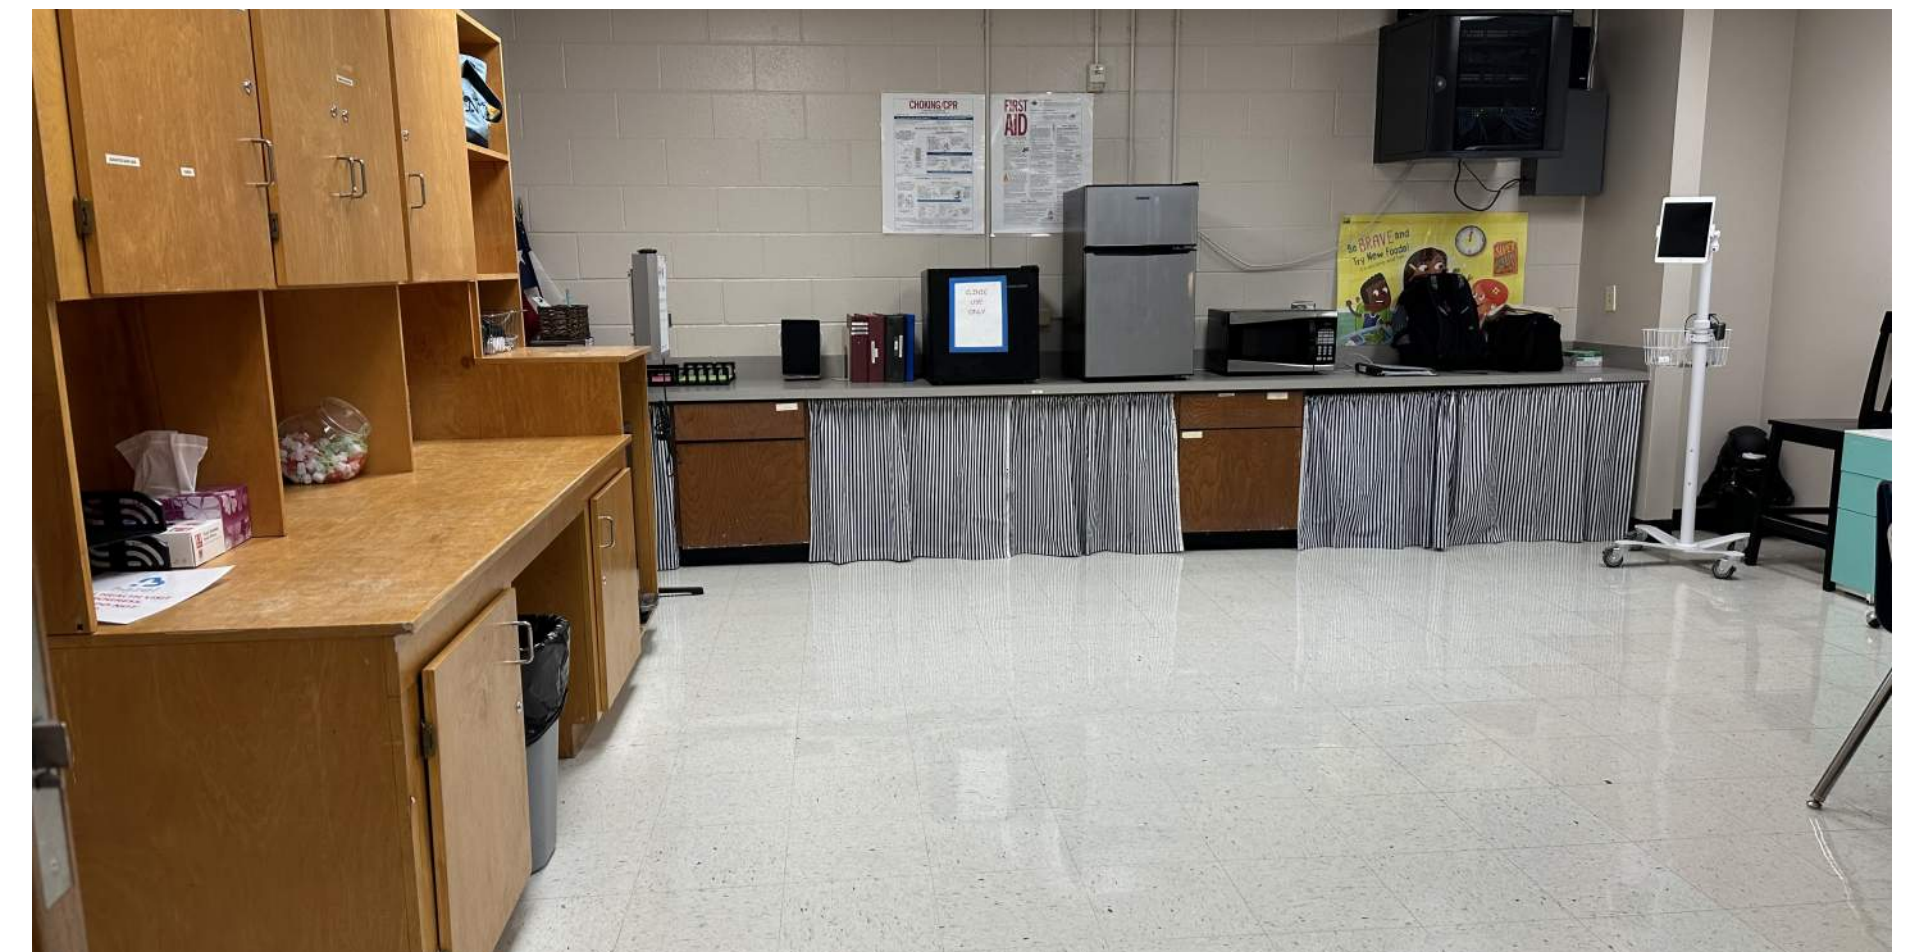
CAMPUS OVERVIEW - LUCILLE NASH ELEMENTARY SCHOOL

- Site Circulation Security Fencing/Parking
- Sidewalk repairs/replacement/clean
- Accessible path to play area
- Replace basketball goals
- Paving repairs/replacement/Restripe
- Irrigation
- Remove unused fencing
- Replace gutters and downspouts, tie into storm
- Address erosion
- Replace sealant
- Provide accessible ramps at entry/exit doors
- Dumpster screen
- Address traffic flow

- Replace flooring at corridors
- Replace ceiling at entry
- Replace restrooms not ADA
- Replace water fountains
- Replace wood doors and hardware not ADA
- Repaint door frames
- Replace damaged ceiling
- Replace wood casework
- Replace damaged raised floor at high density shelving

- Electrical- Replace exterior lighting
- Fire Alarm- Replace
- Provide Sprinkler
- PA- Replace Exterior
- Plumbing- significant issues with cast iron sanitary
- Network, Emergency Call and Security Camera Upgrades
