| OCTOBER 26, 2023

KAUFMAN ISD

LRFP COMMITTEE MEETING NO. 2

CAMPUS OVERVIEW - HELEN EDWARDS EARLY CHILDHOOD CENTER

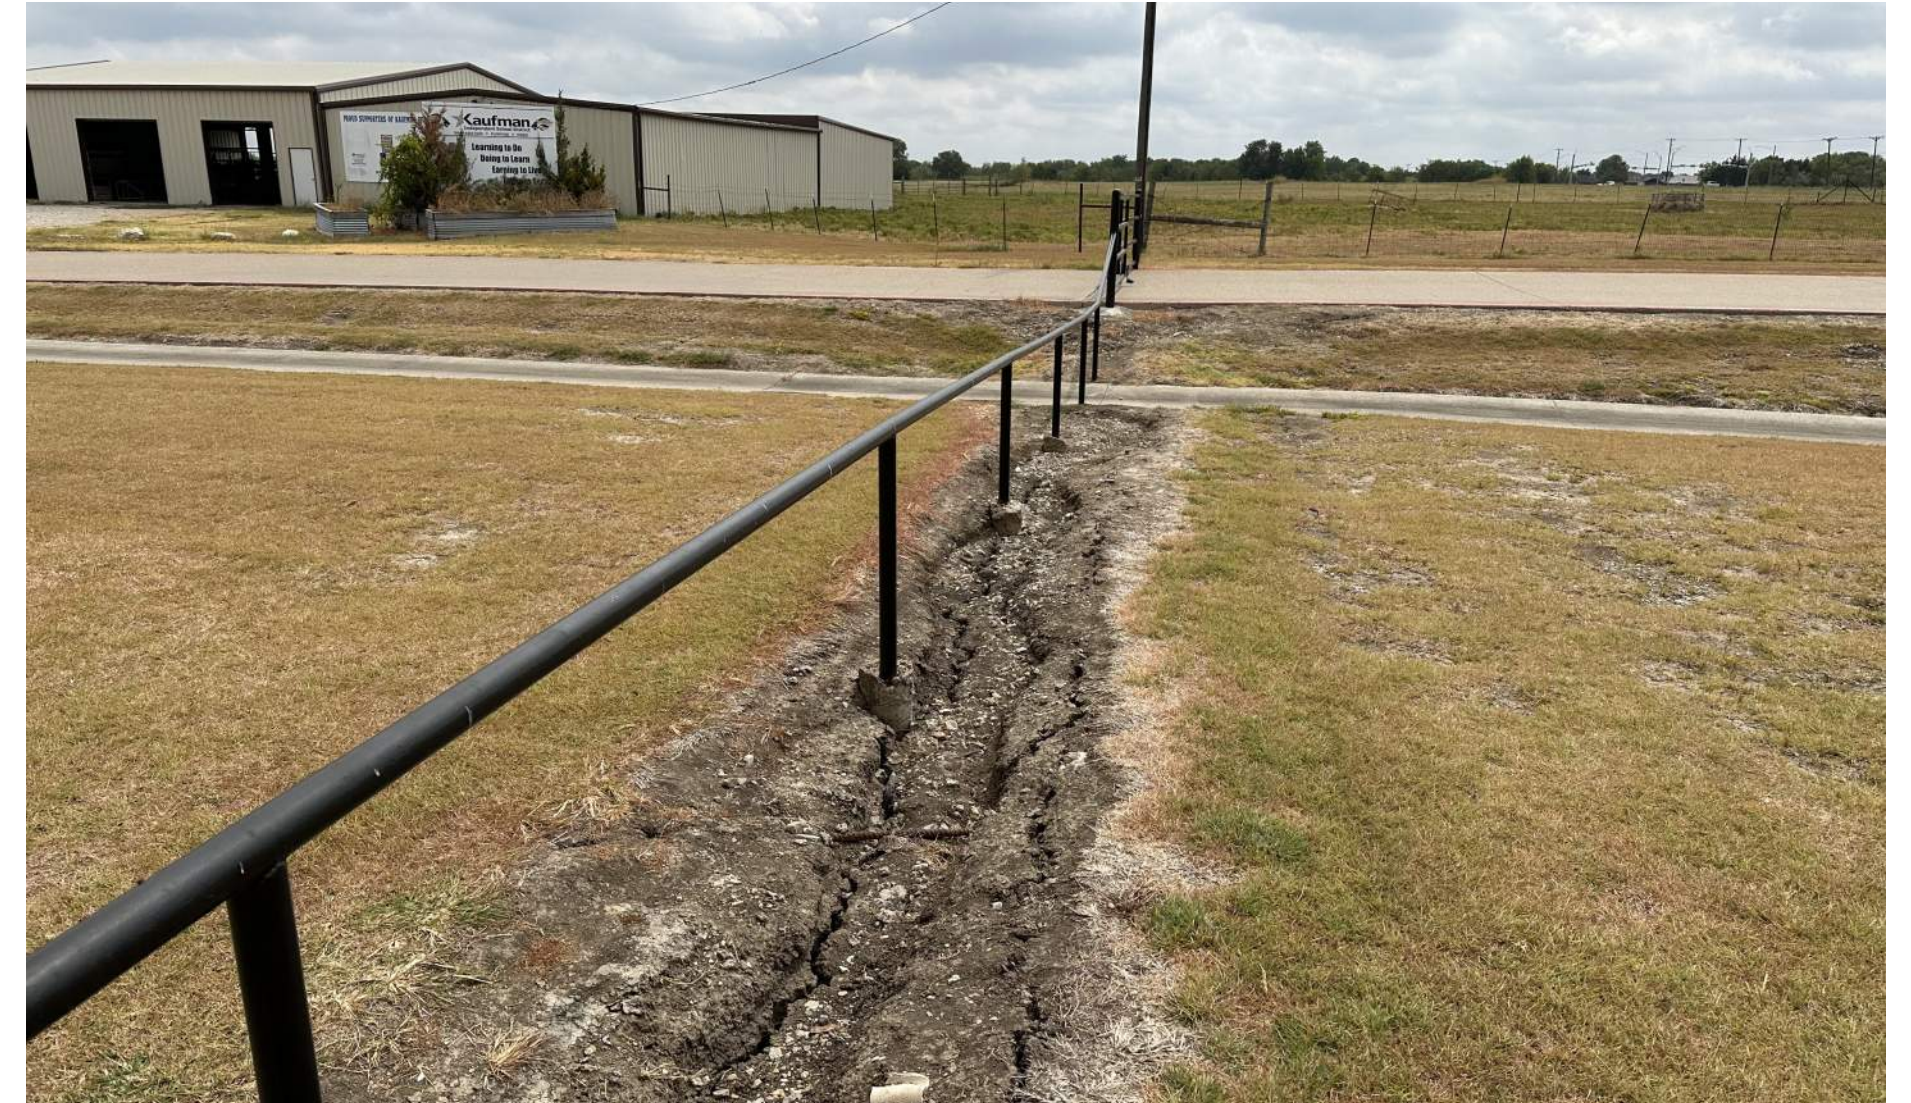
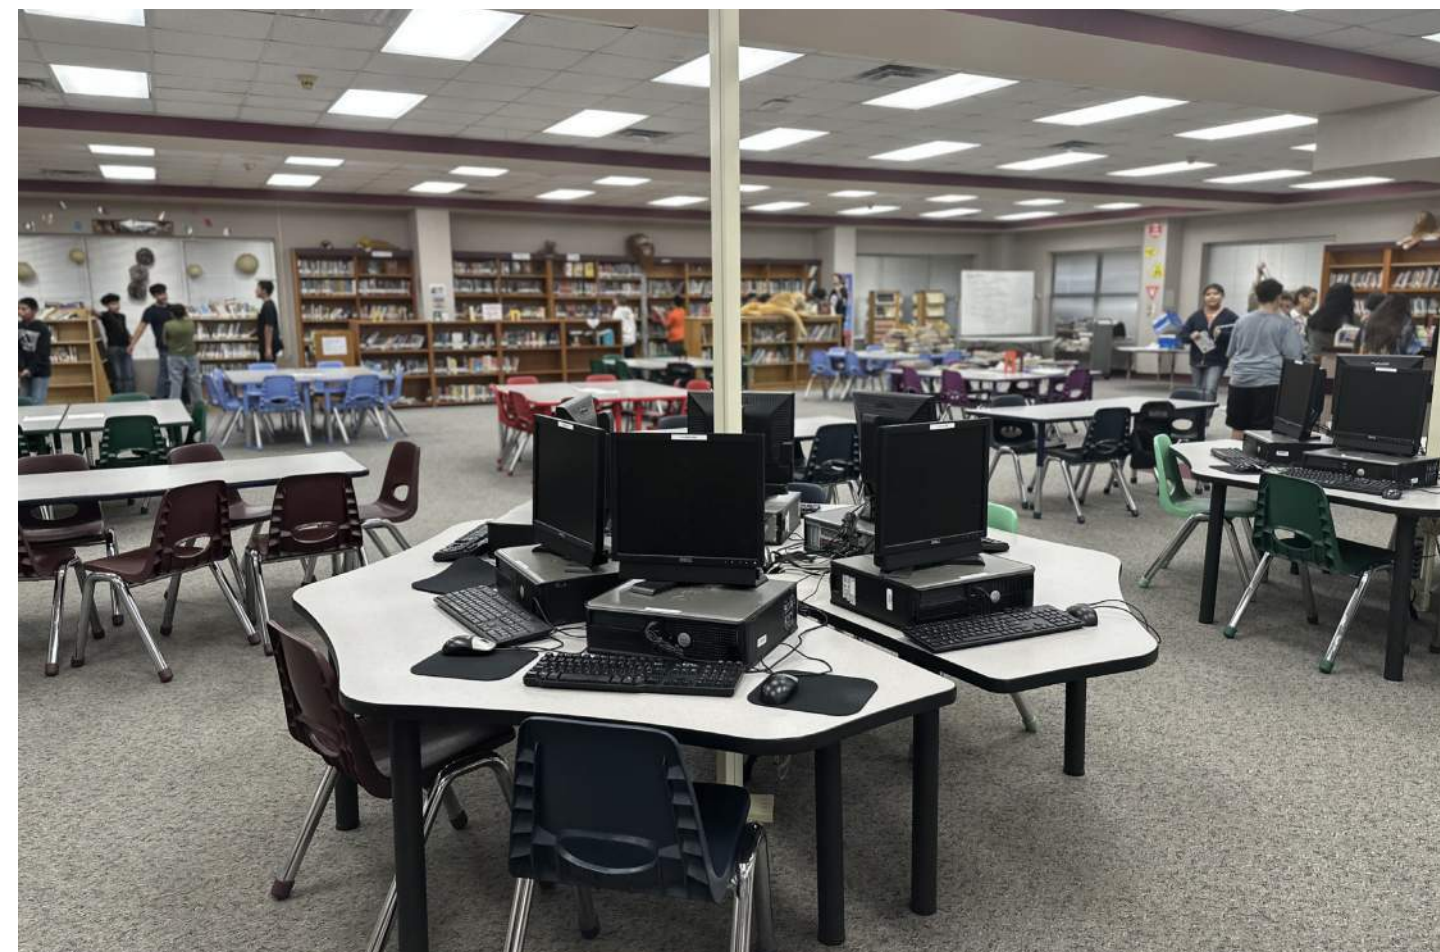
CAMPUS OVERVIEW - NORMAN JR. HIGH SCHOOL

- Water backs up into building at front
- Sidewalk repairs/replacement/clean
- Paving repairs/replacement
- Irrigation
- Replace gutters and downspouts, tie into storm
- Address erosion
- Replace sealant

- Replace exterior aluminum doors and older windows
- Replace sealant
- Repaint exterior steel doors and metal

- Replace VCT flooring at corridors
- Replace ceilings
- Replace restroom sinks not ADA, replace ceilings
- Replace wood doors and hardware at closets of classrooms
- Repaint door frames

- Electrical- Replace exterior lighting
- Fire Alarm- Replace
- Provide Fire Sprinkler
- Plumbing areas with no cleanouts
- Network, Emergency Call and Security Camera Upgrades

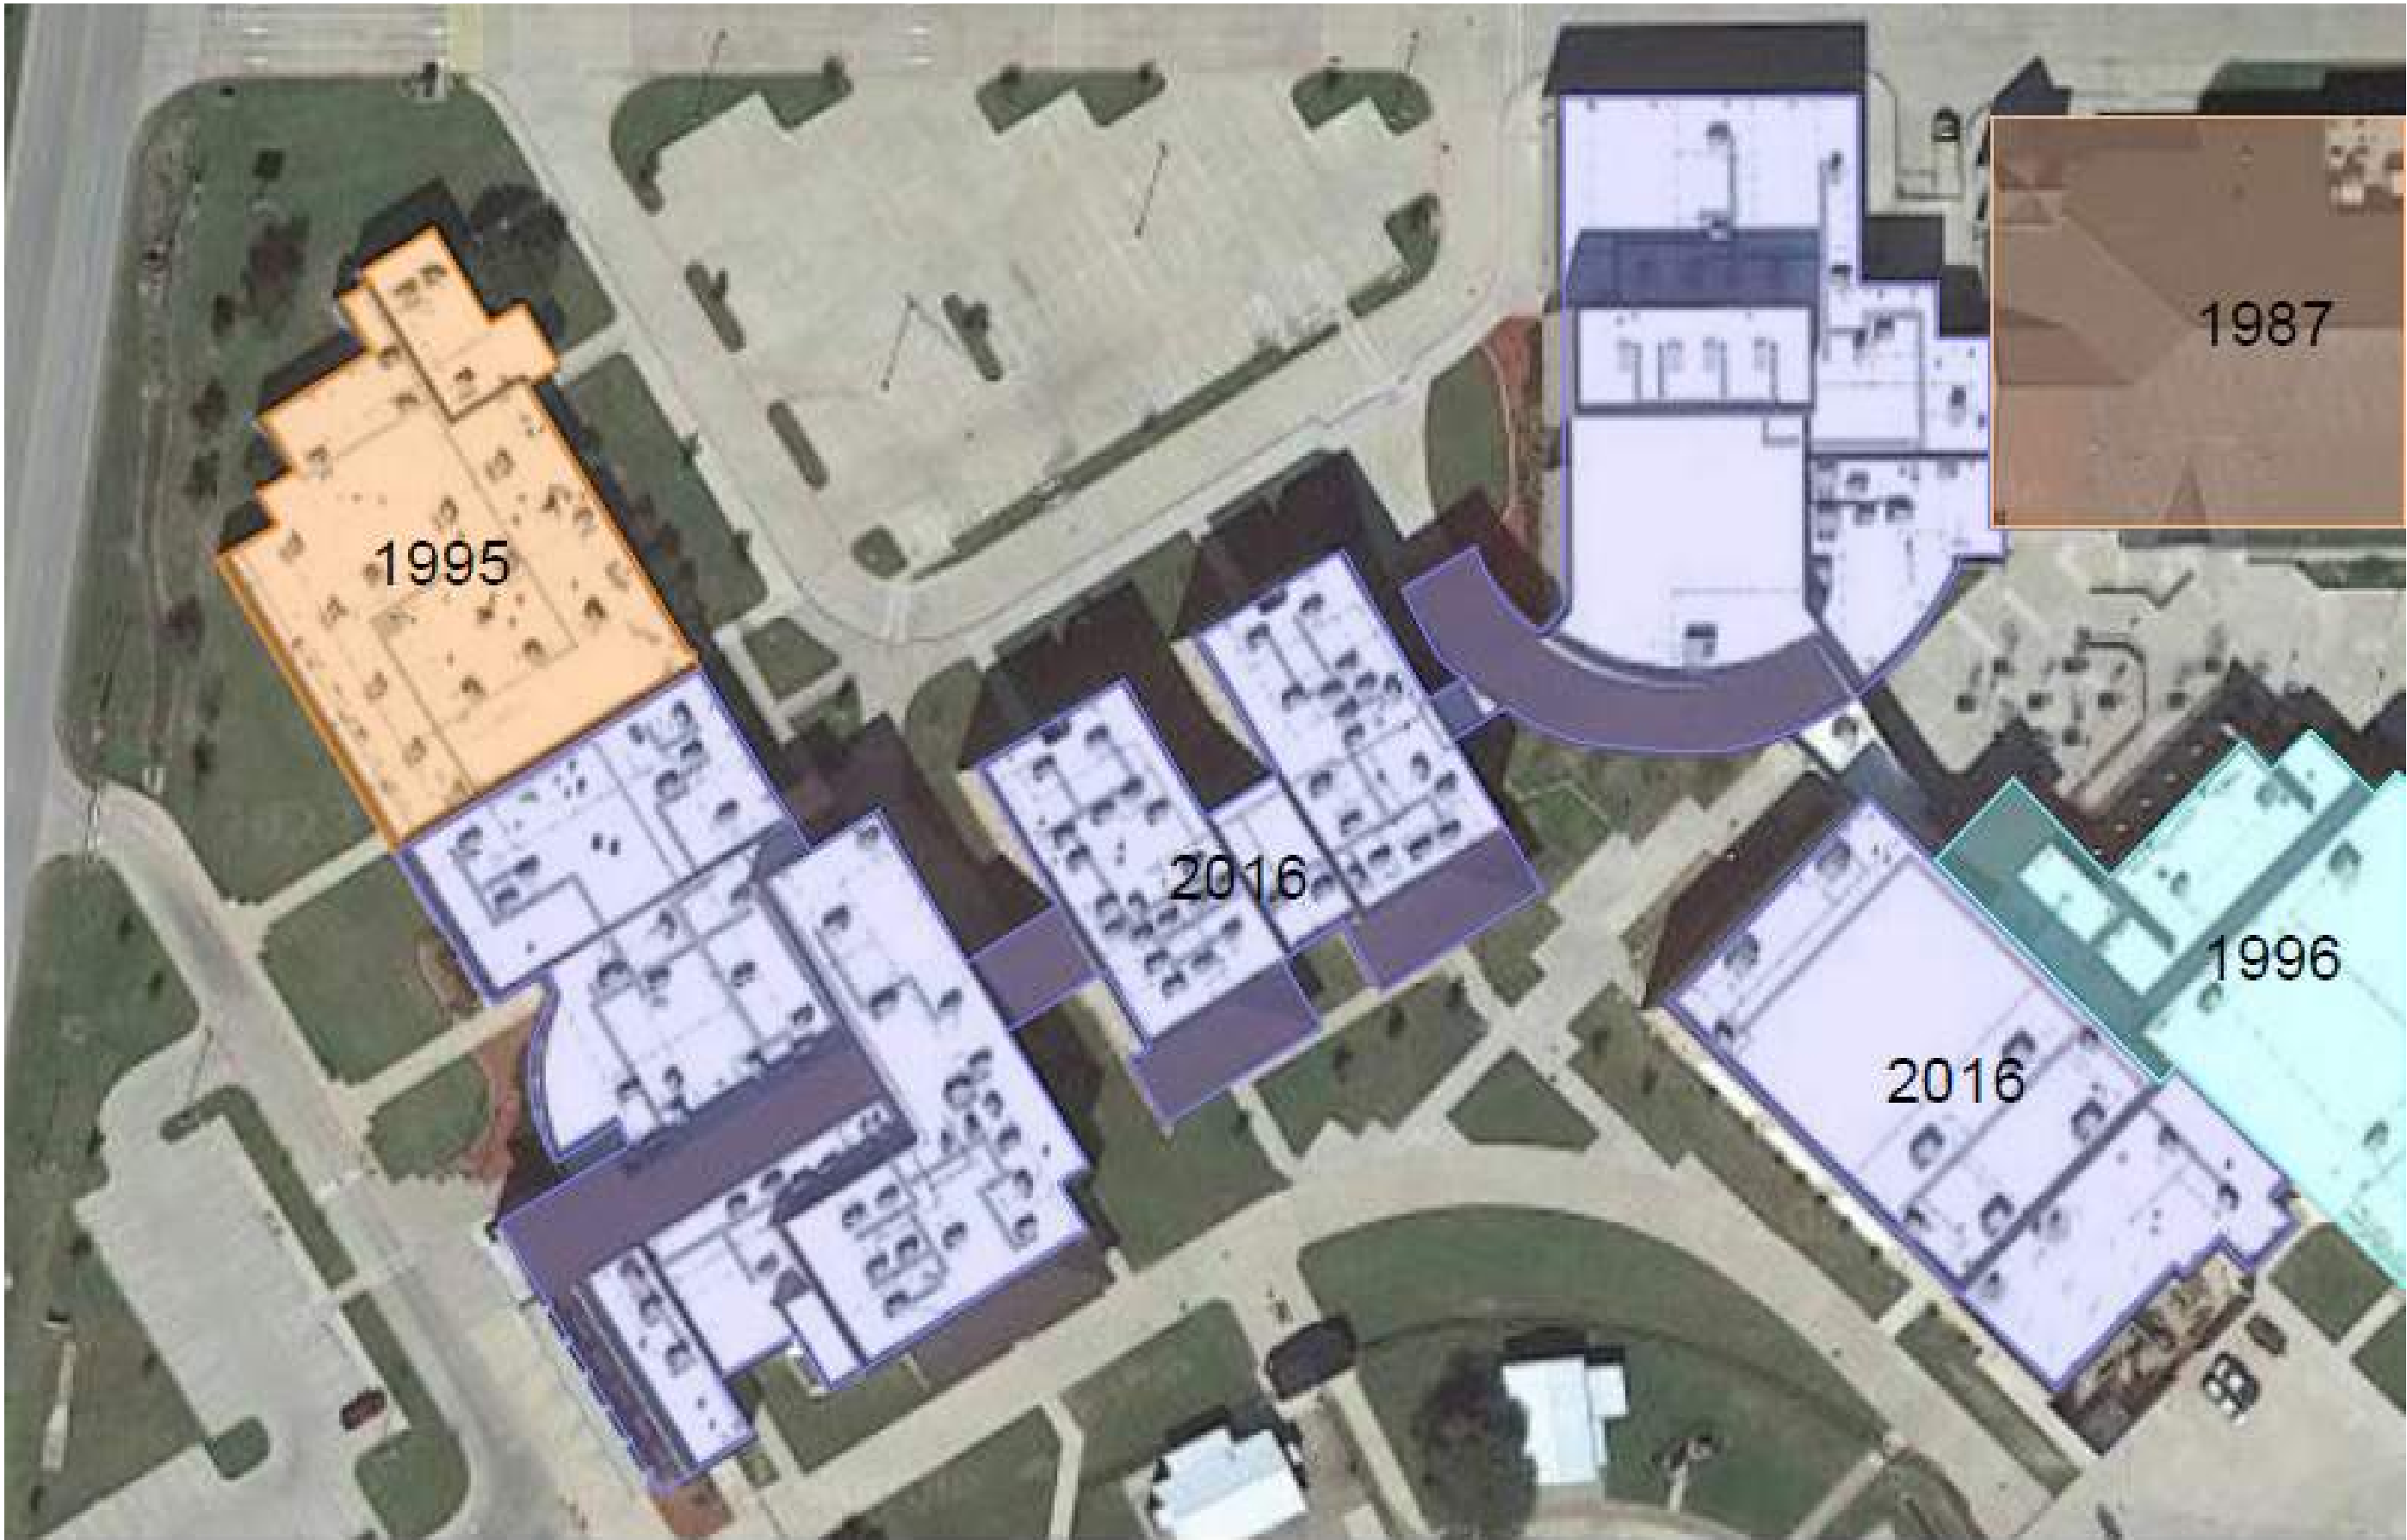
CAMPUS OVERVIEW - KAUFMAN HIGH SCHOOL

BUILT: 1987 | 1995 | 1996 | 2016
TOTAL BUILDING AREA: 265,000 SF
EDUCATIONAL ADEQUACY SCORE (EAI): -19
AS USED FUNCTIONAL CAPACITY: 1,300
STUDENTS AT 104% EFFICIENCY
POTENTIAL FUNCTIONAL CAPACITY: 1,300
STUDENTS - GROSS

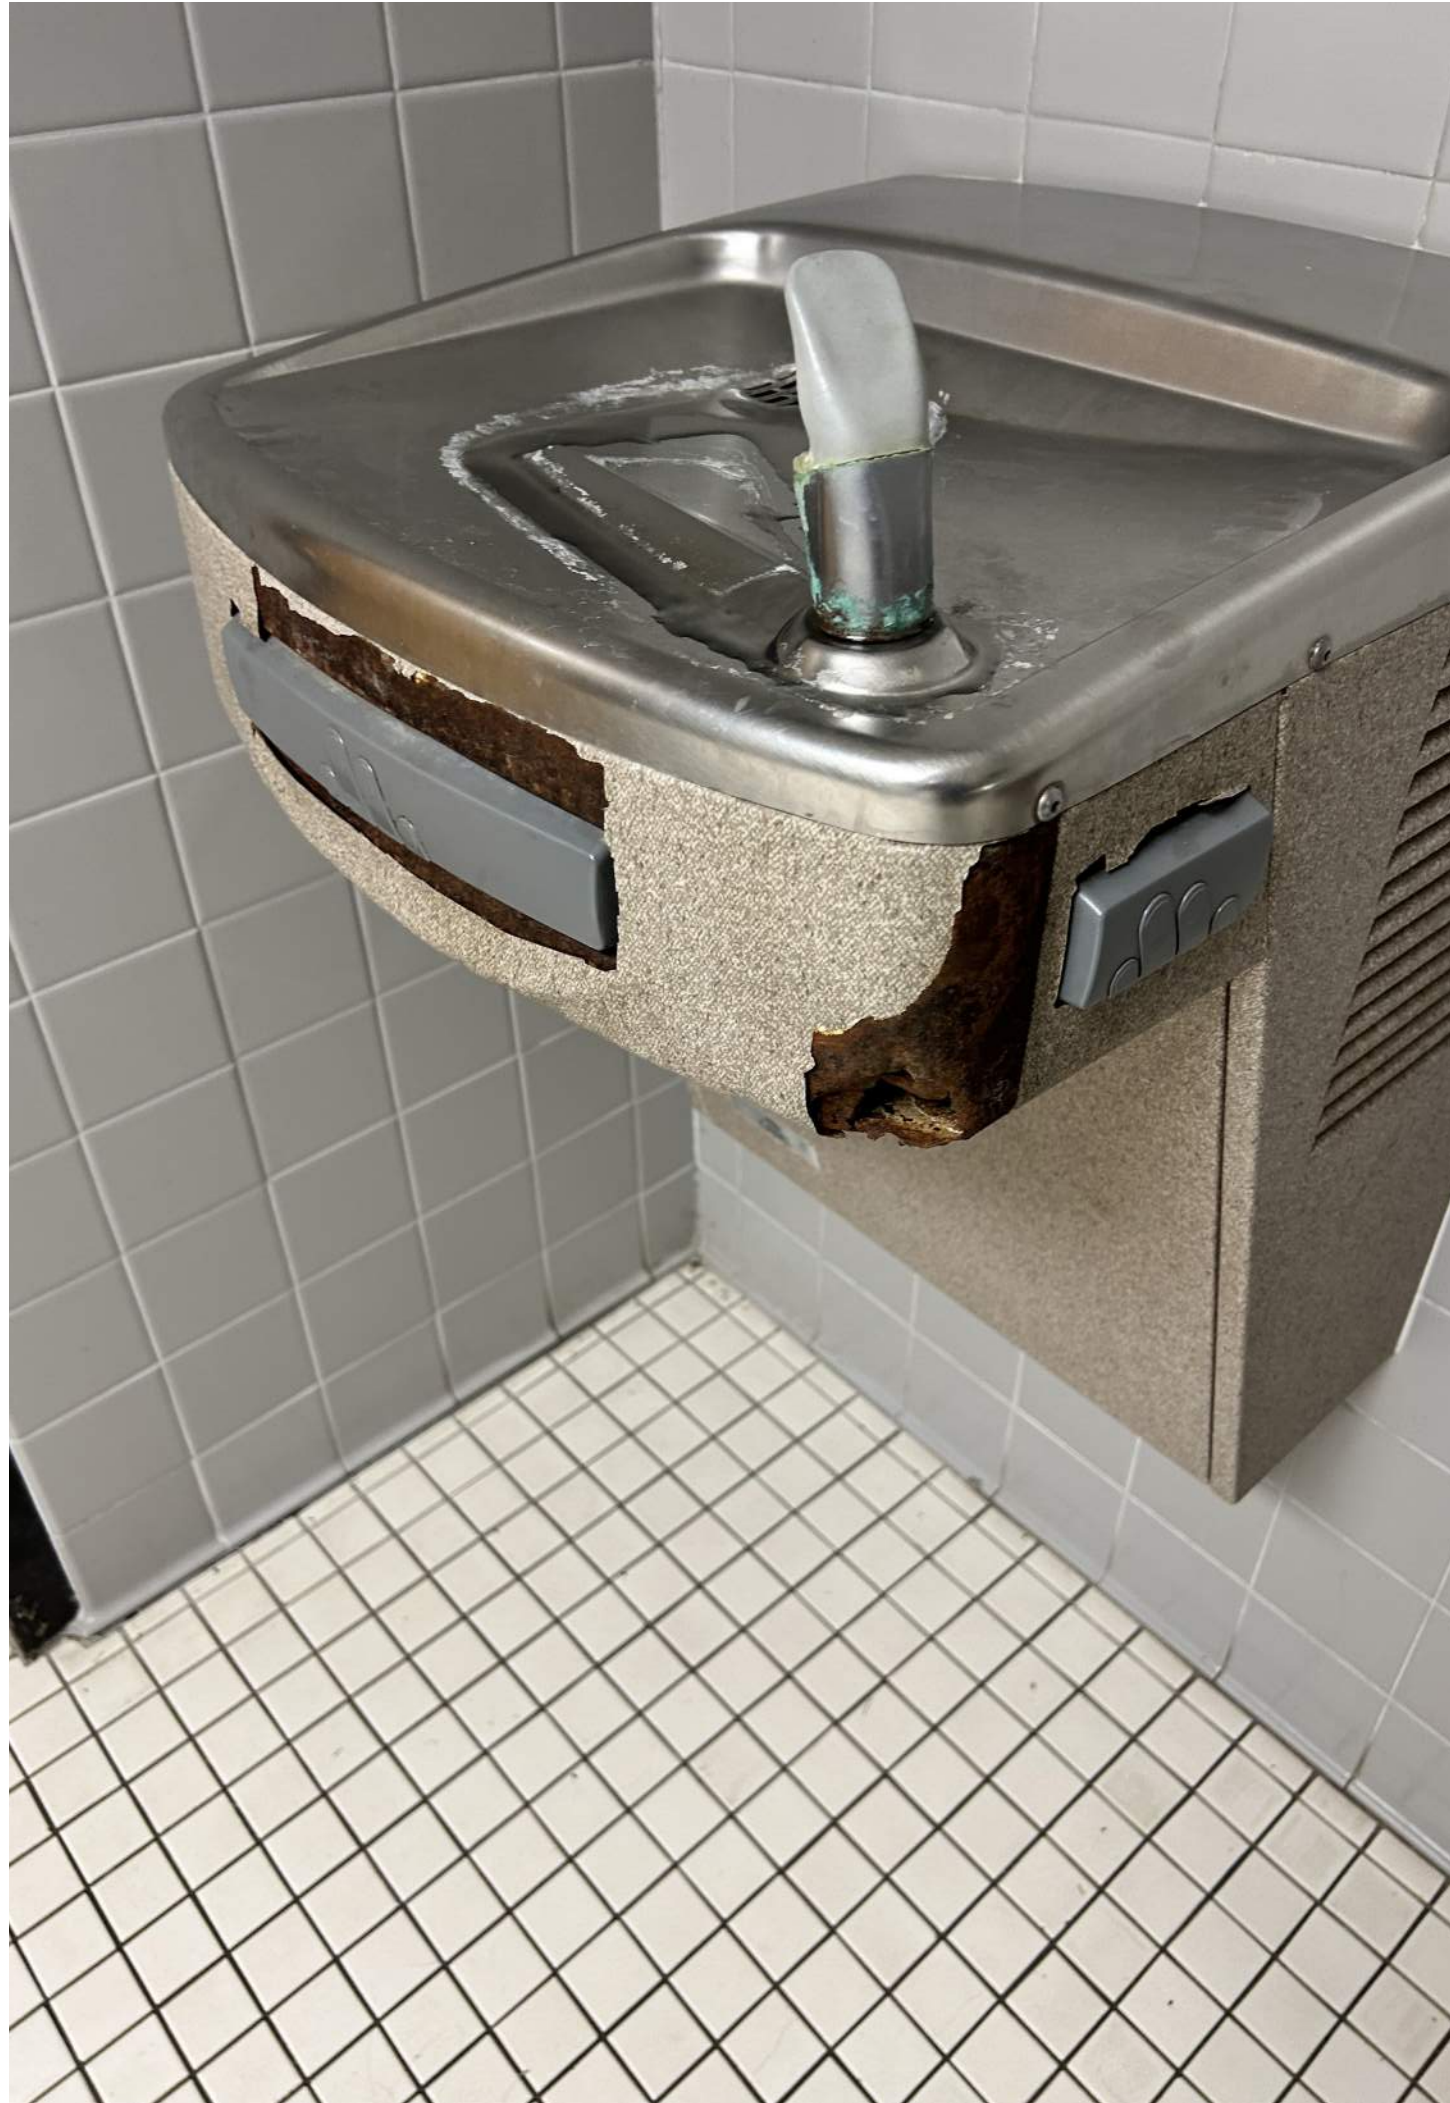
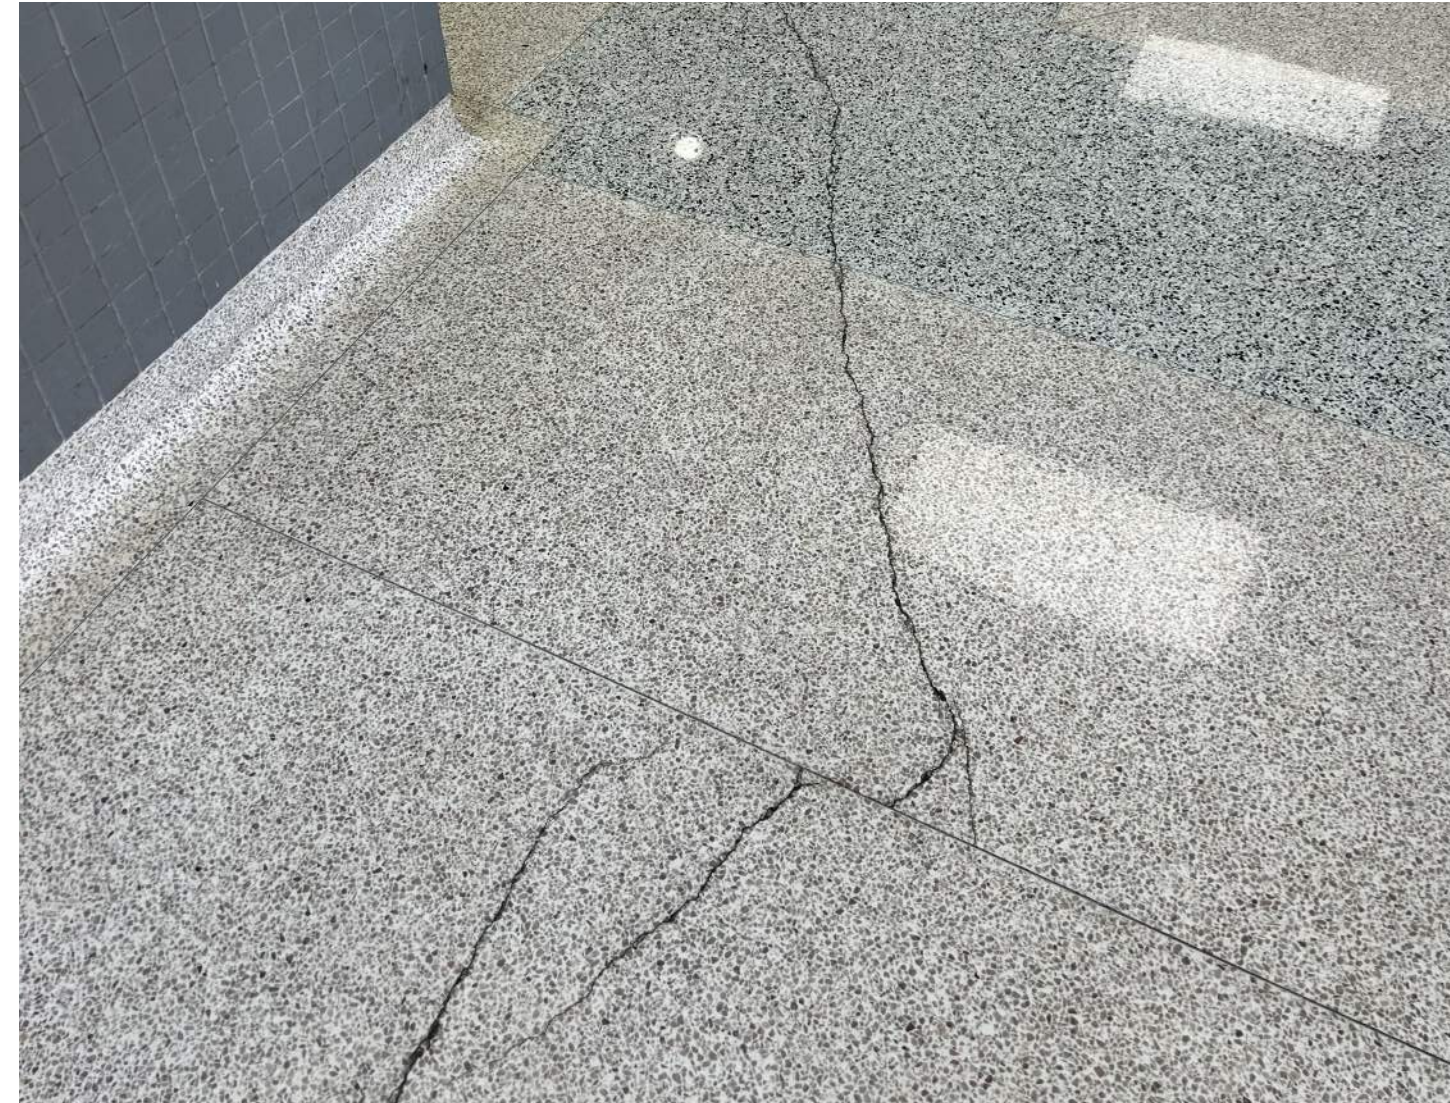
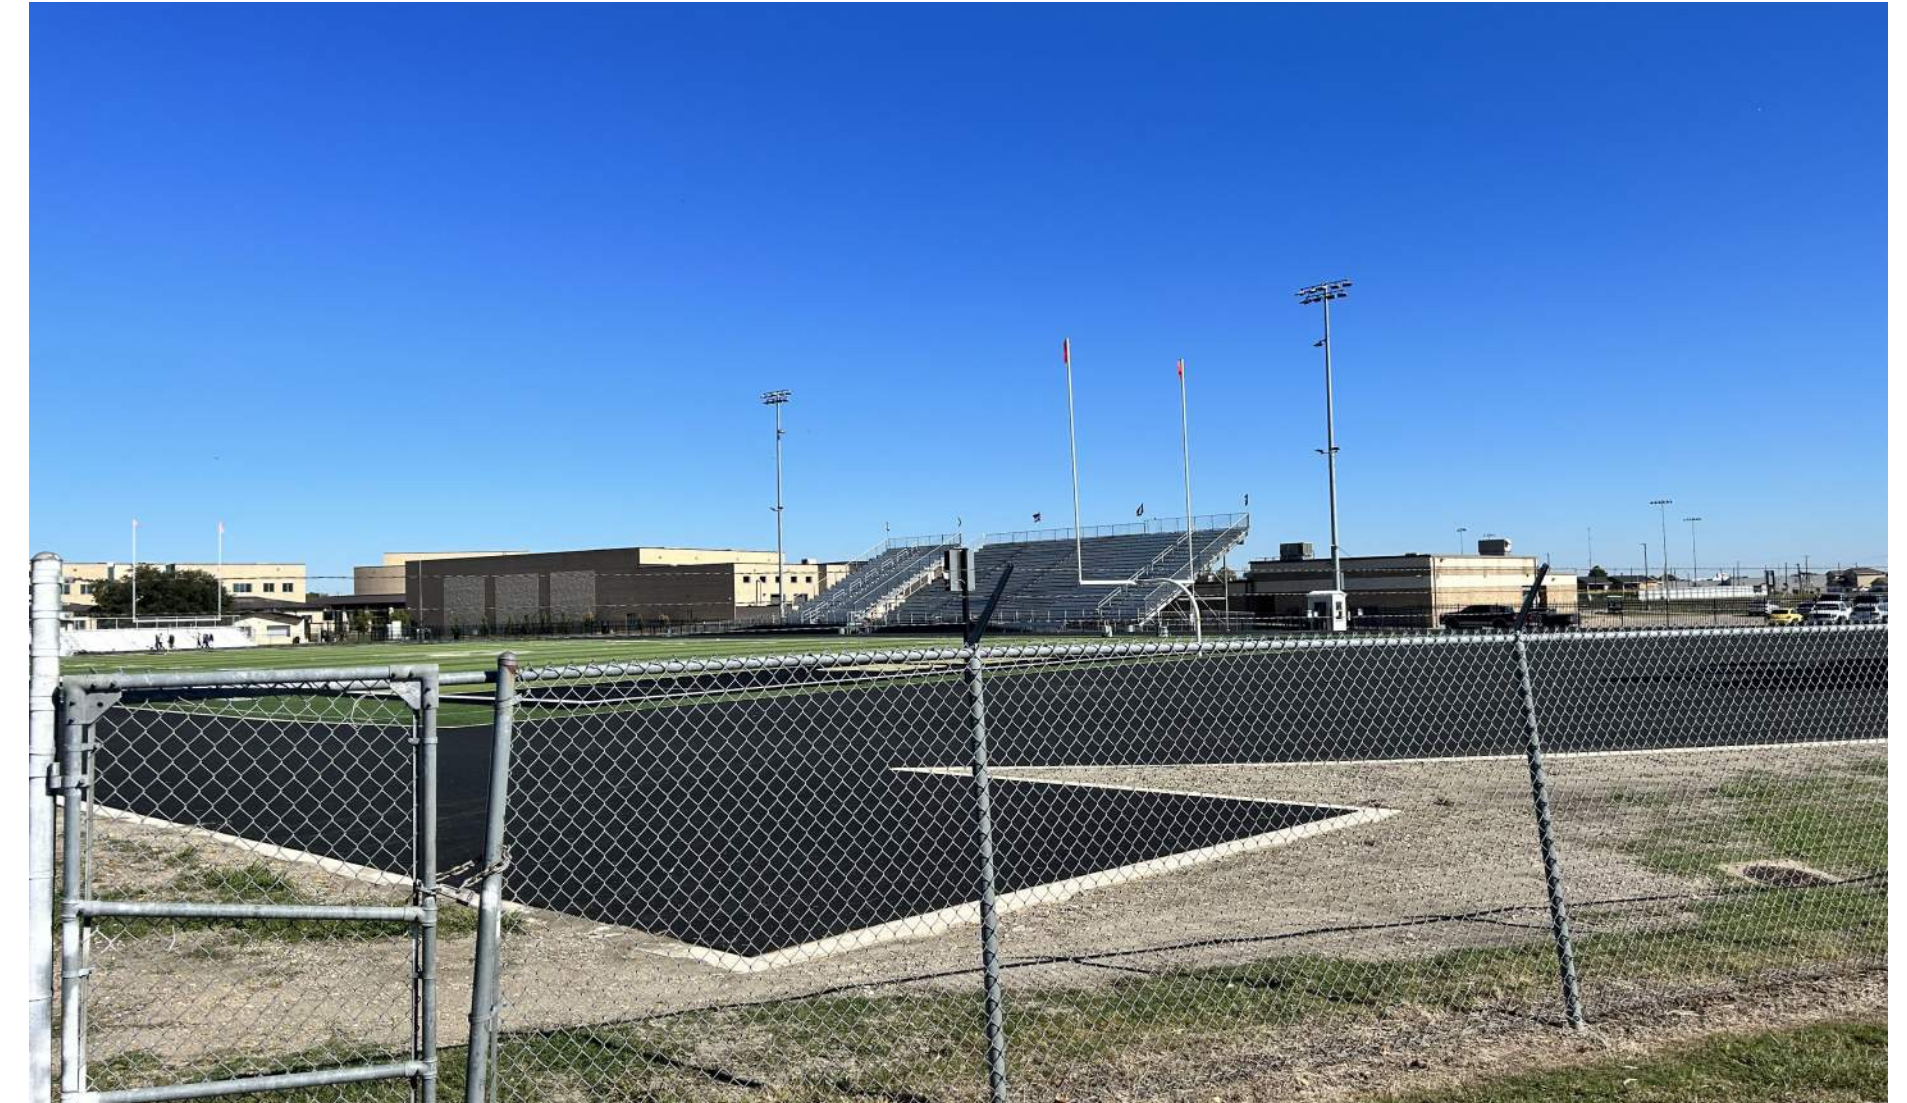
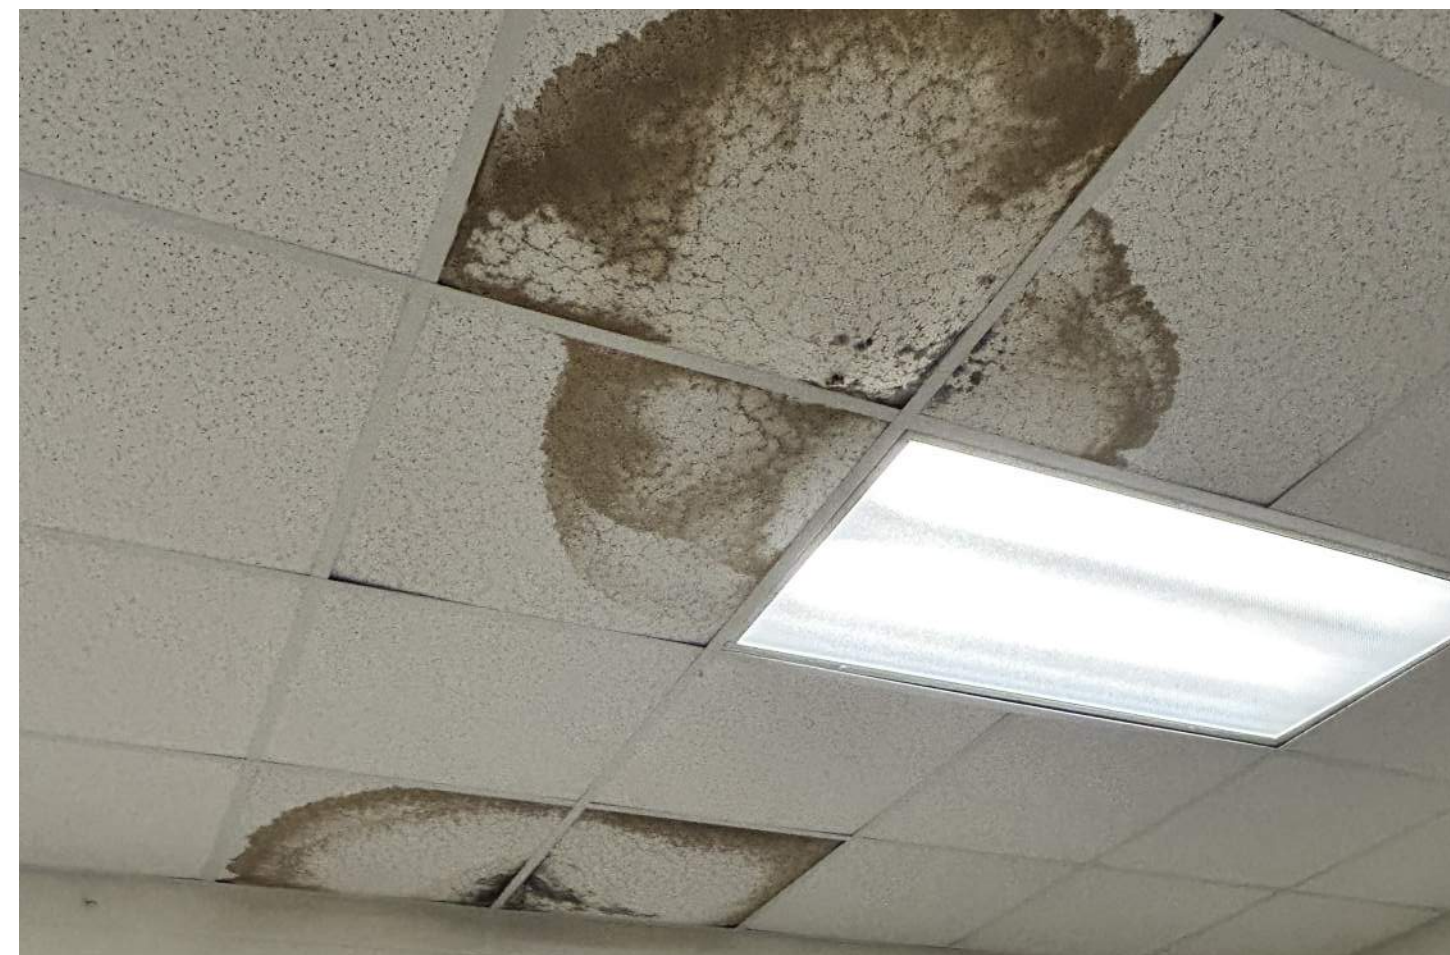
CAMPUS OVERVIEW - KAUFMAN HIGH SCHOOL

- Sidewalk repairs/replacement at oldest portion
- Paving repairs/replacement at oldest portion & dock
- Replace site sealant at flatwork
- Security Fencing/Gates site access & speedbumps
- Address maintainability of planting beds near building where grass is taking over
- Repair/Replace batting cages
- Repair/Replace goal-posts at practice fields
- Repair/Replace fencing at stadium

- Replace exterior aluminum doors and older windows
- Replace sealant at flatwork
- Repaint exterior steel doors and metal
- Security glazing
- Replace/repair roofing above 1987 portion
- Repair damaged metal panel

- Repair/Replace Terrazzo flooring where cracked
- Replace ceiling
- Replace classroom sinks where not accessible
- Replace doors and hardware where not accessible and beyond lifecycle
- Replace restroom finishes and fixtures serving 1987 portion where not accessible and beyond lifecycle
- Replace finishes in cafeteria
- Repair/replace flooring at stage in cafeteria (being used as classrooms)
- Replace finishes in corridors and rooms around cafeteria

- Replace ceilings
- Repaint doors and frames
- Replace laminate doors in locker areas with steel
- Replace damaged doors in public areas
- Address uneven settling, doors out of alignment, cracking
- Upgrade storage
- Upgrade weight room
- Replace lockers, provide enough space for athletes
- Replace elevator
- Replace finishes and fixtures at showers and lockers and public restrooms
- Replace water coolers beyond lifecycle
- Upgrade fire alarm
- Provide fire sprinkler
- Repair damaged flooring
- Provide restrooms on second floor
- Replace finishes on second floor
- Replace glazing where seals broken
- Replace roof
- Provide fire sprinkler

- Replace damaged ceiling tile, repair leak
- Address temporary offices
- Address temporary classrooms
- CTE Shop- upstairs classroom not accessible

- Replace damaged doors and hardware
- Replace damaged and sagging ceiling tile and grid
- Address building settlement, cracking doors misaligned
- Repaint door frames
- Enclose electrical panels, fire riser, and network equipment
- Replace fixtures beyond lifecycle

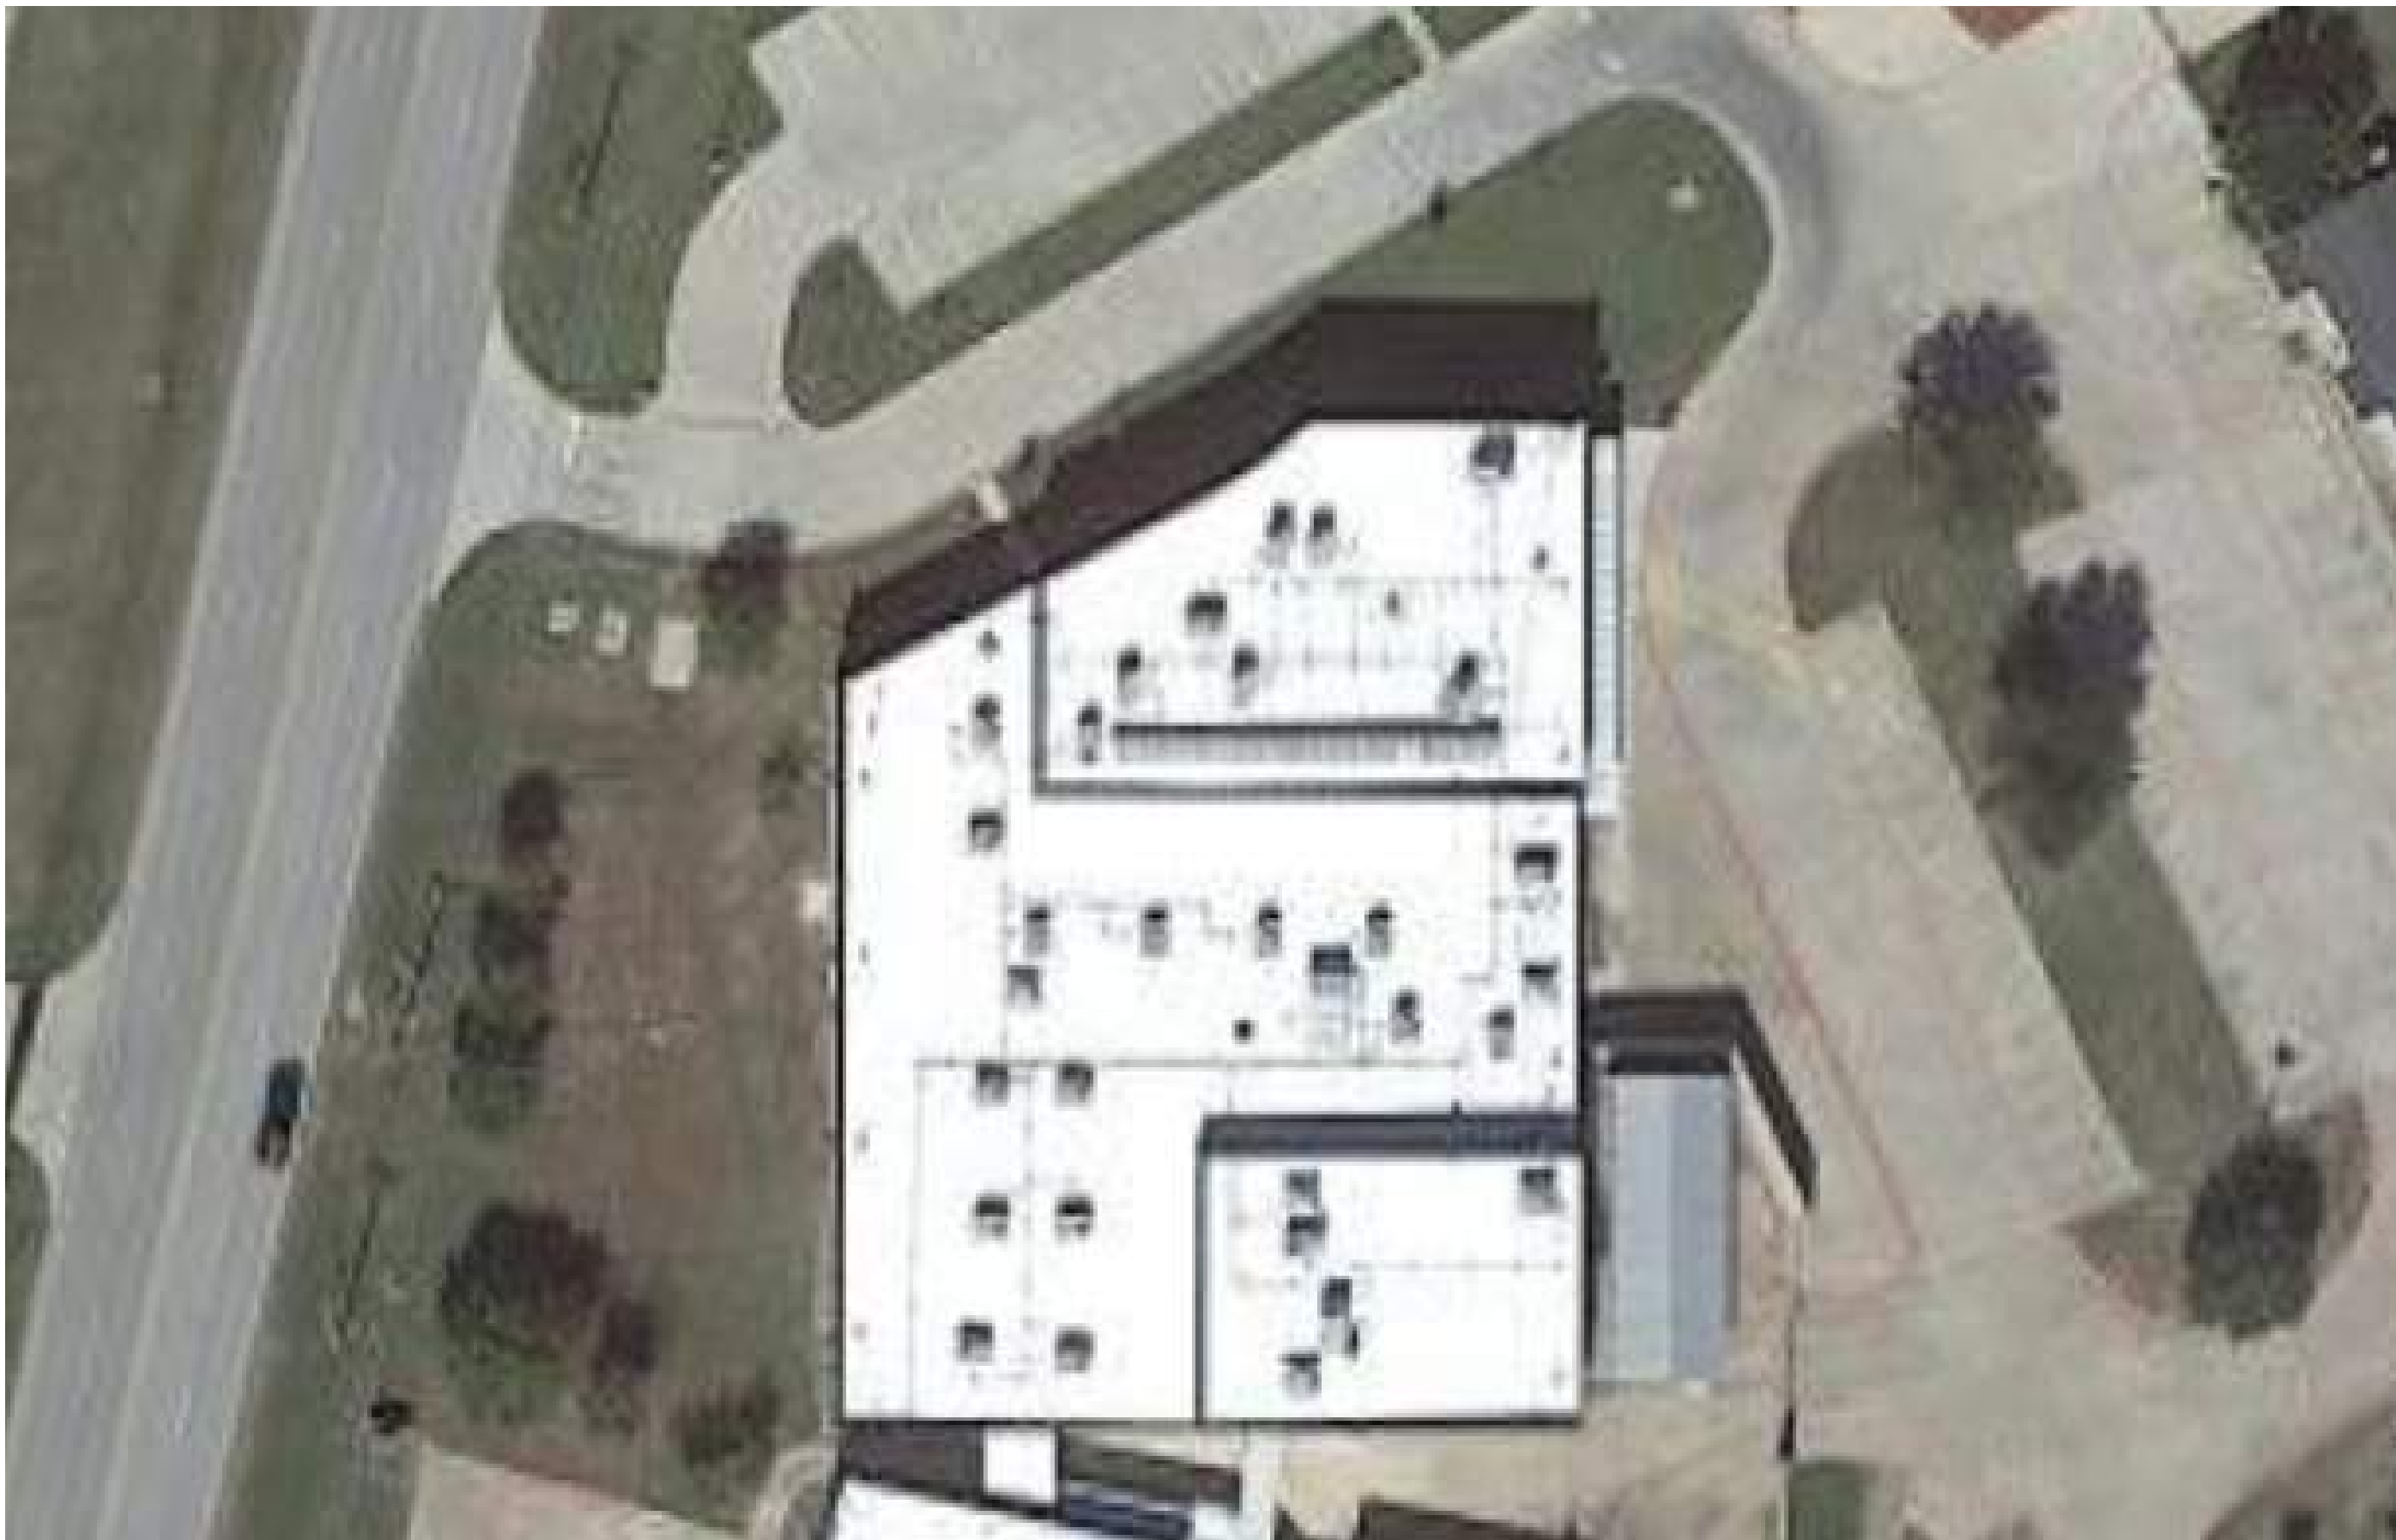
CAMPUS OVERVIEW - GARY W. CAMPBELL HIGH SCHOOL

BUILT: 2016
TOTAL BUILDING AREA: 16,650 SF
EDUCATIONAL ADEQUACY SCORE (EAI): N/A
AS USED FUNCTIONAL CAPACITY: 175
STUDENTS AT 37% EFFICIENCY
POTENTIAL FUNCTIONAL CAPACITY: 175
STUDENTS - GROSS
