| OCTOBER 26, 2023

KAUFMAN ISD

LRFP COMMITTEE MEETING NO. 2

CAMPUS OVERVIEW - HELEN EDWARDS EARLY CHILDHOOD CENTER

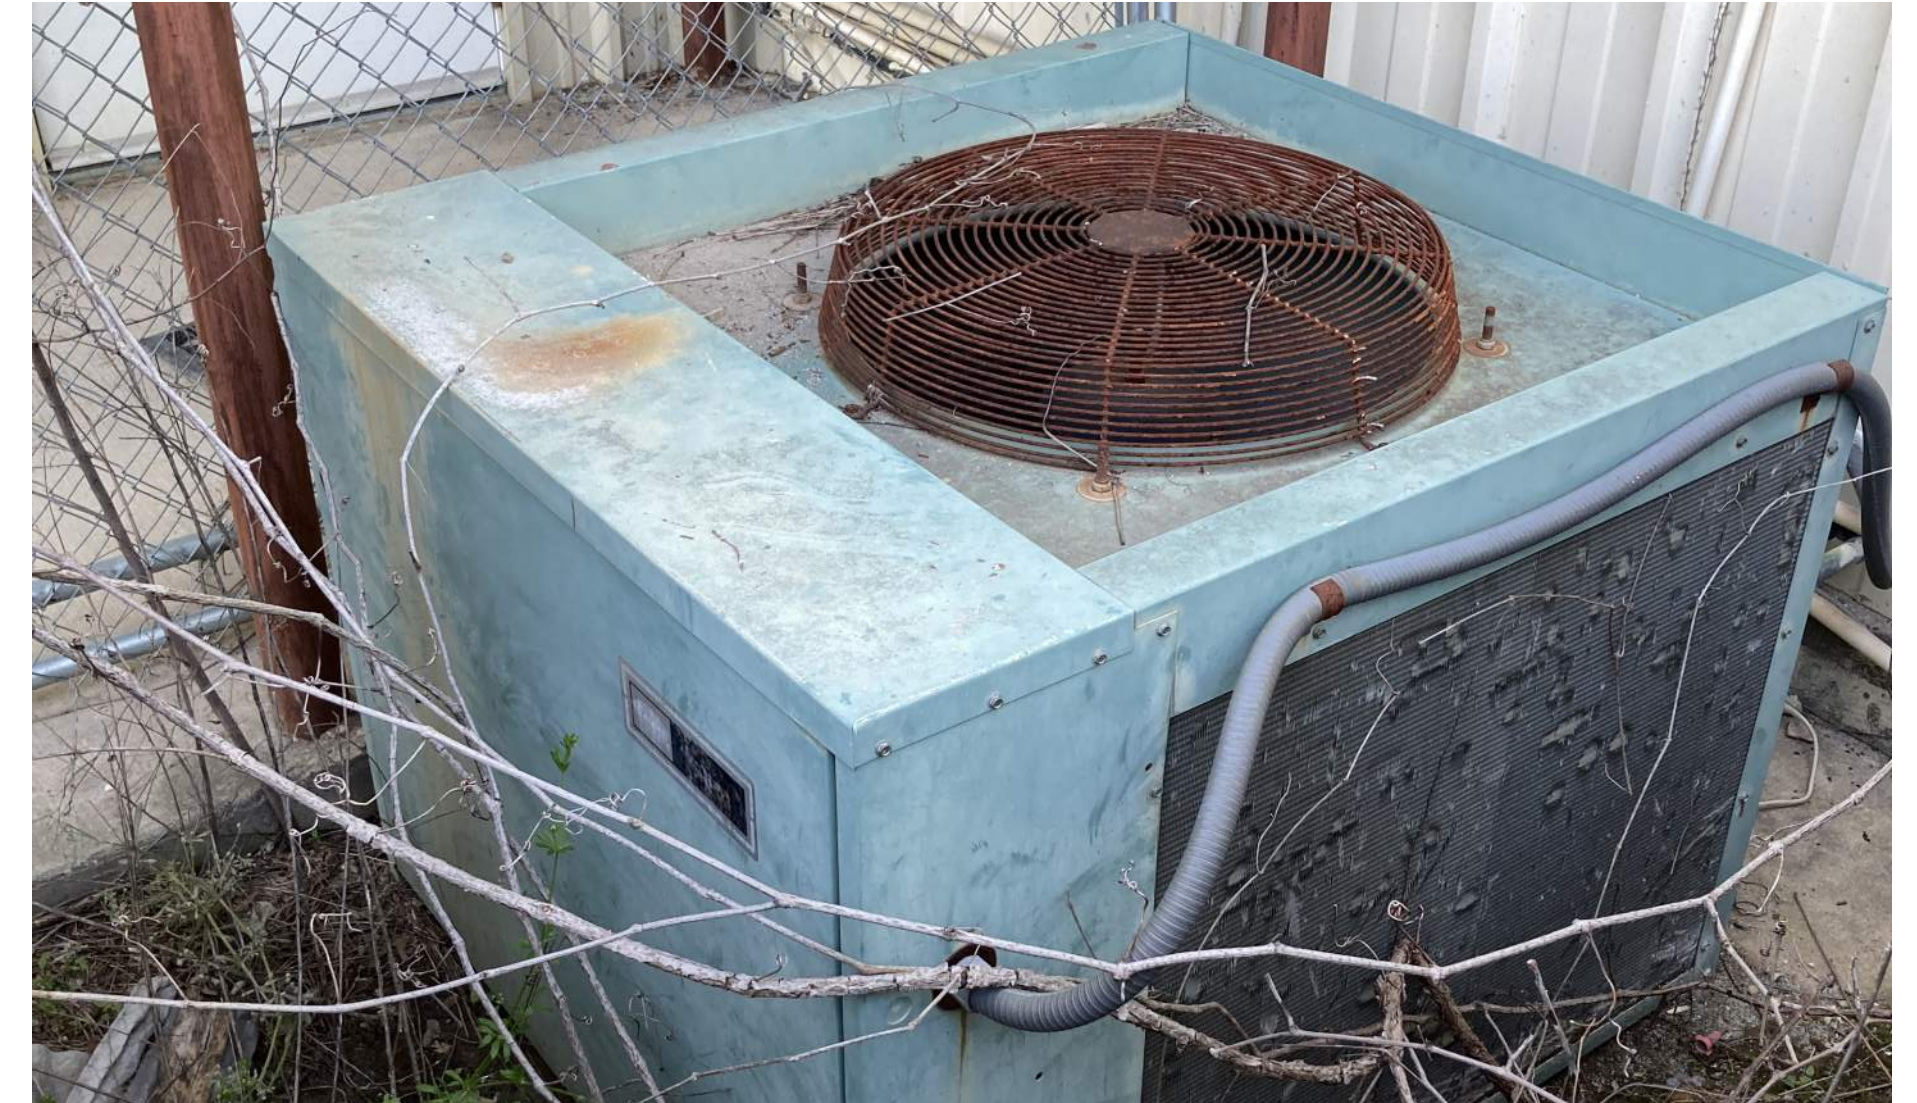
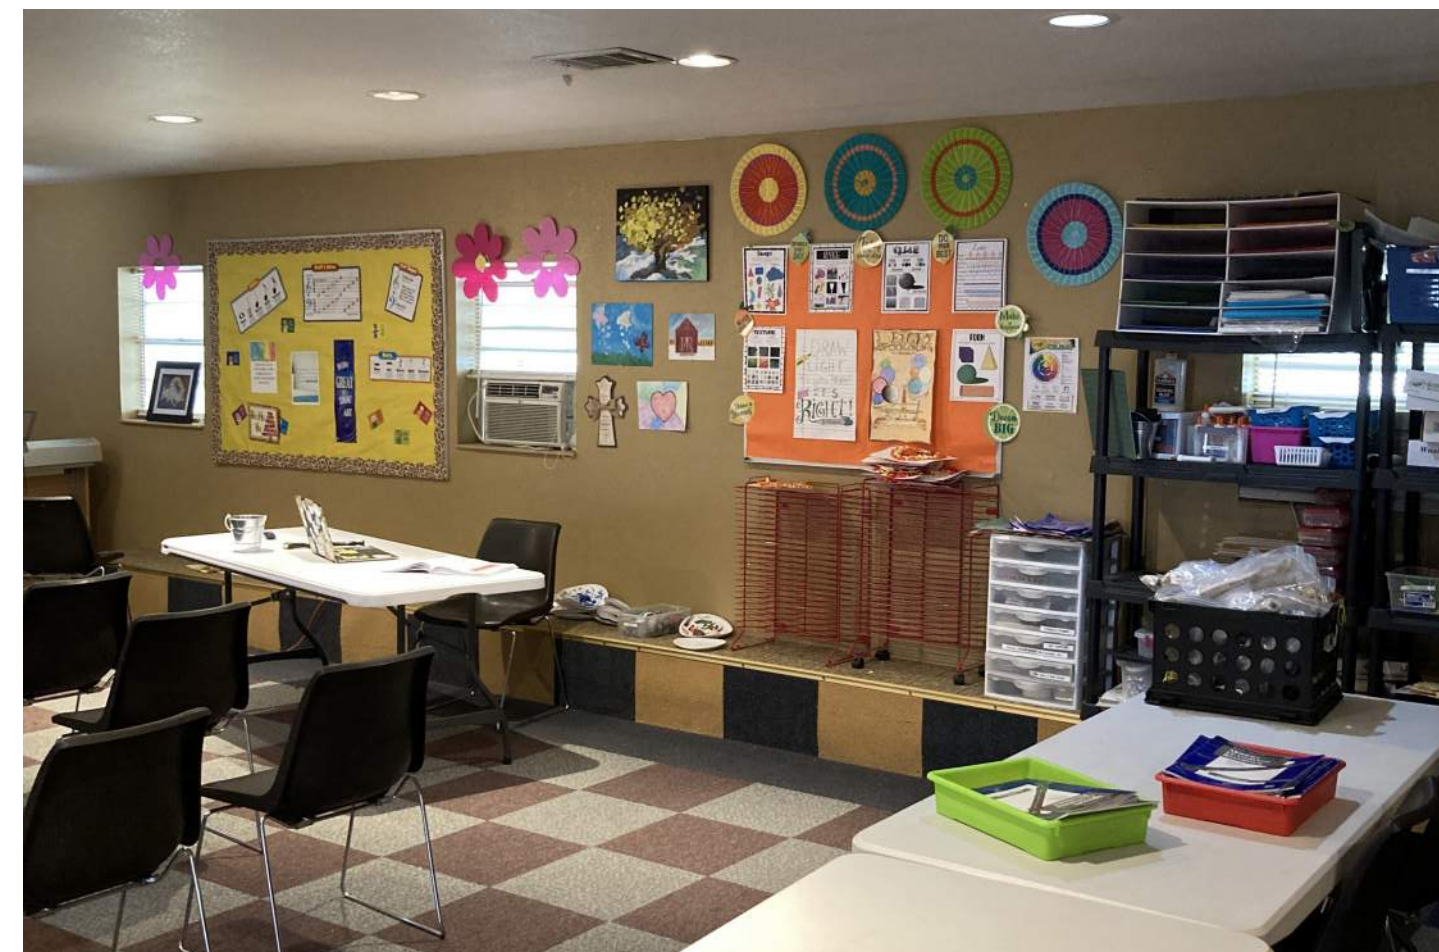
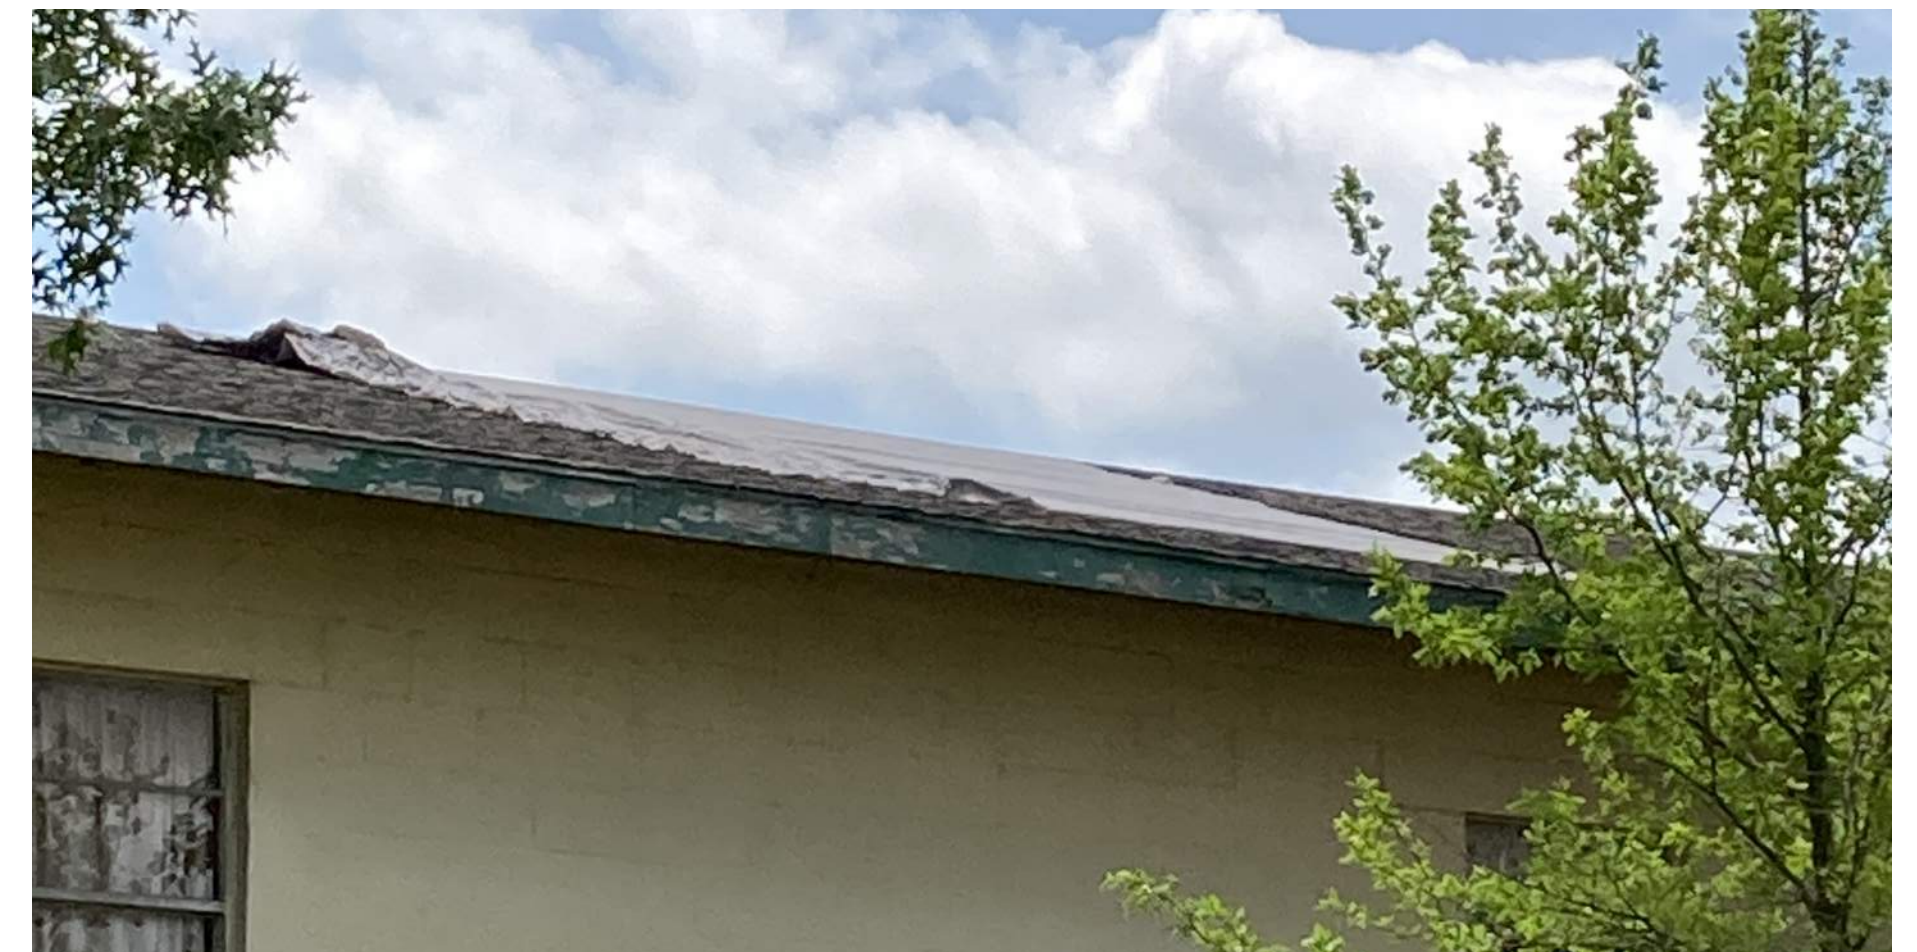
CAMPUS OVERVIEW - CHURCH PROPERTY

- Replace paving
- Provide compliant fire access to all buildings
- Regrade and replace sidewalk to provide accessible access to all buildings
- Security Fencing/Gates site access

- Replace all doors and windows and hardware to be accessible
- Repair Cracked CMU, address foundation settlement
- Repaint all exterior
- Security glazing
- Replace roofing
- Replace awnings
- Replace damaged metal panel

- Replace majority of flooring, carpet and VCT
- Replace ceilings
- Replace restrooms, update to current code and accessibility standards
- Replace doors and hardware to be accessible
- Repaint all walls
- Replace casework

- Electrical- Replace exterior and interior lighting
- Fire Alarm- Provide/replace
- Provide Fire Sprinkler
- Replace HVAC
- Replace hot water service
- Network, Emergency Call and Security Camera Upgrades
- Replace electrical service, transformer, panels, etc. to meet current code
