2023 - 2024 Ventilation Assessment

Saint Paul Public Schools Central Senior High School

Assessment Date:
4/7/2023 - 4/10/2023

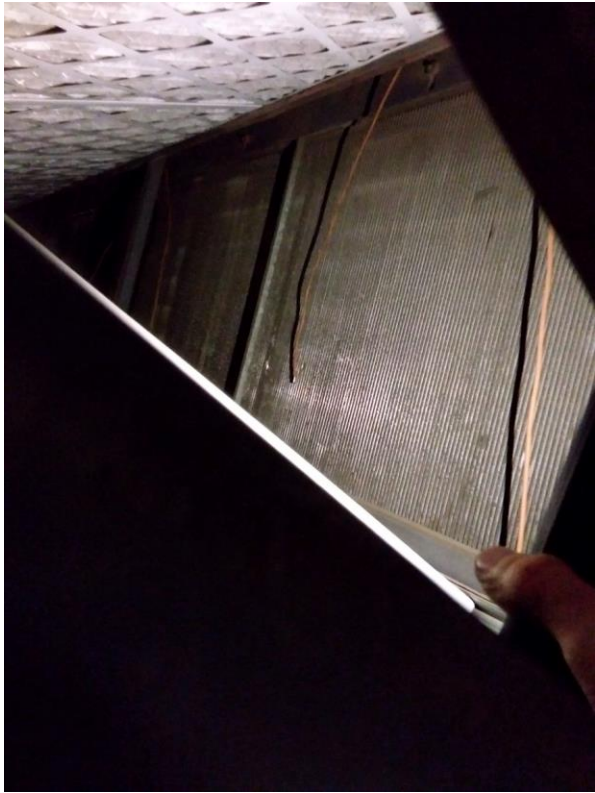
Unit Designation:	AHU_04	
Location of Unit:	Mechanical Room 5101	
Areas Served:	See attached map.	
System Enhancements:	None	
Supply System	Outdoor Air	Cleanliness and Observations
Type <ul style="list-style-type: none"> • Supply System - VAV • Heating - Hot Water • Cooling - None • Energy Recovery Unit (ERU) - None 	<p>Outdoor air intake is accessible</p> <p>Outdoor air intake is located on an exterior wall.</p> <p>No nearby pollution sources were found.</p>	<p>Outdoor air filters are not present.</p> <p>Return air filters are not present.</p> <p>Mixed air pre-filters are not present. Mixed air main filters are clean and not in need of replacement (scoring 2 out of 5) and fit well. Mixed air main filters are installed correctly.</p> <p>Drain pans are not applicable or not present. Drain pan condition is not known.</p>
Filter Type - Mixed <ul style="list-style-type: none"> • Pre-filter: None • Main filter: Pleated, MERV 11 	<p>Outdoor air intake is in good condition.</p>	<p>Heating coils are dirty.</p> <p>Heat wheels are not present.</p> <p>Exterior ducting is visible. Exterior ducting insulation is not present.</p> <p>Interior ducting is visible. Interior ducting insulation is in good condition. Interior ducting is dirty.</p> <p>Air handling room is free of trash/chemicals.</p> <p>Outside damper is open, and its condition is good.</p> <p>Return damper is open, and its condition is good.</p> <p>The general condition of the unit is good.</p>

Dirty Coils were observed on units AHU_04, AHU_07, AHU_09, AHU_10, AHU_14, AHU_18, AHU_25 and AHU_26 during the ventilation inspection.

AHU_04
Heating Coils

Recommendation: Impacted/dirty coils can result in poor ventilation air supply as well as be a source for mold and bacterial growth on the coils. Coils should be cleaned annually, or as needed, as identified in the operations and maintenance program.

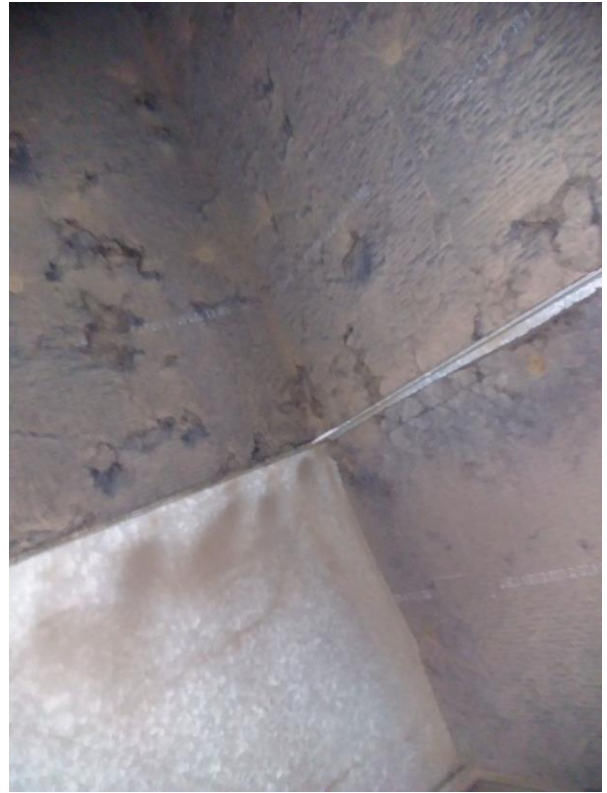
The accessible ductwork for units AHU_04, AHU_05, AHU_06, AHU_07, AHU_12 (100% RA), AHU_15 and AHU_19 was visibly dirty, damaged, or had evidence of moisture at the time of the site inspection.

AHU_04
Interior Ducting

Recommendation: IEA recommends further inspection into the overall condition of the interior ductwork and level of dirt/debris quantified. If deemed a concern, it is recommended that the interior ducting be cleaned by a professional contractor to improve the impact on the IAQ for the supply spaces.

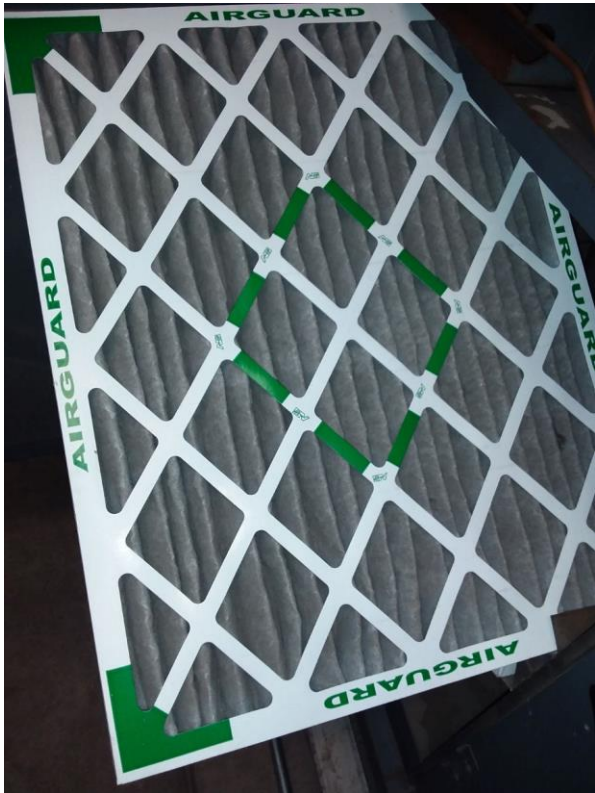
Unit Designation:	AHU_02	
Location of Unit:	Mechanical room 5101	
Areas Served:	Auditorium Storage and Lower Level See attached map	
System Enhancements:	None	
Supply System	Outdoor Air	Cleanliness and Observations
Type <ul style="list-style-type: none"> Supply System - Constant Volume Heating - Hot Water Cooling - None Energy Recovery Unit (ERU) - None 	<p>Outdoor air intake is inaccessible</p> <p>Outdoor air intake is located on an exterior wall.</p> <p>It is not known if there are nearby pollution sources.</p>	<p>Outdoor air filters are not present.</p> <p>Return air filters are not present.</p> <p>Mixed air pre-filters are not present. Mixed air main filters are somewhat dirty and on the border of needing replacement (scoring 3 out of 5) and fit well. Mixed air main filters are installed correctly.</p> <p>Drain pans are not applicable or not present. Drain pan condition is not known.</p>
Filter Type - Mixed <ul style="list-style-type: none"> Pre-filter: None Main filter: Pleated, MERV 11 	<p>Outdoor air intake is in good condition.</p>	<p>Heating coils are clean.</p> <p>Heat wheels are not present.</p> <p>Exterior ducting is visible. Exterior ducting insulation is not present.</p> <p>Interior ducting is not visible. Interior ducting insulation is in an unknown condition. Interior ducting is of unknown cleanliness.</p> <p>Air handling room is free of trash/chemicals.</p> <p>Outside damper is open, and its condition is good.</p> <p>Return damper is open, and its condition is good.</p> <p>The general condition of the unit is good.</p>

AHU_02
Mixed Main Filter Cleanliness

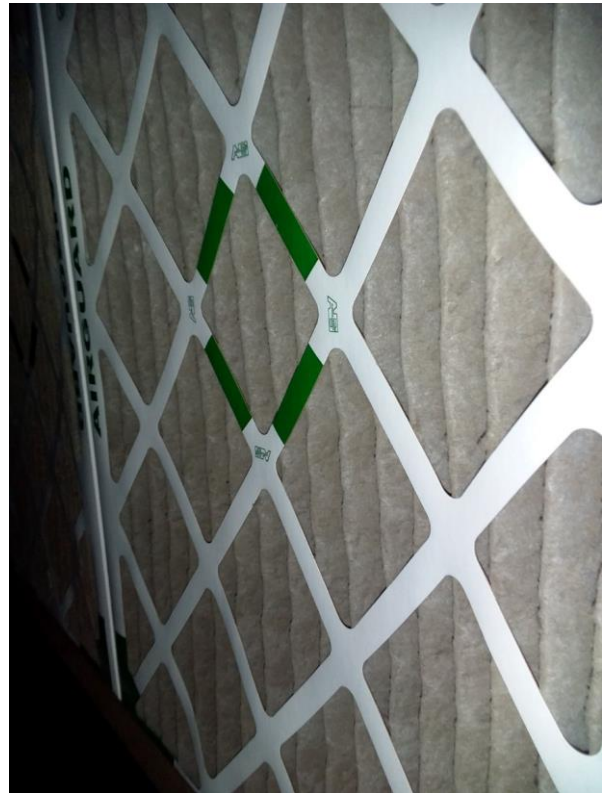
Unit Designation:	AHU_03	
Location of Unit:	Mechanical room 5101	
Areas Served:	Black Box Studio 0202 See attached map	
System Enhancements:	None	
Supply System	Outdoor Air	Cleanliness and Observations
Type <ul style="list-style-type: none"> Supply System - Constant Volume Heating - Hot Water Cooling - Dx Energy Recovery Unit (ERU) - None 	Outdoor air intake is inaccessible Outdoor air intake is located on an exterior wall. It is not known if there are nearby pollution sources.	Outdoor air filters are not present. Return air filters are not present. Mixed air pre-filters are not present. Mixed air main filters are somewhat dirty and on the border of needing replacement (scoring 3 out of 5) and fit well. Mixed air main filters are installed correctly. Drain pans are not plugged. Drain pan condition is good.
Filter Type - Mixed <ul style="list-style-type: none"> Pre-filter: None Main filter: Pleated, MERV 11 	Outdoor air intake is in good condition.	Heating coils are clean and cooling coils are clean. Heat wheels are not present. Exterior ducting is visible. Exterior ducting insulation is in good condition. Interior ducting is visible. Interior ducting insulation is not present. Interior ducting is of unknown cleanliness. Air handling room is free of trash/chemicals. Outside damper is open, and its condition is good. Return damper is open, and its condition is good. The general condition of the unit is good.

AHU_03
Mixed Main Filter Cleanliness

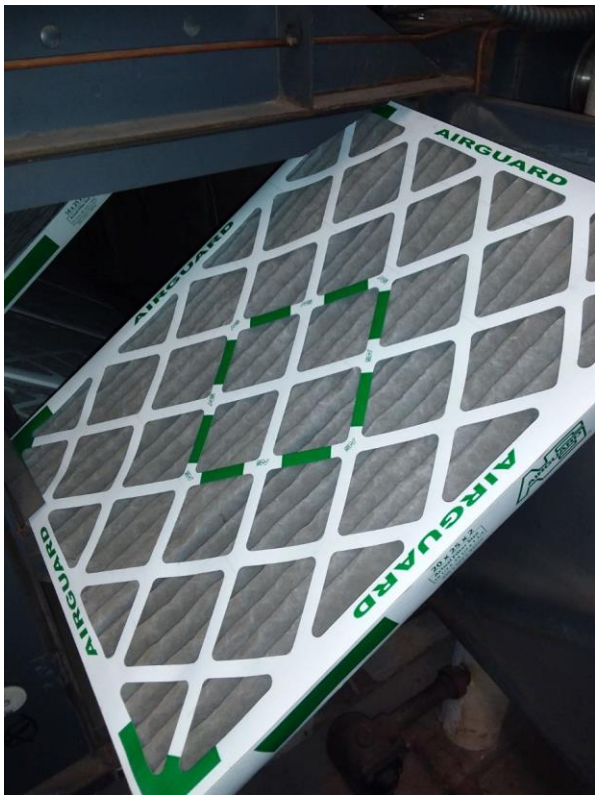
Unit Designation:	AHU_01	
Location of Unit:	Mechanical Room 5101	
Areas Served:	4FL & 5FL Interior South See attached map	
System Enhancements:	None	
Supply System	Outdoor Air	Cleanliness and Observations
Type <ul style="list-style-type: none"> • Supply System - VAV • Heating - Hot Water • Cooling - None • Energy Recovery Unit (ERU) - None 	<p>Outdoor air intake is inaccessible</p> <p>Outdoor air intake is located on an exterior wall.</p> <p>It is not known if there are nearby pollution sources.</p>	<p>Outdoor air filters are not present.</p> <p>Return air filters are not present.</p> <p>Mixed air pre-filters are not present. Mixed air main filters are somewhat dirty and on the border of needing replacement (scoring 3 out of 5) and fit well. Mixed air main filters are installed correctly.</p> <p>Drain pans are not applicable or not present. Drain pan condition is not known.</p> <p>Heat wheels are not present.</p> <p>Exterior ducting is visible. Exterior ducting insulation is not present.</p> <p>Interior ducting is not visible. Interior ducting insulation is in an unknown condition. Interior ducting is of unknown cleanliness.</p> <p>Air handling room is free of trash/chemicals.</p> <p>Outside damper is open, and its condition is good.</p> <p>Return damper is open, and its condition is good.</p> <p>The general condition of the unit is good.</p>

Mixed Main Filter Cleanliness

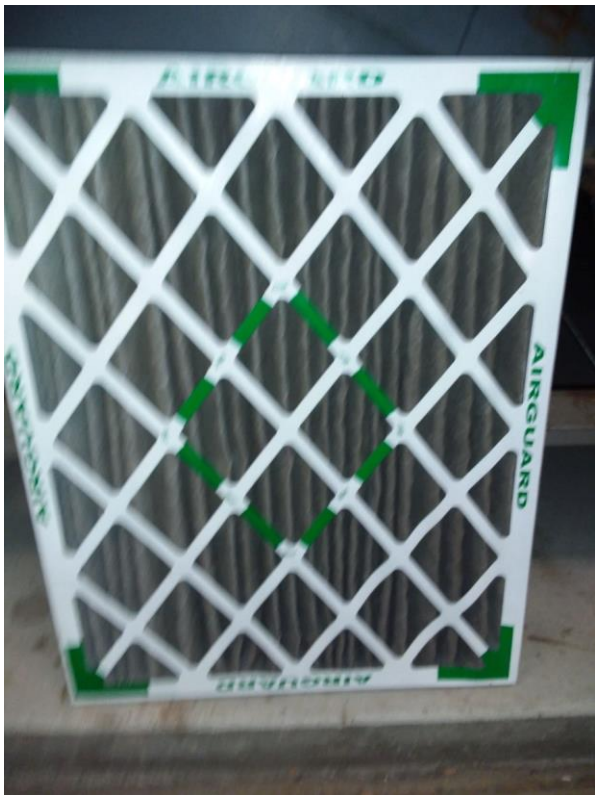
Unit Designation:	AHU_06	
Location of Unit:	Mechanical room 5401	
Areas Served:	Auditorium See attached map	
System Enhancements:	None	
Supply System	Outdoor Air	Cleanliness and Observations
Type <ul style="list-style-type: none"> Supply System - Constant Volume Heating - Hot Water Cooling - None Energy Recovery Unit (ERU) - None 	Outdoor air intake is accessible Outdoor air intake is located on an exterior wall. No nearby pollution sources were found.	Outdoor air filters are not present. Return air filters are not present. Mixed air pre-filters are not present. Mixed air main filters are somewhat dirty and on the border of needing replacement (scoring 3 out of 5) and fit well. Mixed air main filters are installed correctly. Drain pan plugged status is not known. Drain pan condition is not known.
Filter Type - Mixed <ul style="list-style-type: none"> Pre-filter: None Main filter: Pleated, MERV 11 	Outdoor air intake is in good condition.	Heating coils are inaccessible. Heat wheels are not present. Exterior ducting is visible. Exterior ducting insulation is not present. Interior ducting is visible. Interior ducting insulation is in good condition. Interior ducting is dirty. Air handling room is free of trash/chemicals. Outside damper is open, and its condition is good. Return damper is inaccessible, and its condition is not known. The general condition of the unit is good.

Mixed Main Filter Cleanliness

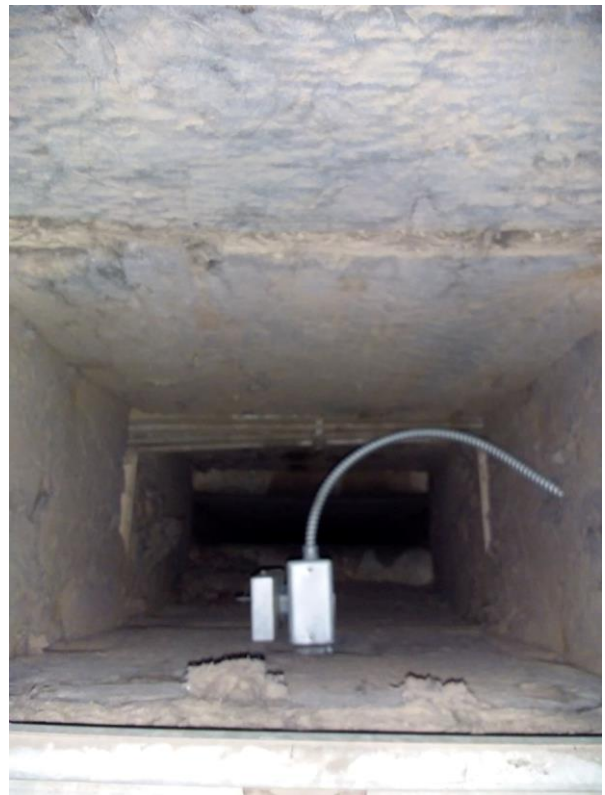
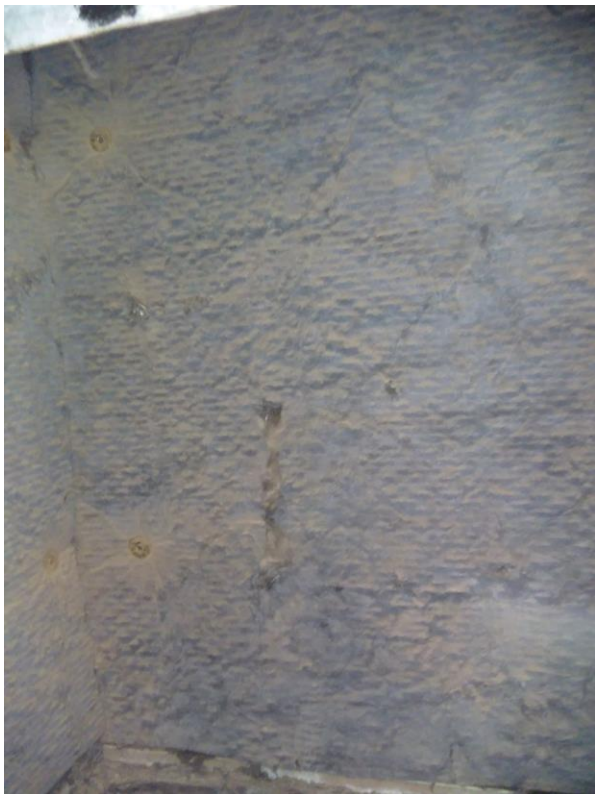
Interior Ducting

AHU_06
Interior Ducting

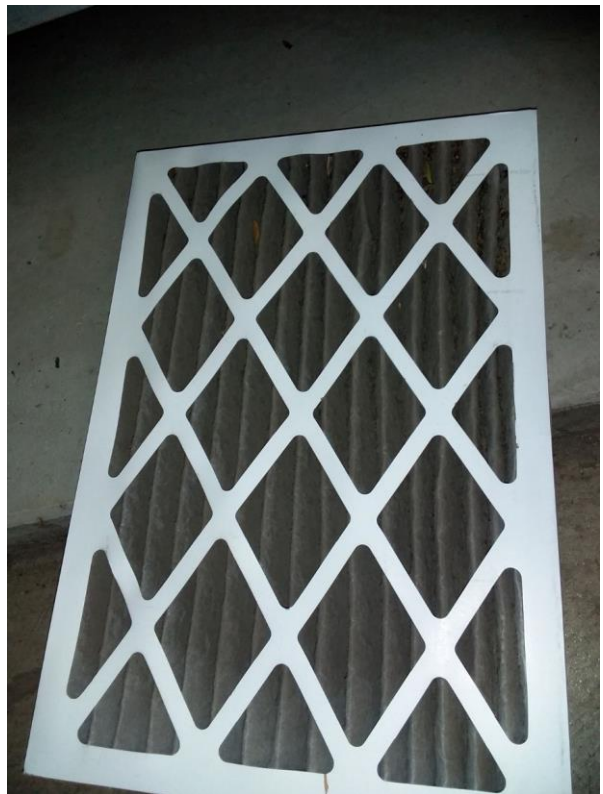
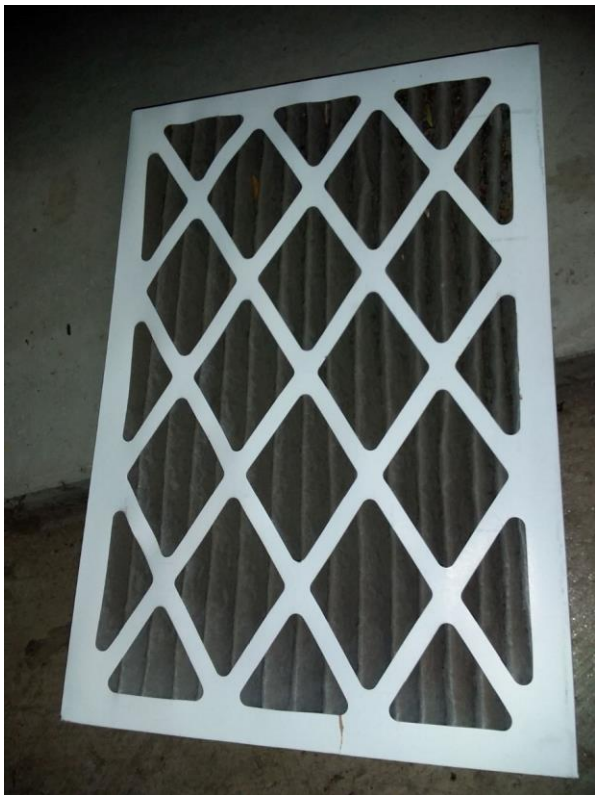
Unit Designation:	AHU_07	
Location of Unit:	Mechanical room PENTHOUSE B	
Areas Served:	4FL & 5FL Interior North See attached map	
System Enhancements:	None	
Supply System	Outdoor Air	Cleanliness and Observations
Type <ul style="list-style-type: none"> • Supply System - VAV • Heating - Hot Water • Cooling - None • Energy Recovery Unit (ERU) - None 	Outdoor air intake is accessible Outdoor air intake is located on an exterior wall. No nearby pollution sources were found.	Outdoor air filters are not present. Return air filters are not present. Mixed air pre-filters are not present. Mixed air main filters are somewhat dirty and on the border of needing replacement (scoring 4 out of 5) and fit well. Mixed air main filters are installed correctly. Drain pans are not applicable or not present. Drain pan condition is not known.
Filter Type - Mixed <ul style="list-style-type: none"> • Pre-filter: None • Main filter: Pleated, MERV 11 	Outdoor air intake is in good condition.	Heating coils are dirty. Heat wheels are not present. Exterior ducting is visible. Exterior ducting insulation is not present. Interior ducting is visible. Interior ducting insulation is in good condition. Interior ducting is dirty. Air handling room is free of trash/chemicals. Outside damper is open, and its condition is good. Return damper is open, and its condition is good. The general condition of the unit is good.

AHU_07
Mixed Pre-Filter Cleanliness

AHU_07
Mixed Main Filter Cleanliness

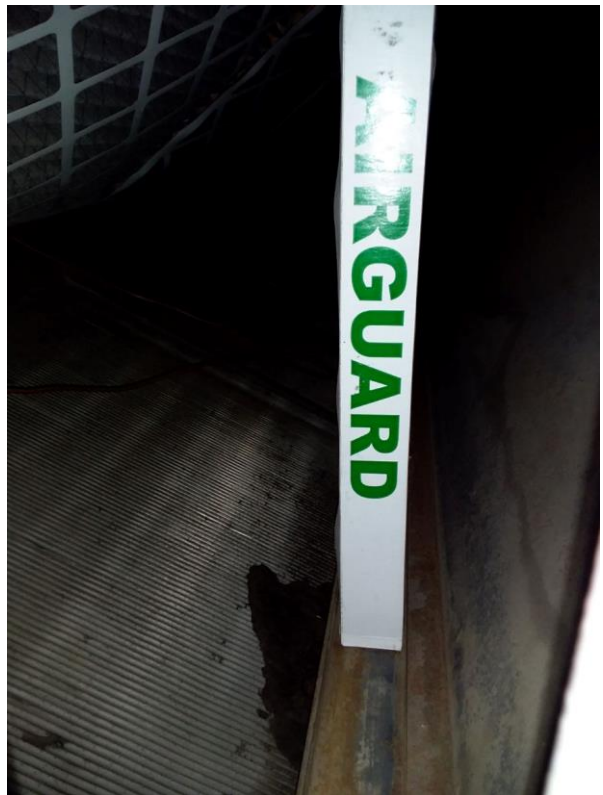
AHU_07
Heating Coils

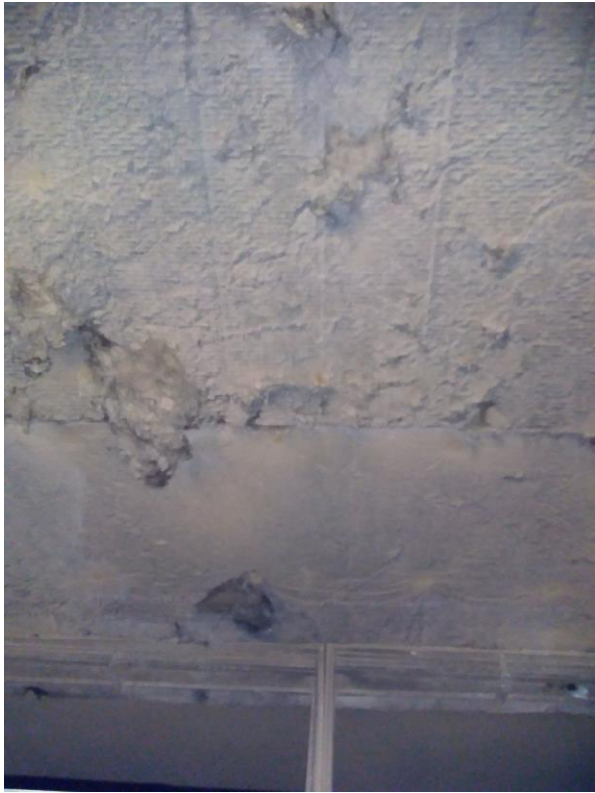
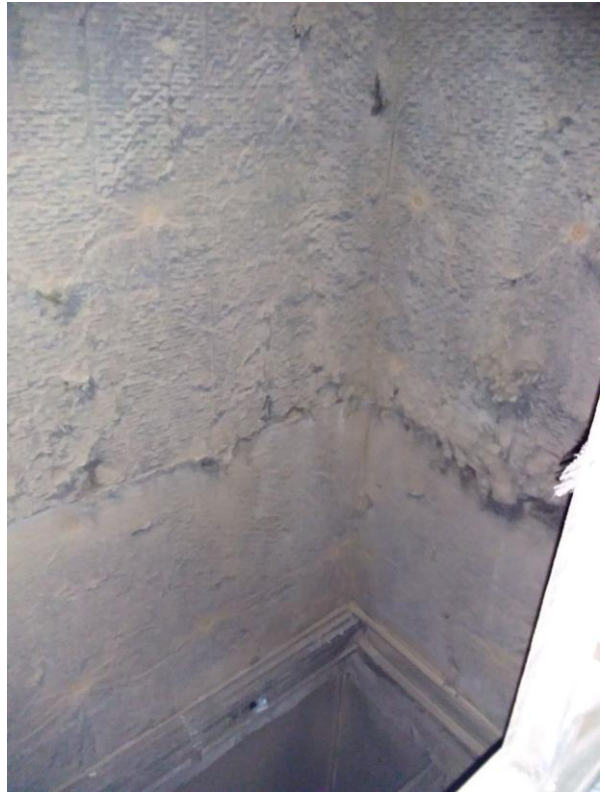
AHU_07
Interior Ducting

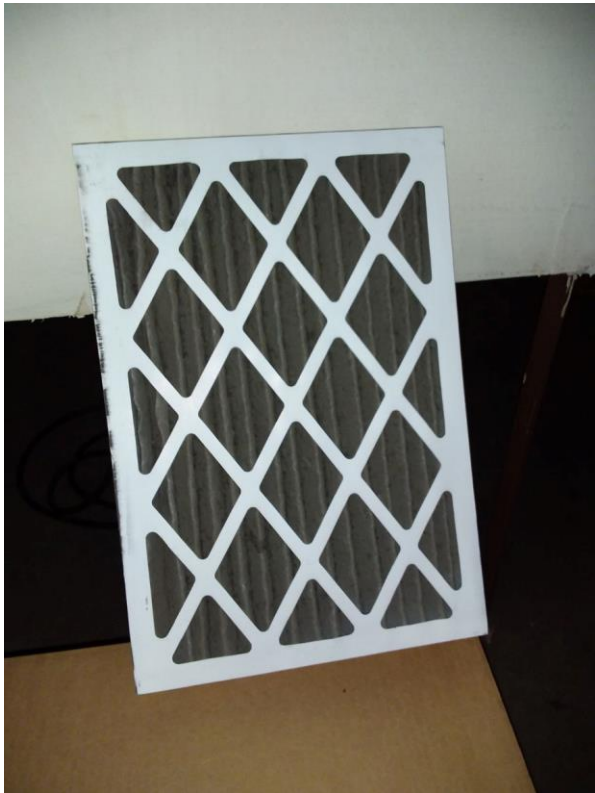
Unit Designation:	AHU_08	
Location of Unit:	Mechanical room 2120	
Areas Served:	Pool See attached map	
System Enhancements:	None	
Supply System	Outdoor Air	Cleanliness and Observations
Type <ul style="list-style-type: none"> Supply System - Constant Volume Heating - Hot Water Cooling - None Energy Recovery Unit (ERU) - None 	<p>Outdoor air intake is inaccessible</p> <p>Outdoor air intake is located on an exterior wall.</p> <p>It is not known if there are nearby pollution sources.</p>	<p>Outdoor air filters are not present.</p> <p>Return air filters are not present.</p> <p>Mixed air pre-filters are not present. Mixed air main filters are somewhat dirty and on the border of needing replacement (scoring 4 out of 5) and fit well. Mixed air main filters are installed correctly.</p> <p>Drain pans are not applicable or not present. Drain pan condition is not known.</p>
Filter Type - Mixed <ul style="list-style-type: none"> Pre-filter: None Main filter: Pleated, MERV 11 	<p>Outdoor air intake is in good condition.</p>	<p>Heating coils are clean.</p> <p>Heat wheels are not present.</p> <p>Exterior ducting is visible. Exterior ducting insulation is not present.</p> <p>Interior ducting is visible. Interior ducting insulation is not present. Interior ducting is of unknown cleanliness.</p> <p>Air handling room is free of trash/chemicals.</p> <p>Outside damper is open, and its condition is good.</p> <p>Return damper is open, and its condition is good.</p> <p>The general condition of the unit is good.</p>

AHU_08
Mixed Main Filter Cleanliness

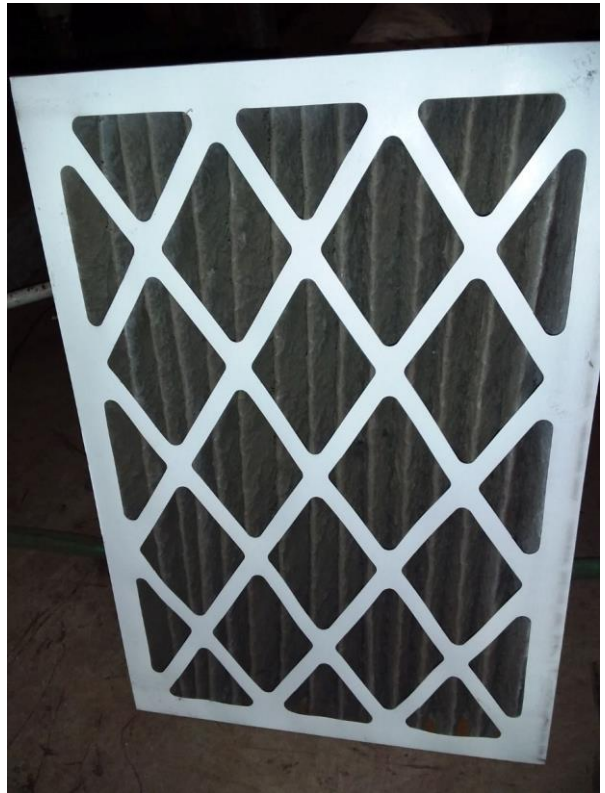
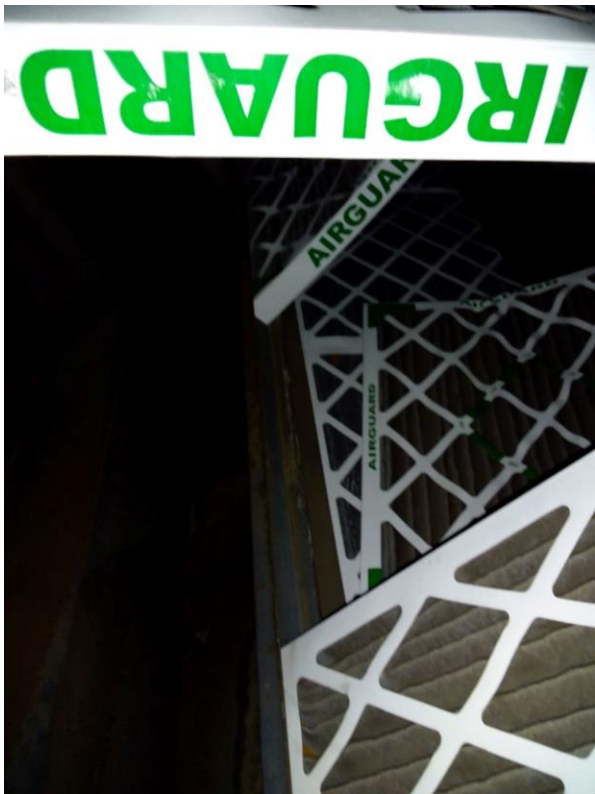
Dirty or poorly fitting filters were observed in units AHU_05, AHU_09 and AHU_21 during the ventilation inspection.

AHU_09
Mixed Main Filter Cleanliness

AHU_09
Mixed Main Filter Fit

Recommendation: The operations and maintenance program for filter changes should be reviewed and revised to ensure proper filter changes to optimize filtration capacity.

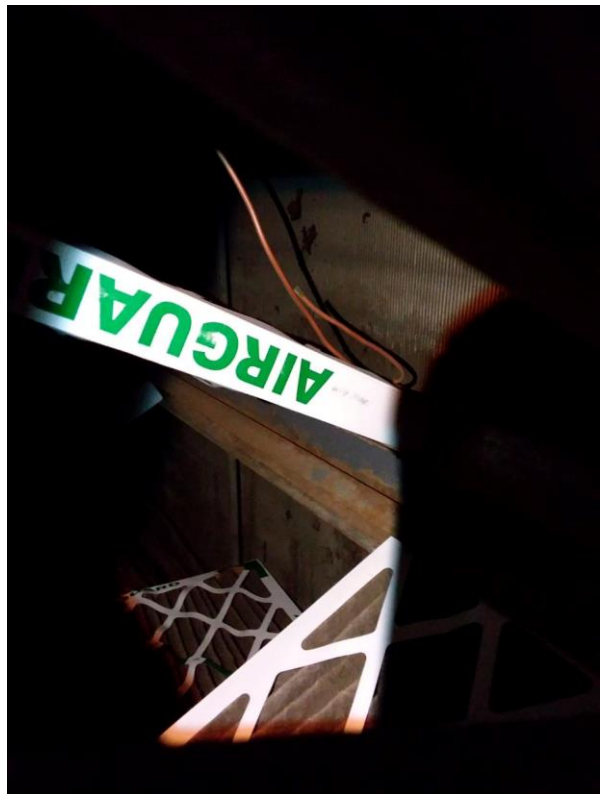
AHU_09
Heating Coils

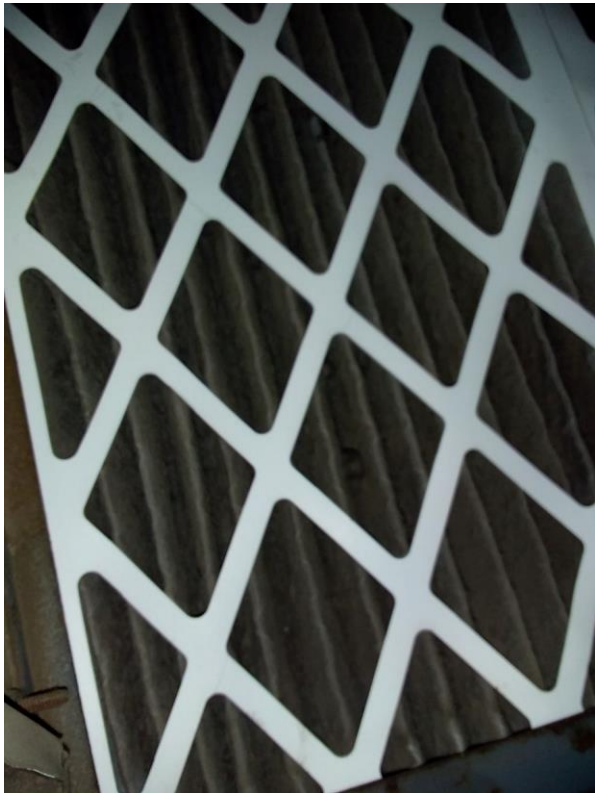
Unit Designation:	AHU_10	
Location of Unit:	Mechanical room 1501	
Areas Served:	Gym East See attached map	
System Enhancements:	None	
Supply System	Outdoor Air	Cleanliness and Observations
Type <ul style="list-style-type: none"> Supply System - Constant Volume Heating - Hot Water Cooling - None Energy Recovery Unit (ERU) - None 	Outdoor air intake is inaccessible Outdoor air intake is located on an exterior wall. It is not known if there are nearby pollution sources.	Outdoor air filters are not present. Return air filters are not present. Mixed air pre-filters are not present. Mixed air main filters are somewhat dirty and on the border of needing replacement (scoring 4 out of 5) and fit well. Mixed air main filters are installed correctly. Drain pans are not applicable or not present. Drain pan condition is not known.
Filter Type - Mixed <ul style="list-style-type: none"> Pre-filter: None Main filter: Pleated, MERV 11 	Outdoor air intake is in good condition.	Heating coils are dirty. Heat wheels are not present. Exterior ducting is visible. Exterior ducting insulation is not present. Interior ducting is not visible. Interior ducting insulation is in good condition. Interior ducting is of unknown cleanliness. Air handling room is free of trash/chemicals. Outside damper is inaccessible, and its condition is not known. Return damper is inaccessible, and its condition is not known. The general condition of the unit is good.

AHU_10
Mixed Main Filter Cleanliness

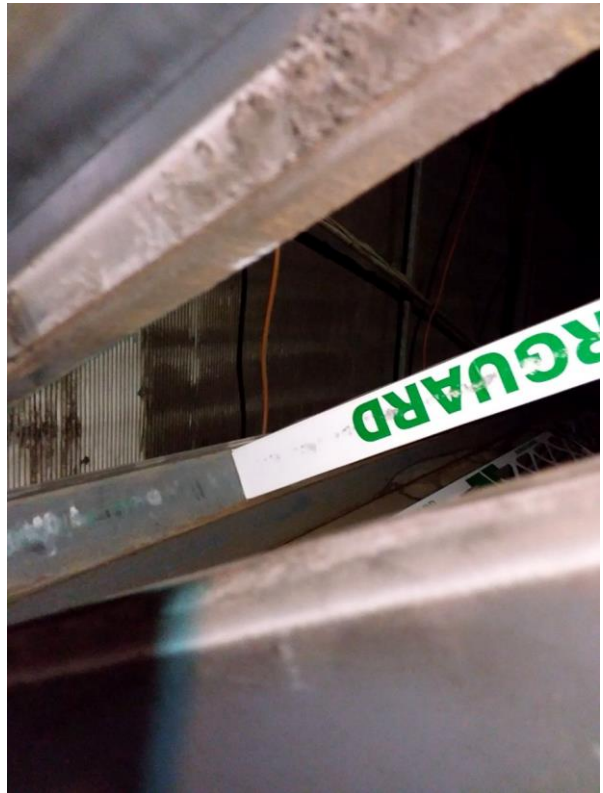
AHU_10
Heating Coils

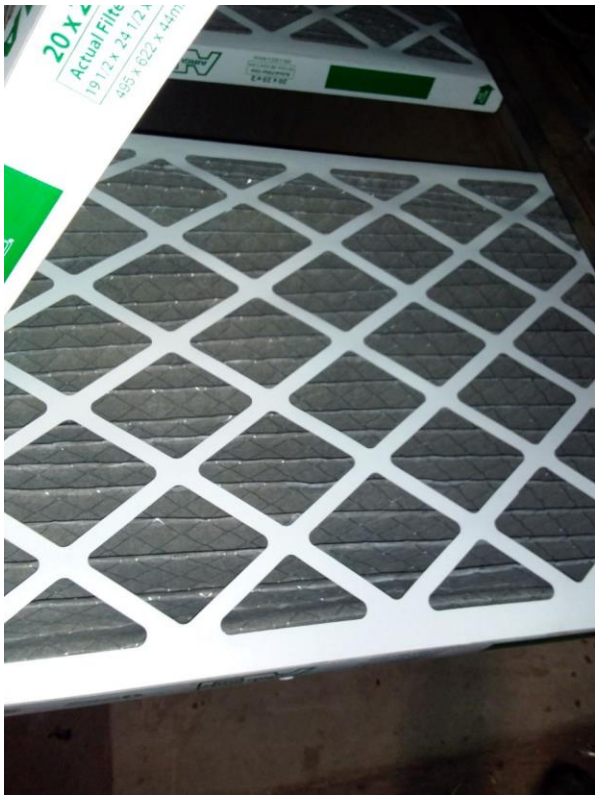
Unit Designation:	AHU_11	
Location of Unit:	Mechanical Room 2512	
Areas Served:	See attached map.	
System Enhancements:	None	
Supply System	Outdoor Air	Cleanliness and Observations
Type <ul style="list-style-type: none"> Supply System - Unknown Heating - Hot Water Cooling - None Energy Recovery Unit (ERU) - None 	<p>Outdoor air intake is inaccessible</p> <p>Outdoor air intake is located on an exterior wall.</p> <p>It is not known if there are nearby pollution sources.</p>	<p>Outdoor air filters are not present.</p> <p>Return air filters are not present.</p> <p>Mixed air pre-filters are not present. Mixed air main filters are somewhat dirty and on the border of needing replacement (scoring 3 out of 5) and fit well. Mixed air main filters are installed correctly.</p> <p>Drain pans are not applicable or not present. Drain pan condition is not known.</p>
Filter Type - Mixed <ul style="list-style-type: none"> Pre-filter: None Main filter: Pleated, MERV 11 	<p>Outdoor air intake is in good condition.</p>	<p>Heating coils are clean.</p> <p>Heat wheels are not present.</p> <p>Exterior ducting is visible. Exterior ducting insulation is not present.</p> <p>Interior ducting is not visible. Interior ducting insulation is in an unknown condition. Interior ducting is of unknown cleanliness.</p> <p>Air handling room is free of trash/chemicals.</p> <p>Outside damper is open, and its condition is good.</p> <p>Return damper is open, and its condition is good.</p> <p>The general condition of the unit is good.</p>

AHU_11
Mixed Main Filter Cleanliness

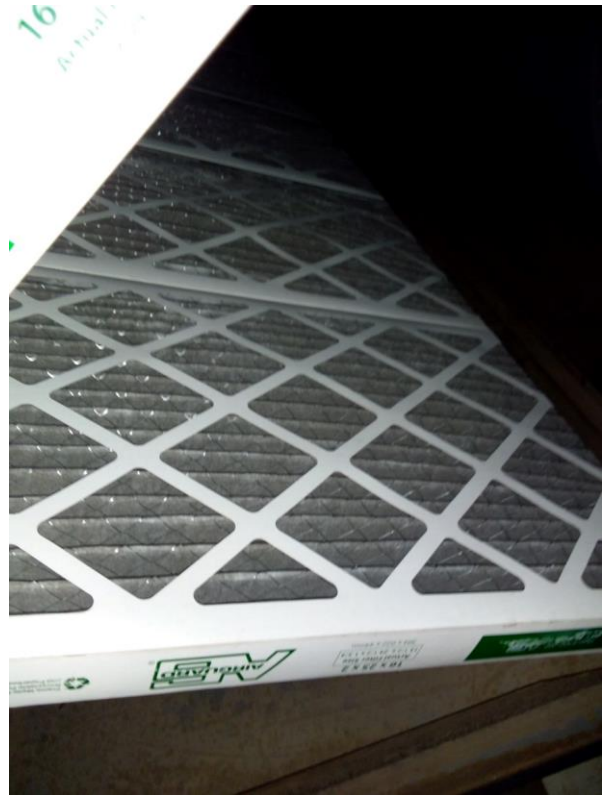
Filter Type - Return <ul style="list-style-type: none"> Pre-filter: None Main filter: Pleated 	<p>Condition of the outdoor air intake is not known.</p>

AHU_12 (100% RA)
Return Main Filter Cleanliness

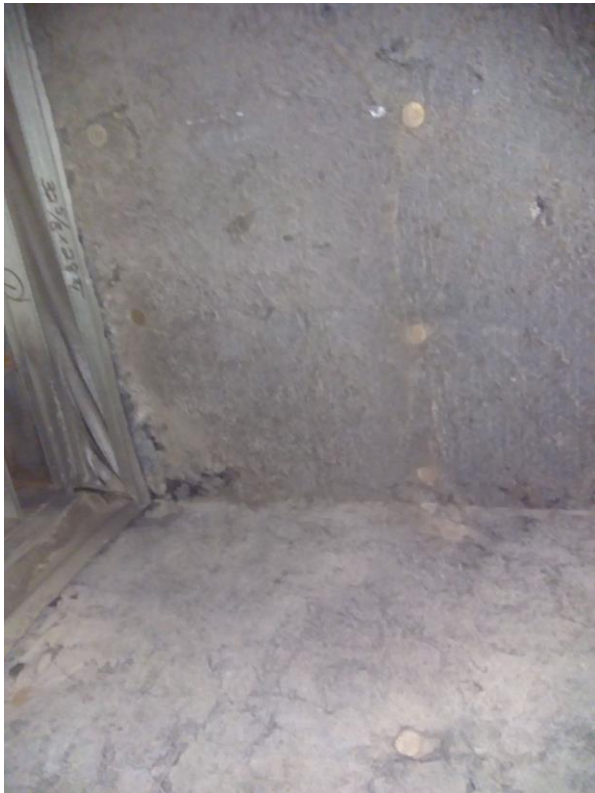
AHU_12 (100% RA)
Interior Ducting

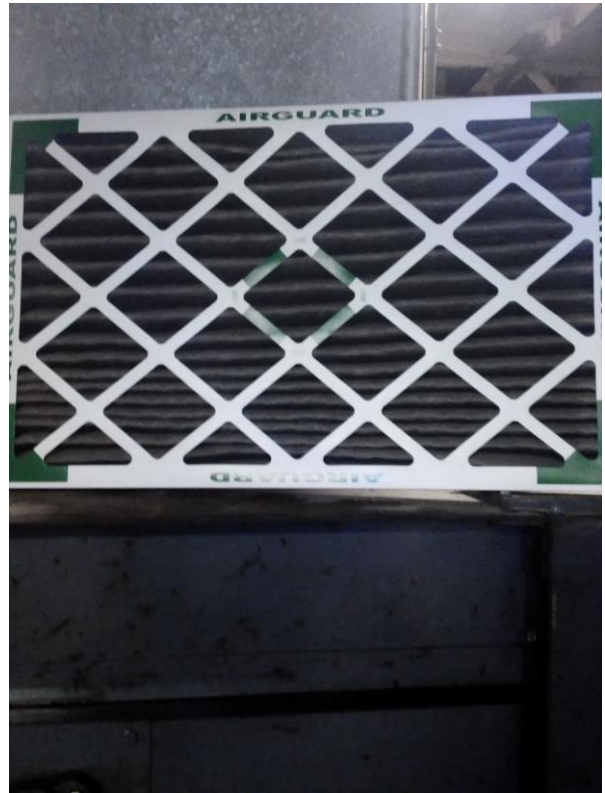
Unit Designation:	AHU_13	
Location of Unit:	Mechanical Room 2511	
Areas Served:	See attached map. Chorus Room	
System Enhancements:	None	
Supply System	Outdoor Air	Cleanliness and Observations
Type <ul style="list-style-type: none"> • Supply System - Unknown • Heating - Hot Water • Cooling - None • Energy Recovery Unit (ERU) - None 	<p>Outdoor air intake is inaccessible</p> <p>Outdoor air intake is located on an exterior wall.</p> <p>It is not known if there are nearby pollution sources.</p>	<p>Outdoor air filters are not present.</p> <p>Return air filters are not present.</p> <p>Mixed air pre-filters are not present. Mixed air main filters are somewhat dirty and on the border of needing replacement (scoring 4 out of 5) and fit well. Mixed air main filters are installed correctly.</p> <p>Drain pans are not applicable or not present. Drain pan condition is good.</p>
Filter Type - Mixed <ul style="list-style-type: none"> • Pre-filter: None • Main filter: Pleated, MERV 11 	<p>Outdoor air intake is in good condition.</p>	<p>Heating coils are clean.</p> <p>Heat wheels are not present.</p> <p>Exterior ducting is visible. Exterior ducting insulation is not present.</p> <p>Interior ducting is not visible. Interior ducting insulation is in an unknown condition. Interior ducting is of unknown cleanliness.</p> <p>Air handling room is free of trash/chemicals.</p> <p>Outside damper is open, and its condition is good.</p> <p>Return damper is inaccessible, and its condition is not known.</p> <p>The general condition of the unit is good.</p>

AHU_13
Mixed Main Filter Cleanliness

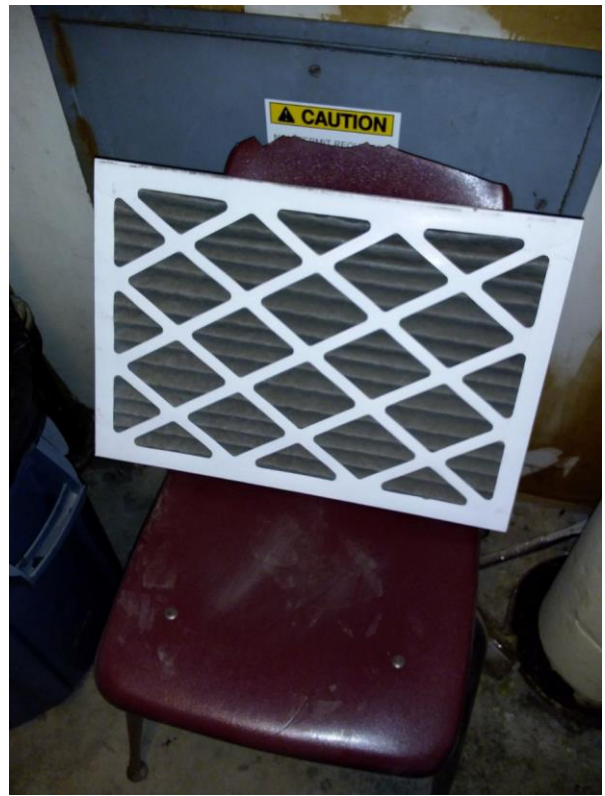
Unit Designation:	AHU_17	
Location of Unit:	Mechanical room 2117	
Areas Served:	1st Floor South See attached map	
System Enhancements:	None	
Supply System	Outdoor Air	Cleanliness and Observations
Type <ul style="list-style-type: none"> • Supply System - VAV • Heating - Hot Water • Cooling - None • Energy Recovery Unit (ERU) - None 	Outdoor air intake is accessible Outdoor air intake is located on an exterior wall. No nearby pollution sources were found.	Outdoor air filters are not present. Return air filters are not present. Mixed air pre-filters are not present. Mixed air main filters are somewhat dirty and on the border of needing replacement (scoring 3 out of 5) and fit well. Mixed air main filters are installed correctly. Drain pans are not applicable or not present. Drain pan condition is not known.
Filter Type - Mixed <ul style="list-style-type: none"> • Pre-filter: None • Main filter: Pleated, MERV 11 	Outdoor air intake is in good condition.	Heating coils are clean. Heat wheels are not present. Exterior ducting is visible. Exterior ducting insulation is not present. Interior ducting is not visible. Interior ducting insulation is in an unknown condition. Interior ducting is of unknown cleanliness. Air handling room is free of trash/chemicals. Outside damper is open, and its condition is good. Return damper is inaccessible, and its condition is not known. The general condition of the unit is good.

Mixed Main Filter Cleanliness

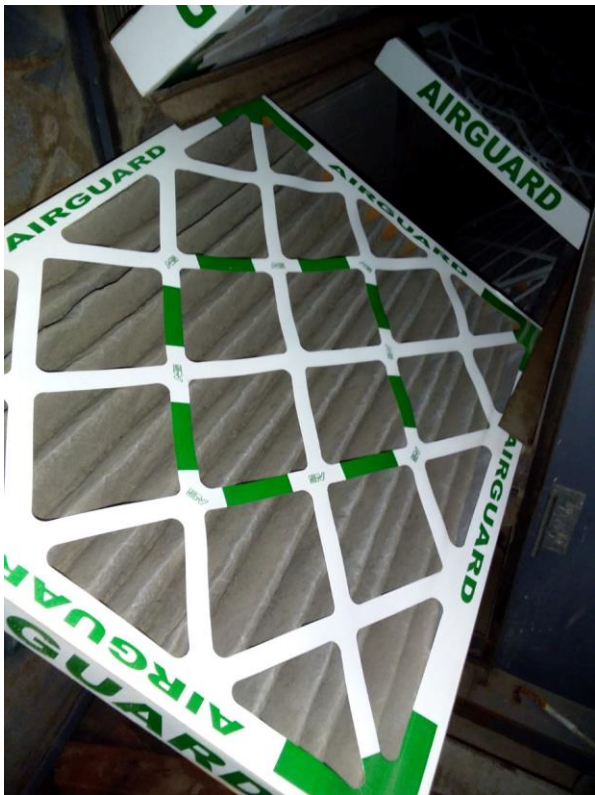
Unit Designation:	AHU_18	
Location of Unit:	Mechanical room 2117	
Areas Served:	Administration See attached map	
System Enhancements:	None	
Supply System	Outdoor Air	Cleanliness and Observations
Type <ul style="list-style-type: none"> • Supply System - VAV • Heating - Hot Water • Cooling - None • Energy Recovery Unit (ERU) - None 	Outdoor air intake is accessible Outdoor air intake is located on an exterior wall. No nearby pollution sources were found.	Outdoor air filters are not present. Return air filters are not present. Mixed air pre-filters are not present. Mixed air main filters are somewhat dirty and on the border of needing replacement (scoring 3 out of 5) and fit well. Mixed air main filters are installed correctly. Drain pans are not applicable or not present. Drain pan condition is not known.
Filter Type - Mixed <ul style="list-style-type: none"> • Pre-filter: None • Main filter: Pleated, MERV 11 	Outdoor air intake is in good condition.	Heating coils are dirty. Heat wheels are not present. Exterior ducting is visible. Exterior ducting insulation is not present. Interior ducting is not visible. Interior ducting insulation is in an unknown condition. Interior ducting is of unknown cleanliness. Air handling room is free of trash/chemicals. Outside damper is open, and its condition is good. Return damper is inaccessible, and its condition is not known. The general condition of the unit is good.

Mixed Main Filter Cleanliness

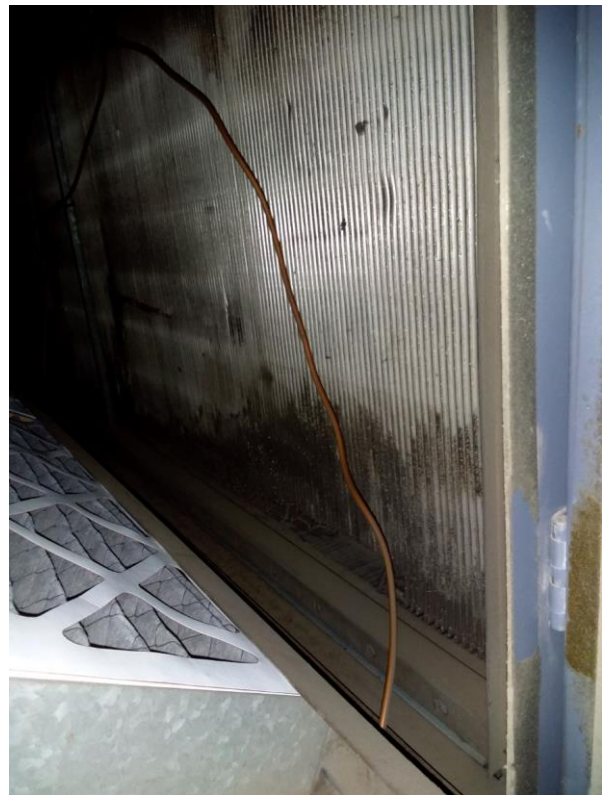
AHU_18

Heating Coils

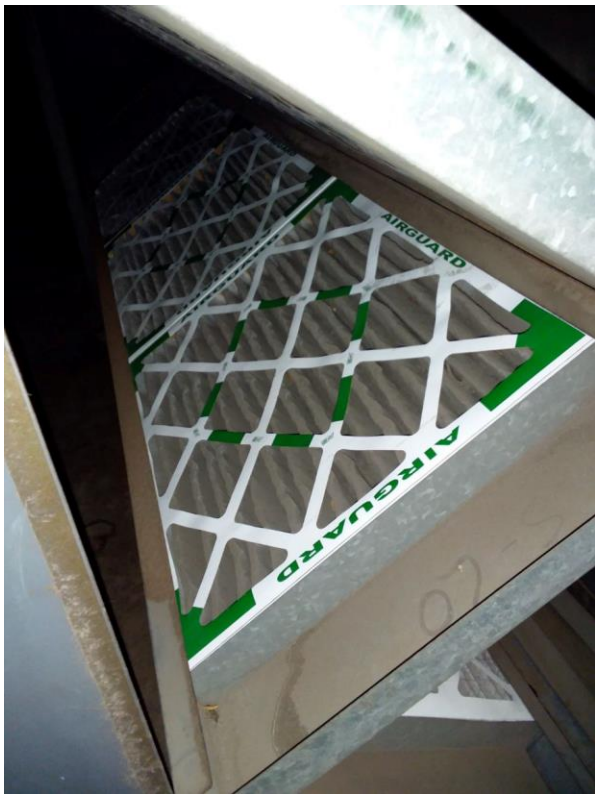
AHU_20

Filter Type - Mixed <ul style="list-style-type: none"> • Pre-filter: None • Main filter: Pleated, MERV 11 	<p>Outdoor air intake is in good condition.</p>

Mixed Main Filter Cleanliness

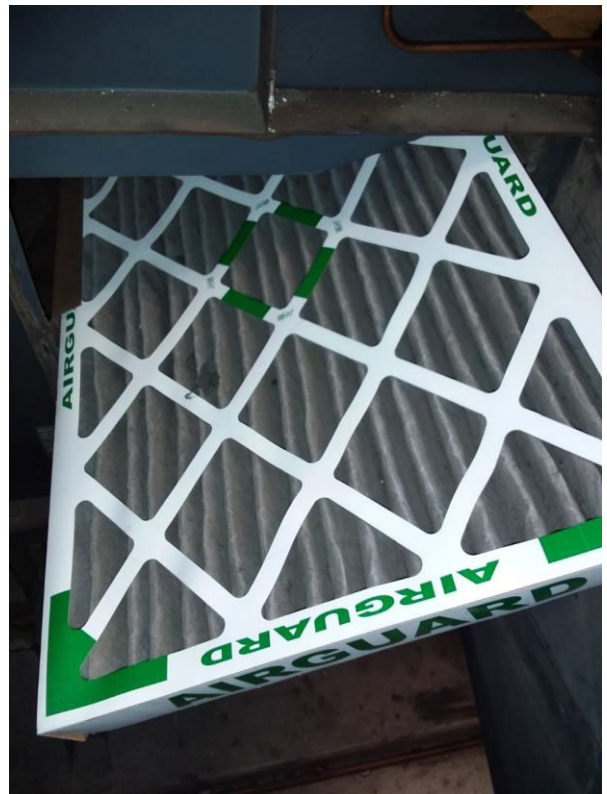
AHU_19

Filter Type - Mixed <ul style="list-style-type: none"> • Pre-filter: None • Main filter: Pleated, MERV 11 	<p>Outdoor air intake is in good condition.</p>	<p>Heating coils are inaccessible.</p> <p>Heat wheels are not present.</p> <p>Exterior ducting is visible. Exterior ducting insulation is not present.</p> <p>Interior ducting is visible. Interior ducting insulation is in good condition. Interior ducting is dirty.</p> <p>Air handling room is free of trash/chemicals.</p> <p>Outside damper is open, and its condition is good.</p> <p>Return damper is open, and its condition is good.</p> <p>The general condition of the unit is good.</p>

Mixed Main Filter Cleanliness

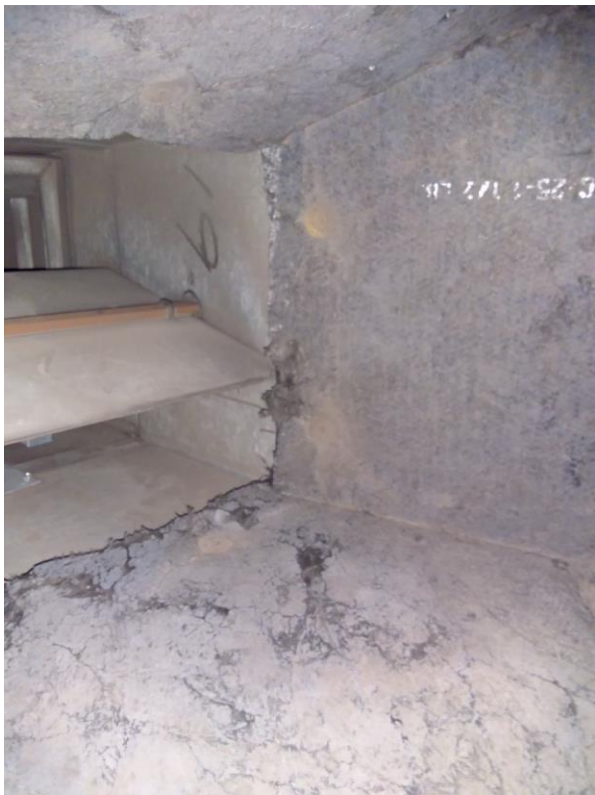
AHU_19

Interior Ducting

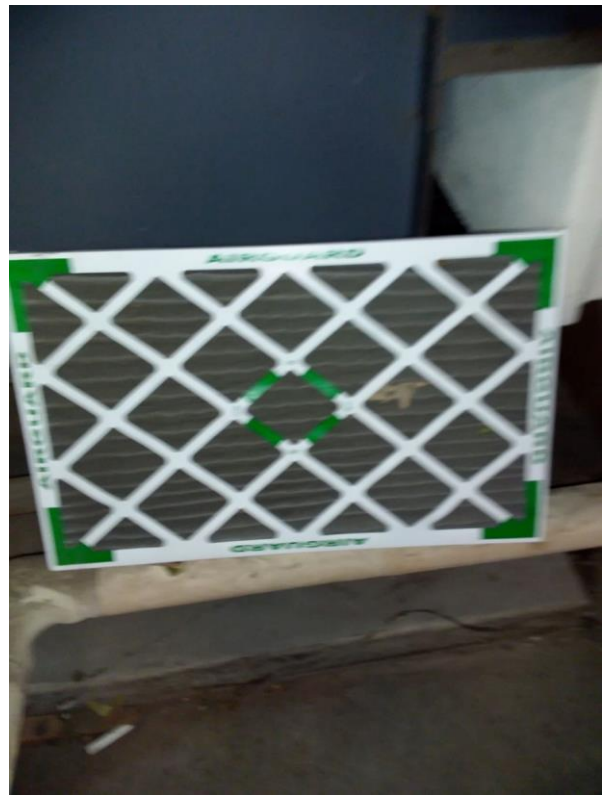
AHU_21

Mixed Main Filter Cleanliness

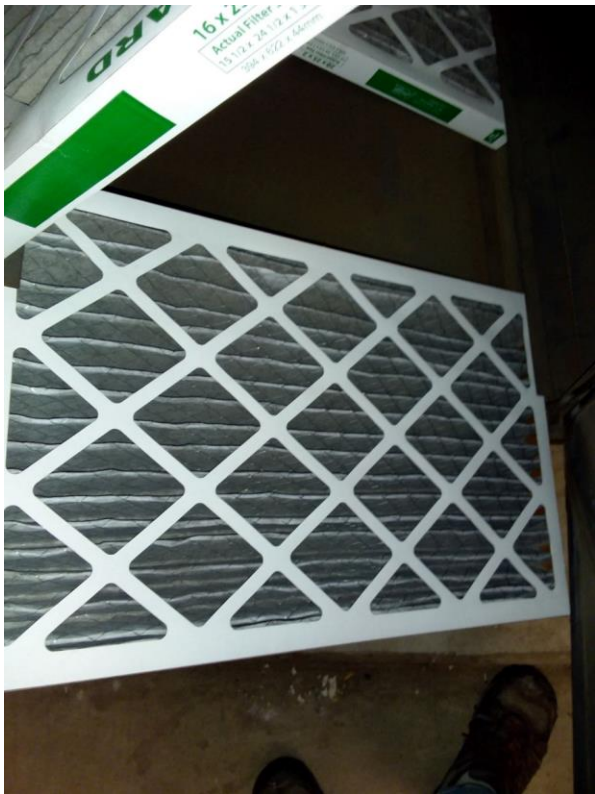
Unit Designation:	AHU_23	
Location of Unit:	Mechanical room 2308 (Access through 2307)	
Areas Served:	Metal Shop See attached map	
System Enhancements:	None	
Supply System	Outdoor Air	Cleanliness and Observations
Type <ul style="list-style-type: none"> Supply System - Constant Volume Heating - Hot Water Cooling - None Energy Recovery Unit (ERU) - None 	<p>Outdoor air intake is inaccessible</p> <p>Outdoor air intake is located on an exterior wall.</p> <p>It is not known if there are nearby pollution sources.</p>	<p>Outdoor air filters are not present.</p> <p>Return air filters are not present.</p> <p>Mixed air pre-filters are not present. Mixed air main filters are somewhat dirty and on the border of needing replacement (scoring 3 out of 5) and fit well. Mixed air main filters are installed correctly.</p> <p>Drain pans are not applicable or not present. Drain pan condition is not known.</p>
Filter Type - Mixed <ul style="list-style-type: none"> Pre-filter: None Main filter: Pleated, MERV 11 	<p>Outdoor air intake is in good condition.</p>	<p>Heating coils are clean.</p> <p>Heat wheels are not present.</p> <p>Exterior ducting is visible. Exterior ducting insulation is not present.</p> <p>Interior ducting is not visible. Interior ducting insulation is in an unknown condition. Interior ducting is of unknown cleanliness.</p> <p>Air handling room is free of trash/chemicals.</p> <p>Outside damper is open, and its condition is good.</p> <p>Return damper is open, and its condition is good.</p> <p>The general condition of the unit is good.</p>

Mixed Main Filter Cleanliness

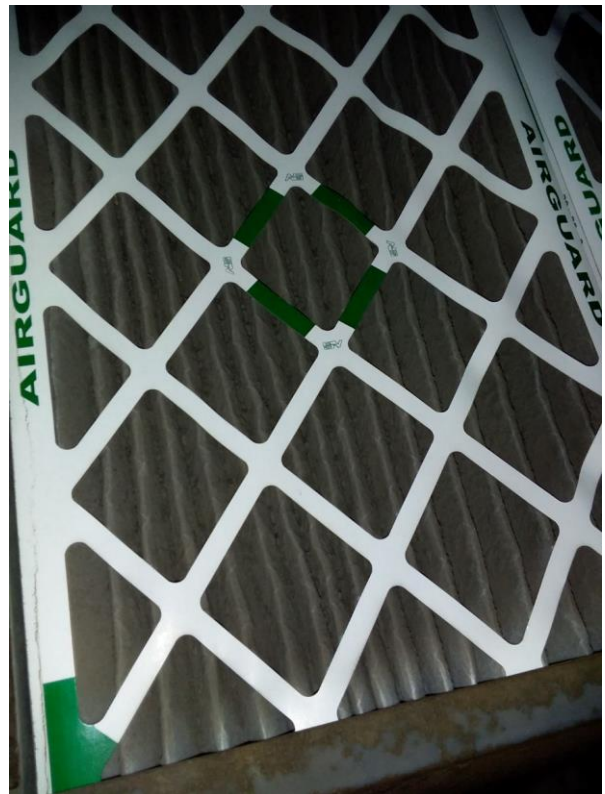
AHU_25

Filter Type - Mixed <ul style="list-style-type: none"> • Pre-filter: None • Main filter: Pleated, MERV 11 	<p>Outdoor air intake is in good condition.</p>

Mixed Main Filter Cleanliness

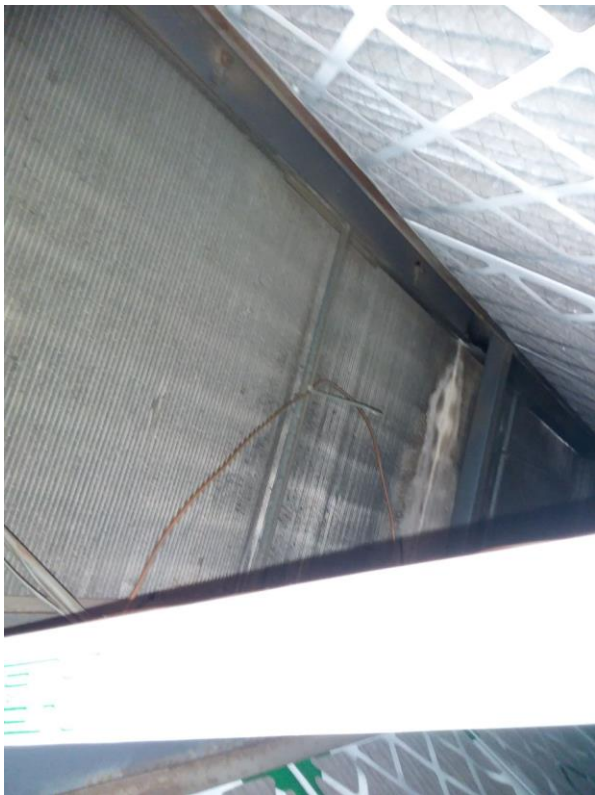
AHU_25

Heating Coils
