2023 - 2024 Ventilation Assessment

Saint Paul Public Schools Central Senior High School

Assessment Date:
4/7/2023 - 4/10/2023

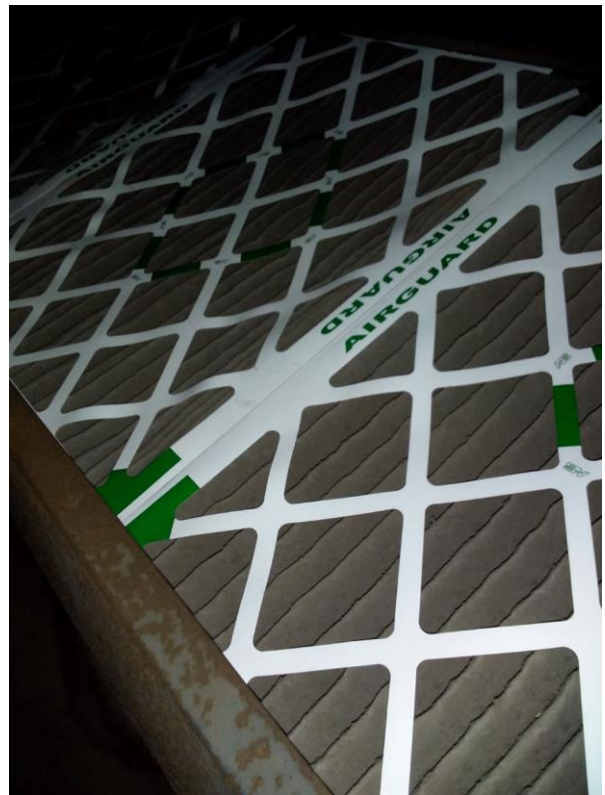
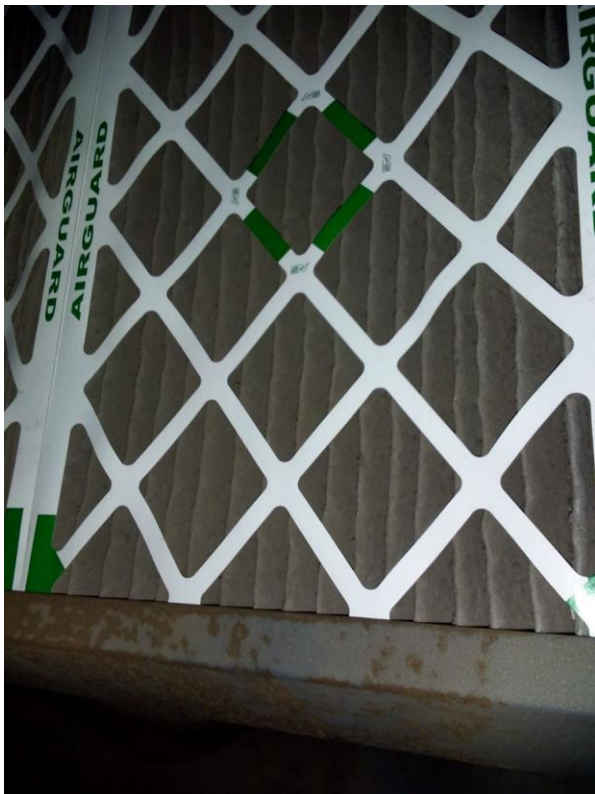
AHU_26

Filter Type - Mixed <ul style="list-style-type: none"> • Pre-filter: None • Main filter: Pleated, MERV 11 	<p>Outdoor air intake is in good condition.</p>

Mixed Pre-Filter Cleanliness

Mixed Main Filter Cleanliness

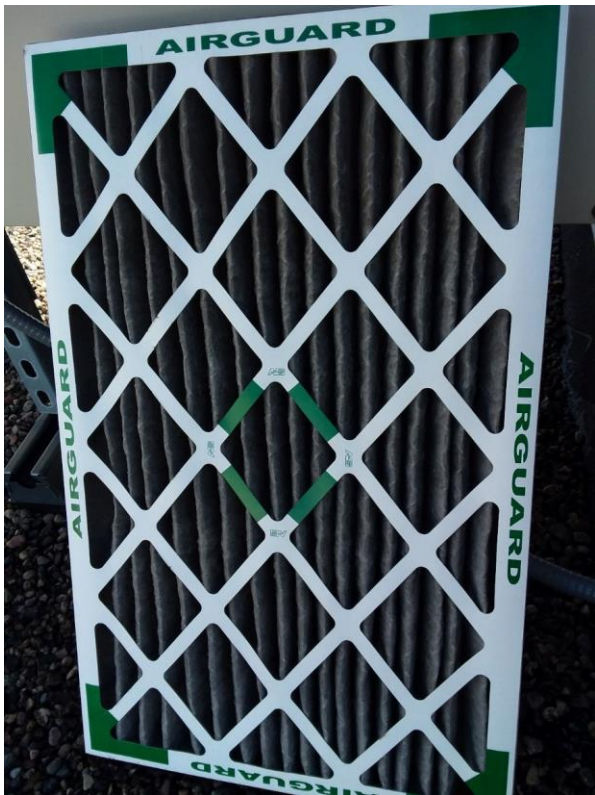
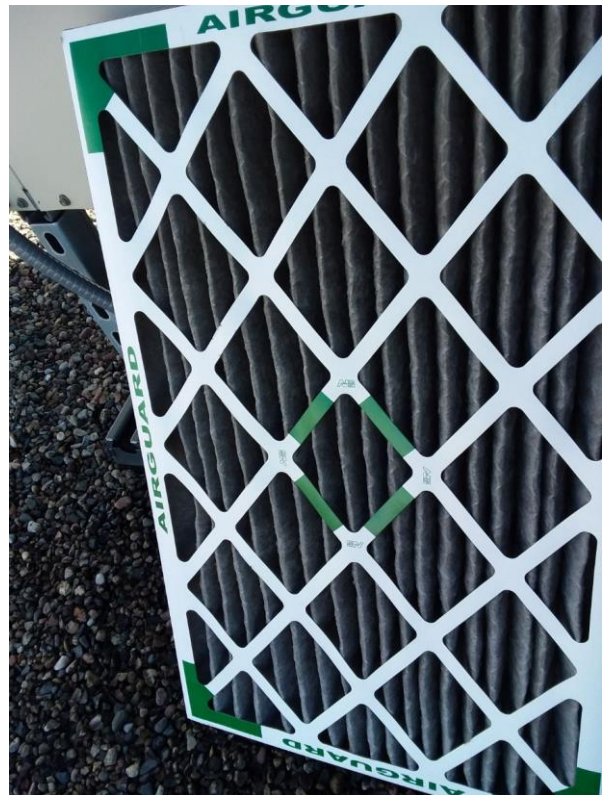
ERU_33

Heating coils are clean and cooling coils are clean.
		Heat wheels are inaccessible.
Filter Type - Mixed <ul style="list-style-type: none"> Pre-filter: None Main filter: Pleated, MERV 11 		Exterior ducting is not visible. Exterior ducting insulation is in an unknown condition.
		Interior ducting is not visible. Interior ducting insulation is in an unknown condition. Interior ducting is of unknown cleanliness.
		Air handling room is free of trash/chemicals.
		Outside damper is open, and its condition is good.
		Return damper is open, and its condition is not known.
		The general condition of the unit is good.

Mixed Pre-Filter Cleanliness

Mixed Main Filter Cleanliness

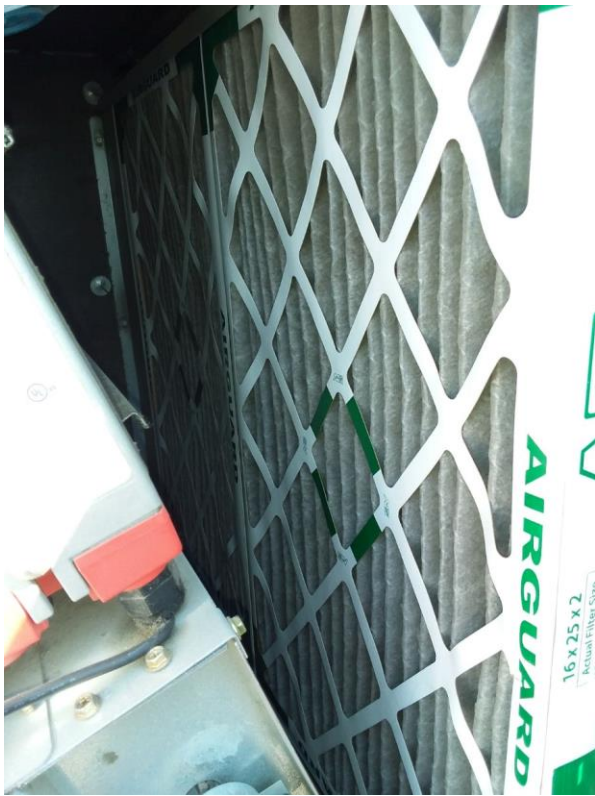
ERU_34

Heating coils are inaccessible and cooling coils are clean.
		Heat wheels are inaccessible.
Filter Type - Mixed <ul style="list-style-type: none"> Pre-filter: None Main filter: Pleated, MERV 11 		Exterior ducting is not visible. Exterior ducting insulation is in an unknown condition.
		Interior ducting is not visible. Interior ducting insulation is in an unknown condition. Interior ducting is of unknown cleanliness.
		Air handling room is free of trash/chemicals.
		Outside damper is open, and its condition is good.
		Return damper is inaccessible, and its condition is good.
		The general condition of the unit is good.

Mixed Main Filter Cleanliness

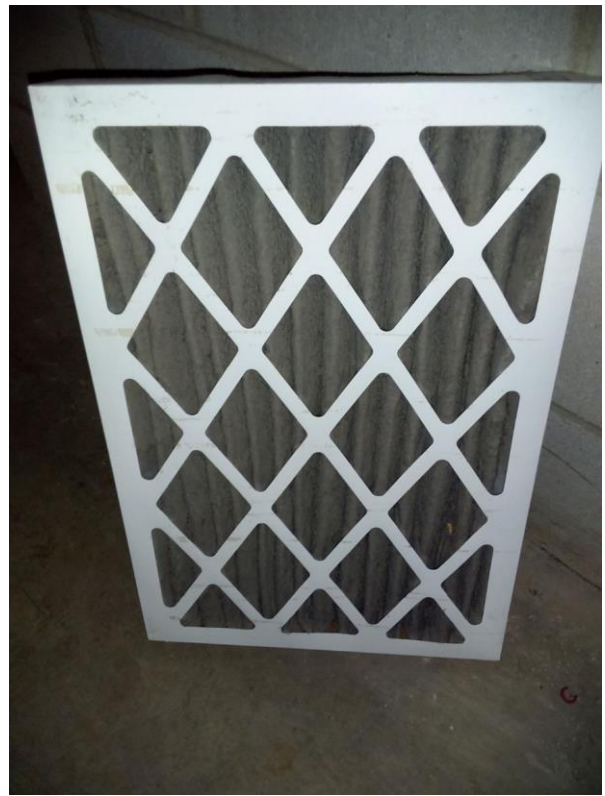
Unit Designation:	AHU_14	
Location of Unit:	Mechanical Room 251w	
Areas Served:	See attached map.	
System Enhancements:	None	
Supply System	Outdoor Air	Cleanliness and Observations
Type <ul style="list-style-type: none"> • Supply System - Unknown • Heating - Hot Water • Cooling - None • Energy Recovery Unit (ERU) - None 	<p>Outdoor air intake is inaccessible</p> <p>Outdoor air intake is located in an unknown location.</p> <p>It is not known if there are nearby pollution sources.</p>	<p>Outdoor air filters are not present.</p> <p>Return air pre-filters are not present. Return air main filters are somewhat dirty and on the border of needing replacement (scoring 4 out of 5) and fit well. Return air main filters are installed correctly.</p> <p>Drain pans are not applicable or not present. Drain pan condition is not known.</p> <p>Heating coils are dirty.</p>
Filter Type - Return <ul style="list-style-type: none"> • Pre-filter: None • Main filter: Pleated, MERV 11 	<p>Condition of the outdoor air intake is not known.</p>	<p>Heat wheels are not present.</p> <p>Exterior ducting is visible. Exterior ducting insulation is not present.</p> <p>Interior ducting is not visible. Interior ducting insulation is in an unknown condition. Interior ducting is of unknown cleanliness.</p> <p>Air handling room is free of trash/chemicals.</p> <p>Outside damper is not present.</p> <p>Return damper is inaccessible, and its condition is not known.</p> <p>The general condition of the unit is good.</p>

Return Main Filter Cleanliness
