2023 - 2024 Ventilation Assessment

Saint Paul Public Schools Cherokee Heights Elementary School

Assessment Date:
Monday, April 3, 2023

Project Description

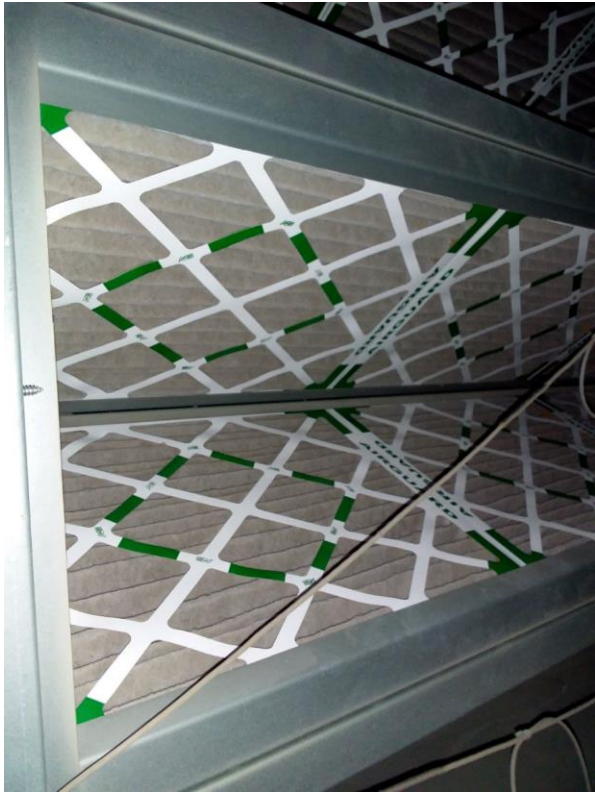
Unit Designation:	AHU-1	
Location of Unit:	Mechanical room C106	
Areas Served:	See attached map Serving Upper & Lower Level Baker Center	
System Enhancements:	None	
Supply System	Outdoor Air	Cleanliness and Observations
Type <ul style="list-style-type: none"> Supply System - VAV Heating - Hot Water Cooling - Dx Energy Recovery Unit (ERU) - None 	Outdoor air intake is inaccessible Outdoor air intake is located on an exterior wall. It is not known if there are nearby pollution sources.	Outdoor air filters are not present. Return air filters are not present. Mixed air pre-filters are not present. Mixed air main filters are somewhat dirty and on the border of needing replacement (scoring 3 out of 5) and fit well. Mixed air main filters are installed correctly. Drain pans are not plugged. Drain pan condition is good.
Filter Type - Mixed <ul style="list-style-type: none"> Pre-filter: None Main filter: Pleated, MERV 11 	Outdoor air intake is in good condition.	Heating coils are clean and cooling coils are clean. Heat wheels are not present. Exterior ducting is not visible. Exterior ducting insulation is not present. Interior ducting is not visible. Interior ducting insulation is in an unknown condition. Interior ducting is of unknown cleanliness. Air handling room is free of trash/chemicals. Outside damper is open, and its condition is good. Return damper is closed, and its condition is good. The general condition of the unit is good.

Mixed Main Filter Cleanliness

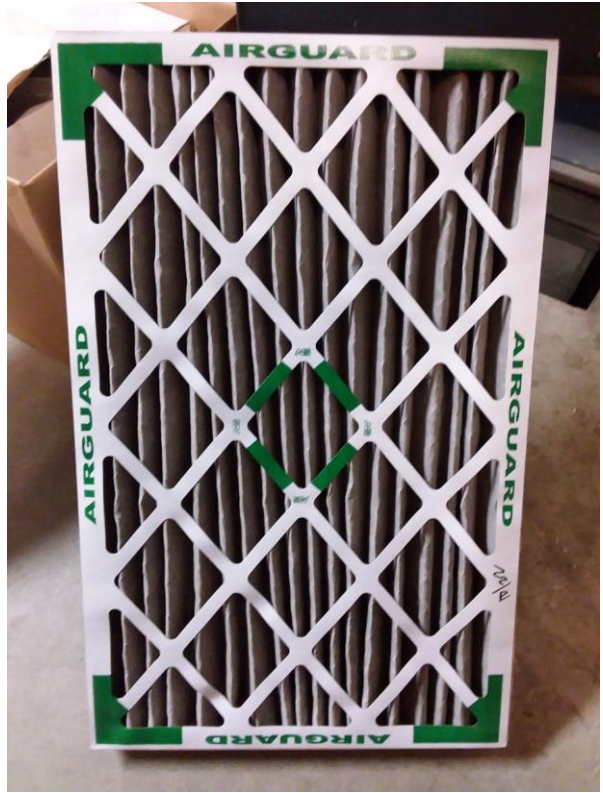
Unit Designation:	AHU-01	
Location of Unit:	Mechanical room 2111	
Areas Served:	See attached map Gymnasium	
System Enhancements:	None	
Supply System	Outdoor Air	Cleanliness and Observations
Type <ul style="list-style-type: none"> • Supply System - Unknown • Heating - Hot Water • Cooling - None • Energy Recovery Unit (ERU) - None 	<p>Outdoor air intake is inaccessible</p> <p>Outdoor air intake is located on an exterior wall.</p> <p>It is not known if there are nearby pollution sources.</p>	<p>Outdoor air filters are not present.</p> <p>Return air filters are not present.</p> <p>Mixed air pre-filters are not present. Mixed air main filters are somewhat dirty and on the border of needing replacement (scoring 3 out of 5) and fit well. Mixed air main filters are installed correctly.</p> <p>Drain pans are not applicable or not present. Drain pan condition is not known.</p>
Filter Type - Mixed <ul style="list-style-type: none"> • Pre-filter: None • Main filter: Pleated, MERV 11 	<p>Outdoor air intake is in good condition.</p>	<p>Heating coils are dirty.</p> <p>Heat wheels are not present.</p> <p>Exterior ducting is visible. Exterior ducting insulation is in poor condition.</p> <p>Interior ducting is not visible. Interior ducting insulation is in an unknown condition. Interior ducting is of unknown cleanliness.</p> <p>Air handling room is free of trash/chemicals.</p> <p>Outside damper is open, and its condition is poor. The seal is damaged.</p> <p>Return damper is open, and its condition is poor. The seal is damaged.</p> <p>The general condition of the unit is good.</p>

Mixed Main Filter Cleanliness

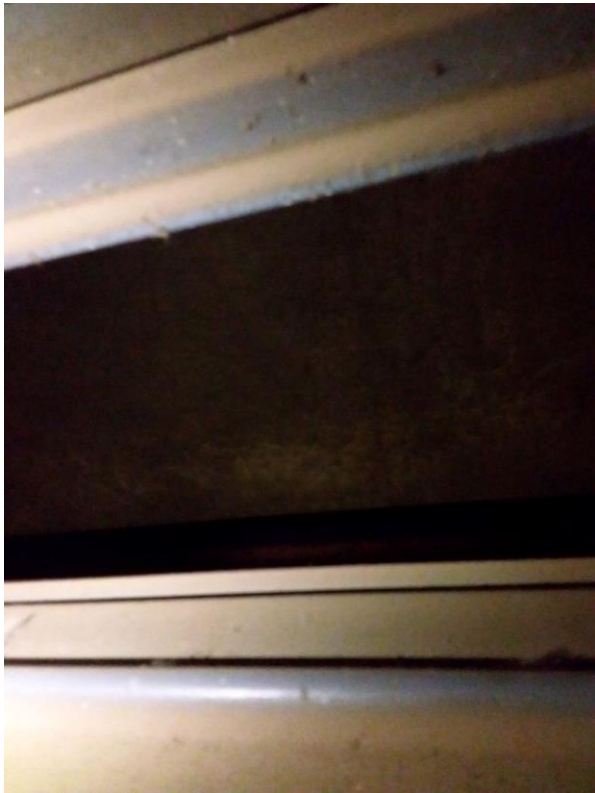
Dirty Coils were observed on units AHU-01 and MAU-01 during the ventilation inspection.

Heating Coils

Recommendation: Impacted/dirty coils can result in poor ventilation air supply as well as be a source for mold and bacterial growth on the coils. Coils should be cleaned annually, or as needed, as identified in the operations and maintenance program.

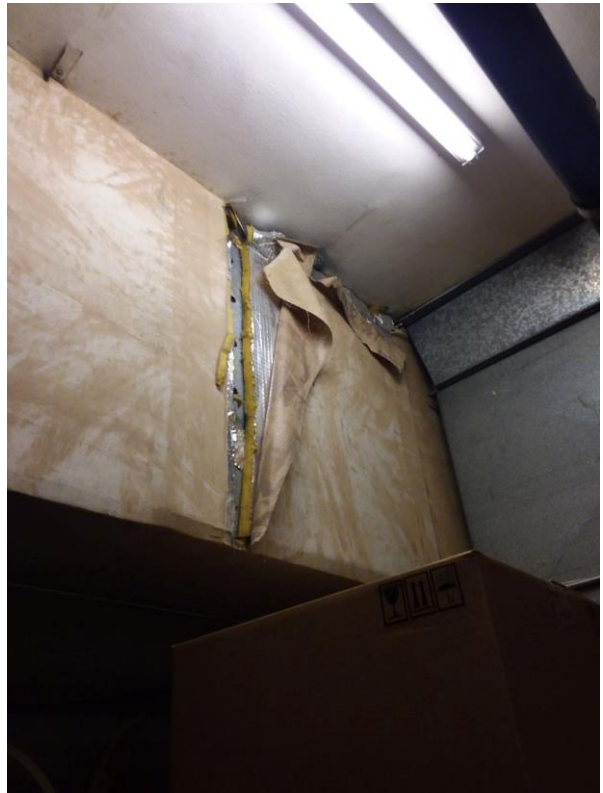
The accessible ductwork for unit AHU-01 was visibly dirty, damaged, or had evidence of moisture at the time of the site inspection.

Exterior Ducting

Recommendation: IEA recommends further inspection into the overall condition of the interior ductwork and level of dirt/debris quantified. If deemed a concern, it is recommended that the interior ducting be cleaned by a professional contractor to improve the impact on the IAQ for the supply spaces.

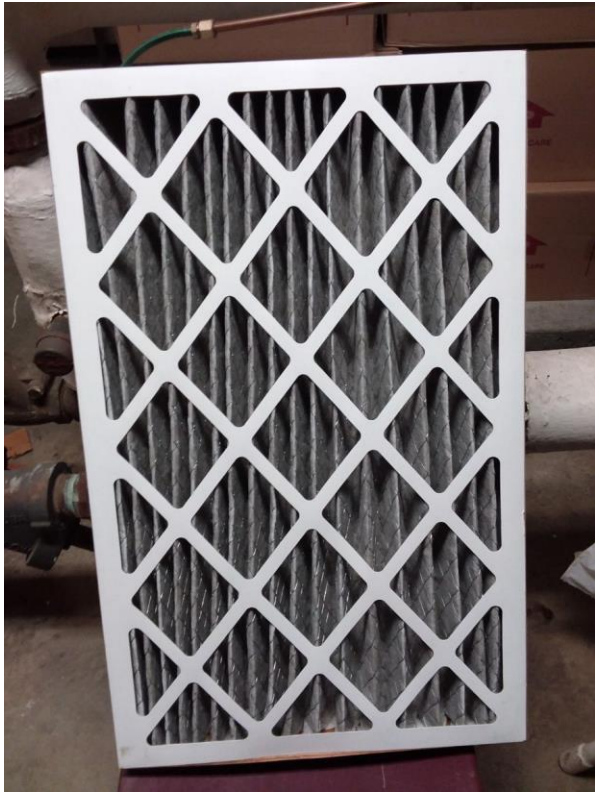
Unit Designation:	AHU-02	
Location of Unit:	Mechanical Room 2111	
Areas Served:	See attached map Library	
System Enhancements:	None	
Supply System	Outdoor Air	Cleanliness and Observations
Type <ul style="list-style-type: none"> • Supply System - Unknown • Heating - Hot Water • Cooling - None • Energy Recovery Unit (ERU) - None 	<p>Outdoor air intake is inaccessible</p> <p>Outdoor air intake is located on the roof.</p> <p>It is not known if there are nearby pollution sources.</p>	<p>Outdoor air filters are not present.</p> <p>Return air filters are not present.</p> <p>Mixed air pre-filters are not present. Mixed air main filters are somewhat dirty and on the border of needing replacement (scoring 3 out of 5) and fit well. Mixed air main filters are installed correctly.</p> <p>Drain pans are not applicable or not present. Drain pan condition is not known.</p> <p>Heating coils are clean.</p> <p>Heat wheels are not present.</p> <p>Exterior ducting is visible. Exterior ducting insulation is in good condition.</p> <p>Interior ducting is not visible. Interior ducting insulation is in good condition. Interior ducting is of unknown cleanliness.</p> <p>Air handling room is free of trash/chemicals.</p> <p>Outside damper is closed, and its condition is poor. The seal is damaged.</p> <p>Return damper is open, and its condition is poor. The seal is damaged.</p> <p>The general condition of the unit is poor.</p>

Mixed Main Filter Cleanliness

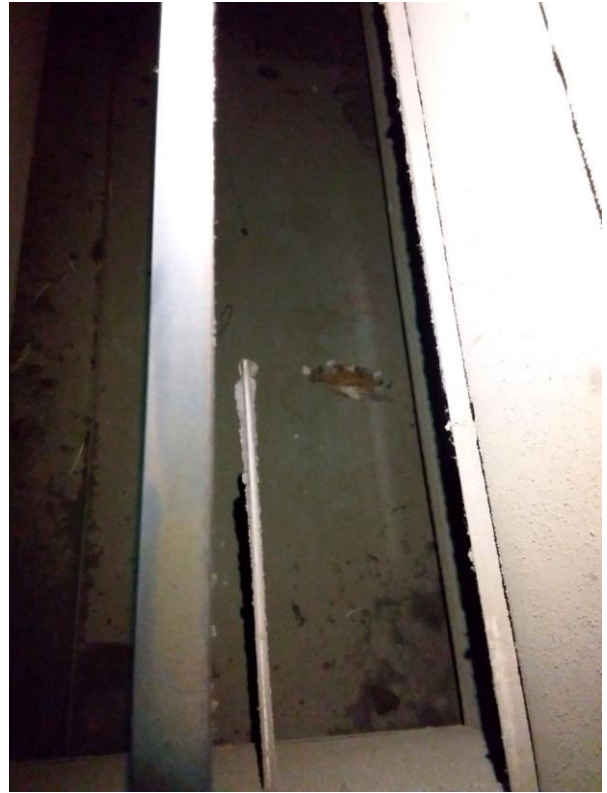
The general condition of unit AHU-02 was poor.

General Condition

Recommendation: The units should be repaired or cleaned as needed.

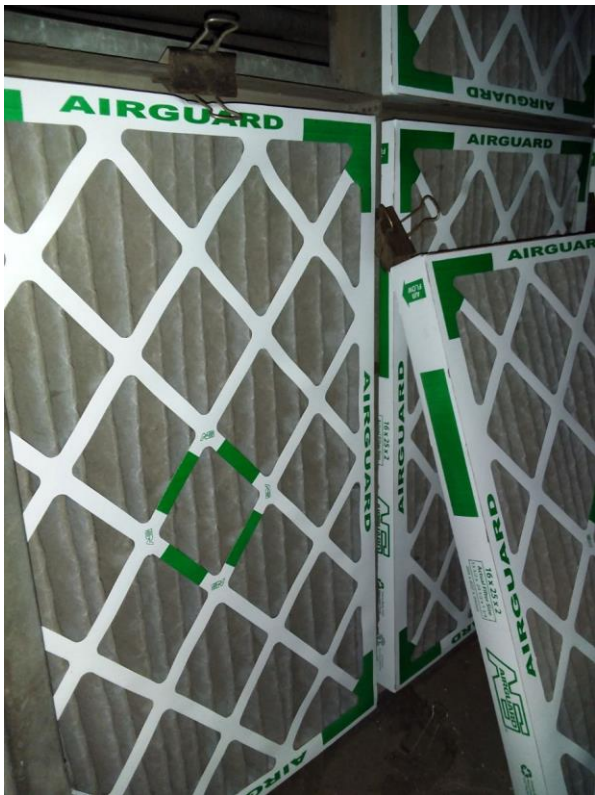
Unit Designation:	AHU-04	
Location of Unit:	Mechanical room 2204	
Areas Served:	See attached map Main Building	
System Enhancements:	None	
Supply System	Outdoor Air	Cleanliness and Observations
Type <ul style="list-style-type: none"> • Supply System - Unknown • Heating - Hot Water • Cooling - Chilled Water • Energy Recovery Unit (ERU) - None 	<p>Outdoor air intake is inaccessible</p> <p>Outdoor air intake is located in an unknown location.</p> <p>It is not known if there are nearby pollution sources.</p>	<p>Outdoor air filters are not present.</p> <p>Return air filters are not present.</p> <p>Mixed air pre-filters are not present. Mixed air main filters are somewhat dirty and on the border of needing replacement (scoring 3 out of 5) and fit well. Mixed air main filters are installed correctly.</p> <p>Drain pans are not applicable or not present. Drain pan condition is not known.</p>
Filter Type - Mixed <ul style="list-style-type: none"> • Pre-filter: None • Main filter: Pleated, MERV 11 	<p>Outdoor air intake is in good condition.</p>	<p>Heating coils are clean and cooling coils are inaccessible.</p> <p>Heat wheels are not present.</p> <p>Exterior ducting is not visible. Exterior ducting insulation is not present.</p> <p>Interior ducting is not visible. Interior ducting insulation is in an unknown condition. Interior ducting is of unknown cleanliness.</p> <p>Air handling room is free of trash/chemicals.</p> <p>Outside damper is inaccessible, and its condition is not known.</p> <p>Return damper is inaccessible, and its condition is not known.</p> <p>The general condition of the unit is good.</p>

Mixed Main Filter Cleanliness

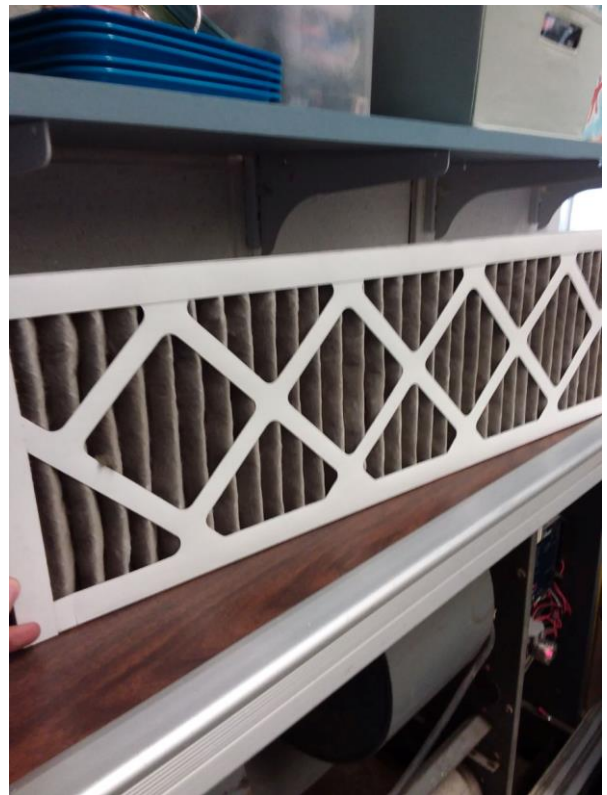
Unit Designation:	UV 11	
Location of Unit:	2107	
Areas Served:	2107	
System Enhancements:	None	
Supply System	Outdoor Air	Cleanliness and Observations
Type <ul style="list-style-type: none"> • Supply System - Constant Volume • Heating - Hot Water • Cooling - None • Energy Recovery Unit (ERU) - None 	<p>Outdoor air intake is inaccessible</p> <p>Outdoor air intake is located in an unknown location.</p> <p>It is not known if there are nearby pollution sources.</p>	<p>Outdoor air filters are not present.</p> <p>Return air filters are not present.</p> <p>Mixed air pre-filters are not present. Mixed air main filters are somewhat dirty and on the border of needing replacement (scoring 3 out of 5) and fit well. Mixed air main filters are installed correctly.</p> <p>Drain pans are not applicable or not present. Drain pan condition is not known.</p>
Filter Type - Mixed <ul style="list-style-type: none"> • Pre-filter: None • Main filter: Pleated, MERV 8 	<p>Outdoor air intake is in good condition.</p>	<p>Heating coils are clean.</p> <p>Heat wheels are not present.</p> <p>Exterior ducting is not visible. Exterior ducting insulation is not present.</p> <p>Interior ducting is not visible. Interior ducting insulation is not present. Interior ducting is of unknown cleanliness.</p> <p>Air handling room is free of trash/chemicals.</p> <p>Outside damper is not present.</p> <p>Return damper is not present.</p> <p>The general condition of the unit is good.</p>

Mixed Main Filter Cleanliness

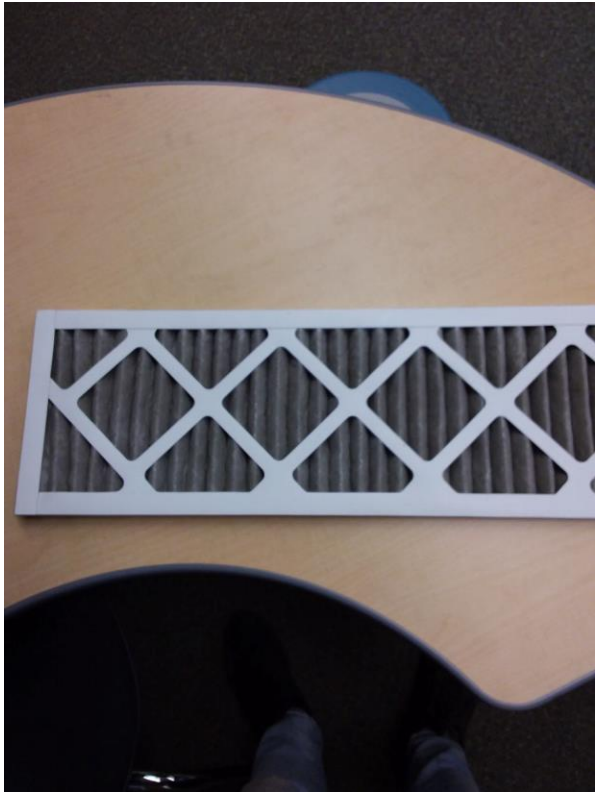
Unit Designation:	UV 10	
Location of Unit:	2108	
Areas Served:	2108	
System Enhancements:	None	
Supply System	Outdoor Air	Cleanliness and Observations
Type <ul style="list-style-type: none"> Supply System - Unknown Heating - Hot Water Cooling - None Energy Recovery Unit (ERU) - None 	<p>Outdoor air intake is inaccessible</p> <p>Outdoor air intake is located in an unknown location.</p> <p>It is not known if there are nearby pollution sources.</p>	<p>Outdoor air filters are not present.</p> <p>Return air filters are not present.</p> <p>Mixed air pre-filters are not present. Mixed air main filters are somewhat dirty and on the border of needing replacement (scoring 3 out of 5) and fit well. Mixed air main filters are installed correctly.</p> <p>Drain pans are not applicable or not present. Drain pan condition is not known.</p>
Filter Type - Mixed <ul style="list-style-type: none"> Pre-filter: None Main filter: Pleated, MERV 8 	<p>Outdoor air intake is in good condition.</p>	<p>Heating coils are clean.</p> <p>Heat wheels are not present.</p> <p>Exterior ducting is not visible. Exterior ducting insulation is in an unknown condition.</p> <p>Interior ducting is not visible. Interior ducting insulation is in an unknown condition. Interior ducting is of unknown cleanliness.</p> <p>Air handling room is free of trash/chemicals.</p> <p>Outside damper is not present.</p> <p>Return damper is not present.</p> <p>The general condition of the unit is good.</p>

Mixed Main Filter Cleanliness

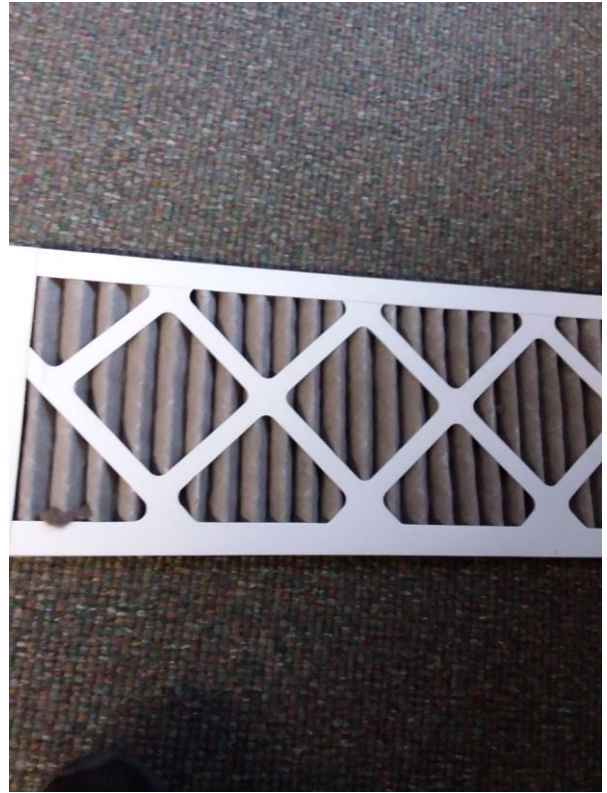
Unit Designation:	UV 0008	
Location of Unit:	2110	
Areas Served:	2110	
System Enhancements:	None	
Supply System	Outdoor Air	Cleanliness and Observations
Type <ul style="list-style-type: none"> • Supply System - Unknown • Heating - Hot Water • Cooling - None • Energy Recovery Unit (ERU) - None 	<p>Outdoor air intake is inaccessible</p> <p>Outdoor air intake is located in an unknown location.</p> <p>It is not known if there are nearby pollution sources.</p>	<p>Outdoor air filters are not present.</p> <p>Return air filters are not present.</p> <p>Mixed air pre-filters are not present. Mixed air main filters are somewhat dirty and on the border of needing replacement (scoring 3 out of 5) and fit well. Mixed air main filters are installed correctly.</p> <p>Drain pans are not applicable or not present. Drain pan condition is not known.</p>
Filter Type - Mixed <ul style="list-style-type: none"> • Pre-filter: None • Main filter: Pleated, MERV 8 	<p>Outdoor air intake is in good condition.</p>	<p>Heating coils are clean.</p> <p>Heat wheels are not present.</p> <p>Exterior ducting is not visible. Exterior ducting insulation is not present.</p> <p>Interior ducting is not visible. Interior ducting insulation is not present. Interior ducting is of unknown cleanliness.</p> <p>Air handling room is free of trash/chemicals.</p> <p>Outside damper is not present.</p> <p>Return damper is not present.</p> <p>The general condition of the unit is good.</p>

Mixed Main Filter Cleanliness

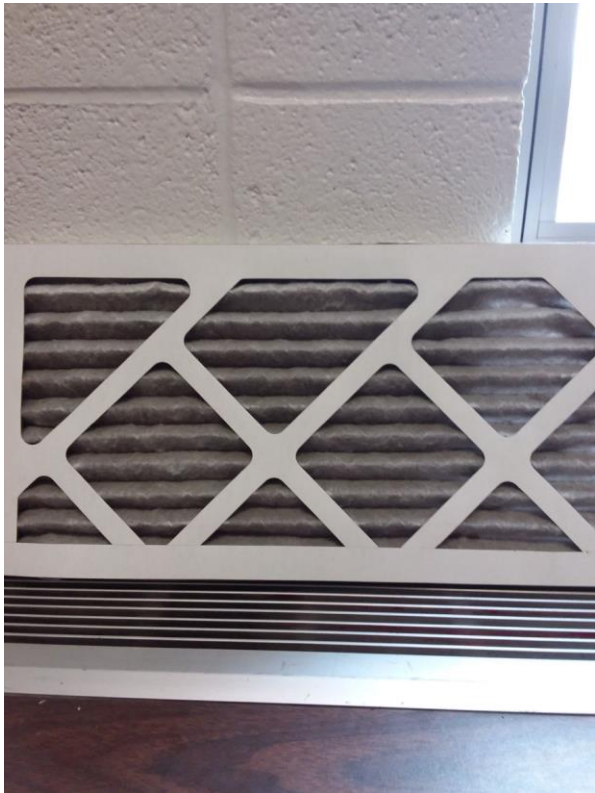
Unit Designation:	UV 0004	
Location of Unit:	1106	
Areas Served:	1106	
System Enhancements:	None	
Supply System	Outdoor Air	Cleanliness and Observations
Type <ul style="list-style-type: none"> • Supply System - Unknown • Heating - Hot Water • Cooling - None • Energy Recovery Unit (ERU) - None 	<p>Outdoor air intake is inaccessible</p> <p>Outdoor air intake is located in an unknown location.</p> <p>It is not known if there are nearby pollution sources.</p>	<p>Outdoor air filters are not present.</p> <p>Return air filters are not present.</p> <p>Mixed air pre-filters are not present. Mixed air main filters are somewhat dirty and on the border of needing replacement (scoring 3 out of 5) and fit well. Mixed air main filters are installed correctly.</p> <p>Drain pans are not applicable or not present. Drain pan condition is not known.</p>
Filter Type - Mixed <ul style="list-style-type: none"> • Pre-filter: None • Main filter: Pleated, MERV 11 	<p>Outdoor air intake is in good condition.</p>	<p>Heating coils are clean.</p> <p>Heat wheels are not present.</p> <p>Exterior ducting is not visible. Exterior ducting insulation is not present.</p> <p>Interior ducting is not visible. Interior ducting insulation is not present. Interior ducting is of unknown cleanliness.</p> <p>Air handling room is free of trash/chemicals.</p> <p>Outside damper is not present.</p> <p>Return damper is not present.</p> <p>The general condition of the unit is good.</p>

Mixed Main Filter Cleanliness

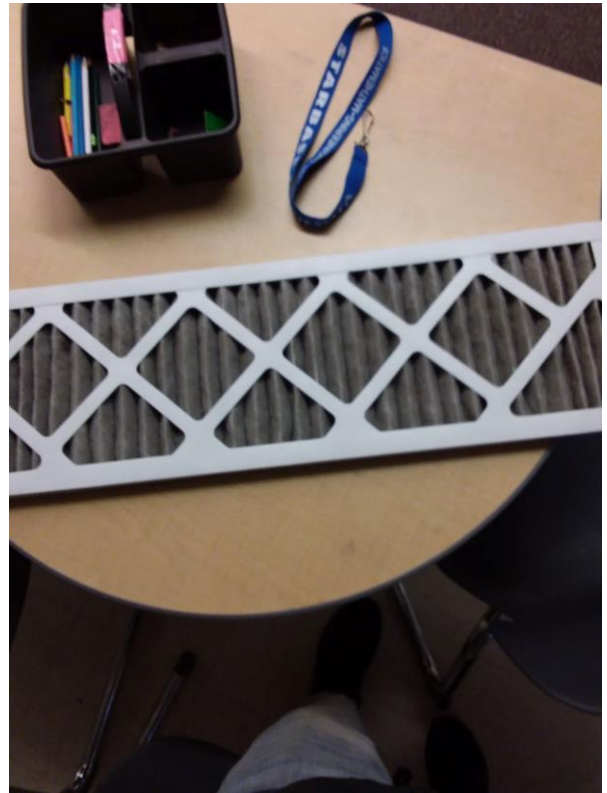
Unit Designation:	UV 0007	
Location of Unit:	1303	
Areas Served:	1303	
System Enhancements:	None	
Supply System	Outdoor Air	Cleanliness and Observations
Type <ul style="list-style-type: none"> • Supply System - Unknown • Heating - Hot Water • Cooling - None • Energy Recovery Unit (ERU) - None 	<p>Outdoor air intake is inaccessible</p> <p>Outdoor air intake is located in an unknown location.</p> <p>It is not known if there are nearby pollution sources.</p>	<p>Outdoor air filters are not present.</p> <p>Return air filters are not present.</p> <p>Mixed air pre-filters are not present. Mixed air main filters are somewhat dirty and on the border of needing replacement (scoring 3 out of 5) and fit well. Mixed air main filters are installed correctly.</p> <p>Drain pans are not applicable or not present. Drain pan condition is not known.</p>
Filter Type - Mixed <ul style="list-style-type: none"> • Pre-filter: None • Main filter: Pleated, MERV 8 	<p>Outdoor air intake is in good condition.</p>	<p>Heating coils are clean.</p> <p>Heat wheels are not present.</p> <p>Exterior ducting is not visible. Exterior ducting insulation is not present.</p> <p>Interior ducting is not visible. Interior ducting insulation is not present. Interior ducting is of unknown cleanliness.</p> <p>Air handling room is free of trash/chemicals.</p> <p>Outside damper is not present.</p> <p>Return damper is not present.</p> <p>The general condition of the unit is good.</p>

Mixed Main Filter Cleanliness

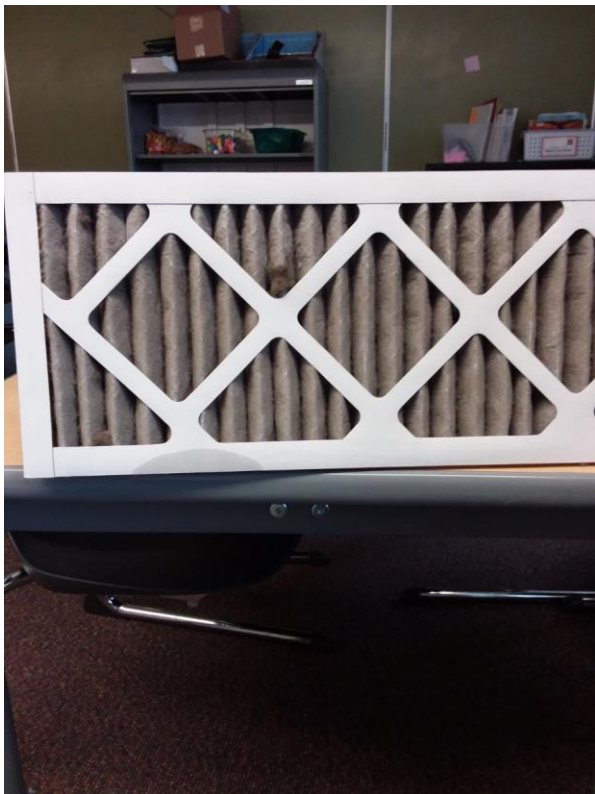
Unit Designation:	UV0020	
Location of Unit:	3110	
Areas Served:	3110	
System Enhancements:	None	
Supply System	Outdoor Air	Cleanliness and Observations
Type <ul style="list-style-type: none"> • Supply System - Unknown • Heating - Hot Water • Cooling - None • Energy Recovery Unit (ERU) - None 	<p>Outdoor air intake is inaccessible</p> <p>Outdoor air intake is located in an unknown location.</p> <p>It is not known if there are nearby pollution sources.</p>	<p>Outdoor air filters are not present.</p> <p>Return air filters are not present.</p> <p>Mixed air pre-filters are not present. Mixed air main filters are somewhat dirty and on the border of needing replacement (scoring 3 out of 5) and fit well. Mixed air main filters are installed correctly.</p> <p>Drain pans are not applicable or not present. Drain pan condition is not known.</p>
Filter Type - Mixed <ul style="list-style-type: none"> • Pre-filter: None • Main filter: Pleated, MERV 8 	<p>Outdoor air intake is in good condition.</p>	<p>Heating coils are clean.</p> <p>Heat wheels are not present.</p> <p>Exterior ducting is not visible. Exterior ducting insulation is not present.</p> <p>Interior ducting is not visible. Interior ducting insulation is not present. Interior ducting is of unknown cleanliness.</p> <p>Air handling room is free of trash/chemicals.</p> <p>Outside damper is not present.</p> <p>Return damper is not present.</p> <p>The general condition of the unit is good.</p>

Mixed Main Filter Cleanliness

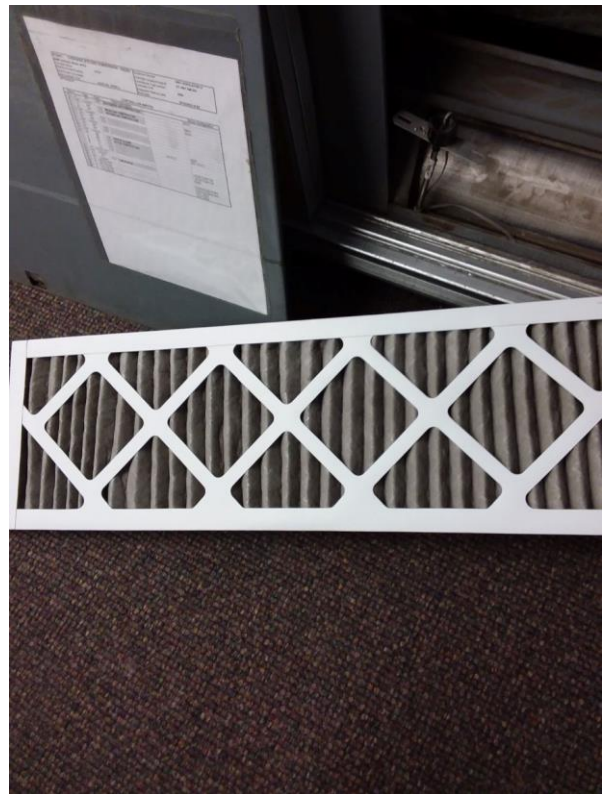
Unit Designation:	UV 27	
Location of Unit:	3103	
Areas Served:	3103	
System Enhancements:	None	
Supply System	Outdoor Air	Cleanliness and Observations
Type <ul style="list-style-type: none"> • Supply System - Unknown • Heating - Hot Water • Cooling - None • Energy Recovery Unit (ERU) - None 	<p>Outdoor air intake is inaccessible</p> <p>Outdoor air intake is located in an unknown location.</p> <p>It is not known if there are nearby pollution sources.</p>	<p>Outdoor air filters are not present.</p> <p>Return air filters are not present.</p> <p>Mixed air pre-filters are not present. Mixed air main filters are somewhat dirty and on the border of needing replacement (scoring 3 out of 5) and fit well. Mixed air main filters are installed correctly.</p> <p>Drain pans are not applicable or not present. Drain pan condition is not known.</p>
Filter Type - Mixed <ul style="list-style-type: none"> • Pre-filter: None • Main filter: Pleated, MERV 8 	<p>Outdoor air intake is in good condition.</p>	<p>Heating coils are clean.</p> <p>Heat wheels are not present.</p> <p>Exterior ducting is not visible. Exterior ducting insulation is not present.</p> <p>Interior ducting is not visible. Interior ducting insulation is not present. Interior ducting is of unknown cleanliness.</p> <p>Air handling room is free of trash/chemicals.</p> <p>Outside damper is not present.</p> <p>Return damper is not present.</p> <p>The general condition of the unit is good.</p>

Mixed Main Filter Cleanliness

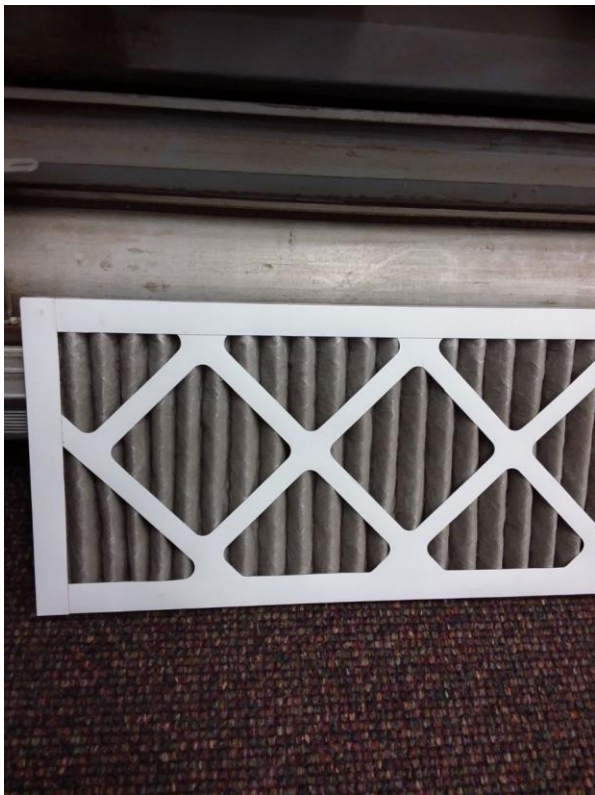
Unit Designation:	UV 22	
Location of Unit:	3108	
Areas Served:	3108	
System Enhancements:	None	
Supply System	Outdoor Air	Cleanliness and Observations
Type <ul style="list-style-type: none"> • Supply System - Unknown • Heating - Hot Water • Cooling - None • Energy Recovery Unit (ERU) - None 	<p>Outdoor air intake is inaccessible</p> <p>Outdoor air intake is located in an unknown location.</p> <p>It is not known if there are nearby pollution sources.</p>	<p>Outdoor air filters are not present.</p> <p>Return air filters are not present.</p> <p>Mixed air pre-filters are not present. Mixed air main filters are somewhat dirty and on the border of needing replacement (scoring 3 out of 5) and fit well. Mixed air main filters are installed correctly.</p> <p>Drain pans are not applicable or not present. Drain pan condition is not known.</p>
Filter Type - Mixed <ul style="list-style-type: none"> • Pre-filter: None • Main filter: Pleated, MERV 8 	<p>Outdoor air intake is in good condition.</p>	<p>Heating coils are clean.</p> <p>Heat wheels are not present.</p> <p>Exterior ducting is not visible. Exterior ducting insulation is not present.</p> <p>Interior ducting is not visible. Interior ducting insulation is in an unknown condition. Interior ducting is of unknown cleanliness.</p> <p>Air handling room is free of trash/chemicals.</p> <p>Outside damper is not present.</p> <p>Return damper is not present.</p>

Mixed Main Filter Cleanliness

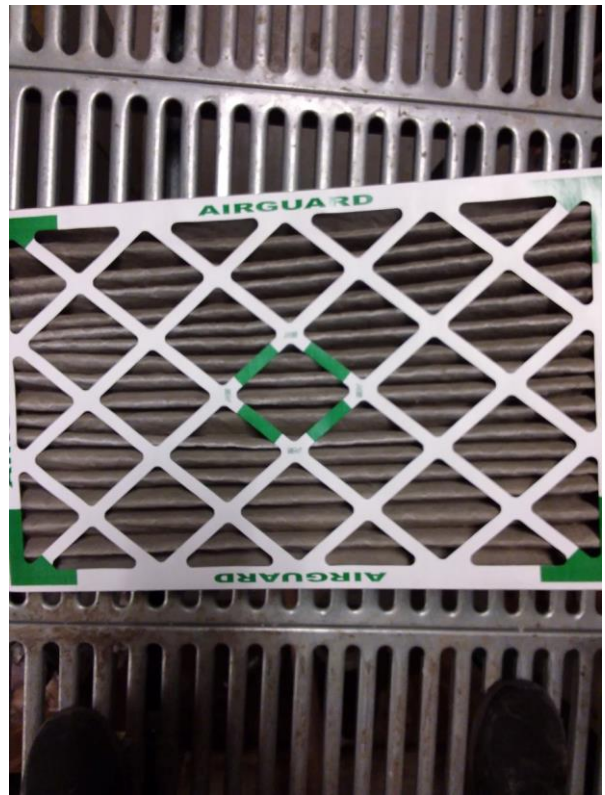
Unit Designation:	AHU-05	
Location of Unit:	Mechanical room 2204	
Areas Served:	See attached map Administration	
System Enhancements:	None	
Supply System	Outdoor Air	Cleanliness and Observations
Type <ul style="list-style-type: none"> • Supply System - Unknown • Heating - Hot Water • Cooling - None • Energy Recovery Unit (ERU) - None 	<p>Outdoor air intake is inaccessible</p> <p>Outdoor air intake is located on the roof.</p> <p>It is not known if there are nearby pollution sources.</p>	<p>Outdoor air filters are not present.</p> <p>Return air filters are not present.</p> <p>Mixed air pre-filters are not present. Mixed air main filters are somewhat dirty and on the border of needing replacement (scoring 3 out of 5) and fit well. Mixed air main filters are installed correctly.</p> <p>Drain pans are not applicable or not present. Drain pan condition is not known.</p> <p>Heating coils are clean.</p> <p>Heat wheels are not present.</p> <p>Exterior ducting is visible. Exterior ducting insulation is in good condition.</p> <p>Interior ducting is not visible. Interior ducting insulation is in an unknown condition. Interior ducting is of unknown cleanliness.</p> <p>Air handling room is free of trash/chemicals.</p> <p>Outside damper is open, and its condition is good.</p> <p>Return damper is closed, and its condition is good.</p> <p>The general condition of the unit is good.</p>

Mixed Main Filter Cleanliness

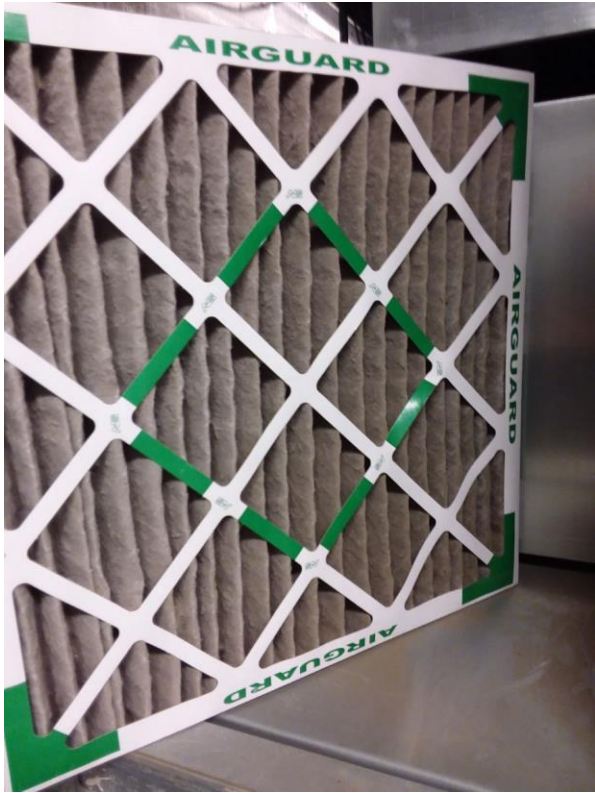
Unit Designation:	AHU-07	
Location of Unit:	Door #6 (only accessible via exterior)	
Areas Served:	See attached map 1999 S Addition	
System Enhancements:	None	
Supply System	Outdoor Air	Cleanliness and Observations
Type <ul style="list-style-type: none"> • Supply System - Unknown • Heating - Hot Water • Cooling - None • Energy Recovery Unit (ERU) - None 	<p>Outdoor air intake is accessible</p> <p>Outdoor air intake is located on an exterior wall.</p> <p>No nearby pollution sources were found.</p>	<p>Outdoor air filters are not present.</p> <p>Return air filters are not present.</p> <p>Mixed air pre-filters are somewhat dirty and on the border of needing replacement (scoring 4 out of 5) and fit well. Mixed air pre-filters are installed correctly. Mixed air main filters are somewhat dirty and on the border of needing replacement (scoring 3 out of 5) and fit well. Mixed air main filters are installed correctly.</p> <p>Drain pans are not applicable or not present. Drain pan condition is not known.</p>

Mixed Pre-Filter Cleanliness

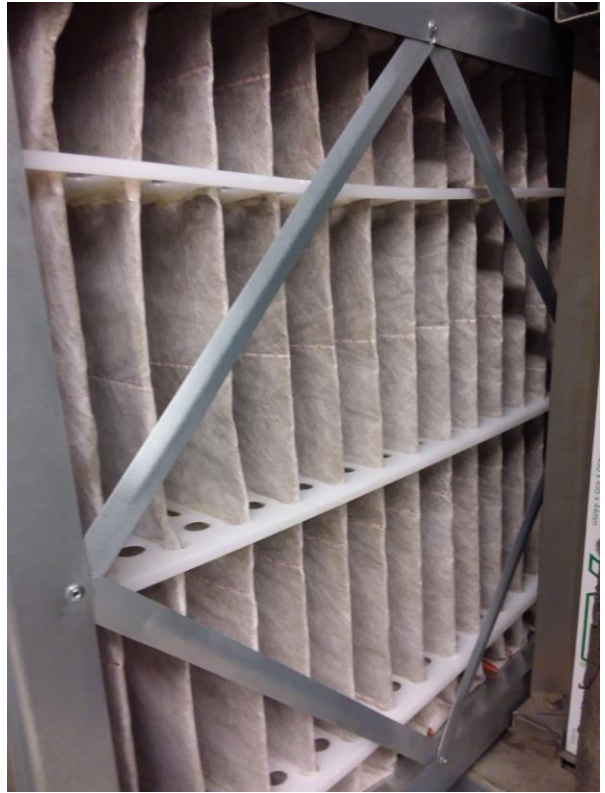
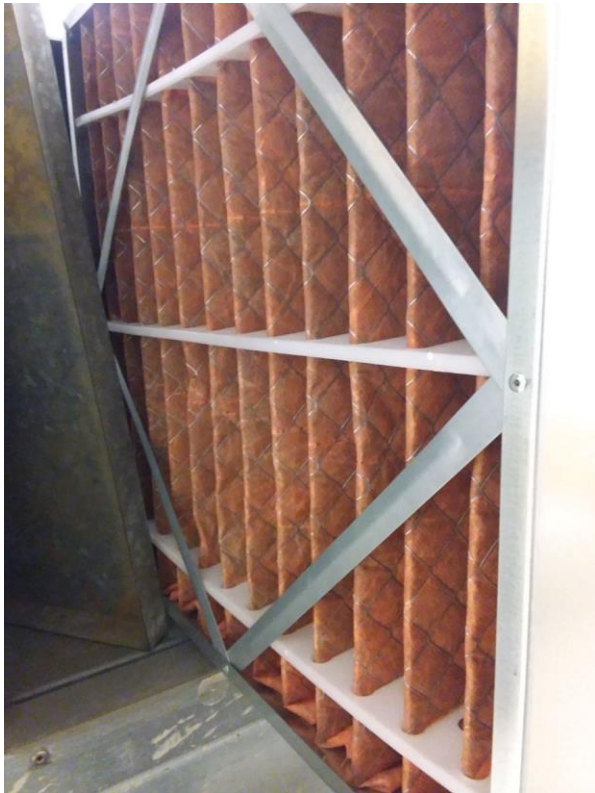
AHU-07

Filter Type - Mixed <ul style="list-style-type: none"> • Pre-filter: Pleated, MERV 11 • Main filter: Pleated, N/A 	<p>Outdoor air intake is in good condition.</p>	<p>Heating coils are clean.</p> <p>Heat wheels are not present.</p> <p>Exterior ducting is visible. Exterior ducting insulation is not present.</p> <p>Interior ducting is not visible. Interior ducting insulation is in an unknown condition. Interior ducting is of unknown cleanliness.</p> <p>Air handling room is free of trash/chemicals.</p> <p>Outside damper is closed, and its condition is good.</p> <p>Return damper is inaccessible, and its condition is good.</p>

Mixed Main Filter Cleanliness

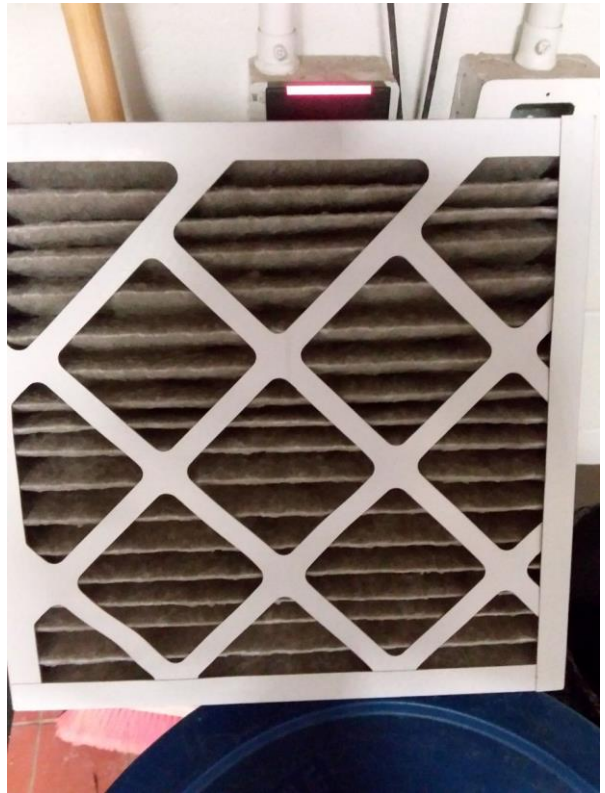
Unit Designation:	MAU-01	
Location of Unit:	Loading Dock, kitchen inside door 19	
Areas Served:	See attached map Kitchen MAU	
System Enhancements:	None	
Supply System	Outdoor Air	Cleanliness and Observations
Type <ul style="list-style-type: none"> Supply System - Unknown Heating - Hot Water Cooling - None Energy Recovery Unit (ERU) - None Filter Type - Outdoor <ul style="list-style-type: none"> Pre-filter: None Main filter: Pleated, Larger filters m11, smaller filters NA 	<p>Outdoor air intake is accessible</p> <p>Outdoor air intake is located on an exterior wall.</p> <p>No nearby pollution sources were found.</p> <p>Outdoor air intake is in good condition.</p>	<p>Outdoor air pre-filters are not present. Outdoor air main filters are somewhat dirty and on the border of needing replacement (scoring 3 out of 5) and fit well. Outdoor air main filters are installed correctly.</p> <p>Return air filters are not present.</p> <p>Drain pans are not plugged. Drain pan condition is good.</p> <p>Heating coils are dirty.</p> <p>Heat wheels are not present.</p> <p>Exterior ducting is not visible. Exterior ducting insulation is not present.</p> <p>Interior ducting is not visible. Interior ducting insulation is in an unknown condition. Interior ducting is of unknown cleanliness.</p> <p>Air handling room is free of trash/chemicals.</p> <p>Outside damper is open, and its condition is good.</p> <p>Return damper is not present.</p> <p>The general condition of the unit is good.</p>

Outdoor Main Filter Cleanliness

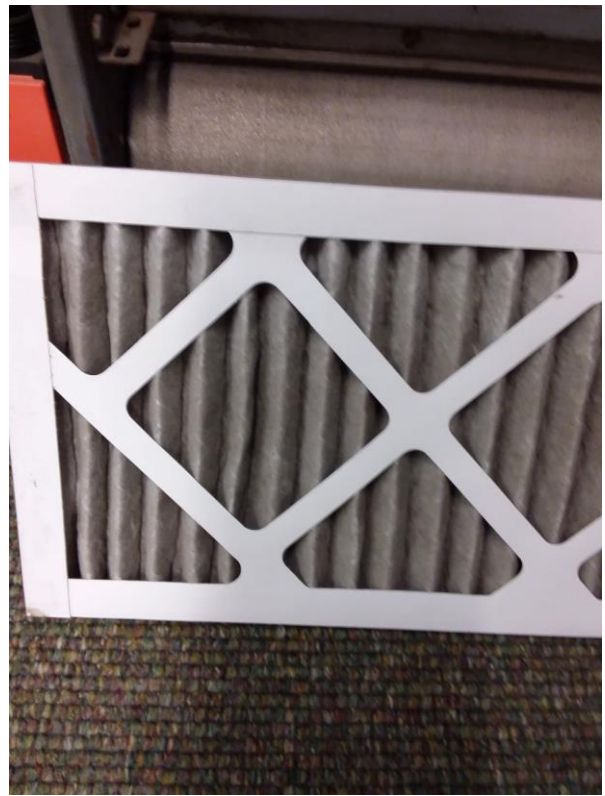
Unit Designation:	2208 UV	
Location of Unit:	2208	
Areas Served:	2208	
System Enhancements:	None	
Supply System	Outdoor Air	Cleanliness and Observations
Type <ul style="list-style-type: none"> Supply System - Unknown Heating - Hot Water Cooling - None Energy Recovery Unit (ERU) - None 	<p>Outdoor air intake is inaccessible</p> <p>Outdoor air intake is located in an unknown location.</p> <p>It is not known if there are nearby pollution sources.</p>	<p>Outdoor air filters are not present.</p> <p>Return air filters are not present.</p> <p>Mixed air pre-filters are not present. Mixed air main filters are somewhat dirty and on the border of needing replacement (scoring 3 out of 5) and fit well. Mixed air main filters are installed correctly.</p> <p>Drain pans are not applicable or not present. Drain pan condition is not known.</p>
Filter Type - Mixed <ul style="list-style-type: none"> Pre-filter: None Main filter: Pleated, MERV 8 	<p>Outdoor air intake is in good condition.</p>	<p>Heating coils are clean.</p> <p>Heat wheels are not present.</p> <p>Exterior ducting is not visible. Exterior ducting insulation is not present.</p> <p>Interior ducting is not visible. Interior ducting insulation is not present. Interior ducting is of unknown cleanliness.</p> <p>Air handling room is free of trash/chemicals.</p> <p>Outside damper is not present.</p> <p>Return damper is not present.</p> <p>The general condition of the unit is good.</p>

2208 UV
Mixed Main Filter Cleanliness
